DOT/FAA/TC-23/39

Assessment of Small Unmanned Aircraft Systems for Pavement Inspections

May 2023

Final Report

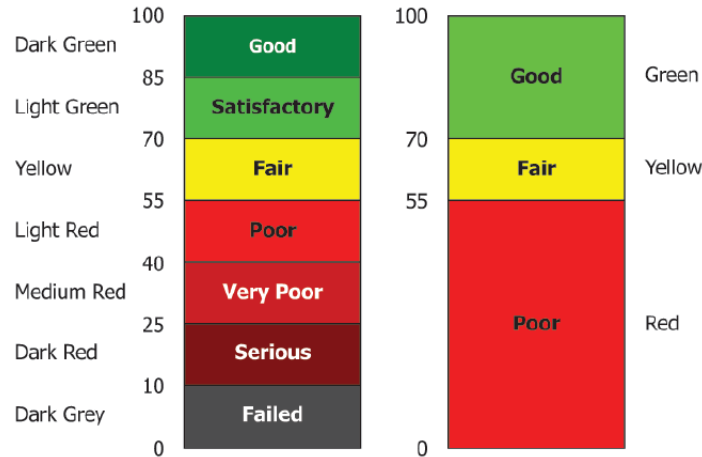
Figure 2. The PCI Rating Scale (ASTM International, 2020)

The Pavement Condition Index (PCI) is a measure of the pavement condition that is used to help prioritize maintenance and rehabilitation needs. A PCI value is calculated by determining distress according to type, severity, and quantity, and ranges from 0 to 100, with 100 representing a new pavement and 0 representing a failed pavement. These rating scales are illustrated in Figure 2.

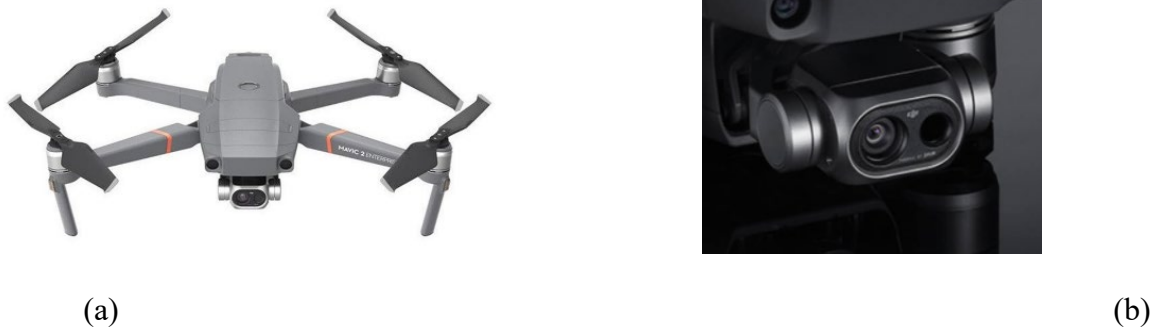
Figure 5. DJI Mavic 2 Enterprise Dual (a) with Onboard Camera (b)

DJI Mavic 2 Enterprise Dual, shown in Figure 5, was selected as it is a commonly used system in many industrial applications. This airframe utilized an onboard camera with RGB and thermal sensors. The onboard camera contains a 12-megapixel RGB, and a 0.30-megapixel thermal sensor, but the RGB was the only sensor evaluated in this research. The DJI Mavic 2 Enterprise Dual will herein be referred to as M2ED.

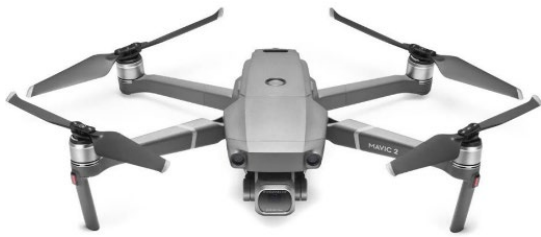
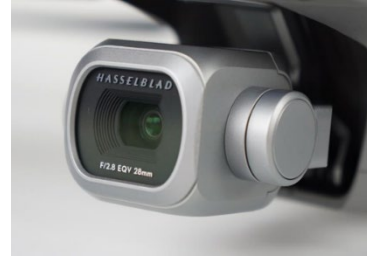
Figure 6. DJI Mavic 2 Pro (a) with Onboard Camera (b)

DJI Mavic 2 Pro, shown in Figure 6, was selected due to it being a commonly used system in many industrial applications. This airframe utilized a 20-megapixel onboard RGB camera. The DJI Mavic 2 Pro will herein be referred to as M2P.

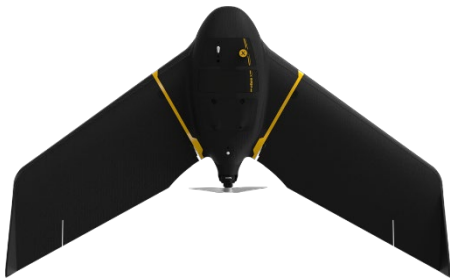
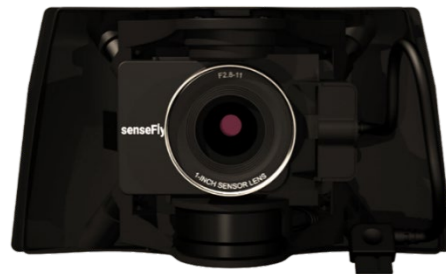
Figure 7. SenseFly eBee X RTK (a) with SenseFly S.O.D.A. 3D (b)

SenseFly eBee X RTK, shown in Figure 7, was selected because it is a fixed-wing system capable of long endurance flight for data collection, thereby increasing operational efficiencies by eliminating the need for repeated landings. This system was equipped with a senseFly S.O.D.A. 3D, a 1-in., 20-megapixel camera that can achieve high resolutions even at a high altitude. The senseFly eBee X RTK will herein be referred to as eBee.

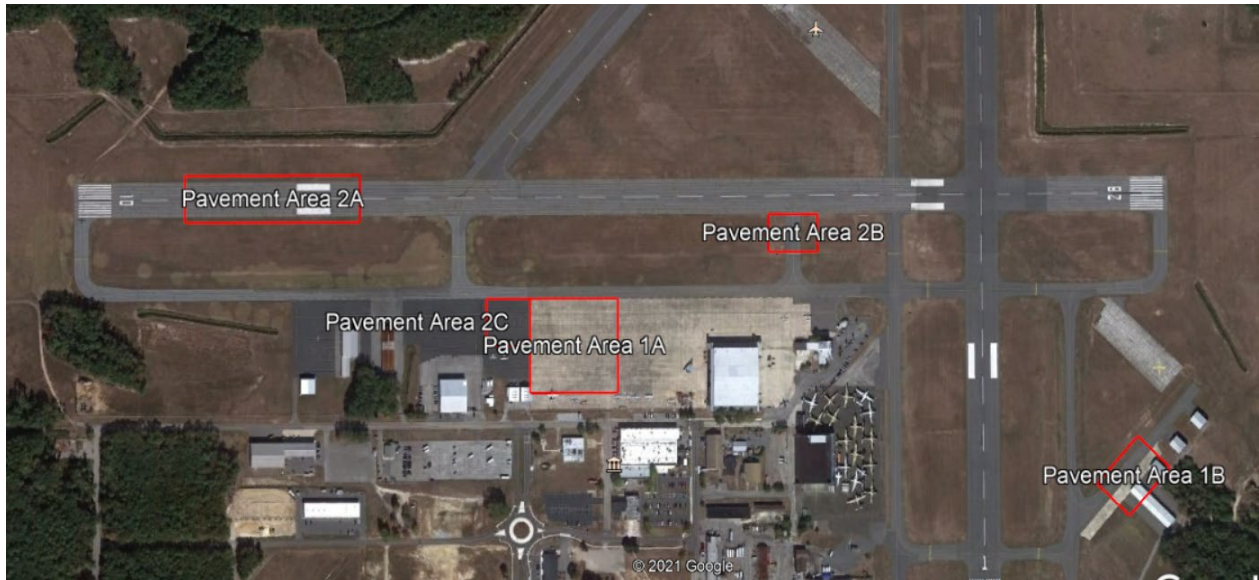
Figure 10. Test Areas at WWD

Figure 10 illustrates the five test areas selected for comparative sUAS, FOG, and DSV testing. PCC areas were designated as 1A and 1B, whereas the AC test areas were marked with 2A, 2B, and 2C.

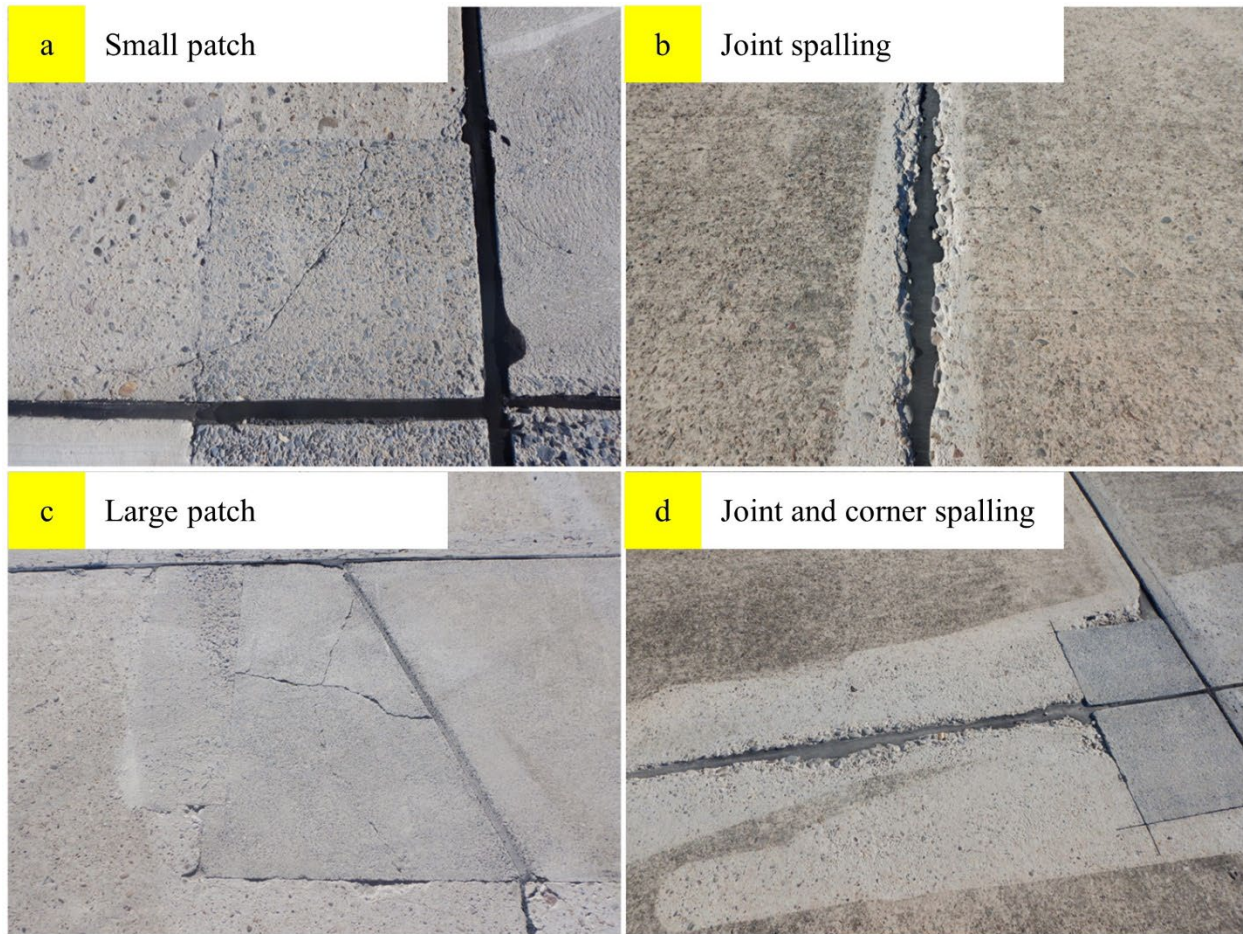
Figure 12. Distresses Observed on 1A at WWD

This test area was divided into representative sample units, each consisting of 24 10-ft x 20-ft slabs. Figure 12 (a) through (d) shows some of the distresses found in this.

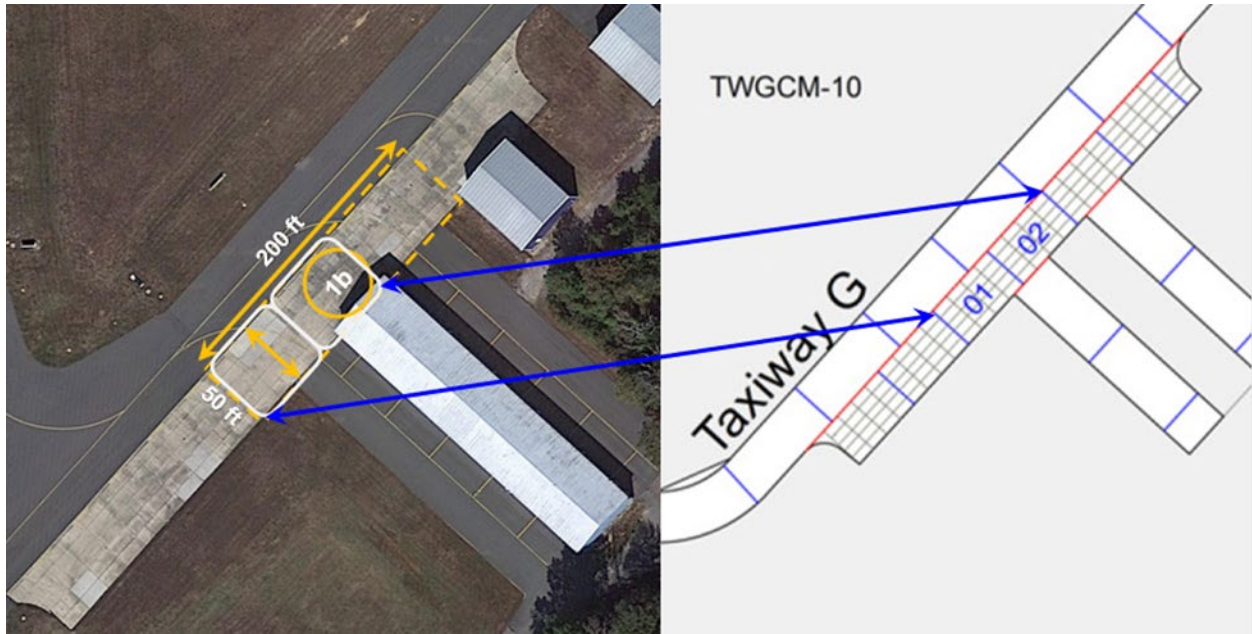
Figure 13. Test Area 1B at WWD

As illustrated in Figure 13, Test Area 1B is a concrete apron located at the southeast corner of the airfield, near Taxiway G. The 2019 PCI data showed the PCC pavement in this test area to be in very poor condition, with a PCI of 40. While the research team did not observe this test area during the site visit, the low PCI suggested that this area might have some unique distresses, such as shattered slabs and corner breaks.

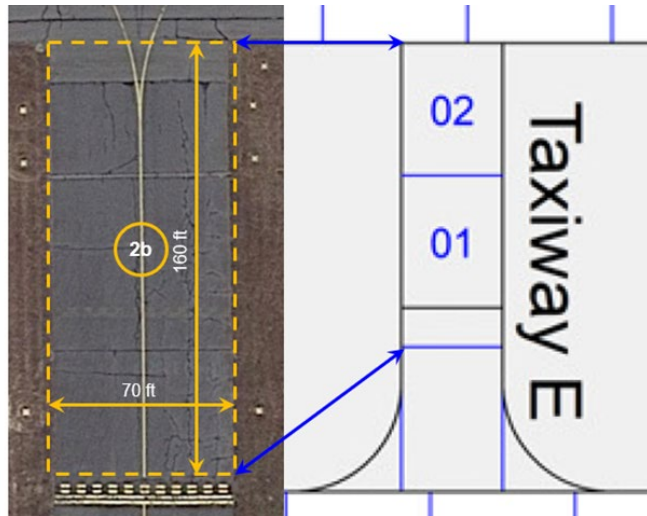
Figure 16. Test Area 2B at WWD

Figure 16 illustrates Test Area 2B, located on Taxiway E. It is an asphalt taxiway with some medium-severity alligator cracking that was observed during the site visit (see Figure 17). The 2019 PCI for Area 2B was 34, indicating that the pavement was in very poor condition. The 70-ft-wide taxiway was segmented into two 80-ft-long sample units. Thus, sample units 11 and 12 had an area of 5,600 sq ft, slightly larger than the Runway 10/28 and apron sample unit areas.

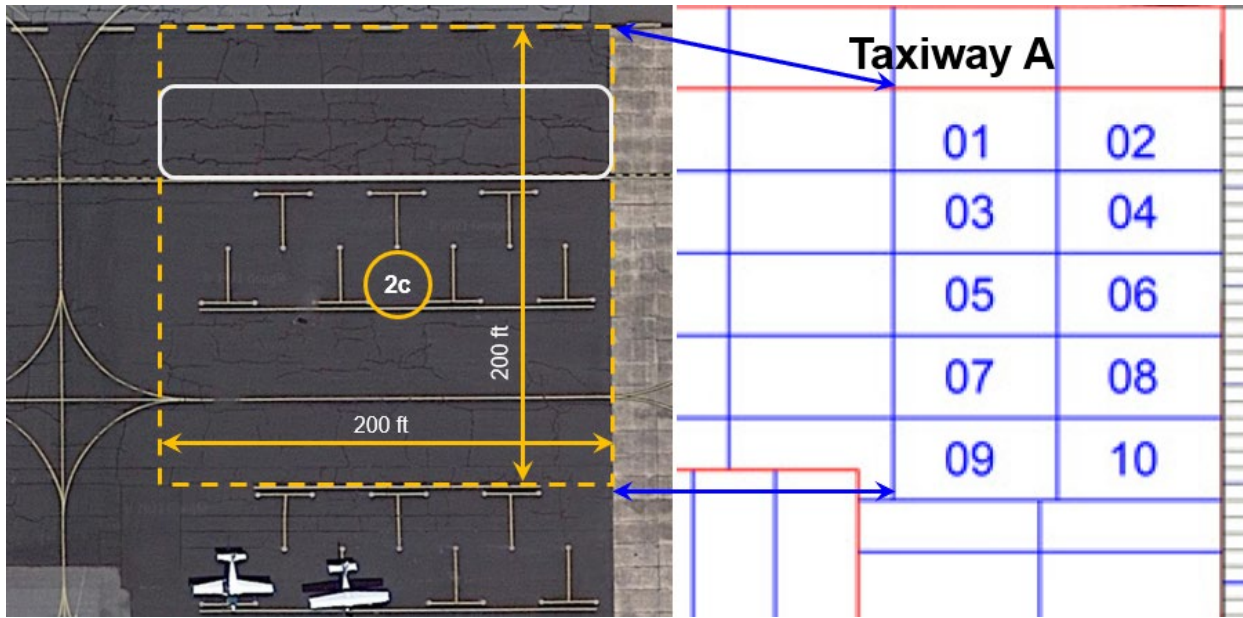
Figure 18. Test Area 2C at WWD

Figure 18 illustrates the AC surface in Test Area 2C. This aged asphalt apron area is adjacent to the PCC Area 1A. The research team selected it as a complementary test location due to three unique distresses that were not observed on Runway 10/28: shoving near the adjacent PCC apron, raveling due to loss of an aged surface seal, and an oil spillage. Like the Runway 10/28 sample units, these samples also had an area of 5,000 sq ft. Figure 19 depicts the shoving, and the oil spillage between the AC and PCC apron interface.

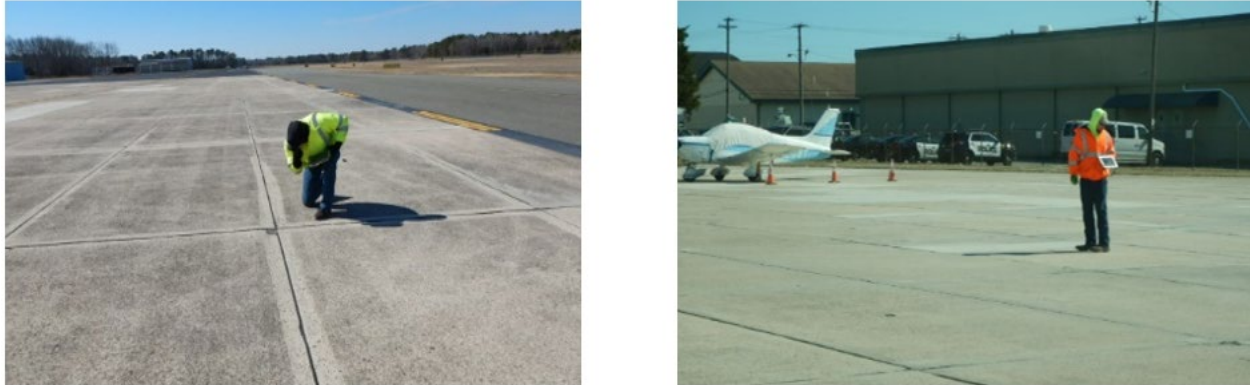
Figure 20. Collection of FOG Data at WWD

Experienced pavement technicians from ARA conducted FOG PCI evaluations for all five test areas at WWD in December 2020. Figure 20 shows ARA technicians on site.

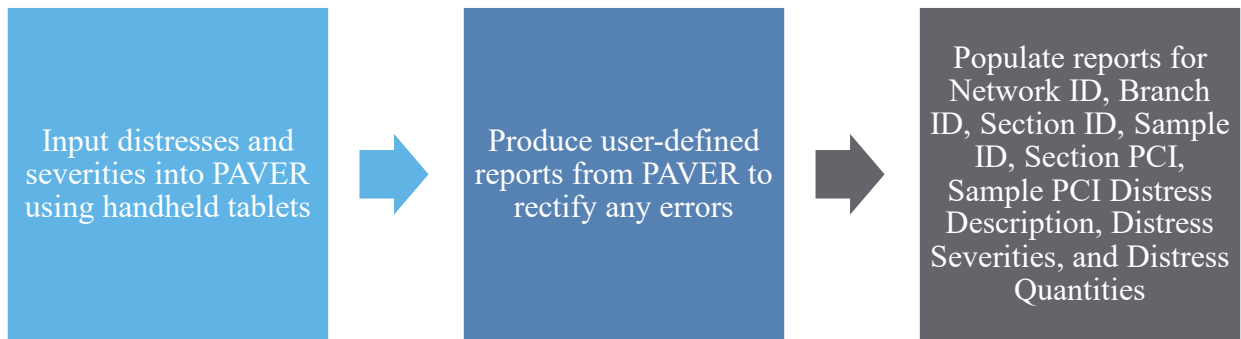
Figure 22. Processing Workflow for FOG Data

The FOG data processing team implemented the following workflow (illustrated in Figure 22) upon completing the field data collection.

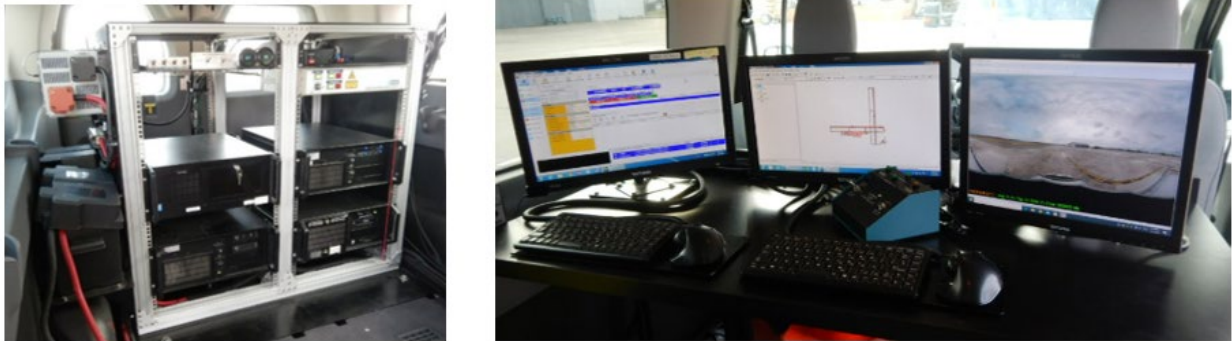
Figure 23. Computers Onboard DSV

- Geolocation and linear distance data for each data element were recorded.
- Four onboard computers, shown in Figure 23, collected and stored each data set.
- Using a triple monitor workstation (also shown in Figure 23), the operator observed and reviewed data as they were collected.

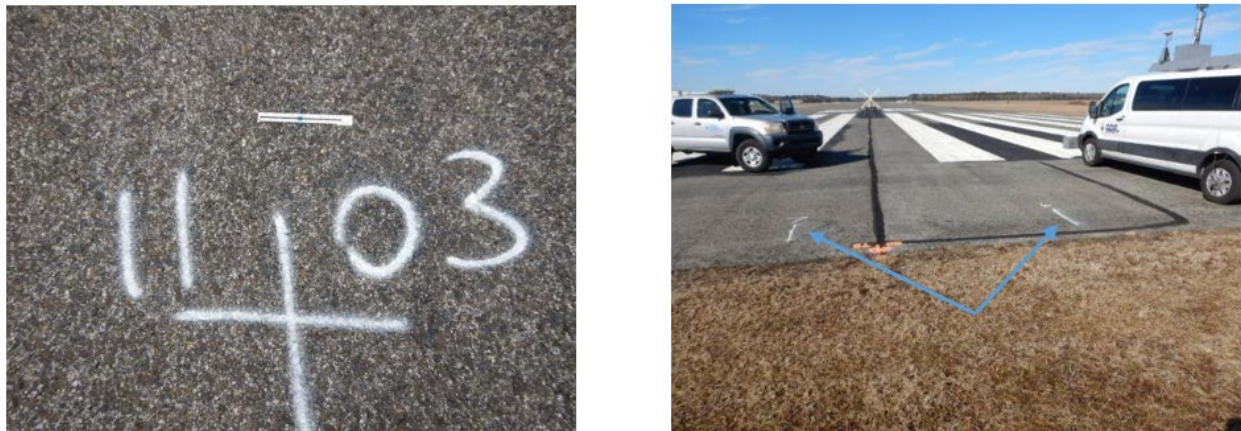
Figure 24. Collection of DSV Data at WWD

- Prior to collection, a routing plan was developed in-office by utilizing the airport's GIS and its predefined sectioning system for FOG PCI survey.
- The DSV traversed along 10 evenly spaced transverse offsets over the full length of the runway to ensure optimal coverage of the entire length and width.
- The photographic scans were overlapped such that no area of the runway was omitted from subsequent distress mapping.
- For PCC sections that were 10-ft wide, one pass was made in the center of each longitudinal set of slabs with the DSV. The DSV's capture range from center is 6.5 ft.
- To ensure that the operator maintained a straight pass, lines were measured and marked with spray paint (shown in Figure 24) at the beginning, middle, and end of each sample.

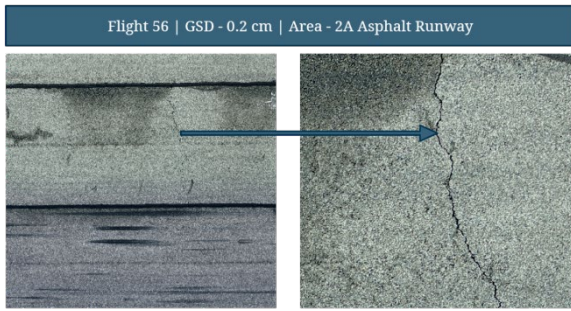
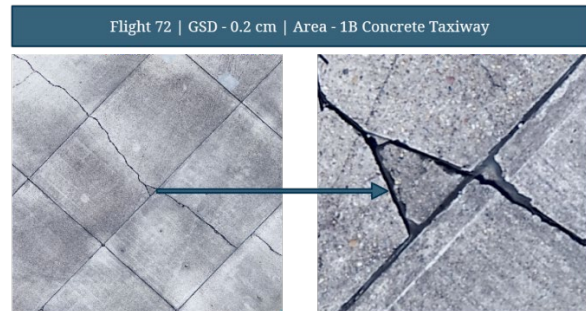
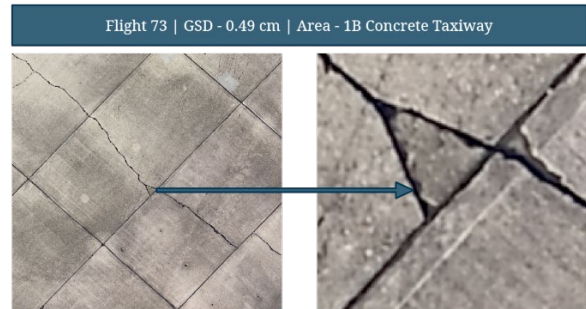
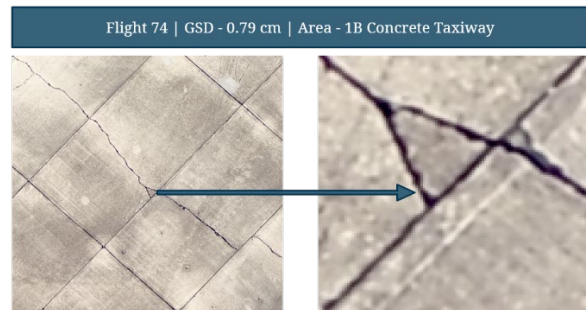
Figure 29. Comparison of GSD on AC and PCC Pavement

Figure 29 represents examples for the quality of sUAS imagery acquired with the same sensor across several GSDs. It was apparent that the 2-mm GSD was the most effective when used for pavement condition assessment due to its ability to capture low-severity distresses. As the GSD increased, the ability to digitally identify low-severity distresses decreased.

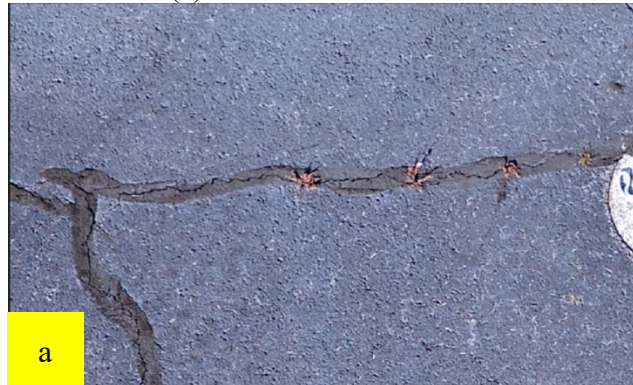
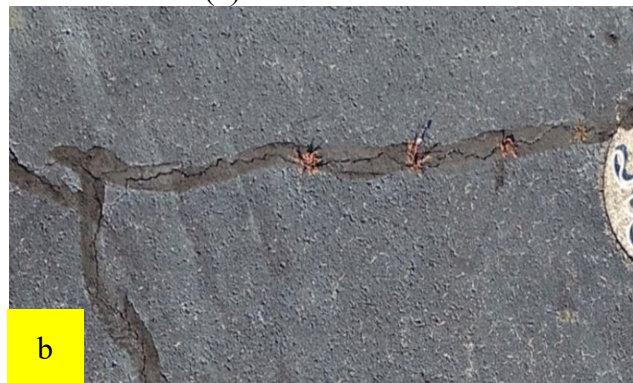
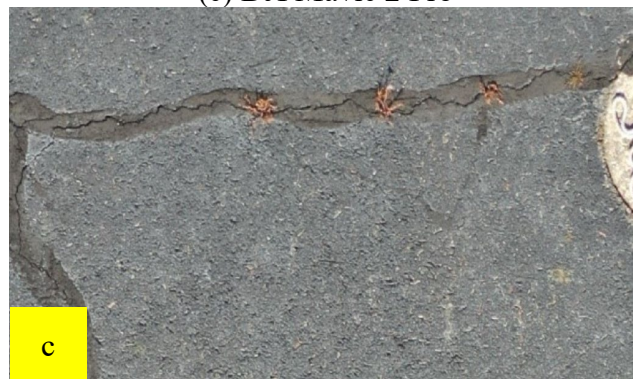
Figure 30. Sensor Comparison at 2-mm GSD

It should be noted that the 2-mm GSD imagery varied in quality when captured with a range of sensors. Figure 30 shows a comparison of the same distress at 2-mm GSD across the variety of sensors tested.

(a) DJI M210 X7-35mm

(b) DJI M210-X5S

(c) DJI Mavic 2 Pro

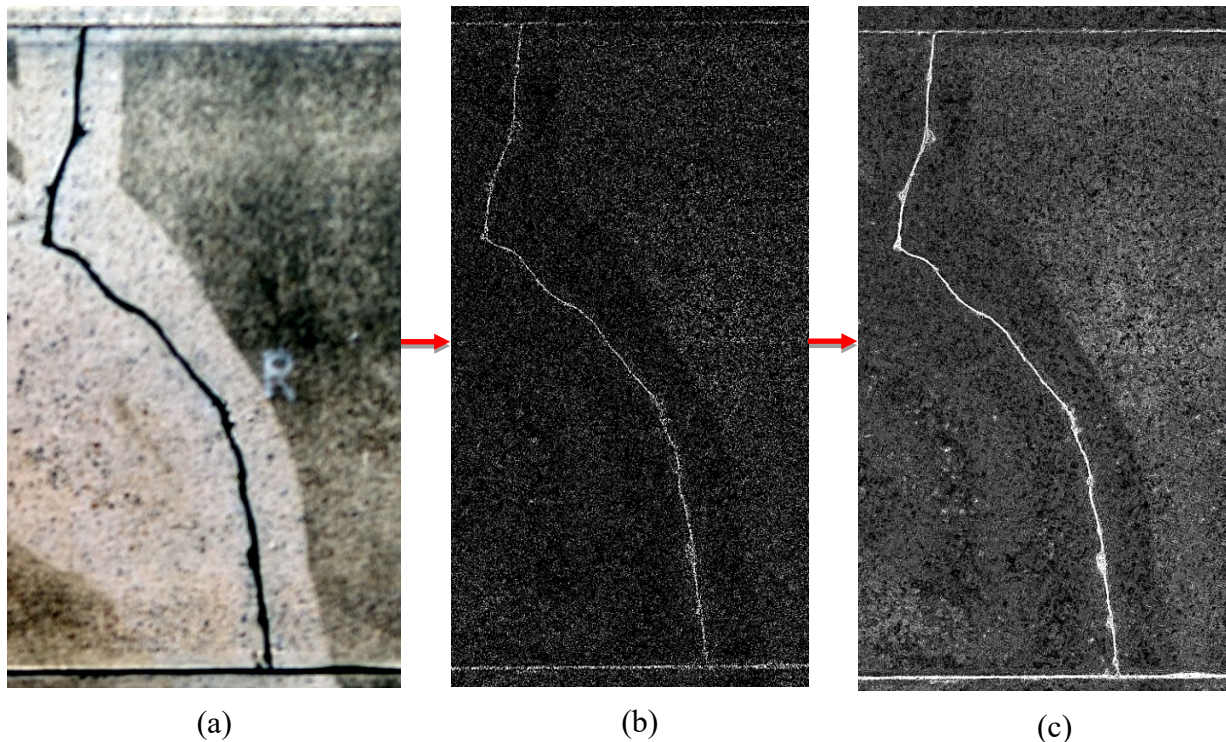
At a finer resolution, edge extraction methods were a viable option and were incorporated into the analysis in combination with simple band ratios. eCognition has different edge extraction processes; for crack analysis, the best option is the Lee Sigma Edge Extraction¹ method as depicted in Figure 32. Before the output layer from this process could be used, the research team utilized a convolutional layer to get rid of noise and pixilation.

Figure 32. Lee Sigma Edge Extraction Showing the Original Image (a), with Convolutional Layer Added (b), and Incorporated Image Segmentation (c)

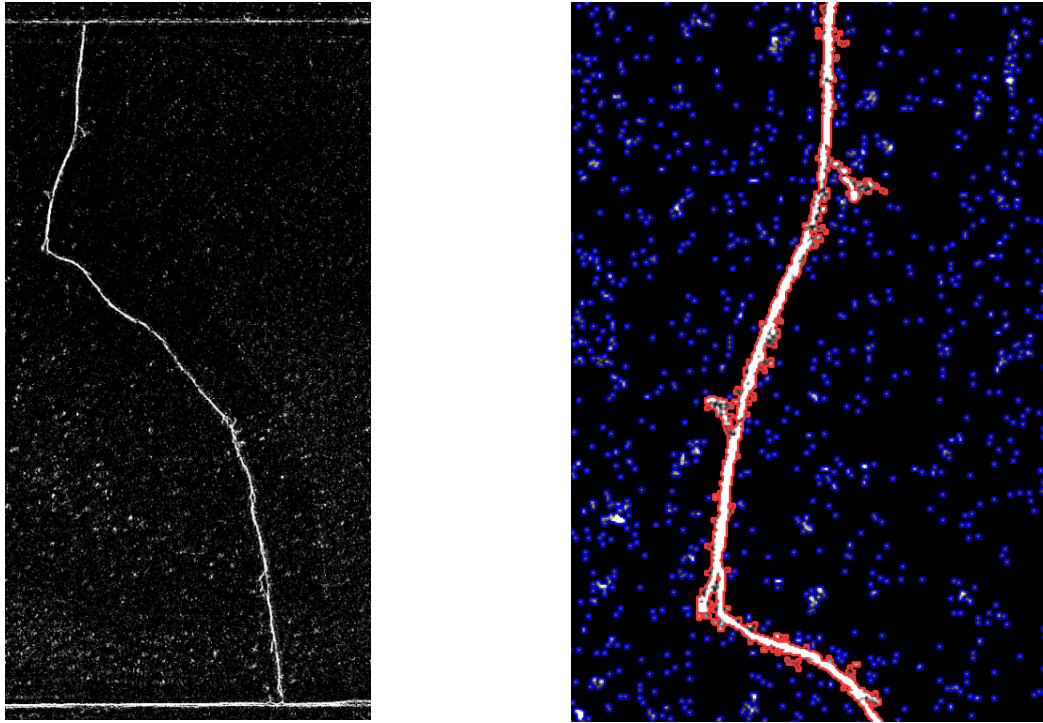
Figure 33. Contrast Split Segmentation

was a pivotal step. For the purpose of this research, the research team chose to use the red band as the input for the edge extraction, as this provided the best information in terms of single-band usage. The edge extraction layer was used as the primary layer for segmentation. After the creation of the edge layer, a contrast split segmentation was implemented. This segmentation method created image objects based on their dissimilarity to neighboring pixels, which was perfect for implementation on an edge layer. Figure 33 displays the final product.

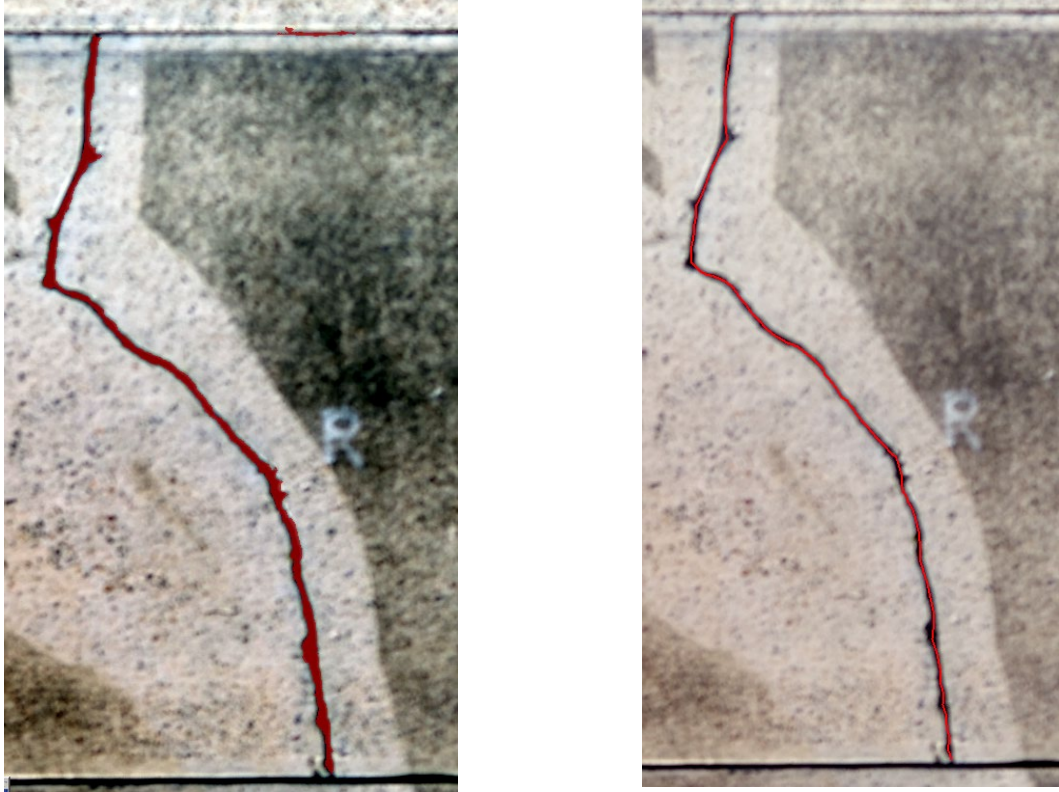
Figure 34. Shapefile Export

This first classification was a broad operation and was refined further due to over-capture. Cracks have distinct geometric features that can be used to distinguish between darker objects that might have also been picked up during the classification. First, cracks often display asymmetrical values with a large perimeter value. Second, cracks will be smaller objects when compared to their homogenized surroundings. Cracks will be present in relation to large slabs of concrete. Once classification is complete, eCognition allows for the extraction of centerlines depicted in Figure 34.

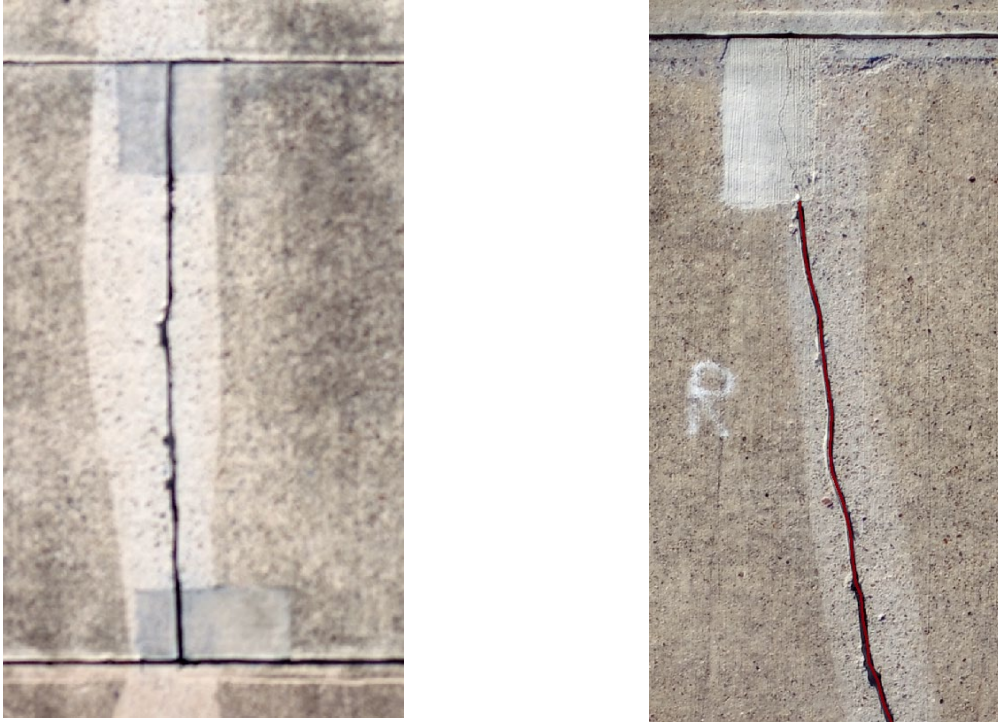
Figure 35. Missed Classification on Left, Partial on Right

Unfortunately, not all cracks will be classified using this method, and manual cleanup will be necessary. Cracks that are not defined enough by image contrast are difficult to detect by this form of automated analysis. This is likely because their pixel values are still somewhat similar to their surrounding neighbors. When this happens, the whole crack is lost during classification. Also, there are cracks that have been partially sealed. It is impossible for this automated method to extract these instances of cracking without the help of a technician. Figure 35 displays both types of missed classification. Overall, out of the 34 cracks present in this subset, the automated process was able to fully extract 25 cracks, with 5 partial classifications and 4 missed classifications.

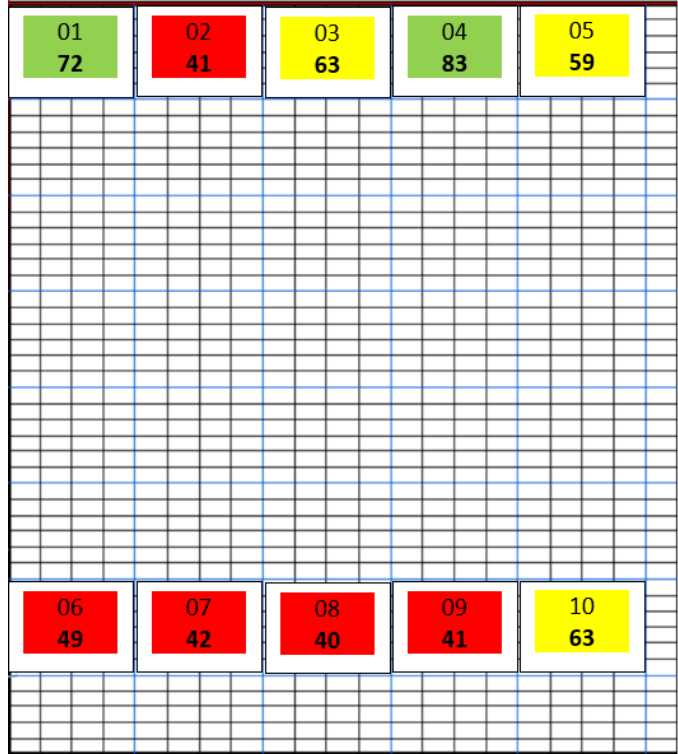
For the manual analysis of Test Area 1A, which is the PCC apron, Flight 1 imagery was used. The sample size was 60 ft x 80 ft = 4,800 sq ft. The slab size was 10 ft x 20 ft = 200 sq ft. There was a total of 24 slabs in each sample unit (4 slabs across and 6 slabs down). Figure 38 illustrates these sample units.

Figure 38. Sample Units of Test Area 1A at WWD (The sample units 9 and 10 were analyzed for 20 slabs [four slabs across and five slabs down] as opposed to 24 due to the missing imagery.)

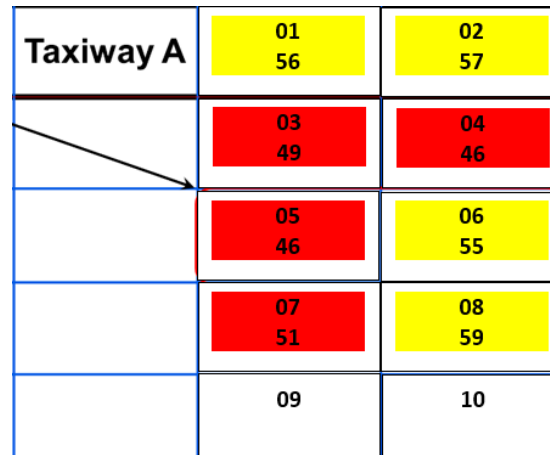
For the manual analysis of Test Area 2C, which is the AC taxiway, Flight 16 imagery was used. The sample size was 50 ft x 10 ft = 5,000 sq ft. Figure 42 illustrates these sample units.

Figure 42. Sample Units of Test Area 2C at WWD (The sample units 9 and 10 were not analyzed due to half-missing imagery.)

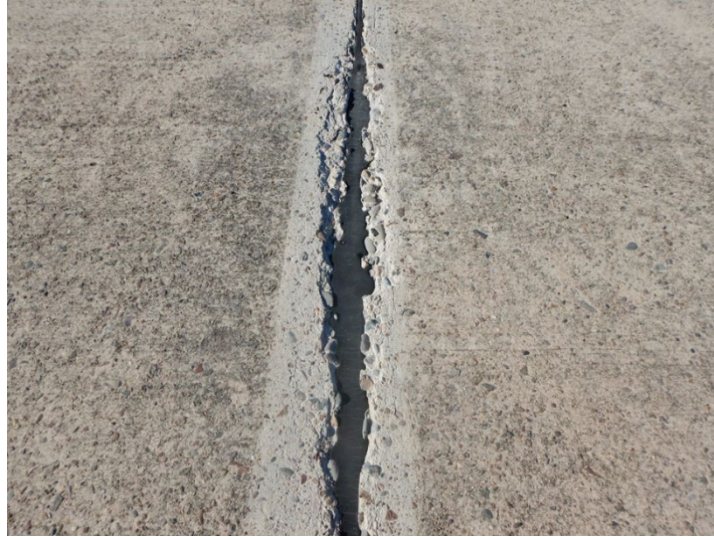
Figure 43. Joint Spall at WWD

During a FOG PCI inspection or a distress takeoff from digital imagery, there is room for interpretation on many of the ASTM distress severities. For example, Figure 43 displays a joint spall on the PCC apron at WWD.

The spall depicted in Figure 43 is greater than 2 ft in length and is either a medium- or high-severity distress (ASTM International, 2020). Since there is no cracking associated with the spall, the determining factor for severity is the amount of foreign object debris (FOD) potential. The ASTM description for FOD potential for a medium-severity joint spall is “some FOD potential” and the description for high severity is “severely frayed.” Depending on the pavement inspector, one might consider this spall to be high-severity due to the amount of fraying. However, another pavement inspector might consider the spall to be medium-severity because the spall has been swept and there does not appear to be a high potential for future FOD. Additionally, there is some amount of estimation occurring for other distresses. Figure 44 displays an example of the network of L&T cracking and a close-up image of one of those cracks on the AC apron at WWD.

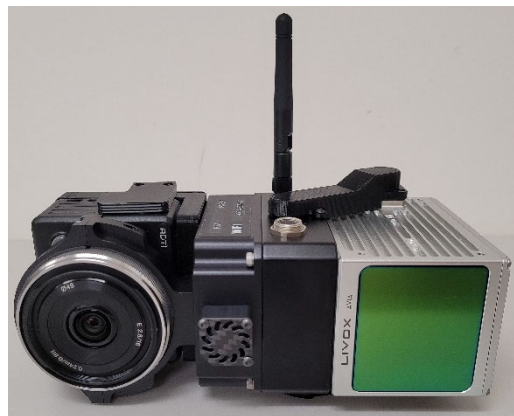
Figure 45. Rock Robotic R2A

Rock Robotic R2A LiDAR, shown in Figure 45, can emit 240,000 pulses per second and is equipped with a Sony A5100 with a 16mm lens for point cloud colorization. This sensor can be carried by a number of airframes, but this study utilized the M210, as that airframe was already being used to test the Zenmuse X7.

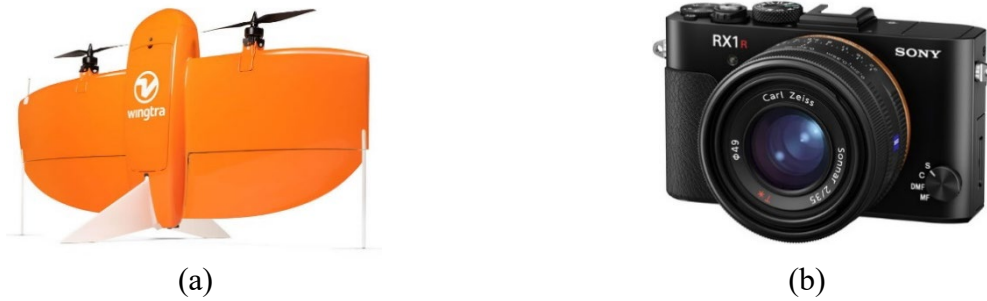
Figure 46. Wingtra One (a) with RX1R-II (b)

Wingtra WingtraOne, shown in Figure 46, was selected due to its unique hybrid system, which allows for VTOL operations for takeoff and landing and transitions into fixed-wing for flight. This system is equipped with a Sony RX1R-II; a full frame, 42-megapixel camera that can

achieve high resolutions even at high altitudes. The Wingtra WingtraOne will herein be referred to as Wingtra.

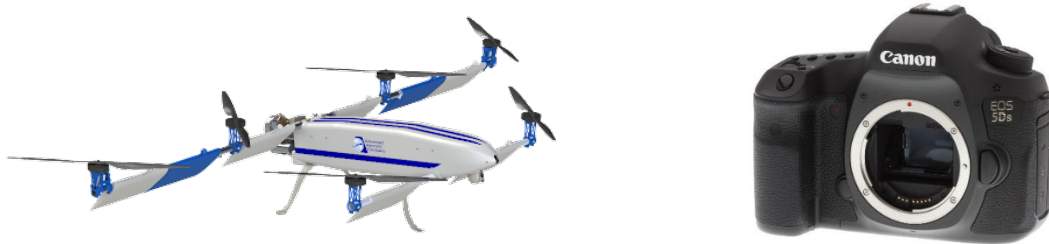
Figure 47. The HAMR Airframe (a) with Canon EOS 5DS (b)

Hybrid Advanced Multi-Rotor (HAMR™), shown in Figure 47, uses a full-frame DSLR (Digital Single-Lens Reflex) camera, the Canon EOS 5DS with a 24mm lens. The HAMR system combines electric and combustion power sources to sustain flight. The HAMR airframe was chosen to evaluate the viability of using a large, heavier, fuel-powered aircraft capable of long endurance flight for data collection, thereby increasing operational efficiencies by eliminating the need for repeated landings.

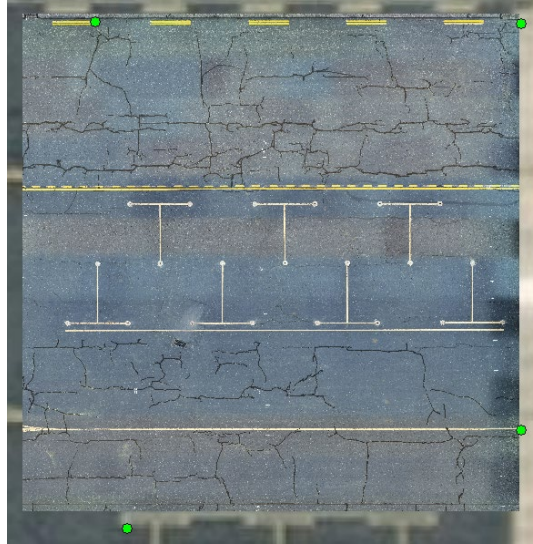
Figure 51. Four GCP Locations over the GA Apron at WWD

GCPs were RTK surveyed using a Trimble R8-3 GNSS receiver connected to a Virtual Reference Station (VRS). These data were used in the processing stage to ensure that the data sets were spatially accurate. Figures 50 and 51 show the numbers and locations of each point.

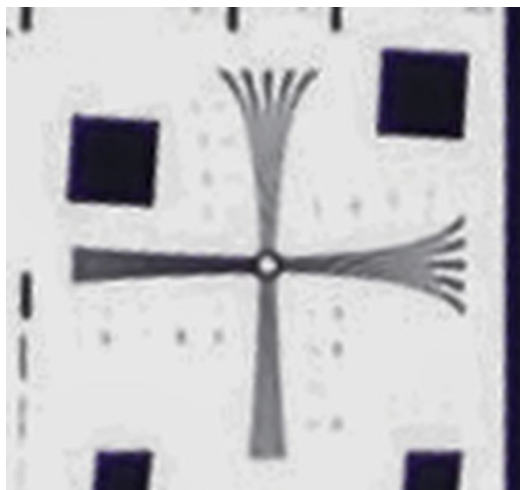
Figure 54. Closeup of Figure 53 Showing the Resolution Limit at 3 mm

Figure 53 illustrates the test chart that was placed in field at WWD while collecting imagery with the M210 at a GSD of 2 mm and Figure 54 illustrates a closeup of Figure 53.

This test was not duplicated for any other sensors used throughout this research.

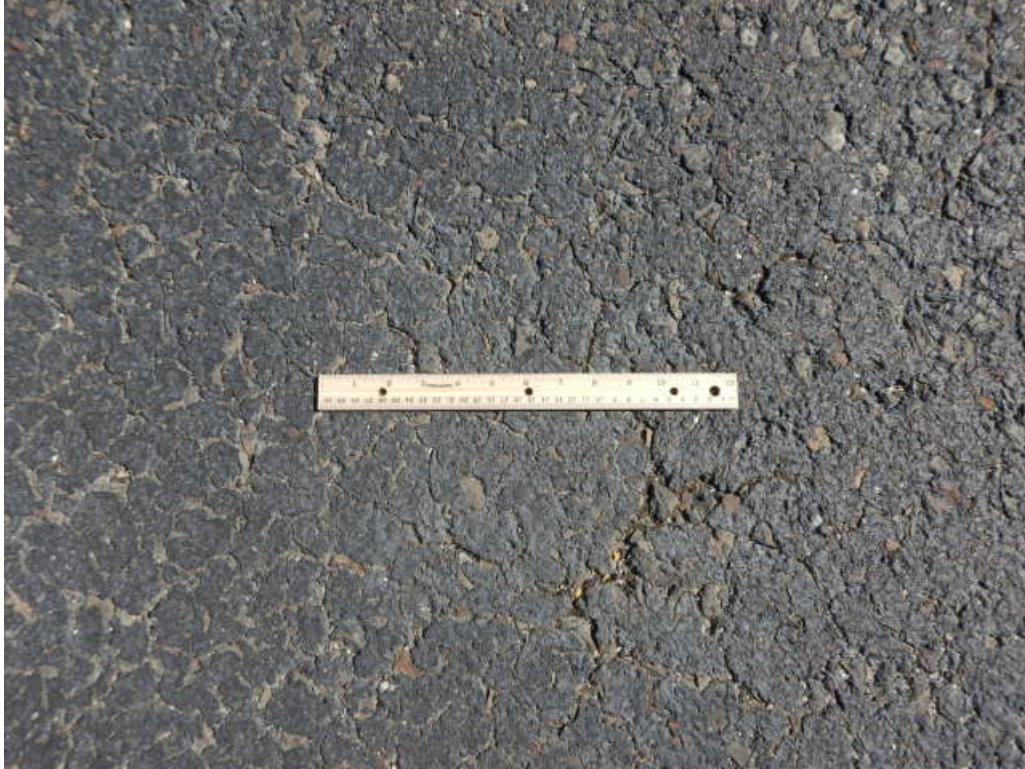
Figure 58. Asphalt Apron Pavement Deterioration at WWD

The GA Asphalt Apron was an aged pavement with a 10+-year-old surface seal and crack seal applied. As shown in Figure 58, these aged/weathered maintenance and rehabilitation (M&R) applications have deteriorated and made observations of the excessive amounts of cracking difficult to track in the field.

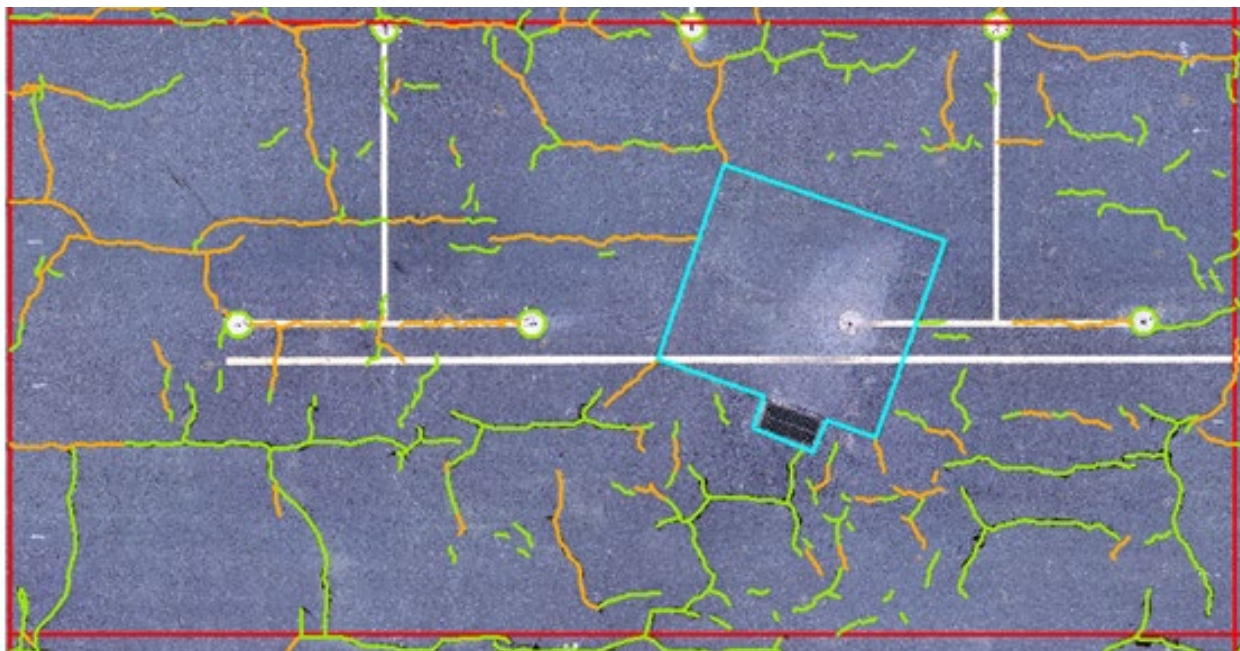
Figure 60. Example of sUAS Distress Analysis for GA Apron at WWD

Figure 60 demonstrates how difficult it would be to accurately track the quantity of cracking in the field. The ability to digitize and track distresses demonstrates superiority over manually measuring distresses in the field or performing a distress takeoff from the DSV laser-based imagery.

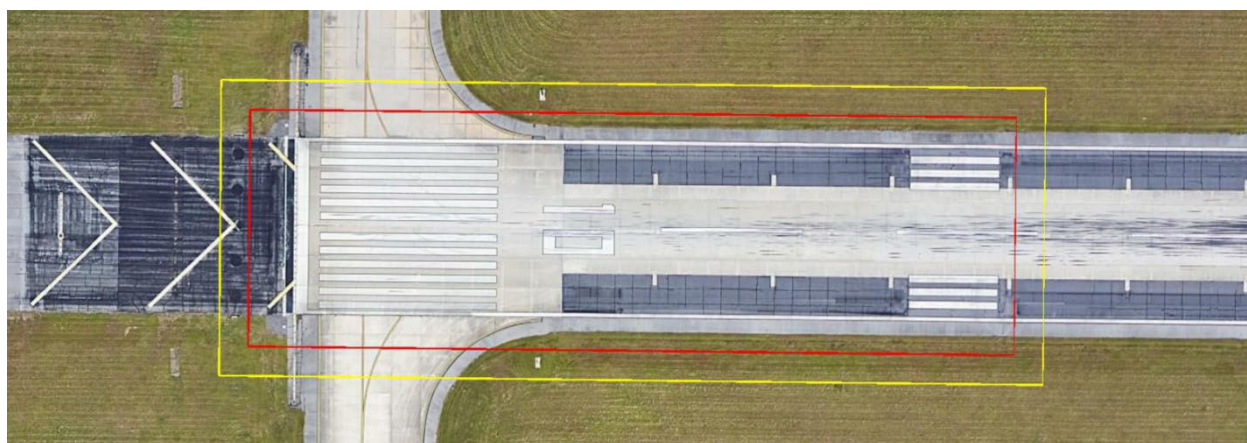
Figure 61. West End of Runway 10/28 at SAV

The test areas at SAV included the west end of Runway 10/28 and Taxiway GA4. Figures 61 and 62 illustrate the capture areas (yellow) and test areas (red) selected for data collection.

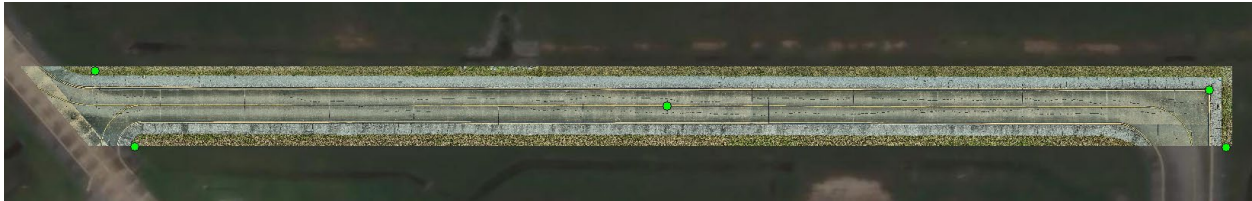
Figure 64. Five GCP Locations over Taxiway GA4 at SAV

GCPs were RTK surveyed using a Trimble R8-3 GNSS receiver connected to a local base station at SAV. These data were assessed in the processing workflow to evaluate the requirement of having GCPs for a pavement distress analysis. Figures 63 and 64 show the numbers and locations of each point.

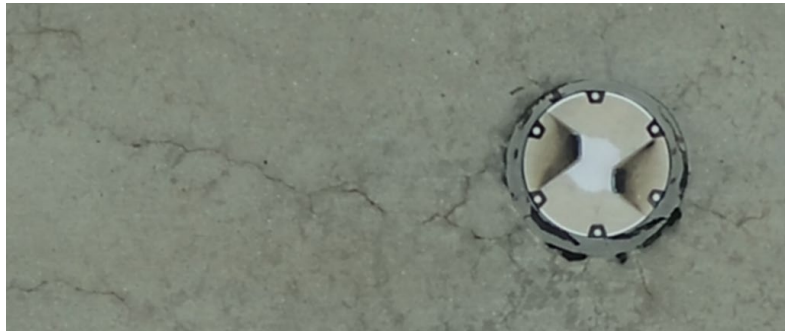
Figure 66. Distress Example on Runway 10/28 at SAV

Joint reflective cracking, weathering, and L&T cracking were observed on both of the asphalt overlay over Portland cement concrete (APC) pavement areas (Sections 10N and 10S). The differences in PCI in the AC sections were attributed to a 6% increase in overall cracking, with 2% more of the cracking recorded as medium severity in the sUAS analysis. It is worth noting that the joint seal damage and weathering previously added as supplemental data from field notes at WWD were analyzed during the sUAS distress takeoff. This analysis yielded the same results as the FOG inspection. Figure 66 illustrates an example of distress identified on Runway 10/28 at SAV.

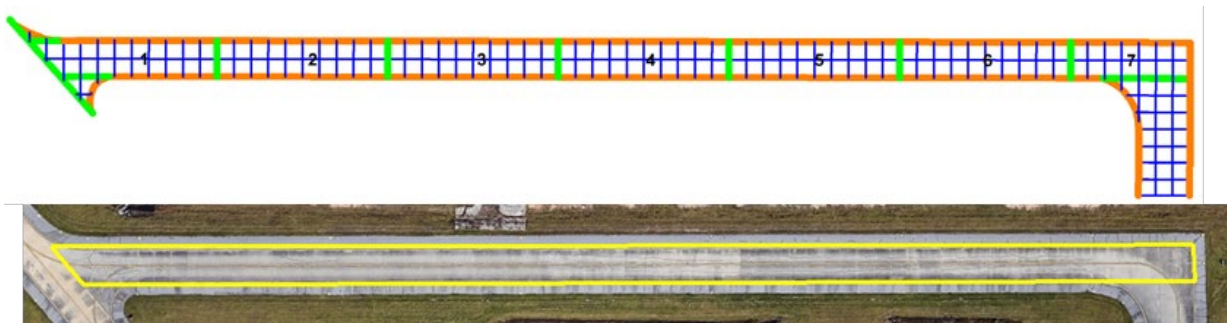
Figure 67. Sample Units of Taxiway GA4 at SAV

Taxiway GA4, a mix of AC and PCC pavement, was broken into sample units, as illustrated in Figure 67.

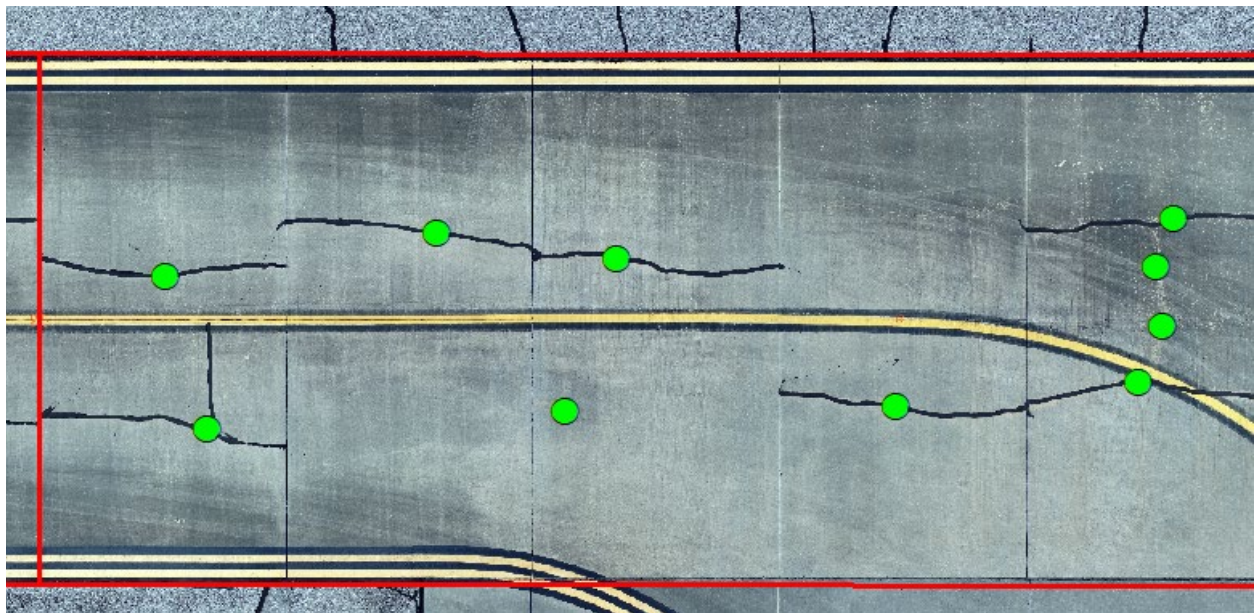
Figure 68. Sample Unit 1 of Taxiway GA4 at SAV

Identical distresses were observed on Taxiway GA4 as on Runway 10/28. The sUAS PCI was 3 points higher than that of the FOG PCI, with the difference directly attributed to three, low-severity blowups recorded in the FOG survey that were not observed in the sUAS data. Figure 68 displays sample unit 1, where two of the blowups were recorded in the FOG survey.

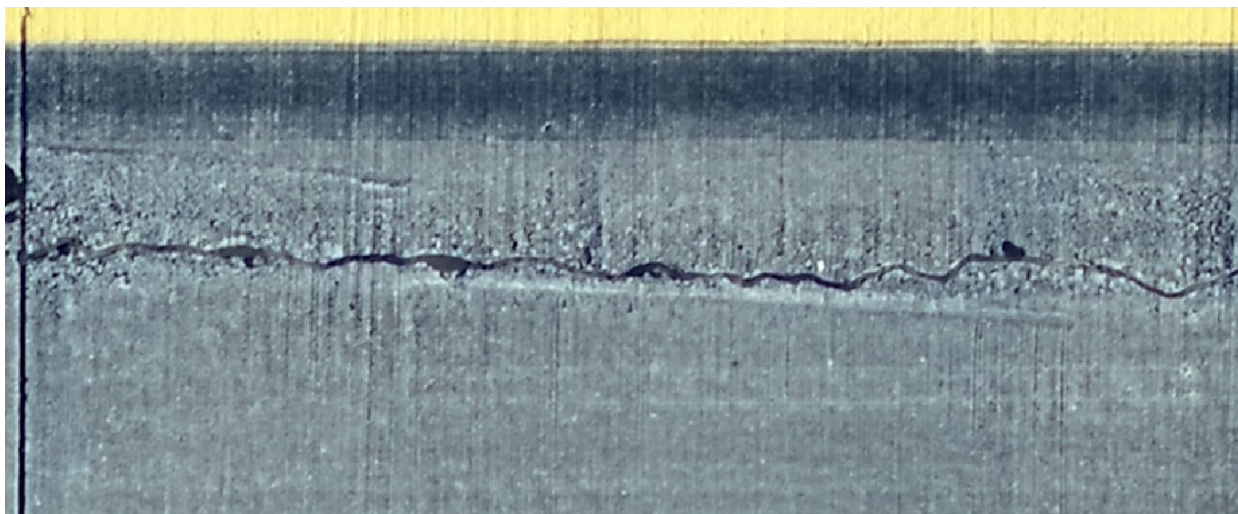
Figure 69. Distress Example on Taxiway GA4 at SAV

While the associated linear cracking was observed, there was no evidence of a blowup along the centerline as indicated in the field notes. Additional research is required to capture depth distresses, such as these blowups. Figure 69 illustrates an example of distress identified on Taxiway GA4 at SAV.
