DOT/FAA/TC-23/39

Assessment of Small Unmanned Aircraft Systems for Pavement Inspections

May 2023

Final Report

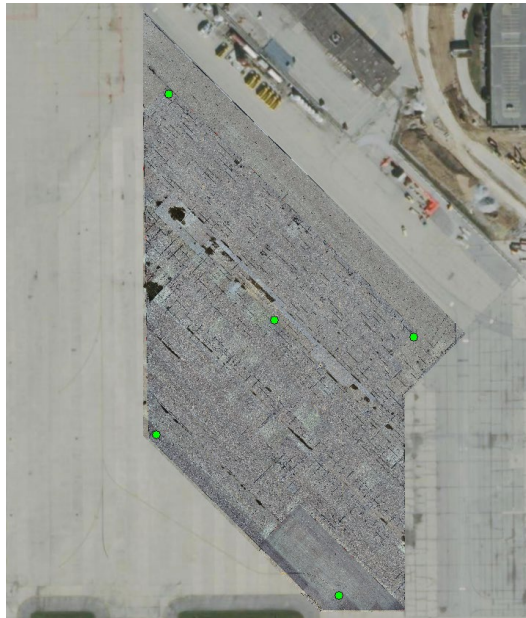
Figure 71. Five GCP Locations Over the Remote Aircraft Parking Apron 1 South at CVG

GCPs were RTK surveyed using a Trimble R8-3 GNSS receiver connected to a VRS. These data were not used in the production of the imagery that was analyzed and were only collected as a

backup for use in image processing if the resulting imagery was not spatially accurate. Figure 71 shows the number and locations of each point.

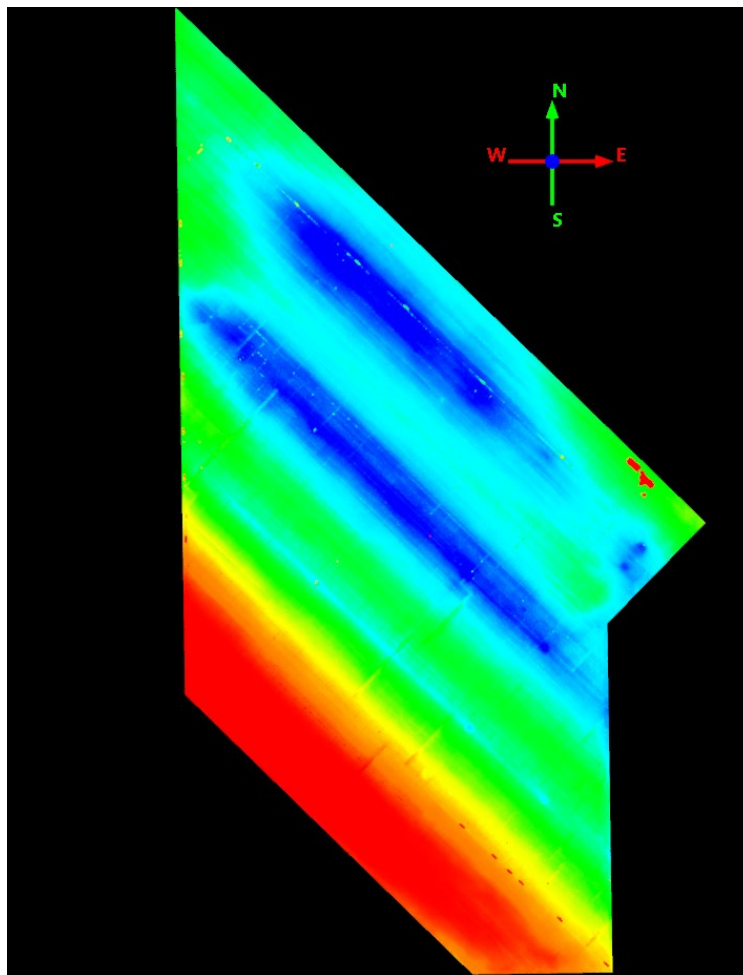
Figure 72. A DEM Derived from LiDAR Point Cloud at CVG

- Calculating laser point position by associating SBET position to each laser point return time, scan angle, intensity, etc. The raw laser point cloud data are created for the entire survey; each point will maintain the corresponding scan angle; return number (echo); intensity; and x, y, z information.
- Ground and nonground points are classified and statistical absolute accuracy is assessed via direct comparisons of ground classified points to the ground control (RTK survey data).
- Data are then converted to orthometric elevations and the appropriate map projection.
- Relative accuracy is tested using ground classified points per each flight line.
- Additional ground models can then be created, such as the DEM shown in Figure 72.

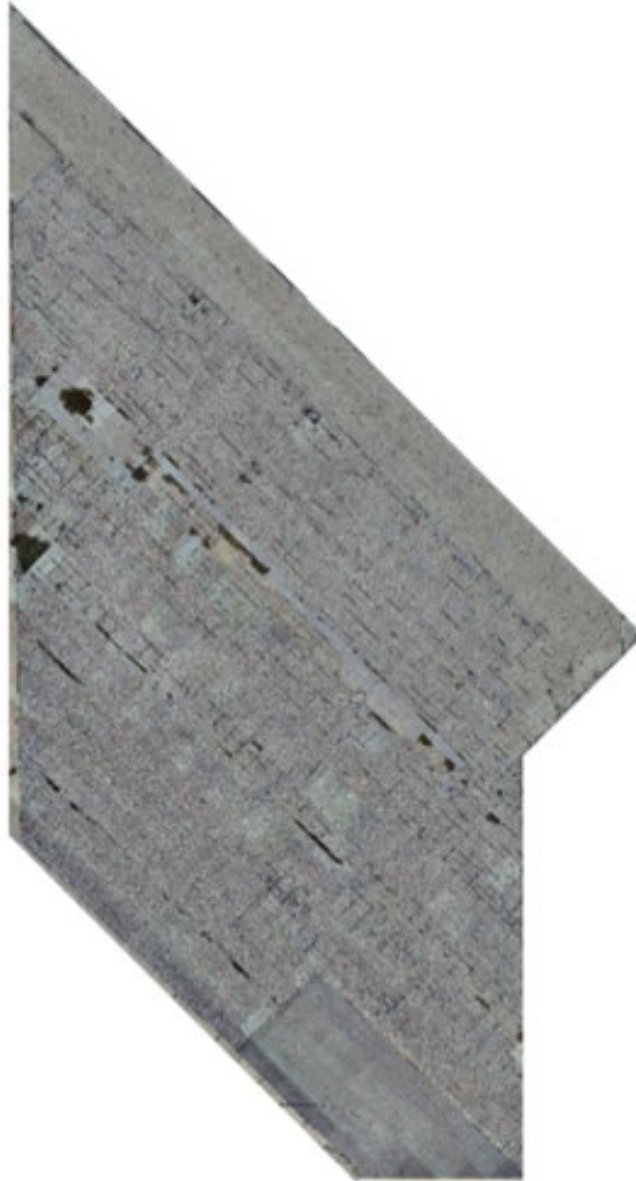
Figure 75. Flight 2 at CVG

Successful Orthomosaic: Yes; no gaps in the orthomosaic due to larger image footprint.

Acceptable for Analysis: Yes.

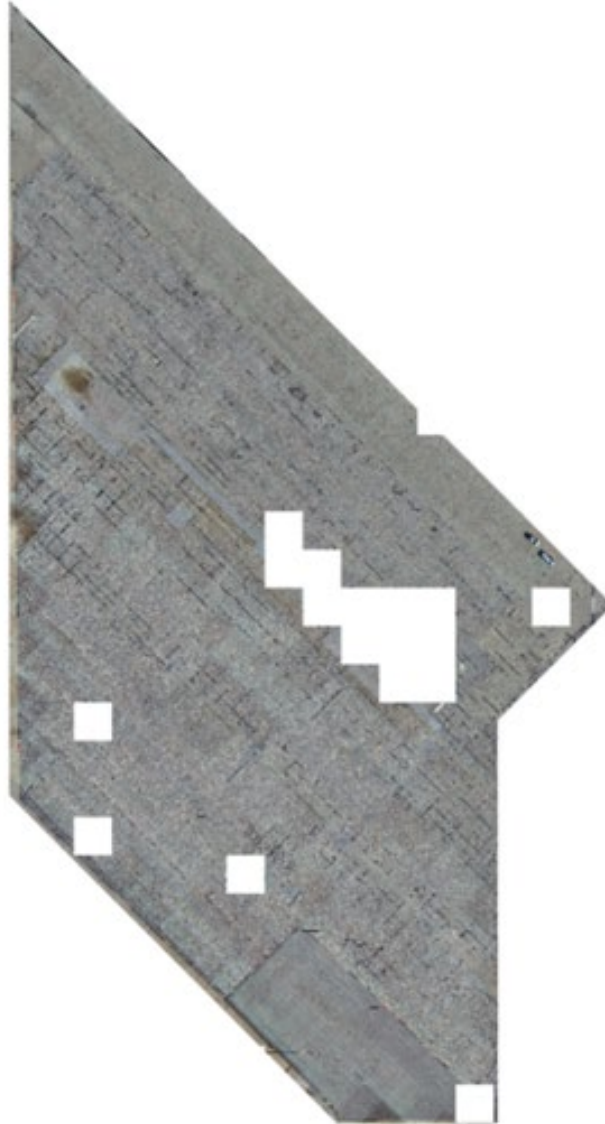
Figure 76. Flight 4 at CVG

Successful Orthomosaic: Yes; however, there are many gaps within the orthomosaic.

Acceptable for Analysis: No.

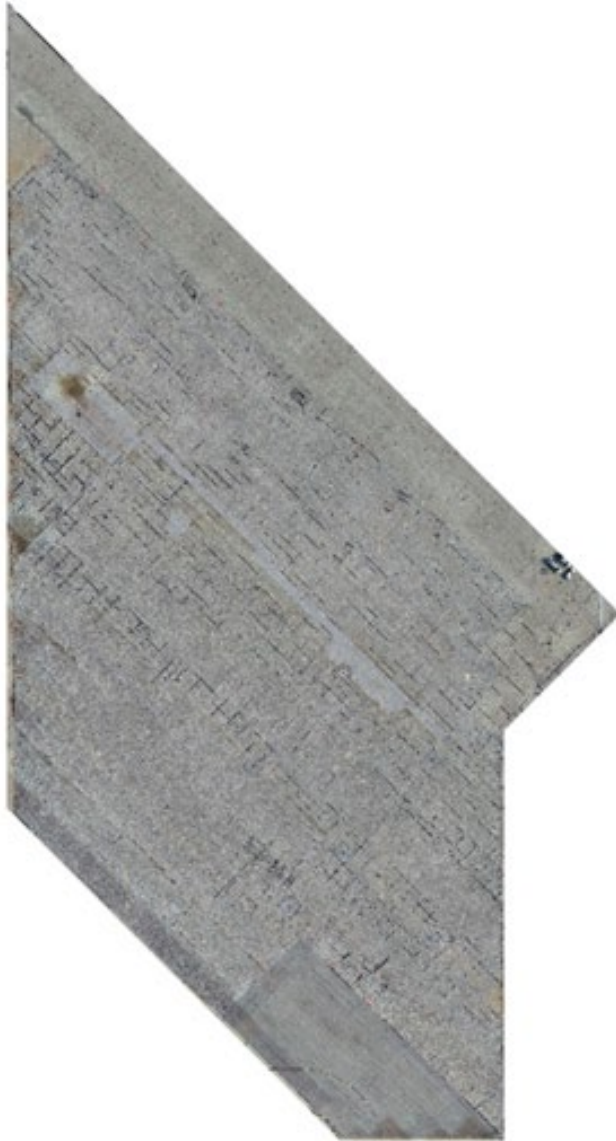
Figure 77. Flight 8 at CVG

Successful Orthomosaic: Yes.

Acceptable for Analysis: Yes.

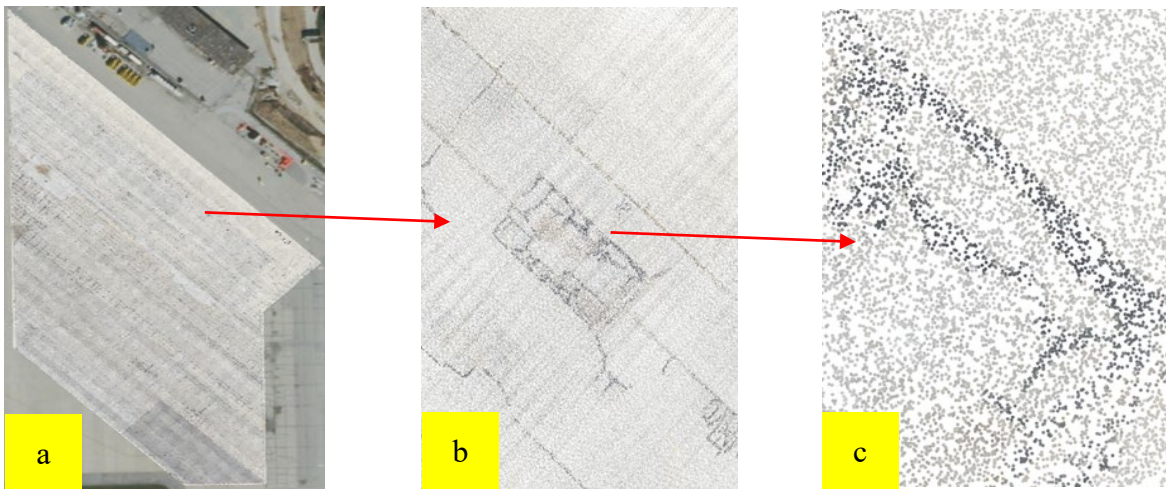
Figure 80. Flight 7 at CVG

Successful Orthomosaic: Not applicable.

Acceptable for Analysis: Further research required.

Table 40 presents a summary of all processed flights for LiDAR data. Flights 5, 6, and 7 did not have enough side overlap to generate an orthomosaic from the RGB images. However, Figures 78 through 80 illustrate the LiDAR point densities for these flights. Further research is required to assess the viability of LiDAR data in PMP inspections. Section 7 details these research gaps and recommendations.

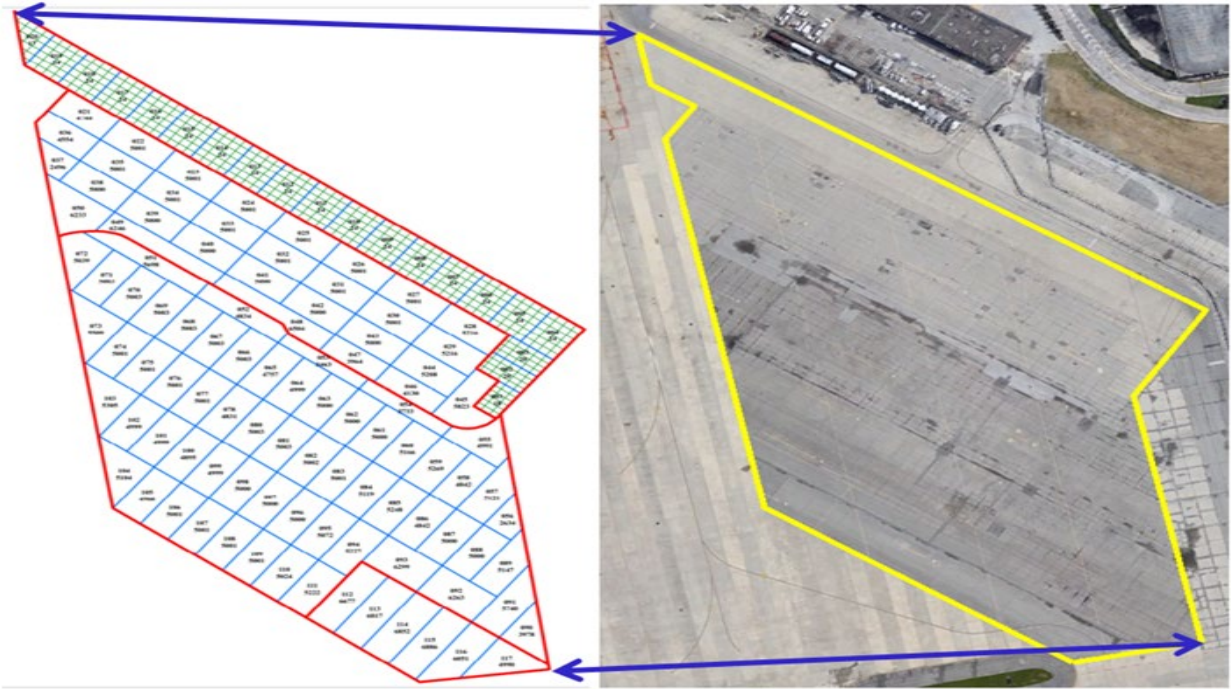
Figure 81. Remote Aircraft Parking Apron 1 South Sample Units at CVG

The Remote Aircraft Parking Apron 1 South is approximately 580,000 sq ft and a mix of APC and PCC pavements. The pavement is divided into four sections and further divided into sample units as shown in Figure 81. Section 10 is PCC pavement with 20 samples. Sections 20, 30, and 40 are APC pavement. The size of the sections and sample units vary. While the capture limits included the entire Remote Aircraft Parking Apron 1 South, the test limits encompassed sections 10 and 40, and only portions of sections 20 and 30.

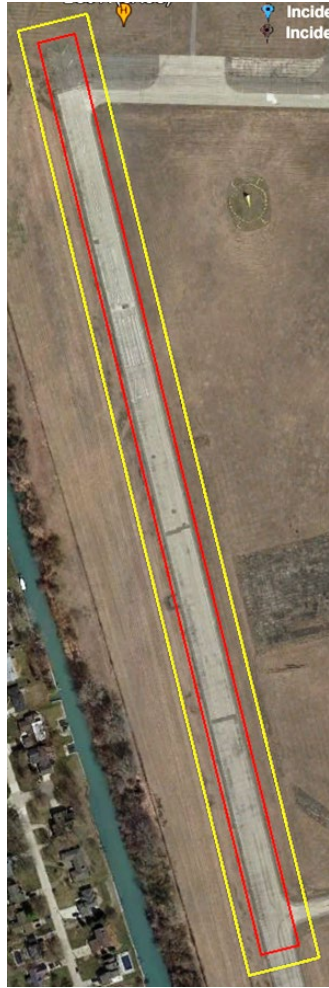
Figure 82. Runway 17/35 at ONZ

The test areas at ONZ included Runway 17/35, Taxiway A, and connector taxiways. Figures 82 and 83 illustrate the data capture areas (yellow) and test areas (red) that were selected for data collection.

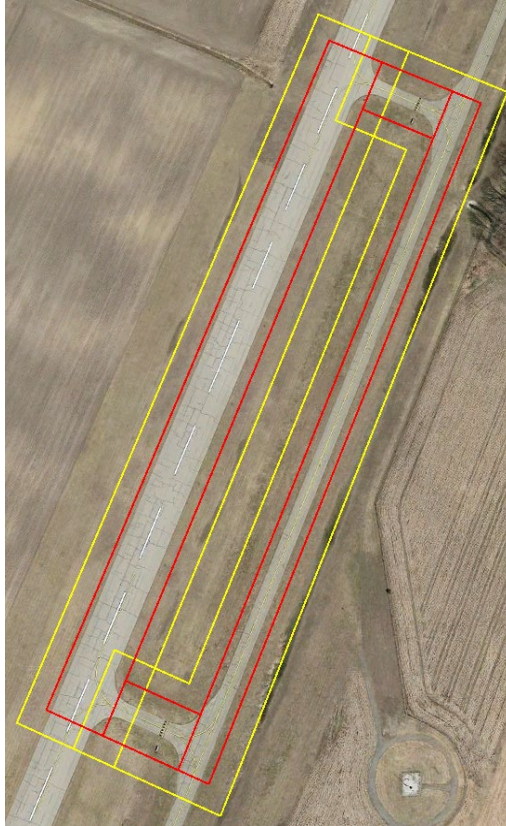
Figure 84. Runway 03/21 and Taxiway A at TTF

The test areas at TTF included Runway 03/21 and Taxiway A. During data collection, the data for the connector Taxiways A2 and A3 were also collected. Hence, Taxiways A2 and A3 were included in the analysis and evaluation of the PCIs. Figure 84 illustrates the capture areas (yellow) and test areas (red) selected for data collection.

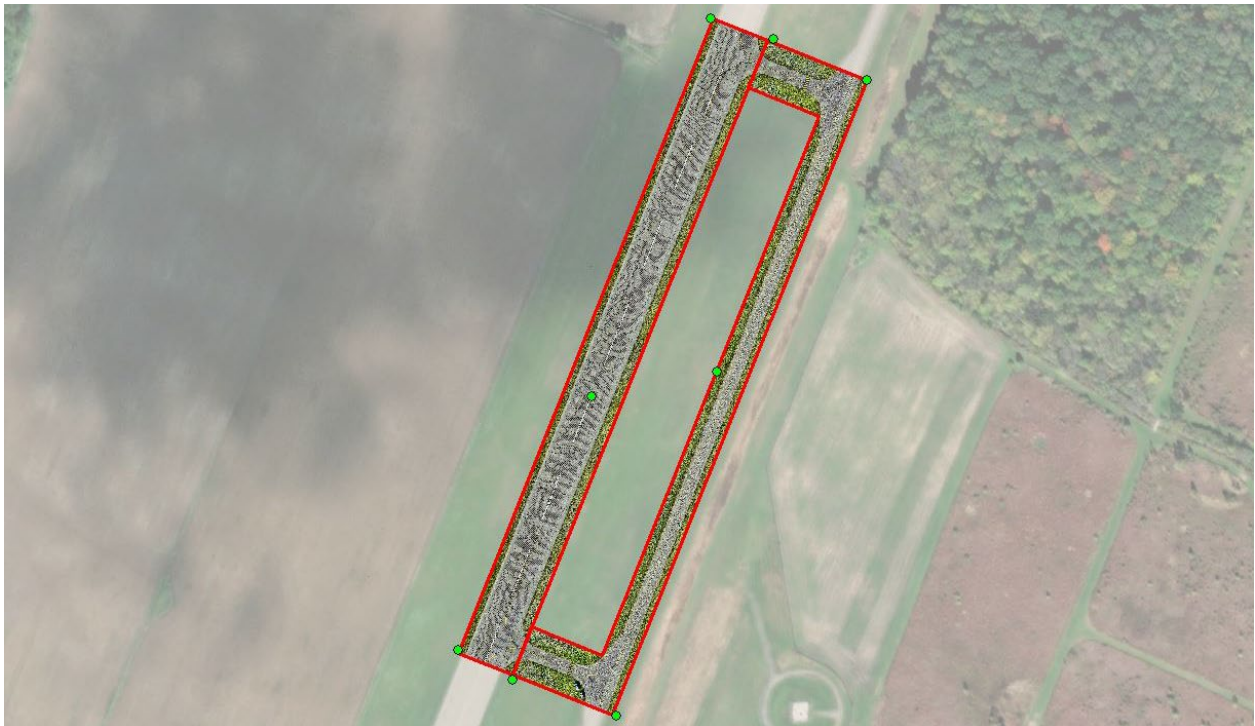
Figure 86. Ground Control Points Locations Over Each Test Area at TTF

processing if the resulting imagery was not spatially accurate. Figures 85 and 86 show the numbers and locations of each point.

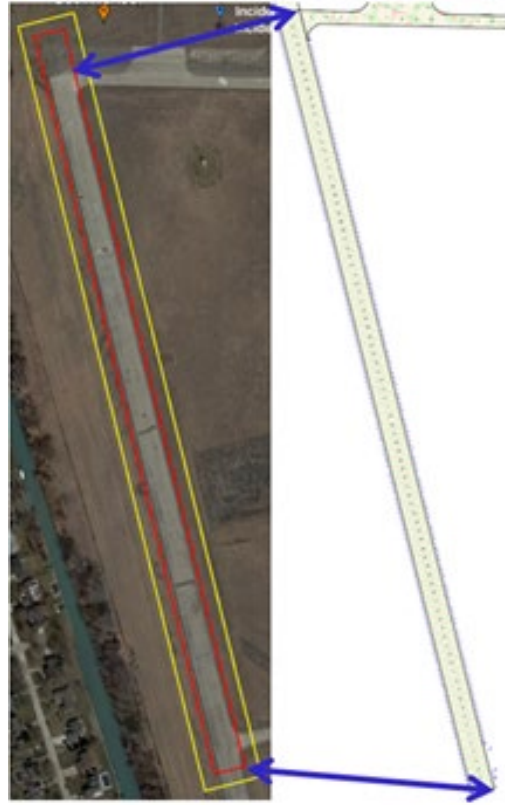
Figure 87. Sample Units of Runway 17/35 at ONZ

Runway 17/35 is 75 ft wide and entirely PCC pavement. The pavement is composed of a single section and divided into sample units, as shown in Figure 87. Each sample unit is 30 ft x 75 ft (2,250 sq ft). While the capture limits included the northern 2,500 ft of the runway, the test limits only encompassed 18 sample units chosen to represent the varied conditions across the section.

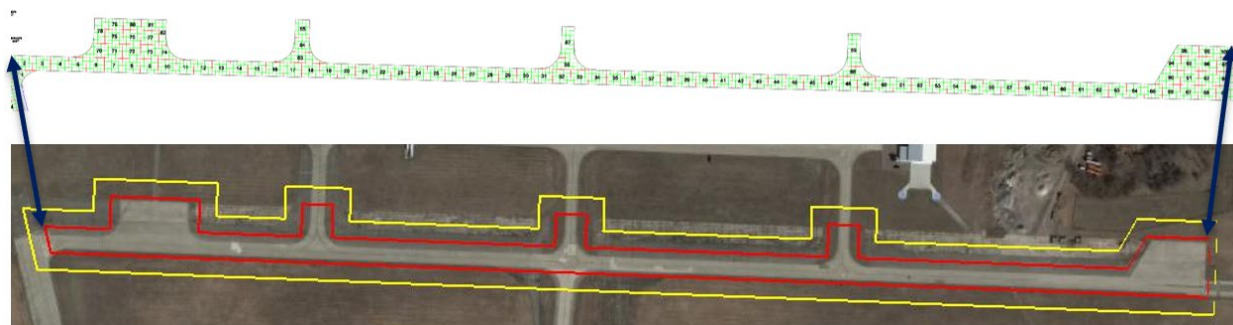
Figure 88. Sample Units of Taxiway A at ONZ

Taxiway A is 40 ft wide and entirely PCC pavement. The pavement is composed of a single section and divided into sample units as shown in Figure 88. Each sample unit on Taxiway A is 40 ft x 50 ft (2,000 sq ft), while the samples on the connector taxiways vary in size. Although the capture limits included the entirety of Taxiway A and portions of associated connectors, the test limits only encompassed 23 sample units chosen to represent the varied conditions across the section.

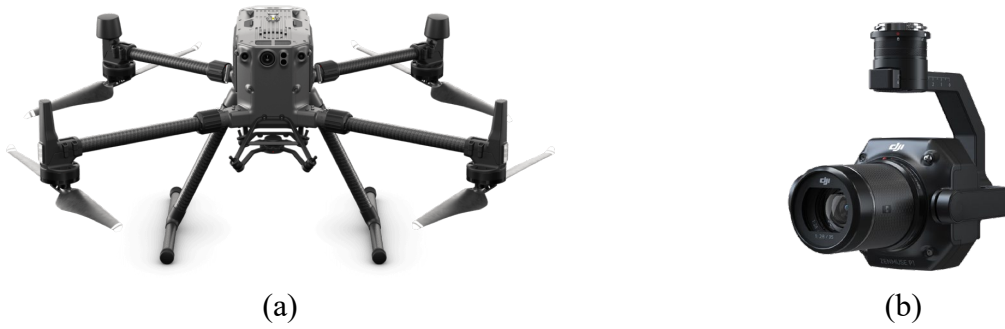
Figure 91. The DJI M300 RTK (a) with Zenmuse P1 (b)

DJI M300 RTK, shown in Figure 91, utilized the DJI Zenmuse P1-35mm (RGB) payload. This airframe and RGB camera were identified during Validation Testing since they were an airframe and payload that were not included in any prior testing. The DJI Zenmuse P1 is a 45-megapixel camera commonly used in the surveying industry. The DJI M300 RTK with Zenmuse P1-35mm payload will herein be referred to as M300.

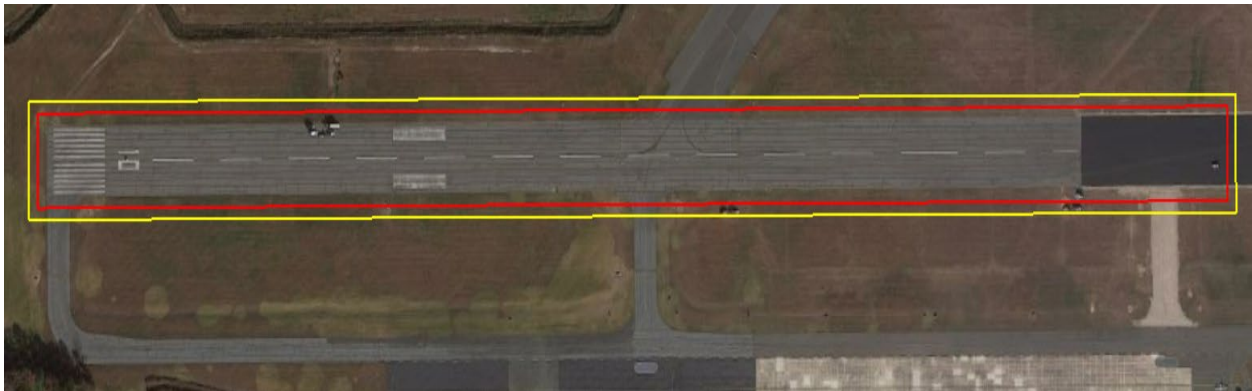
Figure 92. West End of Runway 10/28 at WWD

The test areas for full-scale testing at WWD included the west end of asphalt Runway 10/28 and a GA apron (AC and PCC). When possible, the research team purposely overflowed these areas to ensure full coverage across the edges of the pavement.

Note: Capture limits in yellow, test limits in red.

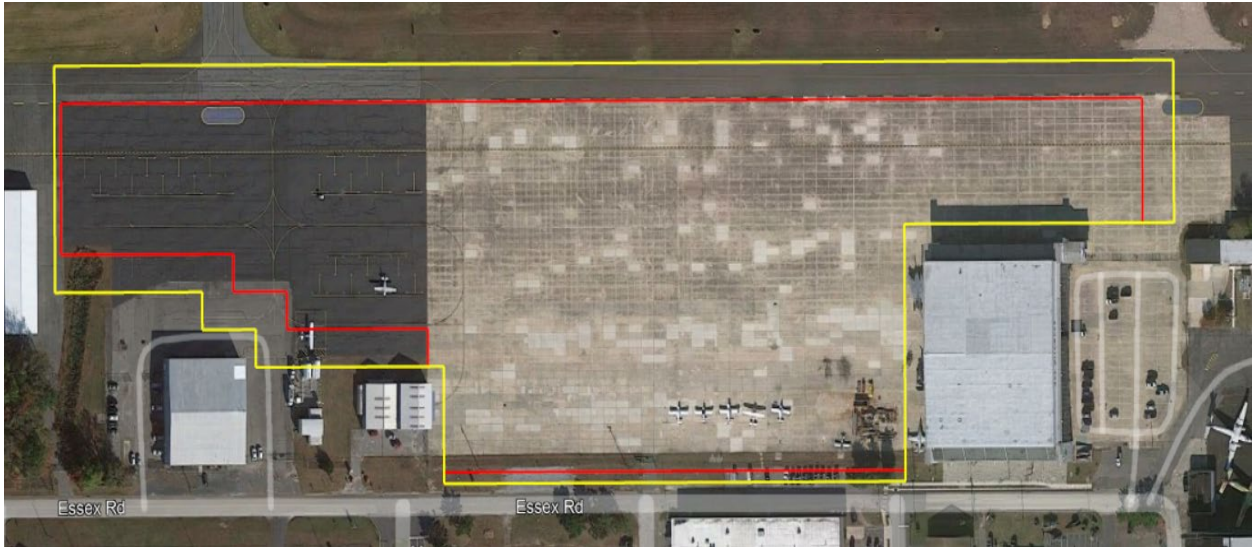
Figure 93. Apron at WWD

Note: Capture limits in yellow, test limits in red.

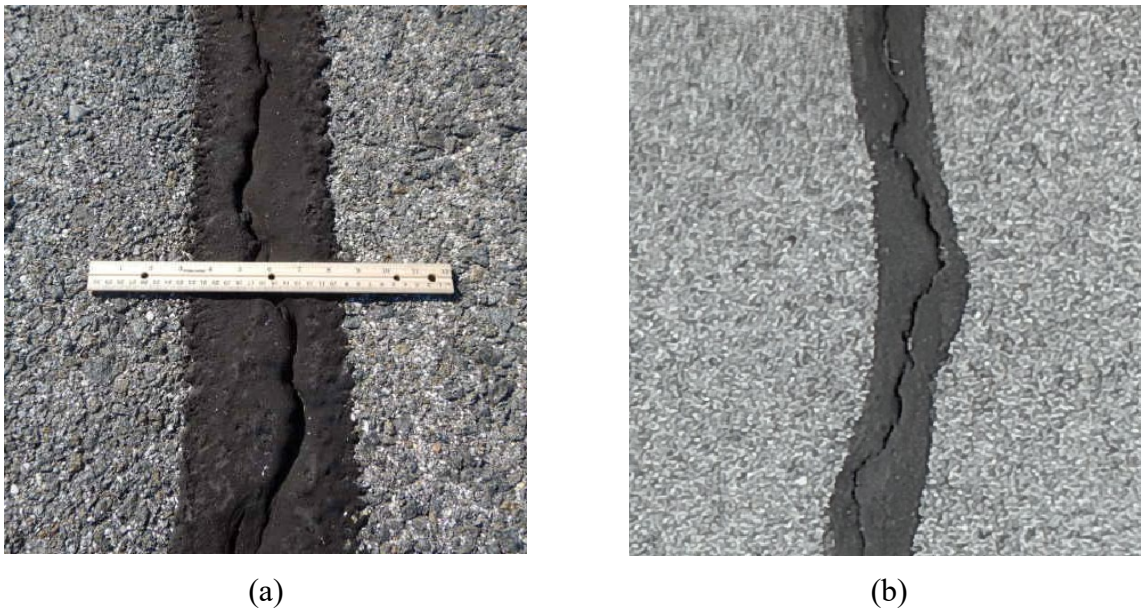
Figure 97 illustrates low-severity longitudinal and transverse (L&T) cracking as identified at WWD via FOG and sUAS inspections.

Figure 97. Low-Severity L&T Cracking Detected via FOG (a) and sUAS (b) Inspections

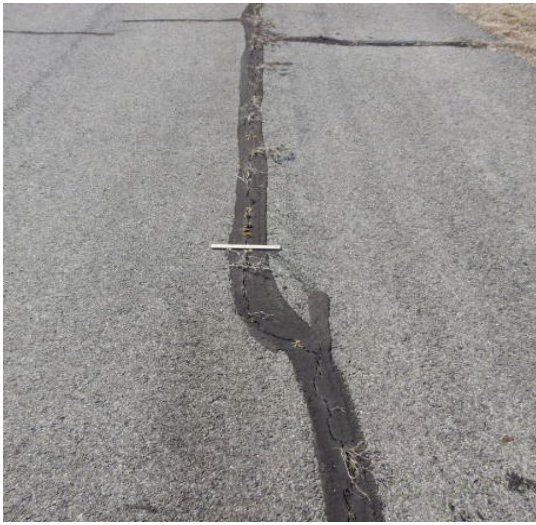
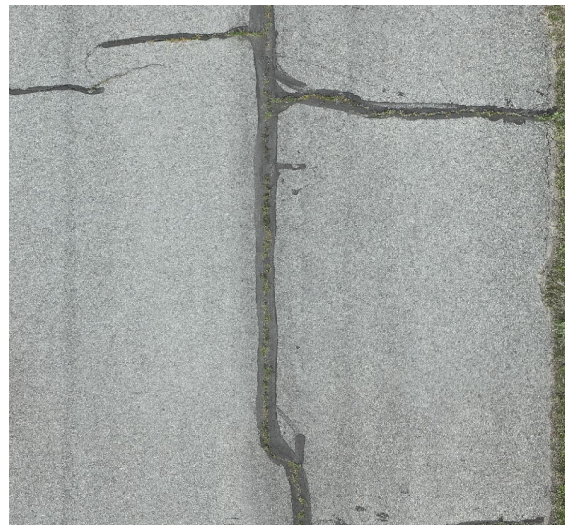
Figure 98. Medium-Severity L&T Cracking Detected via FOG (a) and sUAS (b) Inspections

Figure 98 illustrates medium-severity L&T cracking as identified at WWD via FOG and sUAS inspections.

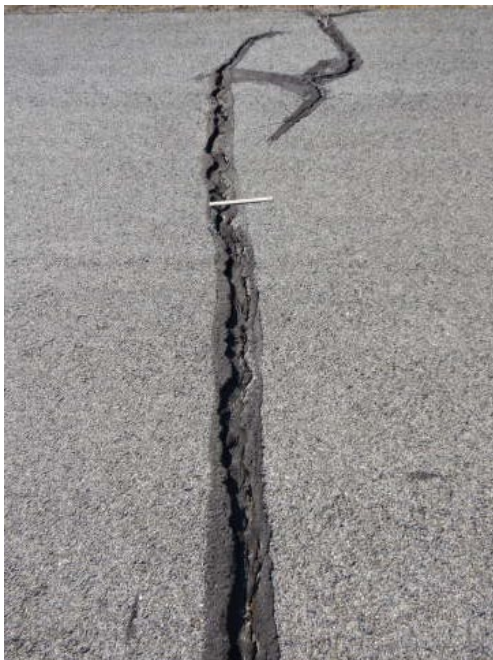
Figure 99. High-Severity L&T Cracking Detected via FOG (a) and sUAS (b) Inspections

Figure 99 illustrates high-severity L&T cracking as identified at Cape May County Airport (WWD) via FOG and sUAS inspections.

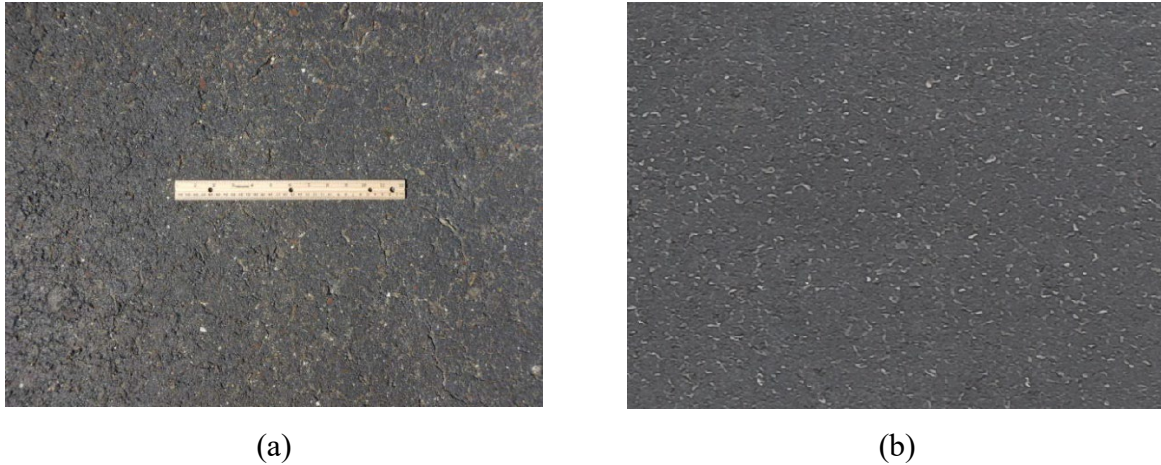
Figure 100. Low-Severity Raveling Detected via FOG (a) and sUAS (b) Inspections

Figure 100 illustrates low-severity raveling as identified at WWD via FOG and sUAS inspections.

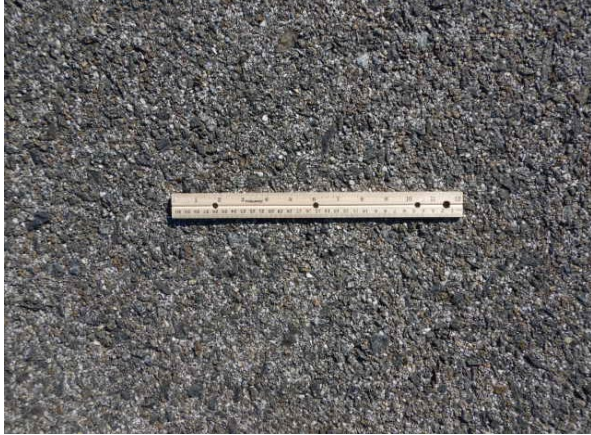
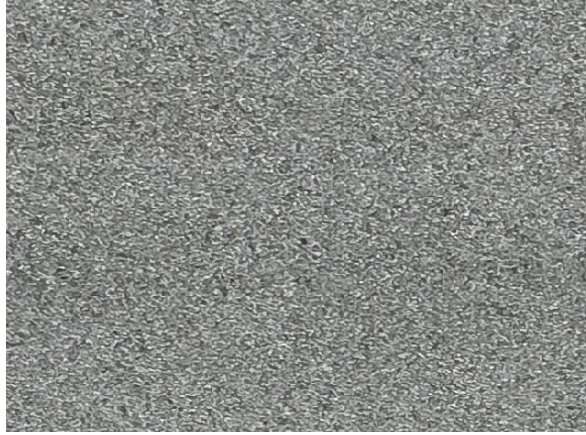
Figure 102. Low-Severity Weathering Detected via FOG (a) and sUAS (b) Inspections

Figure 102 illustrates low-severity weathering as identified at WWD via FOG and sUAS inspections.

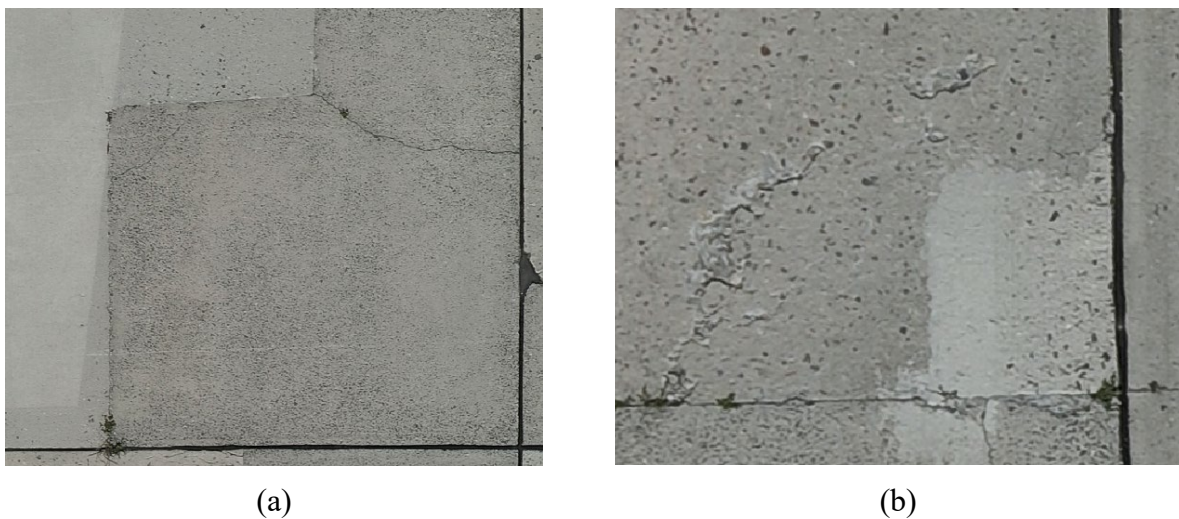
Figure 104. Low- (a) vs Medium-Severity (b) Corner Break Detected via sUAS Inspections

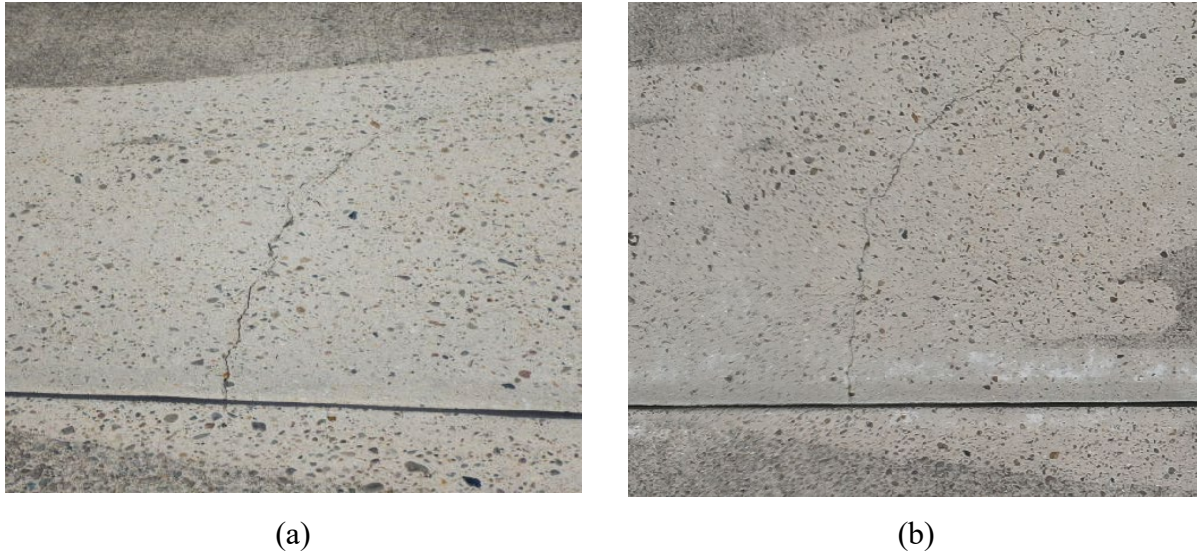
Figure 105. Low-Severity Linear Crack Detected via FOG (a) and sUAS (b) Inspections

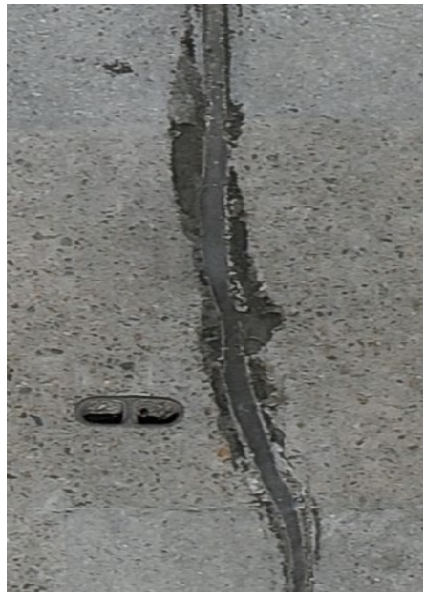
Figure 106. Medium-Severity Linear Crack Detected via sUAS Inspections

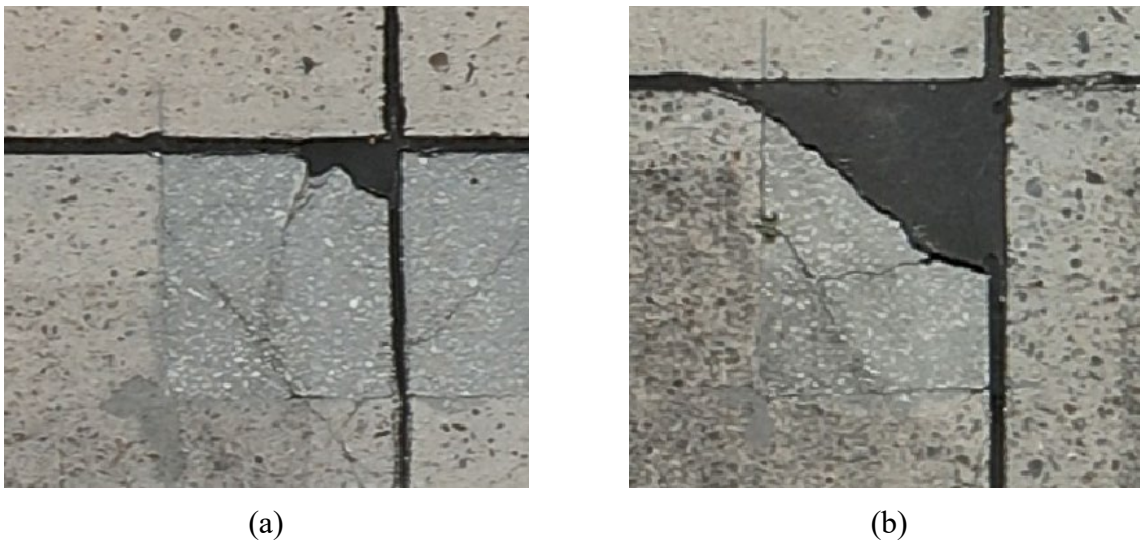
Figure 108. Medium- (a) vs High-Severity (b) Small Patch Detected via sUAS Inspections

Figure 108 compares medium- vs high-severity small patch as identified at WWD via sUAS inspections.

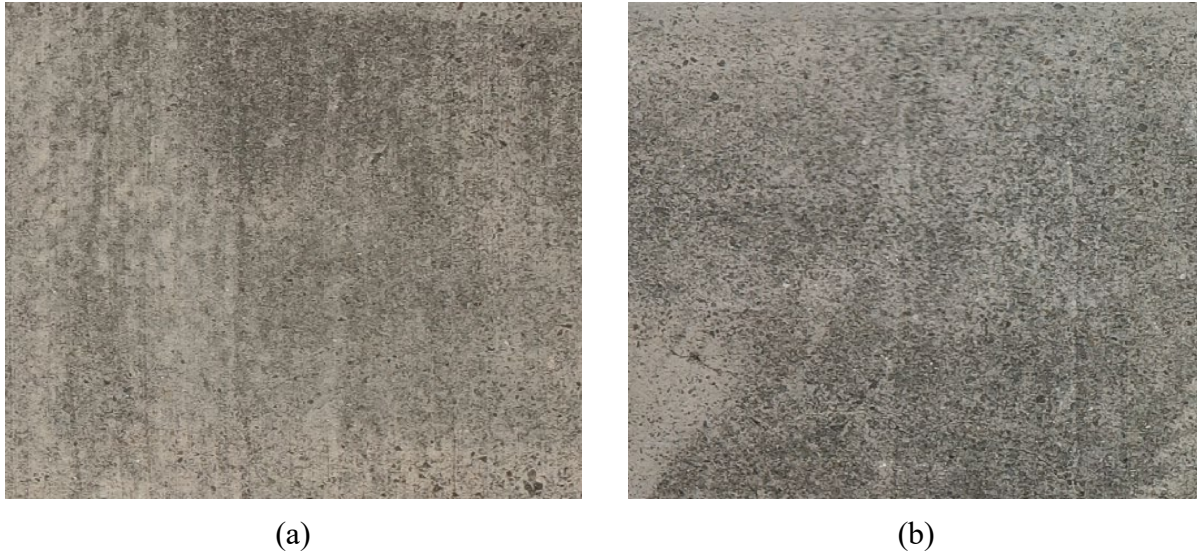
Figure 111. Low- vs Medium-Severity Scaling Detected via sUAS Inspections

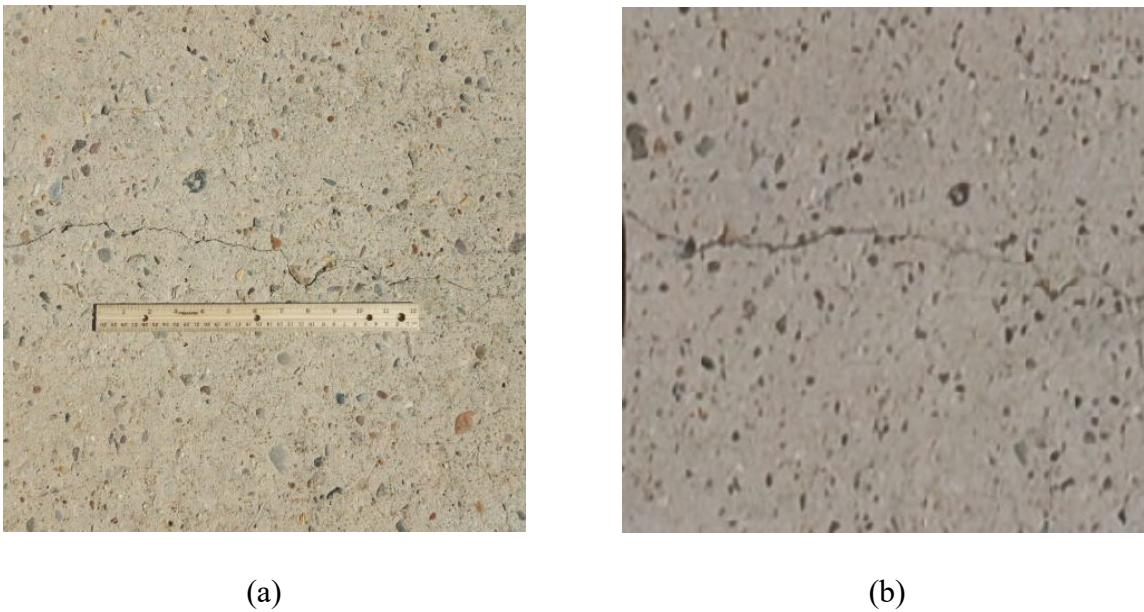
Figure 112. Shrinkage Crack Detected via FOG (a) and sUAS (b) Inspections

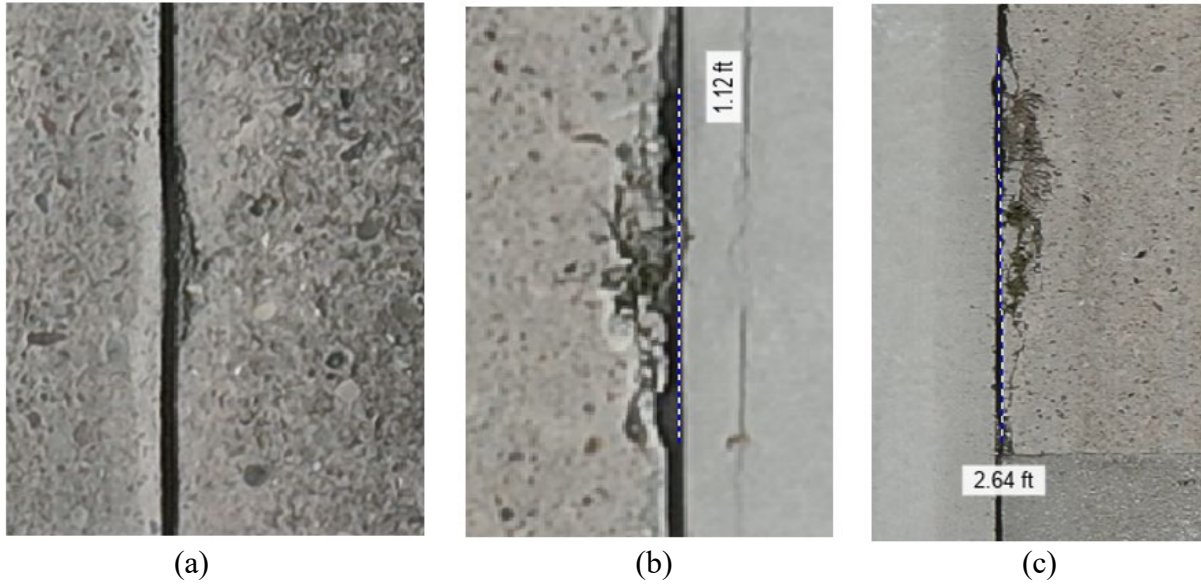
Figure 113. Low- (a), Medium- (b), and High-Severity Joint Spall Detected via sUAS (c) Inspections

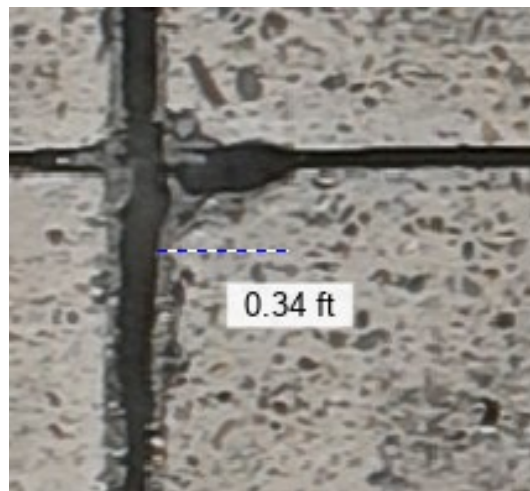
Figure 114. Low-Severity Corner Spall Detected via sUAS Inspections

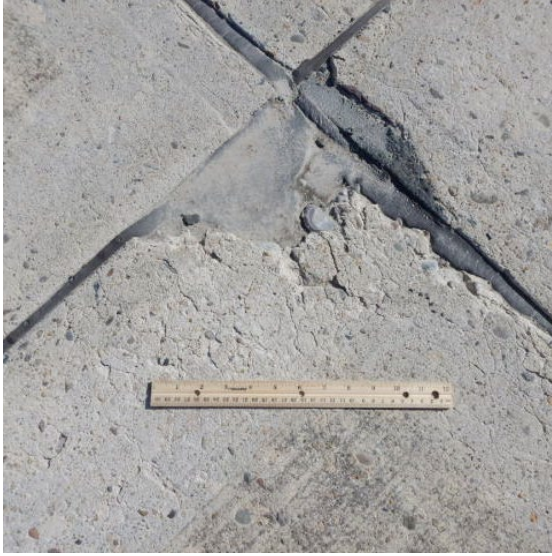
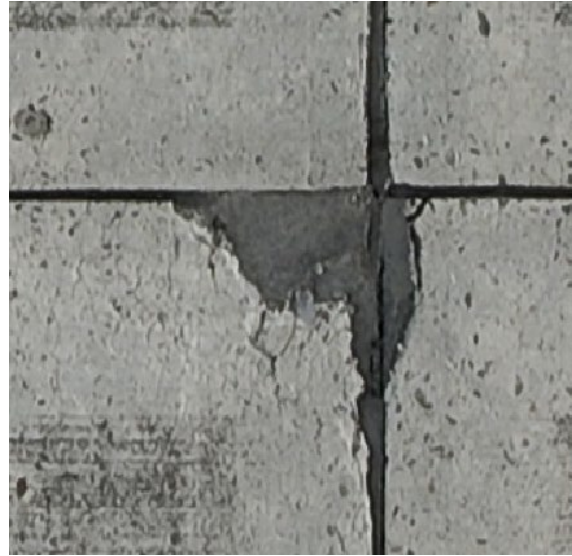
Figure 115. Medium-Severity Corner Spall Detected via FOG (a) and sUAS (b) Inspections

Figure 115 illustrates medium-severity corner spall as identified at WWD via FOG and sUAS inspections.

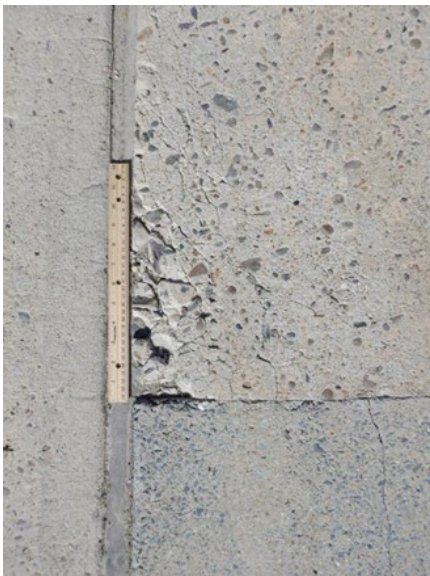
Figure 116 illustrates high-severity corner spall as identified at WWD via FOG and sUAS inspections.

Figure 116. High-Severity Corner Spall Detected via FOG (a) and sUAS (b) Inspections

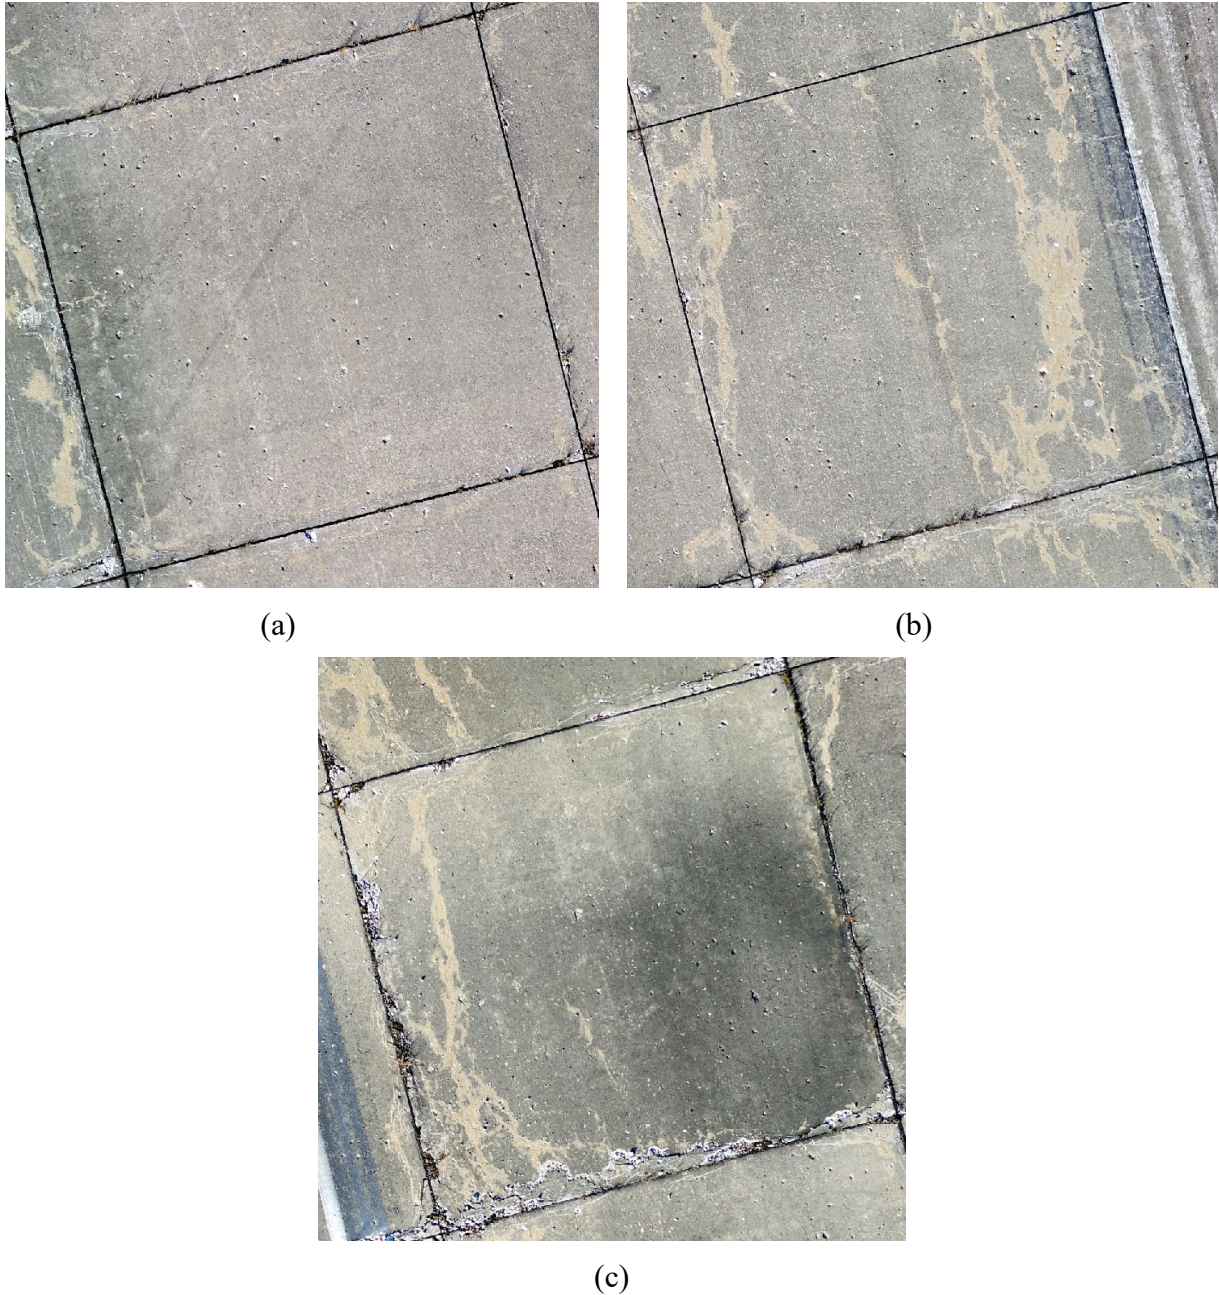
Figure 117. Low-(a), Medium- (b), and High-Severity (c) ASR Detected via sUAS Inspections
