Designing and Implementing Maintainable Pedestrian Safety Countermeasures

FINAL REPORT

Minnesota Department of Transportation Office of Research & Innovation 395 John Ireland Boulevard, MS 330 St. Paul, Minnesota 55155-1899

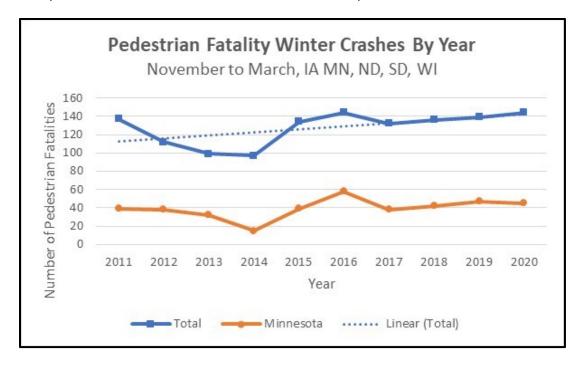
Figure 1.1 Pedestrian-involved fatal winter crashes in Minnesota and the Midwest (created using data from NHTSA's Fatality and Injury Reporting System Tool)

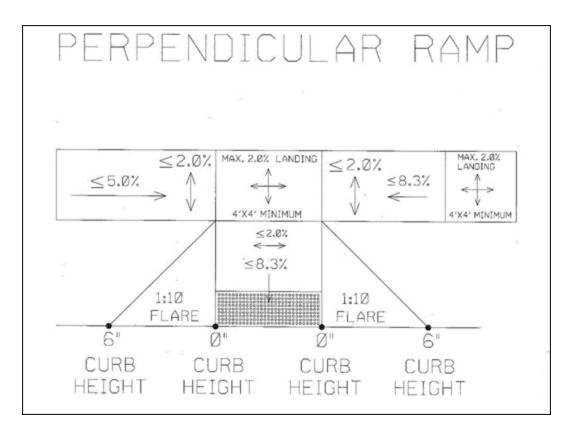
Figure 2.1 Perpendicular ramp design (Source: MnDOT)

The American Association of State Highway Transportation Officials (AASHTO) Guide for the Planning, Design and Operation of Pedestrian Facilities provides items to consider when designing intersection corners and curb ramps (AASHTO, 2004). For example, these areas should be free of obstructions and have enough space for pedestrians to wait to cross. Curb ramps should be designed to the least slope possible that is consistent with curb height and available corner area, while providing a level landing for turning and maneuvering. Detectable warnings, such as truncated domes, also need to be incorporated. The guide notes that ramps for new construction should be a minimum of four feet wide, while retrofits of existing facilities should be a minimum of three feet wide. Drainage grates or inlets should not be located in the ramp/crosswalk area. Finally, the guide presents three different types of ramps that can be considered, depending on site characteristics: perpendicular ramps, parallel ramps, and diagonal ramps. Perpendicular ramps are used where the sidewalk is too narrow to accommodate the length of the curb ramp with the required slope (AASHTO, 2004). Parallel ramps are used where space between the curb and adjacent properties is too tight to allow for the installation of a ramp and landing. A single ramp can also be placed diagonally at the apex of the intersection corner (AASHTO, 2004), but this design is not ideal for visually-impaired users. Examples of each of these ramp types are presented in Figure 2.1, Figure 2.2, and Figure 2.3. The guide does not discuss any maintenance aspects.

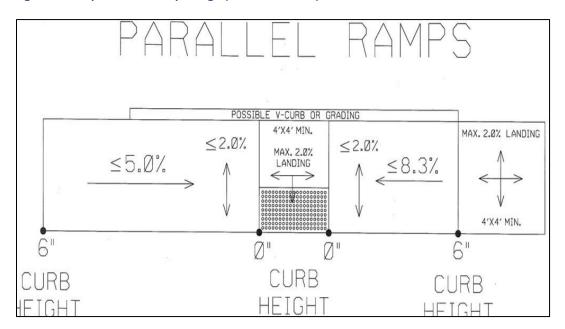
Figure 2.2 Parallel ramp design (Source: MnDOT)

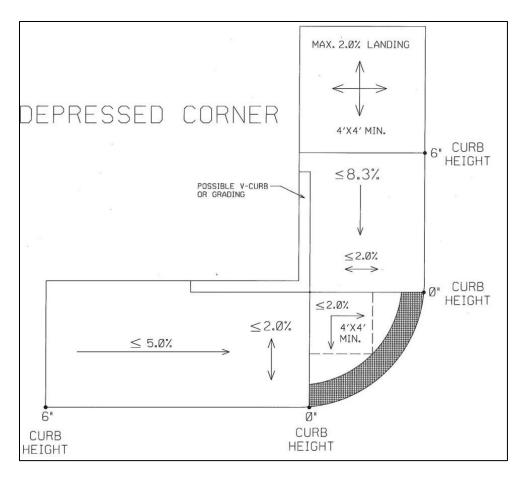
Figure 2.3 Diagonal ramp design (Source: MnDOT)

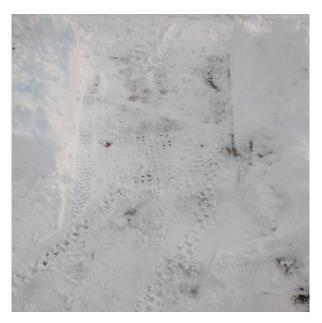
Figure 2.4 Curb ramp immediately after snow removal (left) and one day later with refreeze beginning to occur at bottom of ramp. (Source: John Shaw/Iowa State University)

Scott and Rudd developed a guide for local governments on the winter maintenance of pedestrian facilities in Delaware. The guide notes that the accumulation of snow and ice on curb ramps presents a physical obstacle which limits accessibility for pedestrians, particularly those with disabilities (Scott and Rudd, 2012). To address this, local government standards practices and/or ordinances should be established and snow should be plowed so that it does not block curb ramps (Scott and Rudd, 2012). Additionally, public works departments need to be educated about the problems associated with depositing snow onto curb ramps when plowing. The guide also suggested that residential and commercial property owners could be asked to voluntarily clear snow in these areas (Scott and Rudd, 2012) (Figure 2.4).

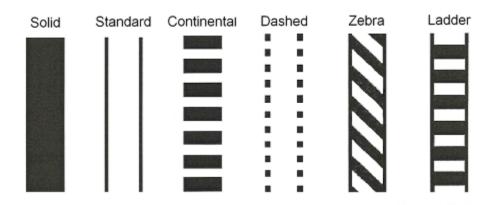
Figure 2.5 Crosswalk pavement marking patterns. (Source: Federal Highway Administration)

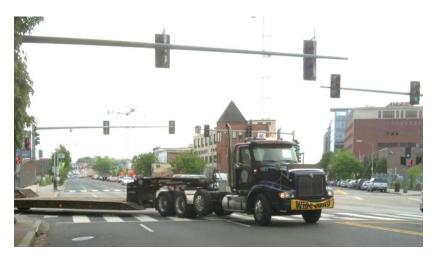
Figure 2.6 Right-turning truck encroaching adjacent lanes. (Source: National Association of City Transportation Officials)

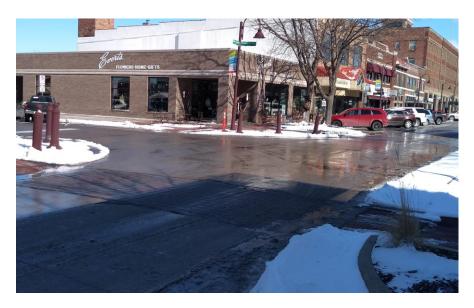
Figure 2.7 Tight corner radius combined with use of bollards and stamped concrete crosswalk. (Source: David Veneziano/Iowa State University)

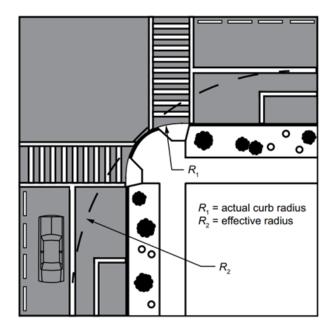
Figure 2.8 Parking lanes, bike lanes, bus stops, and loading zones can affect effective corner radius. (Source: AASHTO)

Since the mid-1980s, a number of designers have advocated tight corner radii to reduce vehicle speeds, improve pedestrian safety, provide more space for ADA-compliant curb ramps, and allow the curb ramps to be better aligned with adjacent pedestrian paths (see Figure 2.7). For example, the National Association of City Transportation Officials (NACTO) Urban Street Design Guide advises, "while standard curb radii are 10–15 feet, many cities use corner radii as small as 2 feet. In urban settings, smaller corner radii are preferred and actual corner radii exceeding 15 feet should be the exception" (NACTO, 2013). In contrast, the 2018 AASHTO Green Book recommends corner radii ranging from 15 feet on residential streets to 40 feet or more for truck freight corridors (AASHTO, 2018); the upper limit in MnDOT guidance is 35 feet (MnDOT, 2021). AASHTO also notes that the effective radius for right turns is affected by special-purpose areas adjacent to the right edge of the roadway, such as parking lanes, bike lanes, bus stops, or loading zones (see Figure 2.8).

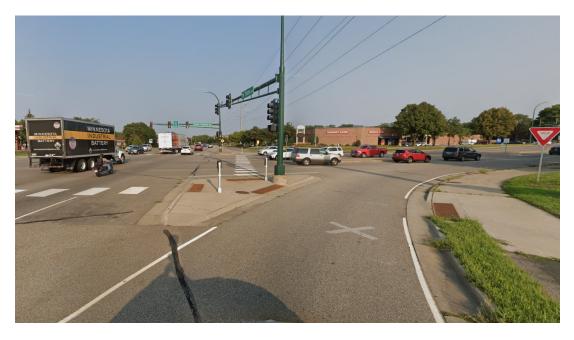
Figure 2.10 Typical slip lane and porkchop island, Arboretum Blvd/78th Street (MN 5) at Eden Prairie Road, Eden Prairie, MN. (Source: Google StreetView)

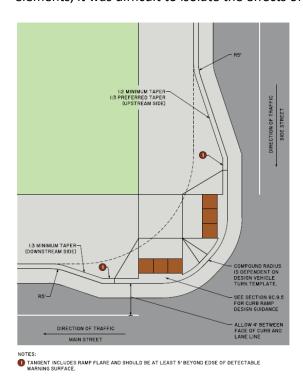
Figure 2.11 Minnesota design guidance for curb extensions. (Source: MnDOT Facility Design Guide section 8C.9.7.4.)

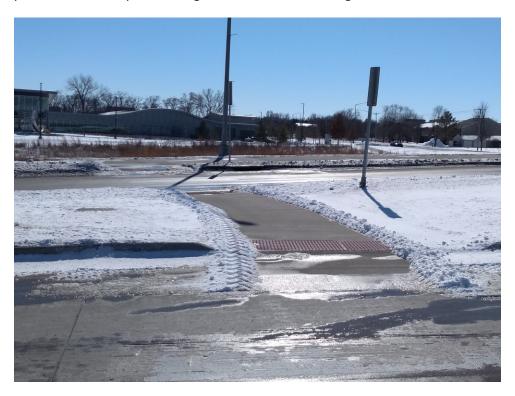
Figure 2.12 Median refuge island. (Source: David Veneziano/Iowa State University)

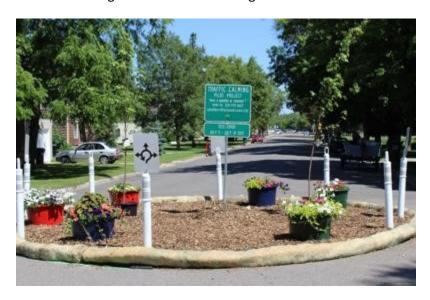
The population of Alexandria triples during the summer due to proximity to lakes, so there are more kids playing, and the need for traffic calming, which includes the use of traffic calming circles. The circles are made using segments of Bio Log (erosion control product consisting of wood chips in black netting), with additional wood chips and plastic planters placed in the center of the circle. An example of this feature is presented in Figure 1. These traffic circles are used mainly in residential areas, and flower planter watering is the only maintenance. The circles are not damaged by vehicles overrunning. Initially, people laughed at the idea, but now more and more residential areas want them. They are easy to install in the spring and remove in the fall when school resumes.

Figure 3.1 Bio-Log roundabout. (Source: Jacob Reuter/MnDOT)

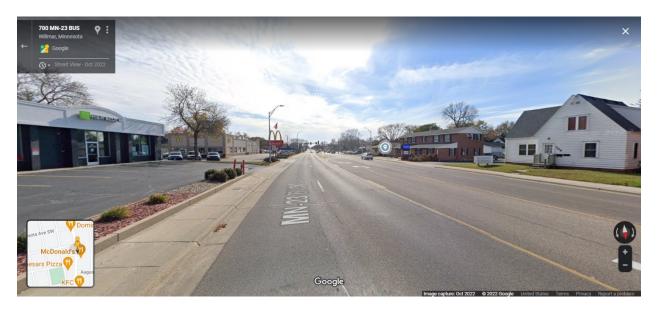
Much of the business district adjoins four-lane trunk highways without medians (see Figure 4.2). Due to the wide expanse of pavement and sidewalks, hauling out snow is a major operation. The absence of a median has both advantages and disadvantages: although there is no snow storage in the middle of the roadway, the city does not have to deal with plowing median pedestrian crossings as a separate operation.

Figure 4.2 Willmar business district along Business US 71. (Source: Google Street View)

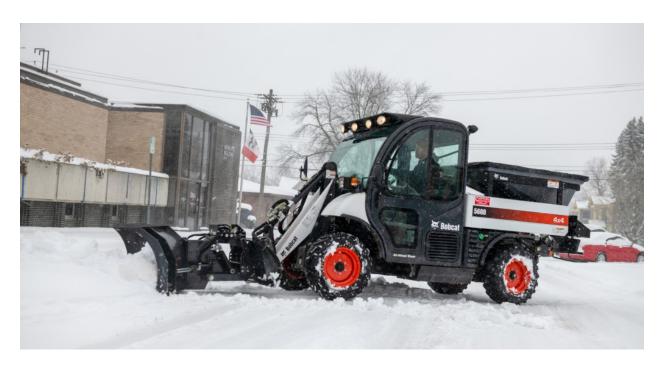
Figure 4.3 Bobcat Toolcat™ with snowplow and salt spreader. (Source: Doosan Group)

Since the city's bike paths and trails are 10 feet wide, the crews typically use Bobcat Toolcat™ vehicles equipped with a wide plow (Figure 4.3). They have also used skid-steer loaders with snow blowers for this purpose. To prevent snow compaction, the city tries to discourage snowmobiles from using the paths and trails.

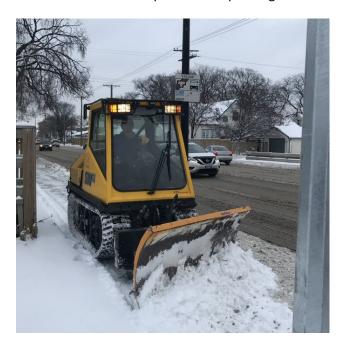
Figure 4.4 Sidewalk snow removal in Winnipeg (Source: City of Winnipeg/Twitter)

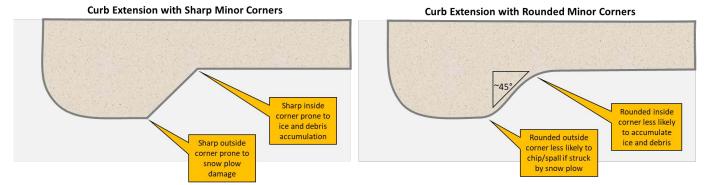
Figure 5.1 Comparison of sharp and rounded minor corners for curb extension (diagram by John Shaw/Iowa State University)

As with curb extensions, all minor corners should be rounded to minimize the risk of damage from snow removal equipment and other vehicles. To avoid creating locations where ice and debris can accumulate, curvilinear longitudinal layouts are preferable to sharp corners and abrupt angles.

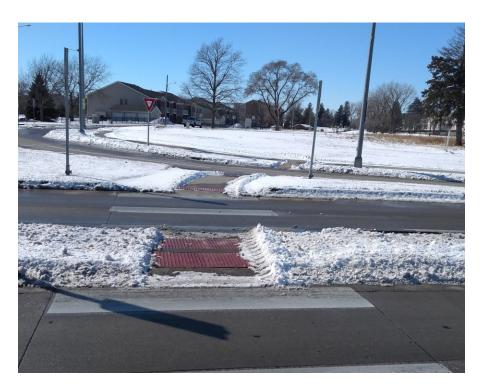
Figure 5.3 Cut-through design for pedestrian walkway across a roundabout splitter island in Ames, IA. (Source: David Veneziano/Iowa State University)

Pedestrian pathways that cross traffic channelization islands (such as median islands, roundabout splitter islands, or "porkchop" islands for free-flow turn lanes) are sometimes overlooked when designing for winter maintainability. Although drainage is usually straightforward when the walkway is above the adjoining road surface, avoiding ponding and refreeze can be challenging when a walkway cuts through an island, as in Figure 5.3. To provide sufficient hydraulic capacity at the correct elevation, it is sometimes necessary to install an inlet on the pedestrian walkway or to use a trench drain or slot drain. In other cases, a small gutter can be installed parallel to the walkway to intercept meltwater.
