Report No. FHWA-RD-78-109

**TECHNIQUES FOR REHABILITATING PAVEMENTS WITHOUT OVERLAYS –  
A SYSTEMS ANALYSIS**

**Vol. 2 Appendixes**

**FEDERAL HIGHWAY ADMINISTRATION**

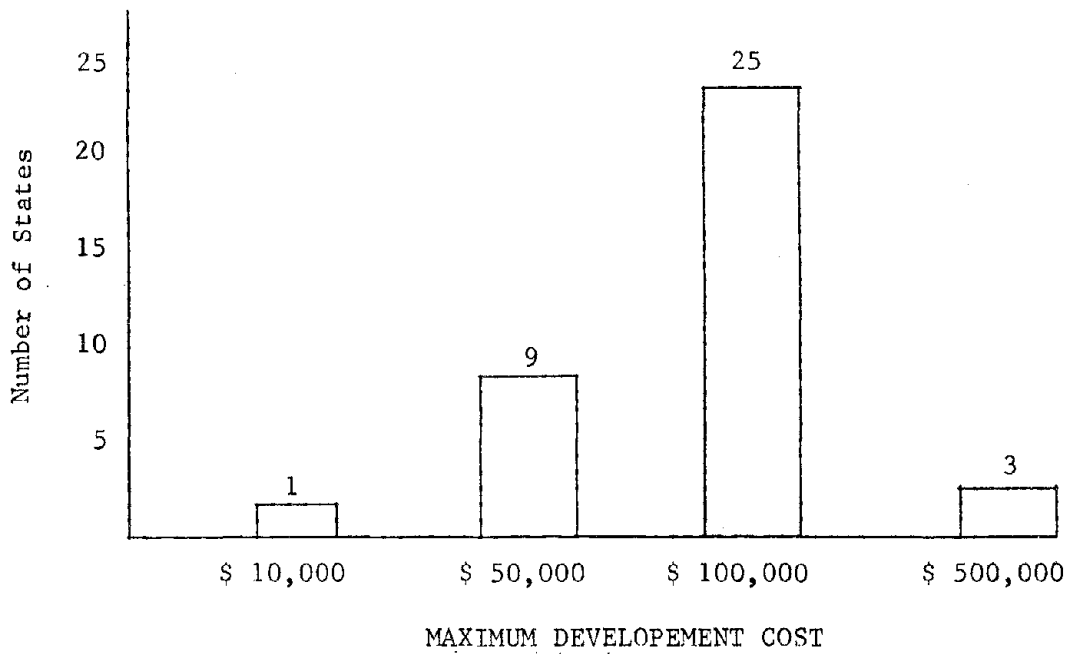
Figure A-1. States Opinion on Maximum Development Cost a Contractor Would Pay for Rehabilitation Equipment.

done to provide some guidance and help with data analysis. Unfortunately they also assuredly influenced the opinions - perhaps to the point where the results are meaningless. What is the upper limit on development cost for a new piece of rehabilitation equipment? Perhaps, the answer is obvious; not so high that the investor does not have a good chance of receiving a minimum attractive rate of return on his investment!

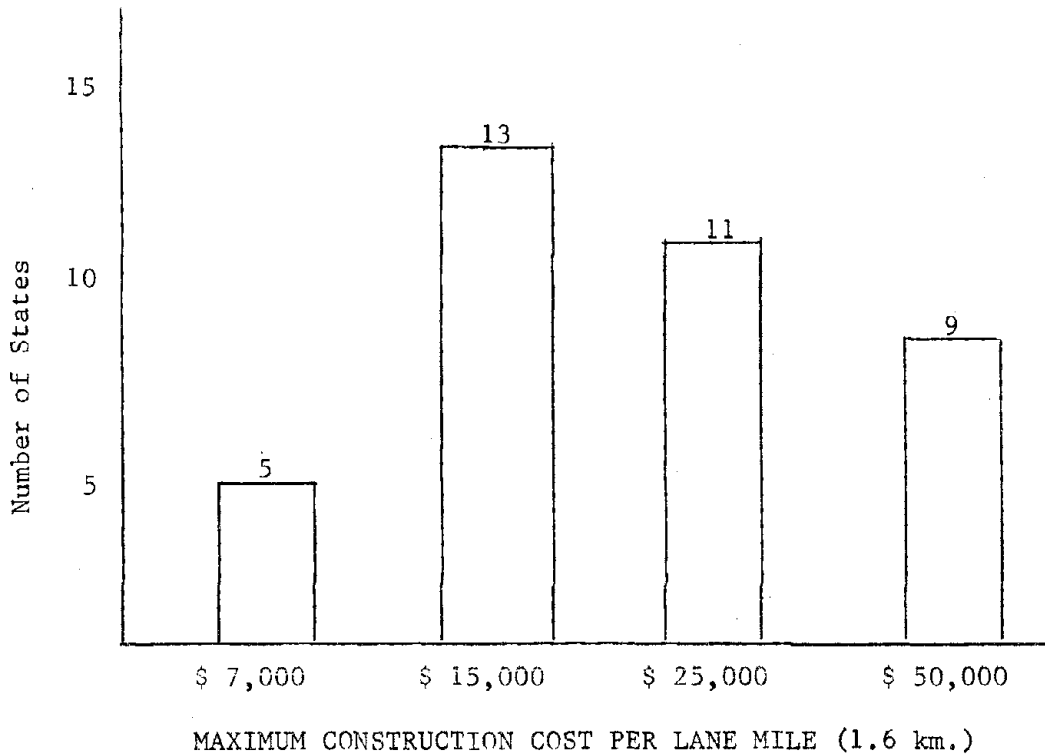
Figure A-2. States Opinion on Maximum Construction Cost Per Lane Mile for Good Rehabilitation Technique.

Even though suggested numbers were supplied for maximum construction costs, the data should reflect the vast experience of the responders. Here a wide variety of opinions exist with 9 states feeling that \$50,000 per lane mile (1.6 km) could be justified for a top technique that would restore the pavement to its original condition, while 29 states felt \$50,000 would be too high. This gives some valuable guidance on the value of potential techniques that involve major construction costs.

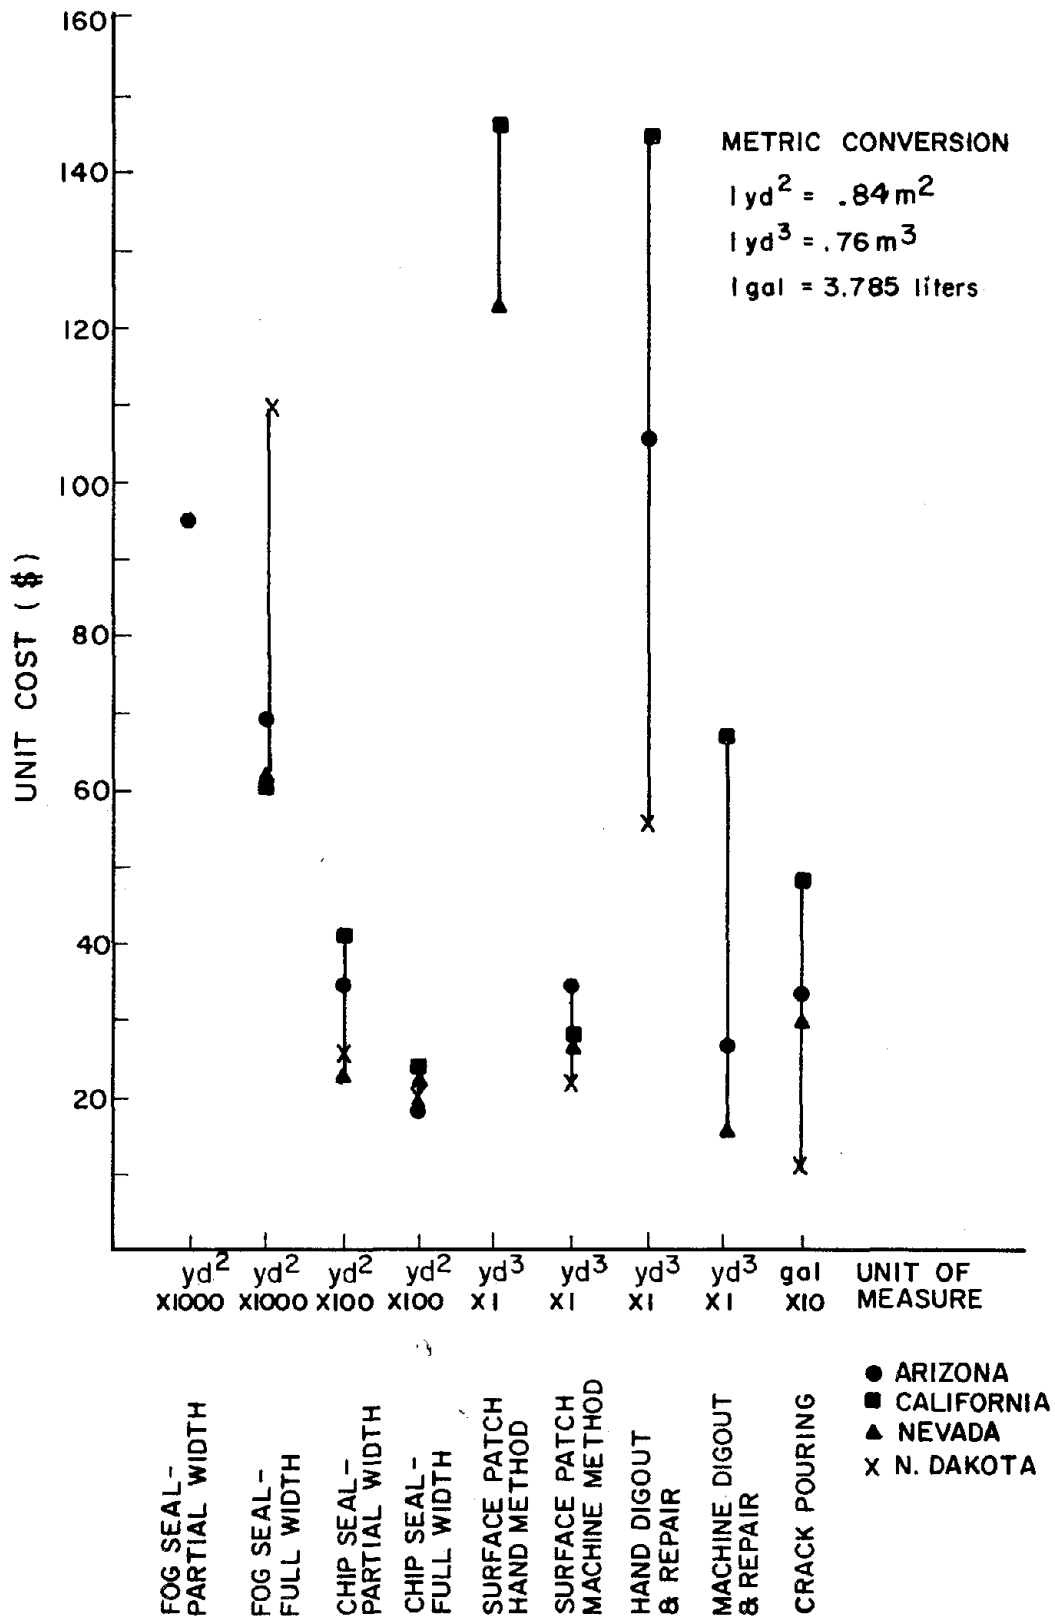
Figure C-1. Ranges in flexible pavement unit costs.

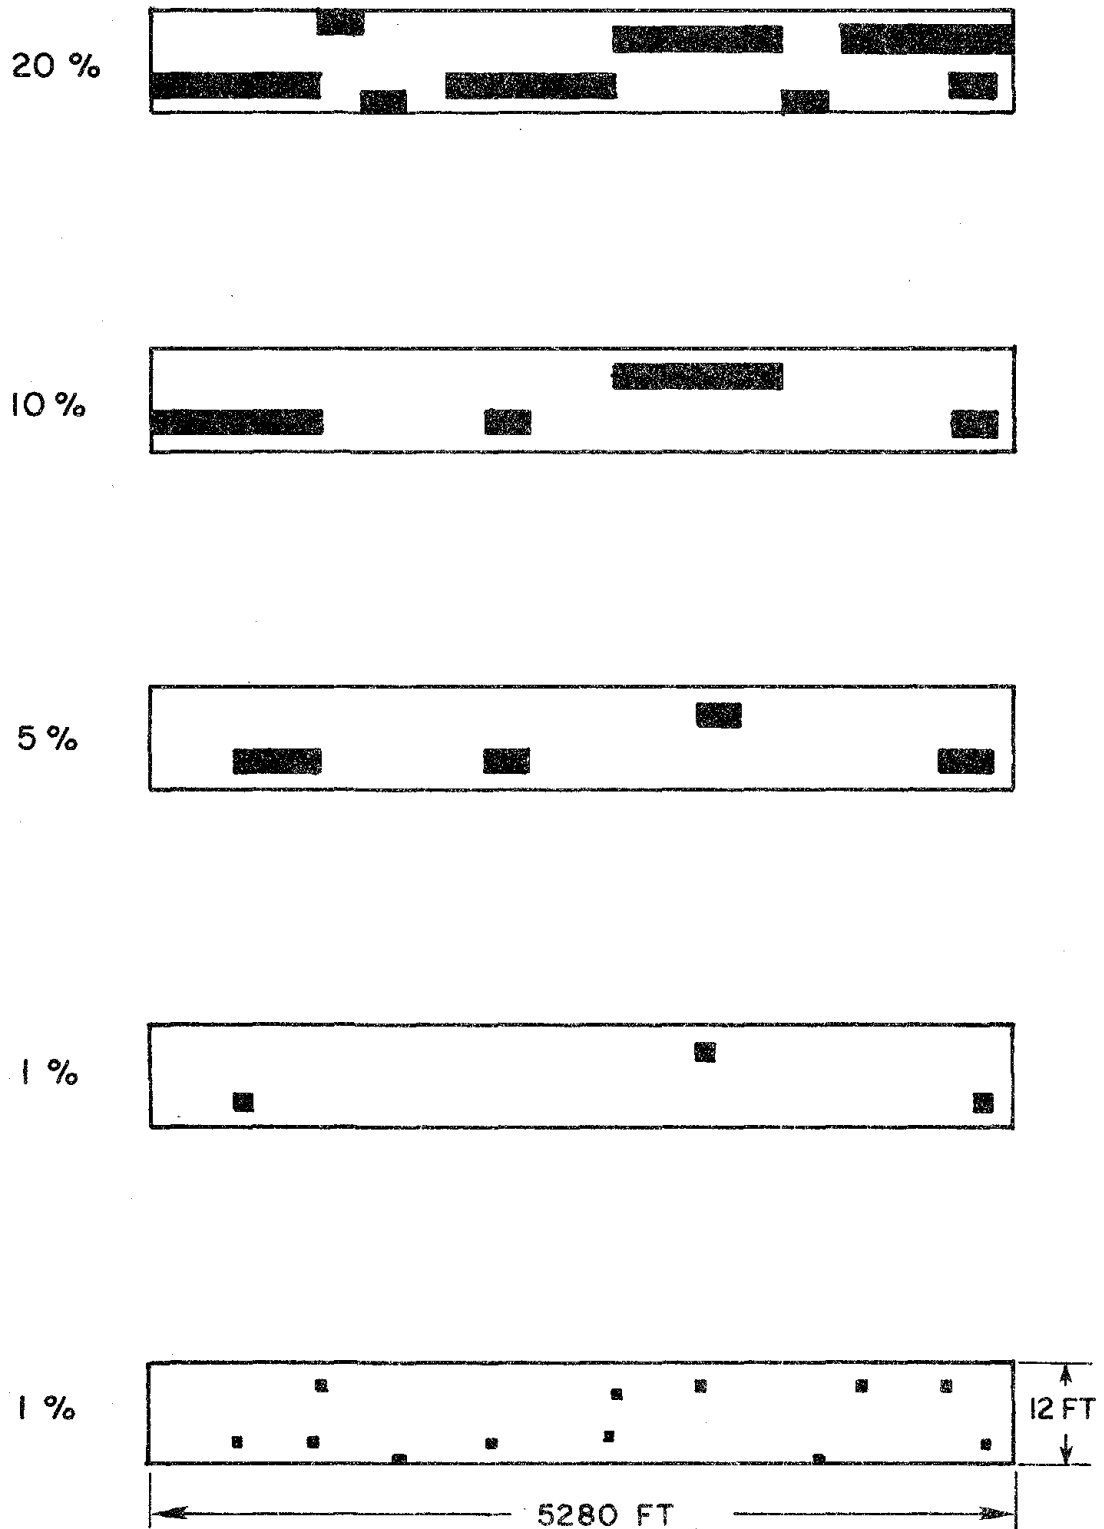
Figure C-2. Graphic representation of area to be repaired.  
 (Metric conversion: 1 ft = 0.3 m)

based on experience, were utilized to alter average unit costs when very small or very large areas of the pavement were treated with a particular maintenance activity. For information purposes, the approximate pavement condition has been estimated in each case, in terms of distress type, distress severity, and distress extent. This condition is in the form of deduct points, as described in reference (C-12). The overall pavement condition is represented by a number from 0 to 100, where 100 represents a distress-free pavement. The deduct points are to be subtracted from 100 (or some existing initial value less than 100) and thus the more extensive the maintenance the higher the deduct points. These deduct points are shown on each figure.

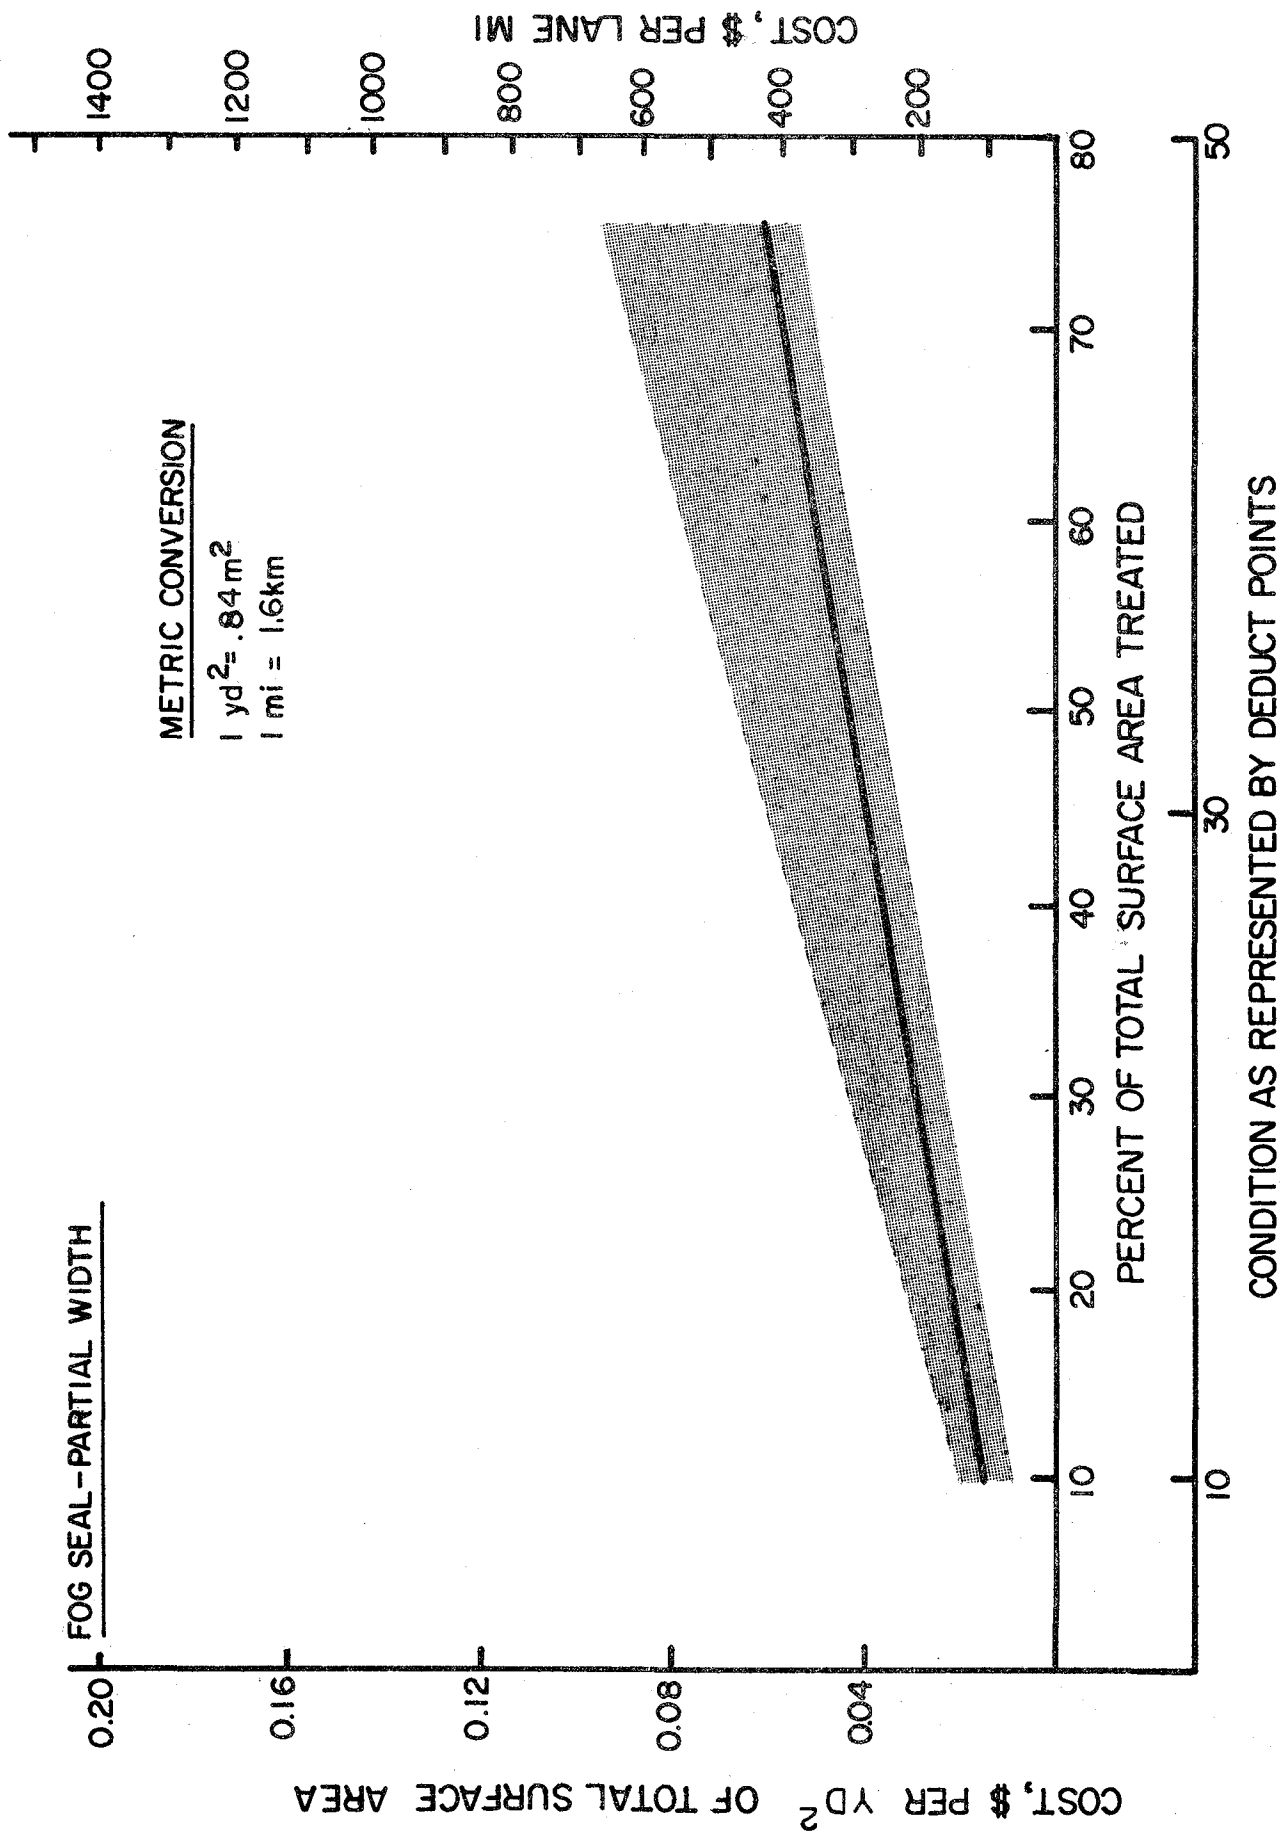
Figure C-3. Representative maintenance costs for partial width fog seal.

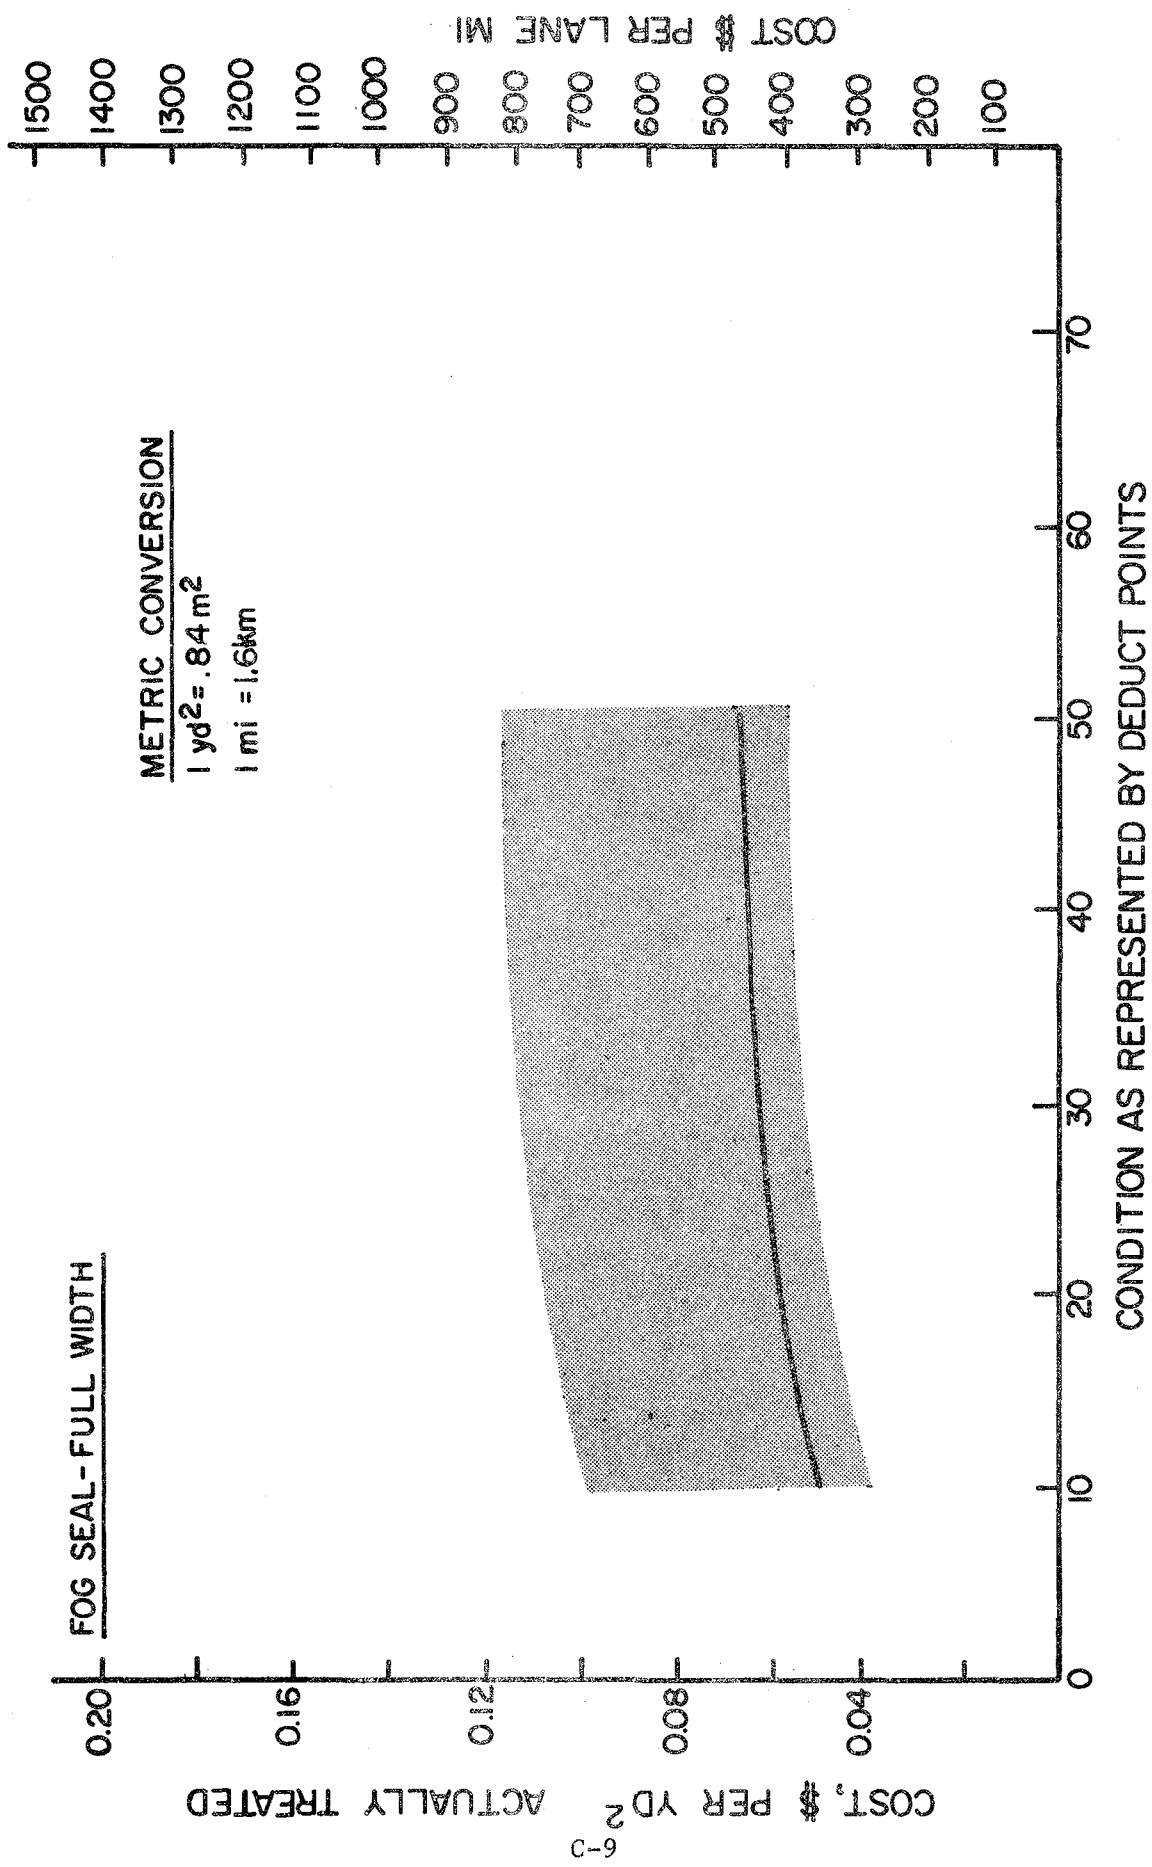
Figure C-4. Representative maintenance costs for full width fog seal.

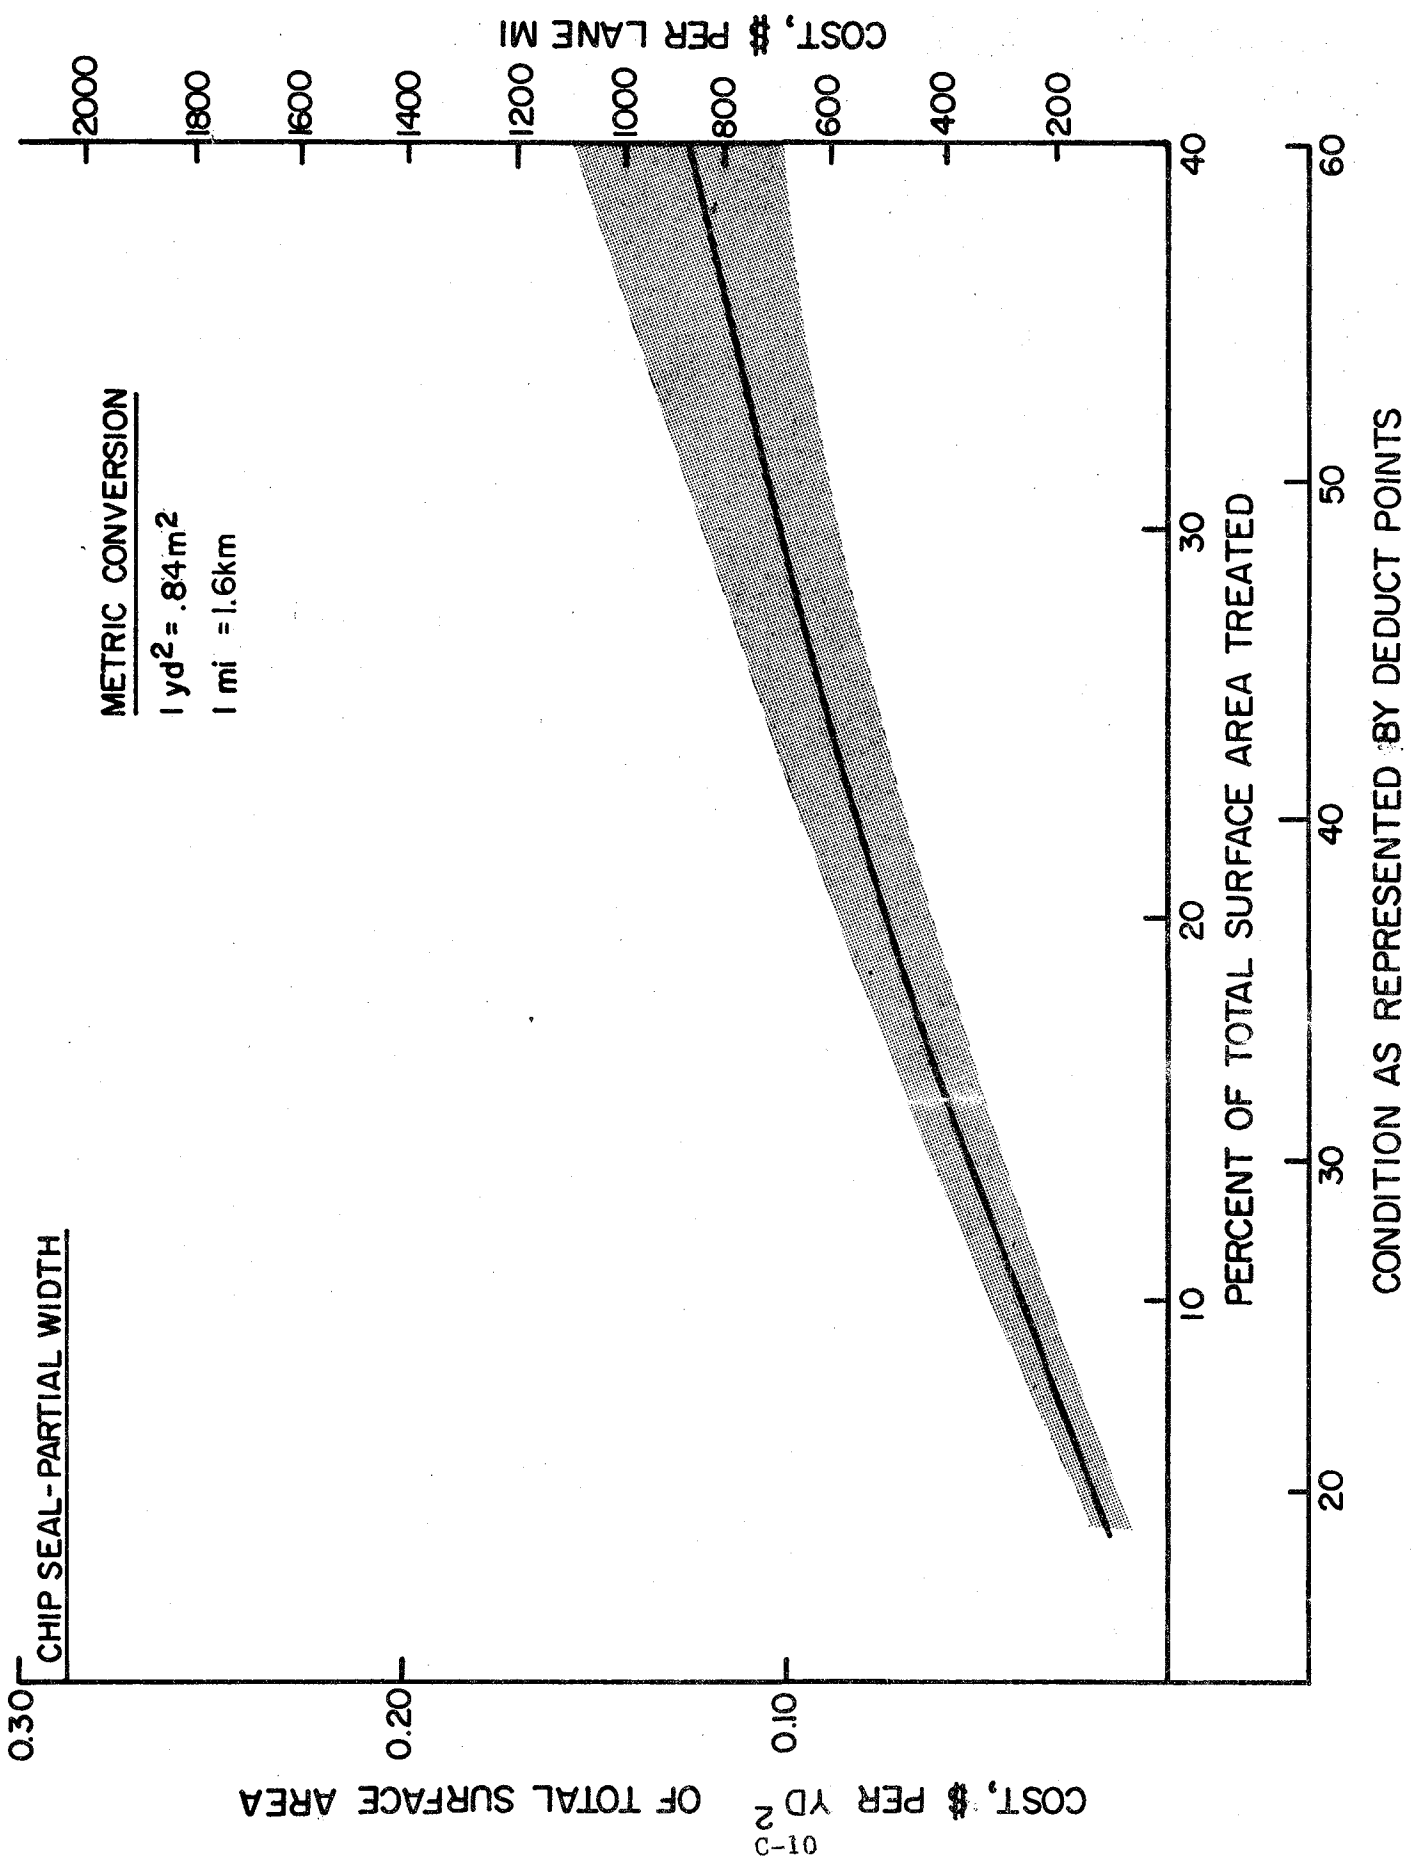
Figure C-5. Representative maintenance costs for partial width chip seal.

Chip Seal - Partial Width. Costs for various percentages of the pavement surface area treated are shown in Figure C-5. An average unit costs of \$0.35 per  $\text{yd}^2$  (\$0.42 per  $\text{m}^2$ ) is the basis for the relationship represented in this Figure.

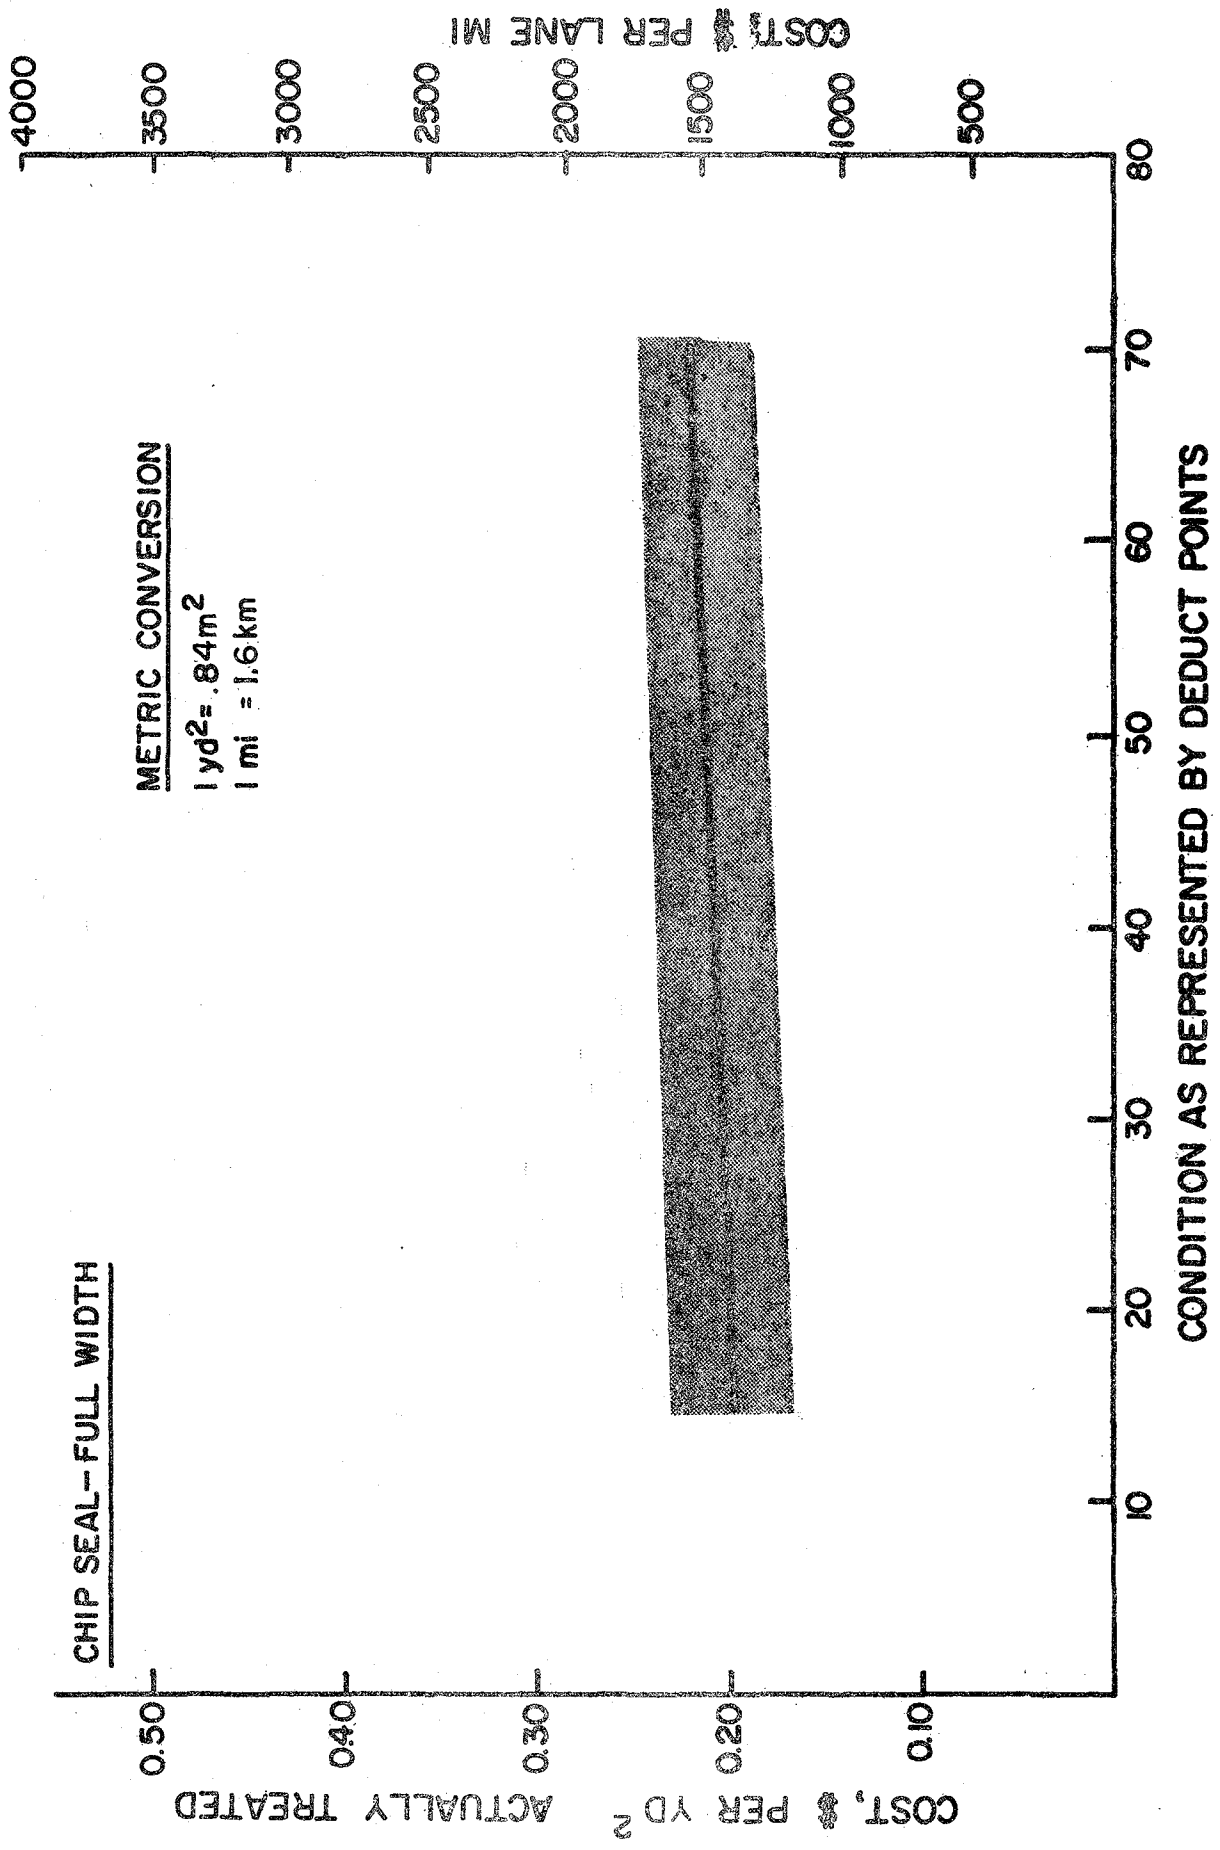
Figure C-6. Representative maintenance costs for full width chip seal.

Chip Seal - Full Width. Costs for various pavement conditions are shown in Figure C-6. An average unit cost of \$0.21 per yd<sup>2</sup> (\$0.25 per m<sup>2</sup>) was used as the basis for this relationship. An appropriate cost adjustment was made for pavements requiring additional asphalt due to their surface condition. Some states placing chip seals under contract have experienced unit costs of the order of \$0.35 per yd<sup>2</sup> to \$0.40 per yd<sup>2</sup> (\$.42 to \$0.48 per m<sup>2</sup>).

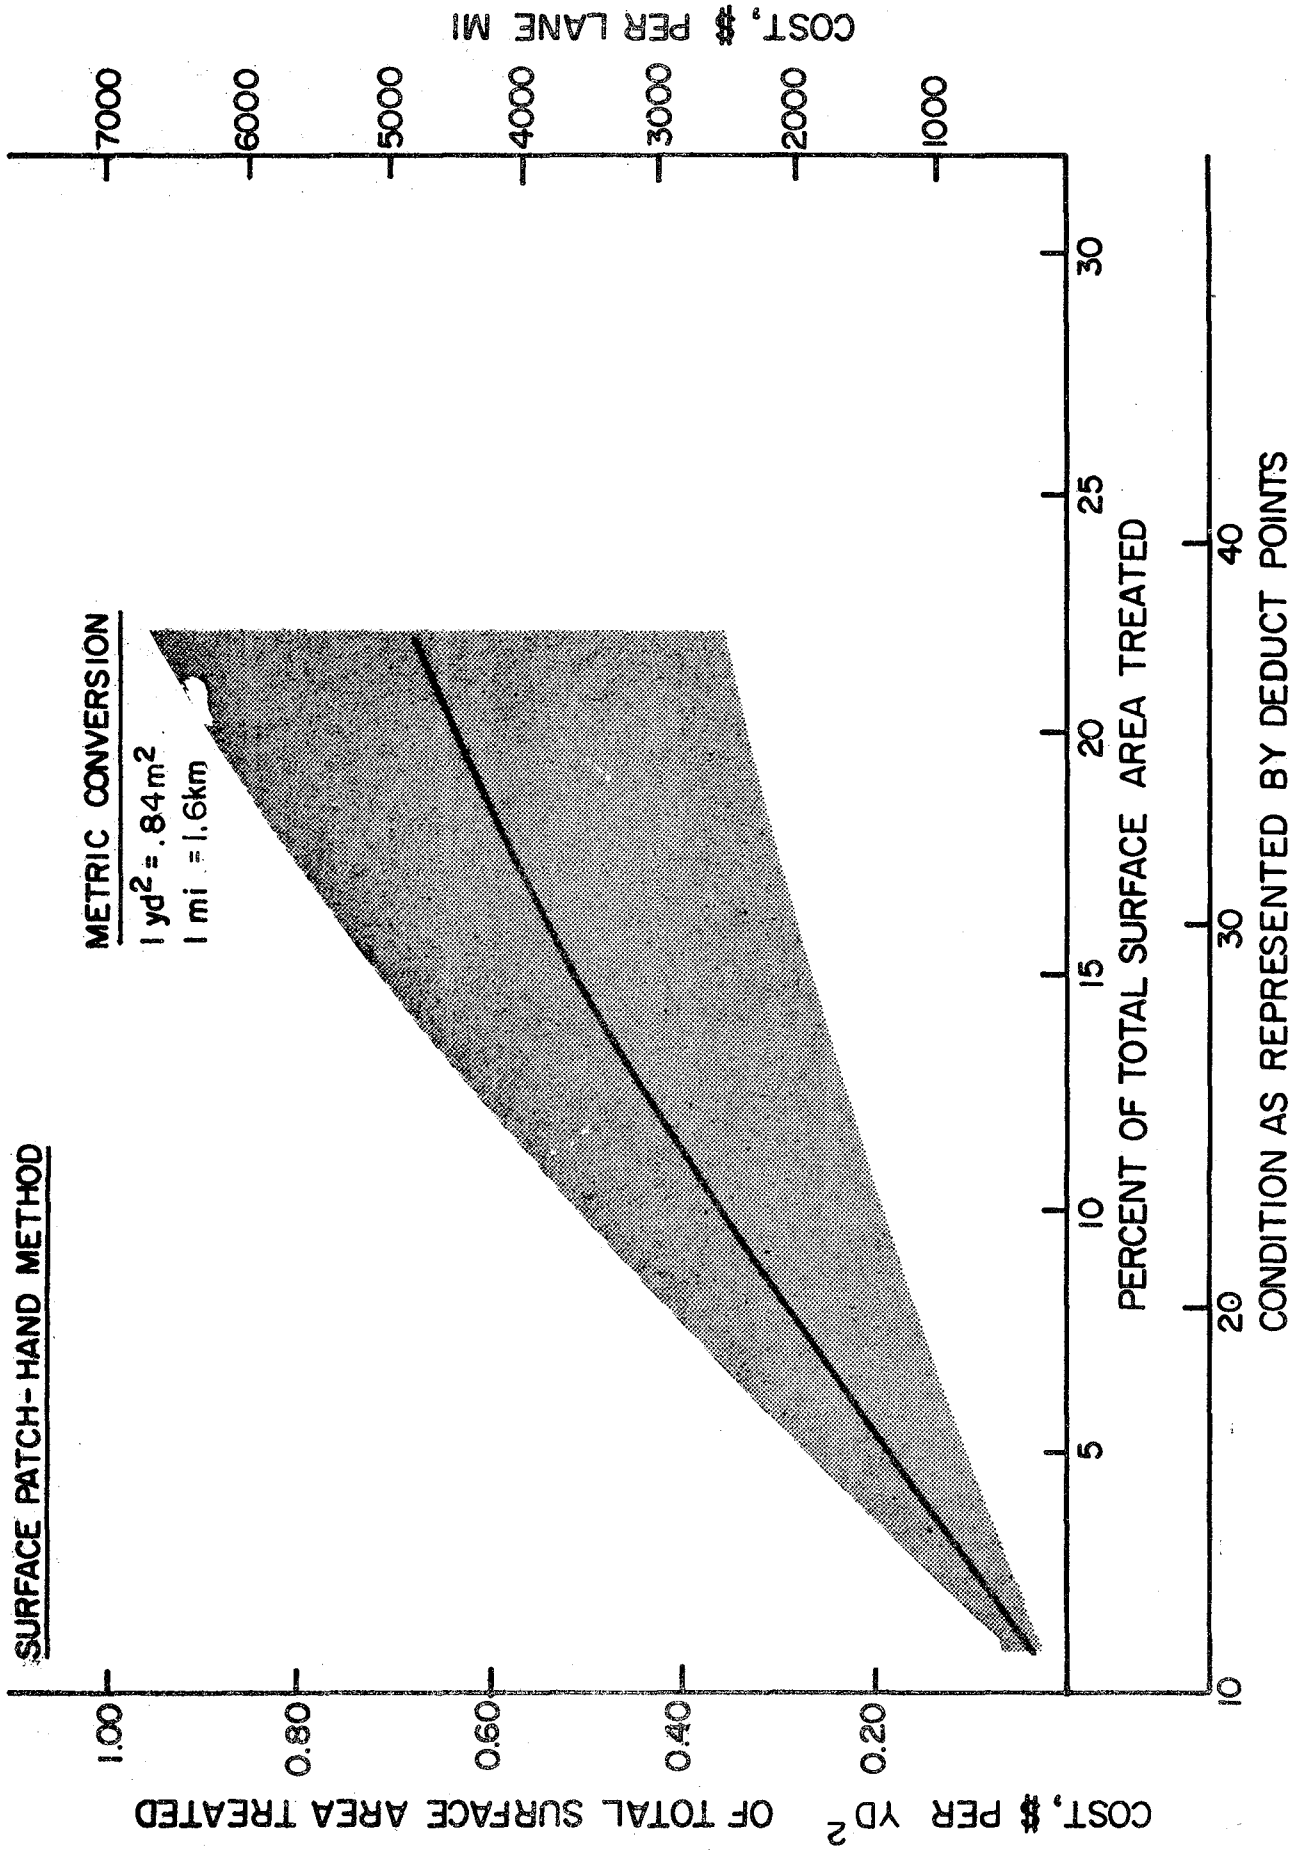
Figure C-7. Representative maintenance costs for hand surface patch.

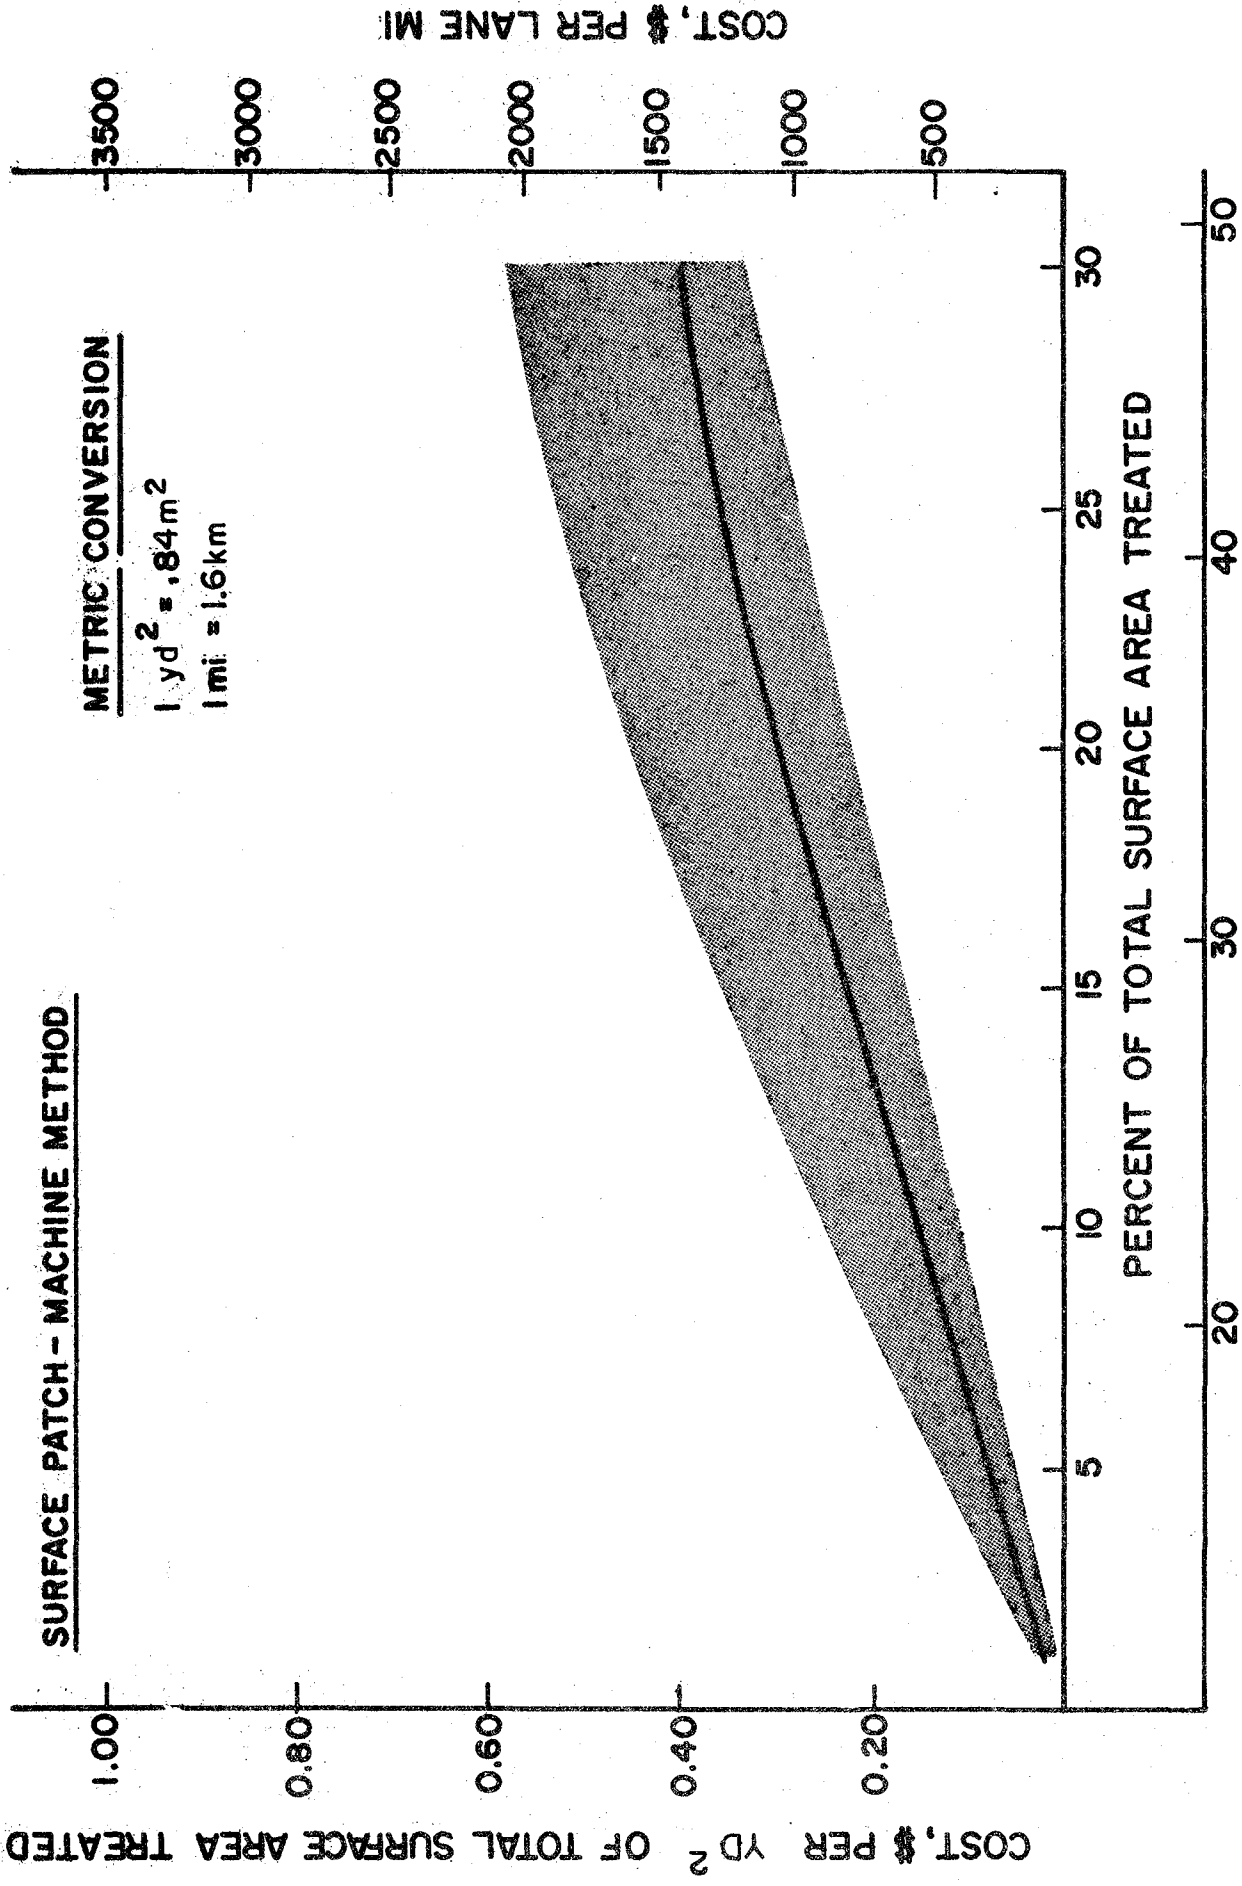
Figure C-8. Representative maintenance costs for machine surface patch.

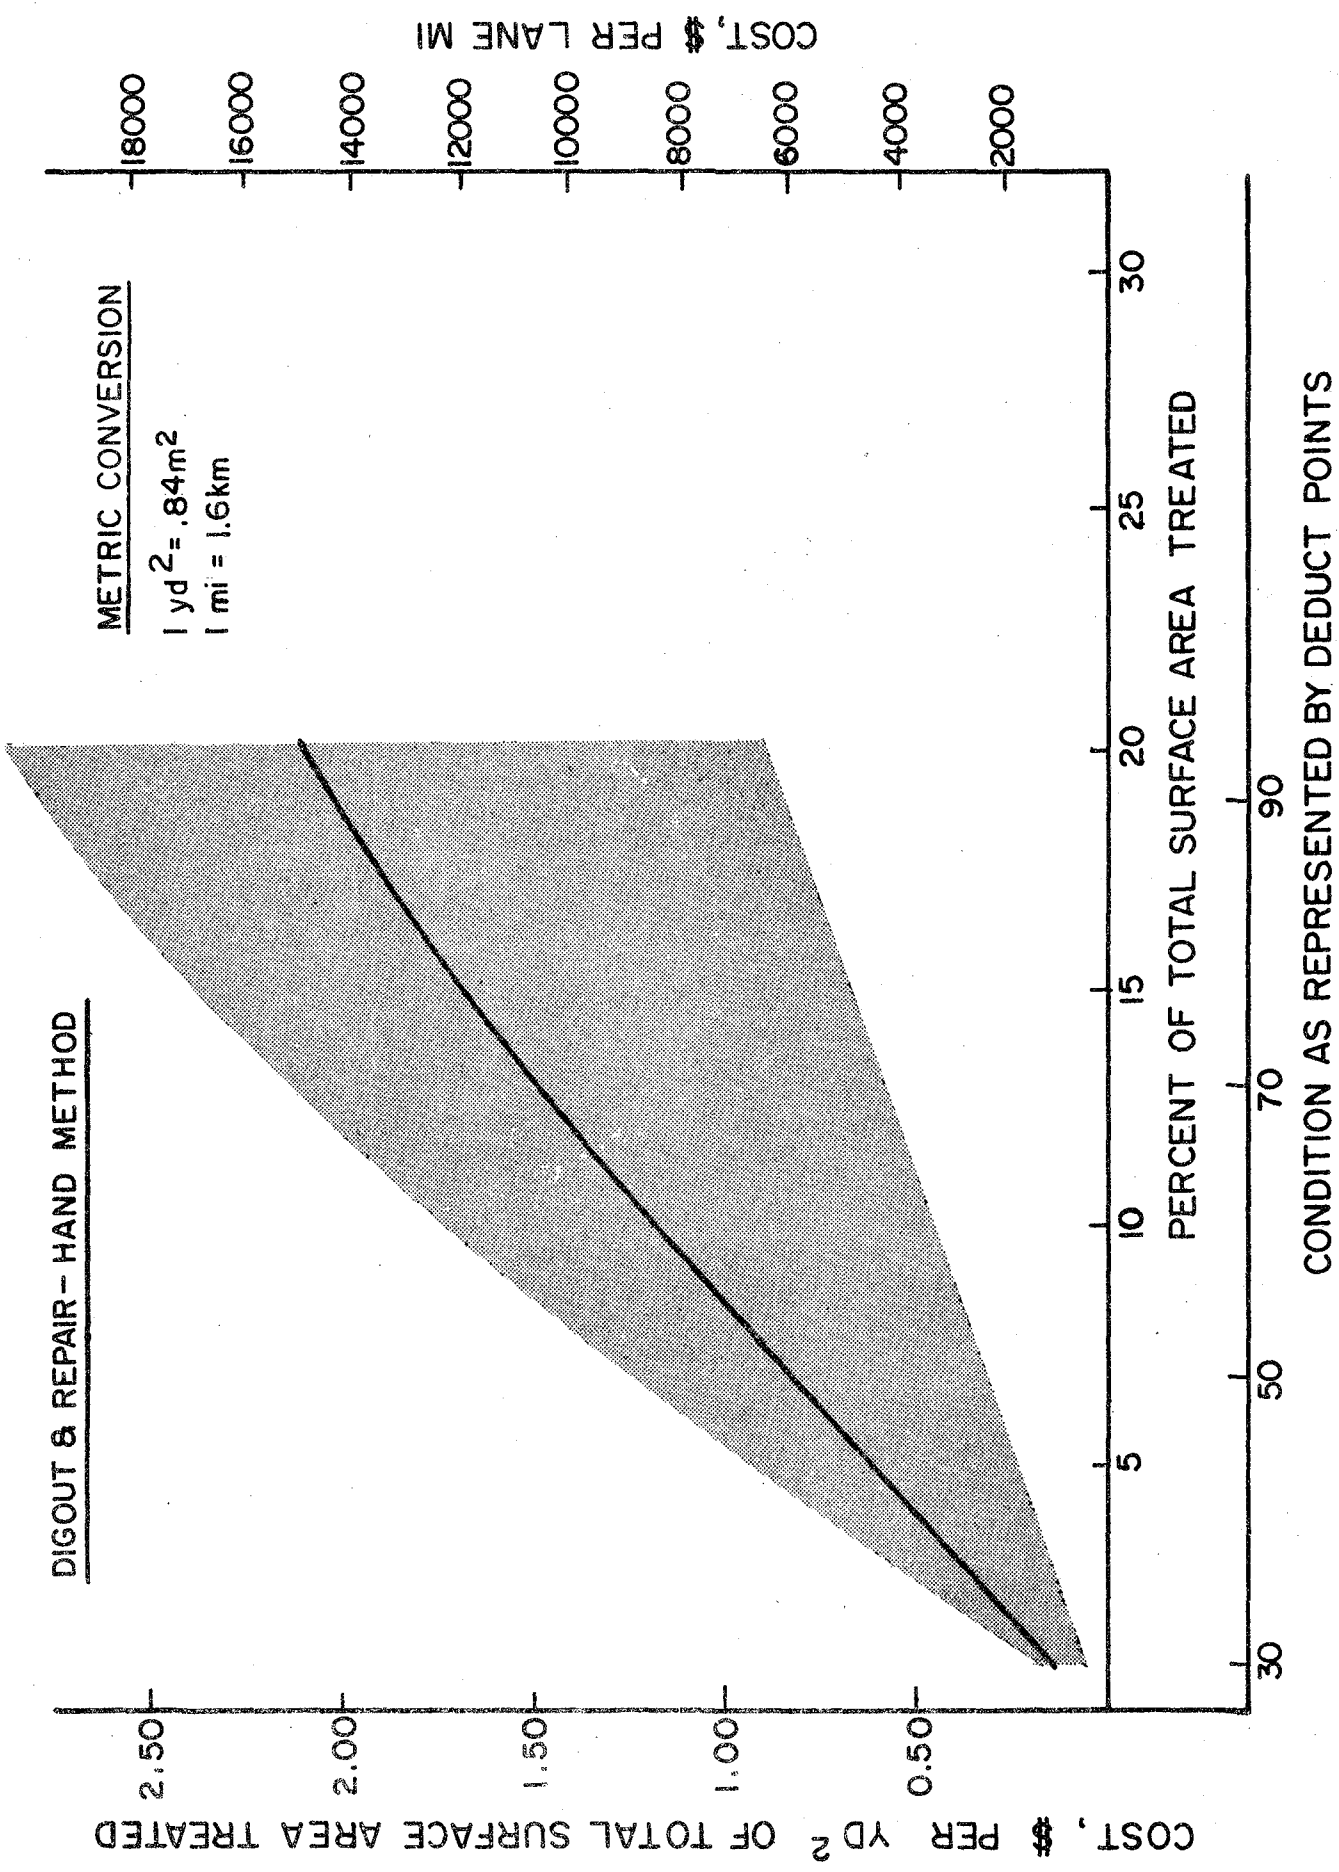
Figure C-9. Representative maintenance costs for hand digout and repair.
