Report No. FHWA-RD-78-109

**TECHNIQUES FOR REHABILITATING PAVEMENTS WITHOUT OVERLAYS –  
A SYSTEMS ANALYSIS**

**Vol. 2 Appendixes**

**FEDERAL HIGHWAY ADMINISTRATION**

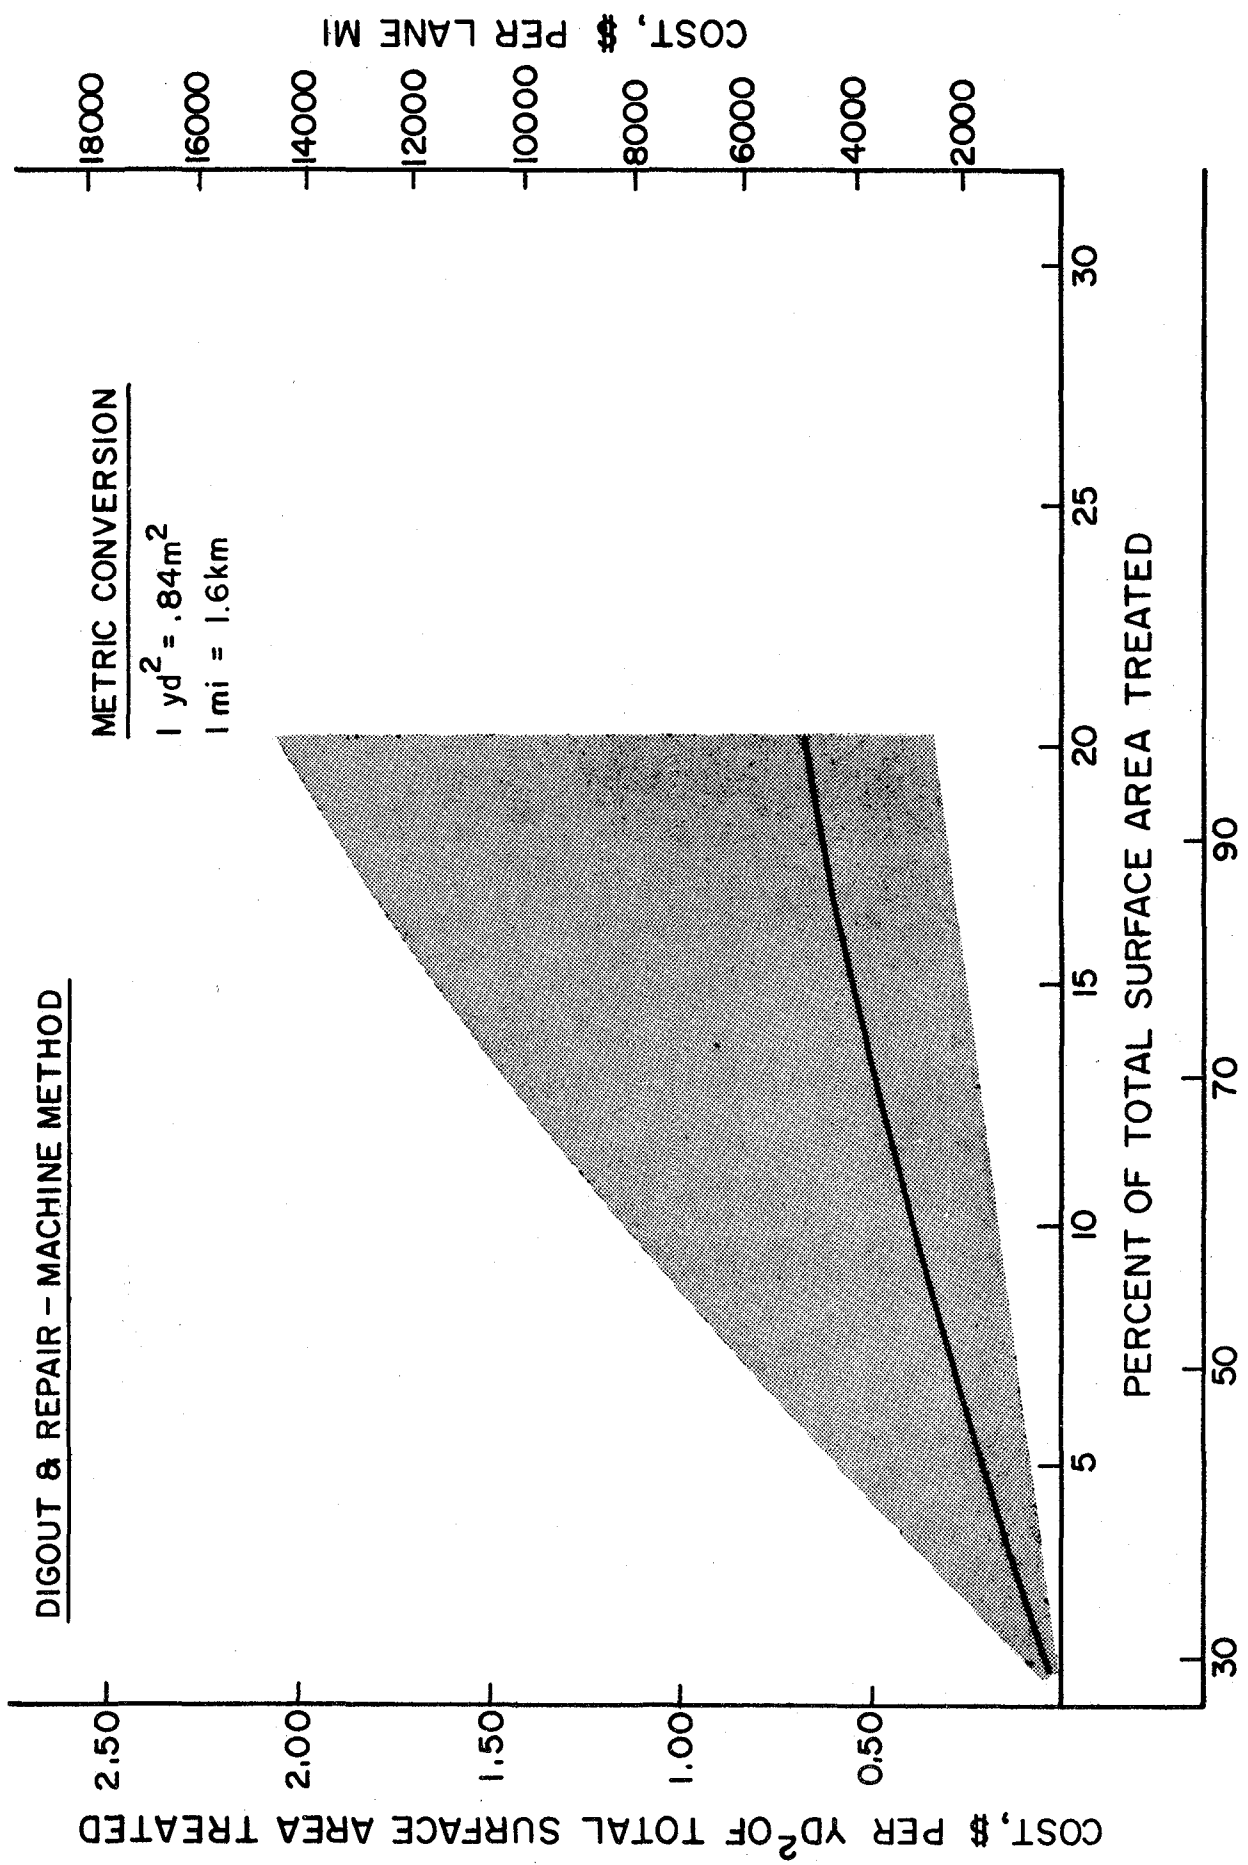
Figure C-10. Representative maintenance costs for machine digout and repair.

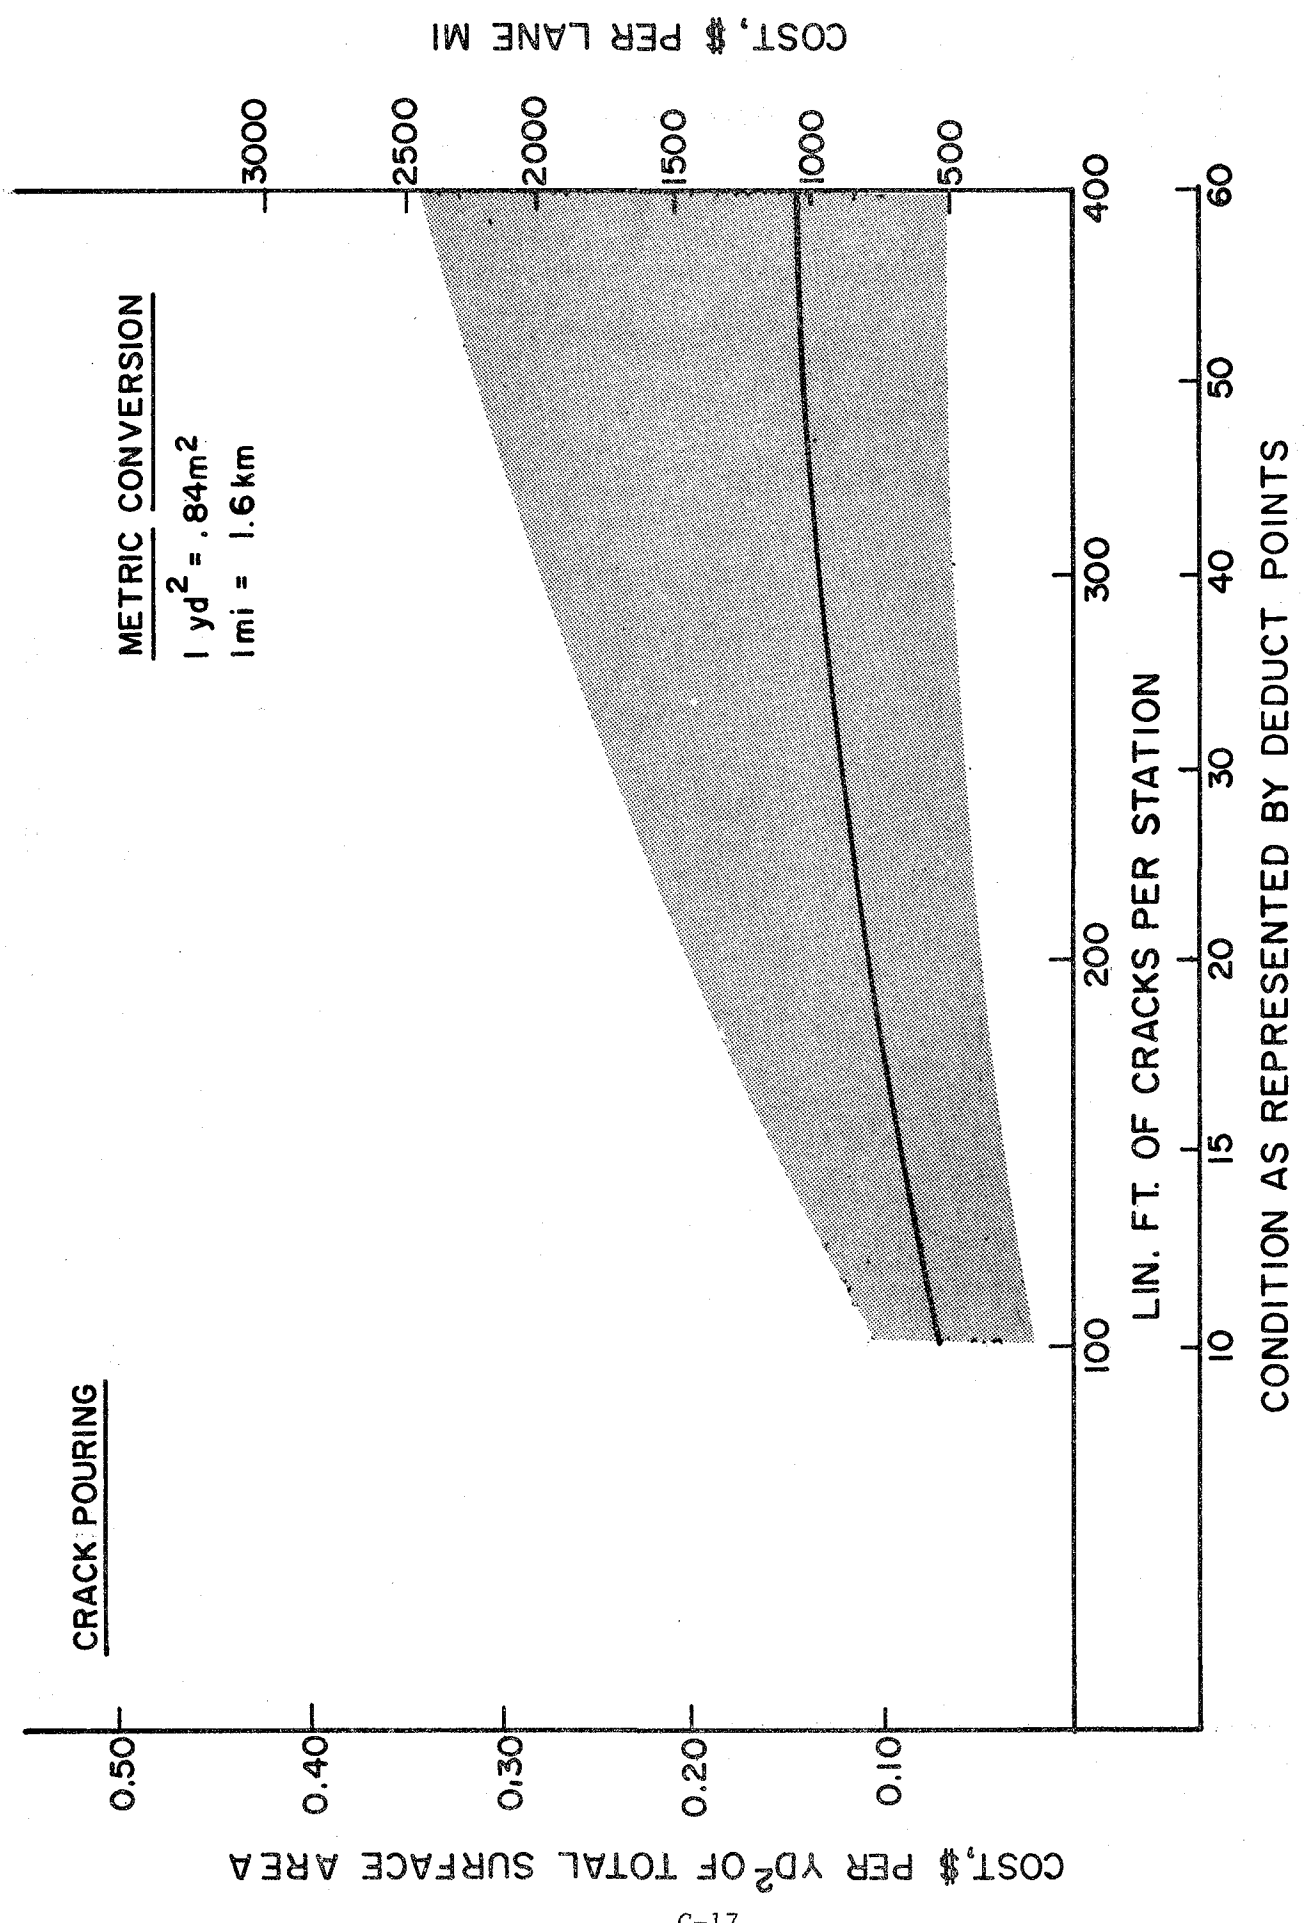
Figure C-11. Representative maintenance costs for crack pouring.

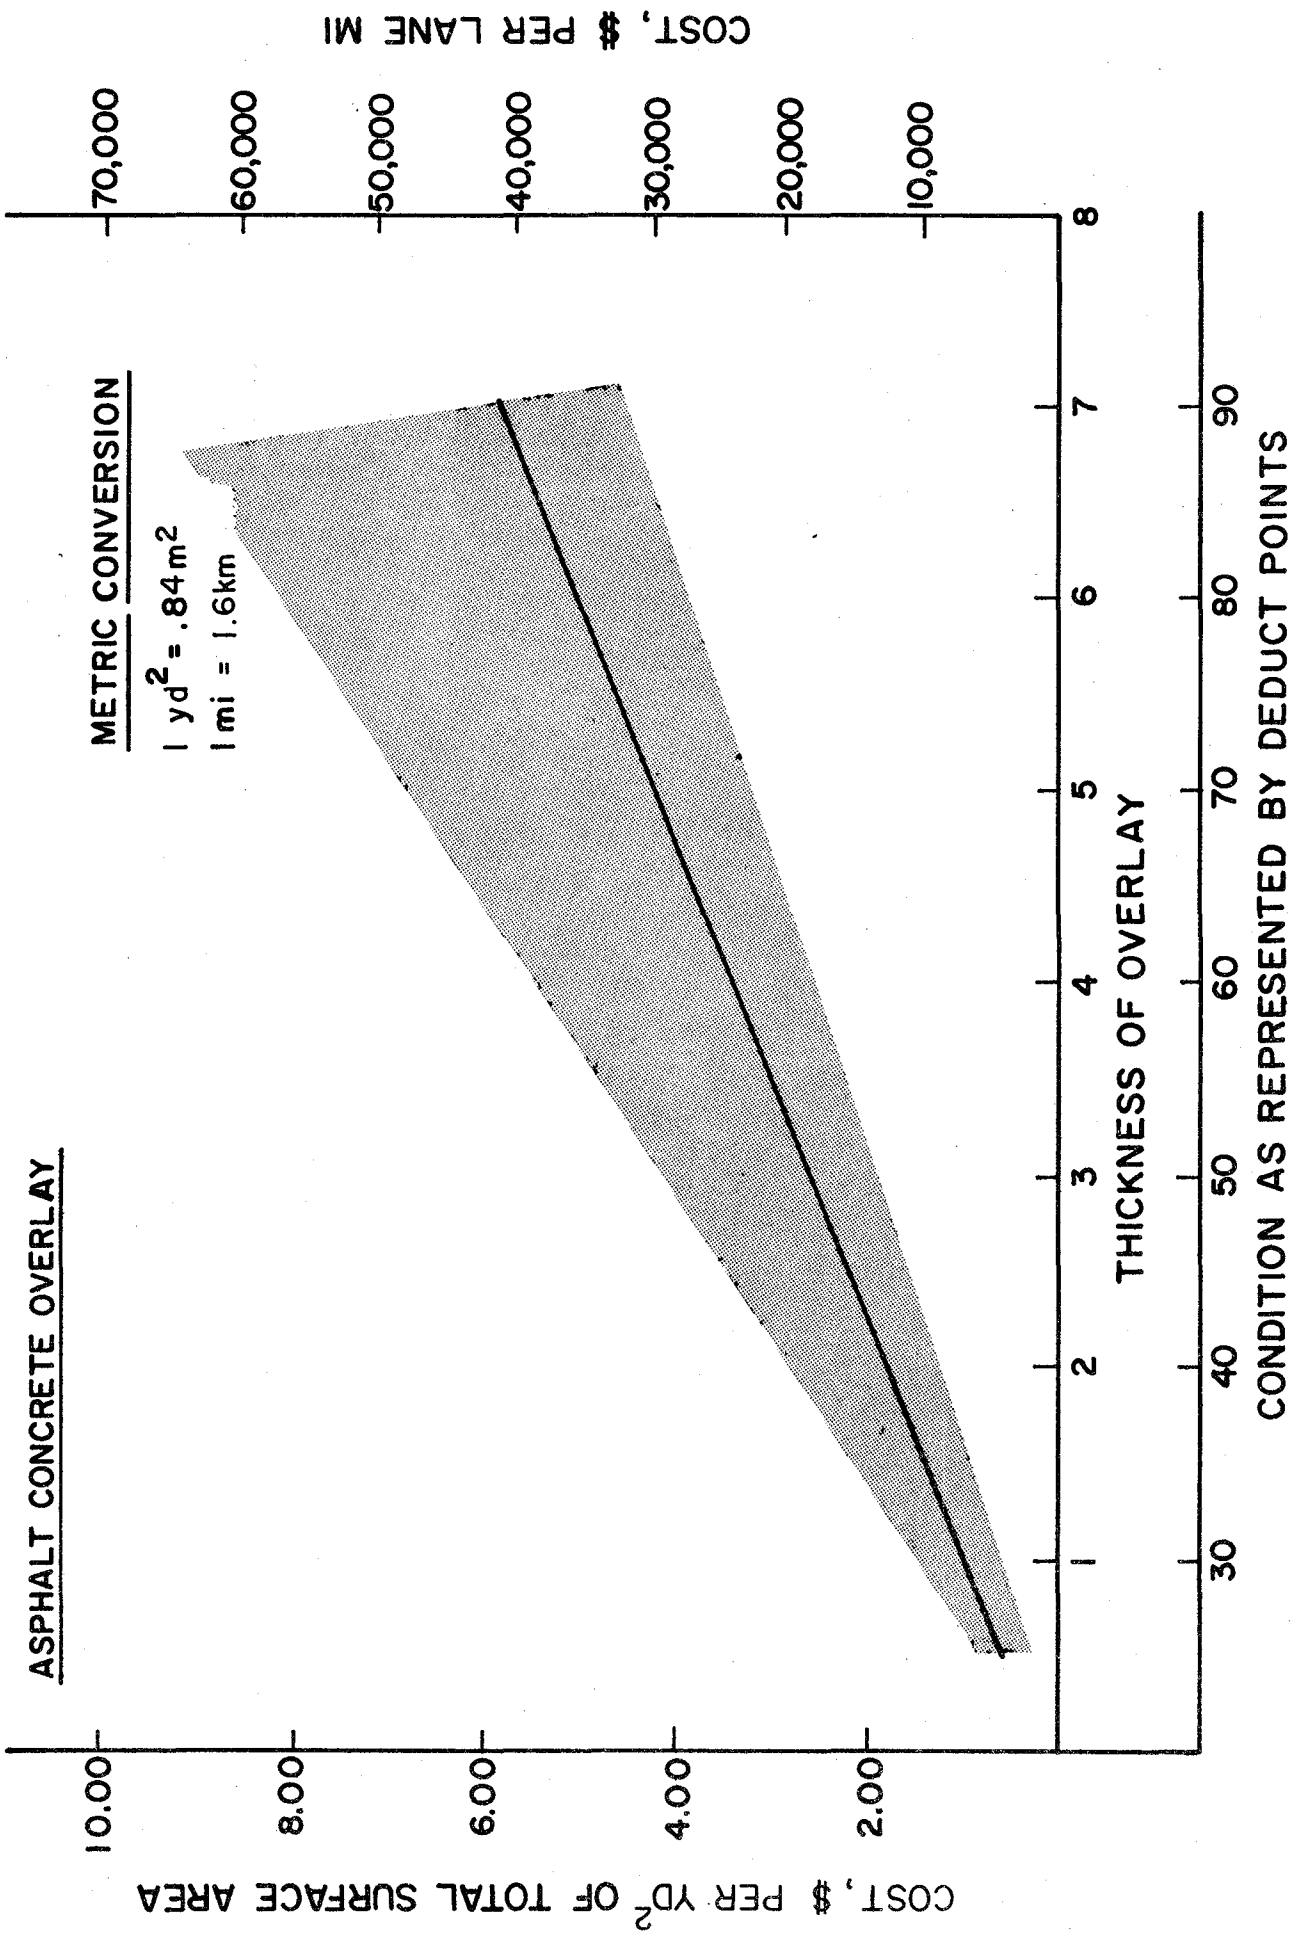
Figure C-12. Representative maintenance costs for asphalt concrete overlay.

Asphalt Concrete Overlay. Costs for the placement of various thicknesses of asphalt concrete are shown on Figure C-12. An average unit cost of \$16/ton or \$31.30/yd<sup>3</sup> (\$.018/kg or \$40.90/m<sup>3</sup>) was used as the basis for this relationship. Overlay costs of the order of \$20/ton (\$.022/kg) are

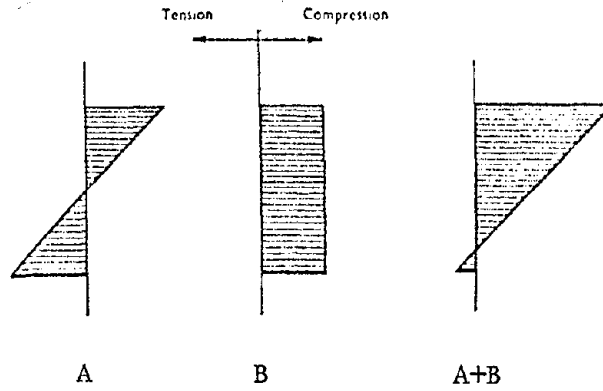
- A. Stress Distribution Across at Concrete Section Due to Applied Bending Moment.
- B. Stress Distribution Due to a Uniform Prestress.
- A+B. Resultant, Actual Stress Distribution Showing a Stress Shift.

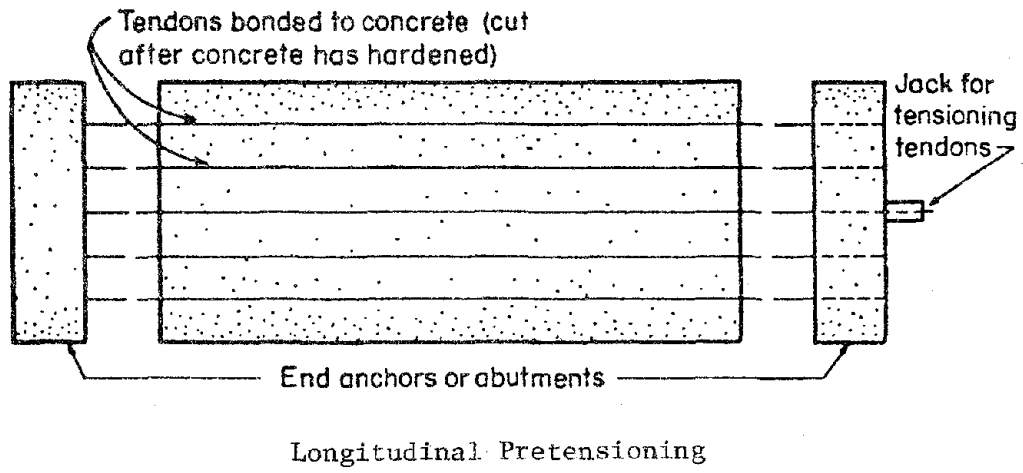
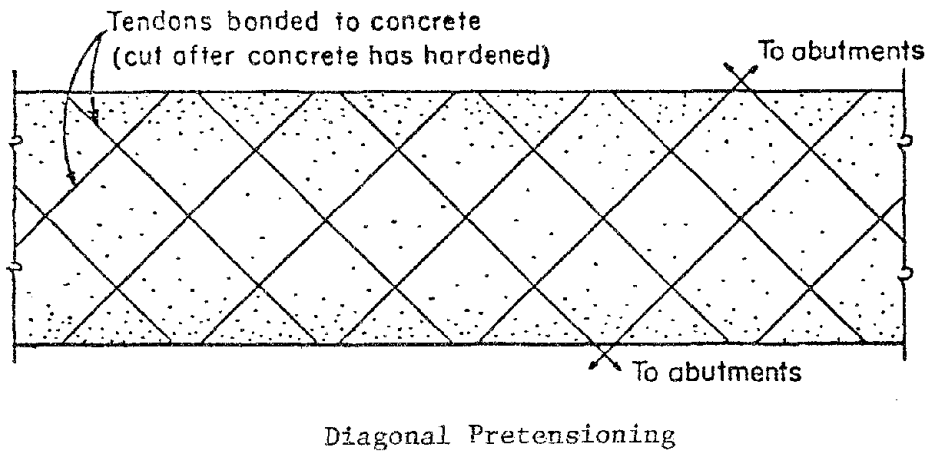
Figure D-2. Two Pretensioning Methods.

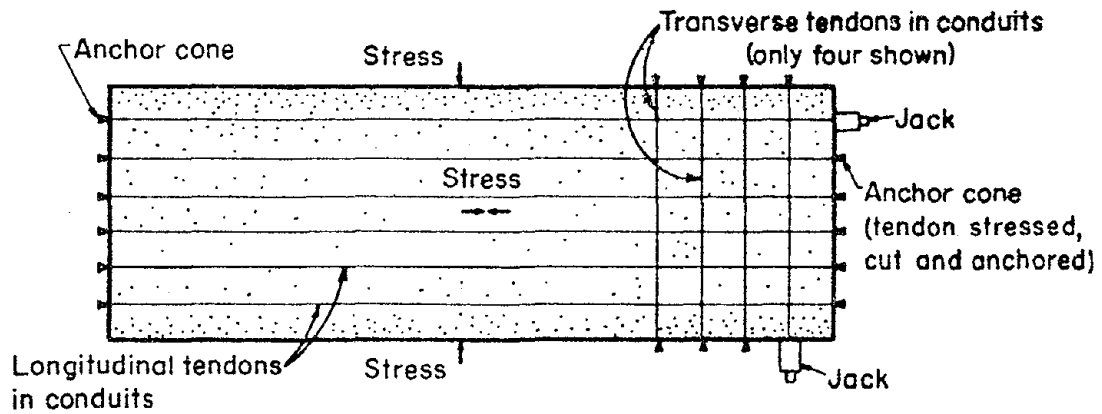
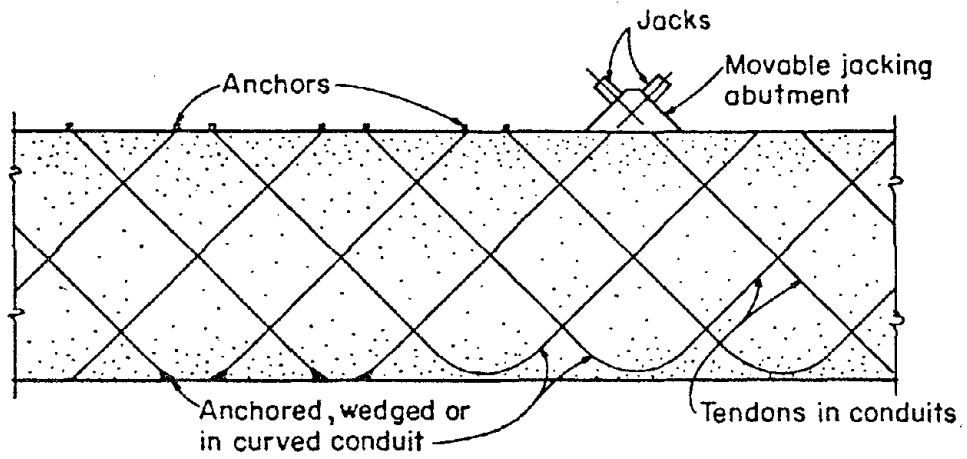
Longitudinal Post-Tensioning

Diagonal Post-Tensioning

Figure D-3. Two Post-Tensioning Methods.

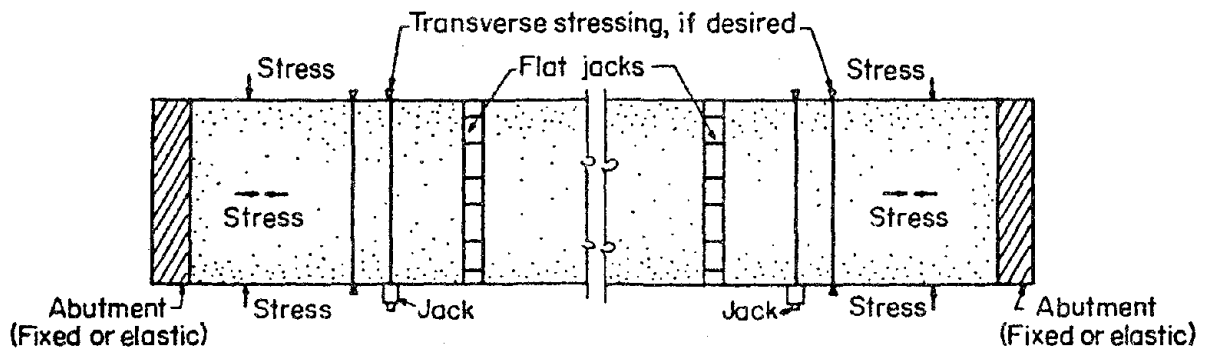
Figure D-4. Typical Longitudinal Poststressing Method.

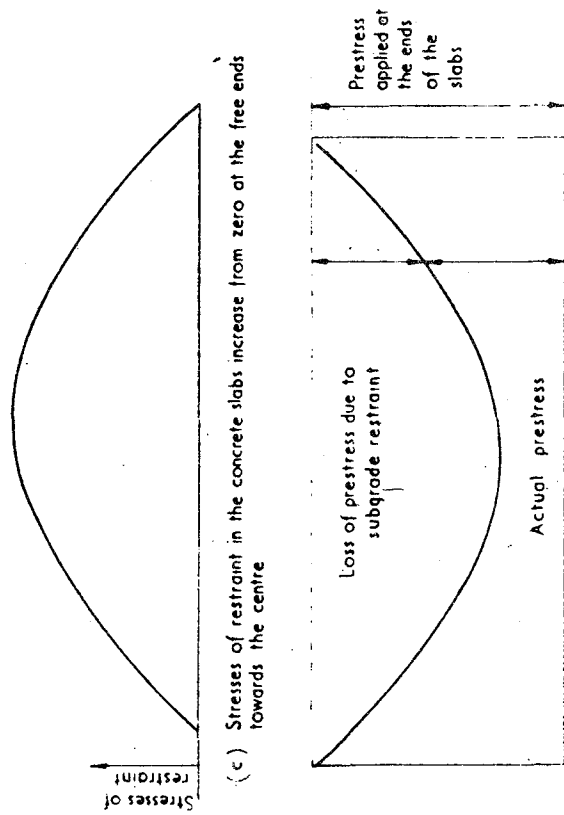
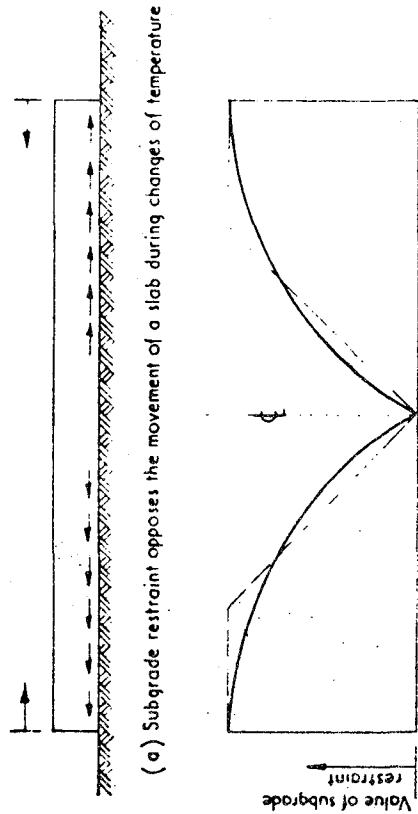
(d) The actual prestress along the slab is due to the combined effects of the applied prestress and subgrade restraint

FIGURE D-5. Effect of Subgrade Restraint on the Prestress in a Concrete Slab.

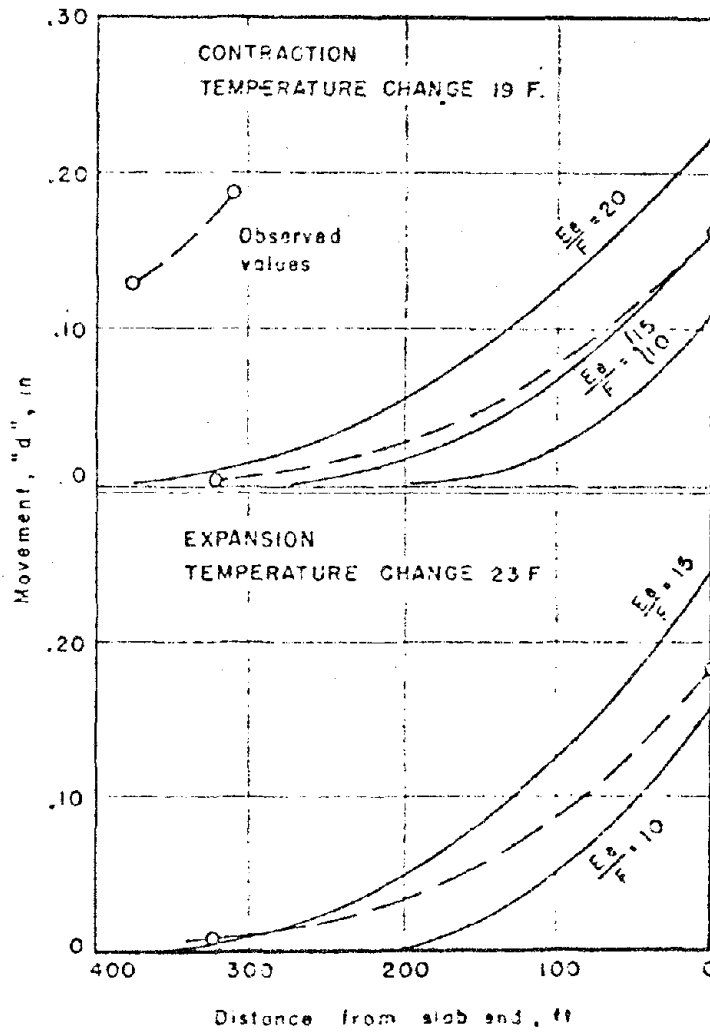
FIGURE D-6. Actual And Calculated Slab Movements At Stilesville For 19°F (11°C) and 23°F (13°C) Temperature Change.

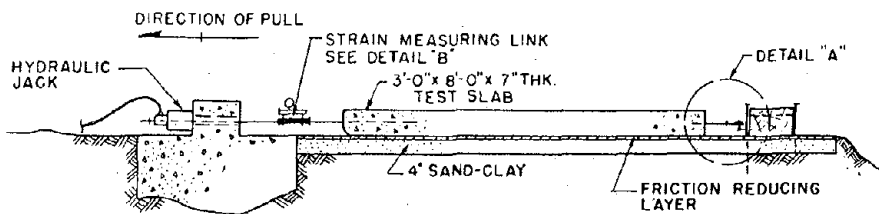
ELEVATION OF FRICTION TEST

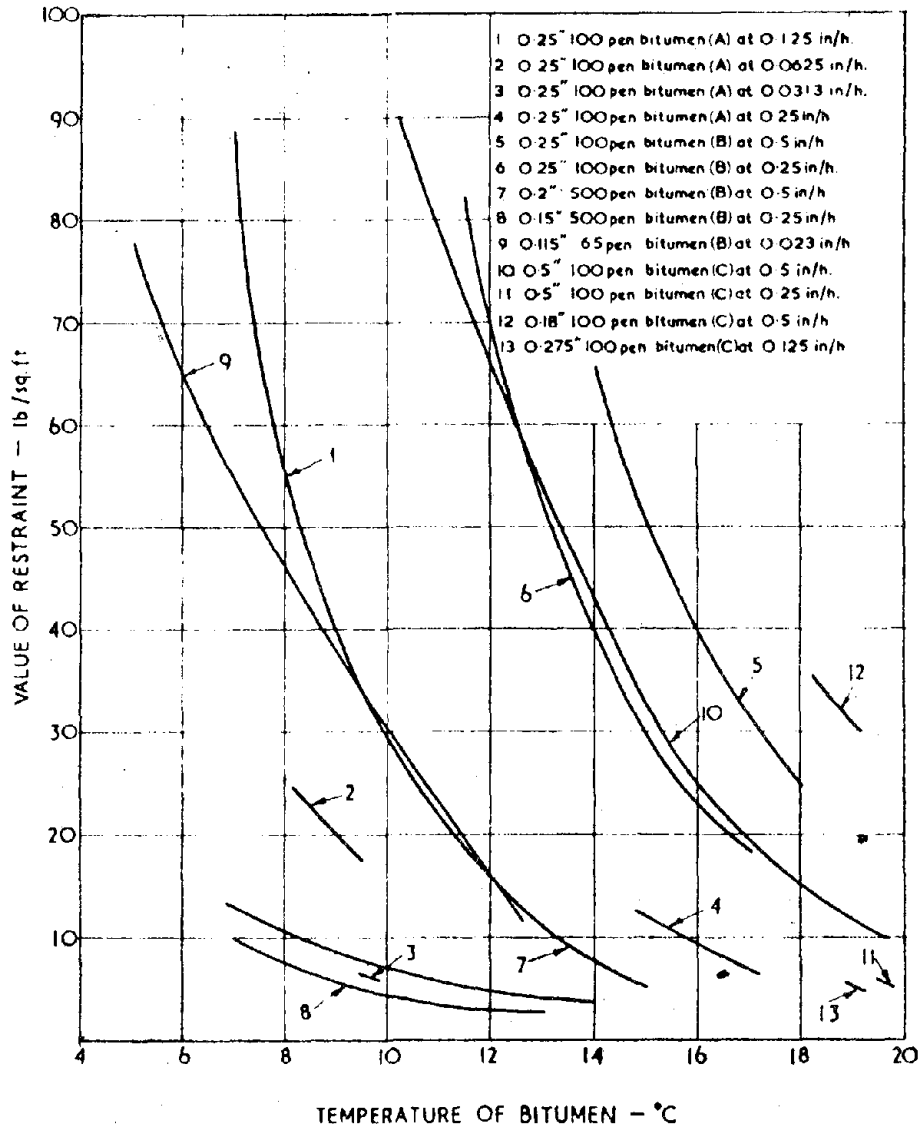
FIGURE D-9. Restraint Versus Temperature For Different Speeds, Thicknesses, and Bitumens.

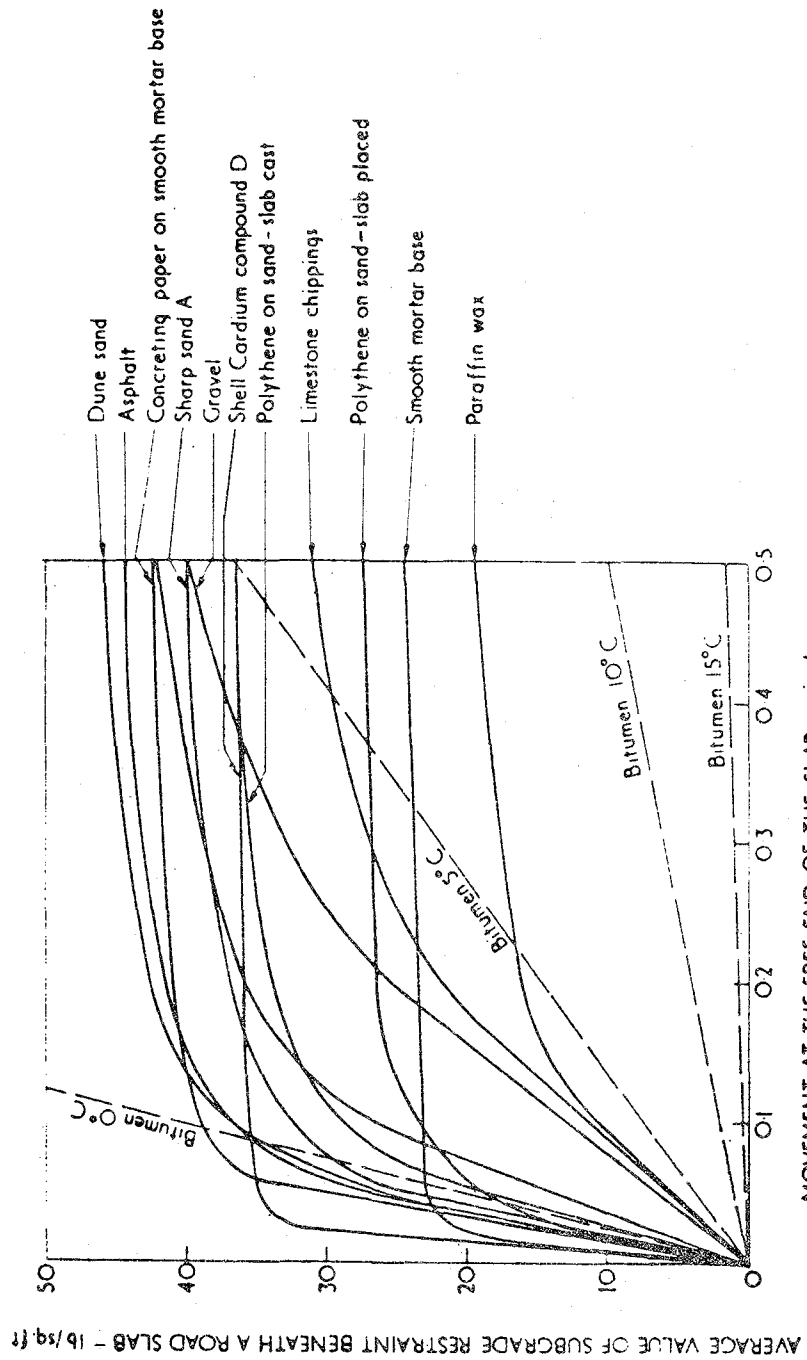
FIGURE D-10. Average Value of Subgrade Restraint Versus Movement at The Free End of A 6 In. Thick Slab.

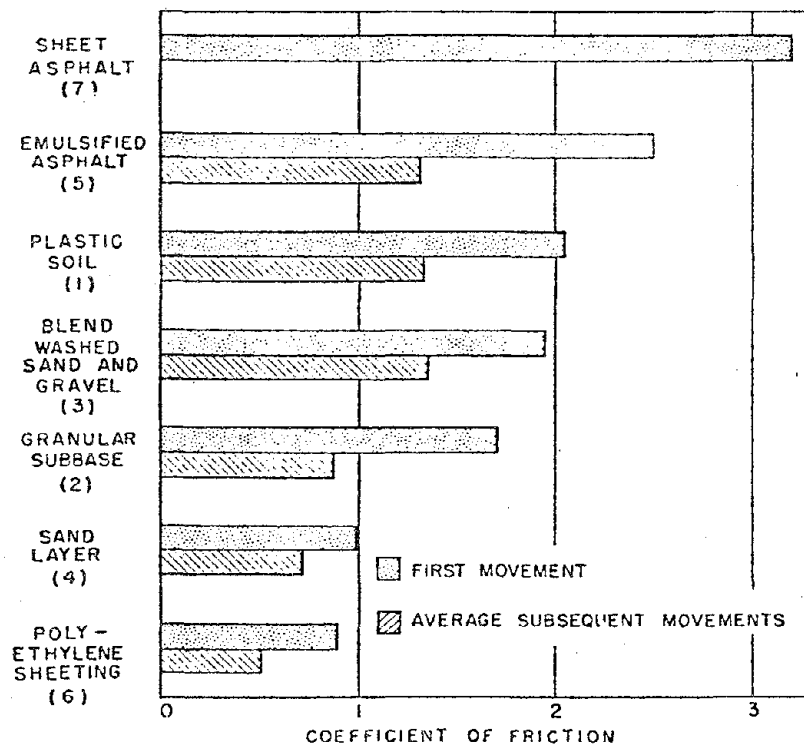
FIGURE D-11. Summary of Coefficients of Friction For 5 In. Slabs.

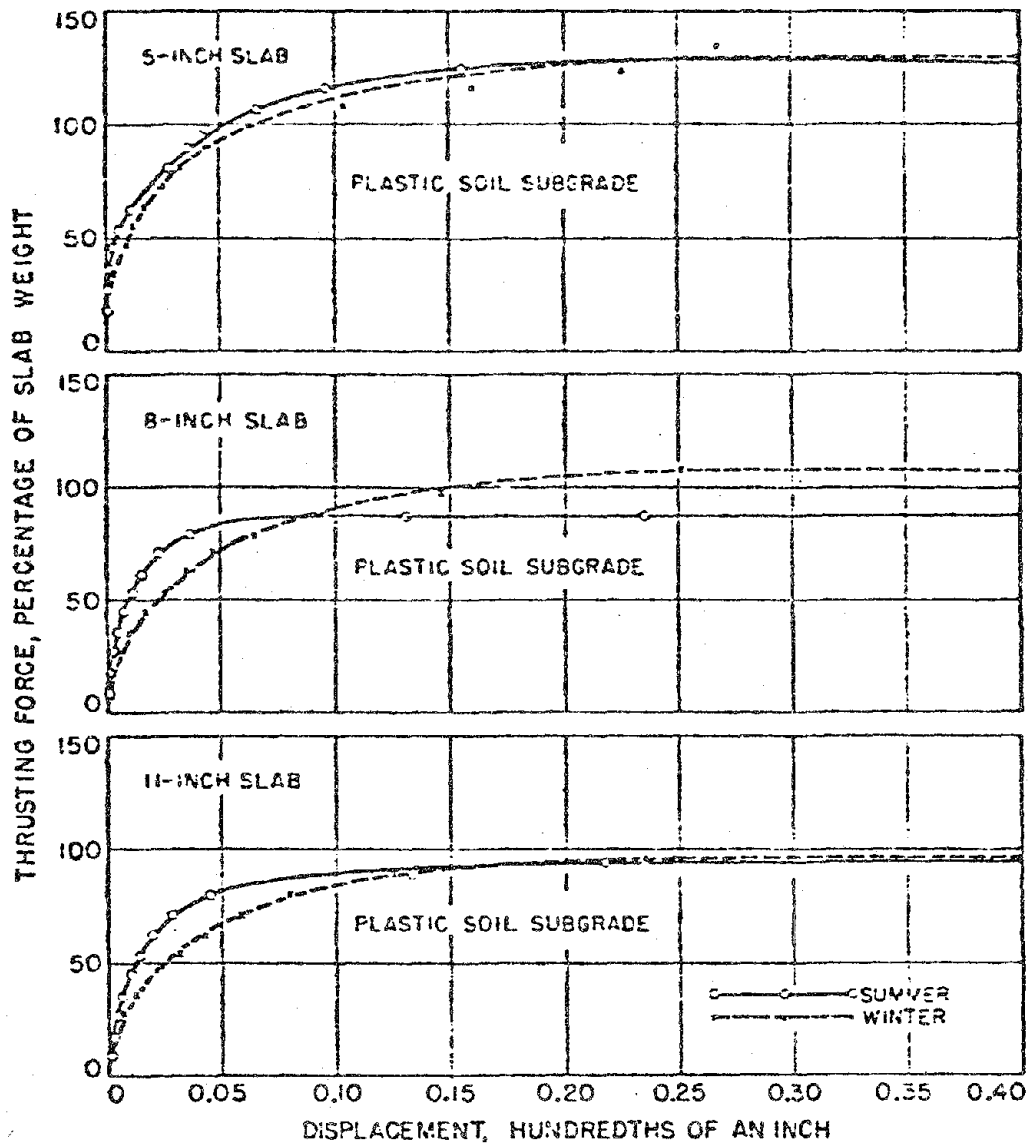
FIGURE D-12. Force-Displacement Curves For Concrete Slabs On Plastic Soil.

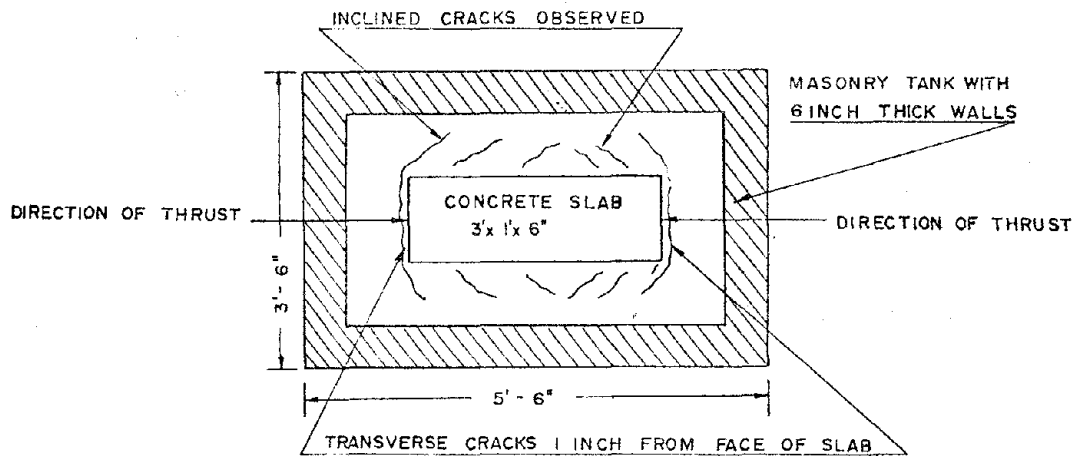
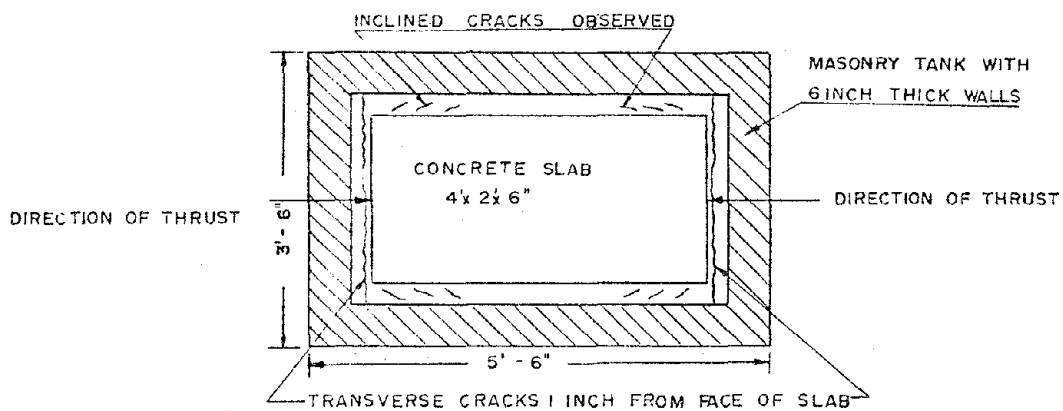
FIGURE D-14. Generalized Plan View of Testing Apparatus  
Used By Venkatasubramanian

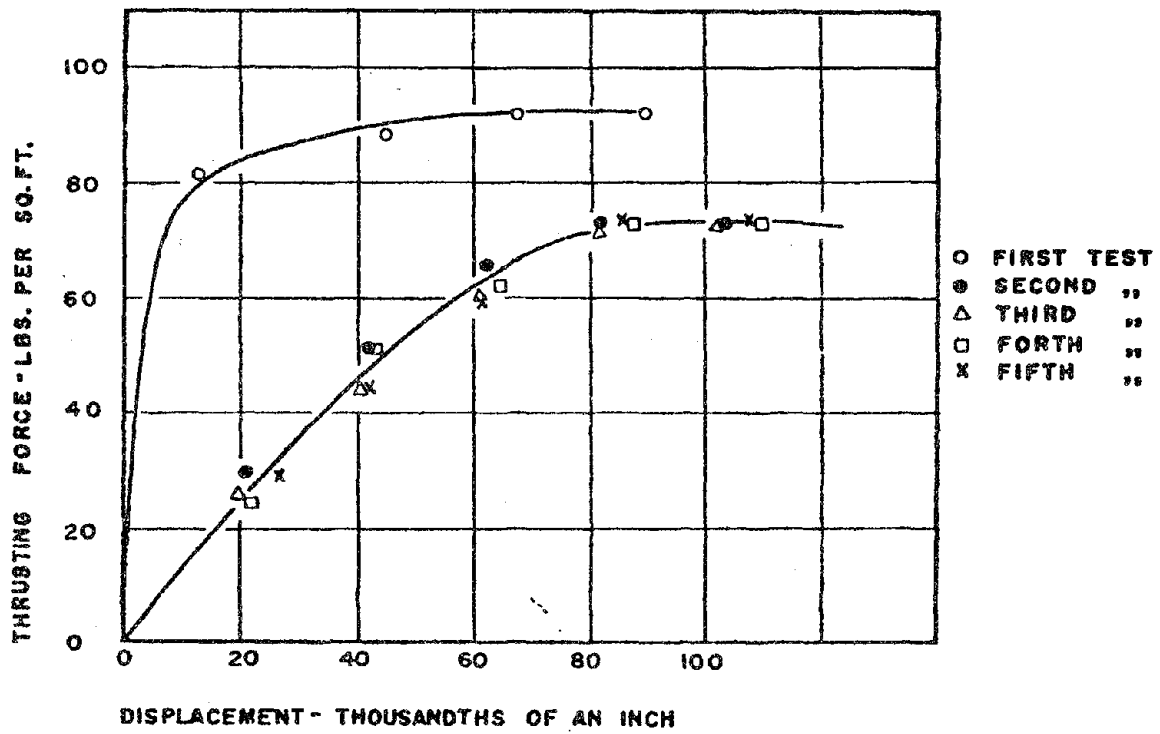
FIGURE D-16. Thrusting Force (Restraint) Versus Displacement For A 3' x1' x6" (0.9m x 0.3m x 15.2cm) Slab Over Damp Sand Base.

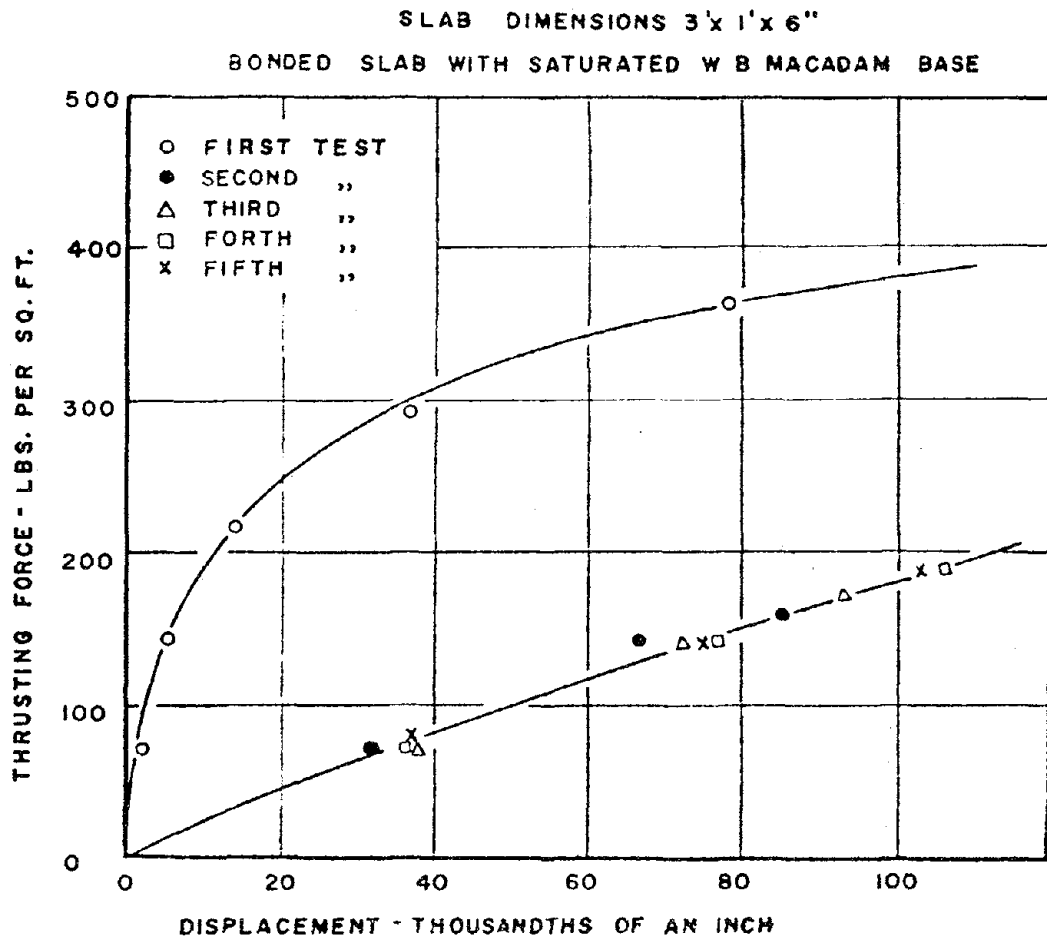
FIGURE D-17. Thrusting Force (Restraint) Versus Displacement For A 3' x 1' x 6" (0.9m x 0.3m x 15.2cm) Slab Over Saturated Macadam Base.

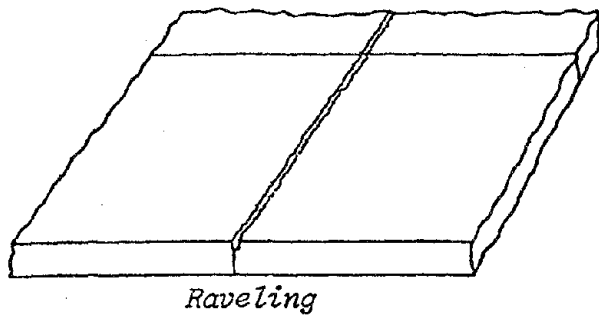
*Raveling*

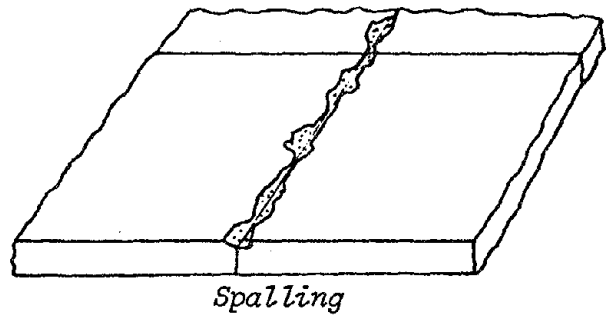
*Spalling*

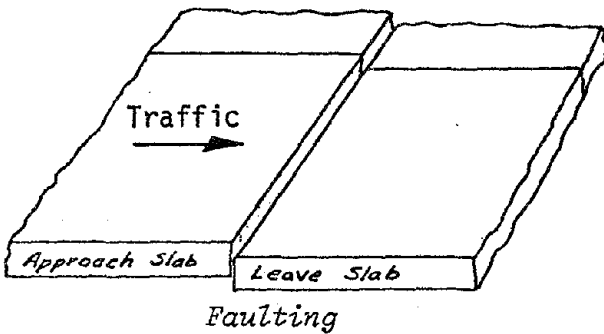
*Faulting*

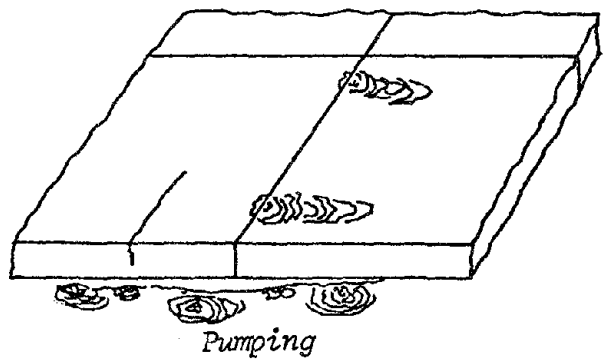
*Pumping*

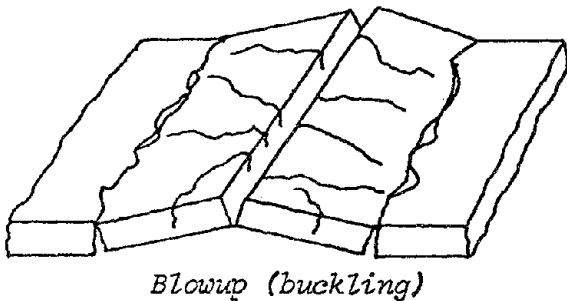
*Blowup (buckling)*

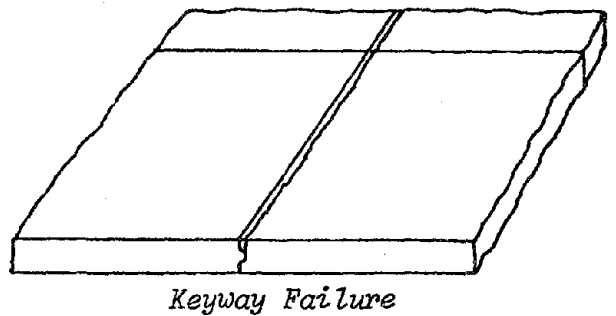
*Keyway Failure*

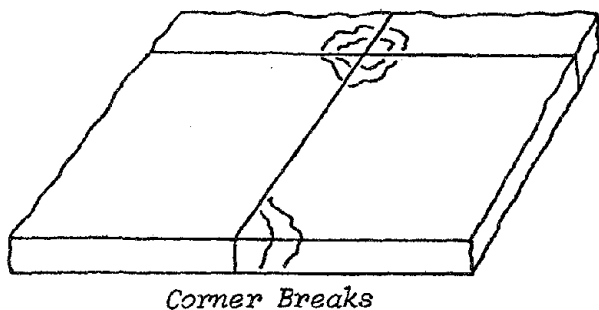
*Corner Breaks*

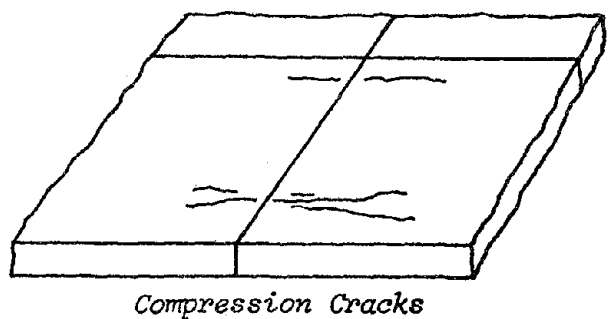
*Compression Cracks*

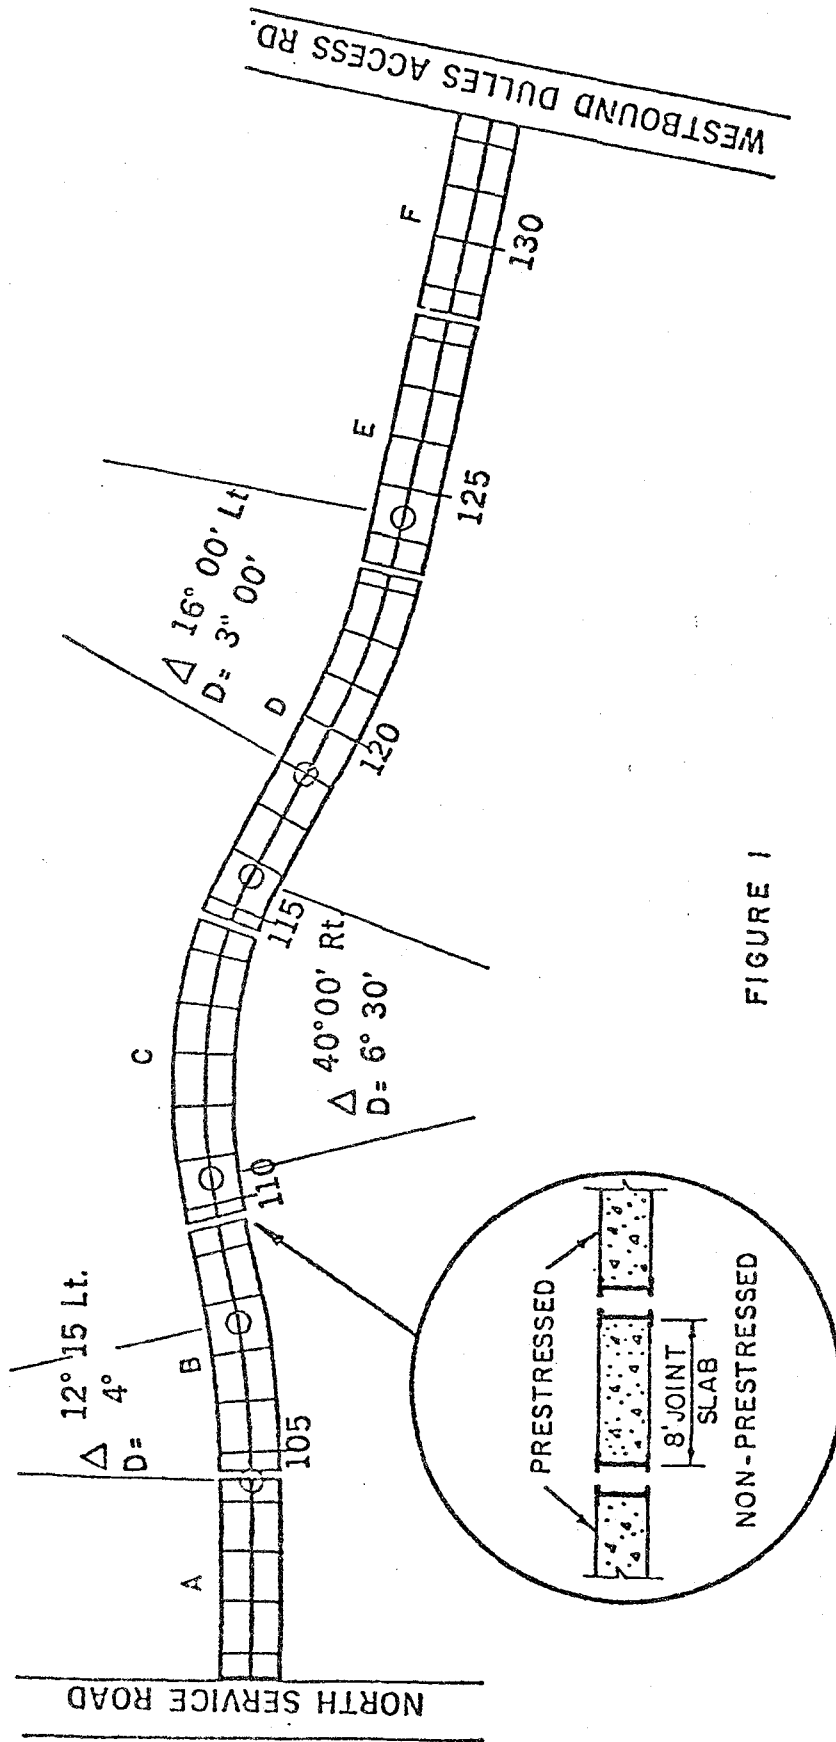
FIGURE 1

FIGURE D-20. Layout of Prestressed Concrete Pavement at Dulles International Airport, Virginia.  
1 ft = 0.305 m

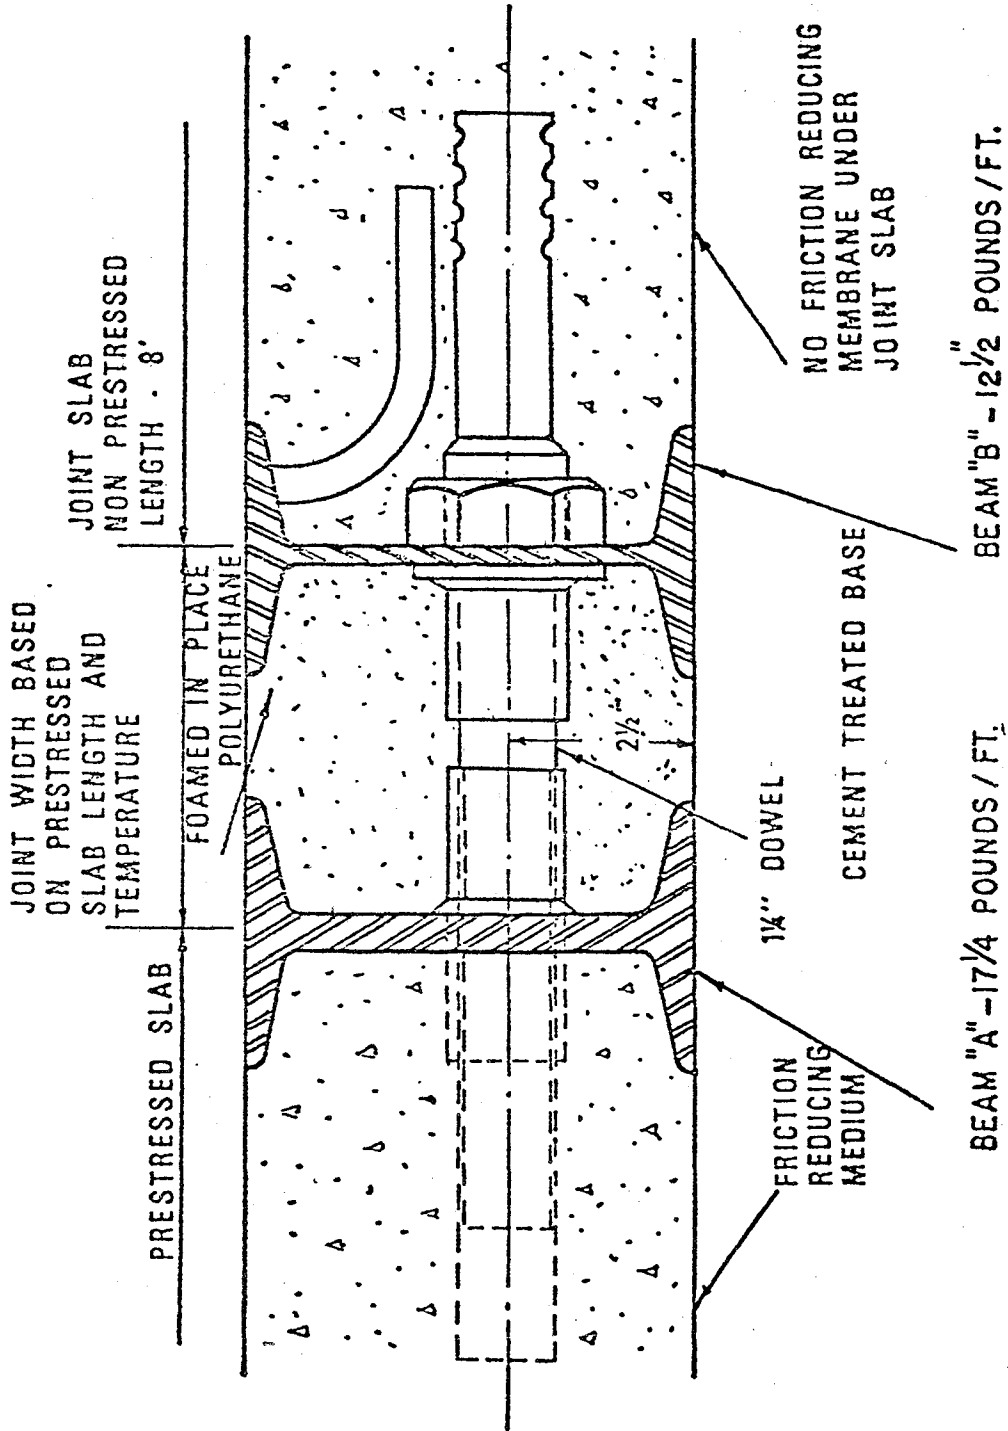
FIGURE D-21. Joint Detail.
