Report No. FHWA-RD-78-109

**TECHNIQUES FOR REHABILITATING PAVEMENTS WITHOUT OVERLAYS –  
A SYSTEMS ANALYSIS**

**Vol. 2 Appendixes**

**FEDERAL HIGHWAY ADMINISTRATION**

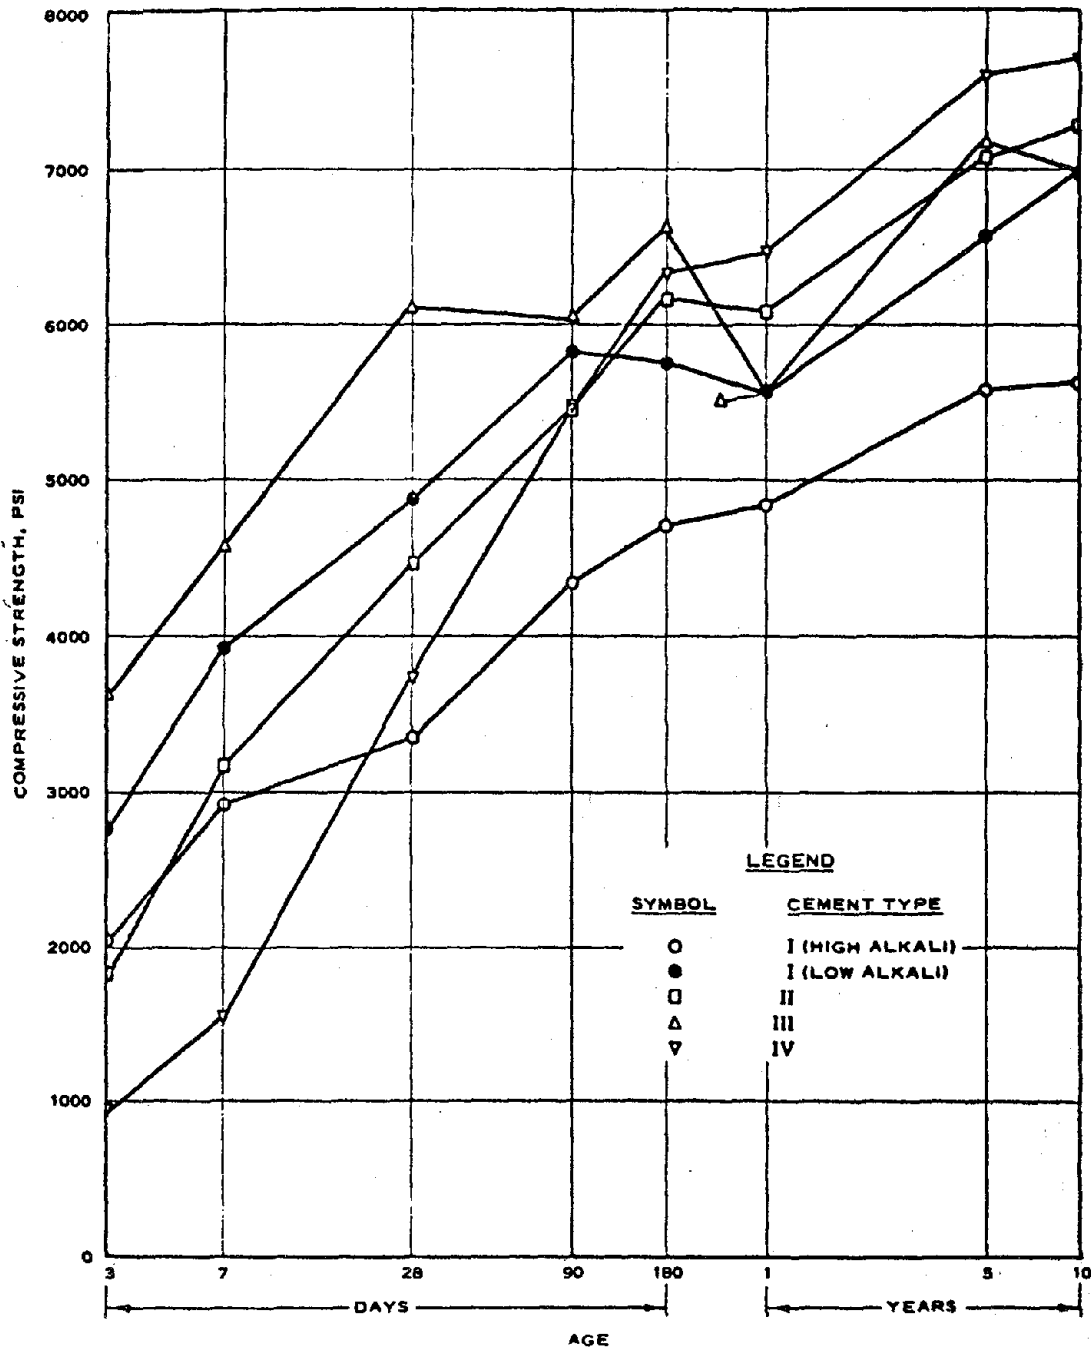
FIGURE D-22 Effect of Cement Characteristics on Strength Development to 10 Years Age With 0.5 Water-Cement Ratio and 6 Percent Entrained Air.  
1 PSI = 6.89 kPa

Mather (D 31) showed several examples of how these factors vary with time. Figure D-22 was obtained from a Waterways Experiment Station

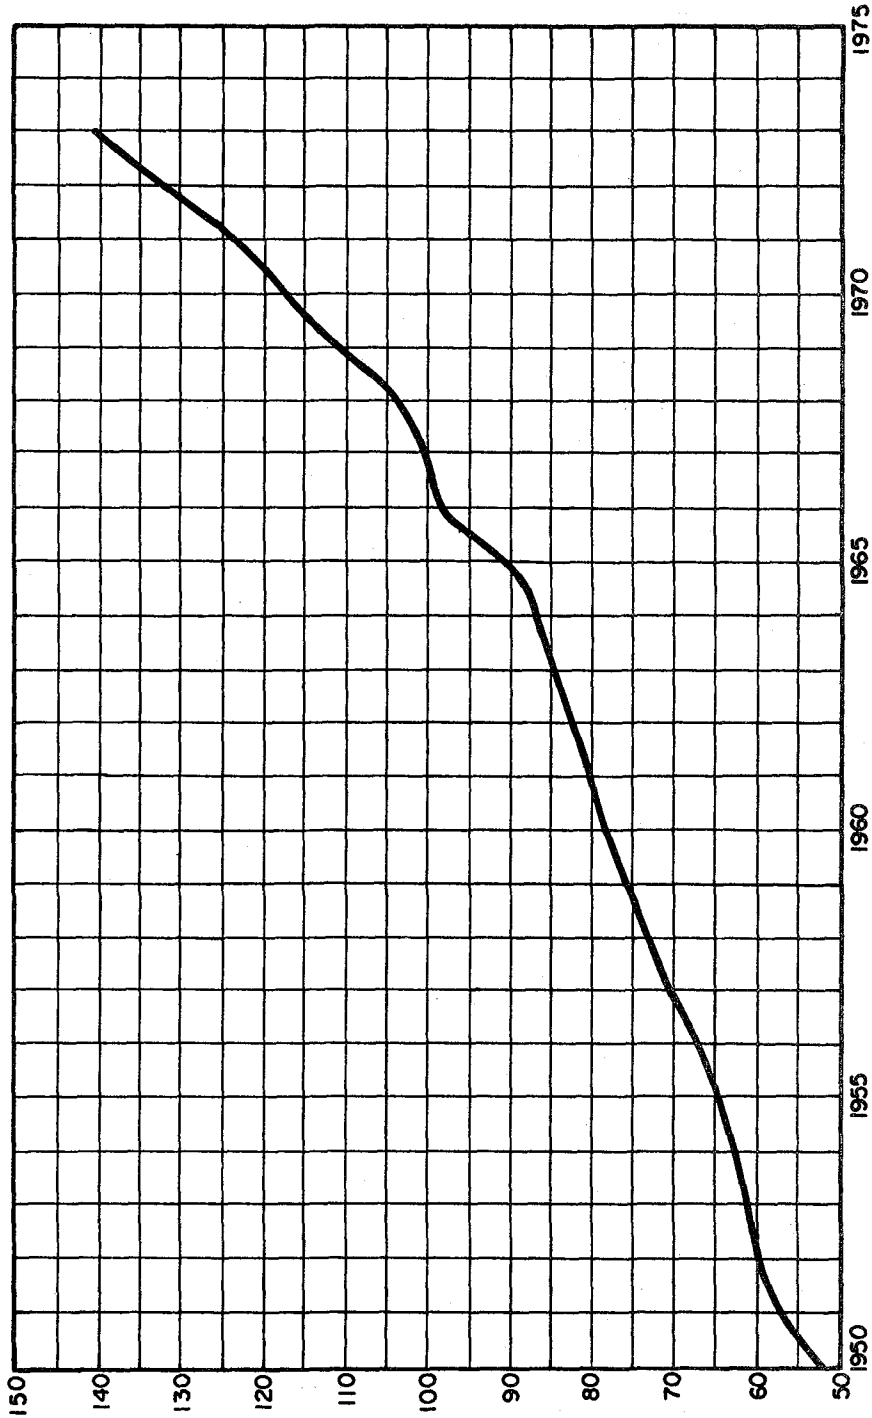
Figure F-1. Highway Maintenance and Operation Cost Index.

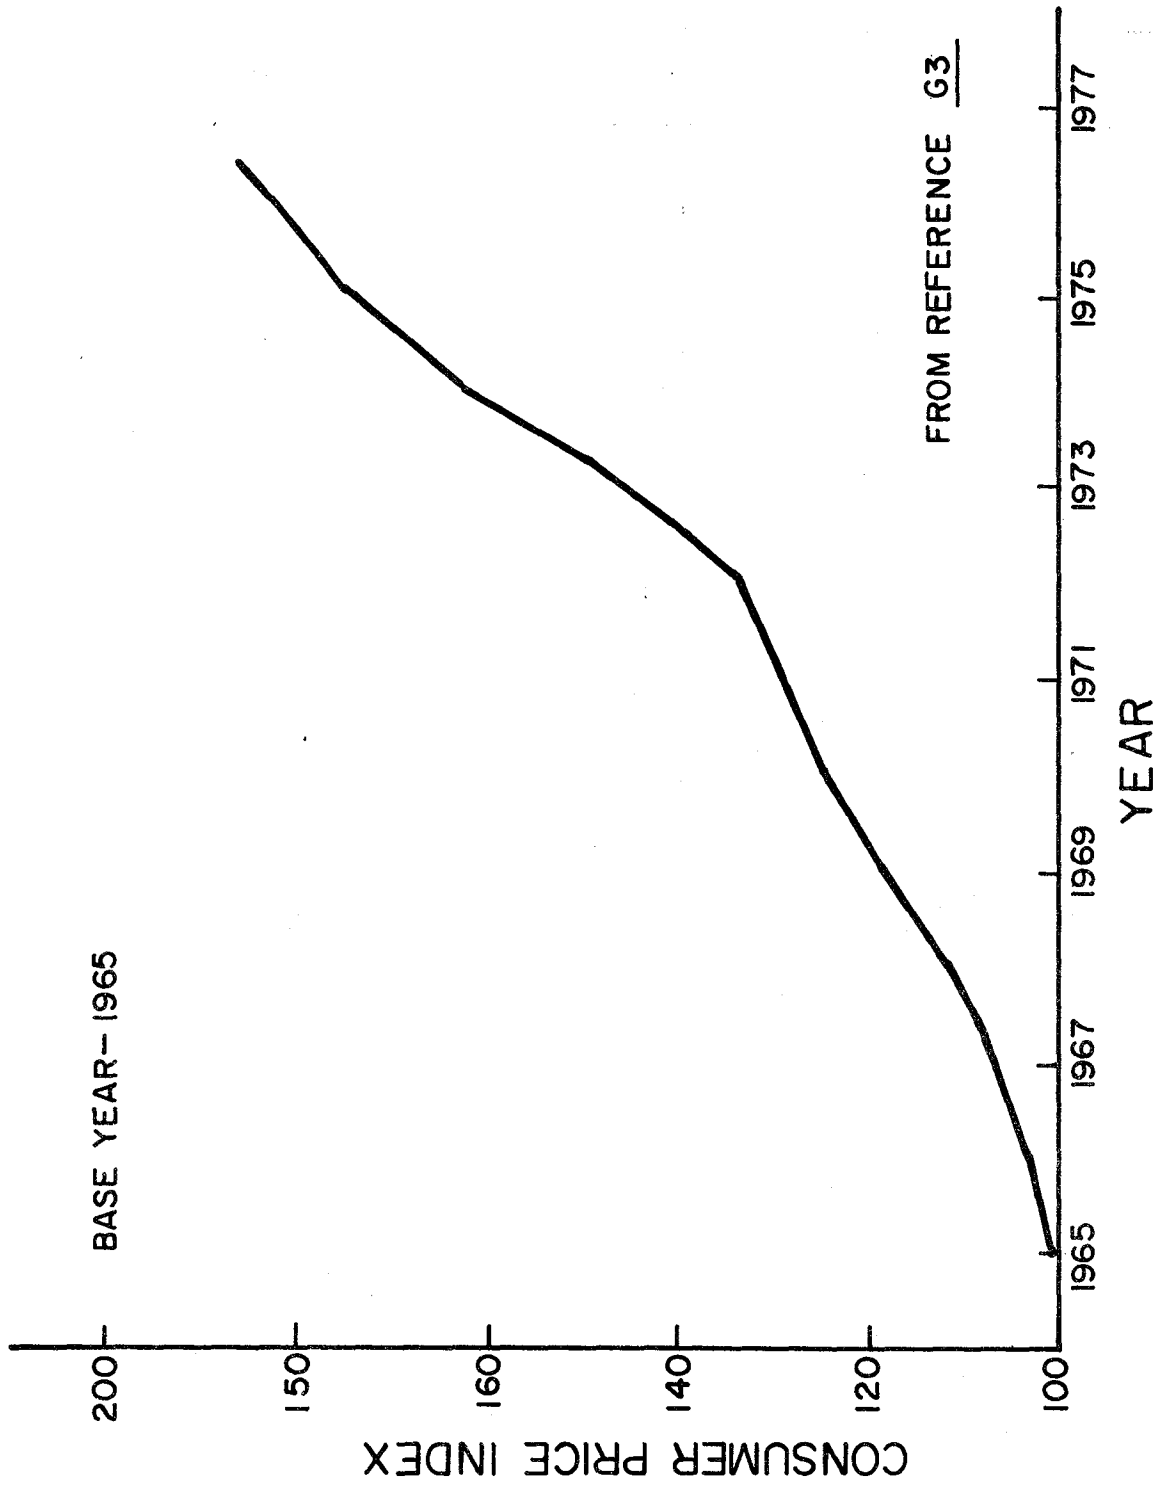
FIG. G-1. Consumer Price Index From 1965 Through 1976

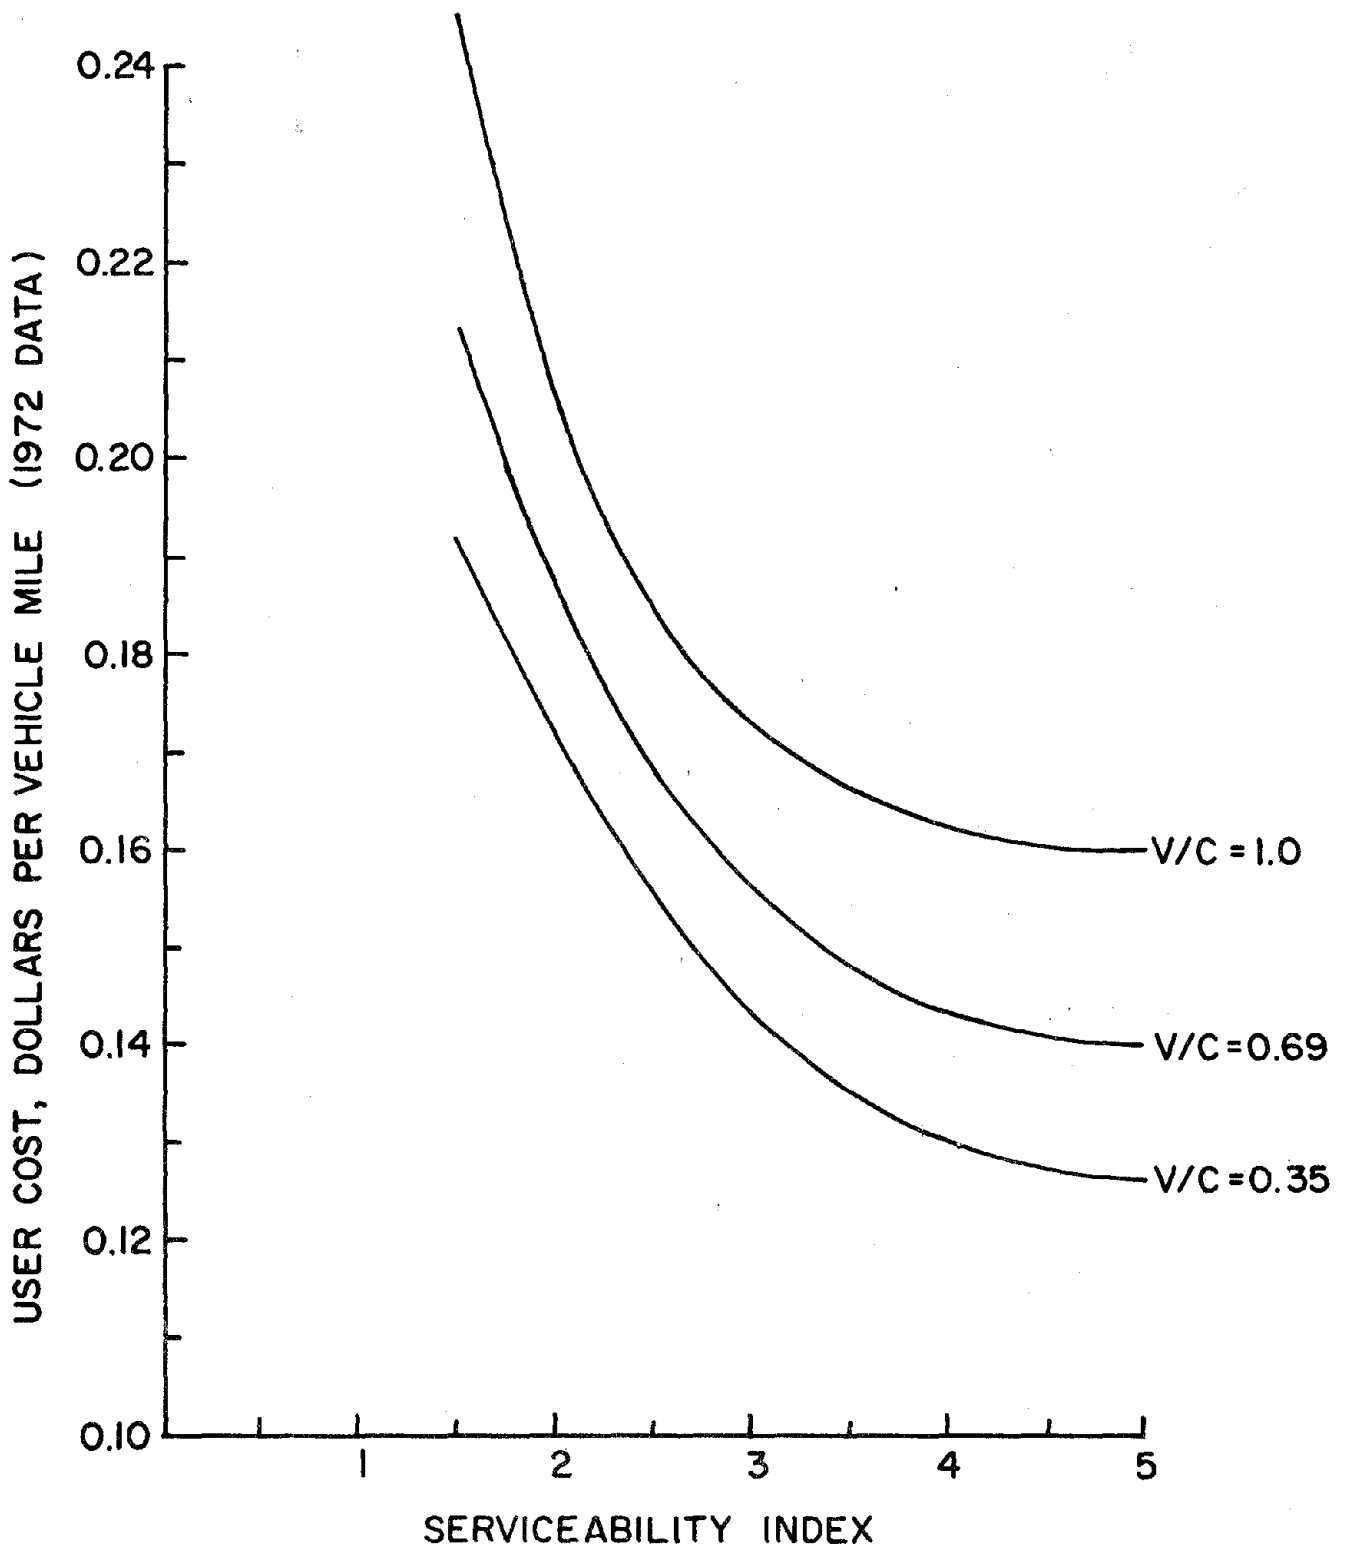
Figure I-2. Variation in Total User Costs With Serviceability Index for Divided Highways in Urban and Suburban Locations.

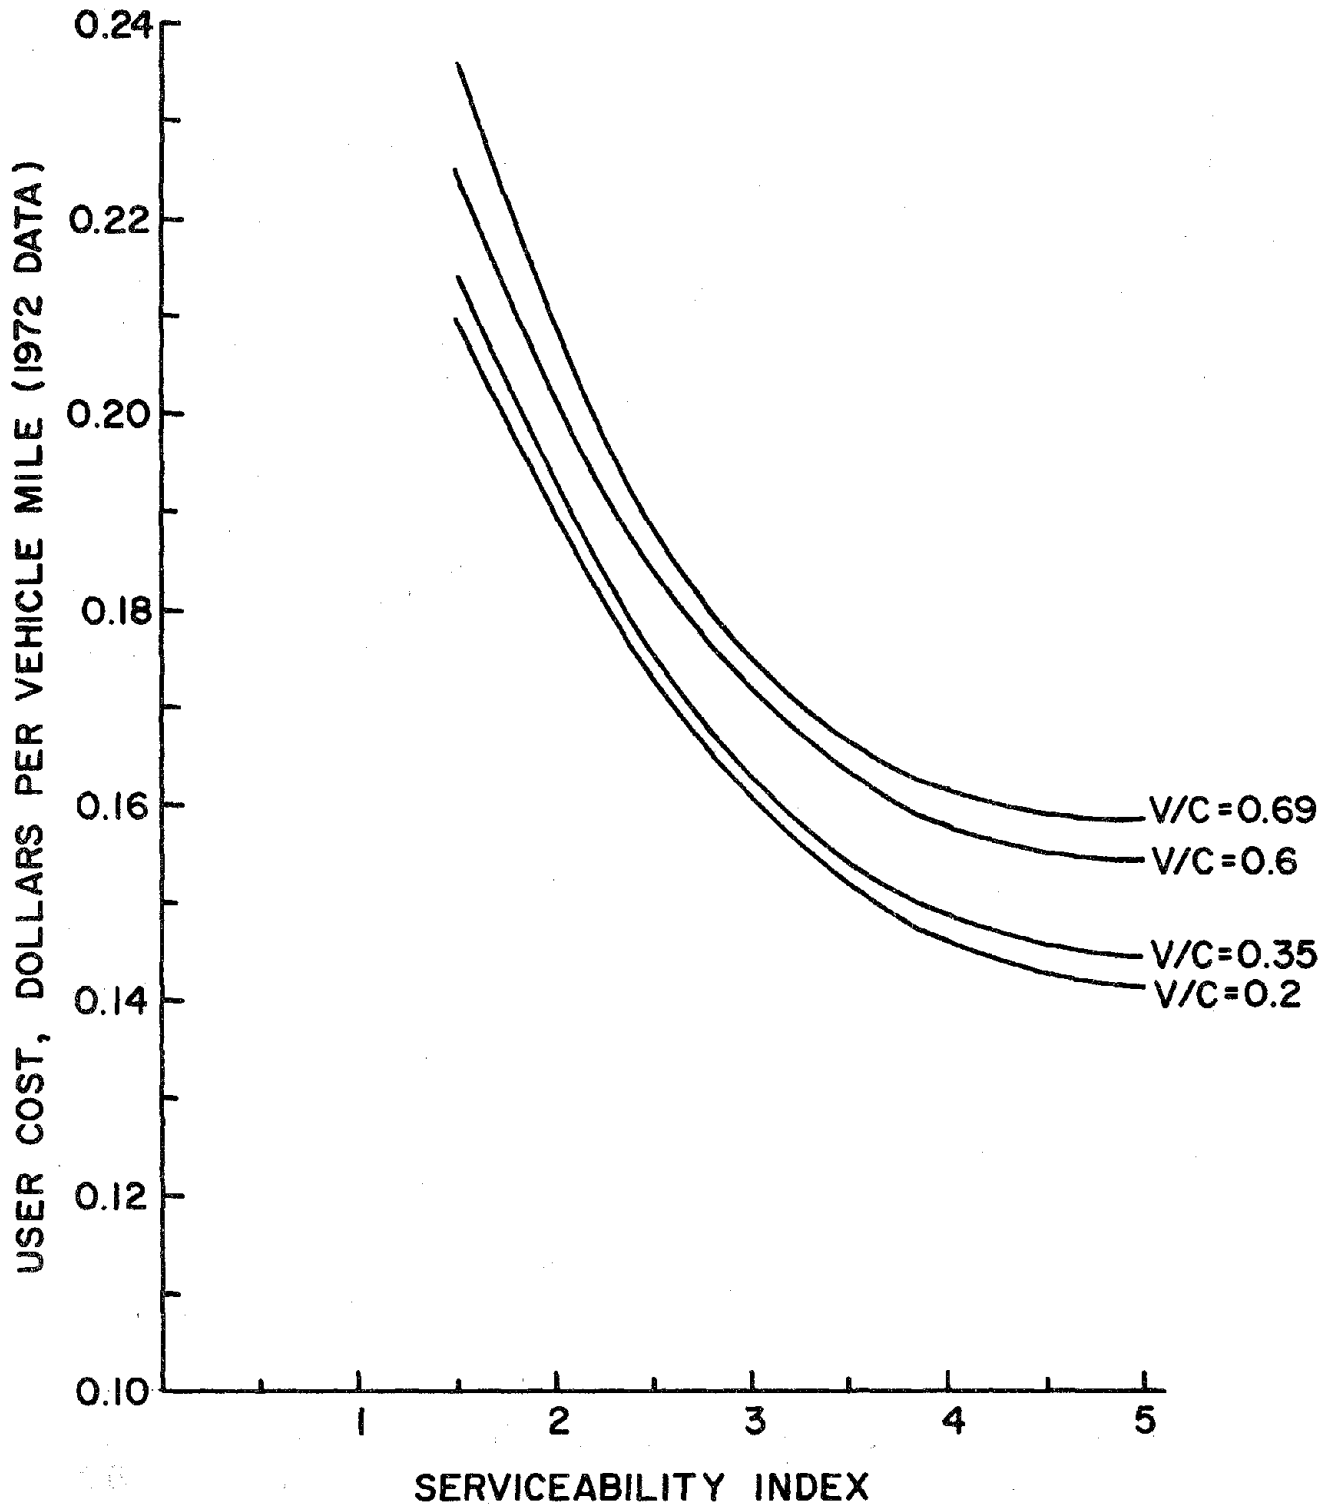
Figure I-3. Variation in Total User Costs With Serviceability Index for Divided Highways in Rural Areas.

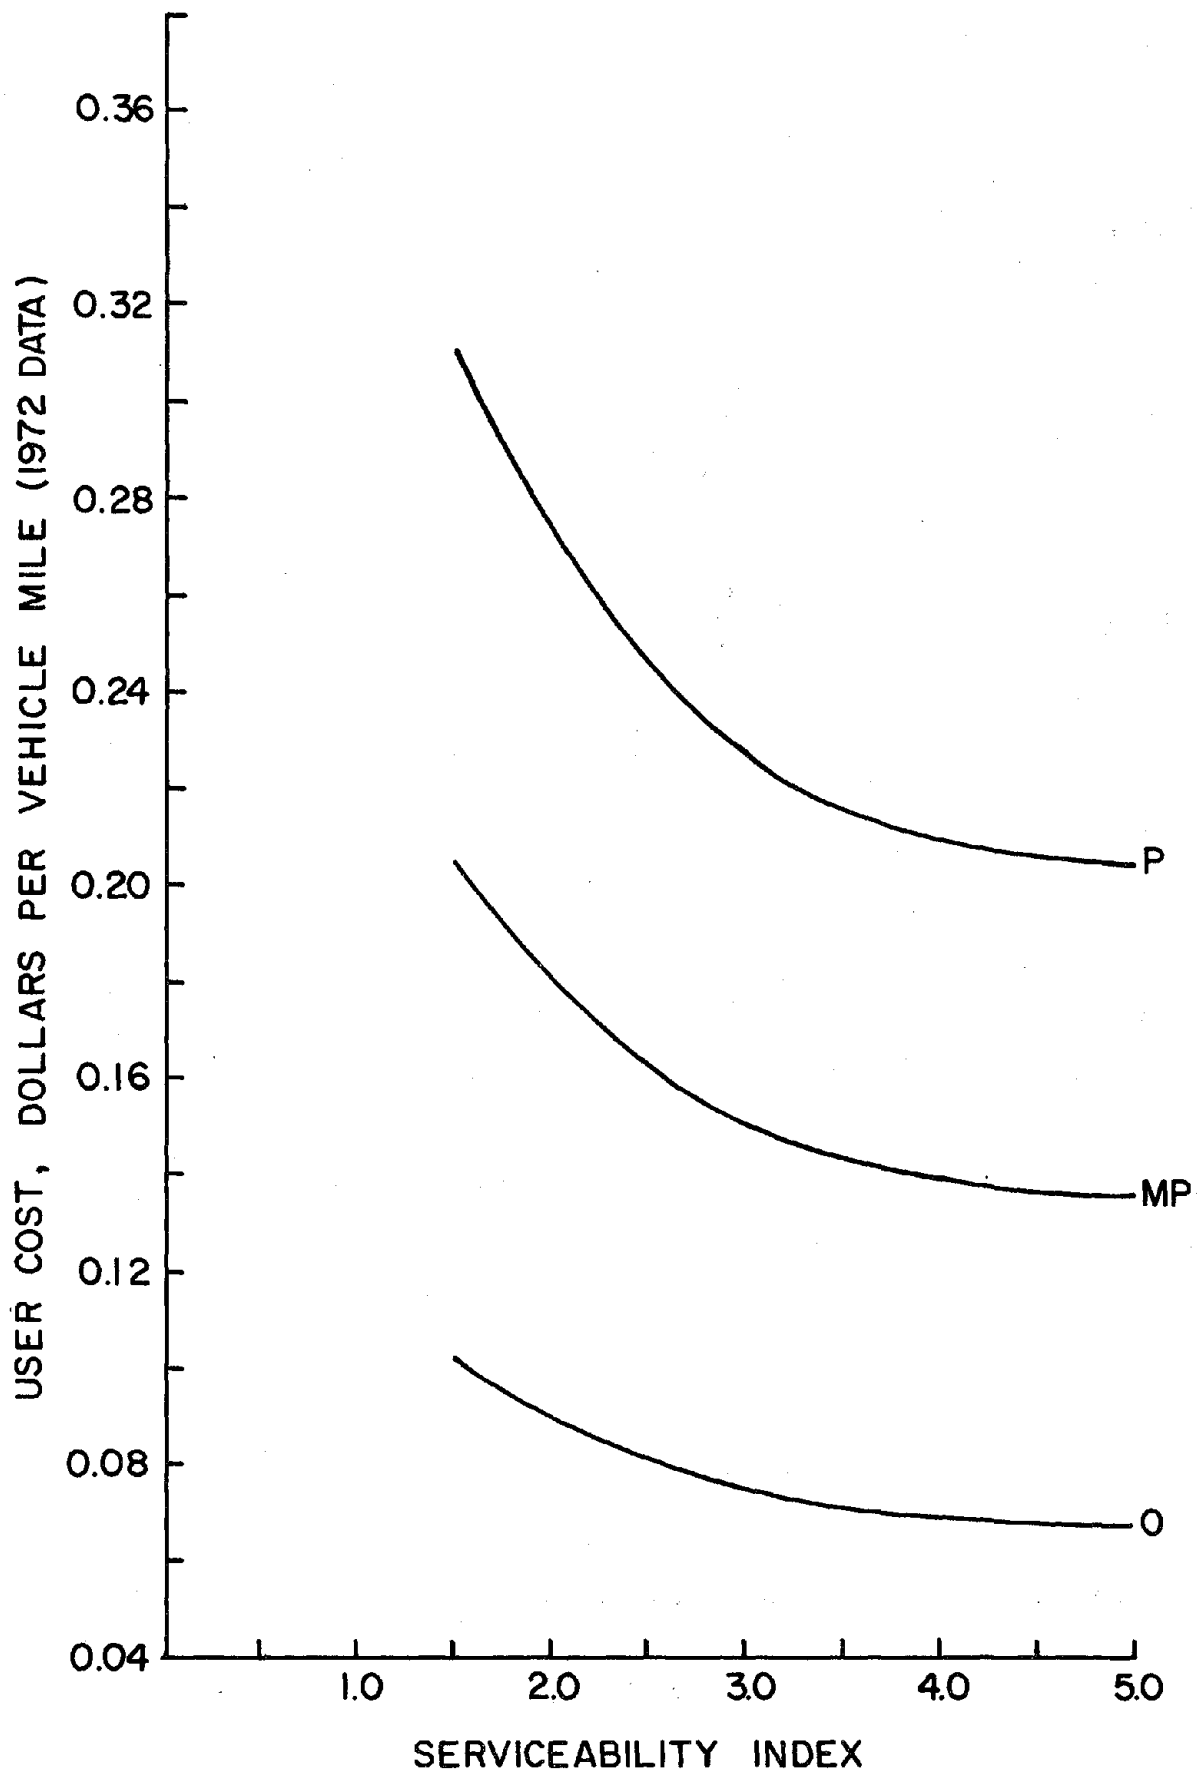
Figure I-4. User Costs Versus Serviceability Index for Urban Conditions.

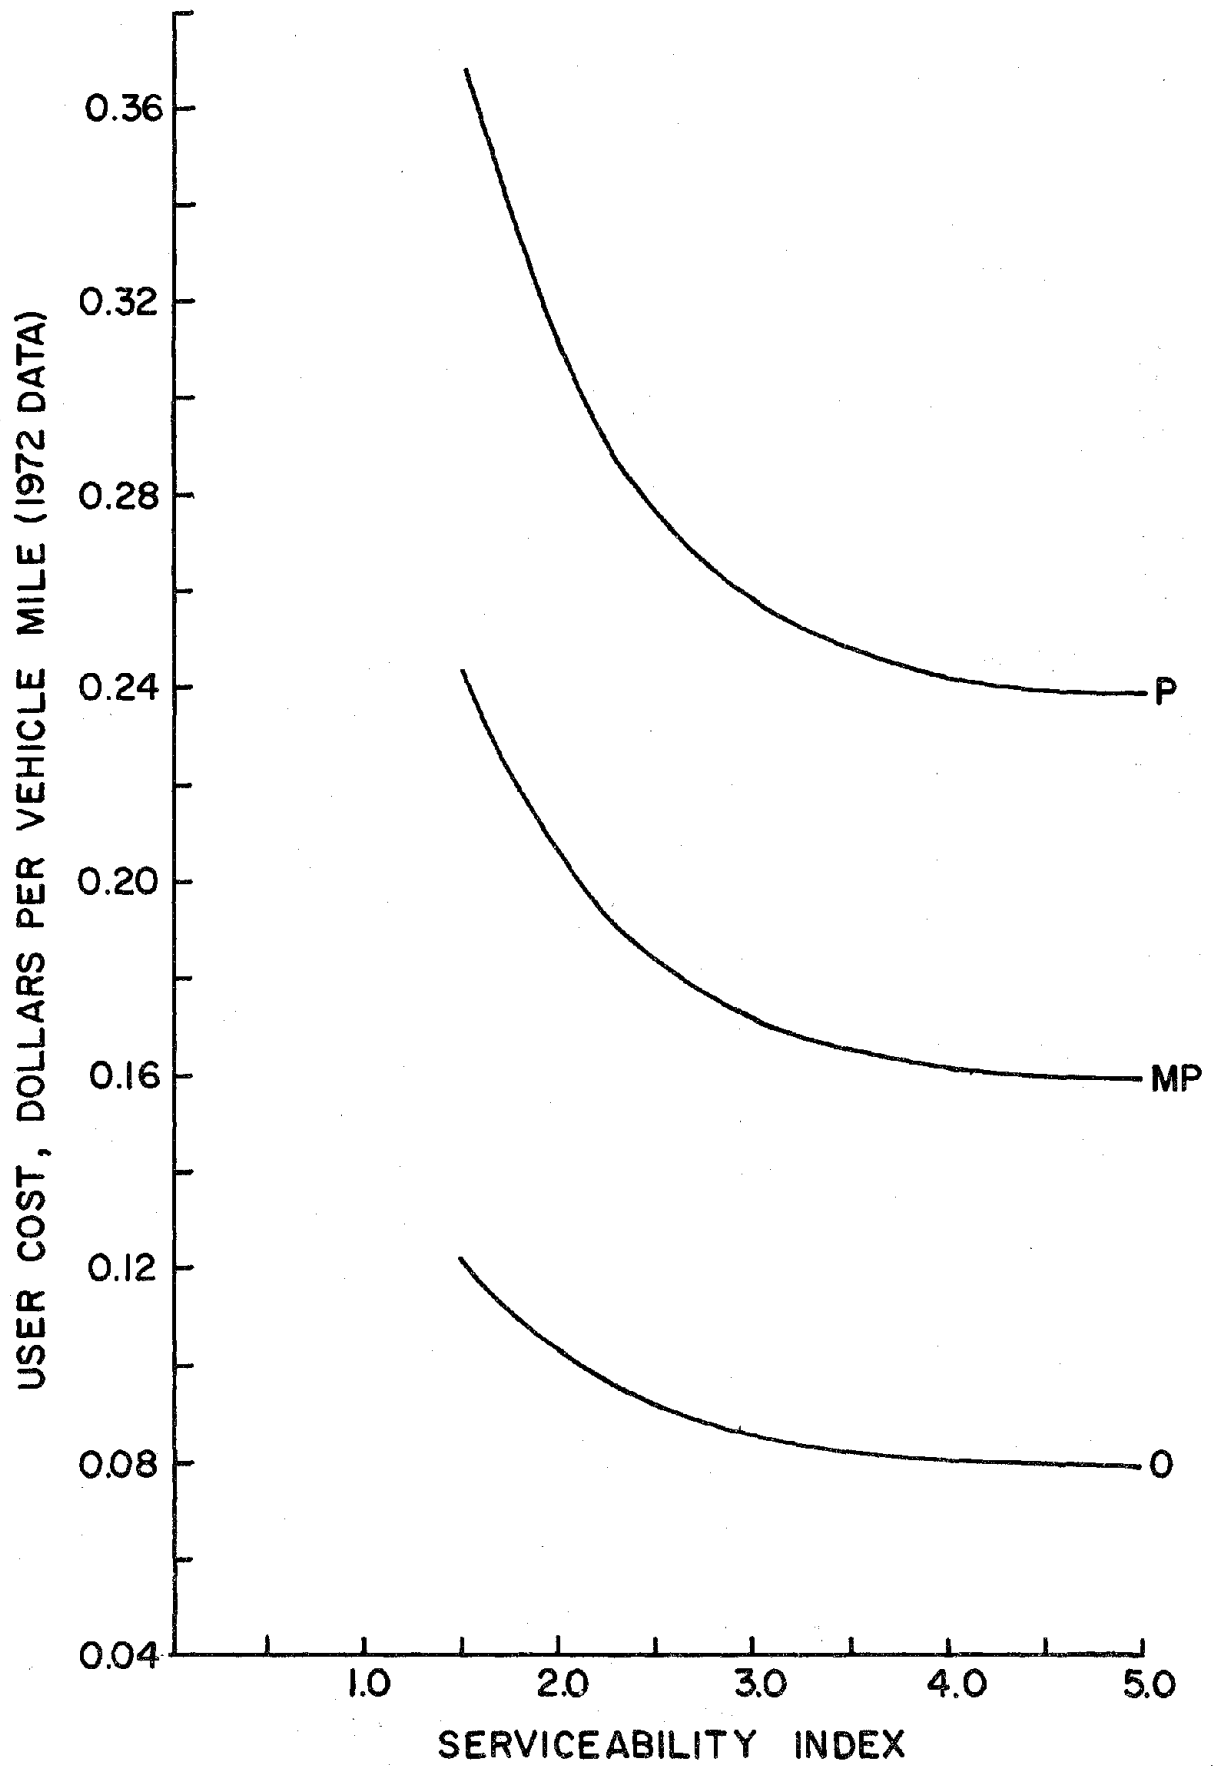
Figure I-5. User Cost Versus Serviceability Index for Suburban Conditions.

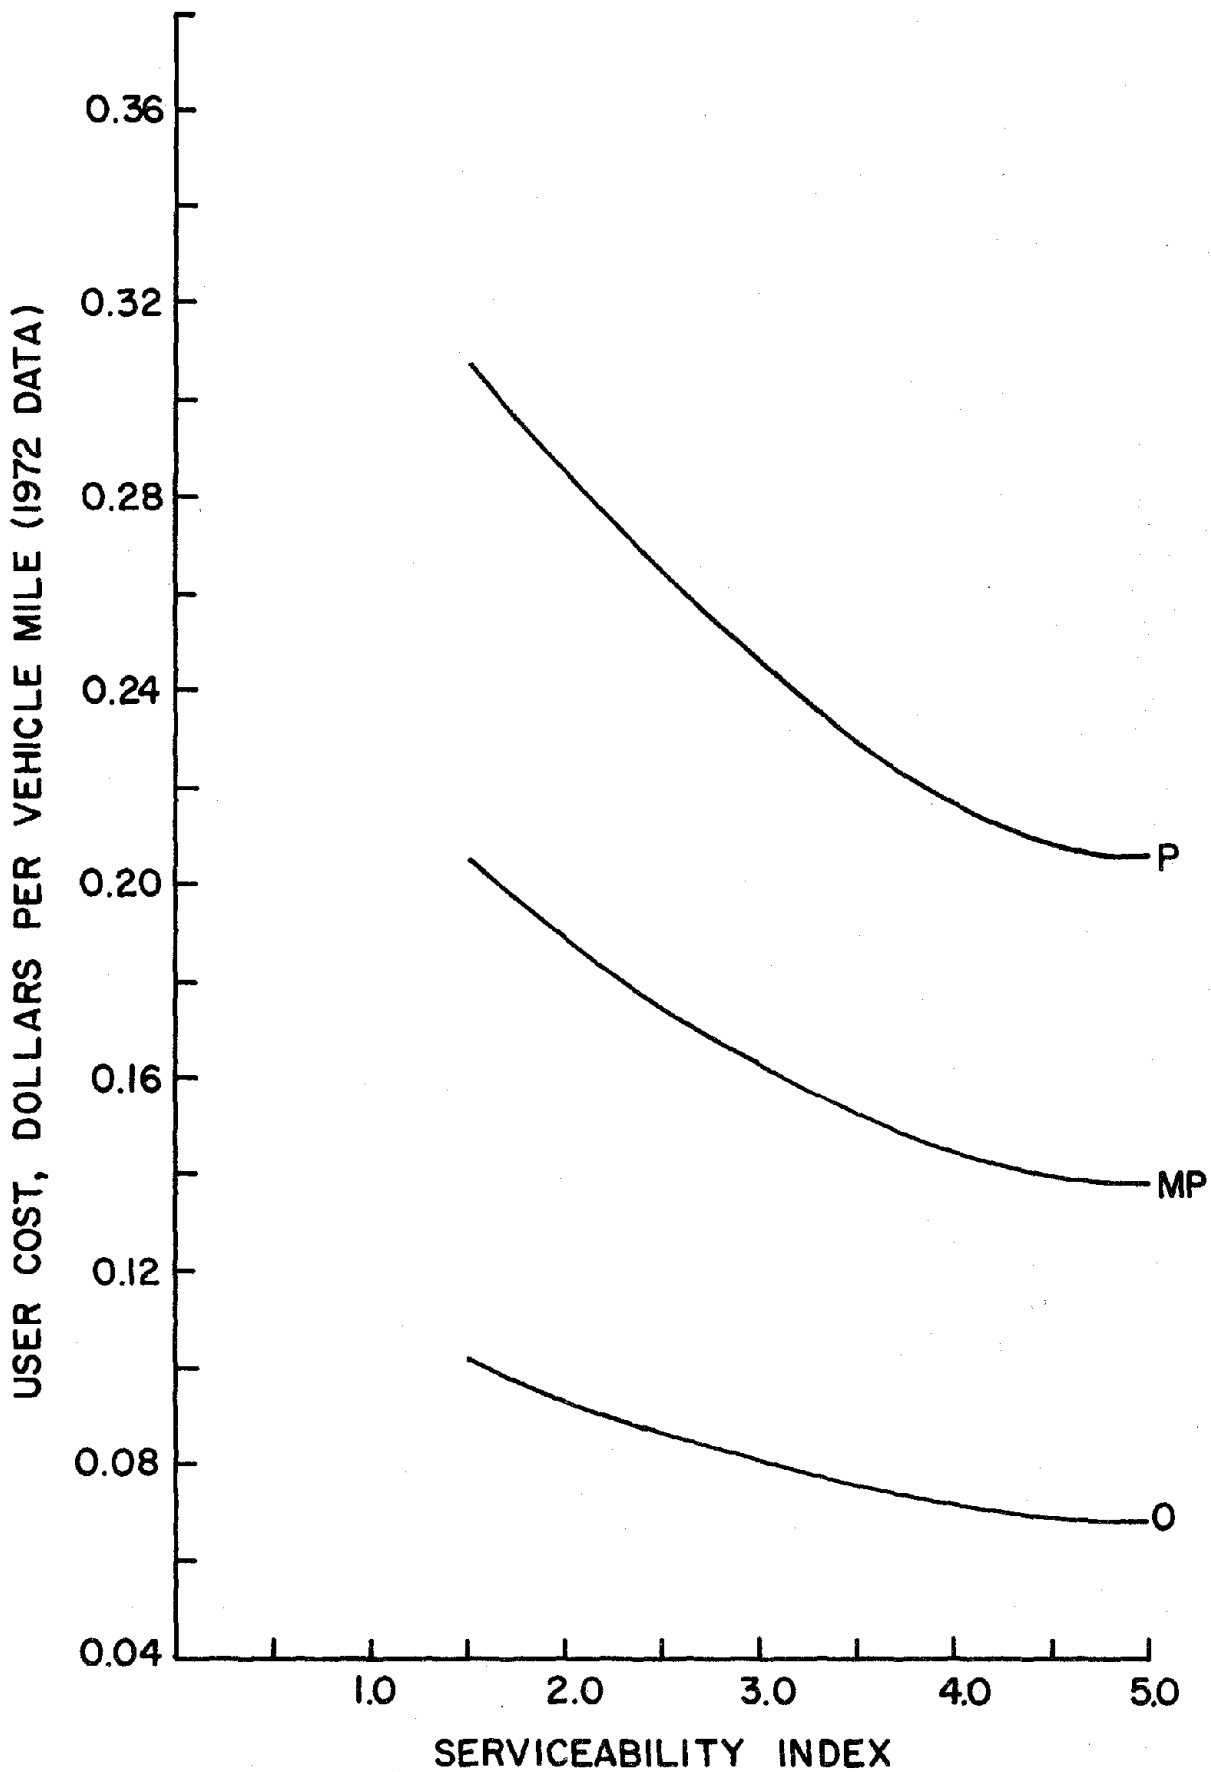
Figure I-6. User Costs Versus Serviceability Index for Rural Conditions.

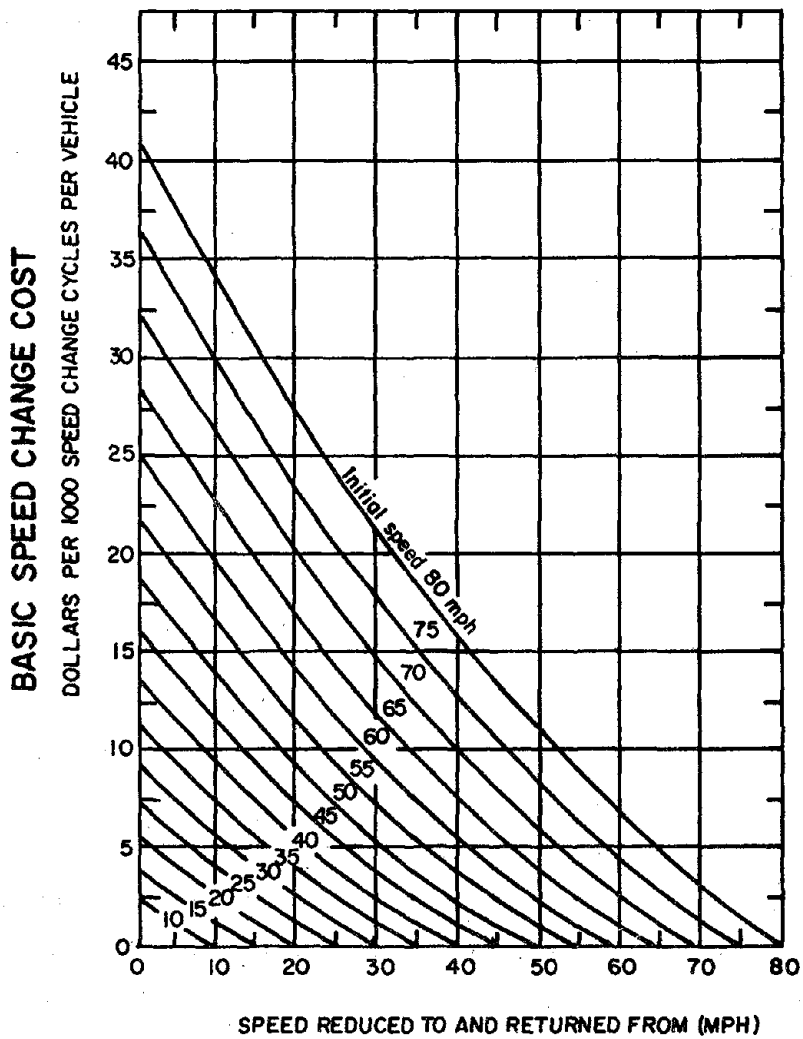
Figure I-7. Passenger Cars--Excess Running Cost of Speed-Change Cycles (Above Cost of Continuing at Initial Speed).

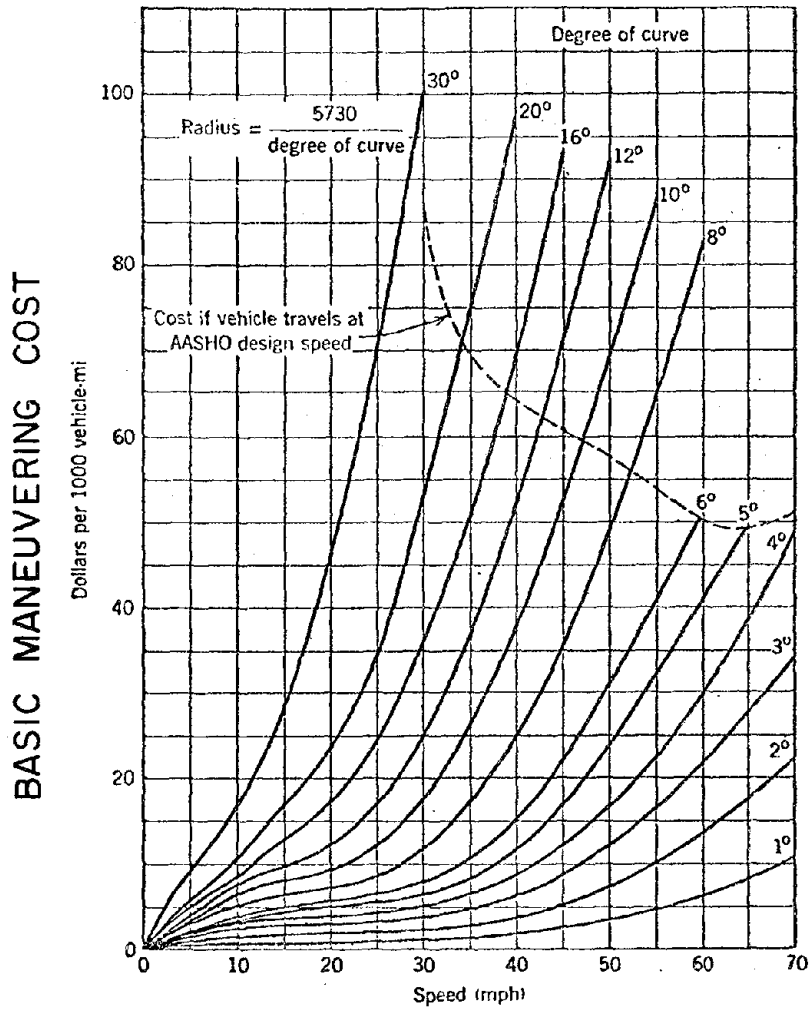
FIGURE I-8. Passenger cars - excess vehicle running cost due to horizontal curves. (Above cost on level tangent). (Source: NCHRP Report 133).
