Report No. FHWA/RD-80/503

CRASH TESTS OF SINGLE POST SIGN INSTALLATIONS USING SUBCOMPACT AUTOMOBILES

May 1980
Interim Report

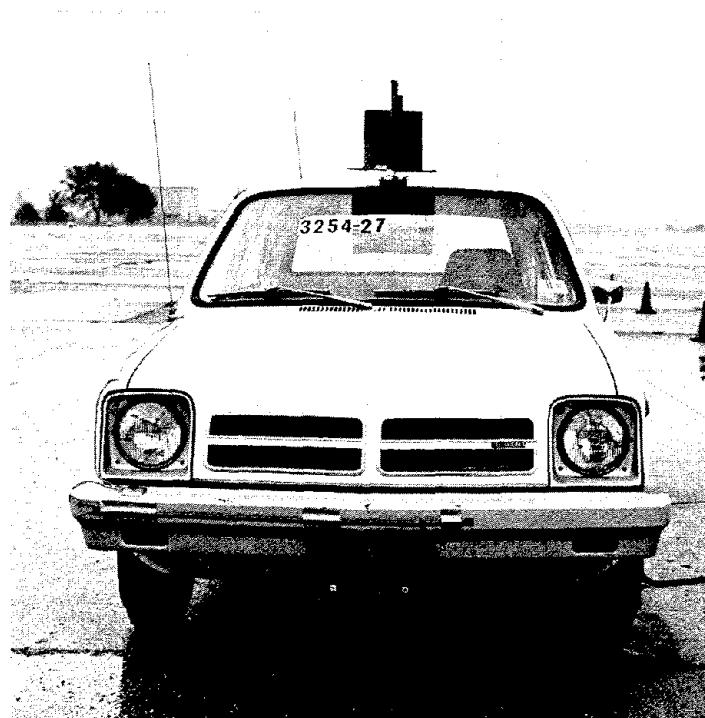
Figure 4. Chevrolet Chevette, 1976 model.

Chevrolet Chevettes were used as test vehicles. All were 1976 models. Pictures of one of the test vehicles are shown in Figure 4. Typical dimensions of a 1976 Chevette are shown in Figure 5.

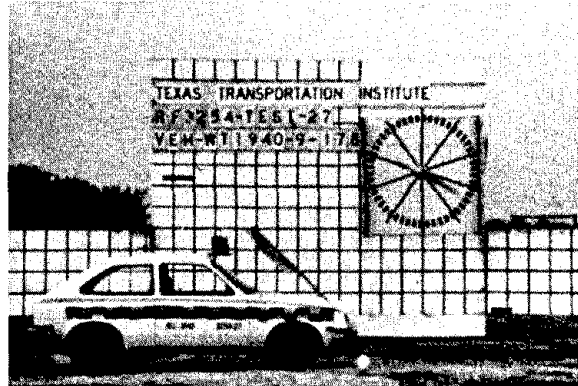
Figure 7. Sequential photos, test 27.

A summary of test 27 is given in Table 2. Figure 7 shows the sequential photos taken from high-speed filming of the impact, and the corresponding time displacement event summary is given in Table 3. Upon impact, the post first wrapped around the bumper and the sign panel, then struck the hood. As the interaction continued, the signpost was pulled from the ground and traveled with the vehicle for 100 ft (30.5 m). Pull-out of the post was attributed to high moisture content in the soil. The test soil had been saturated by rain the day before the test. Impact with the same size post with a 2250 lb (1022 kg) vehicle at 60 mph (96.5 km/h) and dry soil conditions did not pull the post out of the ground (see Section A-3-4 of Reference 1). Test 29 was a repeat of test 27 with dry soil, and as discussed later the post did not pull out of the ground. Subsequent to the tests reported herein, a static load test program was conducted to evaluate effects of soil moisture content

<u>TIME</u> (sec)	<u>NOMINAL VEHICLE</u> <u>DISPLACEMENT</u> (ft)	<u>EVENT</u>
0.000	0.00	Impact
0.008	0.66	Signpost begins bending
0.026	2.24	Post wrapping around bumper
0.050	4.20	Signpost pulling out of ground
0.066	5.46	Maximum hood deformation
0.081	6.69	Sign panel strikes hood

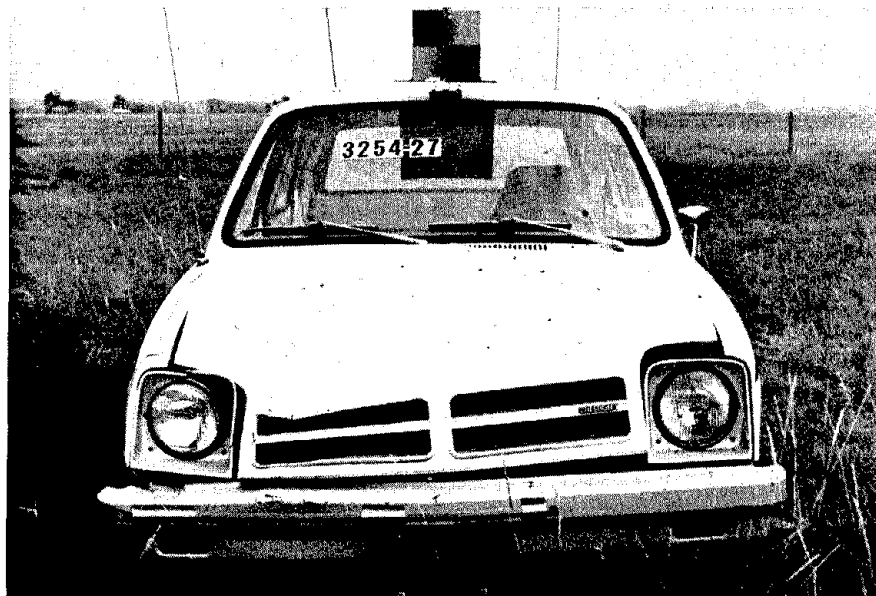
Figure 12. Vehicle damage, test 27.

The vehicle sustained minor damage in the test and was operable after impact. Only the hood and right headlight were damaged as shown in Figure 12. The damage was classified according to TAD and SAE scales, and the results are given in Table 2.

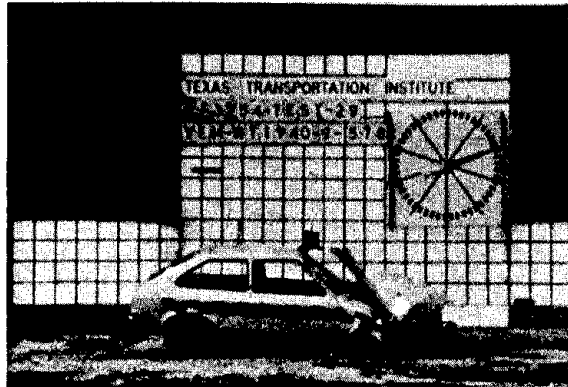
Figure 13. Sequential photos, test 28.

Table 4 summarizes the results of test 28. Sequential photos were taken from high-speed film of the impact, and are shown in Figure 13. Table 5 gives the time displacement event summary. Upon impact, the signpost began to rotate into the vehicle. At the same time, the post forced the bumper down as it wrapped around the hood. This caused the vehicle to spin out and then forced it into a rollover. The vehicle returned to an upright position after rolling. Part of the installation remained in the ground; one U-post was wrapped around the vehicle and part of it broke free of the base.

<u>TIME</u> (sec)	<u>NOMINAL VEHICLE</u> <u>DISPLACEMENT</u> (ft)	<u>EVENT</u>
0.000	0.00	Impact
0.029	2.41	Fender strikes wheel
0.065	5.27	One signpost breaks away
0.112	8.62	Front fender hits ground
0.133	9.79	Free missile travel time
0.155	10.86	Both signposts broken

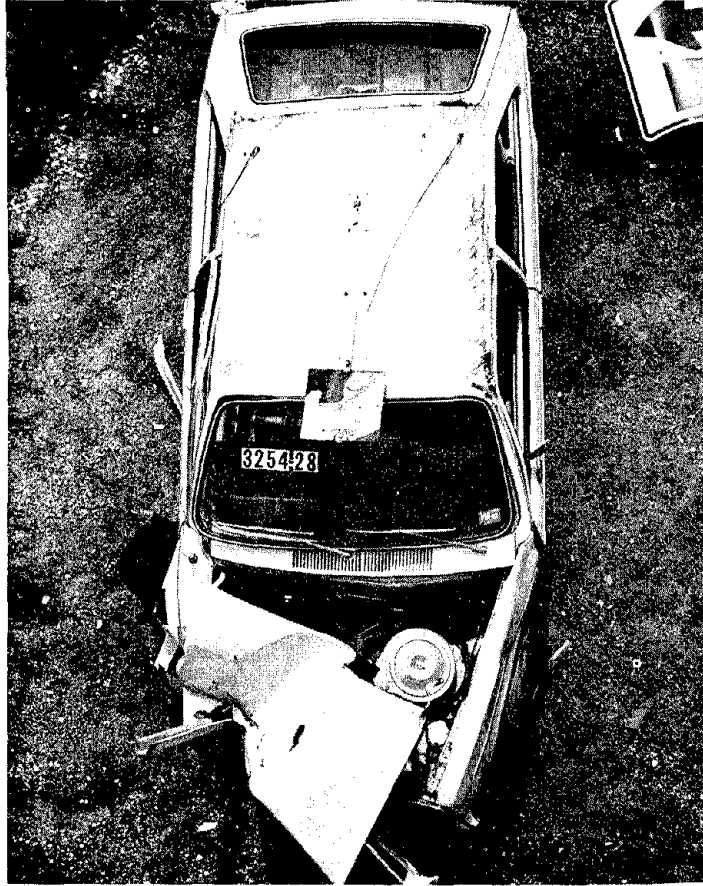
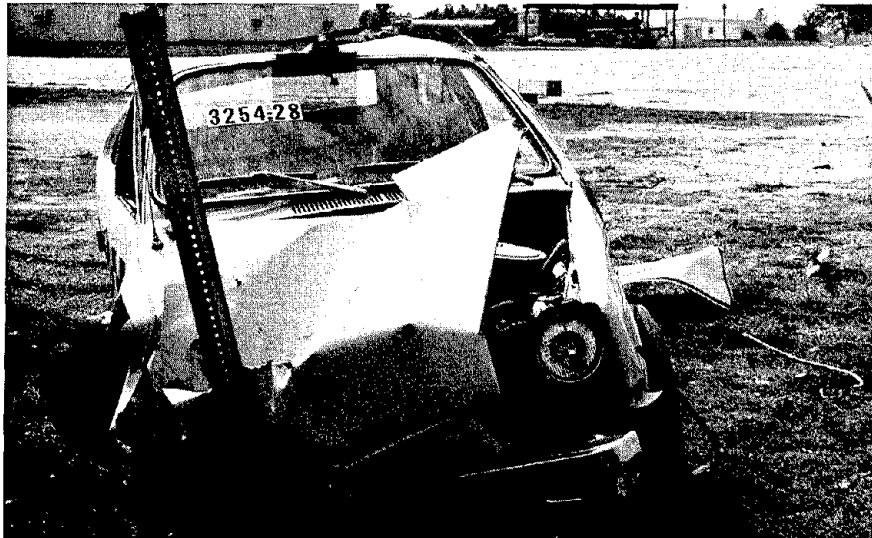
Figure 18. Vehicle damage, test 28.

The vehicle was extensively damaged due in part to the rollover. The front of the car was crushed approximately 2 ft (0.61 m) and the roof was flattened. The damage can be seen in Figure 18. Table 4 gives the TAD and SAE damage ratings.

TAD	FR-6
SAE	12FREN-5
Did test article penetrate the passenger compartment?	No
Was windshield broken?	Yes, by Sign Panel

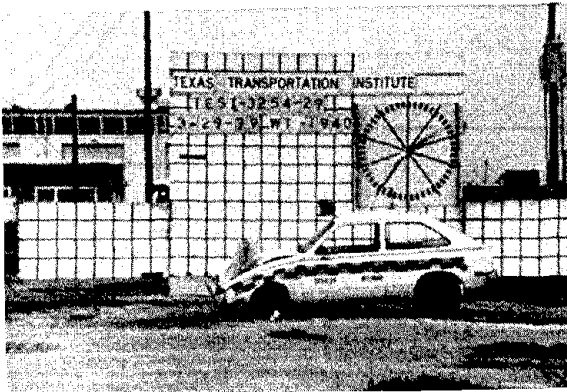
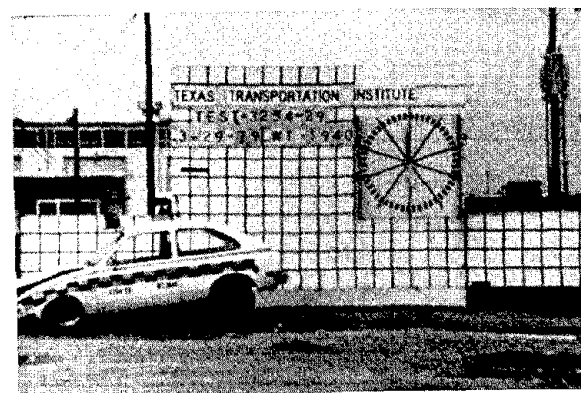
Figure 19. Sequential photos, test 29.

Test 29, which was a repeat of test 27 except with dry soil, is summarized in Table 6. Sequential photos are shown in Figure 19. Table 7 gives a time-displacement event summary. As the vehicle moved

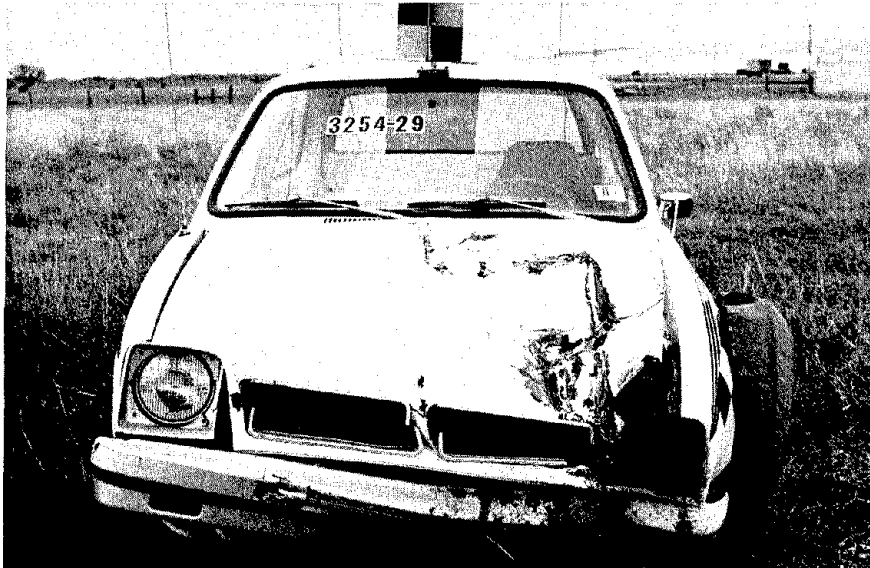
Figure 24. Vehicle damage, test 29.

Vehicle damage was extensive, as shown in Figure 24. The hood, grille, left fender, and bumper were severely bent or crushed. The left headlight was knocked off, and the front left wheel well was nearly separated from the fender. This would have to be replaced, and the right fender would need some repair work. Table 6 gives TAD and SAE damage ratings for test 29.

TAD	FL-3
SAE	12FLEN-2
Did test article penetrate the passenger compartment?	No
Was windshield broken?	No
