**FORUM ON WEATHERING STEEL FOR HIGHWAY STRUCTURES
SUMMARY REPORT**

1. Report No. FHWA-TS-89-016		2. Government Accession No. PB89 - 221063/AS		3. Recipient's Catalog No.	
4. Title and Subtitle Forum on Weathering Steel for Highway Structures: Summary Report				5. Report Date June 1989

16. Abstract On July 12-13, 1988, the Office of Research, Development and Technology of the Federal Highway Administration (FHWA) hosted a forum on Weathering Steel for Highway Structures. This conference took place at the Ramada Hotel in Alexandria, Virginia. The major objectives of this forum were to examine the state of the art in weathering steel use and maintenance, to develop rules for its use in new construction, and for maintenance of existing structures. The forum brought together 131 participants representing Federal and State governments and industry. The forum was organized into four main sessions, including a panel discussion and several individual presentations. This report summarizes the forum.

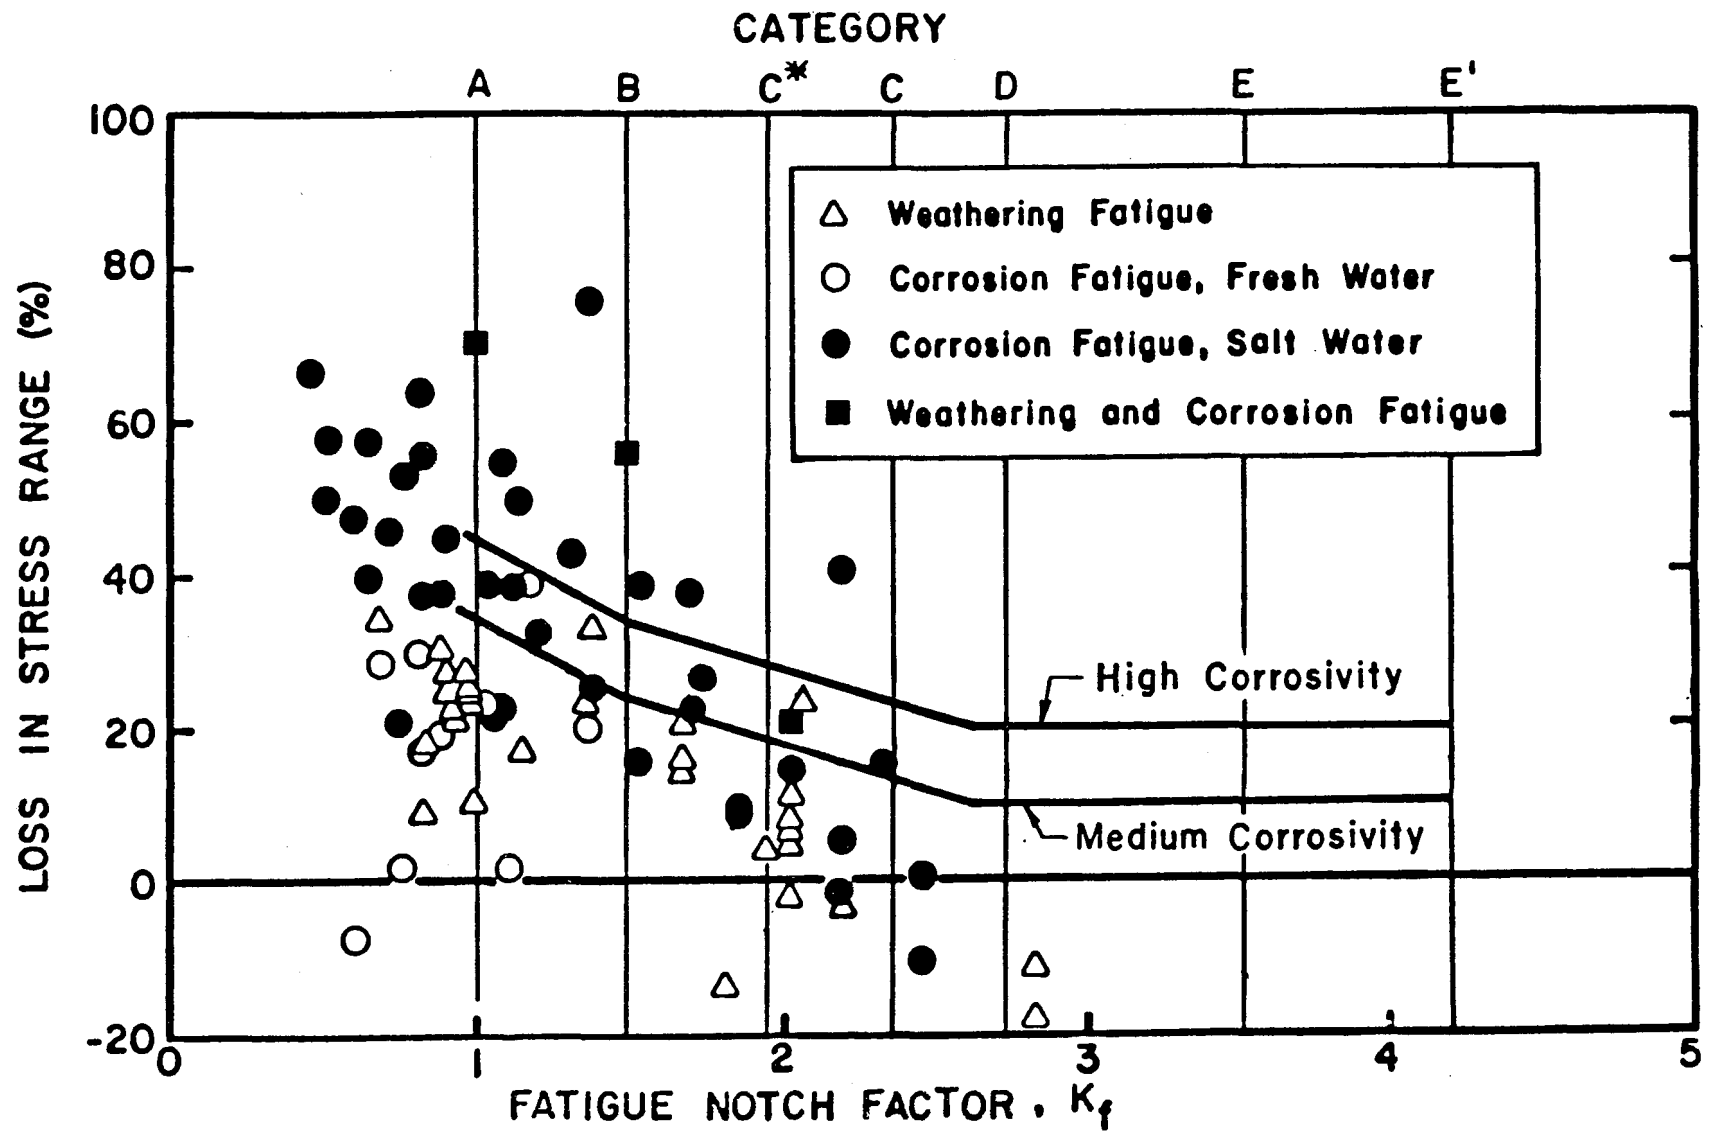
In the other two series, W 14x30 rolled beams as well as welded beams of same cross section as the rolled beams were weathered 5.5 to 7 years (Albrecht 1988c). The beams were lightly sprayed with a 3 percent sodium chloride solution 3 times per week during 3 winter months of every year. They were then stress cycled at 0.75 Hz in a moist salt water environment. The exposure and test environments for the beams were of very high corrosivity. Relative to their nonweathered counterparts cycled in air, the loss in stress range was 71 percent for the category A rolled beams, 56 percent for the category B welded beams, and 23 percent for the category C* transverse stiffeners. The data points were plotted in fig. 5 with solid rectangular symbols. Because

Figure 5. Comparison of loss in stress range with recommended reductions in allowable stress range for bare, exposed weathering steel structures.

the beams had severely corroded during the weathering time and were stress cycled in a moist environment, the losses in stress range were greater than those found in the WFSN and CFSN tests.

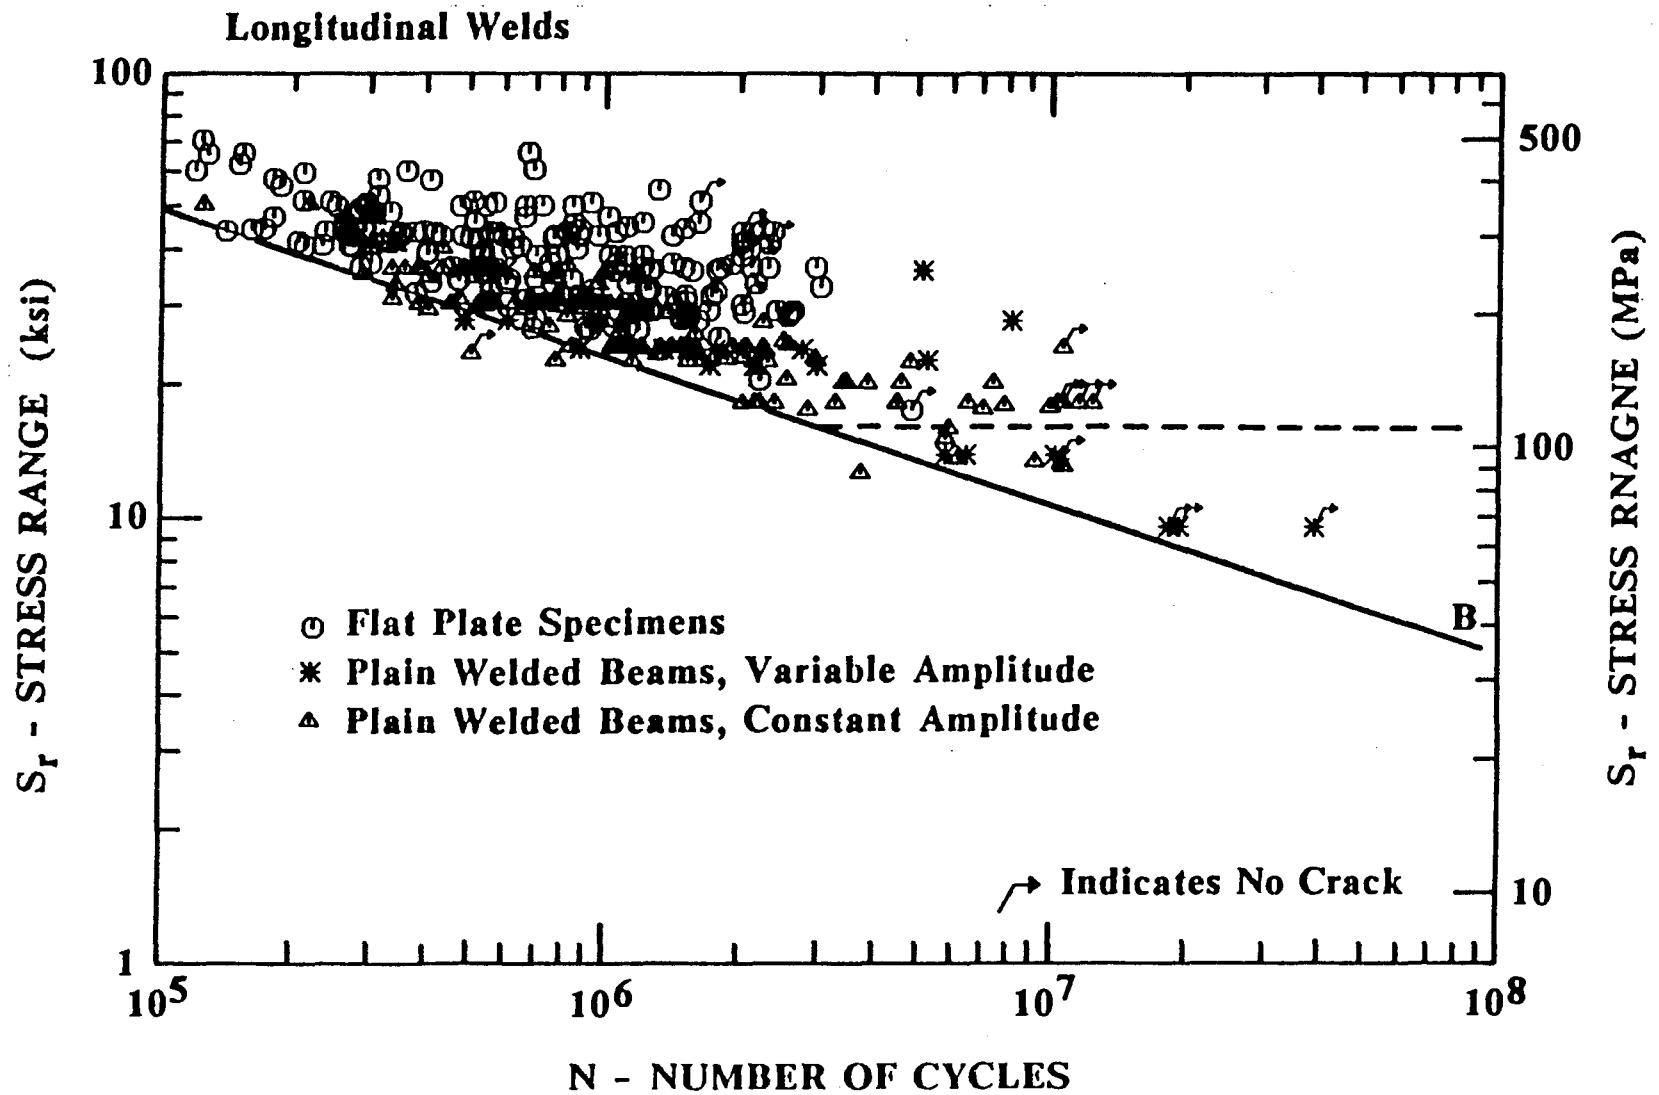
Figure 6. Experimental data on longitudinal fillet and groove welds.

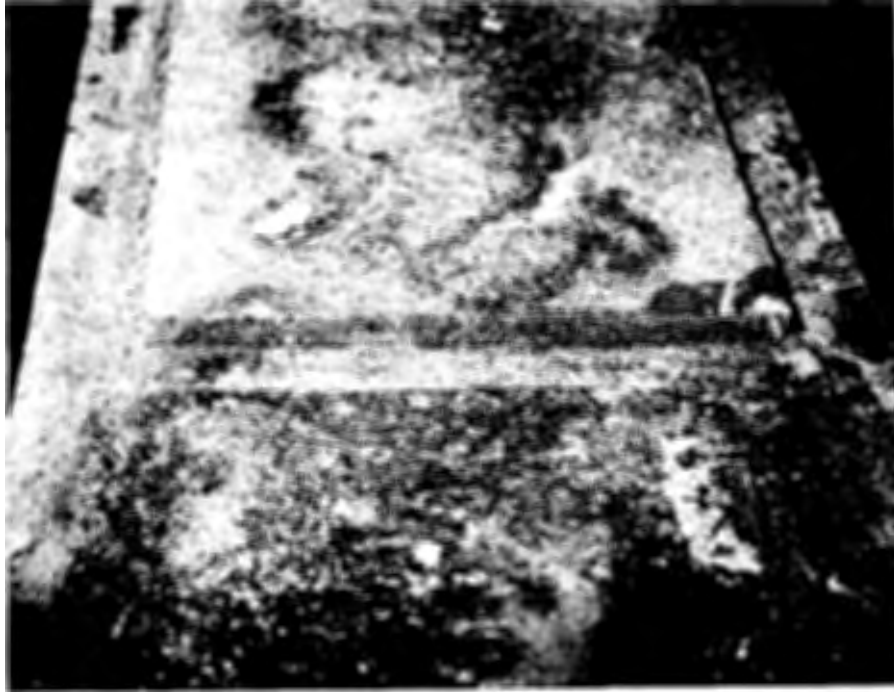
Figure 12. End of cover plate after two years exposure.

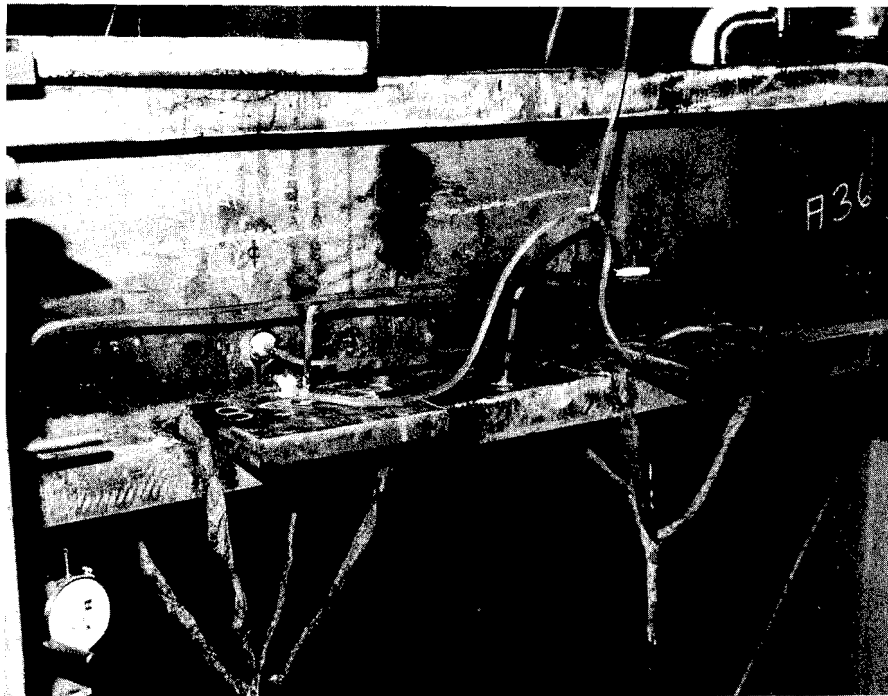
Figure 19. Test set-up showing welded details, tubing to distribute liquid solution, and cotton strips to hold and distribute liquid.

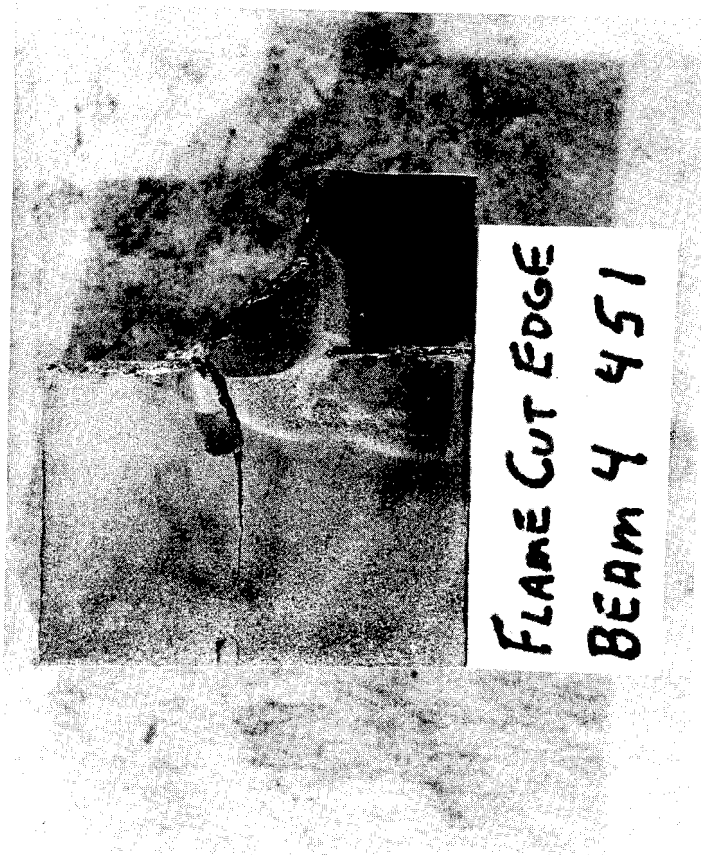
Fig. 21 shows a crack at the flange tip after 13 million cycles. The crack path can be seen to be irregular. Fig. 22 shows the crack tip region and

Figure 21. Flange tip crack at weld toe of A588 beam 3.5 percent NaCl.

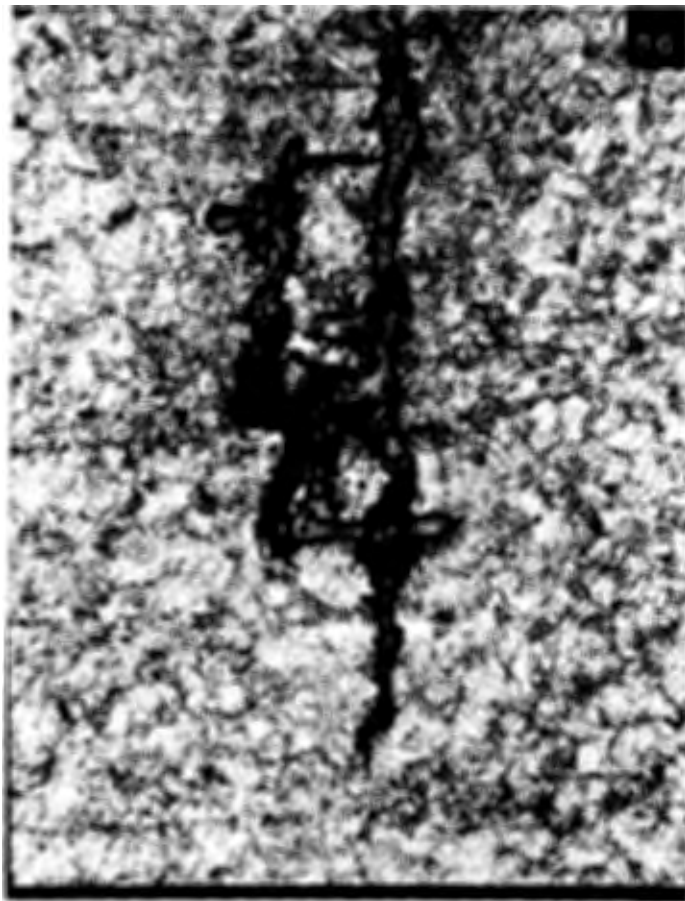
Figure 22. Fatigue crack tip of A588 steel detail at 40X.

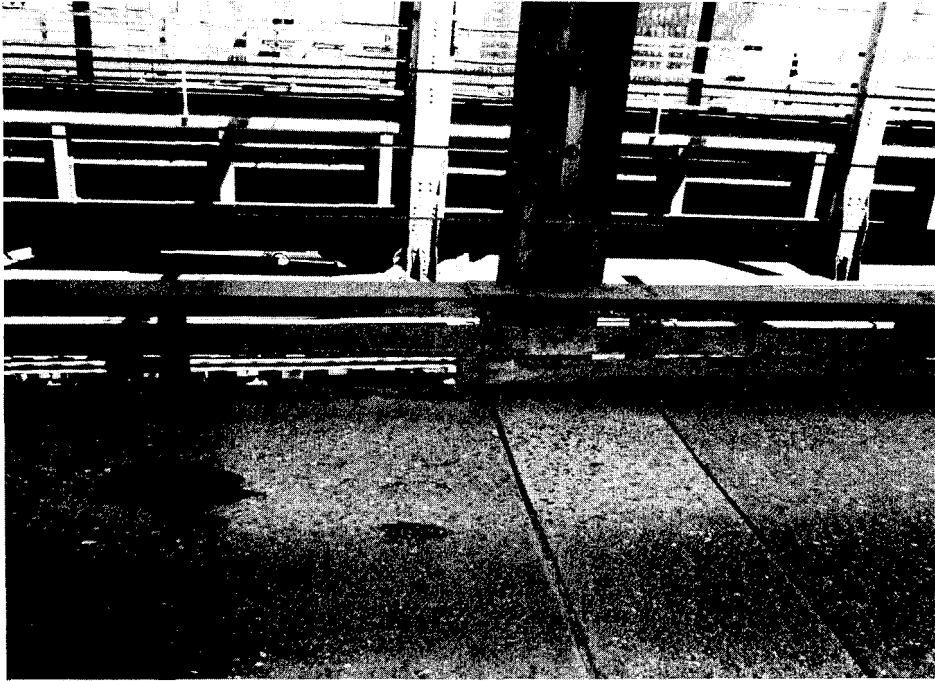
The runoff from the roadway also enhances the oxygen concentration at the corroding areas. It is well known that the splash zone is the location of maximum corrosion rate in steel piling (Fisher et al, 1984). Oxygen is rapidly transported through the thin layer of water splashed on vertical surfaces. The Williamsburg Bridge provided ideal conditions for accelerated corrosion. The paint coating applied in 1973 did not have the durability to protect the structure from the debris and water it was subjected to. Once breaks developed in the paint film, corrosion cell activity was enhanced and accelerated.

Figure 27. View showing roadway joints and discontinuous splash plates along edge of Williamsburg Bridge Roadway.

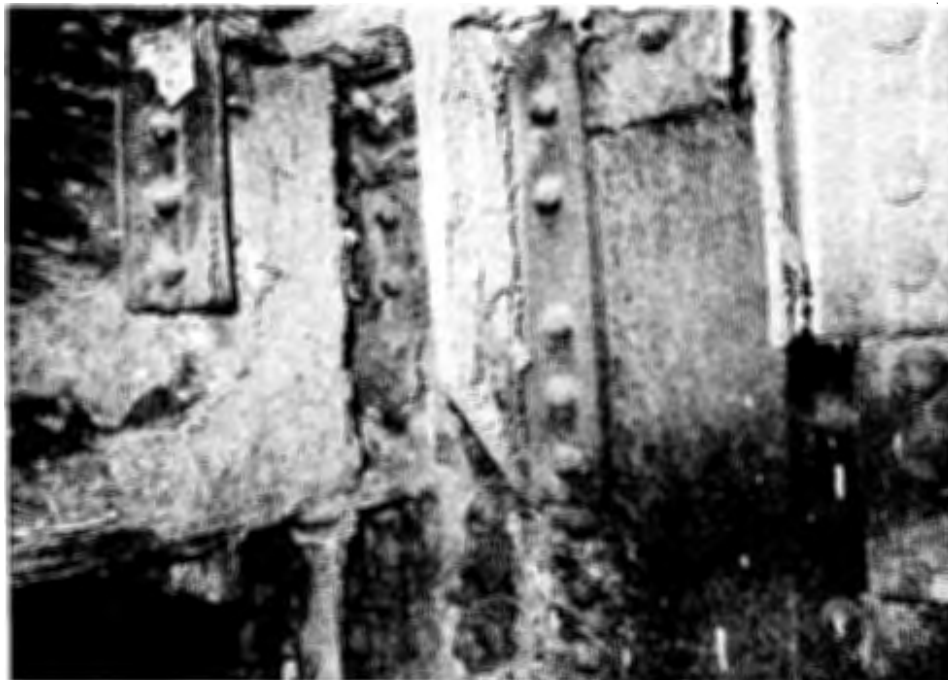
The crevices at the angle web lap joints provide a natural corrosion crevice. Breaks in the coating and mill scale provide ideal pitting conditions. These conditions are easily masked by the dirt and moderate general corrosion which can make visual detection of the corrosion battery difficult unless the area is cleaned.

Figure 28. Dirt adhering to stringer and floor beam webs, stringer flanges and end connection angles.

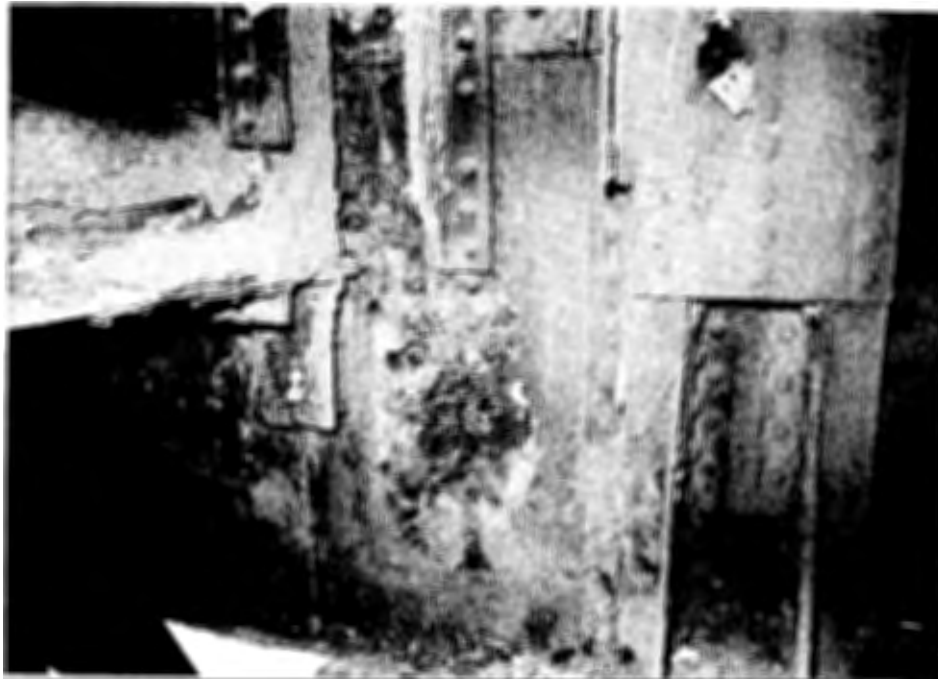
Figure 29. Pitting corrosion observed when dirt, paint, and corrosion products were removed from floor beam web.
