2022 Summary of Special Pavement Test Sections

WA-RD 919.1

Various Projects Statewide

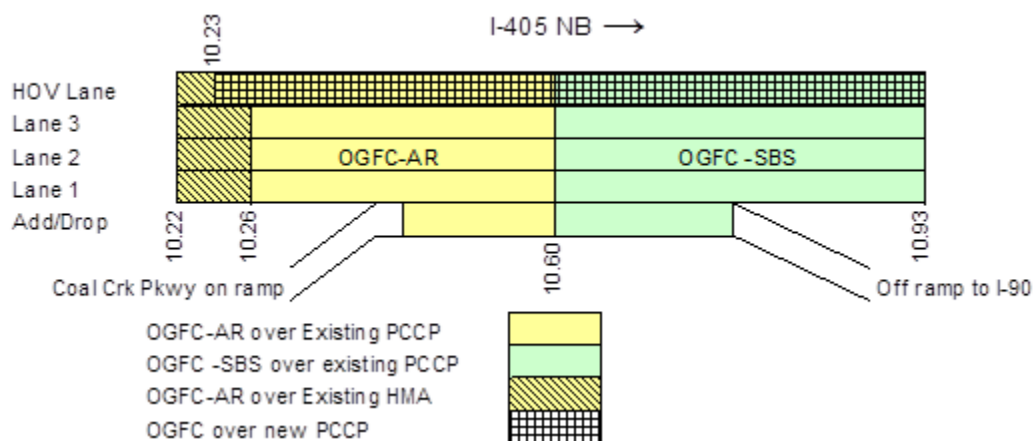
Figure 1. Location of open graded friction course sections on the south section.

The 2009 I-405 project (3) was constructed after the winter of the severe storm and has survived to a current age of 114 months (9.5 years). Two test sections consisting of both OGFC-AR and OGFC-SBS; one south of I-90 (Figure 1) and one north (Figure 2). The control section of HMA was located south of the open-graded sections.

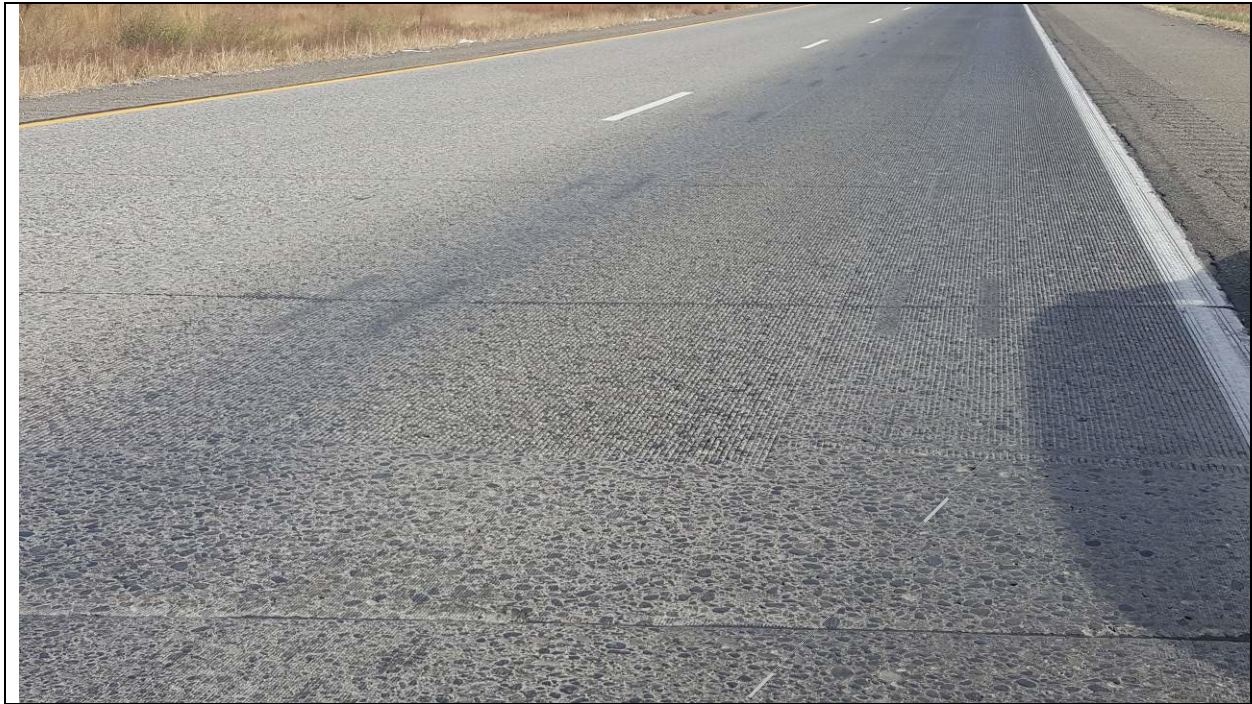
Figure 4. Transition between CDG foreground and NGCS background. Note slight spalling at the transverse joints. October 2017.

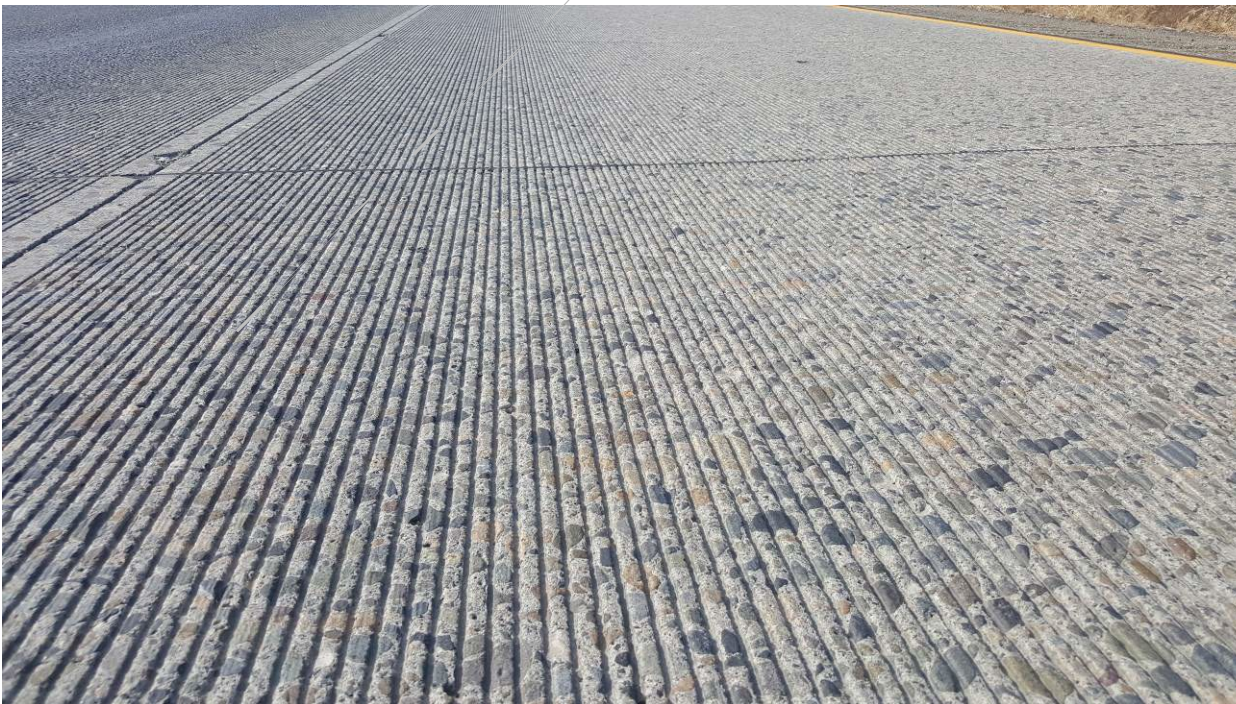
Figure 5. Note erosion of the edges of the land areas on the NGCS. October 2017.

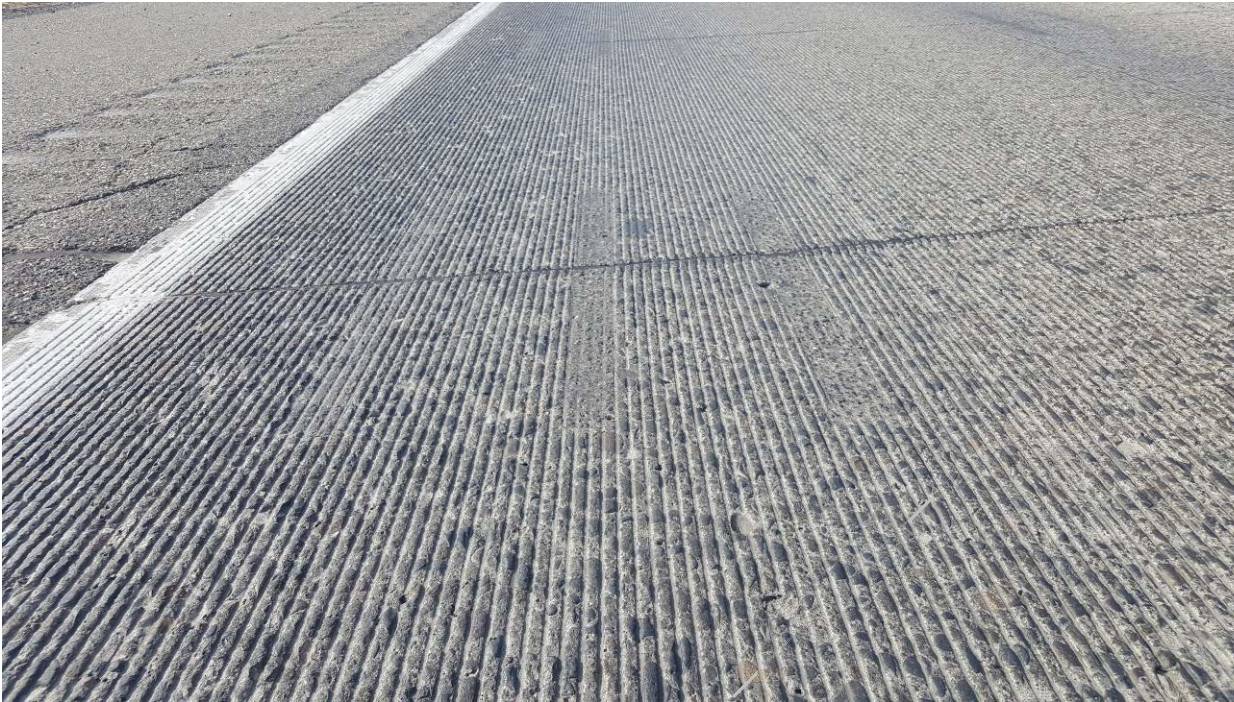
Figure 6. Note erosion of the edges of the land areas on the NGCS and the greater wear on the dowel bar retrofit fill material. October 2017.

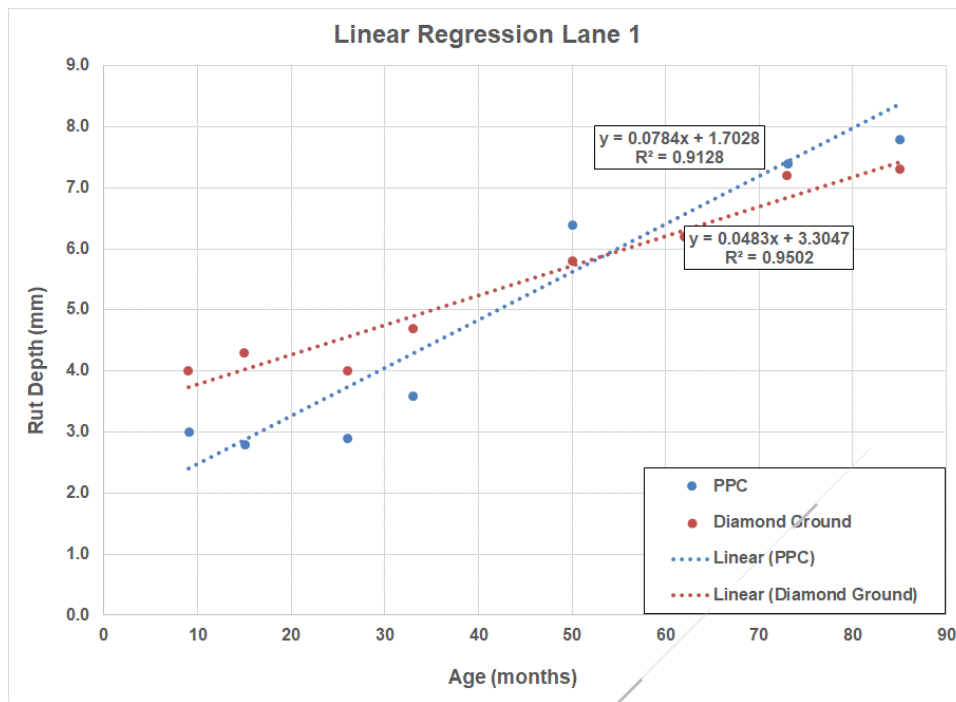
Based on the measurements taken the wear rates for each lane on the PPC test section are approximately 1.5 to 2 times that of the Diamond Ground test section. While the rate of wear is greater in the PPC, additional testing will determine whether the trend found in the first seven years remains the same.

Figure 9. Lane 1 wear measurements for the PPC and Diamond Ground sections. Wear rate per year is equal to 12 times the slope of the line.

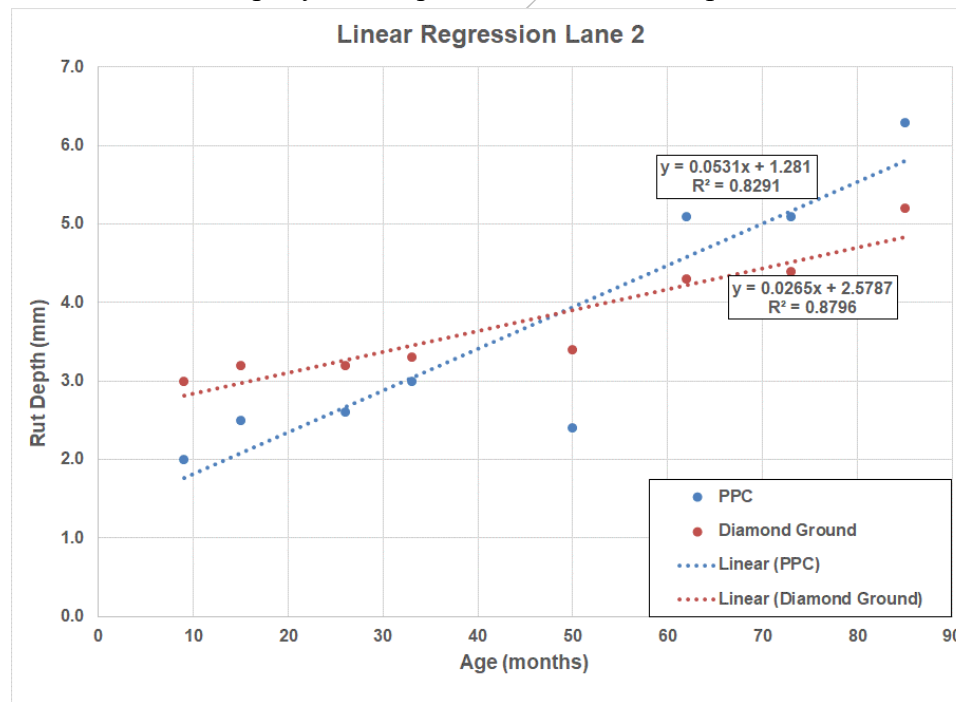
Figure 10. Lane 2 wear measurements for the PPC and Diamond Ground sections. Wear rate per year is equal to 12 times the slope of the line.

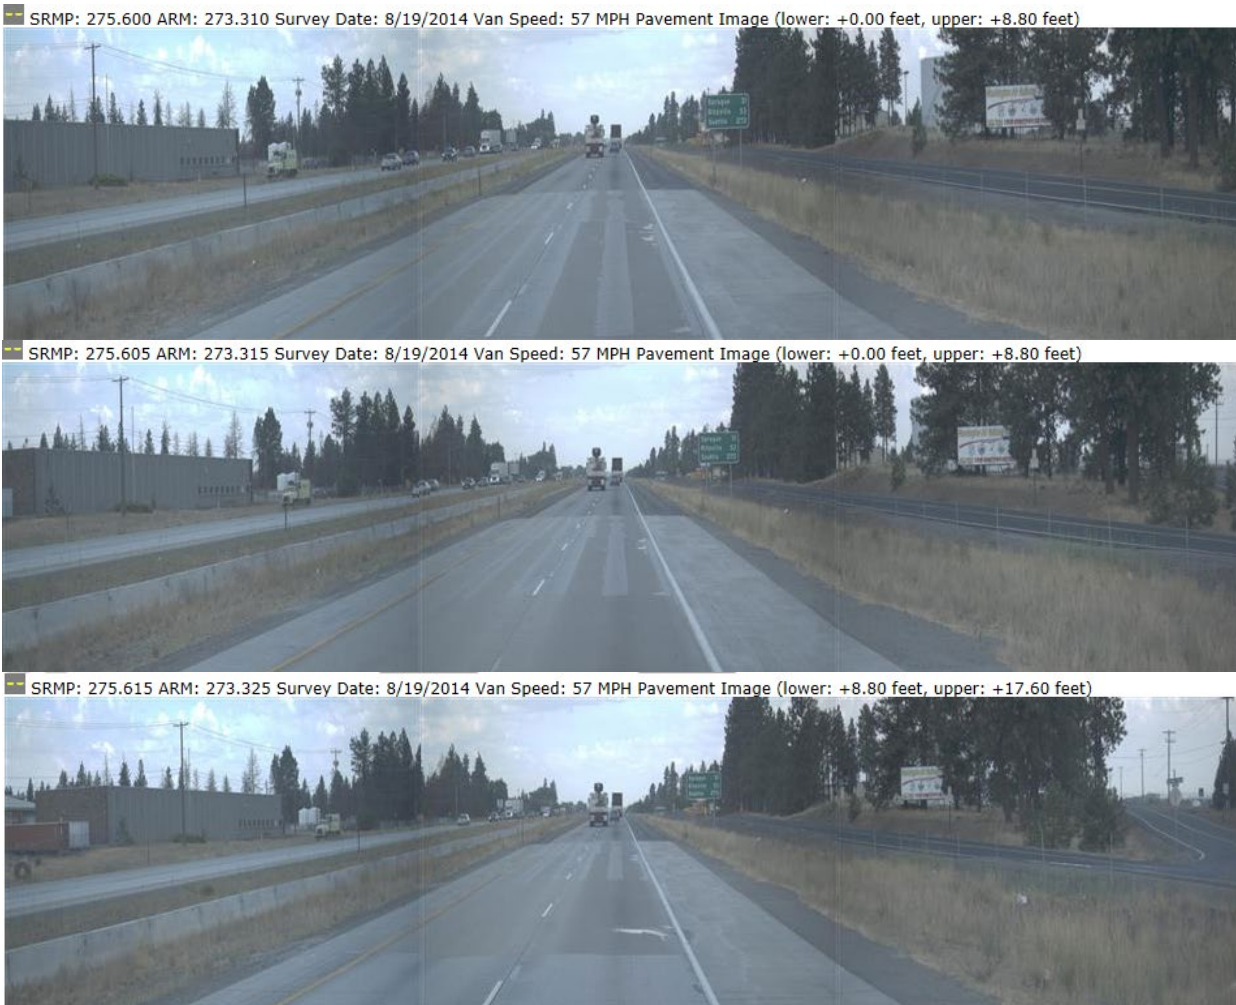
Figure 11 contains photos from the WSPMS video taken in 2014 that show the three sections of the polyester concrete. Figure 12 shows the same three photos from the 2016 video and Figure 13 the 2018 video. The photos show no change in the footprints of the three sections with no spalling or erosion at the edges of the polyester concrete.

Figure 11. 2014 WSPMS views of the three polyester concrete sections. Top photo is of the screed to fill existing ruts, middle photo is the grind and inlay the wheel paths, and bottom photo is the grind and inlay entire lane.

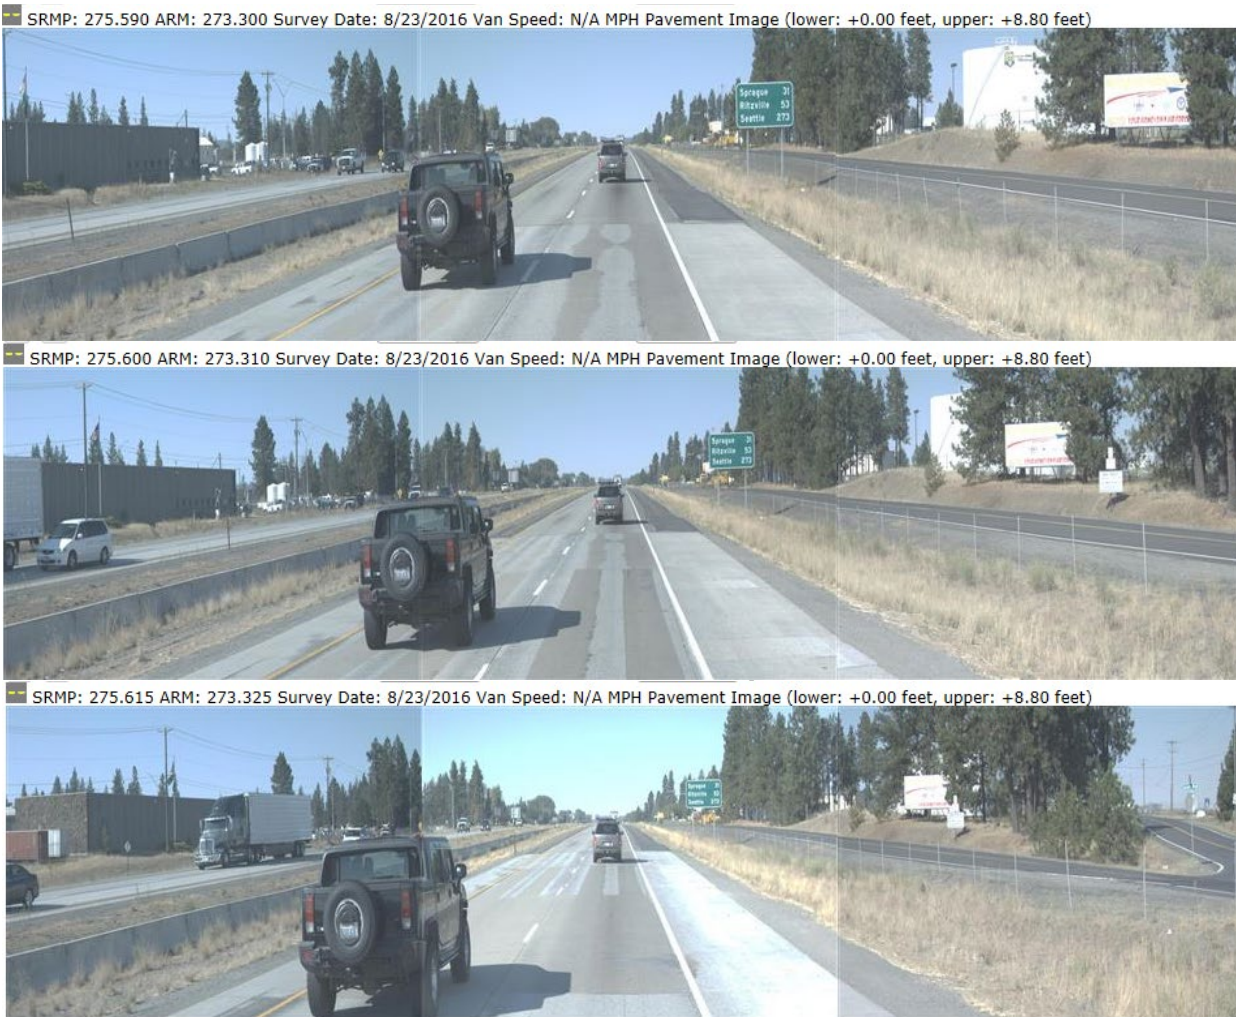
Figure 12. 2016 WSPMS views of the three polyester concrete sections. Top photo is of the screeled to fill existing ruts, middle photo is the grind and inlay the wheel paths, and bottom photo is the grind and inlay entire lane.

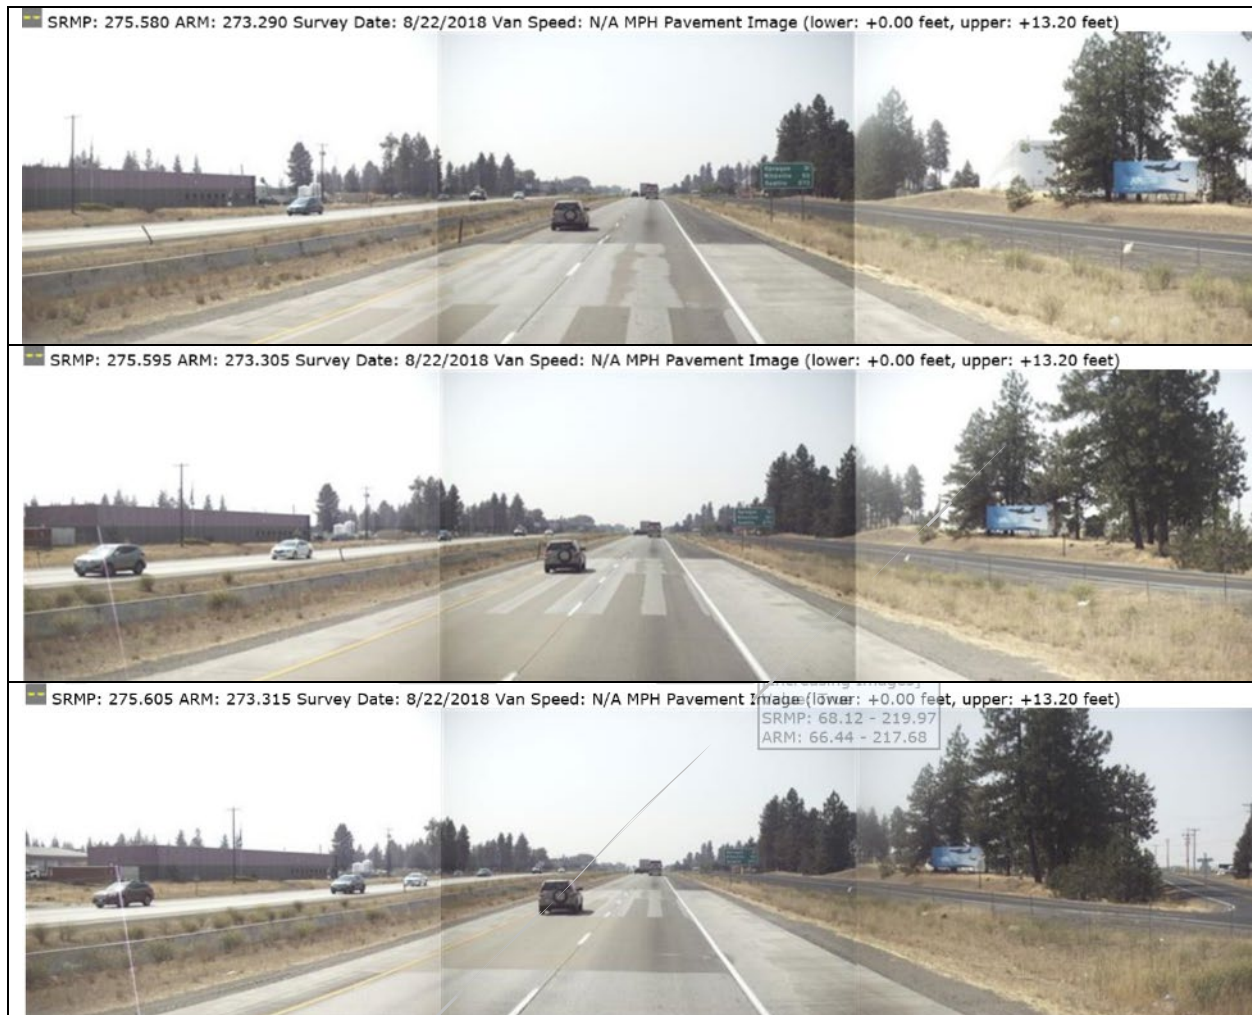
Figure 13. 2018 WSPMS views of the three polyester concrete sections. Top photo is of the screed to fill existing ruts, middle photo is the grind and inlay the wheel paths, and bottom photo is the grind and inlay entire lane.

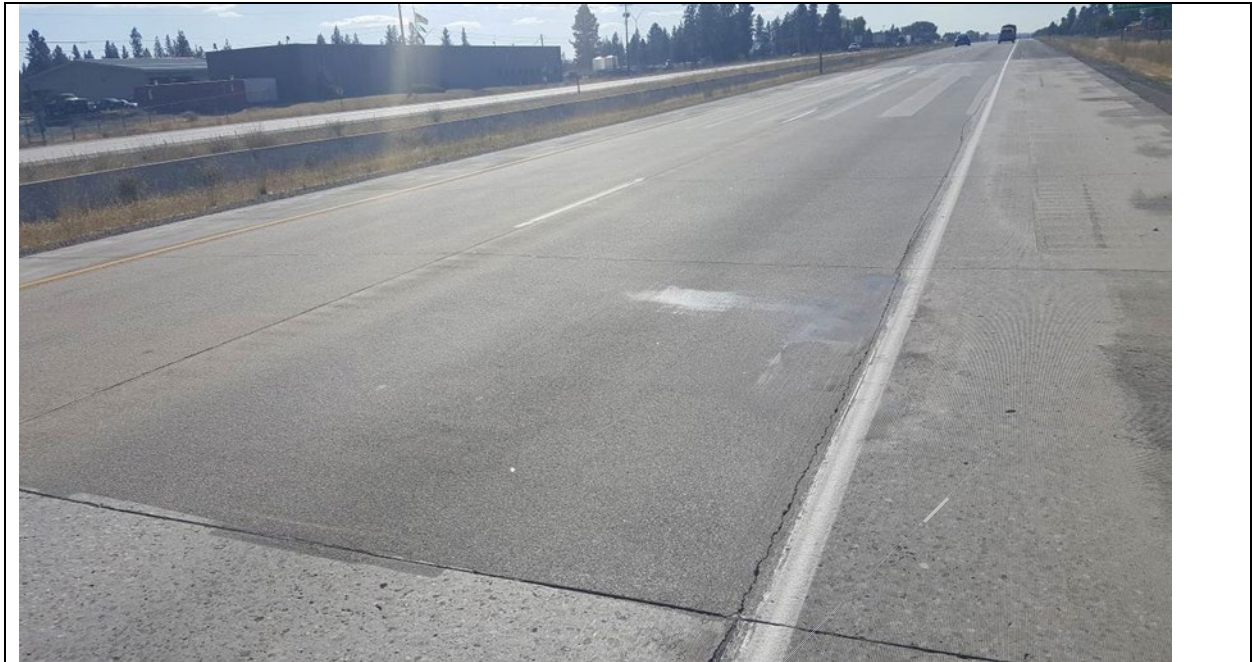
Photos of the section were taken on September 27, 2017 (Figures 14-19). They show very little change in the condition of the polyester concrete with no delamination or cracking noted.

Figure 14. The full lane one inch inlay section of polyester concrete on I-90. (Sept. 2017)

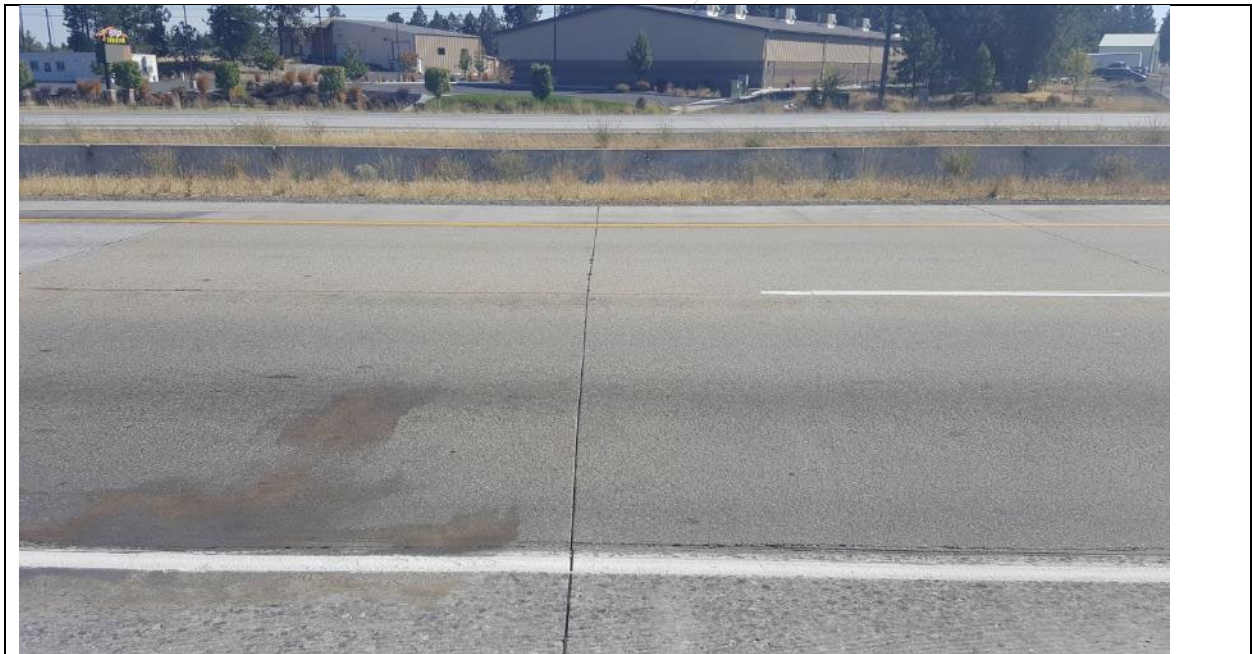
Figure 15. The total lane, one inch inlay section of polyester concrete. (Sept. 2017)

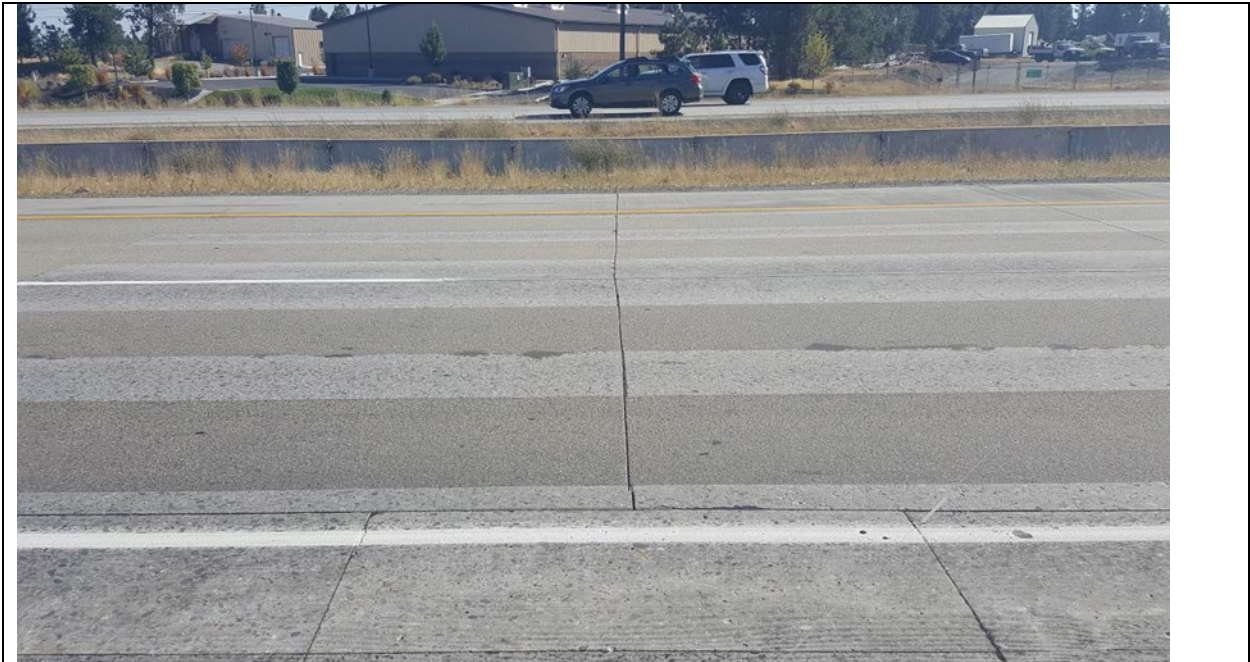
Figure 16. The wheel path one inch inlay section of polyester concrete. (Sept. 2017)

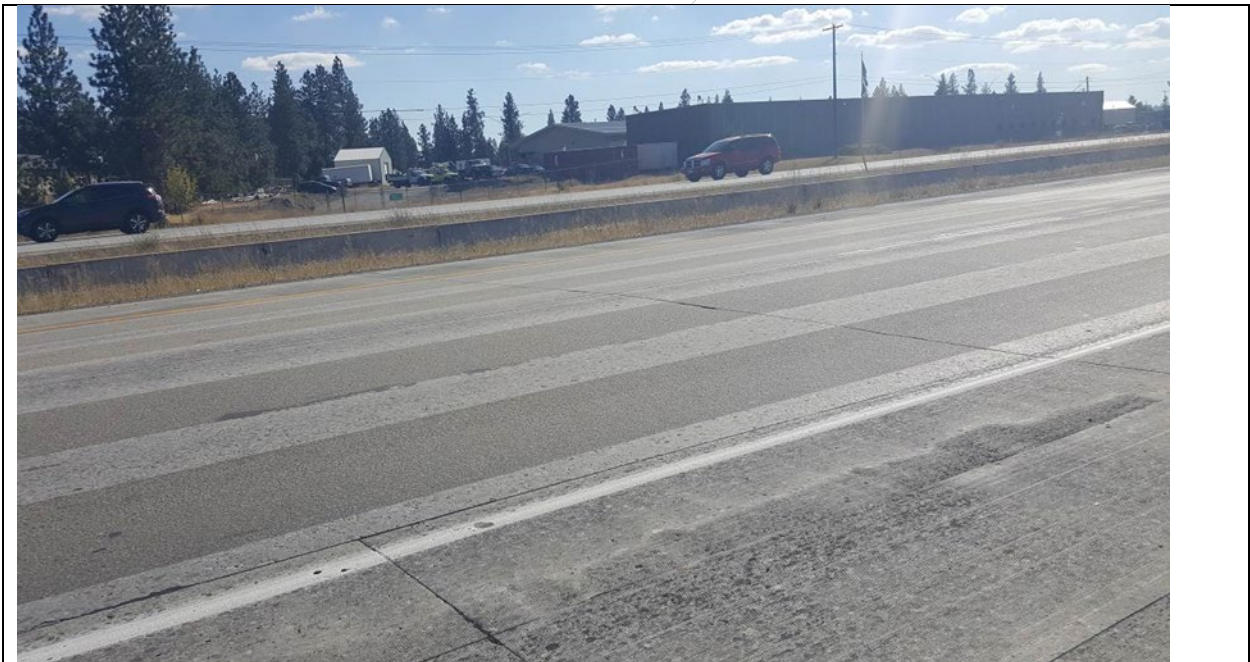
Figure 17. The wheel path one inch inlay section. (September 2017)

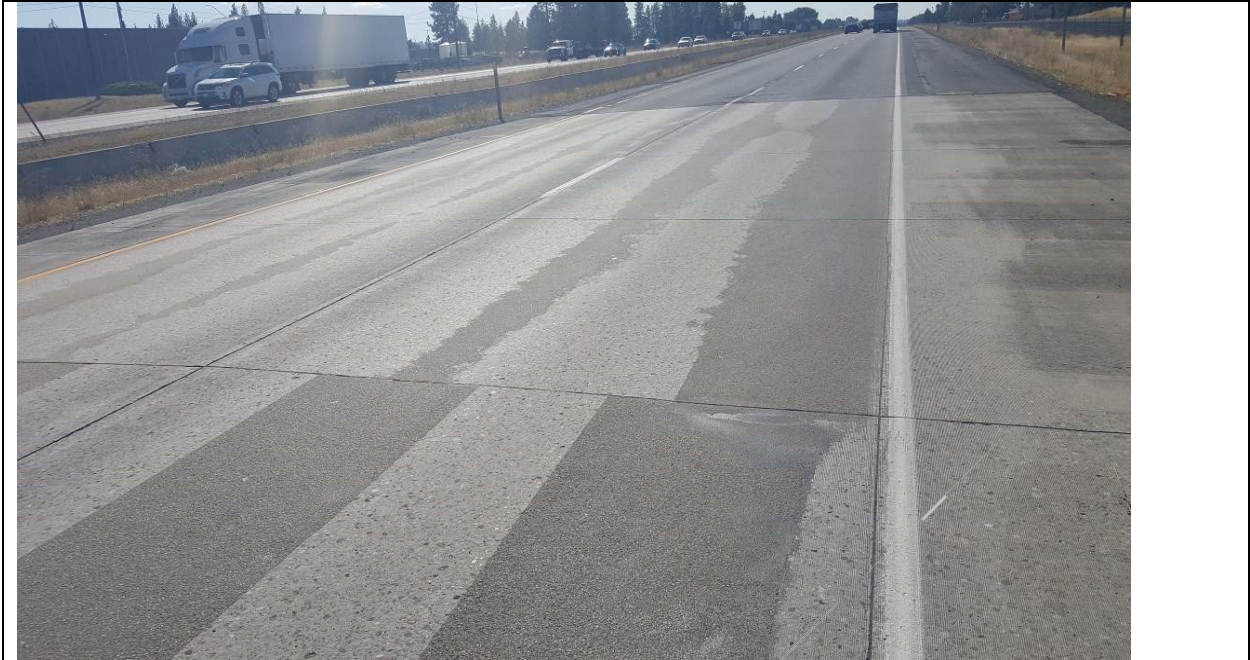
Figure 18. The screed to fill section of polyester concrete. (September 2017)

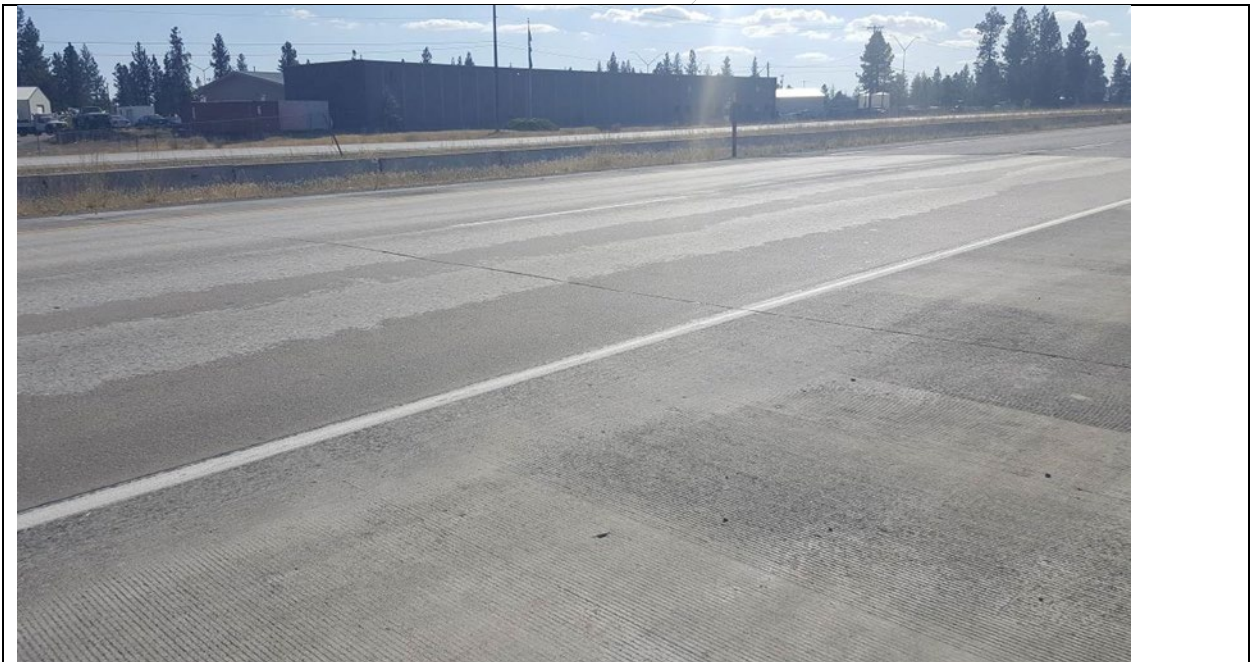
Figure 19. The screed to fill section of polyester concrete. (September 2017)

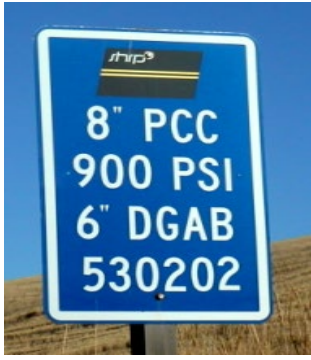
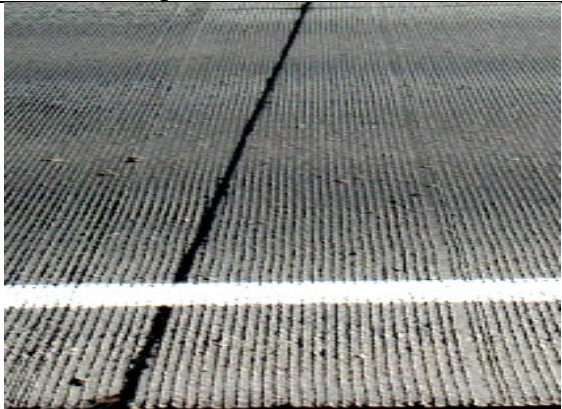
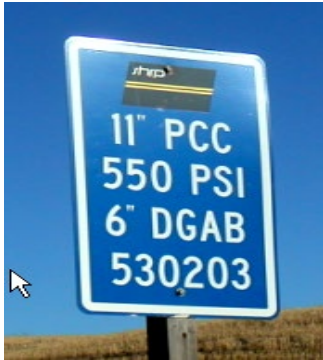
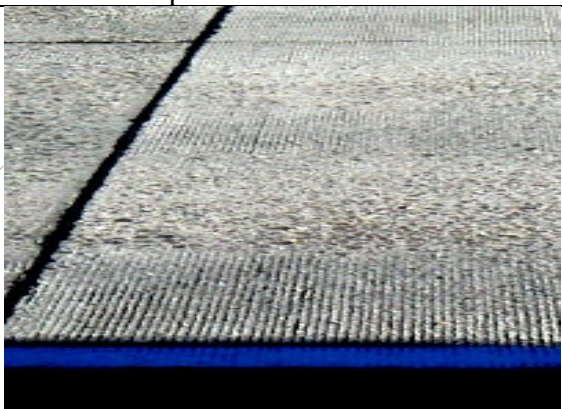
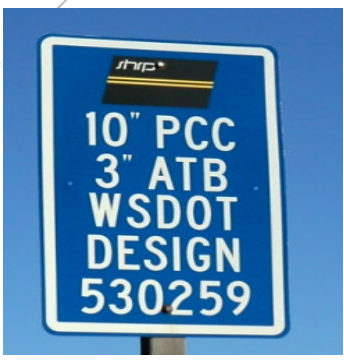
SPS Identification No.	Section PCC Slab and Mix Design Features (Photographs taken November 24, 2002)	
530202	<p data-bbox="852 401 1435 436" style="text-align: center;">8" PCC 900 psi</p>

530203	<p data-bbox="852 842 1435 877" style="text-align: center;">11" PCC 550 psi</p>

530259 (WSDOT Standard Section)	<p data-bbox="852 1283 1435 1318" style="text-align: center;">10" PCC 650 psi</p>

Figure 21. Condition of three of the special pavement sections on SR-395 in November of 2002.

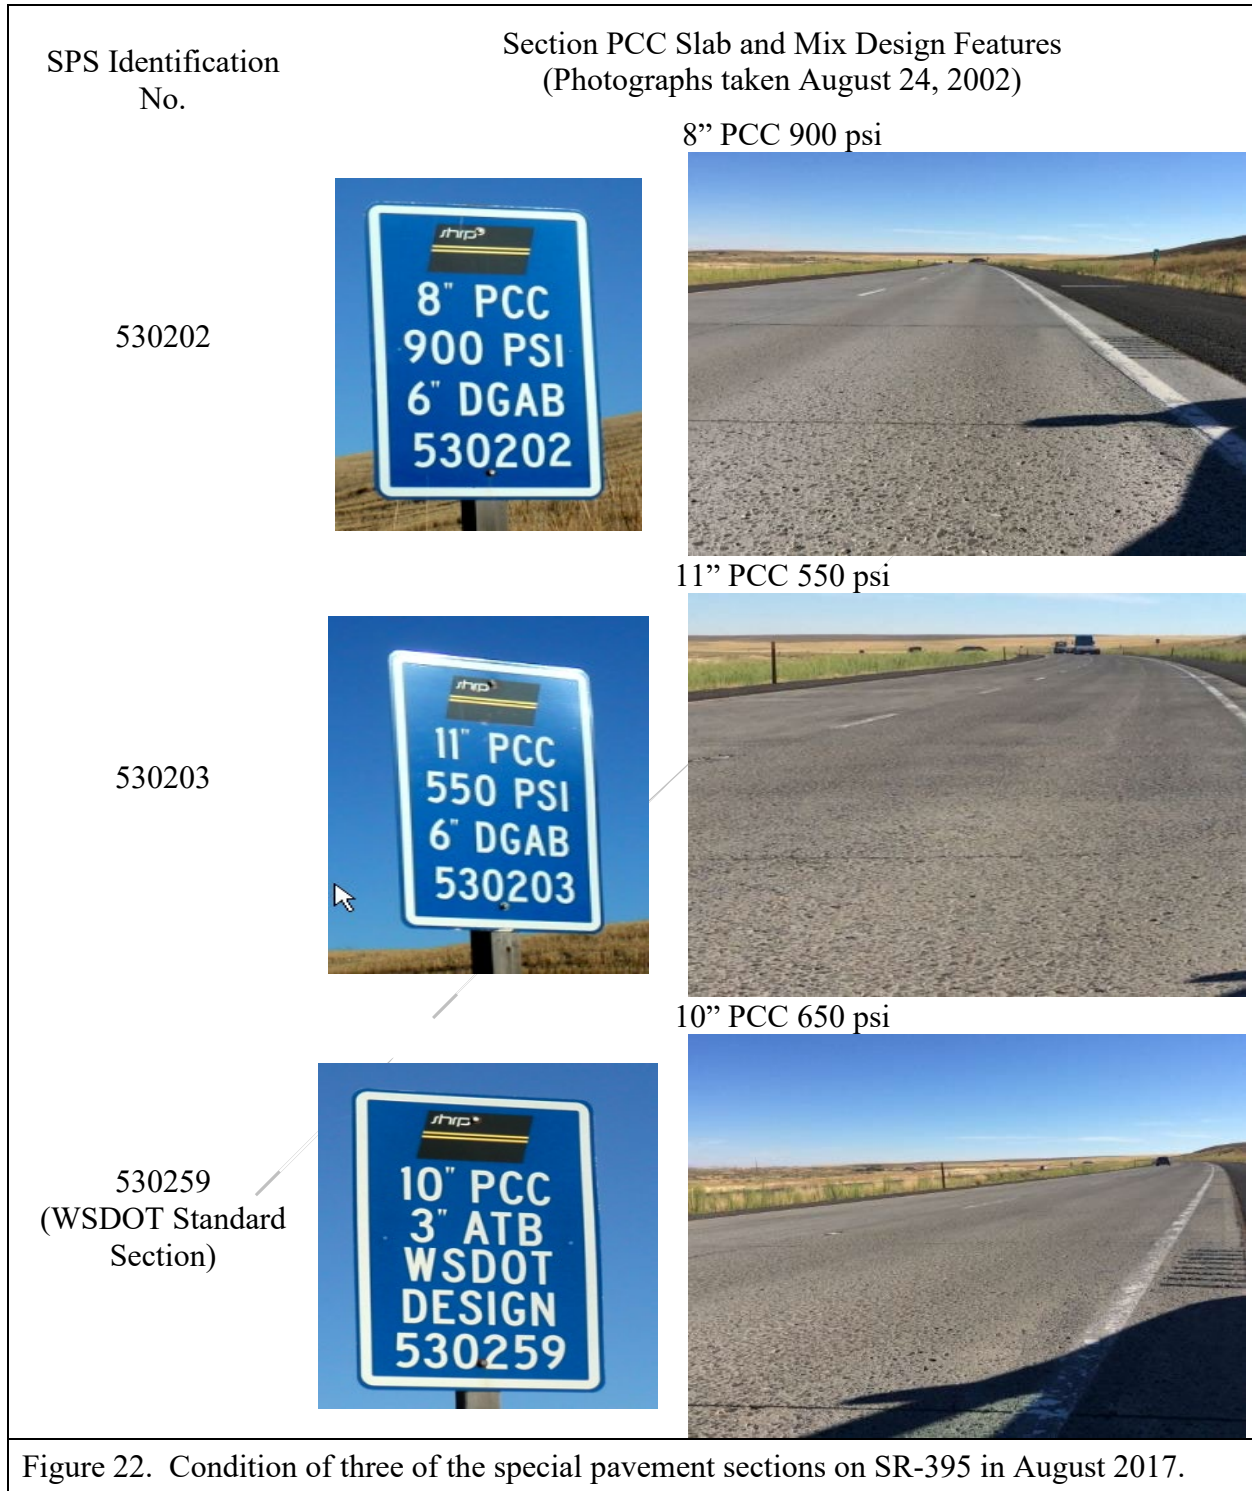
Figure 22. Condition of three of the special pavement sections on SR-395 in August 2017.

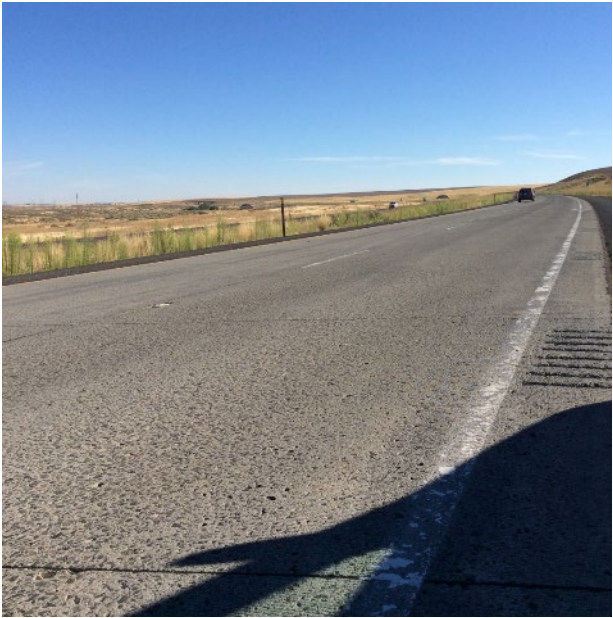
Figure 23. Section 530259, 650 psi, 10” PCC, 3” ATB. August 2017. Some tining visible, no cracks or spalls.

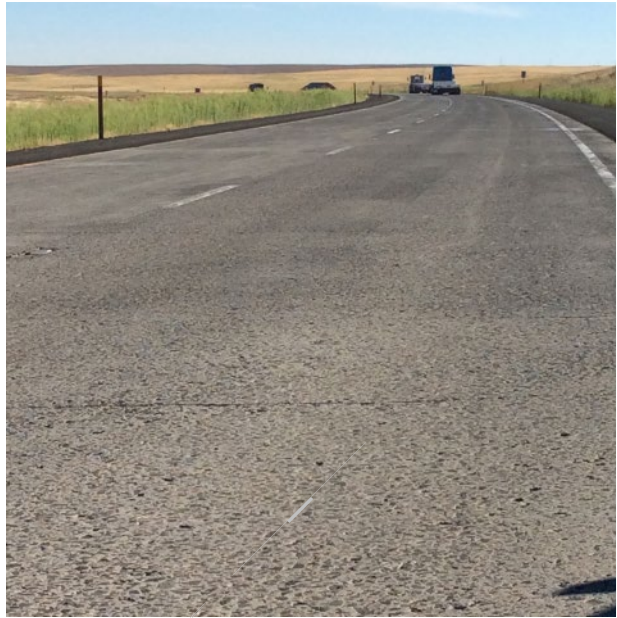
Figure 24. Section 530203, 550 psi, 11” PCC, 6” DGAB. August 2017. Some tining visible, one transverse crack, no spalls.

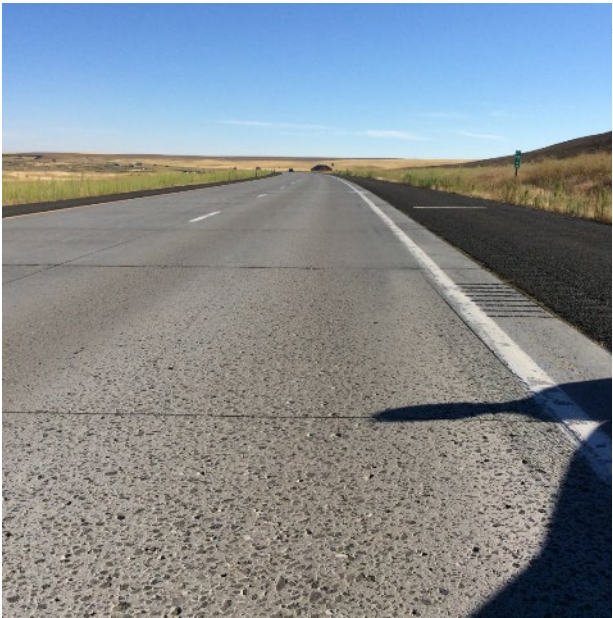
Figure 25. Section 530202, 900 psi, 8” PCC, 6” DGAB. August 2017. Some tining visible, three transverse cracks.

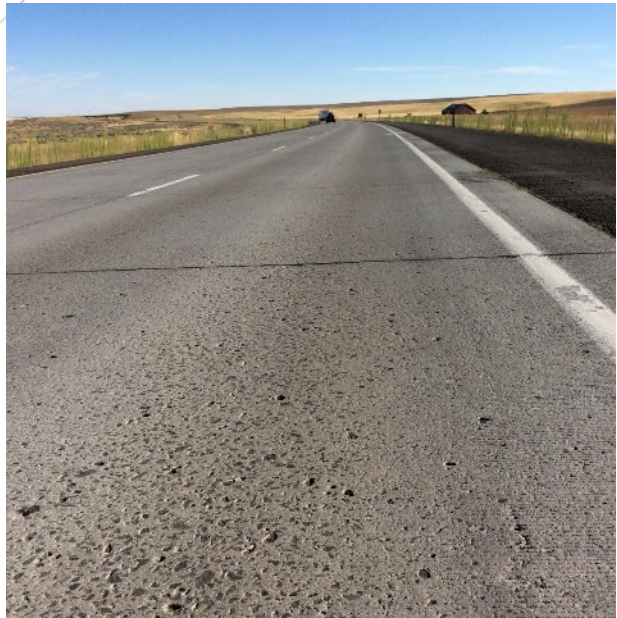
Figure 26. Section 530210, 900 psi, 8” PCC, 4” PATB, 4” DGAB. August 2017. Some tining visible, no cracks.

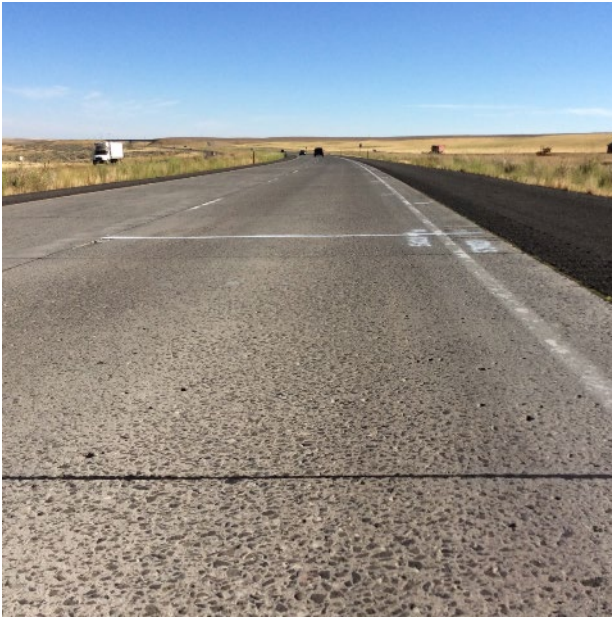
Figure 27. Section 530211, 550 psi, 11” PCC, 4” PATB, 4” DGAB. August 2017. No tining visible, no cracks or spalls.

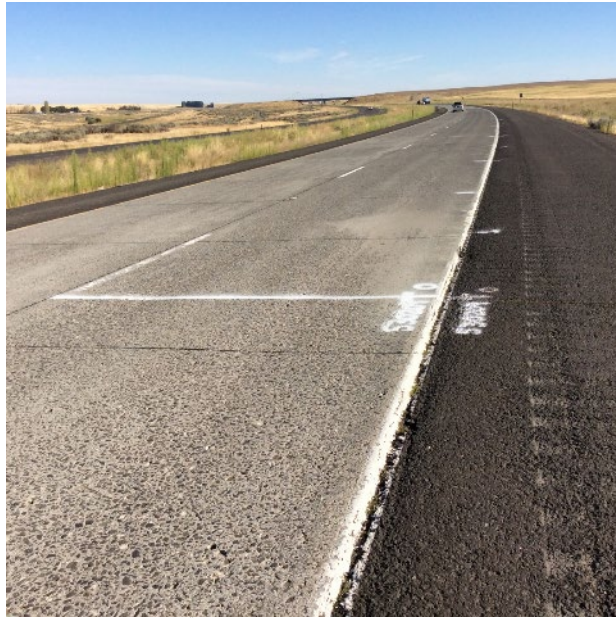
Figure 28. Section 530209, 550 psi, 8” PCC, 4” PATB, 4” DGAB. August 2017. No tining visible, no cracks or spalls.

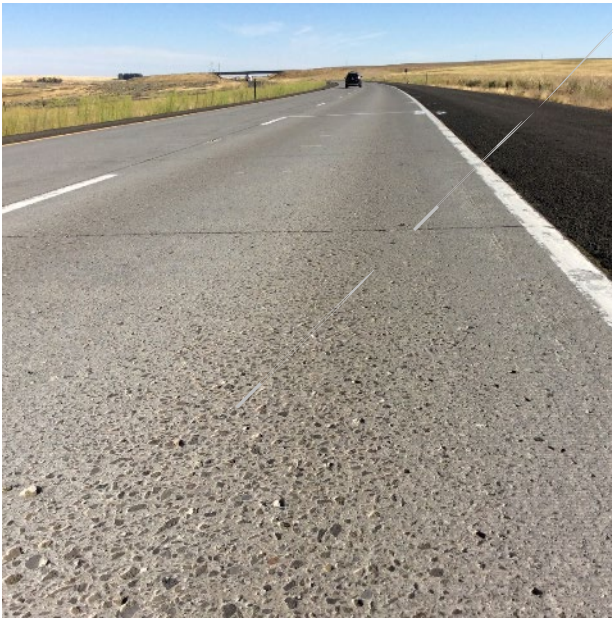
Figure 29. Section 530212, 900 psi, 11” PCC, 4” PATB, 4” DGAB. August 2017. Tining visible, no cracks or spalls.

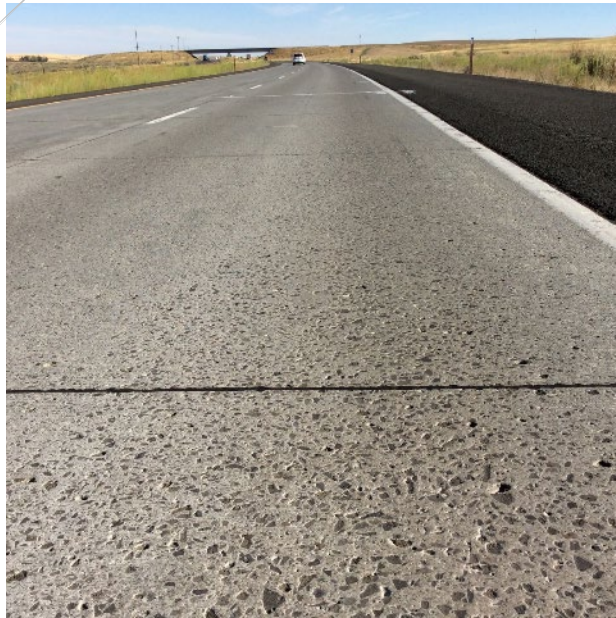
Figure 30. Section 530212, 900 psi, 11” PCC, 4” PATB, 4” DGAB. August 2017. Tining visible, no cracks or spalls.

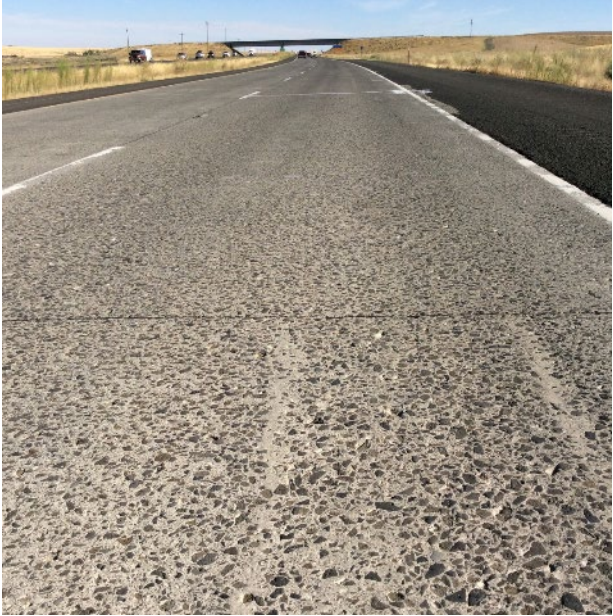
Figure 31. Section 530201, 550 psi, 8" PCC, 6" DGAB. August 2017. No tining visible, two transverse cracks with spalling.

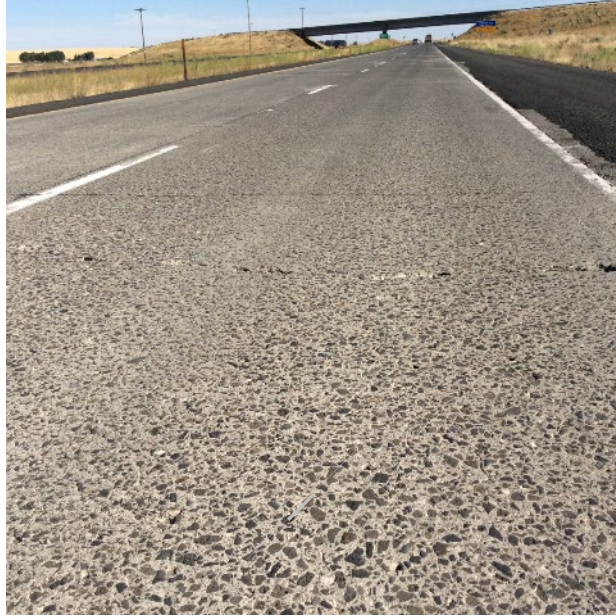
Figure 32. Section 530205, 550 psi, 8" PCC, 6" LCB. August 2017. No tining visible, three transverse cracks with spalling.

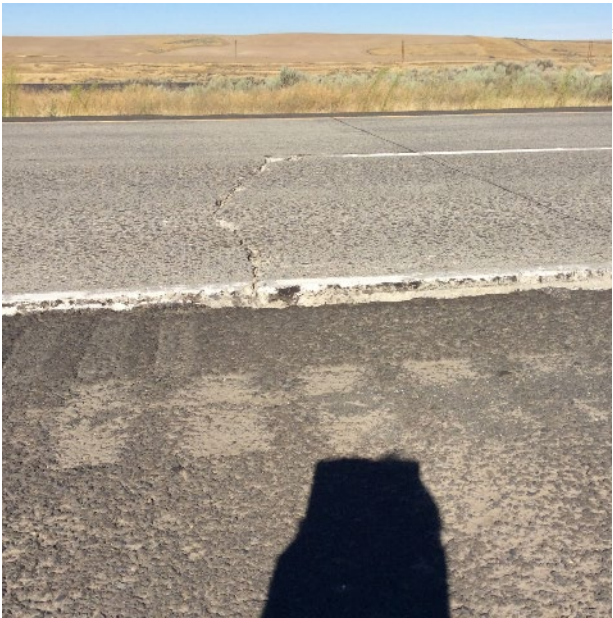
Figure 33. Section 530205, 550 psi, 8" PCC, 6" LCB. August 2017. No tining visible, three transverse cracks with spalling.

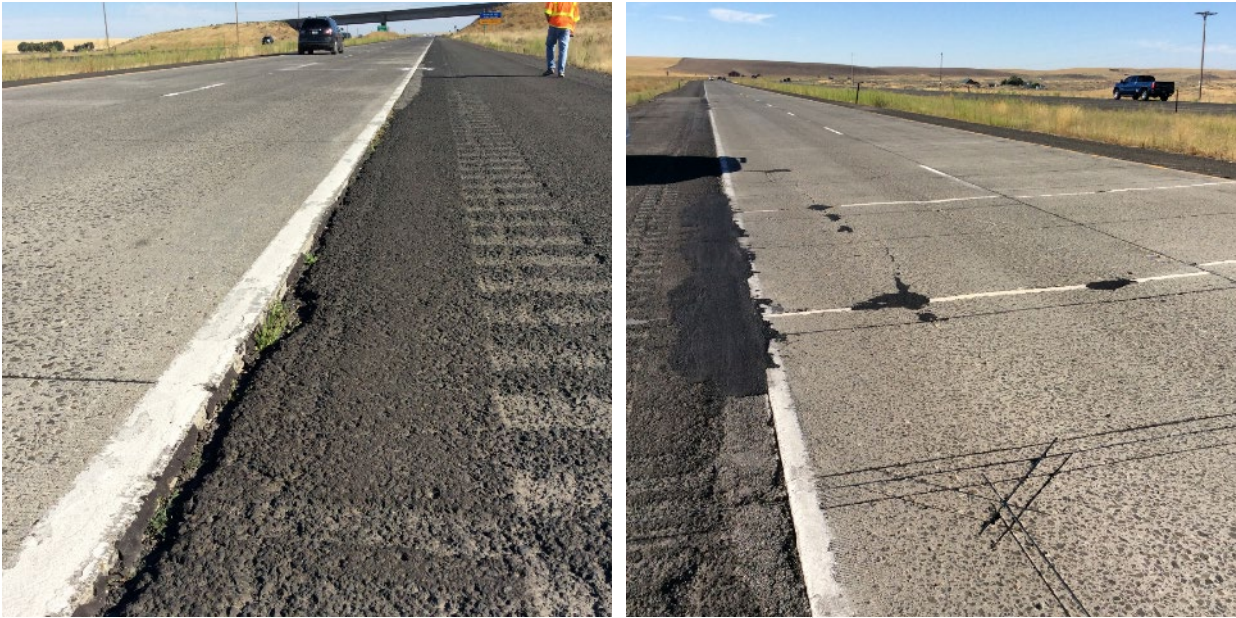
Figure 34. Section 530205, 550 psi, 8" PCC, 6" LCB. August 2017. No tining visible, three transverse cracks with spalling. Some asphalt patching of spalled cracks.

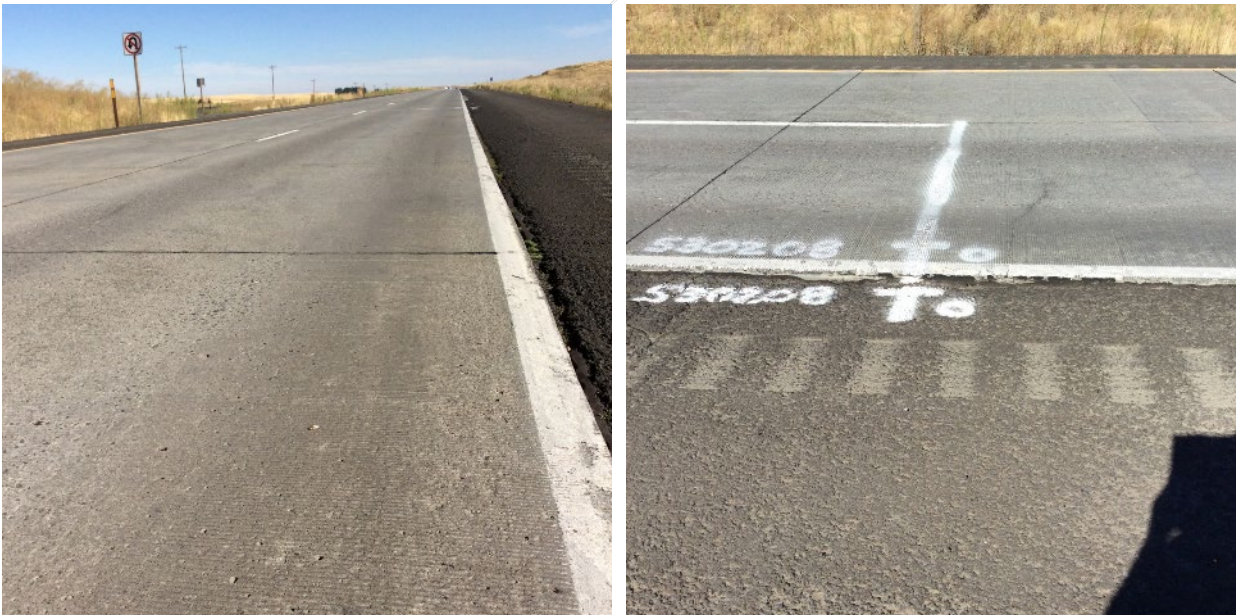
Figure 35. Section 530208, 900 psi, 11" PCC, 6" LCB. August 2017. Some tining visible, transverse cracks and longitudinal cracks in right wheel path.
