2022 Summary of Special Pavement Test Sections

WA-RD 919.1

Various Projects Statewide

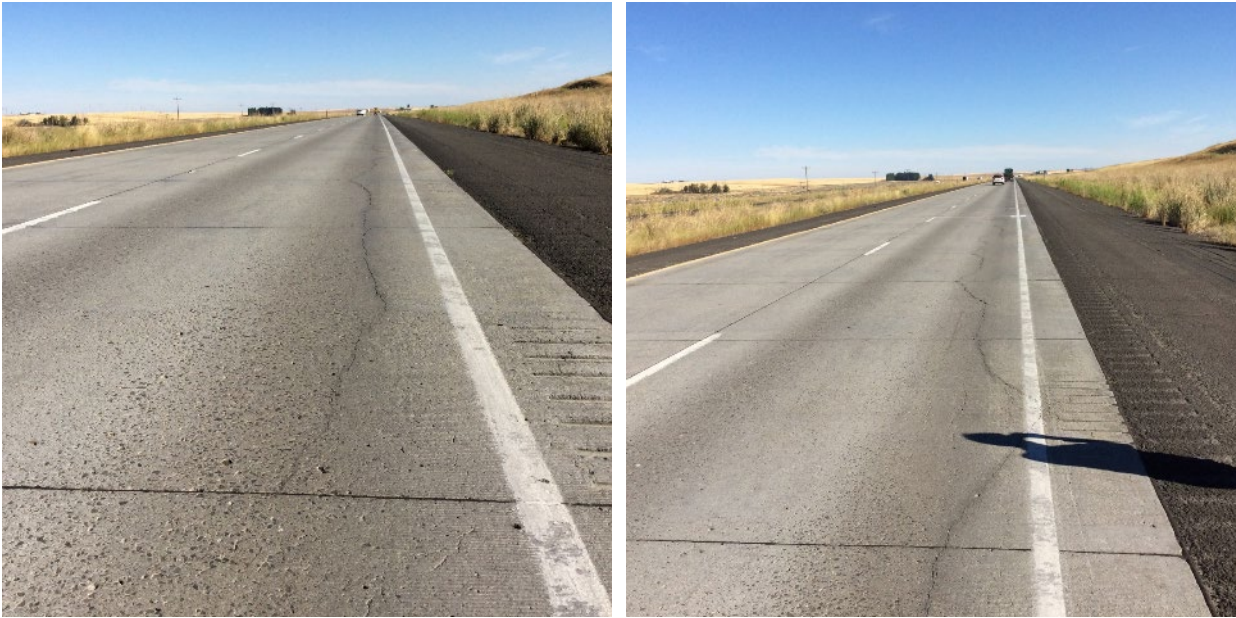
Figure 36. Section 530206, 900 psi, 8" PCC, 6" LCB. August 2017. Some tining visible, longitudinal cracks in both wheel paths that are spalling, appearance of stress induced multi-cracks similar to cracking on bridge decks.

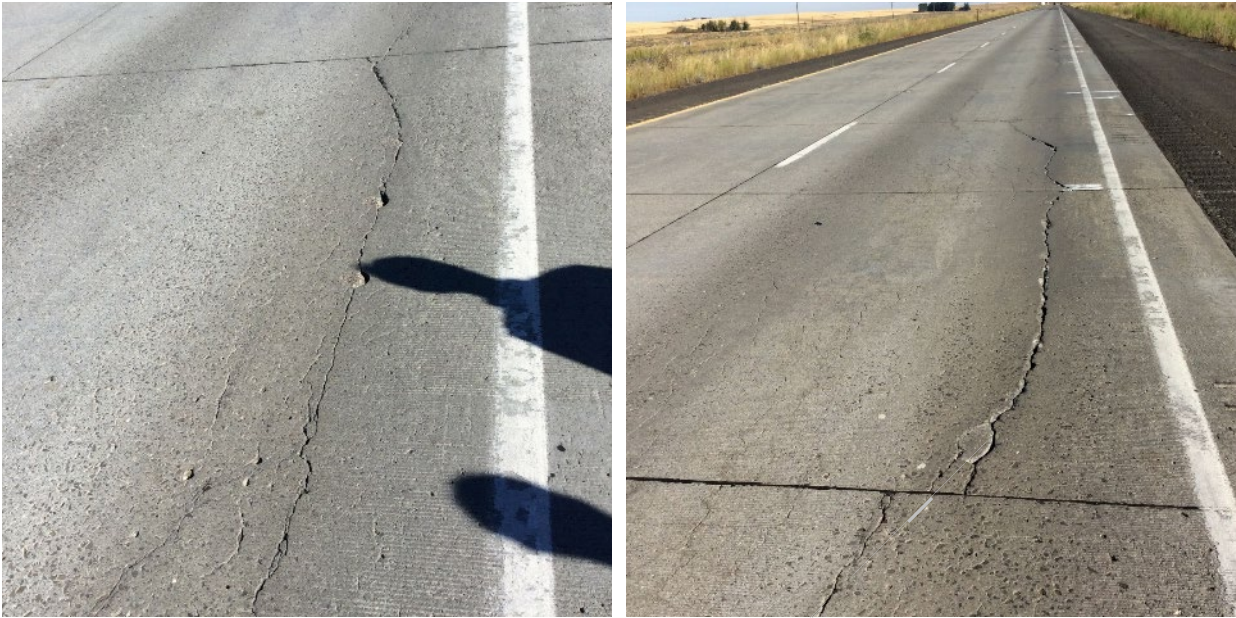
Figure 38. Section 530206, 900 psi, 8" PCC, 6" LCB. August 2017. See Figure 33 for summary of condition statement.

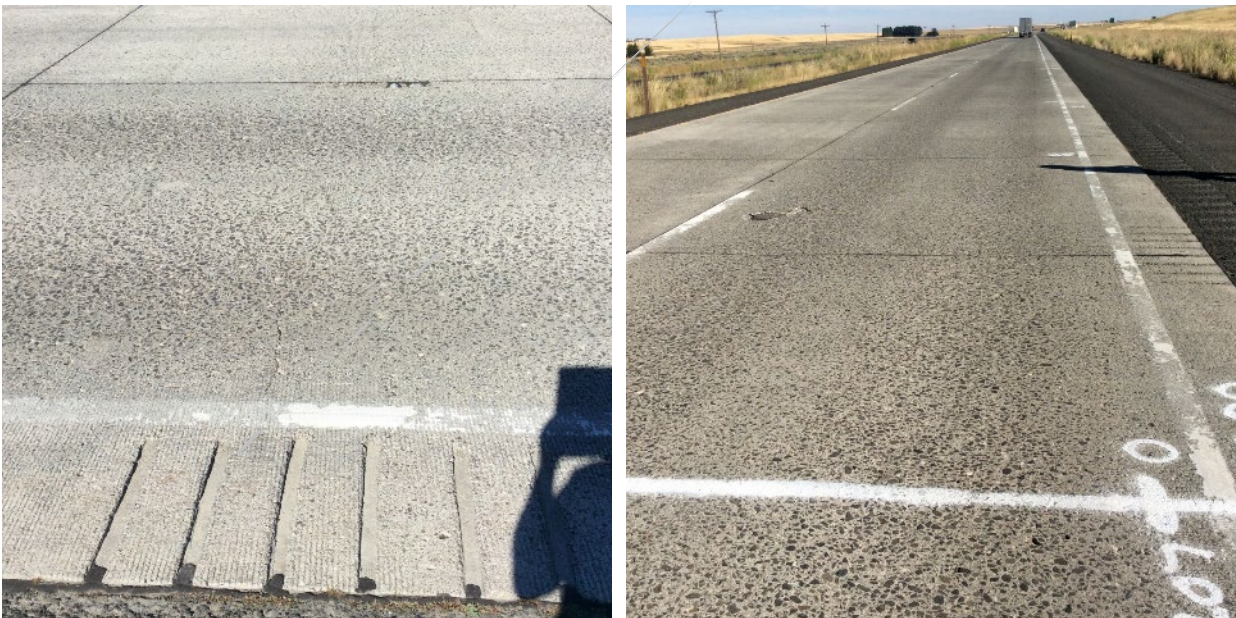
530207	550	11" PCC, 6" LCB	17	Three HMA filled potholes in left wheel path

Figure 39. Section 530207, 550 psi, 11" PCC, 6" LCB. August 2017. No visible tining, three HMA filled potholes in the left wheel path. See Table 11 for summary of condition information for each section.
