Resolution of Non-Repeatable Synchronous Rotor Response of a Power Generator Due to Sand Ingress

Mohammed Ashour — Bently Nevada a Baker Hughes Business

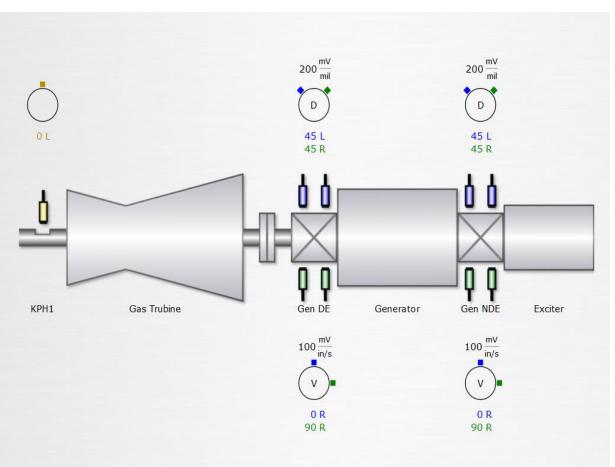
# Machine Train Diagram

This is a machine train consists of gas turbine driving an air-cooled synchronous generator (3600 rpm and 80 MW rated power) Gas turbine is supported on three journal bearings, and generator is supported on two journal bearings. Each bearings is monitored by two shaft relative vibration probes installed 45 degrees left and 45 degrees right. Also, vertical seismic probe installed on each bearing. Two temporary velometers installed on each generator bearing in vertical and horizontal directions.

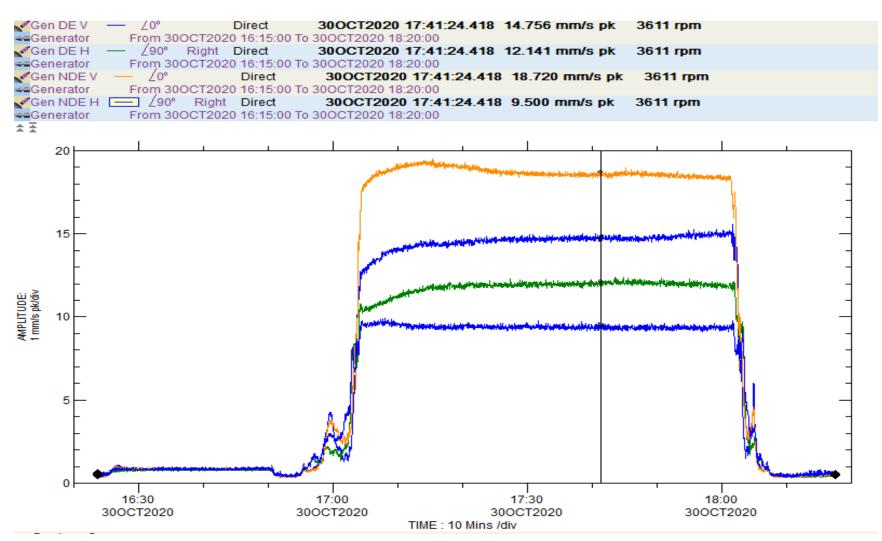
Generator bearing showed increasing vibration levels after each shutdown/startup event starting October 2020 as reported by customer.

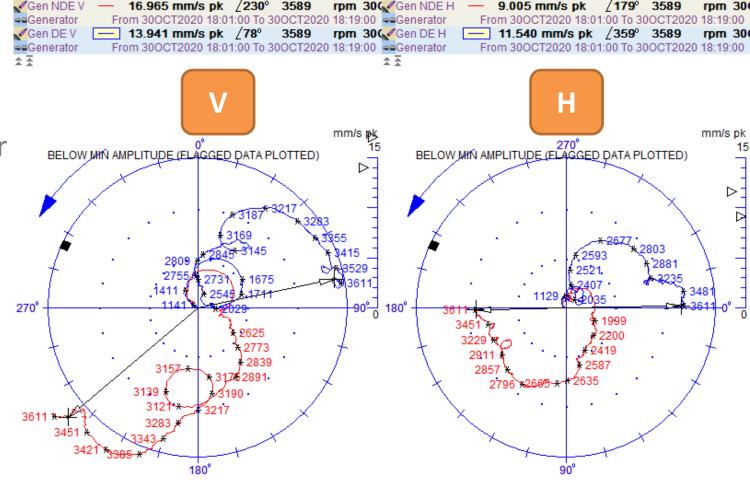
Transient data during shutdown showed clear symptom of couple-unbalance on the generator rotor. Onsite balancing carried out to reduce the vibration levels.

vibration vectors at full speed compared on both bearings in same direction are 180 degrees out of phase.

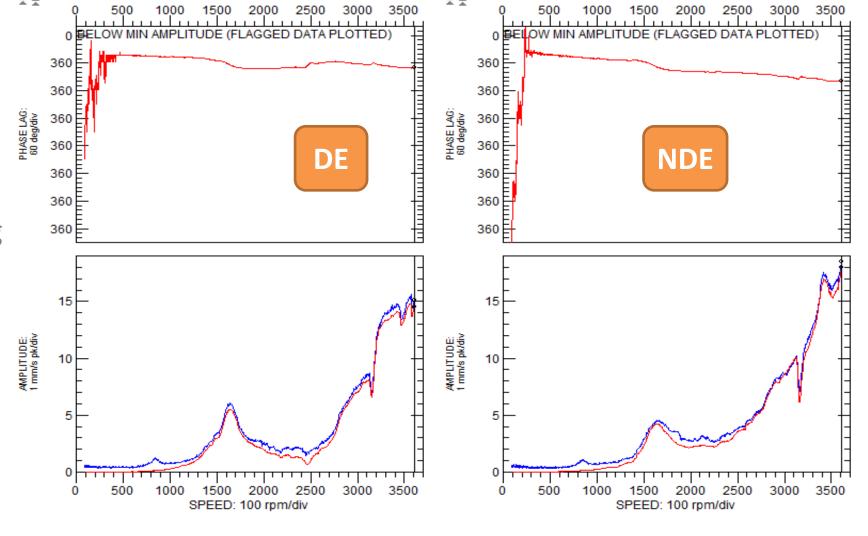
Generator Bearings Direct and 1X Bode plots in the Vertical Direction Seismic vibration during shutdown as found showed unbalance behavior (increasing 1X vibration levels with speed increase in a parabolic shape).

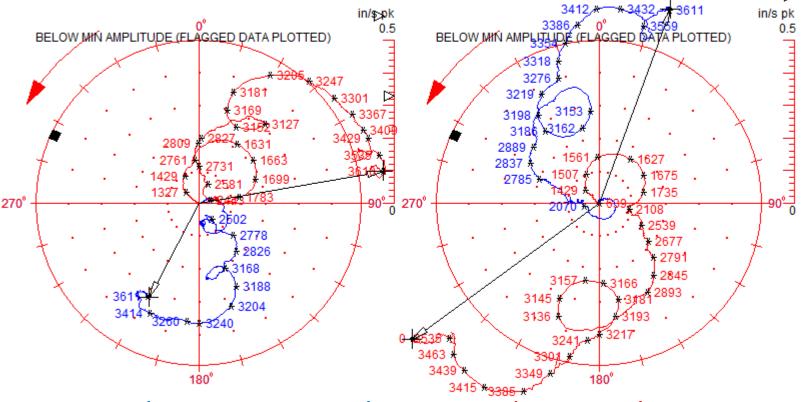
Adding the previous Generator — 0.328 in/s pk From 01NOV2020 20: weight showed Gen DE V Gen DE V unexpected response. the vibration vectors shifted to new location (red is the new 1X vector) compared to original vibration and a new 270° influence vector was calculated based on this response

Blue is original Run Red is Trial Run

Correction weight was calculated based on the trial weight response Calculations WRT Drive End Vertical at FSNL:

Effect of (Original + Trial weight) = 0.33 in/s pk @ 208 degrees

Effect of Trial Weight (T) = (O+T) - O = 0.82 in/s pk @ 241 degrees

New H vector of Trial Weight = T/Wt = 1.92 in/s per Kg @ 11 degrees

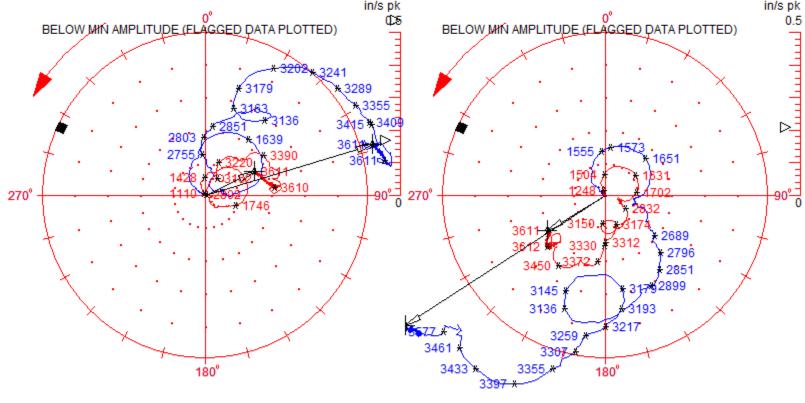
Perfect Response as the vibration decreased in the same direction.

Blue is original Run Red is Correction Run

Effect of (Original + Cor. weight) = 0.212 in/s pk @ 82 degrees

Effect of Trial Weight (T) = (O+T) - O = 0.36 in/s pk @ 259 degrees

New H vector = T/Wt = 1.216 in/s per Kg @ 10 degrees

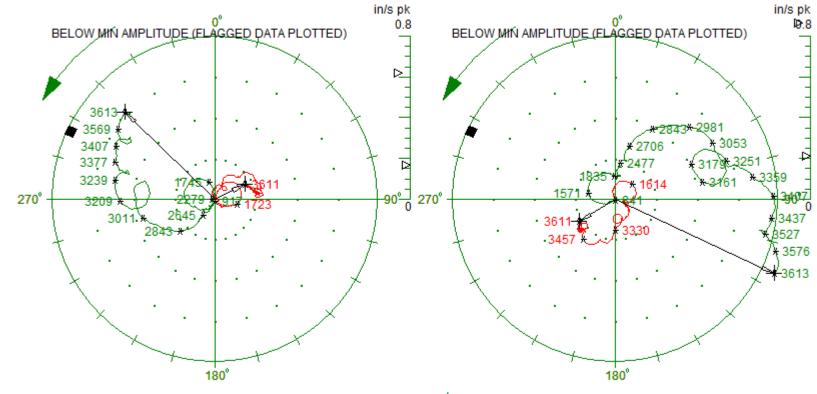
it was decided to test the system repeatability by carrying out another startup without changing weights, however the generator bearing showed totally different synchronous response

Red is the Correction Run

Green is the 2<sup>nd</sup> Run with same weight

Effect of (Original + Cor. weight) = 0.609 in/s pk @ 314 degrees

Effect of Trial Weight (T) = (O+T) - O = 1.05 in/s pk @ 288 degrees

At this step it was confirmed that the rotor system is non-repeatable and non-linear, and another factor is changing the generator rotor synchronous response each run.

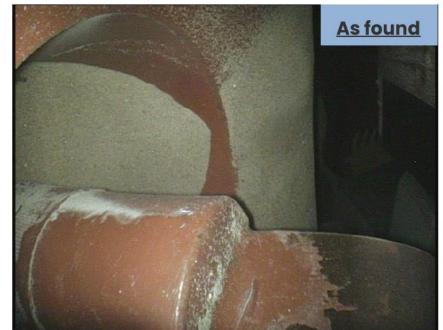
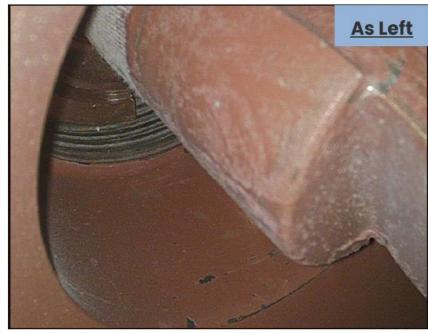
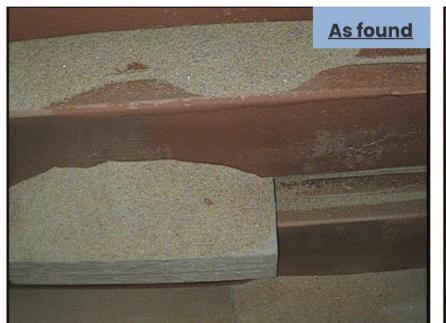
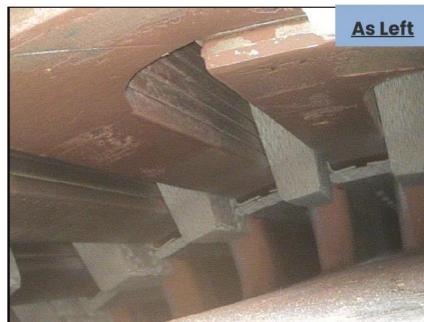
Sand ingress from the makeup generator air breather before and after cleaning

- Based on the above observations it was recommended to perform a borescope on the generator rotor.
- The investigation revealed that the root cause of the nonrepeatable behavior was the sand ingress from the makeup generator air breather due to lack of proper maintenance.
- Dry cleaning of the rotor carried out and sand was removed by vacuum, then filters/gaskets replaced with new and healthy ones.
- Later, machine started with very acceptable vibration levels well below alarm setpoints.

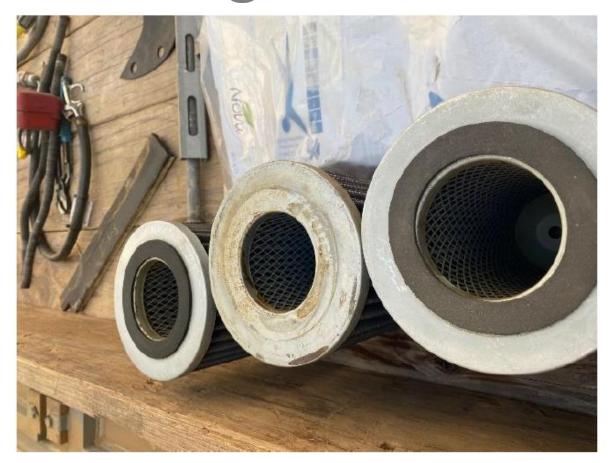
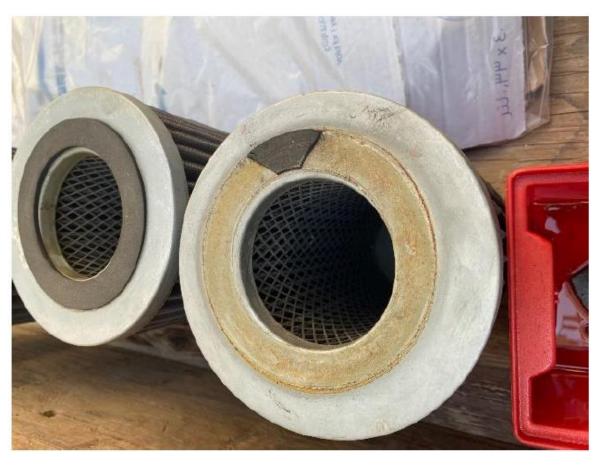
Filters/gaskets damaged

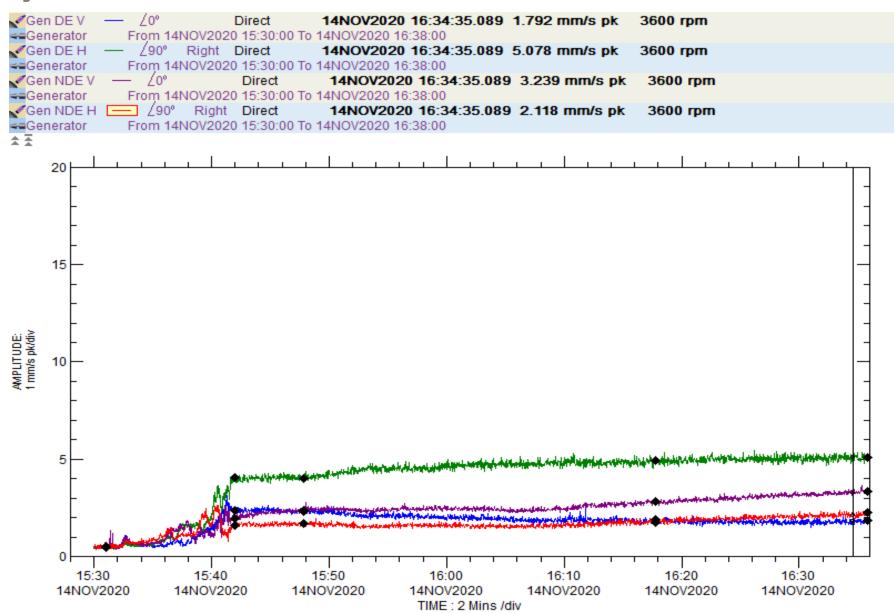
Generator Bearings
Seismic Vibration
Trend Plots After
Cleaning

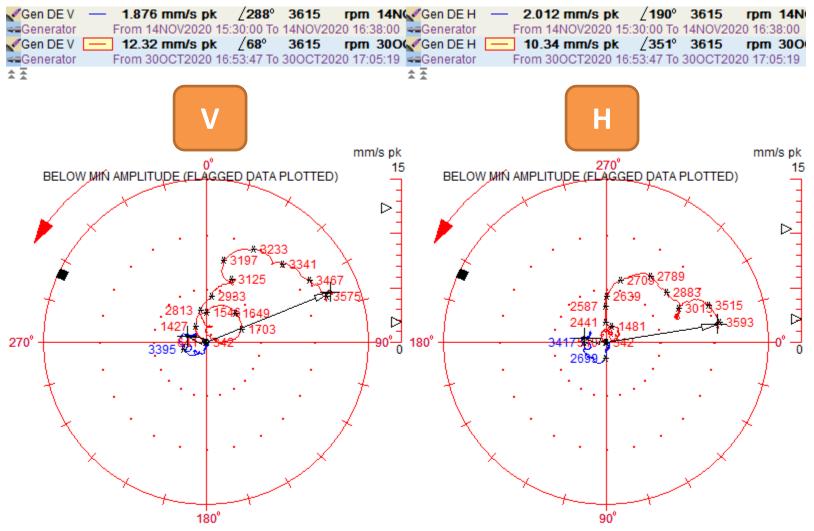
Generator Drive
End Bearing casing
vibration 1X Polar
Plots Overlaid
(Blue is After &
Red is Before
Cleaning)

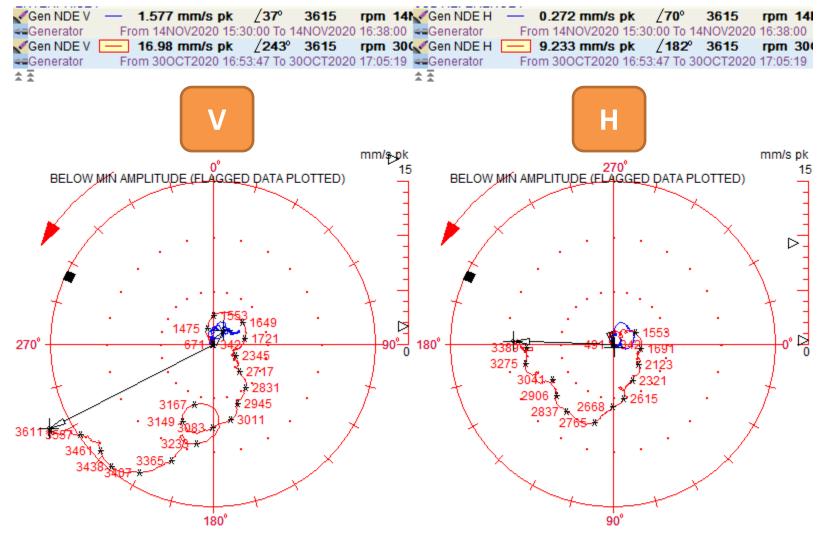
Generator Non-Drive End Bearing casing vibration 1X Polar Plots Overlaid (Blue is After & Red is Before Cleaning)
