# Preserving Modernist Architecture: The Teague Documentation Project

Ben Baaske | Center for Heritage Conservation & Texas Old Missions and Forts Restoration Association

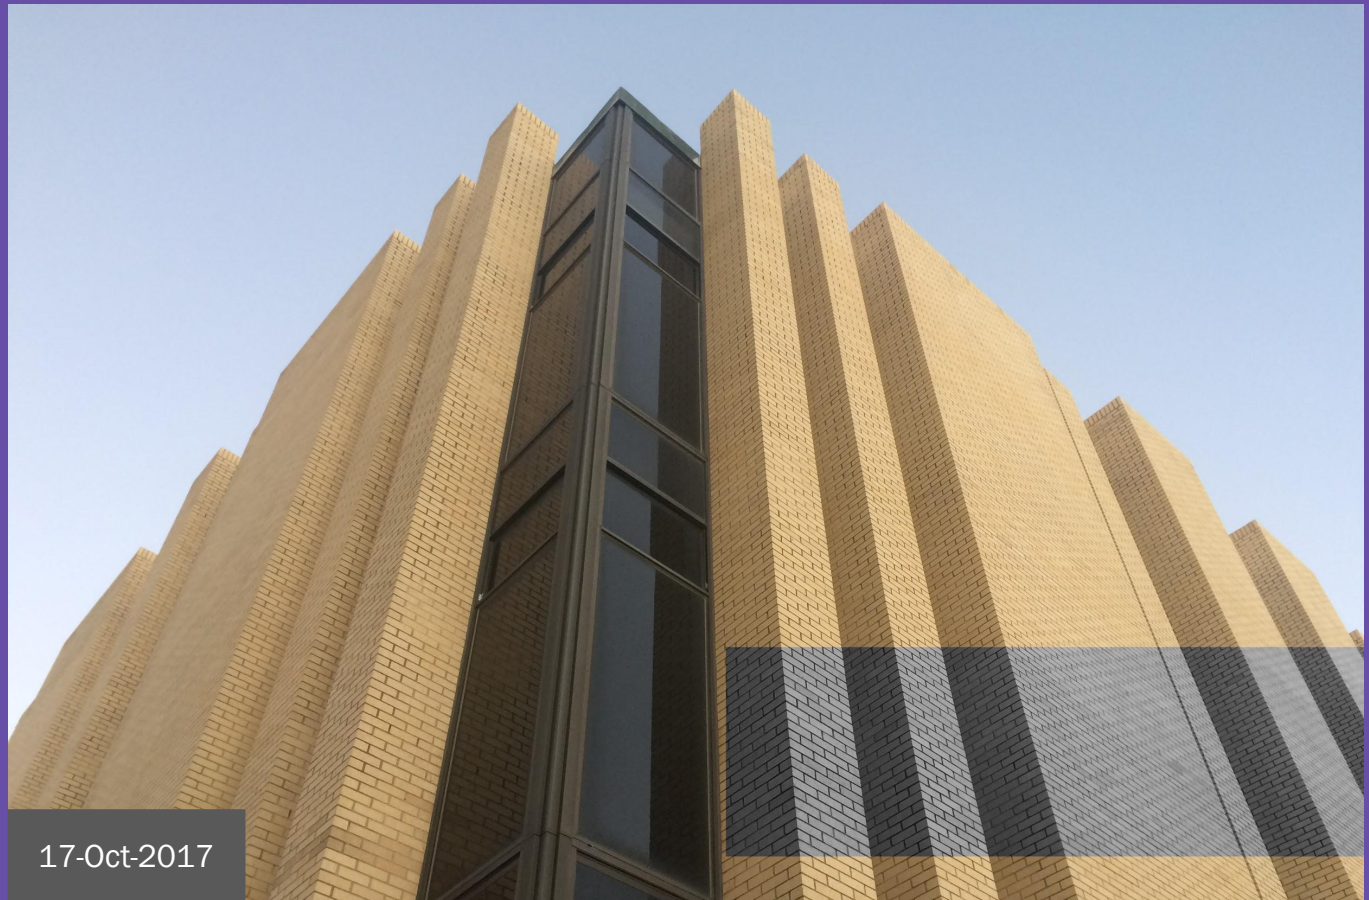
...a seemingly unspectacular building, its primary character lies in the vertically striated exterior and stark contrast between a light masonry and tinted glazing.

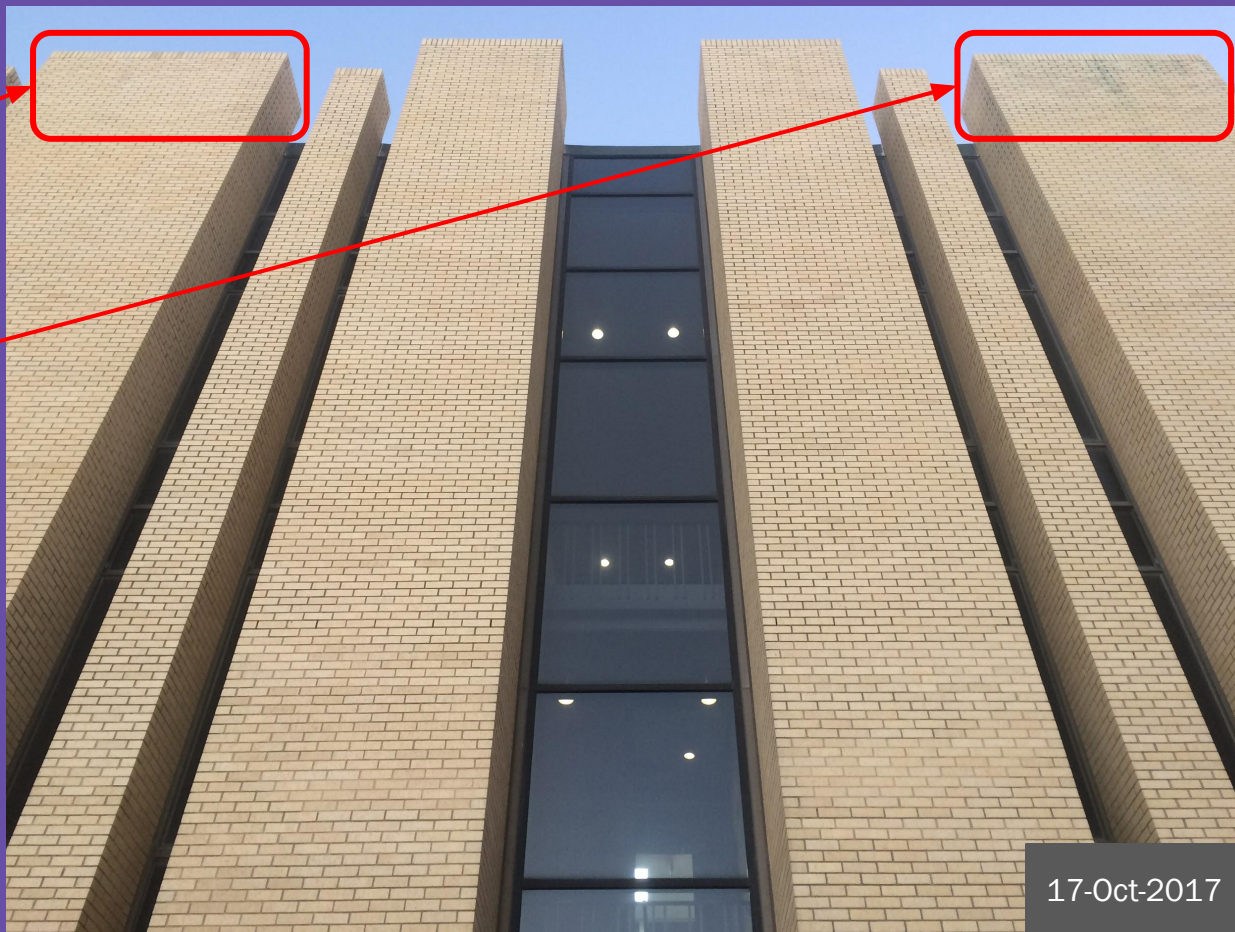
- Individual bricks discolored
- Possibly damaged or recently replaced
- Moisture damage
- Possibly spalling

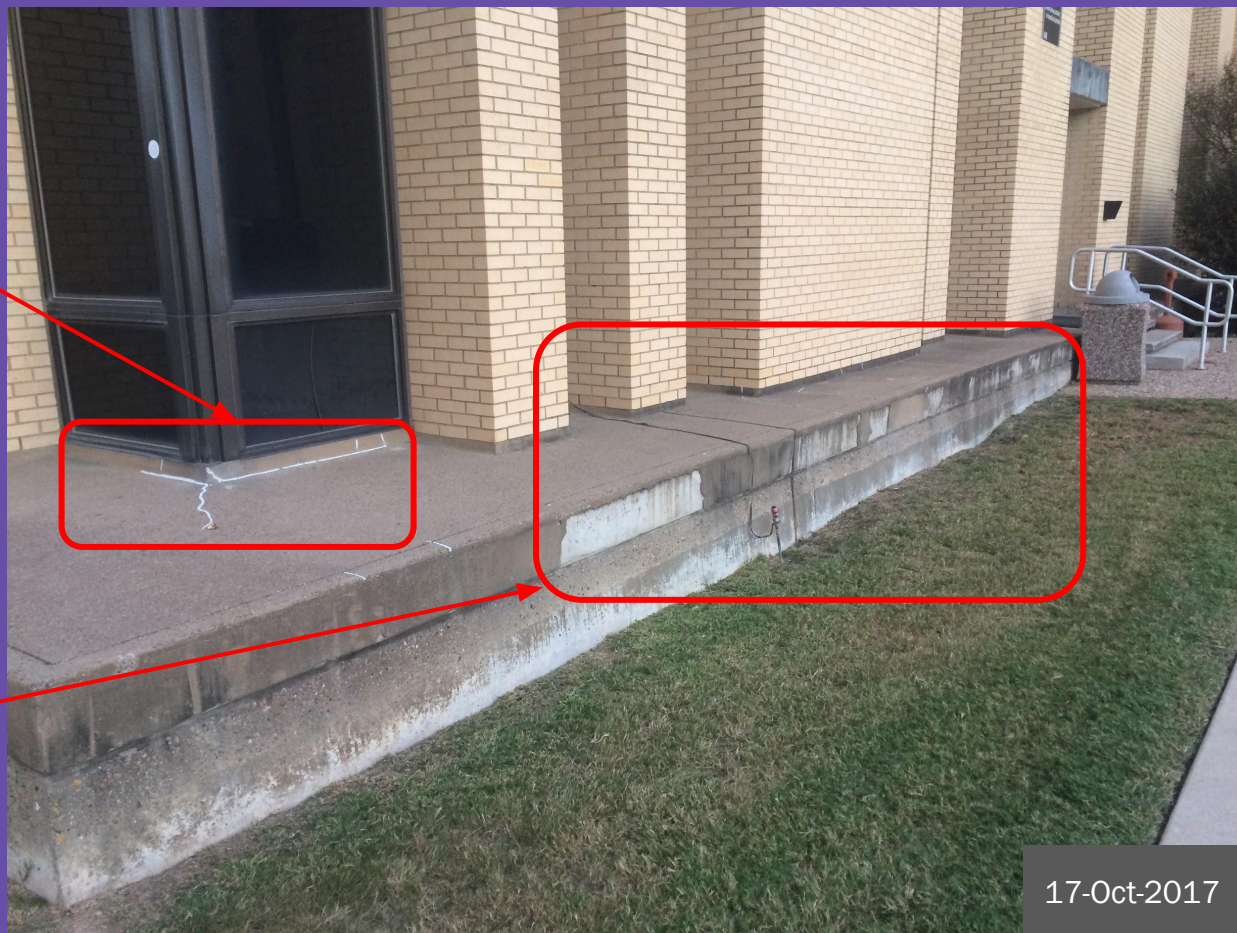
17-Oct-2017

- Repaired cracking in concrete plinth

- Spalling of outer concrete layer

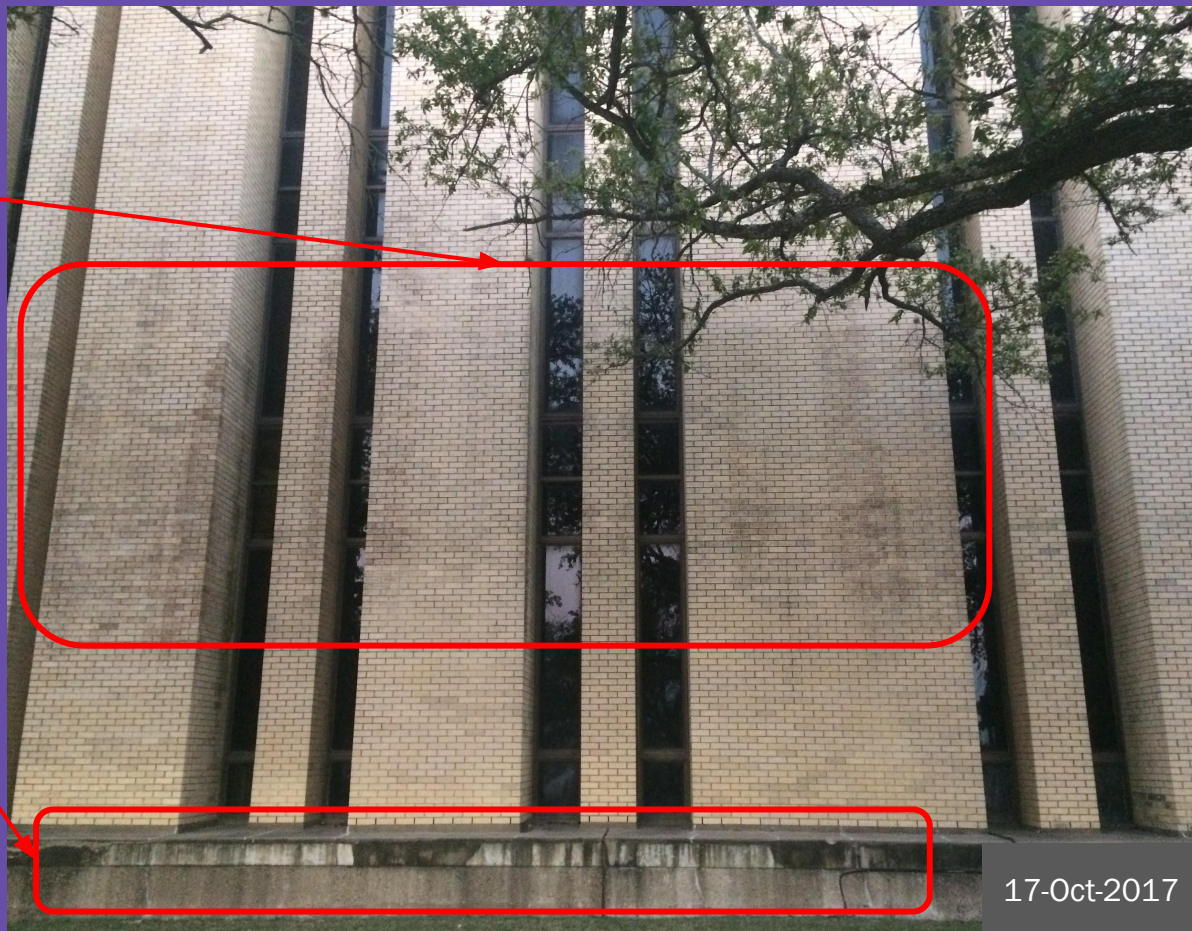
- Moisture damage

- Possibly spalling

- Plinth of the building has considerable degradation; likely due to moisture

- Staining (mildew, algae, maybe minor efflorescence) and spalling

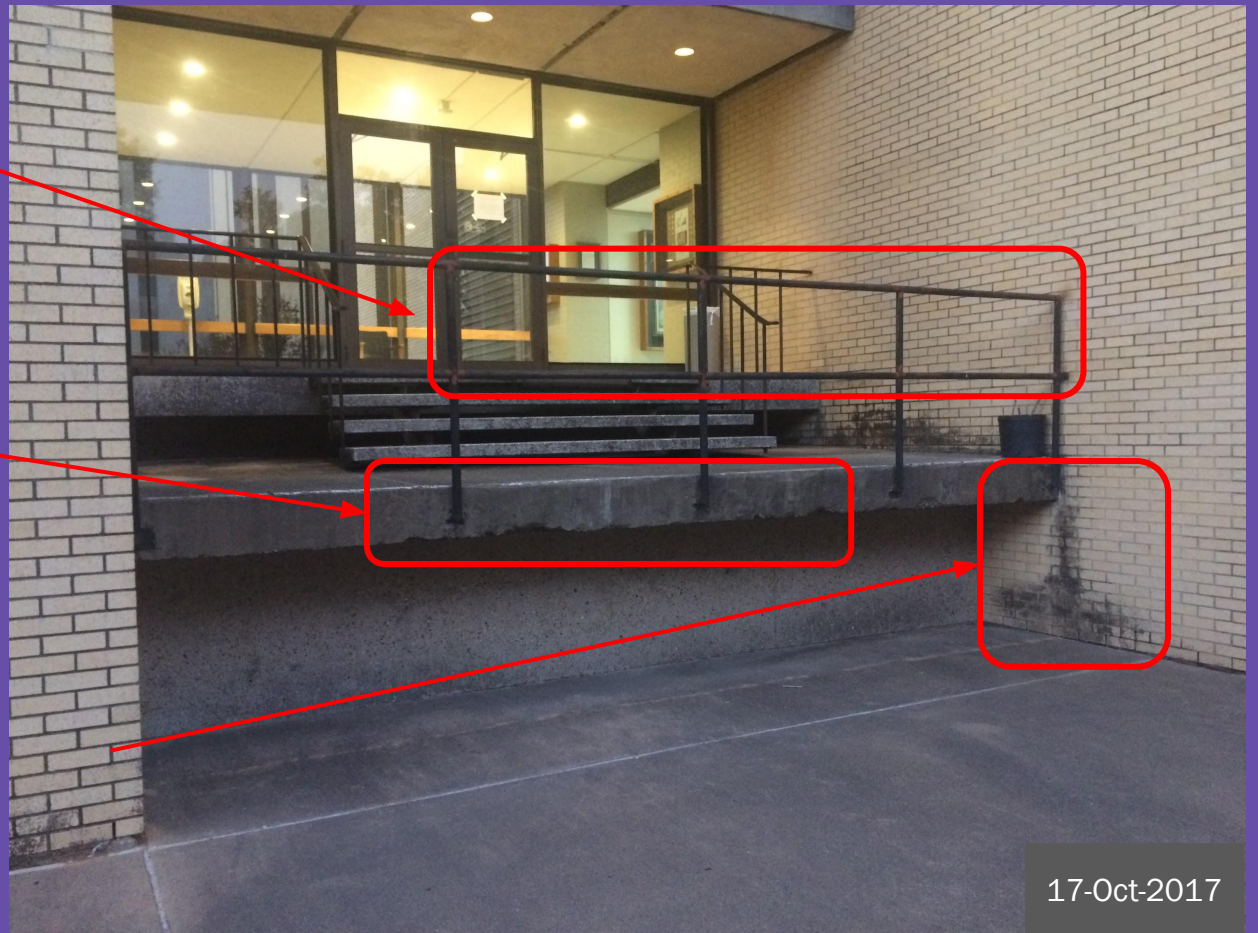
17-Oct-2017

- Rust on railing joints with rust staining on the sandstone masonry

- Concrete cracking and erosion

- Spalling due to moisture runoff

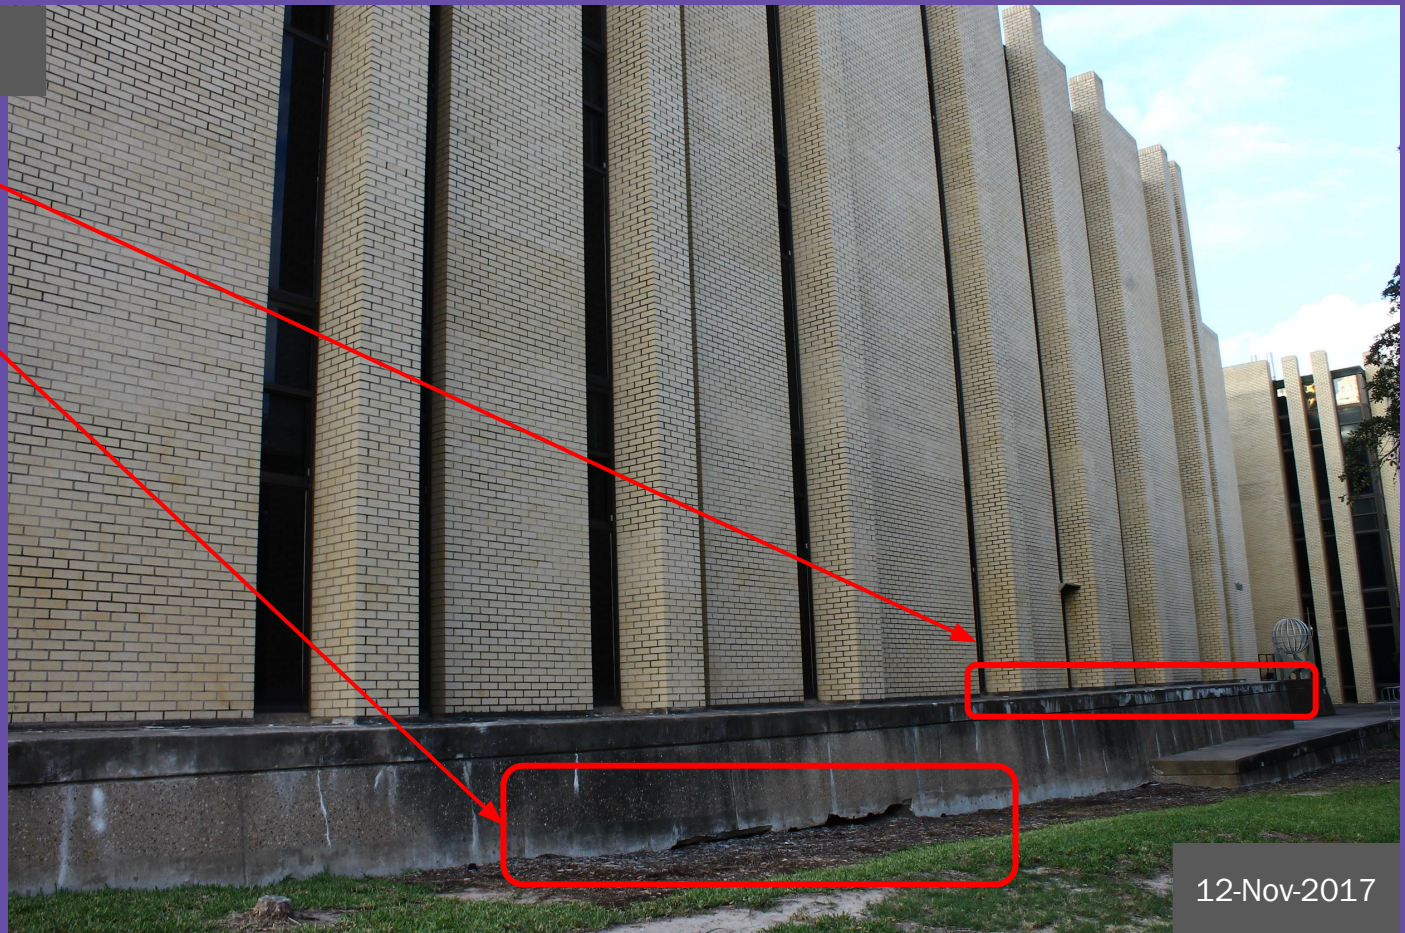
12-Nov-2017

- Spalling and efflorescence of concrete

- Concrete cracking and erosion

- The entire plinth is in poor condition: spalling, cracking, erosion, algae, efflorescence, etc.

- Plinth has no protection from moisture; the building may as well be sitting on an exposed sidewalk.

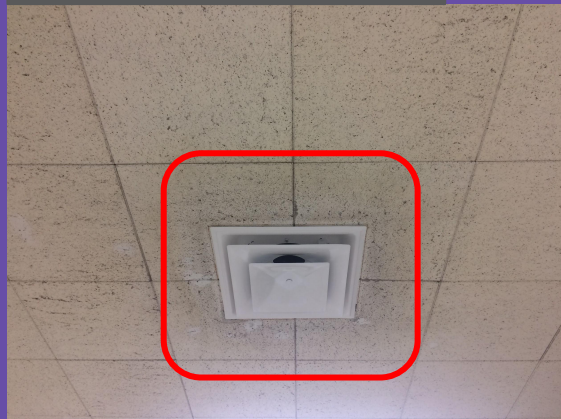
- 1st Floor Corridor
- Ceiling air diffuser with damaged mineral fiber ceiling tiles

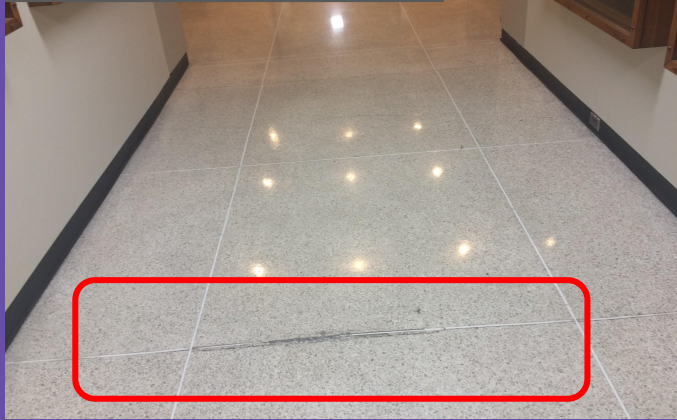
- 1st Floor Corridor
- Close to main entry lobby
- damaged terrazzo floor joint
