# Multitemporal Thermal Imagery Acquisition and Data Processing on Historical Masonry: Experimental Application on a Case Study

**Citation:** Trevisiol, F.; Barbieri, E.; Bitelli, G. Multitemporal Thermal Imagery Acquisition and Data Processing on Historical Masonry: Experimental Application on a Case Study. *Sustainability* **2022**, *14*, 10559. <https://doi.org/10.3390/su141710559>

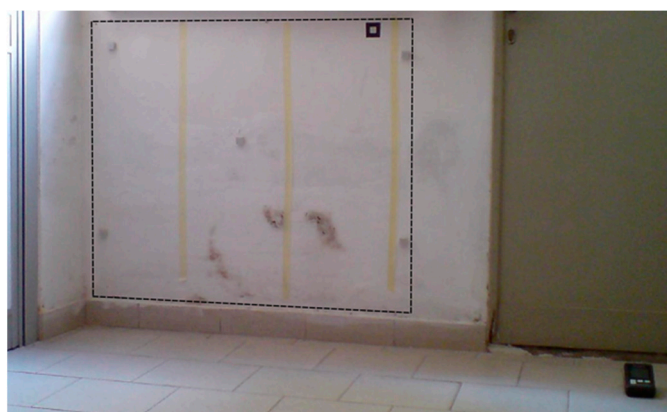
**Figure 3.** Plastered wall for the preliminary test with active thermography.

The wall for the first test was divided into three zones with adhesive tape to assess the behaviour of the material depending on the distance of a fan placed to the left. The test was performed in an area of  $1.20 \times 1.20$  m (Figure 3). Porcelain stoneware targets of  $3 \times 3$  cm with retro-reflective adhesive tape on the front were used. During the test, temperature and relative humidity values were recorded by a data-logger.

Water was sprayed on the wall to reproduce, at least partly, the three different moisture levels identified through passive thermography carried out previously on the Santa Croce masonry. The test was conducted with three different situations: dry wall, damp wall and wet wall. For this purpose, 50 mL of water was sprayed to reproduce the damp wall. Then, another 50 mL was added to produce wet wall. In this way it was possible to evaluate how the active thermography results depend on the level of humidity of the surface. The test was performed capturing one image every 20 s for three minutes with the fan on, then capturing every 20 s for another five minutes with the fan off. After acquiring the main sets (dry, damp and wet wall) the test was repeated after 1 h. Then, thermal images were acquired every 20 min for 4 h to record information concerning evaporation under natural conditions, without the use of a fan.

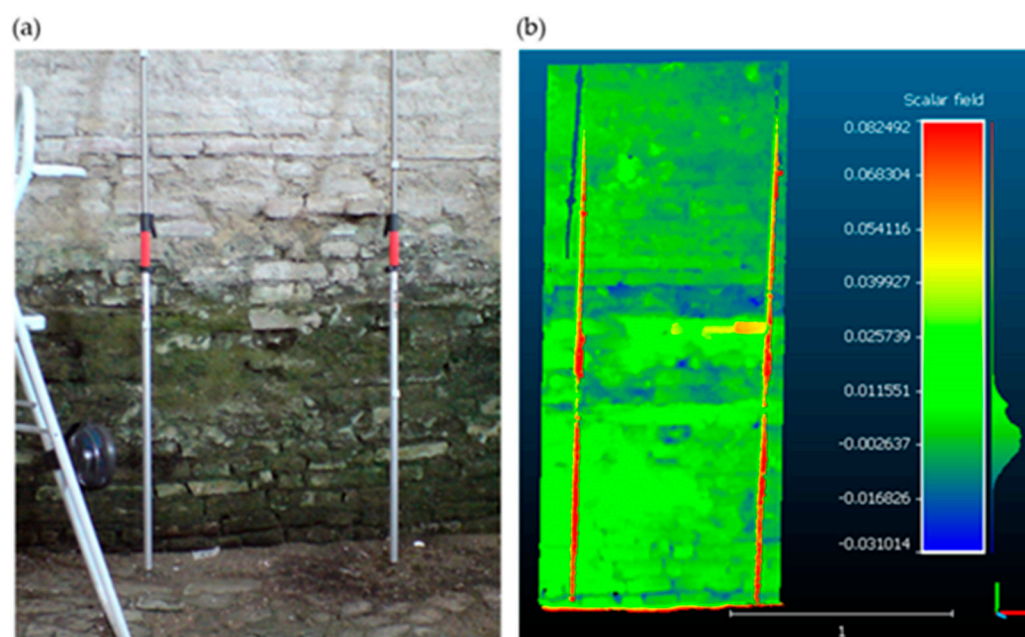
**Figure 5.** Area detected with active thermography in the S. Croce Church (a). Point cloud acquired with the F6 scanner (b). D from the best fit plane is represented using a false colours palette.

Given the irregularity of the wall, the 3D survey of the reference area carried out with the F6 scanner was also used to evaluate possible correlations between humidity and geometric characteristics. To present the results more clearly, a best-fit plane representative of the wall surface was calculated [22]. The best fit plane was calculated excluding the poles, used as reference and to position targets. To obtain a scale of values in meters representing the positive or negative deviation from the best-fit plane, the point cloud was translated in the z-axis of the best-fit plane value. In this way, the zero-value indicates that there is no deviation from the average z given by the best-fit plan. Negative values (blue) indicate indentations, while positive values (green) indicate protrusions. (Figure 5).

The obtained data show that the deviation of the bricks from the best fit plane was significant. It is therefore necessary to integrate the results obtained from the thermal data with this geometric data. The geometric characteristics can influence evaporative flow, accentuating or attenuating the humidity problems present in the whole structure.

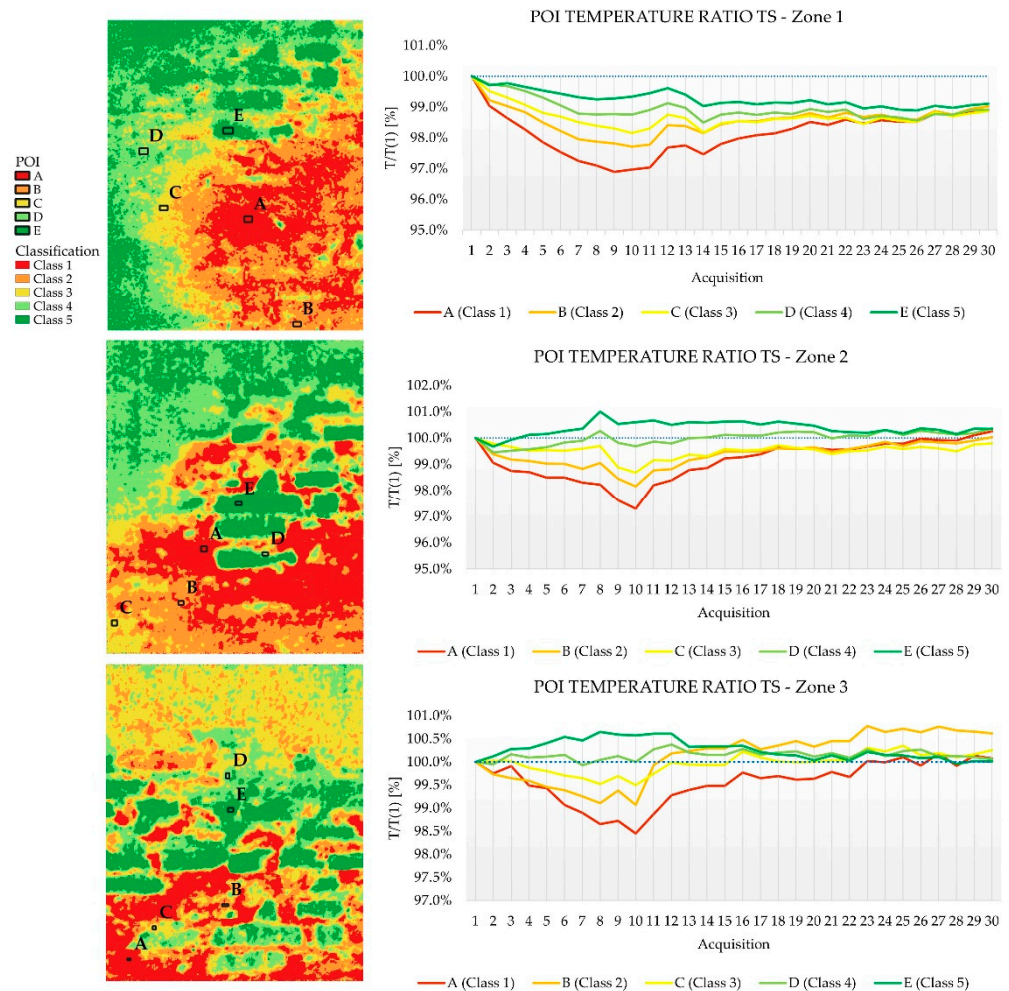
**Figure 9.** Classification results for the three zones. Left: classification with POIs selected for each class. Right: temperature variation over time for each POI.

The K-Means unsupervised classification allowed identification of five classes of T changes due to fan action. The temperature ratio allowed easy comparisons of increases or decreases of temperature with respect to the first acquisition condition. The average T ratio for each class was calculated. Moreover, some Points of Interest (POI) were selected for each class in order to analyse the T changes behaviour of the five different clusters

(Figure 9). The effect of active thermography is clearly visible from the graphs. Indeed, independently from the class, the decrease/increase rate was considerably higher in the first 10 acquisitions when the fan was on. After the 10th acquisition, when the ventilation phase ended, temperature started decreasing/increasing slowly.

Looking at the classification results, it was possible to interpret and labelling classes. Five clusters were identified, from “Class 1” to “Class 5”. Wetter surfaces are those that reacted to ventilation with the highest decrease of superficial temperature. Those areas are identified by “Class 1”. “Class 5” indicates the relative drier area, where the fan action caused the lower decrease of temperature or, in some areas, it even caused an increase of superficial temperature drying the wall. Considering all zones, moving from the bottom (Zone 1) to the top (Zone 3) of the masonry, the effects of ventilation led to increased drying of the surface. Zone 1 was the wettest zone in which the fan action caused a decrease of temperature all over the surface. In Zone 2, pixels clustered in “Class 4 and 5” increased their superficial temperature due to ventilation by the 10th acquisition. In Zone 3, only “Class 1” could not reach an evaporative flux that allowed the surface to dry by the end of the experiment.
