Strengthening and underpinning of a sinking two storey building in lagos state nigeria

To appear in: *Engineering Failure Analysis*

**STRENGTHENING AND UNDERPINNING OF A SINKING TWO STOREY
BUILDING IN LAGOS STATE NIGERIA**

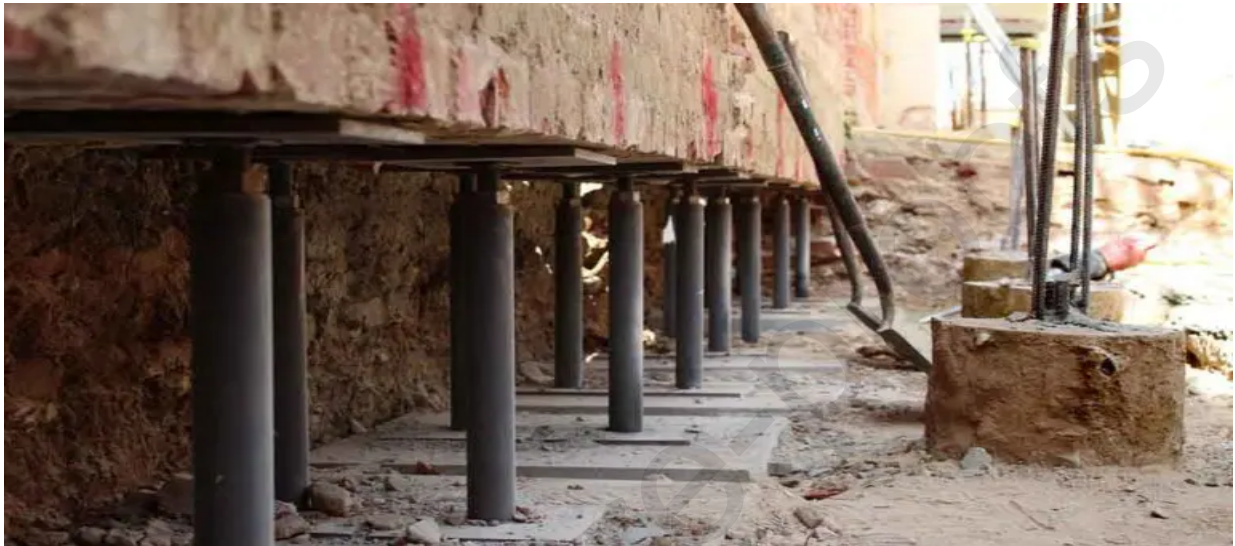
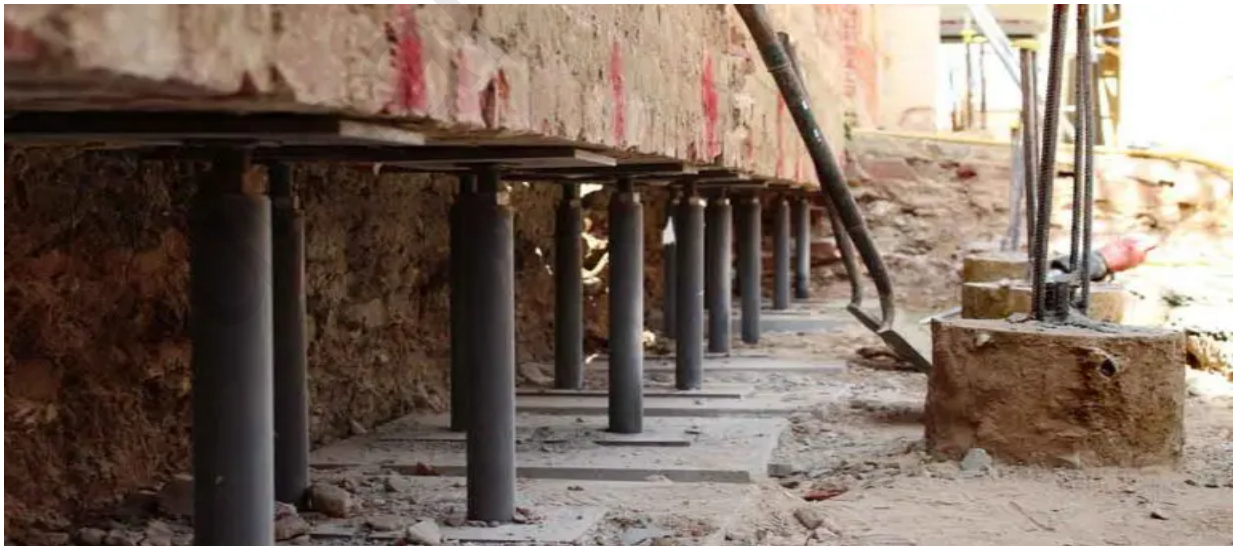
This technique shown in **Fig. 2** is said to be more economical than conventional continuous underpinning for underpinning masonry walls. Forham Pryke created the system in the middle of the 1940s, and he described it in [36]. This approach does not use needle beams; instead, it uses stool that are inserted into the holes at a distance of 0.9 meters from centre to centre to sustain the weights. A strong mortar made of 1:1 Portland cement and sharp sand is used to fill the spaces between the tops of the stools and the walls. Brickwork between the stool is cut once the mortar has dried, and beam reinforcement is then inserted through the stools, followed by the pouring of concrete to create a reinforced concrete beam that extends up to 50 mm below the underside of the wall. The hole is finally filled and secured.

Fig. 2. Pynford stool for underpinning [35]

Fig. 2. Pynford stool for underpinning [35].

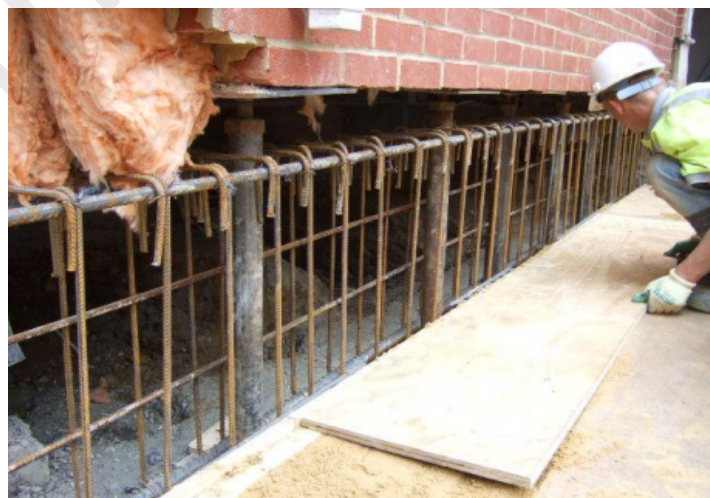
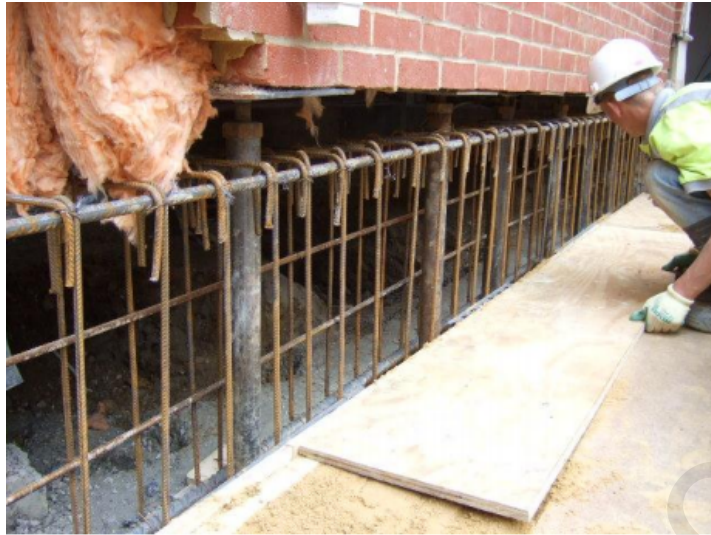
The single beam underpinning is a common method of masonry structure housing. A beam is set at the top of the demolished wall, as shown in Fig. 4 instead of the lower bearing wall to bear the upper load. Due to the change in the load transfer path, the concrete columns are set below both ends of the underpinning beam, and form combination columns with the original walls [32].

Fig. 4. Beam and Column underpinning [32].

Fig. 4. Beam and Column underpinning [32].

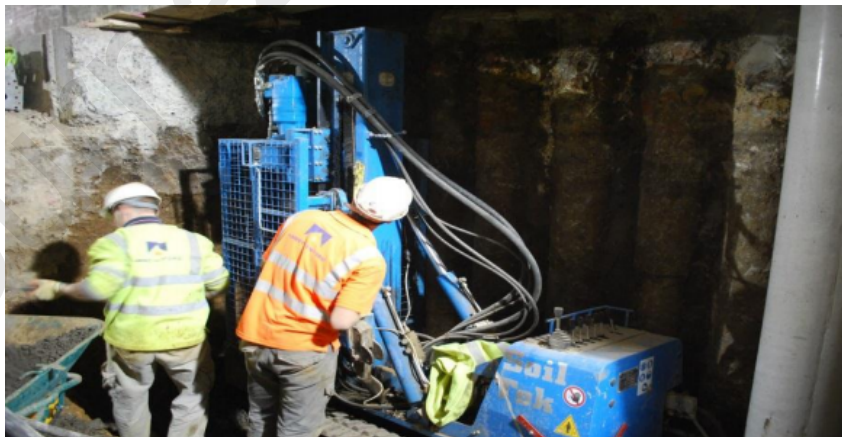
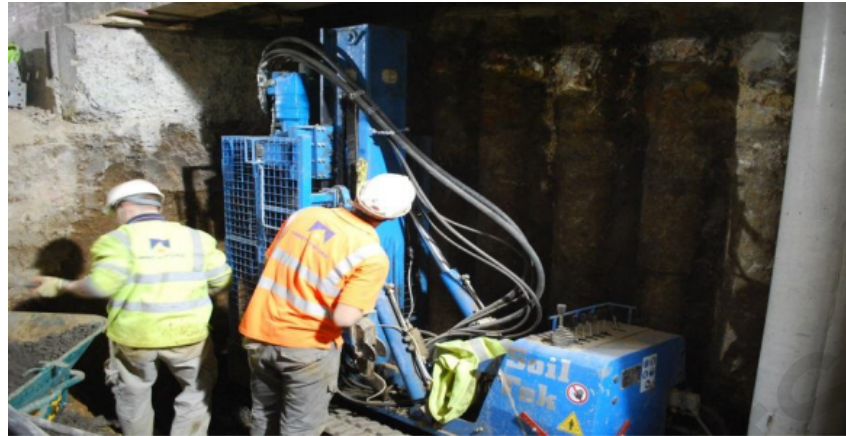
In cases when the depth of loose ground makes mass concrete or beam column approaches impractical, a mining piling system like that in **Fig. 6** is utilized. It has the advantage that it can be constructed into water bearing strata without the use of a pumping machine and allows the unhindered passage of ground water. There are varieties of mini piles, which include Augured/Bored piles, Driven piles, jacked in piles [2].

Fig. 6. Mini piling underpinning to support vertical loads [2].

Fig. 6. Mini piling underpinning to support vertical loads [2].

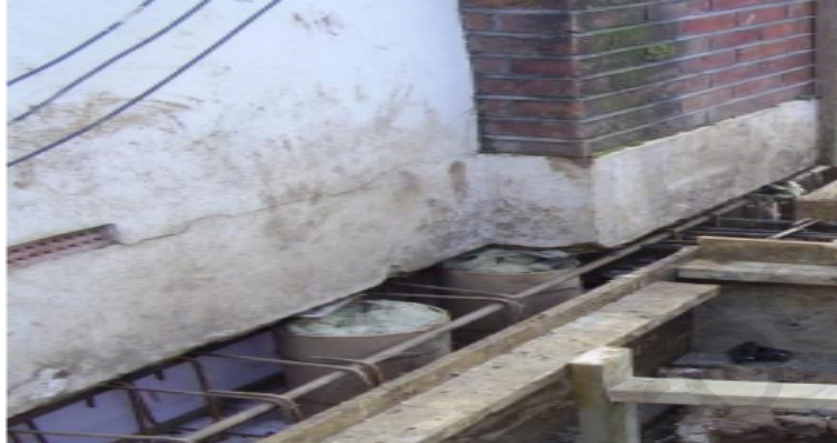
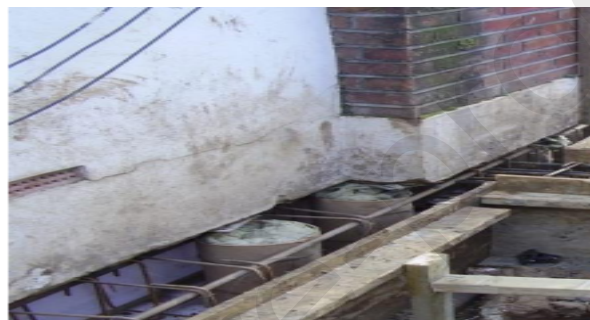
Reinforced concrete underpinning as shown in **Fig. 7** is the procedure of marking the holes to be dug in alternate bays of 1.0m to 1.5m intervals in serial orders of (1,2,3,4,5,6,7,8,9,10,11,etc.). This is the same as for mass concrete underpinning. The difference is that in the reinforced concrete underpinning, light reinforcement cages are fabricated and placed in each hole before concrete is poured and the concrete is fully vibrated with a poker vibrator. This light reinforcement is designed to resist all the tensile forces, which mass concrete cannot withstand [2].

Fig. 7. Piles and Beams to support vertical loads [2].

Fig. 7 Piles and Beams to support vertical loads [2].

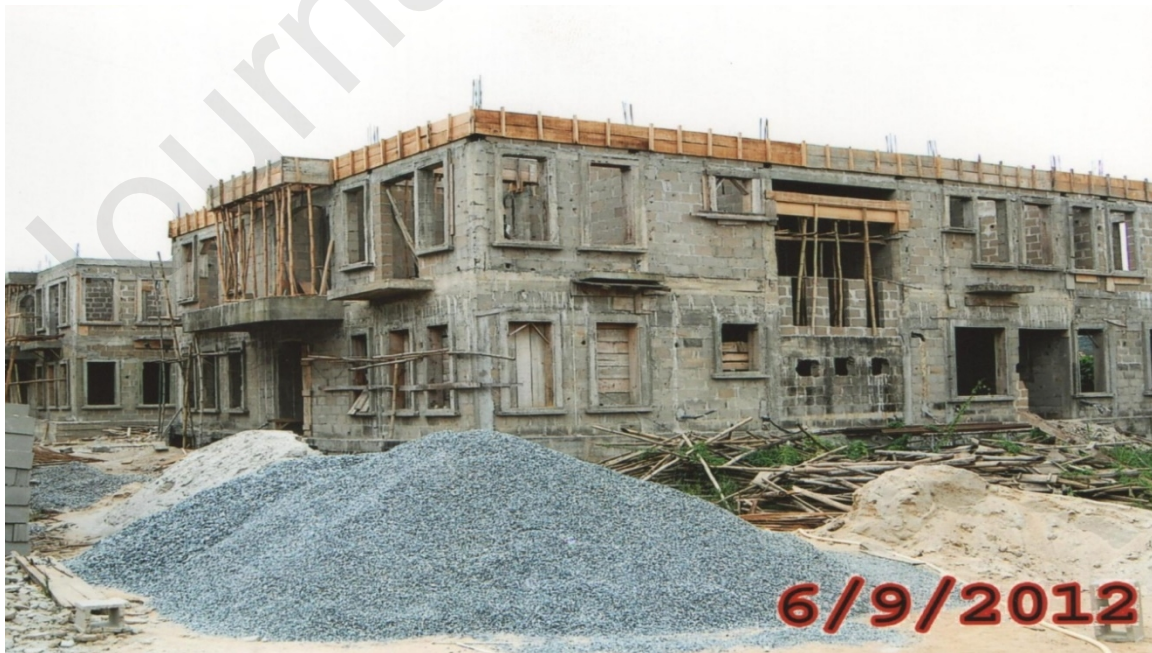
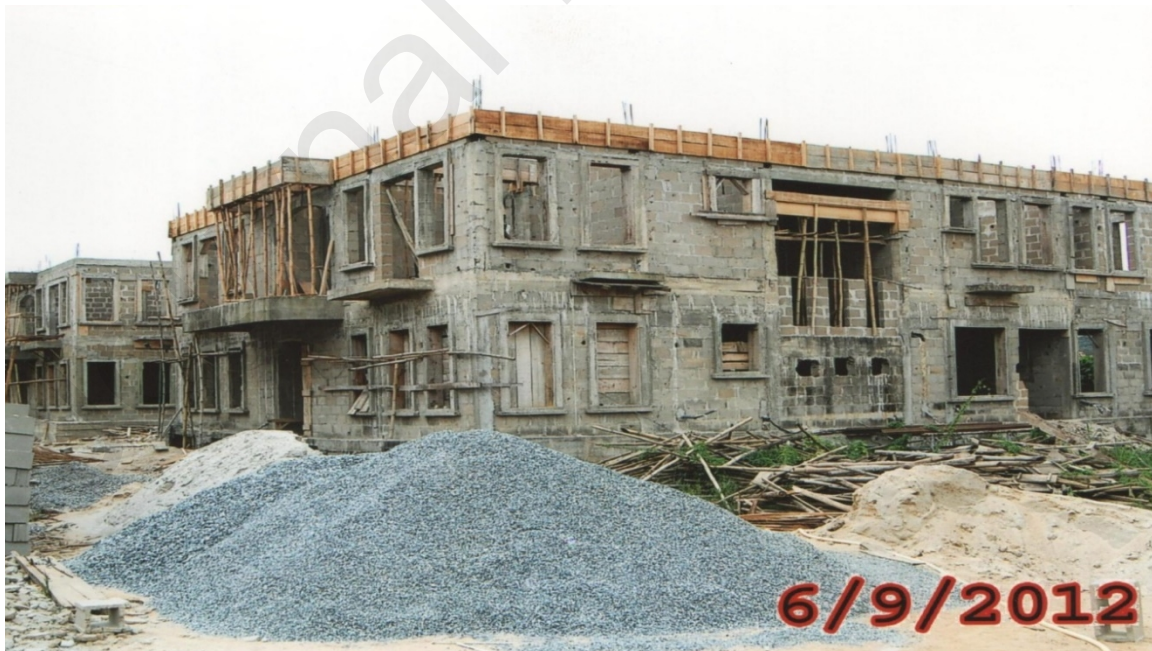
During the construction process, severe cracks began to appear on the wall of the building, which prompted the building committee to seek professional advice to solve the lingering problem. Severe horizontal and vertical cracks began to appear on the walls and on the floors. Looking at the cracks, it clearly showed that it was as a result of the foundation settlement. This was because from the history of the site, the building was previously used as a refuse dump site, which was not considered in the design process of the foundation. Some portion of the land was previously used as an old fish pond which was constructed years ago which led to the organic matter in the soil. The borehole log was wrongly interpreted as the raft terminated at 2 metres below the natural ground level which was in a strata of dark brownish soft compressible organic PEAT and Light Dark brown fine medium silty SAND with organic intrusion.

Fig. 11. Distressed building in 2012

Fig. 11. Distressed building in 2012

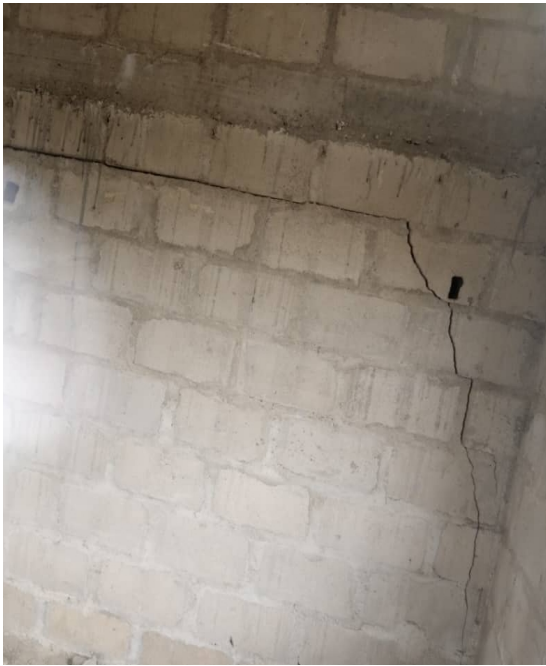
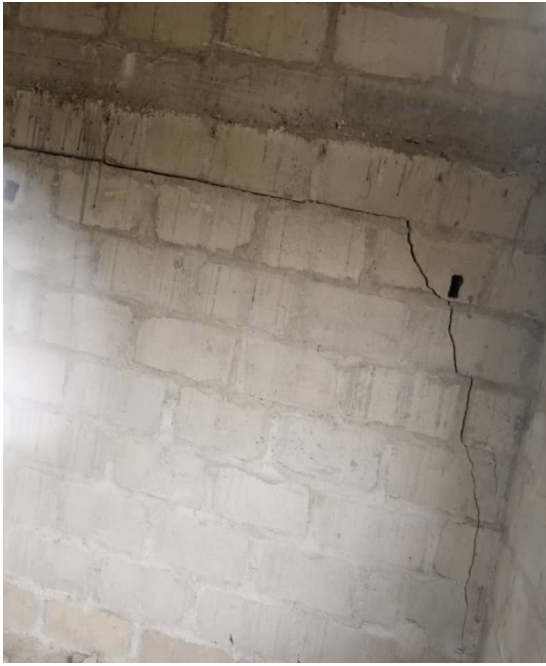
Fig. 12. Cracks noticed on walls

Fig. 12. Cracks noticed on walls

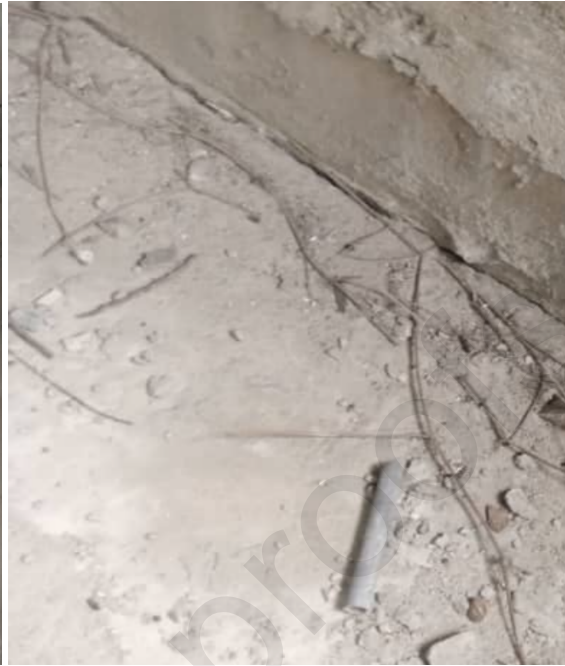
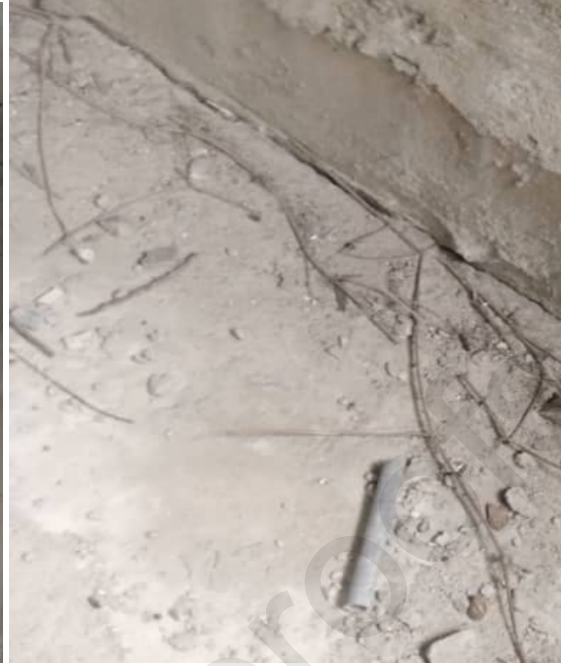
Fig. 13. Crack on joint between wall and floor.

Fig. 13. Crack on joint between wall and floor.

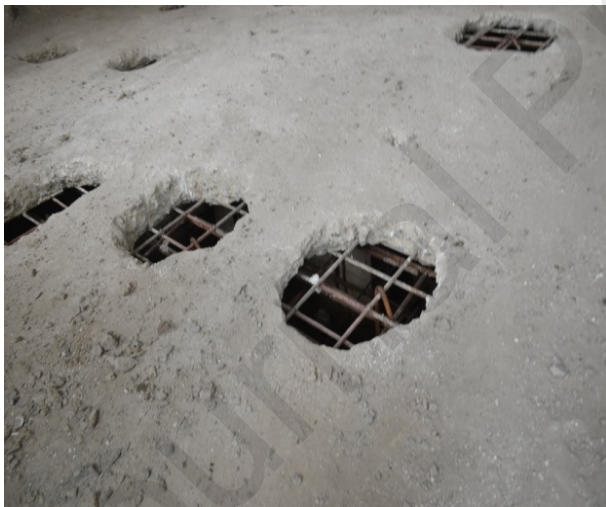
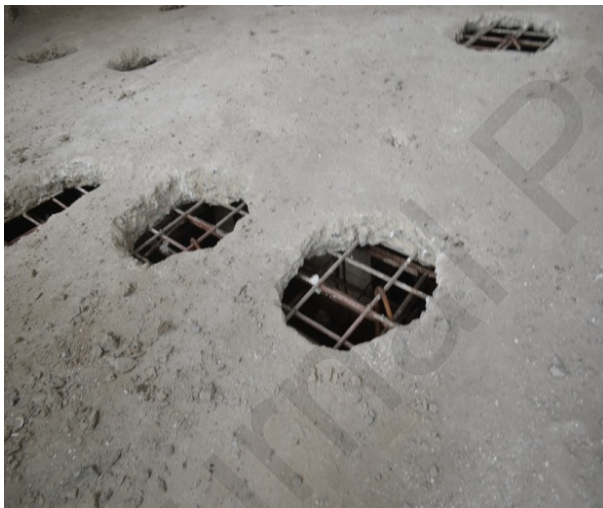
Fig. 14. Opening of holes in the veranda slab

Lafarge transit movable pumpable concrete was used to pour concrete having a concrete grade strength of 40 MPa on the desired building floor with small hole openings. All cracked walls were screeded with 75 mm thick screeding ratio of 1:1 (one head pan of cement to one head pan of sand); the top surface of the screeding was made "rough" so that it bonded well with the screeding for floor tiles or marble.

Fig. 14. Opening of holes in the veranda slab

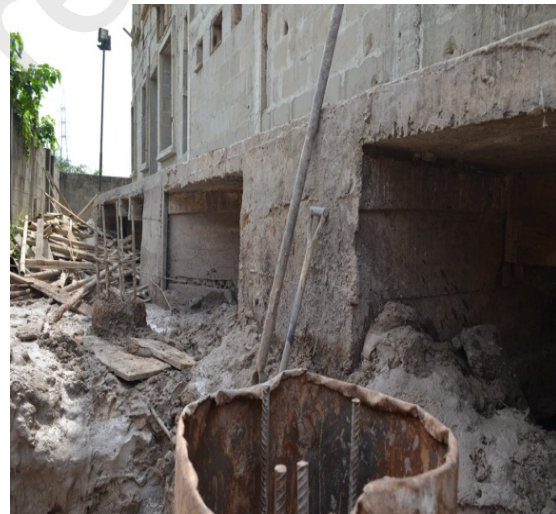
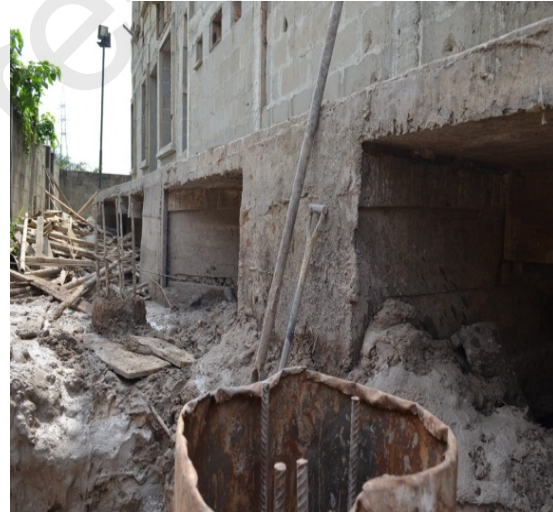
Fig. 15. Bored piles for underpinning

The new underpinning foundation had about 10 pile points with pile width of 450 mm and depth of 15 metres with a basket reinforcement cage anchored to the new underpinning pile and the existing raft foundation.

Fig. 15. Bored piles for underpinning

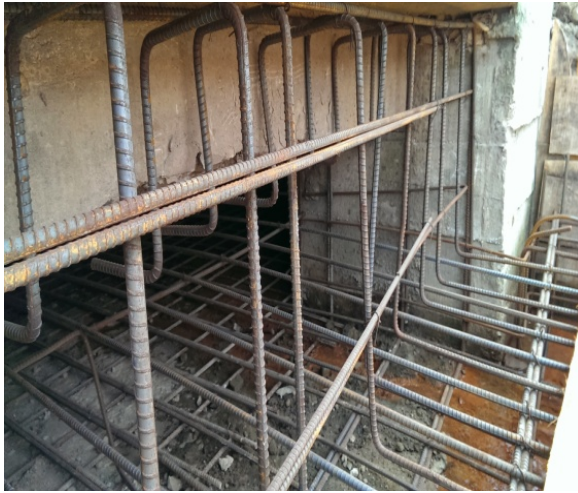
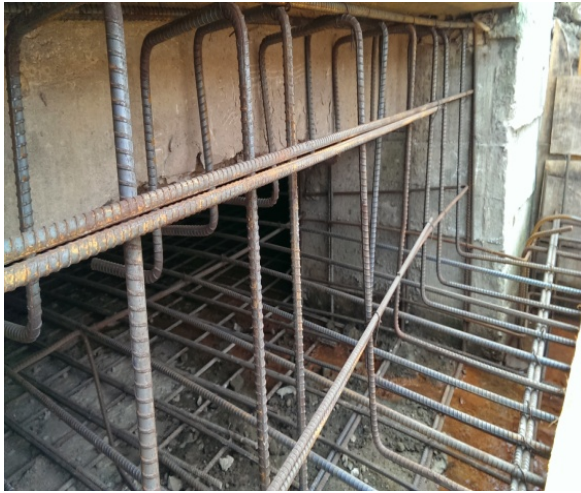
Fig. 16. Laid reinforcement cages

The provision of 20 mm diameter high yield steel in piles and pile cap ground beams, 16 mm diameter high yield steel for underpinning slabs in (2 layers) and 10 mm diameter high yield steel for links.

Fig. 16. Laid reinforcement cages

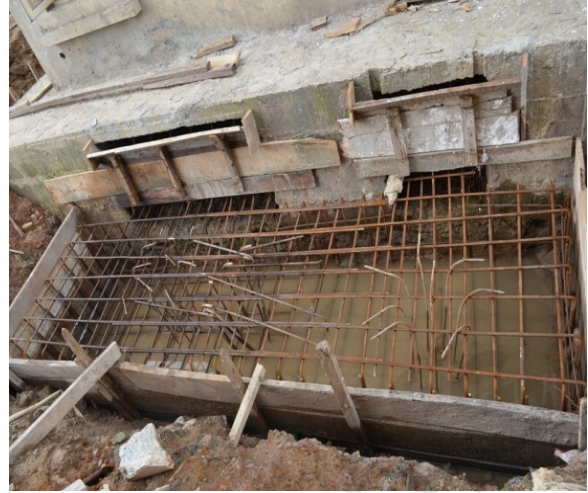
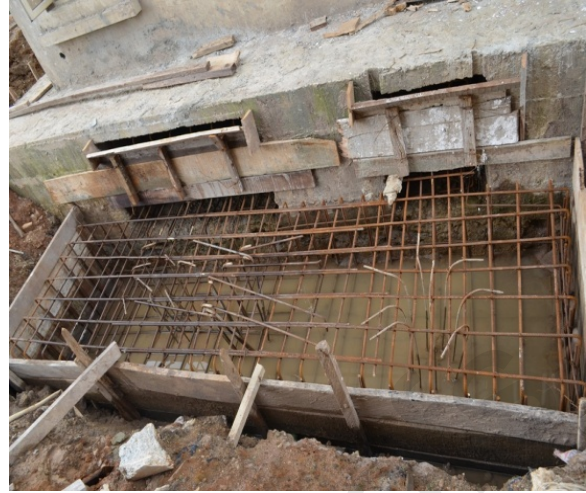
Fig. 17. Laid Beam anchored to underpinning piles

Fig. 17. Laid Beam anchored to underpinning piles

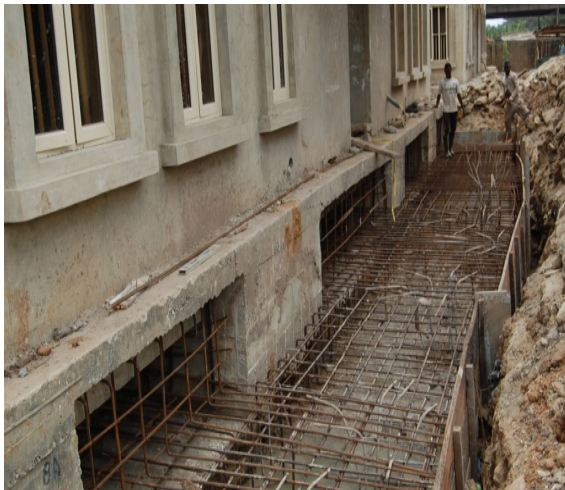
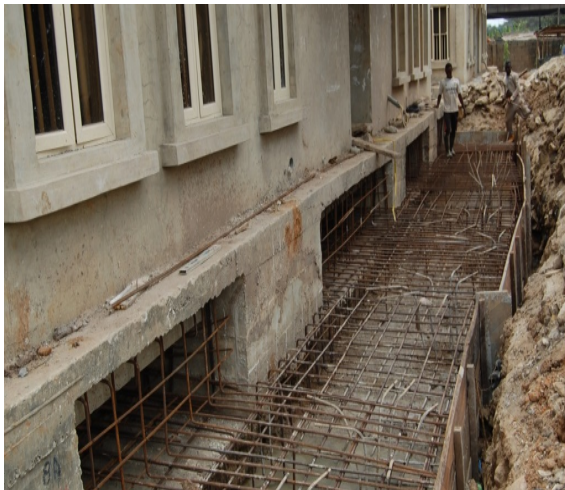
Fig. 18. Laid Beam anchored to existing raft

Fig. 18. Laid Beam anchored to existing raft

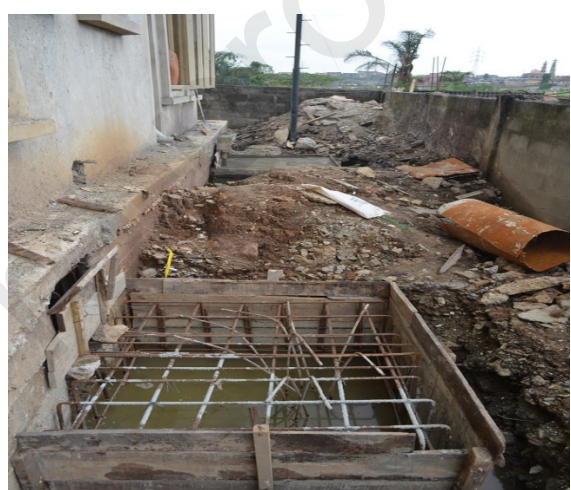
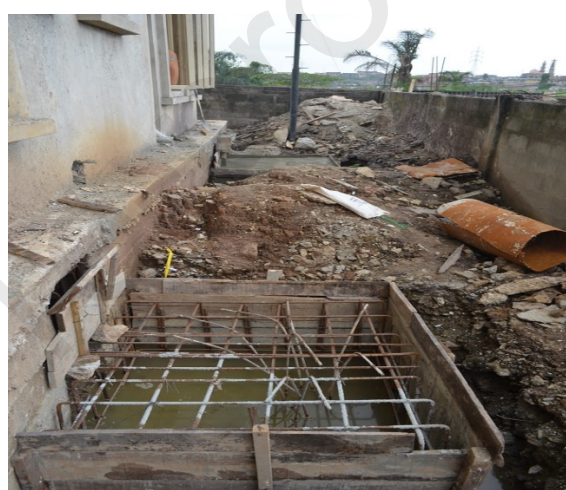
Fig. 19. Pile cap with ground beams

Fig. 19. Pile cap with ground beams

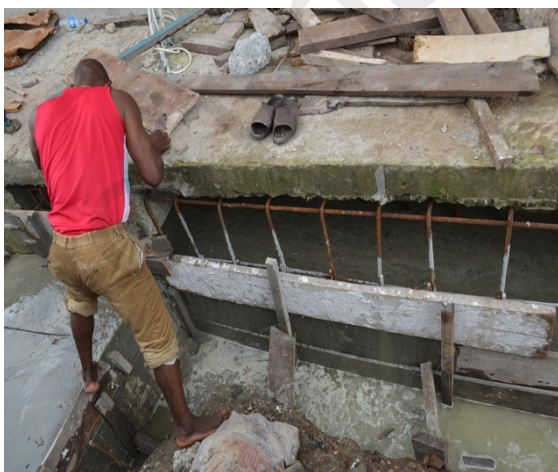
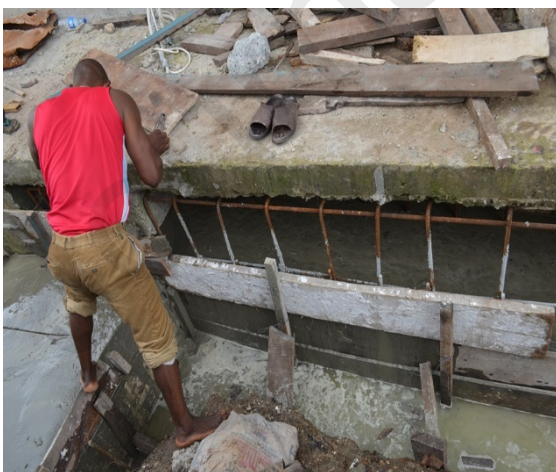
Fig. 20. Shuttering work

Fig. 20. Shuttering work

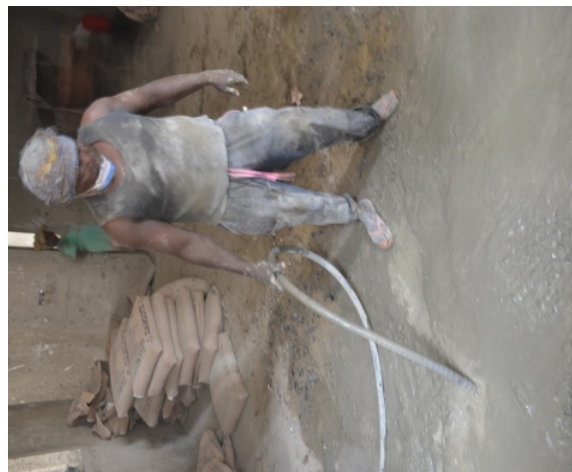
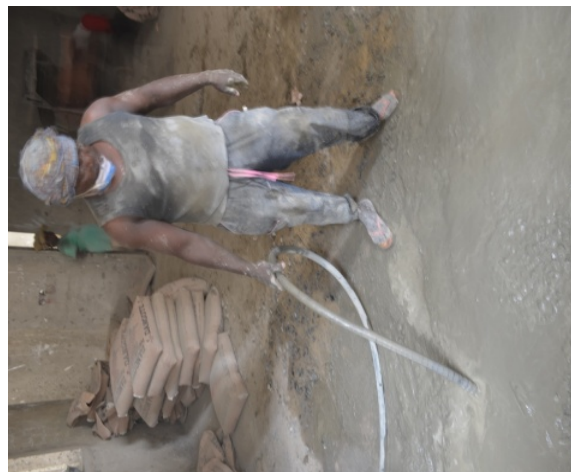
Fig. 21. Use of Poker vibrator

Fig. 21. Use of Poker vibrator

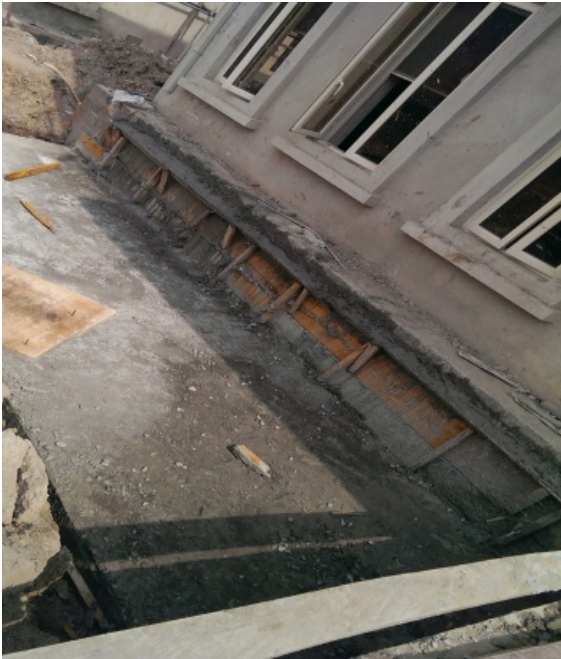
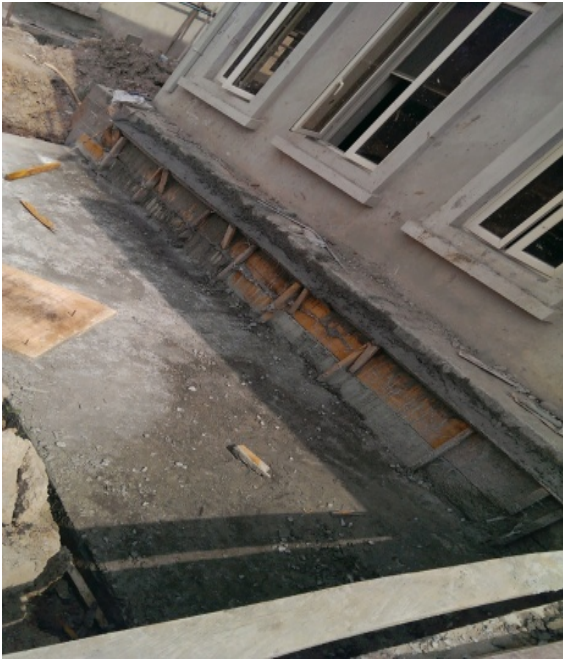
Fig. 22. Completed underpinning work.

Fig. 22. Completed underpinning work.

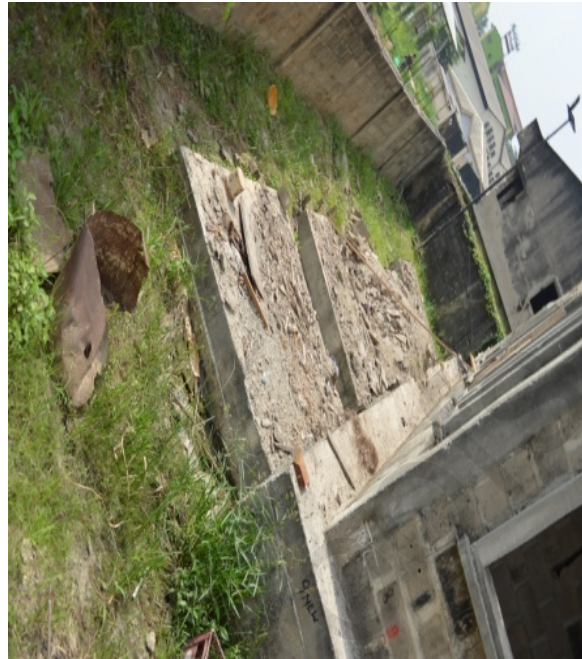
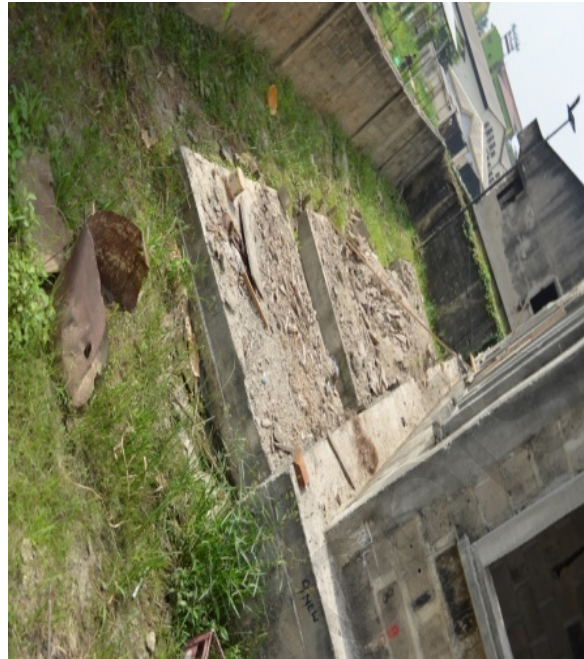
Fig. 23. Completed underpinning work.

Fig. 23. Completed underpinning work.

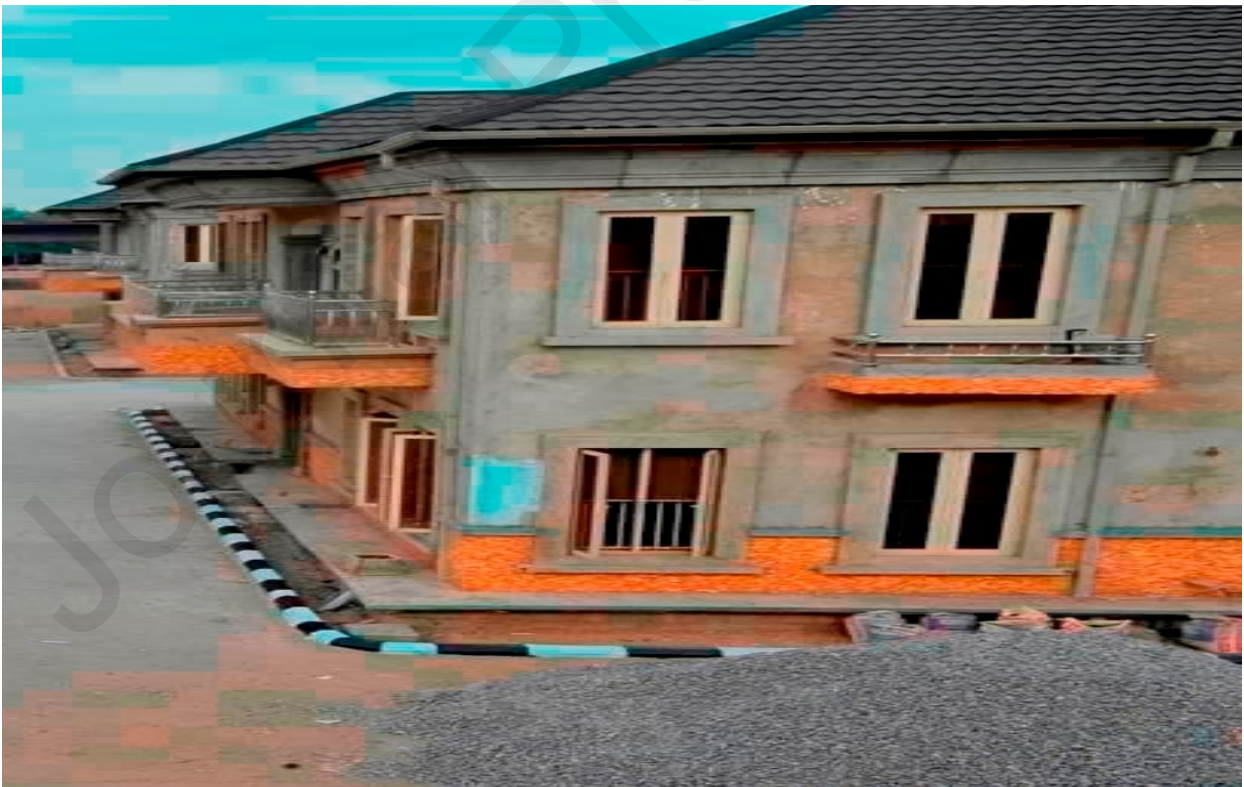
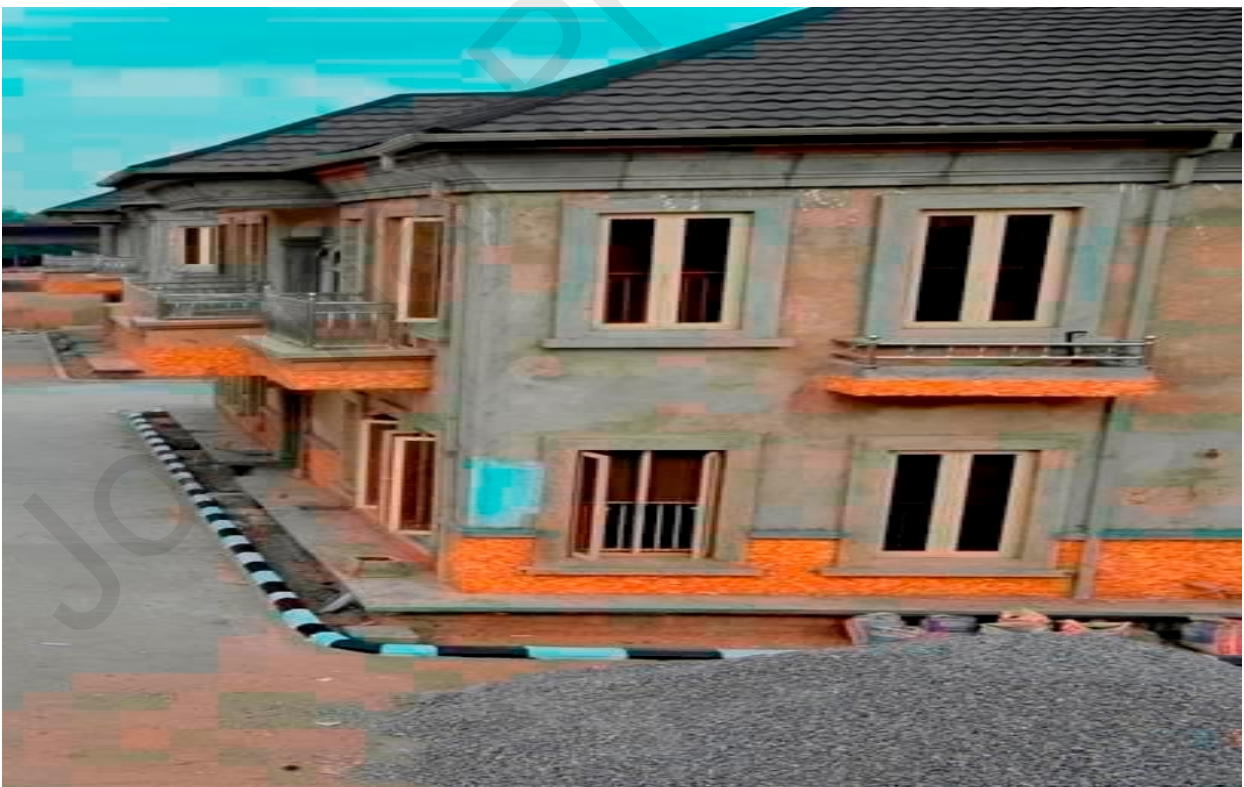
Fig. 24. Completed building in 2018

- After underpinning the sinking structure, it was observed that the angular distortions was less than 1/300. Therefore, the observed differential settlement didn't cause any cracks on any part of the building which, guaranteed the stability of the underpinned building.

Fig. 24. Completed building in 2018
