Journal article published in the Journal of Structural Engineering. The published version may be different from this version

1 **Seismic Performance of Reinforced Concrete Beams Susceptible to Single-** 2 **Crack Plastic Hinge Behavior**

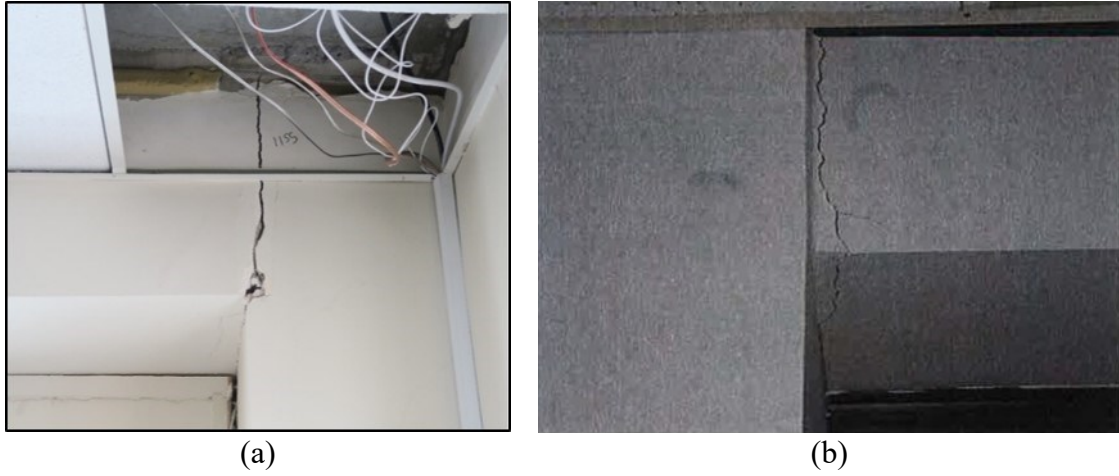
Fig. 1 – Single-crack plastic hinge length after the (a) Kaikoura earthquake; (b) Christchurch earthquake (Photos by Synge A and Smith and Devine (2012))

43 Smith and Devine (2012)) described the formation of a limited cracking mechanism (and
44 vertical sliding displacement) in beams of modern RC structures (Figure 1).

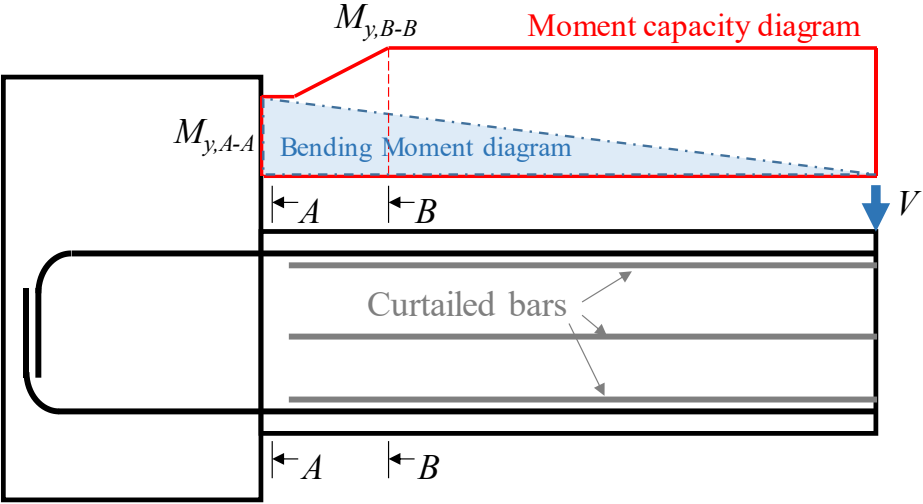
Figure 3 – Graphical explanation for the cause of the single-crack mechanism

61 Figure 3 represents a single-curvature with curtailed bars (similar to Figure 2b and also
62 presented in Figure 4a). As shown in the figure, a lateral load demand V corresponding to the
63 yield moment capacity of the beam at section A-A is insufficient to yield the sections adjacent
64 A-A (e.g., B-B). Hence, inelastic deformations starts concentrating at section A-A, leading to
65 a single crack dominated mechanism. For the beam in Figure 3, secondary flexural cracks may
66 develop at sections away from section A-A if the moment demands at these sections is larger
67 than the cracking moment capacity at these sections. As would be discussed subsequently in
68 this paper, the contribution of these secondary cracks to the inelastic behaviour is insignificant
69 compared with the contribution of the single crack at the beam-column interface.

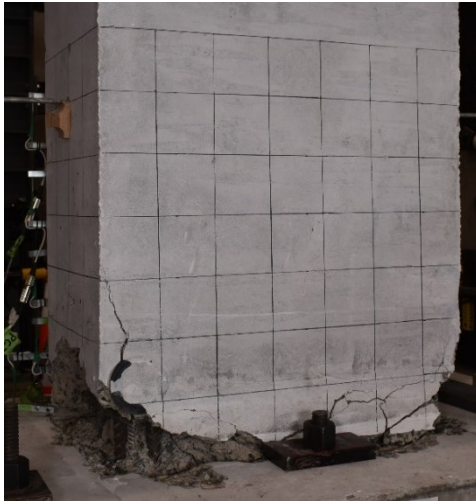
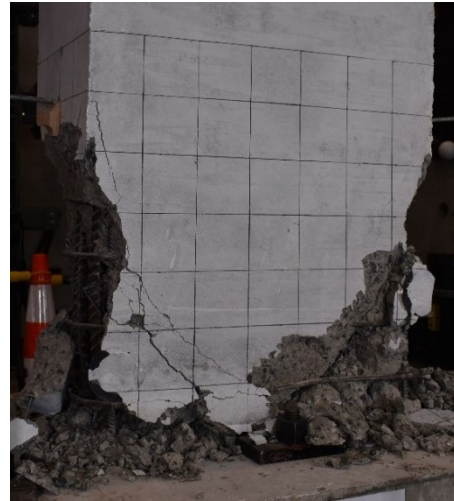
(a) End of EQ protocol

(b) End of Cyclic protocol

Fig. 11 – Pictures of Specimen EQ-S-1.96.25

235 For the residual capacity tests, through cycles up to 3%, no additional damage was noticed in
236 both beams. However, more significant shear sliding, in comparison to CYC-1.96.25 was
237 noticeable (Further discussions on shear sliding are presented subsequently). Once the drift
238 demands exceeded 3%, additional concrete spalling initiated due to dowel actions in the
239 longitudinal bars. Similar to other specimens, no bar fracture occurred (Figure 11b & Figure
240 12b).

334 Despite similarities in observed damages in Specimens EQ-S-1.96.25 and EQ-D-1.96.25 (see
335 Figure 11a and Figure 12a) at the end of the EQ protocol, a slightly larger reduction in strength
336 was observed in the damaged EQ-D-1.96.25 (Figure 16). It is noteworthy, however, that similar
337 effective stiffness values were measured in both damaged specimens.

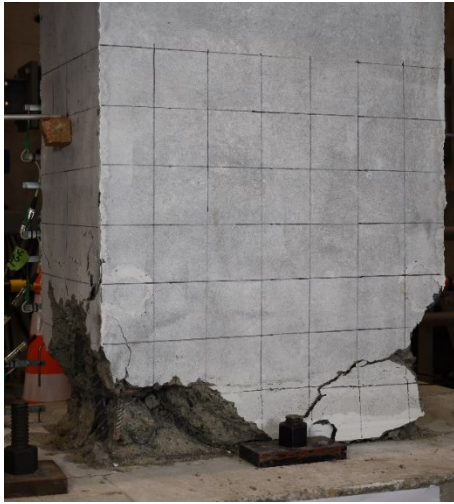
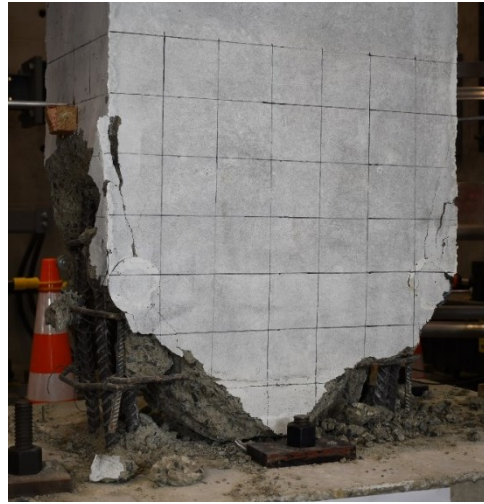
(a) End of EQ protocol

(b) End of Cyclic protocol

Fig. 12 – Pictures of Specimen EQ-D-1.96.25

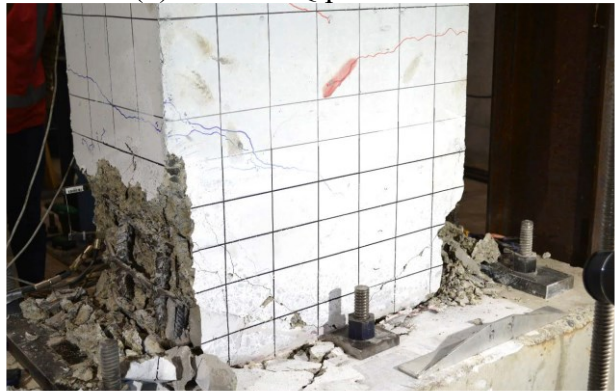
(a) End of Part I

(b) End of EQ phase of Part II

(c) End of Part II full cycle at 3%

(d) After 30 cycles to 2.5% during Part III

Fig. 13 – Photos of Specimen EQ-R-1.96.25

242 Measured residual primary crack width at the base at the end of Part I was 3.6mm with a
243 residual sliding displacement of 1mm. It is noteworthy that post-earthquake evaluation of
244 Building A showed a residual primary crack width of 3 – 4mm and residual vertical sliding
245 displacement of 1.5mm in some of the ground floor beams (See Figure 1a); suggesting that the
246 loading protocol for Part I was sufficient to replicate the real earthquake damage state.

247 The EQ phase of Part II was run non-stop and visual assessment was only possible at the end
248 of the EQ phase. At the end of the EQ phase, a single crack 6-7mm wide had developed at the
249 base. This crack developed slightly above the previously sealed crack (compare Figure 13a and
250 b). This crack increased to 11-12mm after the final cycle to 3%. Concrete cover spalling
251 occurred at only one edge of the beam specimen (Figure 13b).

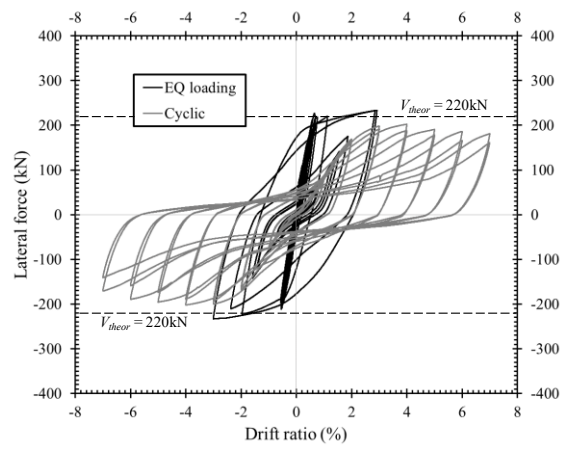
Fig. 14 – Force-displacement response of all beam specimens

267 Load-displacement responses of the beam specimens are presented in Figure 14. The lateral
268 load is the load applied by the actuator while the drift ratio is calculated as the ratio of the
269 displacement demand at the actuator to load height, measured from the beam-foundation
270 interface to the point of lateral load application. From the load-displacement plots, the ultimate
271 drift capacities were measured and presented in Table 3. The ultimate drift capacity was defined
272 as the drift corresponding to 20% loss of lateral resistance. Furthermore, the effective stiffness
273 for all six test specimens, measured using a similar procedure adopted by Opabola and Elwood
274 (2020), are presented in Table 3.

275 Experimental result show that the baseline specimen, CYC-1.96.25, only suffered lateral
276 failure at 5% drift. A decrease in aspect ratio did not have adverse effect on the cyclic response
277 of the beam as Specimen CYC-1.24.25 also suffered lateral failure at 5%. On the other hand,
278 an ultimate drift capacity of 7% was measured in Specimen CYC-1.96.32.

279 A comparison of measured peak strength to theoretical flexural strength (V_{theor}), computed
280 through a section analysis using measured material properties, show that all components
281 attained their flexural strength (see Figure 14). Specimen EQ-S-1.96.25 reached a peak lateral
282 force of 233.5kN during the quasi-static EQ displacement protocol with a maximum peak drift
283 of 3%. Due to the section loss (See Figure 11a for the damage state of test specimen prior to
284 quasi-static tests) during the EQ protocol, the peak strength of the damaged specimen was only
285 202kN. Further discussion on the residual performance of these beams is provided
286 subsequently in this paper.

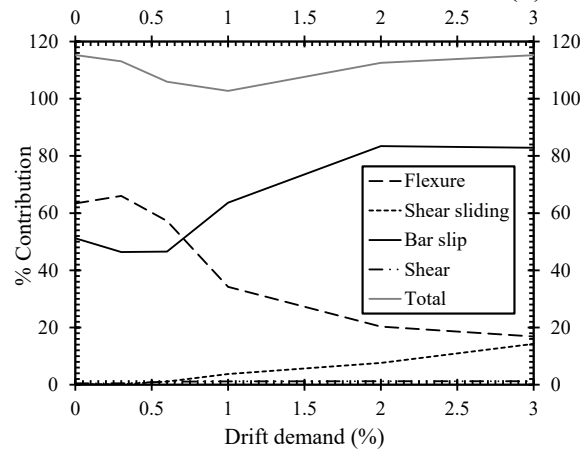
Fig. 15 – Contribution of deformation components to response of Specimens CYC-1.96.25, CYC-1.24.25 and CYC-1.96.32

300 Figure 15 shows the contribution of all deformation components to the response of specimens
301 subjected to the standard cyclic protocol (CYC-1.96.25, CYC-1.24.25 and CYC-1.96.32) up to
302 3% drift demand. To prevent damage, displacement gauges were uninstalled after the cycles to
303 3% drift were completed. As shown in Figure 15a, prior to yielding of the specimen, bar slip
304 deformation contributes about 48% of the total deformation but this increases to about 80% in
305 the post-yield phase. There is also an increase in shear sliding with increasing drift demands,
306 attributed to axial elongation concentrated at the beam-foundation interface, leading to a
307 reduction in aggregate interlock resistance. Experimental data on the axial elongation-shear
308 sliding behavior of the specimens are available in Opabola (2021). The contributions of
309 deformations due to flexure are also quite prominent during the elastic phase but it fades away

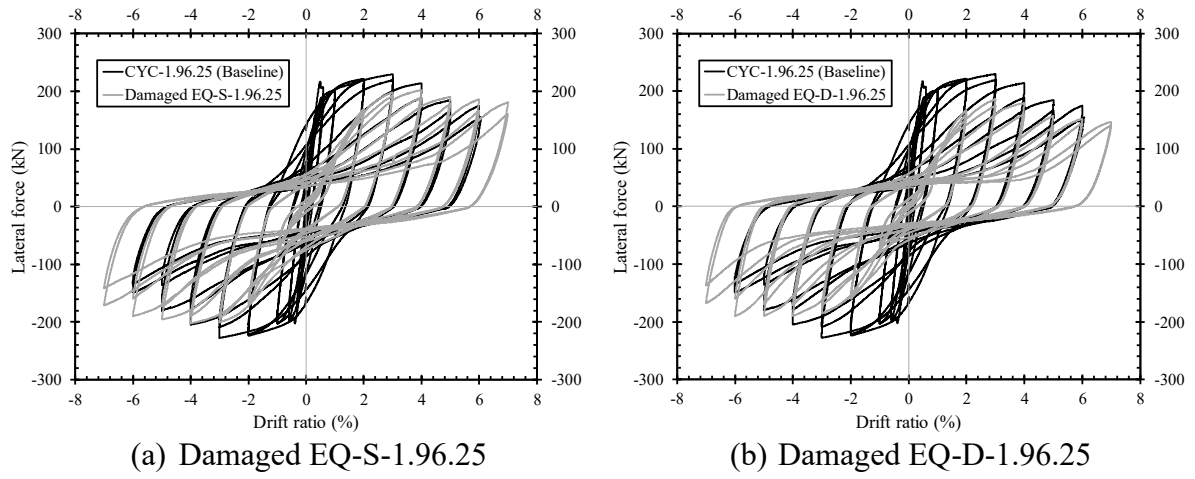
Fig. 16 – Residual performance of (a) damaged EQ-S-1.96.25 and (b) EQ-D-1.96.25

326 Figure 16 compares the hysteresis plot for the baseline specimen (CYC-1.96.25) and the
327 damaged specimens EQ-S-1.96.25 and EQ-D-1.96.25. As shown in Figure 16a, the influence
328 of the initial EQ displacement protocol fades away once the target drift demand exceeds 3%
329 (peak drift of the EQ protocol). The larger strength resistance of the damaged beam in the
330 negative quadrant of the plot is attributed to a lesser amount of 3% cycles in the negative
331 direction. Given the large EQ drift demands on the undamaged EQ-S-1.96.25, one can
332 conclude that, aside from reduced stiffness, unrepaired beams may perform adequately well
333 without reduction in deformation capacity for a subsequent strong earthquake.
