Preferred Precipitations in Some Age-hardened Aluminium Alloys

NISHIMURA, Hideo; MURAKAMI, Yōtaro

NISHIMURA, Hideo ...[et al]. Preferred Precipitations in Some Age-hardened Aluminium Alloys. Memoirs of the Faculty of Engineering, Kyoto University 1953, 15(1): 9-26

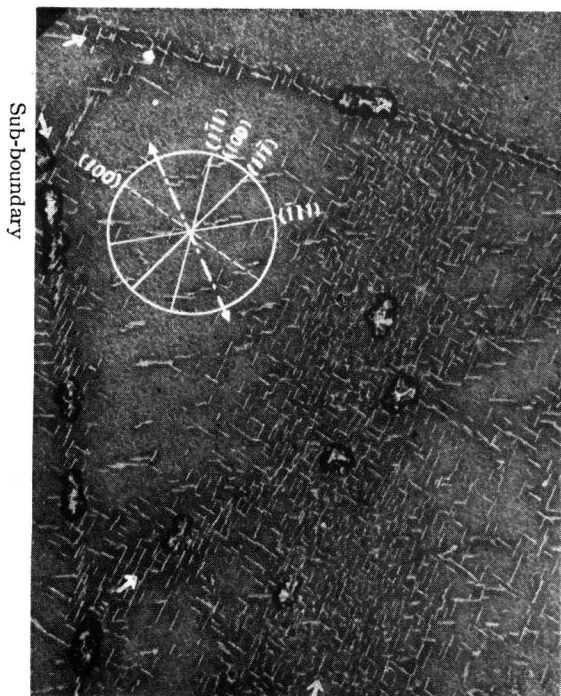
Photo 7 Electron micrograph of the same alloy. Solution treated, elongated by 1.8% with a loading rate of 0.75 g. per mm² per second, and aged similarly. Showing preferred precipitation in slipping regions and sub-boundaries. $\times 10,000$

The preferred precipitations in slipping regions and sub-boundaries are shown in Photo 7 together with the crystallographic projection of crystal lattice. This electron micrograph was obtained from the specimen of the same composition, quenched in oil at room temperature and then stretched by 1.8% in total length with a loading rate of 0.75g. per mm². per second. The preferred precipitation is observed at the slipping regions of two sets of ($\bar{1}\bar{1}1$) and ($1\bar{1}\bar{1}$) planes, whose crystallographic directions are observed to coincide well with the analytical results by X-ray. Similar precipitates exist at sub-boundaries. These precipitates have almost the same orientation with those on both sides of the boundaries. In comparison with the grain boundaries where only a few coarse precipitates are observed, as shown in Photos 3 and 4, minute, discrete, plate-like θ' -CuAl₂ particles are found to exist along the sub-boundaries. They are an indication that the defects in sub-boundaries are not so marked as in the grain boundaries.

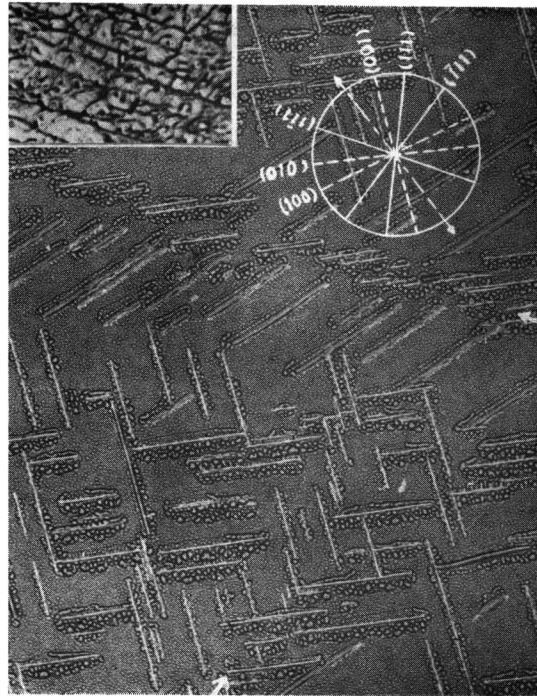
Photo 8 Electron micrograph of the same alloy. Solution treated, stretched by 5%, and annealed at 500°C. for 30 min., and then aged similarly. Showing preferred precipitation in a boundary of polygonization. $\times 10,000$ Its optical micrograph is shown at the upper left corner.

The specimen of the same composition was annealed for 30 minutes at 500°C. after an elongation of about 5 per cent, and then tempered for 2 days at 200°C. As seen in the upper left hand corner of Photo 8, the optical micrograph shows a kind of sub-boundary structure known as "network structure" in Japan.^{8,9)} The electron micrograph is also shown in the same photograph. The preferred precipitation exists in two regions, i. e., one along the slipping regions of ($\bar{1}\bar{1}1$) and the other probably at the boundary formed by polygonization.

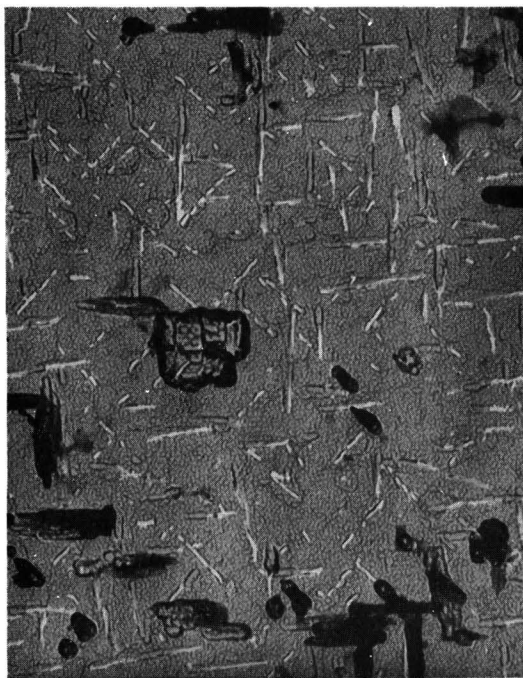
Photo 9 Electron micrograph of the alloy containing 2.85% Cu and 1.09% Mg, quenched from 500°C. and then aged at 250°C. for 5 hrs. Etched slightly in Lacombe's reagent. Showing the formation of plates on two kinds of crystallographic planes of etching pit. $\times 10,000$

Al-S intermetallic compound quasi-binary system, segregate on the two crystallographic planes $\{100\}$ and probably $\{110\}$. This conclusion was given from the observation of the directions of the precipitates on the etching pits as shown in Photo 9, which is the micrograph of the specimen containing 2.85% copper and 1.09% magnesium and tempered for 5 hrs. at 250°C. From the result of the determination of the directions of slip bands in the present work, it was occasionally found that the conclusion is correct. For example, Photo 10 is an electron micrograph of an alloy containing 3.12% copper and 0.97% magnesium and elongated by about 1 per cent. In this photograph, the crystallographic directions of the matrix crystals determined by X-ray analysis are so described that the predicted results from X-ray analysis may coincide with those observed under an electron microscope with the aid of the direction of slip band at which the preferred precipitation occurs.

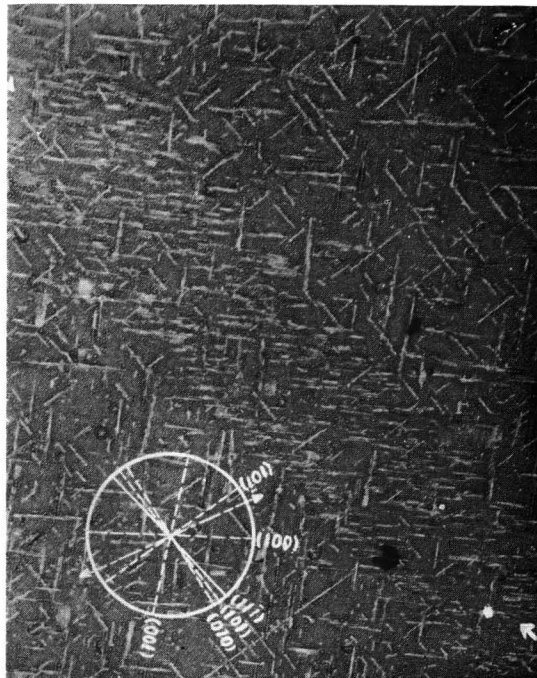
Photo 10 Electron micrograph of the alloy containing 3.12% Cu and 0.97% Mg. Solution treated, elongated by 1% and then aged at 200°C. for 2 days. Showing that the precipitation planes of the alloy are parallel to $\{100\}$ and $\{110\}$ of the matrix crystal, by the aid of the direction of slip band where preferred

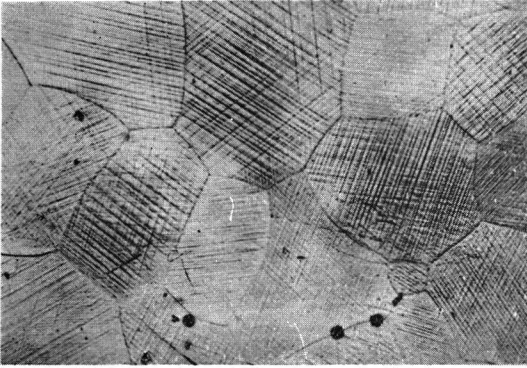
Photo 1 Optical micrograph of the alloy containing 4.02% Cu, aged at 200°C. for 30 hrs. Etched with Keller's reagent. Showing slip lines produced by quenching. $\times 48$

Photos 1 and 2 represent respectively the optical and the electron micrographs of the aluminium alloy containing 4.02% copper, quenched in ice water from 500°C. and subsequently aged for 30 hrs. at 200°C. Photo 1 shows typical slip lines, but the electron micrograph Photo 2 does not show any distinct preferred precipitation at the slipping regions. It is probably due to the fact that so many slip bands were produced by the plastic deformation resulted from drastic quenching in ice water. Photo 3 is an electron micrograph showing the junction of two different grains in an alloy with the same composition whose grain size was about 3 mm. in diameter. In one grain small plate-like θ' -CuAl₂ particles are seen scattered almost uniformly throughout the grain, but in

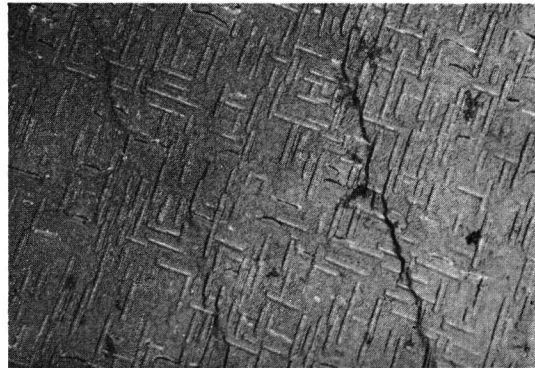
Photo 2 Electron micrograph of the same alloy. The field similar to that of Photo. 1. Showing no distinct preferred precipitation at the slipping regions, probably due to the formation of so many slip bands by rapid quenching. $\times 10,000$

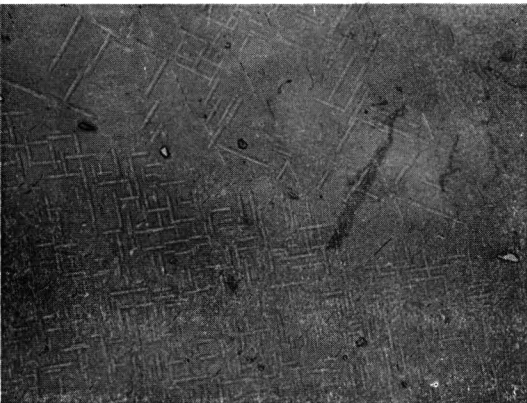
Photo 3 Electron micrograph of the same alloy with larger grain size. Showing the difference of precipitation behavior in grains, depending upon the orientation of crystal and grain size. $\times 10,000$

another grain large precipitate particles are distributed more preferentially than in the former. This fact indicates that the effect of plastic deformation owing to quenching differs according to the orientation of crystal grains and the size of grains. On the other hand, the same specimen, whose micrograph is shown in Photo 1, was quenched from 500°C. in oil bath at about 100°C., then aged and etched similarly. The structure known as "veining" or "sub-boundary"^{4,8,9} was observed instead of slip lines under an optical microscope as shown at upper left corner in Photo 4. This structure is revealed more clearly under an electron microscope as shown also in the same photograph. A few of the plate-like θ' -CuAl₂ particles which are comparatively larger in size, are distributed along rather definite lines, but are not homogeneously in grains. In this case, the rate of quenching was not so great as to produce a plastic deformation accompanied with slipping and, therefore, the preferred precipitation did not take place in the slipping regions. These rather definite lines along which the preferred precipitation has occurred may be considered to be the boundaries of subdivisions in grain, because the orientations of the θ' -CuAl₂ on both sides of the lines are nearly the same.

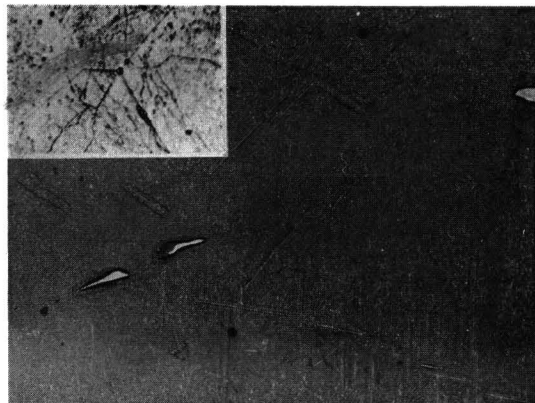
Photo 4 Electron micrograph of the same alloy. Quenched from 500°C in oil bath at 100°C and then tempered similarly. Showing the preferred precipitation in the boundaries of sub-divisions within grains. $\times 10,000$ Its optical micrograph is shown at the upper left corner.

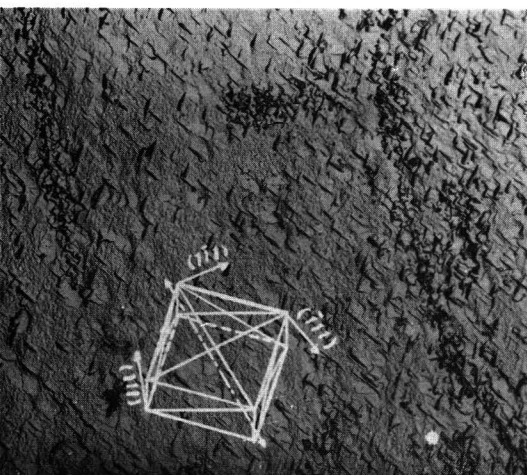
Photo 5 Electron micrograph of the same alloy. Solution treated, elongated by 5.2% with the slow rate of strain, and aged at 200°C for 30 hrs. Etched slightly prior to the preparation of oxide replica. Showing the preferential precipitation of plate-like θ' -CuAl₂ and the fragmentation of mosaic blocks at the regions of slipping. $\times 10,000$

Photo 5 shows an electron micrograph of the aluminium alloy containing 4.02% copper and etched slightly by Keller's reagent. In this photograph, the projection of its crystal lattice obtained from X-ray analysis is so drawn by white lines that the crystallographic directions may coincide with those of the precipitates and slip bands in this photograph. In this specimen, which was subjected to the slow rate of straining and stretched by 5.2% in total length, the occurrence of the preferential precipitation and the fragmentation of mosaic blocks at the regions of slipping are evident. Photo 6 shows an electron micrograph of the alloy with the same composition but with different crystallographic orientation, stretched by 4.7% in total length with a rapid rate of straining. In this photograph, it is apparent that the denuded zone between the regions of slipping, where a remarkable preferred precipitation occurred, exists. Photos 5 and 6 also show a good agreement with the well-known fact observed in pure metal crystals that the breadth of slip bands and their spacing are affected by the straining rate.

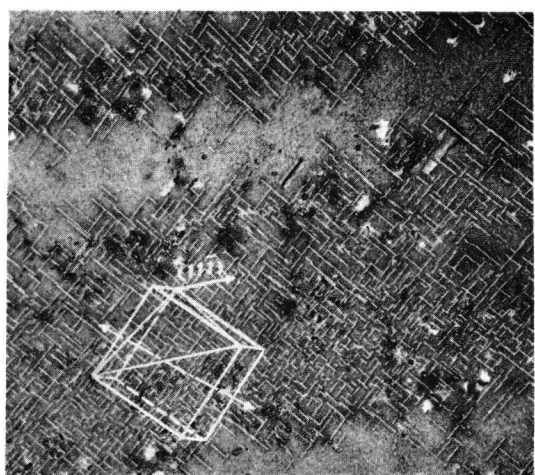
Photo 6 Electron micrograph of the same alloy. Solution treated, elongated 4.7% with the rapid rate of strain and aged similarly. Showing the denuded zones between the regions of slipping where a remarkable preferred precipitation exists. $\times 10,000$

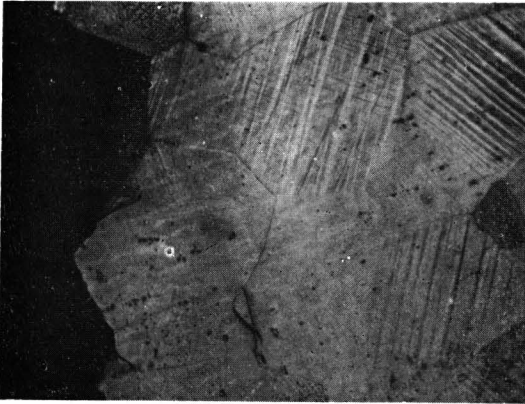
Photo 11 Optical micrograph of the alloy containing 1.54% Mg and 8.51% Zn, quenched from 450°C., aged at 140°C. for 5 hrs., and then subjected to the stress-corrosion test in brine. Showing the intergranular crack in the alloy. $\times 48$

Photo 11 shows the intergranular cracks under a magnification of 48 diameters in the alloy containing 1.45% magnesium and 8.51% zinc, tempered for 5 hrs. at 140°C . and then subjected to the stress-corrosion test as described above. In this photograph, it is noted that slip lines exist in each grain.

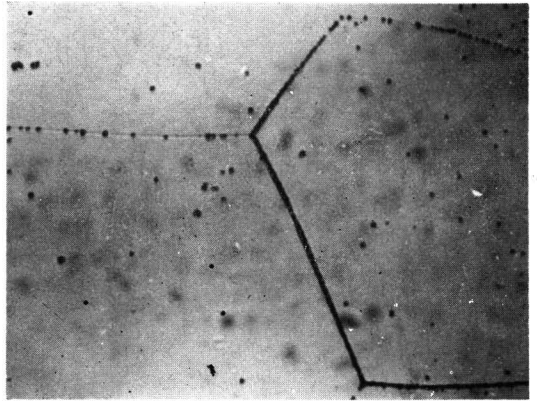
Photo 12 Optical micrograph of the alloy with the same composition as that of Photo 11, aged at 100°C. for 5 hrs. Etched with Wassermann's reagent. Showing the sharply etched grain boundary. $\times 700$

Photo 12 is a microphotograph of the specimen aged at 100°C ., polished electrolytically and then etched with Wassermann's reagent. It is noticeable that the grain boundaries are etched sharply and that many etching pits exist in the grains and somewhat in the grain boundaries. An electron micrograph of this specimen is shown under a magnification of 10,000 diameters in Photo 13. No sign of any definite precipitate is recognized in the grain boundaries and within the grains, but the aspect of the oxide film is slightly different from that obtained from the quenched specimen. The difference seems to be related to the earlier stage of the precipitation from the saturated solid solution. This conclusion was derived from the change of dilatation of the specimen on heating which was executed separately.^{1,2)}

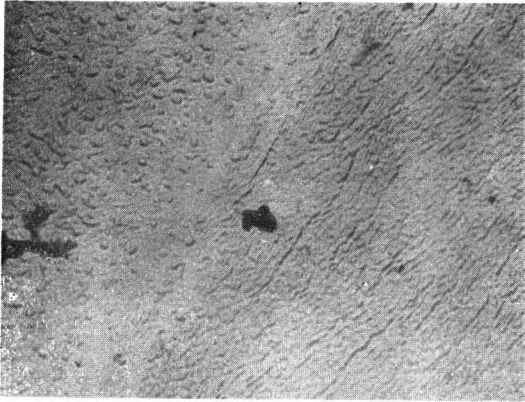
Photo 13 Electron micrograph of the same alloy. The field similar to that of Photo 12. Showing that no sign of any definite precipitates is recognizable in grain boundaries and within grains, though the aspect of the oxide film is not normal. $\times 10,000$

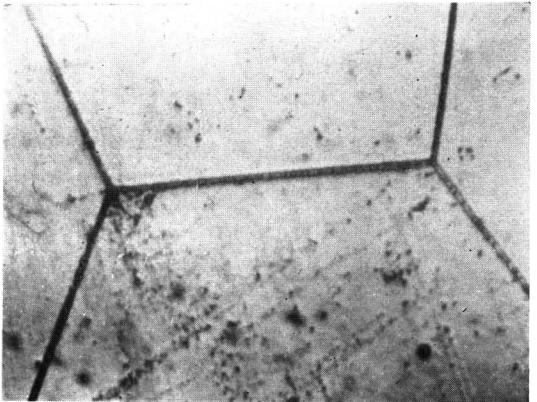
Photo 14 Optical micrograph of the same alloy, aged at 140°C. for 5 hrs., etched with Wassermann's reagent. Showing that the grain boundaries are etched more sharply. $\times 700$

The microstructure of the specimen aged at 140°C . is shown under a magnification of 700 diameters in Photo 14. It appears that the grain boundaries are more sharply etched and the slip lines are present obviously. Photo 15 is its electron micrograph under a magnification of 10,000 diameters. The aspect of the oxide film is quite different from that of the specimen as shown in Photo 13. A greater amount of minute precipitates is present continuously in the grain boundary on the left of this photograph and within the grains the precipitates may exist also. The continuity of the precipitates in the grain boundaries varies from one grain boundary to another, depending upon the relative orientation of the neighbouring grains. This variation may be due to the fact that the slight difference of orientation between the adjacent grains does not cause the higher rate of precipitation in their boundaries. The relation between hardness or stress-corrosion and tempering temperatures being considered as shown in Fig. 1, the susceptibility to stress-corrosion is evidently related to the aspect of the grain boundaries, although the difference of chemical potential between the precipitates and the matrix may also affect it considerably.

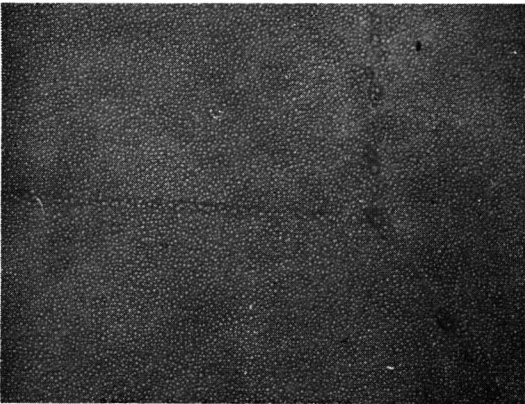
Photo 15 Electron micrograph of the same alloy. The field similar to that of Photo 14. Showing that a greater amount of minute precipitates is present within grains and continuously in grain boundaries. Such aspects of the grain boundaries may probably be related to the susceptibility of stress-corrosion of this alloy. $\times 10,000$

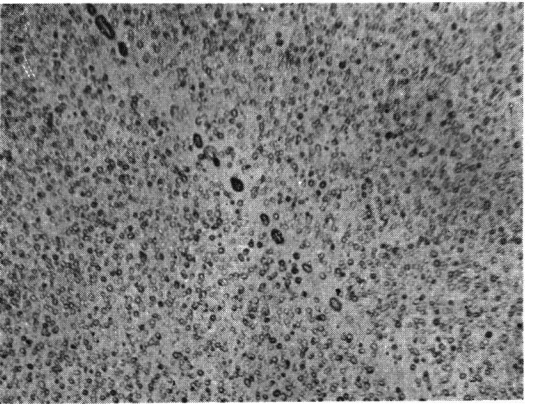
Photo 16 Electron micrograph of the same alloy, aged at 200°C. for 5 hrs. Showing the coagulation of the boundary precipitates and the growth of innercrystalline precipitates. $\times 10,000$

Photo 16 is an electron micrograph of the specimen aged for 5 hrs. at 200°C .

This photograph shows the presence of innercrystalline precipitates which have coagulated as compared with those shown in Photo 15, while at the grain boundaries the precipitates have grown in size, therefore, that there is a zone denuded of the precipitates. The alloy, which shows such a grain boundary, seems to be not very susceptible to stress-corrosion.

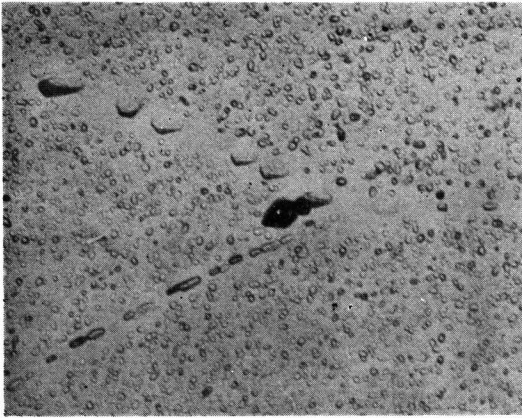
Photo 17 Electron micrograph of the same alloy, aged at 250°C. for 5 hrs. Showing the denuded zones of precipitates in grain boundaries widen and the precipitates within grains grow in size. $\times 10,000$

The electron-micrographic structure of the specimens tempered at 250°C. and 310°C. are shown in Photos 17 and 18 respectively. They show that the denuded zones become wider and the precipitates grow in size with the rise of tempering temperature. Furthermore, it is to be noticed that in Photo 18 a part of the precipitates has dissolved again. This fact was also proved by the increase in hardness after a lapse of several days. Such a specimen no longer showed the phenomenon of stress-corrosion, even if it had been tested for fairly long time in 3% brine.

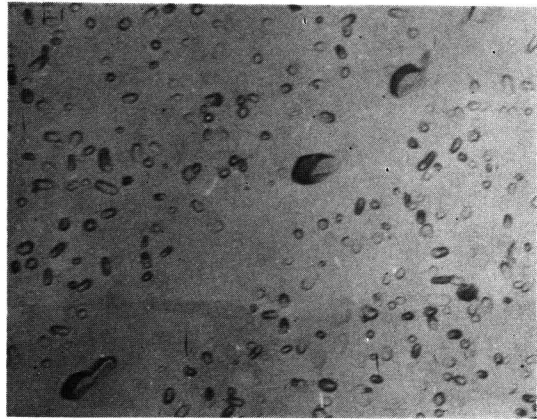
Photo 18 Electron micrograph of the same alloy, aged at 310°C. for 5 hrs. Showing that a part of the precipitates is dissolved again into the matrix. $\times 10,000$

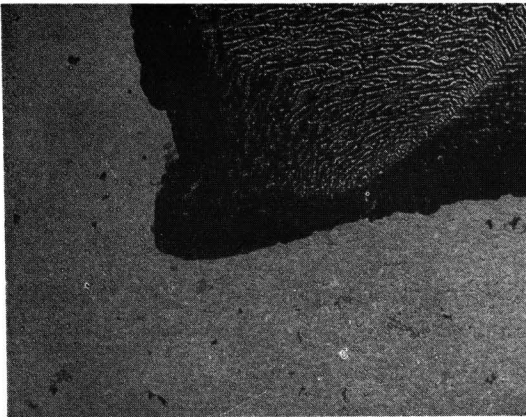
Photo 19 Electron micrograph of the alloy containing 1.52% Mg, 8.47% Zn and 1.57% Cu, aged at 100°C. for 5 hrs. Etched with Lacombe's reagent. Showing the distinct precipitation on the edges of steps in the surface of a large etch pit and the indistinct precipitation at the grain boundary. $\times 10,000$

The alloy containing 1.52% magnesium, 8.47% zinc and 1.57% copper was examined similarly. No considerable difference was observed in its microstructure. But it was found that the resistance to stress-corrosion had been improved, and compared with the alloy containing no copper, its hardness showed higher value as seen in Fig. 1. Photo 19 is an electron micrograph of the specimen aged for 5 hrs. at 100°C. It is evident that the precipitation at

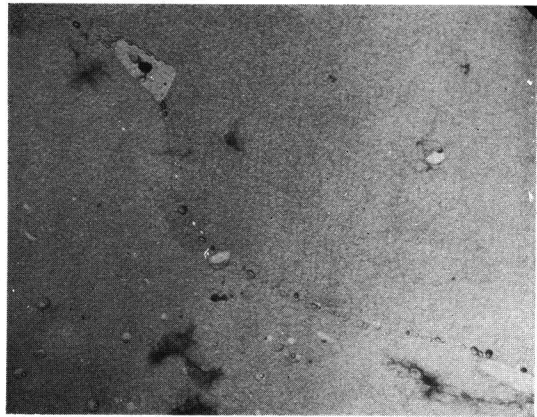
Photo 20 Electron micrograph of the alloy containing 1.63% Mg, 8.75% Zn and 0.47% Mn, aged at 140°C. for 5 hrs., Showing a sinuous grain boundary. This may probably be due to the presence of the intermetallic compound. $\times 10,000$

The typical electron micrographs of the alloys containing manganese and chromium in addition are shown in Photos 20~22 under a magnification of 10,000 diameters. In the alloy containing 1.63% magnesium, 8.75% zinc and 0.47% manganese aged for 5 hrs. at 140°C., the precipitation has taken place in the grain boundaries, and the boundary becomes sinuous probably by the presence of the intermetallic compound as shown in Photo 20. Photo 21 shows an electron micrograph of the specimen containing 1.57% magnesium, 8.57% zinc and 0.39% chromium. The specimen was tempered for 5 hrs. at 200°C. The shape of grains is also irregular. Intermetallic compounds probably containing chromium are present along the grain boundaries, even if they are not shown in this photograph. It is also noted that at the grain boundaries the zones denuded of the precipitates are not so evident as in the alloy with no addition of the alloying elements. This is probably due to the slow rate of diffusion of these addition elements. Photo 22 shows the microstructure of an alloy containing manganese and aged for 5 hrs. at 250°C. In this photograph, the innercrystalline precipitates have grown in size and the precipitates at the grain boundaries have coagulated, but the denuded zones are not distinct as in Photo 21. By the addition of manganese and chromium, the growth of grains was considerably suppressed and the shape of the grains was very sinuous. The zones denuded of the precipitates at the grain boundaries were not evident. These aspects of the grain boundaries in the alloys containing manganese and chromium may be the reason why these alloys are less susceptible to stress-corrosion.

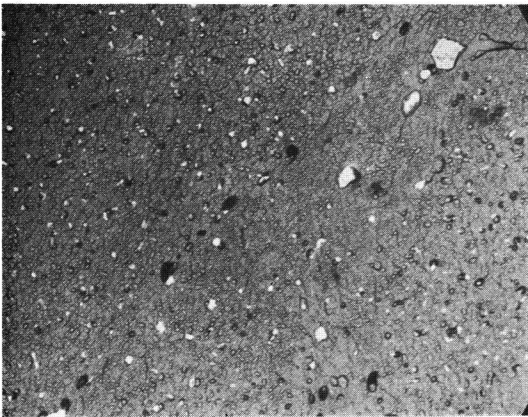
Photo 21 Electron micrograph of the alloy containing 1.57% Mg, 8.57% Zn and 0.39% Cr, aged at 200°C. for 5 hrs. Showing also a sinuous grain boundary and the absence of evident zones denuded of the precipitates. $\times 10,000$

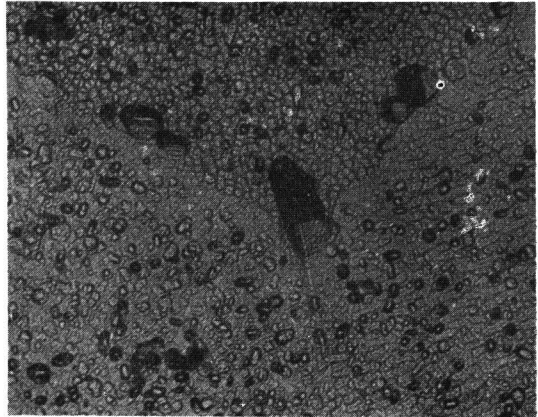
Photo 22 Electron micrograph of the alloy with the same composition as that of Photo 20, aged at 250°C. for 5 hrs. Showing also the absence of denuded zones in grain boundaries. $\times 10,000$

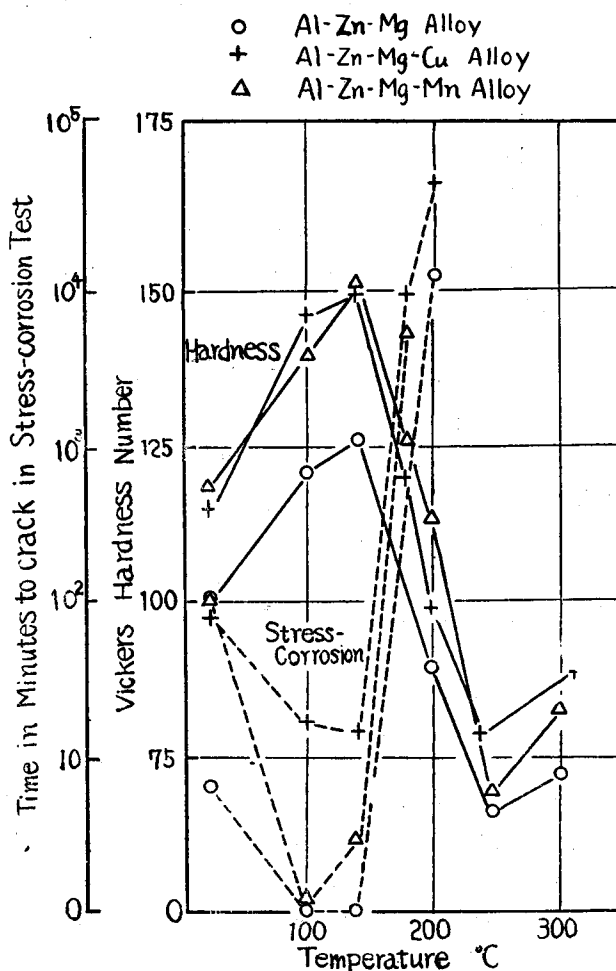
Fig. 1 The relation between hardness and stress-corrosion and tempering temperatures, and the effect of alloying elements.

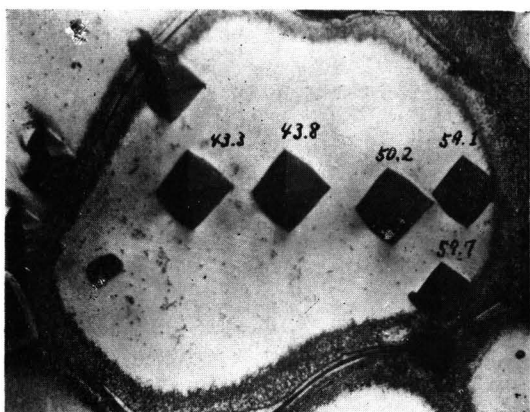
Photo 23 Optical micrograph of the alloy containing 8.38% Zn and 1.56% Mg. Showing the variation of hardness of the cored structure in as cast state measured by Akashi micro-hardness tester. $\times 250$

Photo 23 shows the optical micrograph of the alloy containing about 10% $MgZn_2$ (8.38% Zn and 1.56% Mg in chemical composition) in the cast state. In this photograph, the impressions formed on the specimen are shown together with their hardness numbers. The hardness was measured 7 days after casting. The increase in micro-hardness indicates that the concentration of the alloying elements increases from the center towards the boundary of the grains.

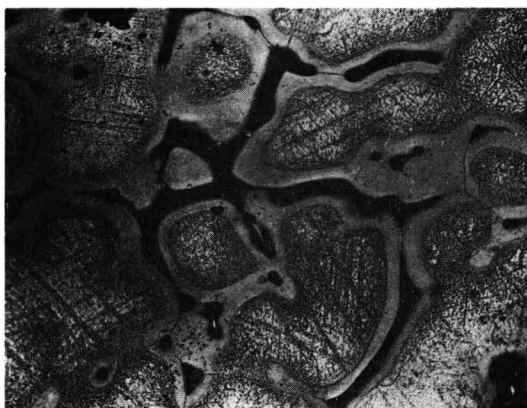
Photo 24 Optical micrograph of the alloy similar as that of Photo 23, aged at 180°C . for 16 hrs. Etched with Wassermann's reagent. Showing the three different parts in the cored structure, i. e. outer white unetched zone, intermediate somewhat more heavily etched zone, and inner region. $\times 96$

Photo 24 is an optical micrograph under a low magnification of the same specimen etched with Wassermann's reagent after tempering it for 16 hrs. at 180°C. The etching characteristic of the cored structure becomes more distinct. This is probably due to the precipitation having occurred in a different way from the boundary region to the cored part. It is also noted that there exist slip lines and sub-boundaries. When this specimen was observed under a higher magnification, the precipitates were more definitely recognized to differ in size and distribution as shown in Photo 25. From these observations, it is evident that the cored structure consists of the following three different parts: an outer unetched white zone adjacent to the grain boundary with a constant breadth; an intermediate zone somewhat more heavily etched; and an inner region slightly etched except in the slipping regions

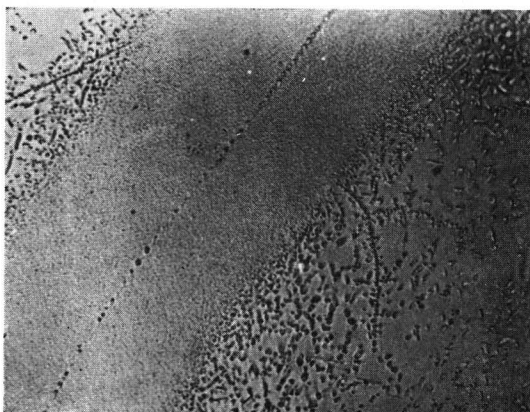
Photo 25 Optical micrograph of the same alloy. The field similar to that of Photo 24 but under a higher magnification. Showing the aspects of the cored structure more distinctly. $\times 1,000$

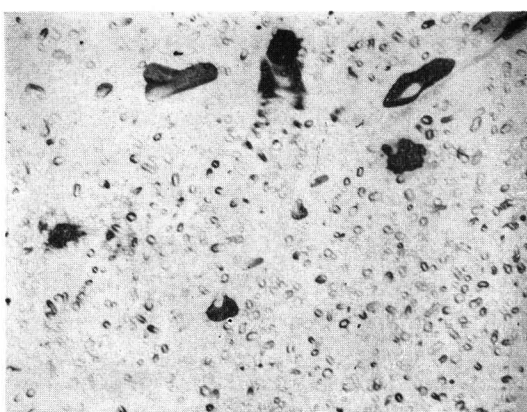
Photo 26 Electron micrograph of the same alloy. The field corresponding to the outer white unetched zone of Photo 24. Showing the homogeneous distribution of minute precipitates. $\times 7,000$

The electron micrographs of these three parts in the cored structure are shown in Photos 26, 27 and 28 under a magnification of 7,000 diameters. In these micrographs, the conditions of the cored structure may be readily recognized. In the outer unetched white zone, as shown in Photo 26 and on the left hand side of Photo 27, a large number of minute precipitate particles are distributed homogeneously. This may show that the concentration of the

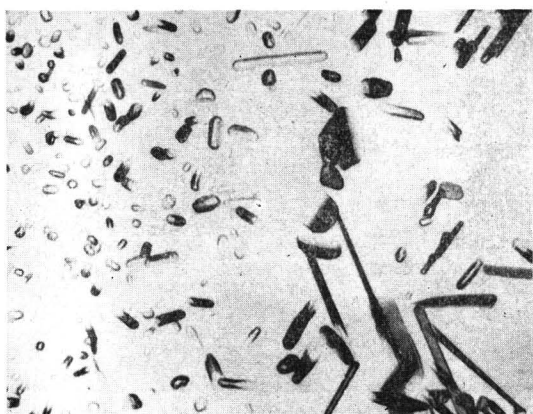
Photo 27 Electron micrograph of the same alloy. The field corresponding to the junction of the outer and the intermediate parts of Photo 24. Showing the distinct differences among the precipitates in size and distribution. $\times 7,000$

alloying elements is almost constant in this zone. Photo 27 shows that at the junction of the outer and the intermediate zones, the precipitate particles distinctly differ in size and distribution. It is also observed that the growth of precipitates occurs probably due to the low concentration of the alloying elements. In the inner region, a few precipitates which have grown up to the complete form are seen to have been distributed in groups at random as shown in Photo 28. These observations indicate that the concentration of the alloying elements in the cored structure is almost homogeneous in the outer zone whose breadth is about 150μ in the present case, then decreases rapidly towards the intermediate zone and again becomes homogeneous in the inner part of the grain. This will give some suggestions to the idea of the solidification of an alloy consisting of a solid solution.

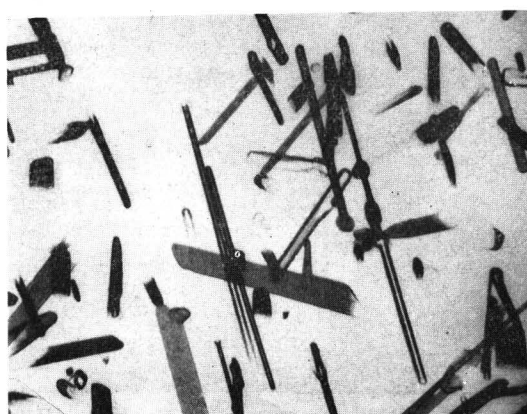
Photo 28 Electron micrograph of the same alloy. The field corresponding to the inner region of Photo 24. Showing that the precipitates in a complete form are distributed in groups at random. $\times 7,000$

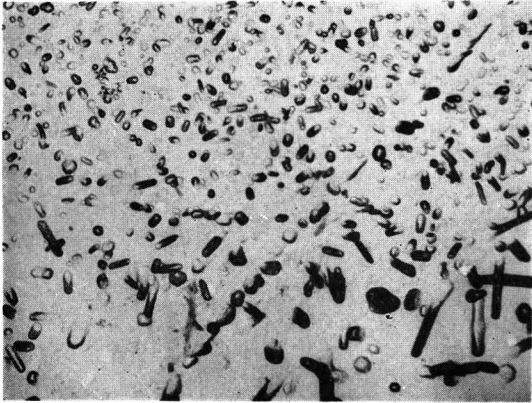
Photo 29 Electron micrograph of the same alloy. Showing the subboundary across the junction of the intermediate and inner regions in cored structure. $\times 7,000$

It has already been noted that the preferential precipitation during ageing takes place as a network structure in relation with crystal imperfections along the polygonization boundaries which are produced by annealing. Another kind of sub-division was reported to have been observed in cast alloys.¹⁴⁾ In the present investigation, such a sub-boundary was also observed in the both cast alloys. The electron micrographs of the sub-boundaries in the cast Al-Zn-Mg alloy are shown in Photos 29 and 30. In the sub-boundary through the junction of the outer and the intermediate zone of the cored structure as shown in Photo 29, the aspects of the precipitates are similar to those at the sub-boundaries discussed previously, though the precipitates are different in size according to the variation in concentration. Photo 30 shows the sub-boundary in the inner region of a grain. It is also noted that the precipitates in this region do not show any marked growth.

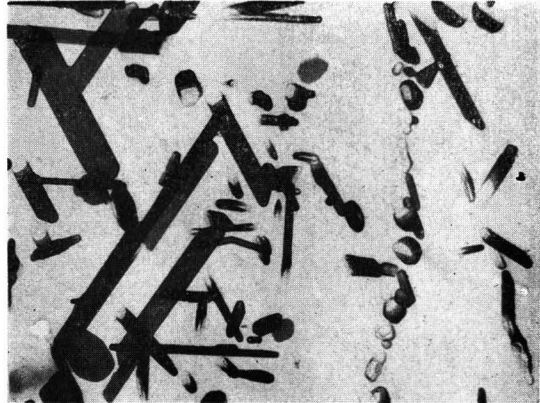
Photo 30 Electron micrograph of the same alloy. Showing the sub-boundary in the inner region. $\times 7,000$

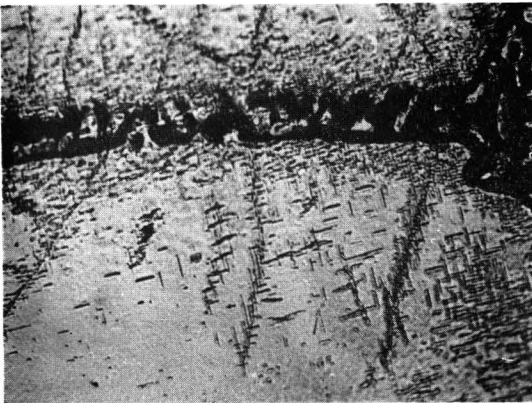
Photo 31 Optical micrograph of the alloy containing 4.03% Cu, aged at 240°C. for 5 hrs. Showing a micro-segregation within grains and a sub-boundary structure. $\times 1,000$

Photo 31 shows the sub-boundary structure in the core of a cast aluminium alloy containing 4.03% copper, quenched in ice water immediately after the end of solidification, then tempered for 5 hrs. at 240°C . In this optical micrograph, it is evident that the micro-segregation within a grain exists similarly as in the cast aluminium alloy containing 10% MgZn₂. Photo 32 is an electron micrograph showing the grain boundary and the outer zone of the cored structure. The sub-boundaries in the inner region of the core are shown in Photo 33.

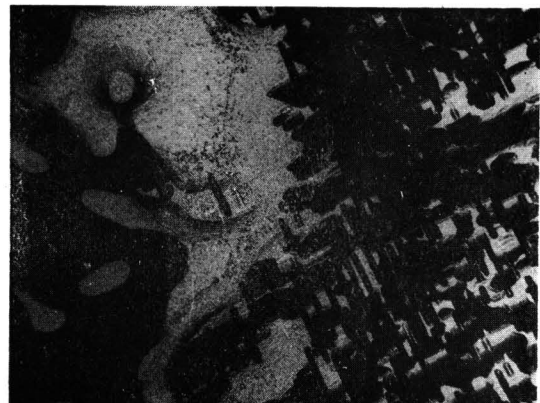
Photo 32 Electron micrograph of the same alloy. The field corresponding to that near the grain boundary of Photo 31. $\times 7,000$

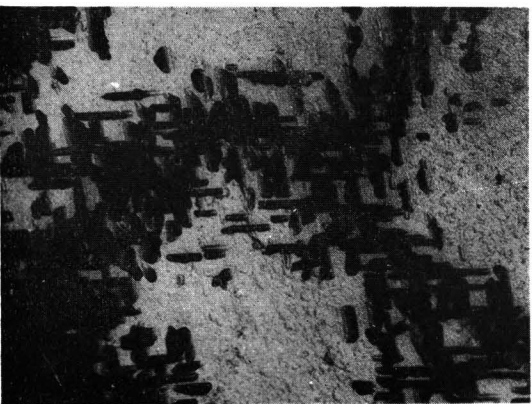
Photo 33 Electron micrograph of the same alloy. The field corresponding to the sub-boundary in the inner region of the core of Photo 31. $\times 7,000$

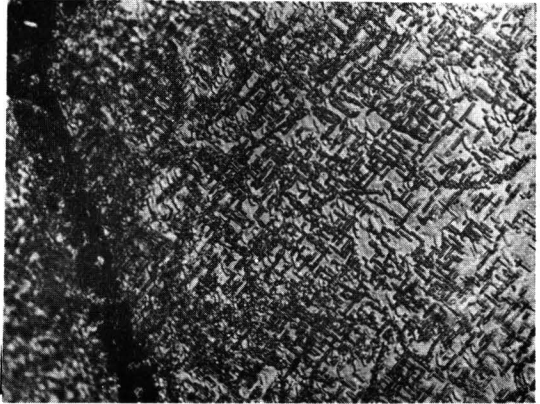
Photo 34 Optical micrograph of the alloy similar to that of Photo 31, annealed at 500°C. for 2 days, and quenched from this temperature, and then tempered similarly. Showing that the subboundaries in the cast structure have a tendency to disappear gradually. $\times 1,000$

These sub-boundary structures in the cast state show a tendency to disappear gradually on annealing. For example, Photo 34 is an optical micrograph obtained from the same specimen after annealing for 2 days at 500°C . and tempered similarly. In comparison with the nature of dynamic movability of the sub-boundaries caused by polygonization, sub-boundaries observed in the cast alloy
