# Discharge Phenomena of the Insulator Assembly and Occurrence of Critical Cascading Flashover Phenomena

KOUNO, Toshihiko ...[et al]. Discharge Phenomena of the Insulator Assembly and Occurrence of Critical Cascading Flashover Phenomena. *Memoirs of the Faculty of Engineering, Kyoto University* 1983, 45(3): 69-78

This paper describes conditions for an occurrence of cascading flashover phenomena on the insulator assembly with the use of a high voltage transmission line by experiments in a laboratory room. The 154 kV suspension insulator assembly is employed as testing apparatus which consists of a chain of 9 standard suspension insulators equipped with an arcing horn. In the experiments, the apparatus is separated into two parts consisting of a bare insulator chain and a pair of arcing horns. The lightning impulse with positive polarity or negative are applied to the test pieces, and the over-voltage is used in those tests. Thus, the creeping flashover occurred with short lag time. The  $V-t$  curves and the 50% cascading flashover voltage were obtained and the pre-breakdown phenomena were observed from the tests, then, it is concluded that the critical cascading flashovers occur

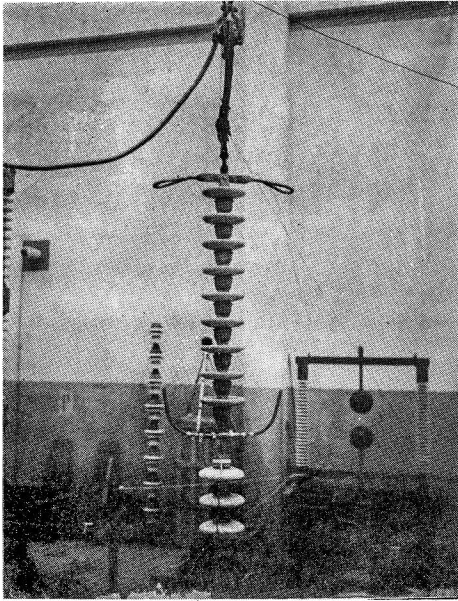
Fig. 1. The Testing Suspension Insulator Assembly for Transmission Line (It is reversed hanging)

An insulator assembly equipped with the 250 mm suspension insulators, the arcing horn and the suspending metal fittings which are used for high voltage transmission lines are shown in Figs. 1 and 2. The number of the suspension insulators is calculated from an estimated maximum density of salt deposit on the surface of the porcelain, and from the class of the transmission voltage.<sup>2)</sup>

For our experiments, the 154 kV suspension insulator assembly is employed as the test apparatus, which is shown in Figs. 1 and 2.

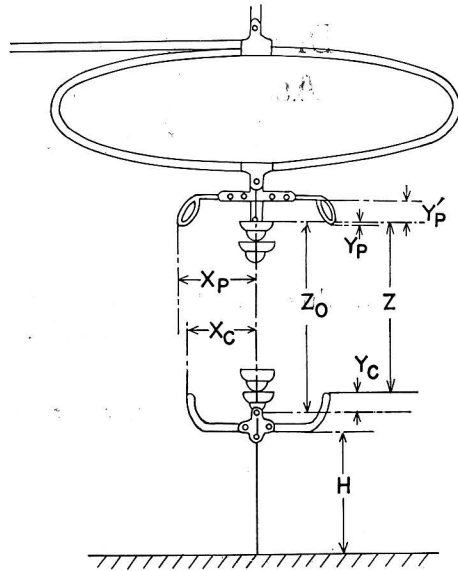
Fig. 2. The Testing Insulator Assembly and the Horn Arrangement

This insulator assembly consists of a chain of 9 standard suspension insulators equipped with an arcing horn. The dimensions of the arcing horn are shown in Fig. 2 and Table 1. In this breakdown test, the insulator assembly is hung in an opposite direction from the ordinary setting by reason of the limited height of the ceiling and the arrangement of the measuring instruments. Also this insulator assembly is located far from other various conductive substances and the floor which distort the electric

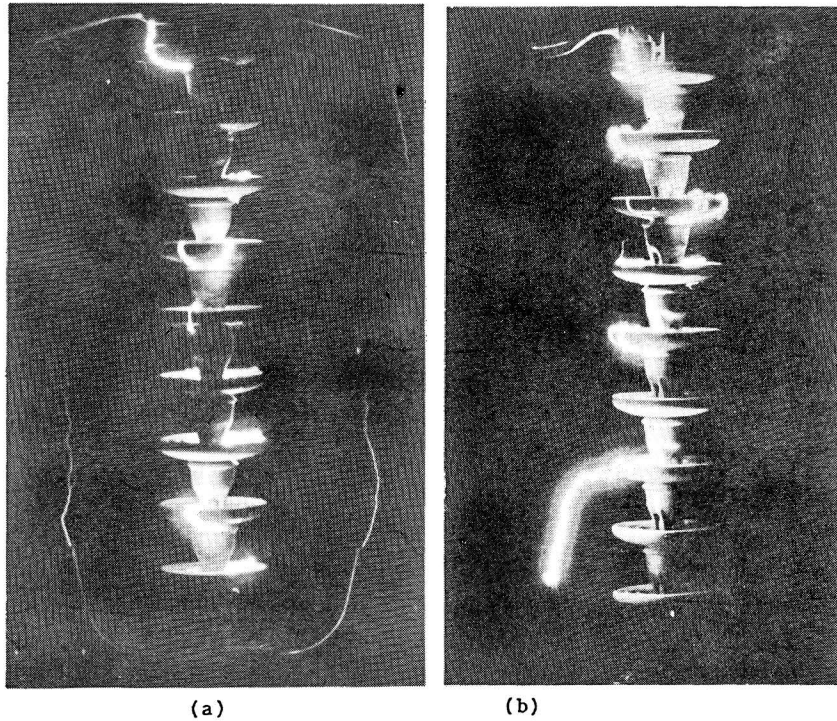
Fig. 3. The Creepage Flashover Phenomena  
 (a) Positive Applied Voltage  
 (b) Negative Applied Voltage

The phenomenon of the critical cascading flashover is shown in Fig. 3. The

photograph as shown in the figure was taken under the conditions that the applied voltage was positive 1200 kV, about 1.8 times as much as  $V_{50}$  of the insulator assembly and the breakdown time was  $T_b = 0.8 \mu\text{sec.}$

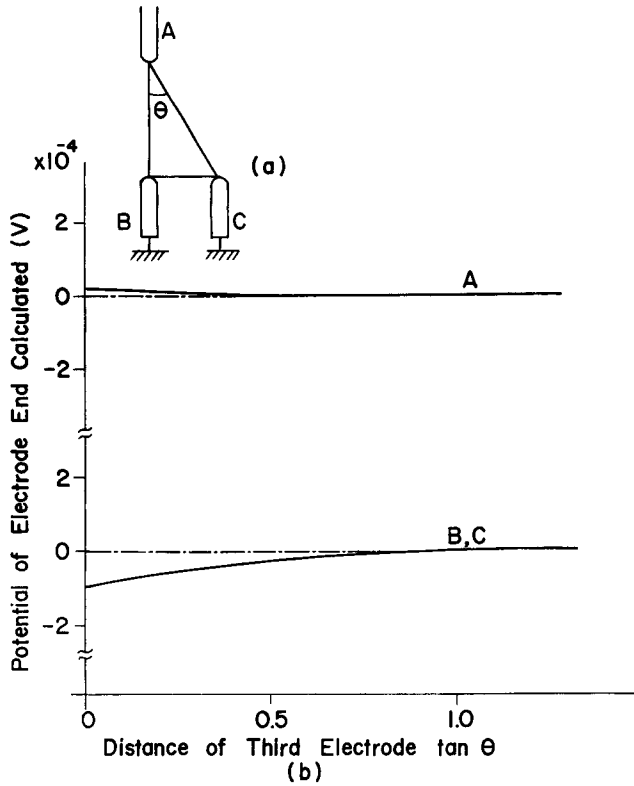
Fig. 4. Potential Correctness of Each Electrodes When Exist Nearby the Third Electrode

field. These separated distances are the twice or more the gap length, as determined by the calculation of the electric field that is investigated in the case of the rod-rod electrodes with the nearby third electrode shown in Fig. 4 (a). From the calculation, the electric field in the gap, in such a case, is distorted to a certain percent, due to the surroundings as shown in Fig. 4 (b).

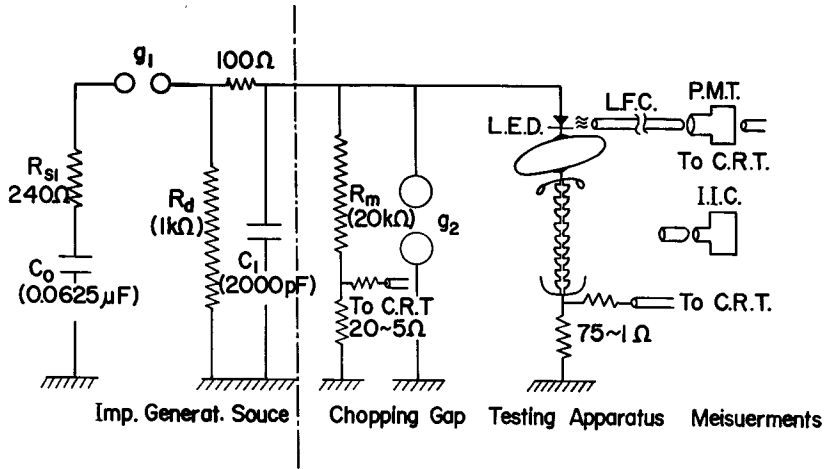
Fig. 5. The Circuit in Use of the Experiment

The electrical circuit and measuring instruments are shown in Fig. 5. The wave form of applied voltage is  $\pm(0.6 \times 40 \mu \text{ sec.})$ . The circuit contains chopping gap

consisting of a pair of spheres. By the adjusting gap length, the chopping time can be varied, and the pre-breakdown corona at each stage can be observed by means of a camera with an image intensifier tube combined with a chopped wave voltage. Against the following three types of testing apparatus consisting of an arcing horn pair and a chain of the standard suspension insulators, a fifty percent breakdown voltage by the up-down method and the voltage-time ( $V-t$ ) curve were obtained for the impulse voltage. The types of electrodes tested here are as follows;

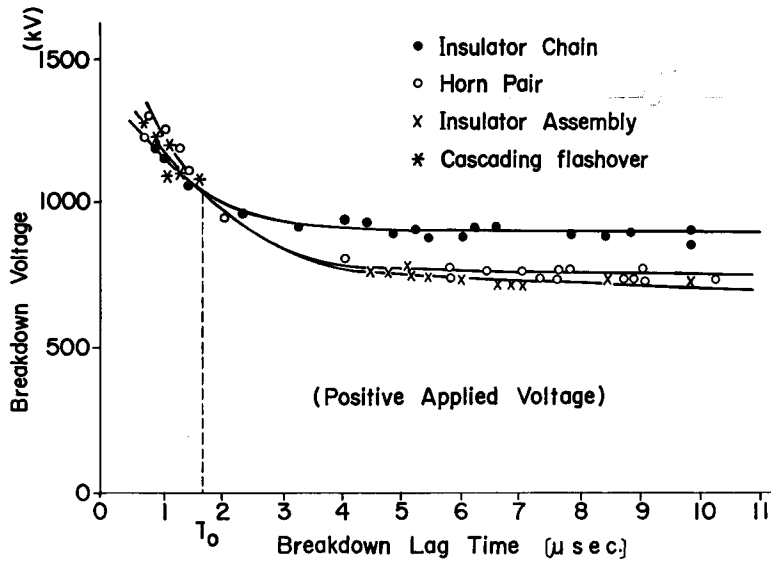
Fig. 6.  $V-t$  Characteristics of Various Conditions of Insulator Assembly

The results of a breakdown test on a normal insulator assembly of 9 standard suspension insulators with the arcing horn are shown in Table 2 and Figs. 6 and 7 against positive and negative impulse voltages respectively. In those figures, it is deduced that if the breakdown voltage

are shown in Fig. 6 for the positive polarity and in Fig. 7 for the negative respectively.

In both figures, where the breakdown time is longer than  $1.8 \mu \text{ sec.}$ , the  $V-t$  curve for type 1) is lowest, one for type 3) is middle, and the breakdown voltage for type 2) is highest. It is considered that such a relation of three  $V-t$  curves comes from the reason why the length of the insulator chain (1330 mm) is longer than the length of the arcing horn gap (1130mm). The difference of these distances is just the depth of the overlapping arcing horn (200mm).

In both figures, the breakdown voltages become very high where the breakdown occurs in a shorter time than the crossing point ( $T_o=1.8 \mu \text{ sec.}$ ). In this region, the  $V-t$  curves are located in the order of types 1), 2) and 3), where the order is reversed as compared with the case of the region of longer times than  $T_o$ . In this short time region, the flashover creeps on the surface of the insulator chain, namely, a critical cascading flashover occurs. as indicated by the mark "\*" in Figs. 6 and 7.

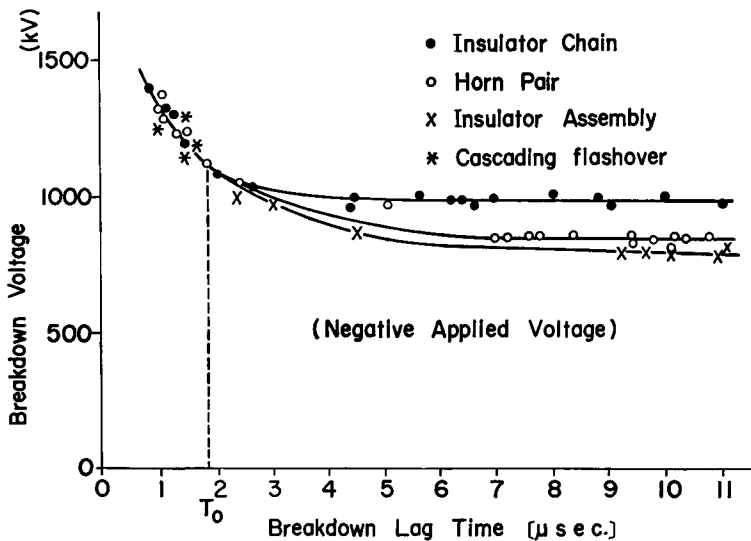
Fig. 7.  $V-t$  Characteristics of Various Conditions of Insulator Assembly

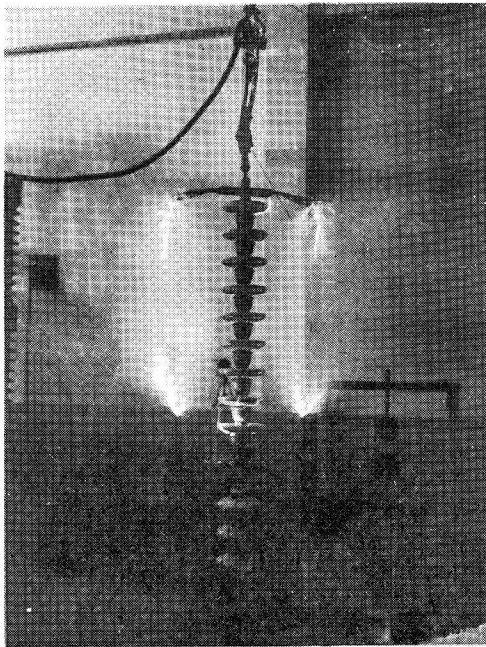
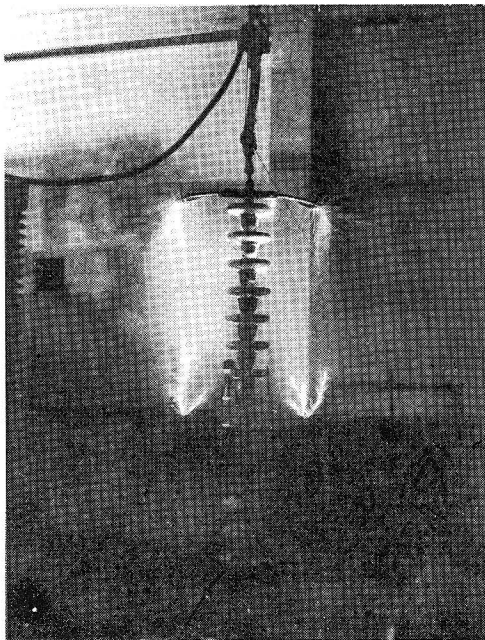
Fig. 8. The Pre-Breakdown Phenomena of the Creeping Flashover (Chopping Time ;  $2.5 \mu$  sec.)

(a) Positive Applied Voltage

(b) Negative Applied Voltage

Furthermore, a pre-breakdown corona was observed before an ordinary flashover by means of the chopping voltage method. Unfortunately, in these experiments, the propagating streamer couldn't be observed in the case of critical cascading breakdown phenomena, because, the breakdown time lag was very short and it couldn't be chopped. A picture under the conditions of negative voltage application and a chopping time of  $T_c = 1.5 \mu\text{sec.}$  is shown in Fig. 8. In the figure, many corona growing on the whole surface, and a growing leader stage corona from the sharp horn tip on the earth side can be seen. It is especially remarkable that surface corona begin to grow on the surface of the insulator at the negative high voltage side.

These phenomena come from the reason why the depth of the overlapping horn was shallow, and the voltage shared by each insulator became larger at the high voltage side. Hence, the surface corona does not start from the positive voltage side on which the corona inception is easy, but not from the negative voltage side. Even if the ordinary breakdown path occurred in the negative voltage side, the arc path would not complete. When the applied voltage is much higher than a critical flashover voltage, the surface corona grows very well, and a critical cascading flashover occurs without fail.
