E-FLOWS FOR THE LIMPOPO RIVER BASIN:

# PRESENT ECOLOGICAL STATE - ECOLOGICAL RESPONSE TO CHANGE

*(Submitted in partial fulfilment of Milestone 6 : Wet Season Field Survey Report)*

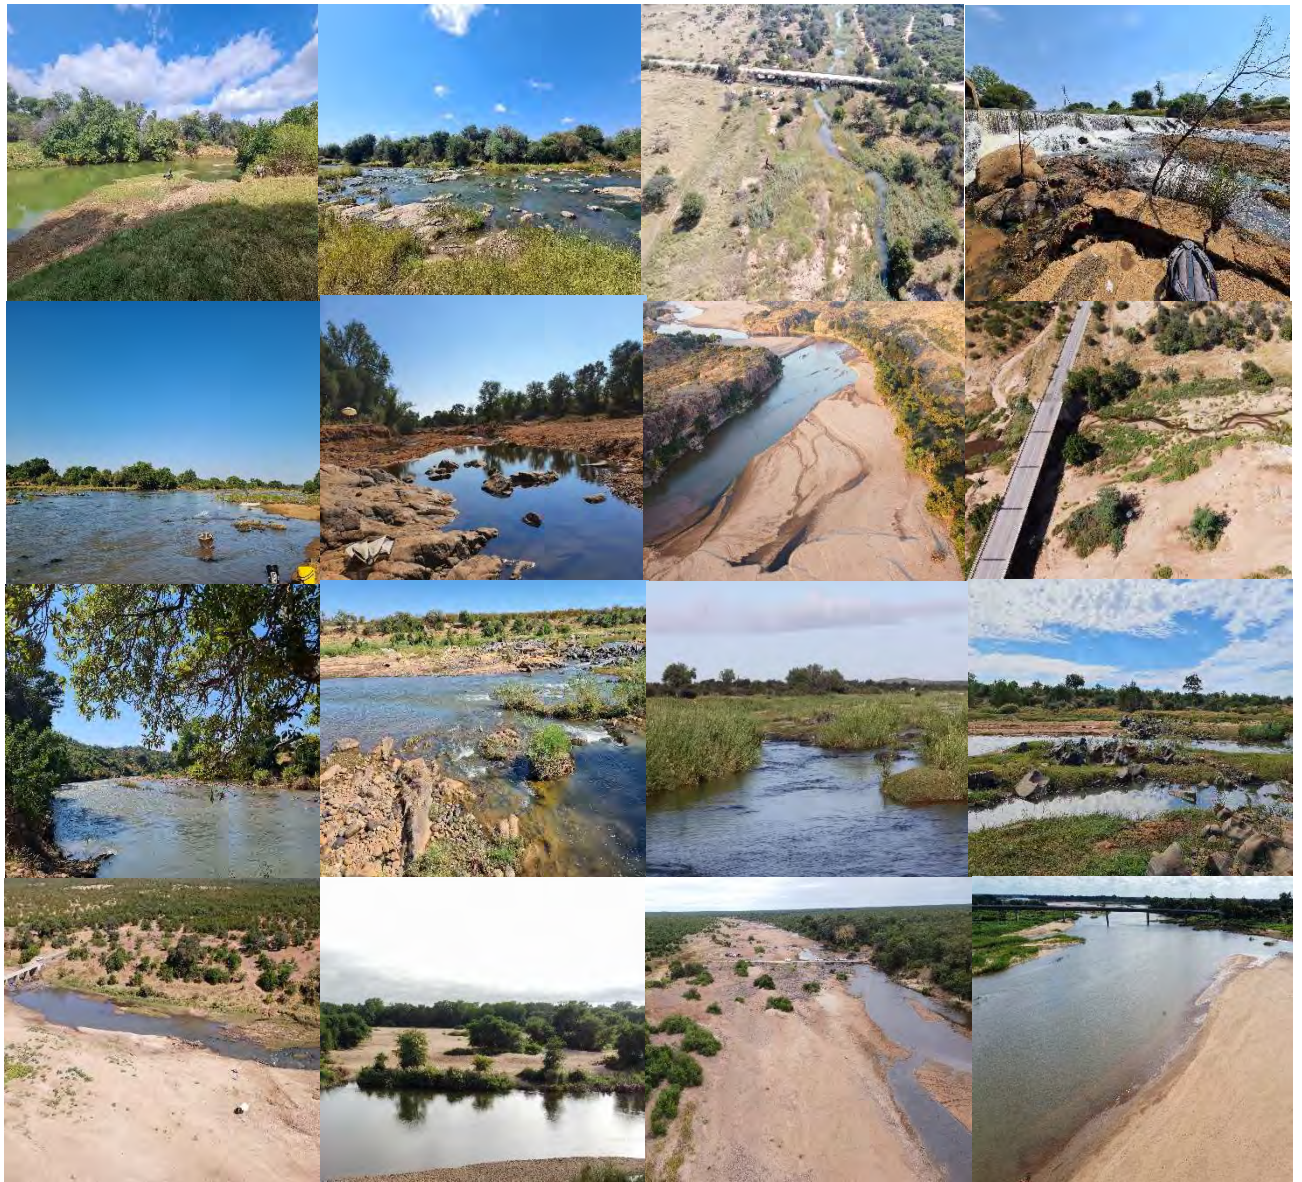
**FIGURE 3.1: PHOTOS OF THE DIFFERENT SITES THE ORDER FROM TOP LEFT CORNER IS CROC-A24J-ROOIK, LIMP-A41D-SPANW, MATL-A41D-WDRAAI, LEPH-A50H-SEEKO, LIMP-A36C-LIMPK, MOGA-A36D-LIMPK, LIMP-A71-MAPUN, SAND-A71K-R508B, LUVU-A91K-OUTP, OLIF-B73C-MAMBA, OLIF-B73H-BALUL, GLET-B81J-LRANC, LETA-B83A-LONEB, ELE-730C-SINGU, SHIN-B90H-POACH, LIMP-Y30F-CHOKWE.**

Eighteen sites were selected in the Limpopo River Basin ([FIGURE 3.1](#)). The sites were selected based on historical data available (EWR studies conducted at the site previously), sites on the tributaries and the Limpopo River main stem, sites in Botswana, Mozambique and Zimbabwe, and to include sampling in protected areas (Kruger National Park, Mapungubwe National Park, Greater Limpopo Trans frontier Park). Each site was divided into different efforts based on the habitat and velocity depth classes ([TABLE 3.1](#)) as proposed by Kleynhans et al. (2007).

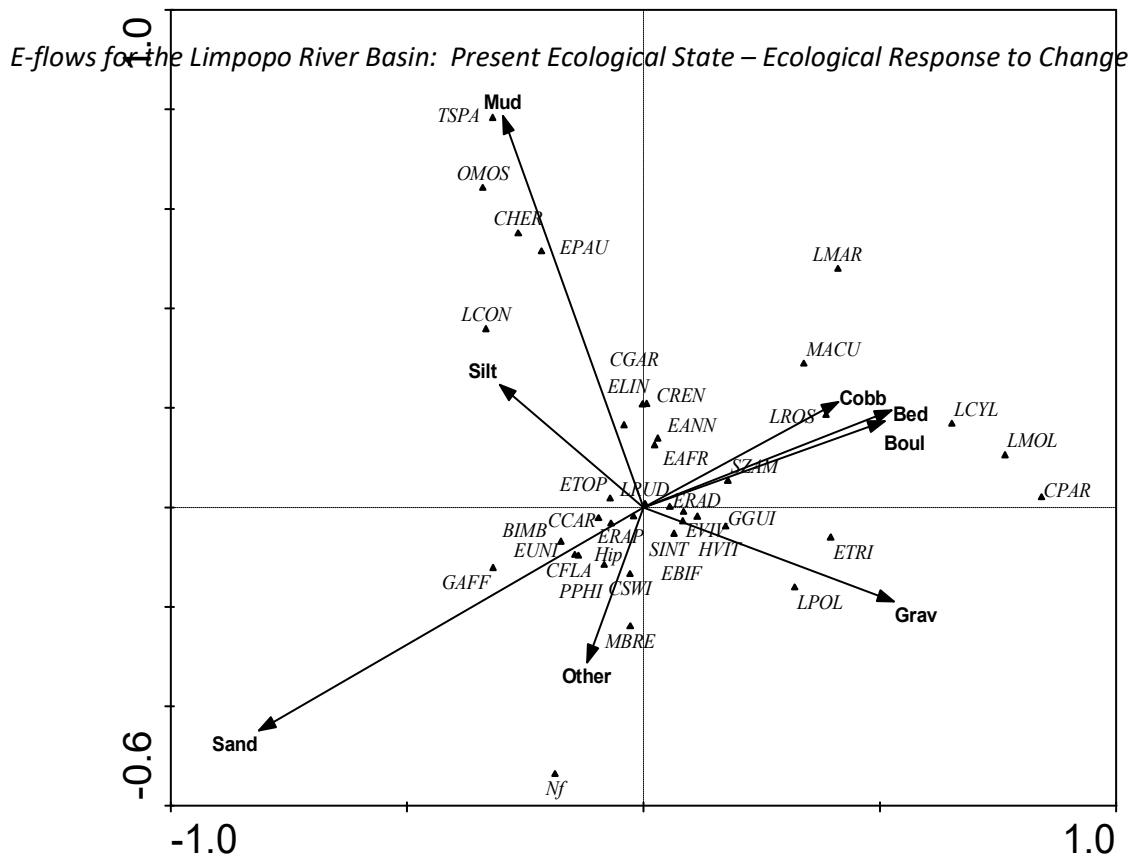
**FIGURE 3.5: REDUNDANCY ANALYSES PLOTS SHOWING DISSIMILARITY BASED ON THE FISH COMMUNITIES AMONG SITES CONSIDERED IN THE STUDY, WITH DIFFERENT SUBSTRATES (ARROWS) AS ENVIRONMENTAL VARIABLES SUPERIMPOSED. THE TRI-PLOT DESCRIBES 76.3% OF THE VARIATION IN THE DATA WHERE 51.6% IS DISPLAYED ON THE FIRST AXIS (X) AND AN ADDITIONAL 24.4% ON THE SECOND AXIS (Y).**

There was a significant difference between the fish community structure in relation to their preferences for different substrate types (Figure 106). The different substrate types explained 76.3% of the variation seen in the fish community structure. Of all the substrate types, sand accounted for the greatest variation in fish community structure (RDA test;  $F = 5.91$ ,  $p = 0.001$ ). *Chiloglanis paratus*, *Labeo molybdinus*, *Labeo cylindricus* and *Labeobarbus marequensis* were closely associated with cobbles, boulders and bedrock. *Tilapia sparrmanii*, *Oreochromis mossambicus*, *Enteromius paludinosus* and *Carnax herberi* were associated with mud. *Enteromius trimaculatus* were associated with gravel.

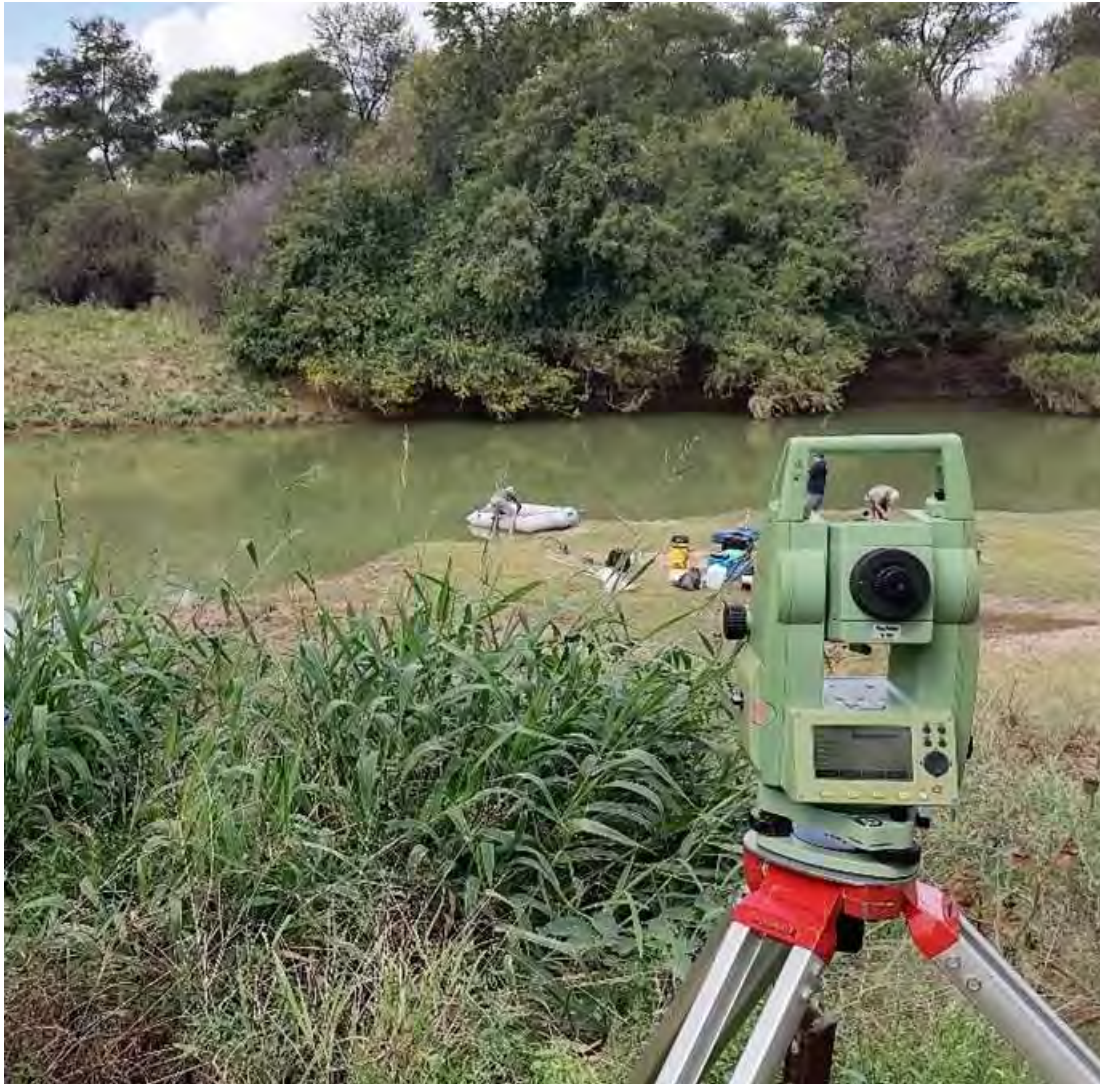
**FIGURE 5.1. SURVEY SETUP - LEICA TCR403 POWER TOTAL STATION ON TRIPOD.**

large boulders, bedrock or infrastructure. The purpose of the benchmarks was to allow for the linking of future cross-section profiles to this study. In some cases, sites had been previously surveyed, therefore existing benchmarks were utilized in order to link historical cross-section data to transects surveyed during this study.

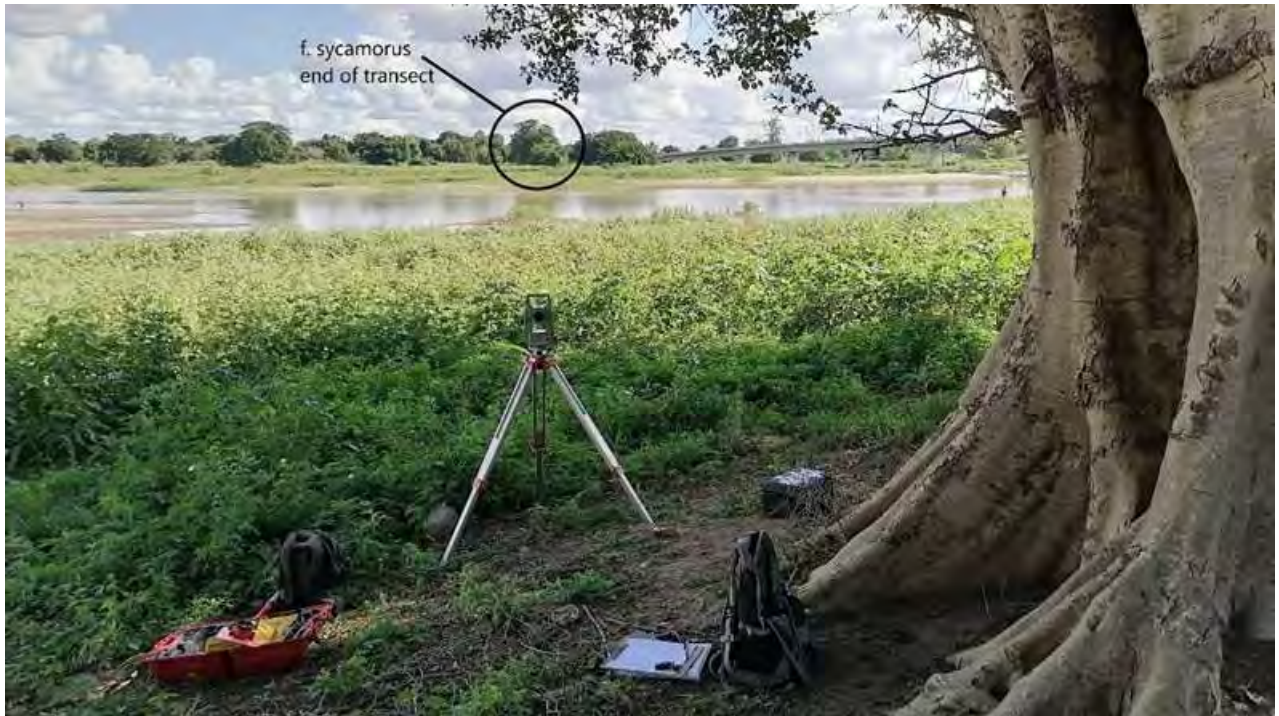
**FIGURE 5.2. LIMPOPO RIVER, CHOKWE IN MOZAMBIQUE. THE TOTAL STATION WAS POSITIONED ON-LINE WITH THE BASE OF THE LARGE FICUS SYCOMORUS INDICATED IN THE PHOTOGRAPH ABOVE AS THE END OF THE TRANSECT.**

Several of the sites surveyed during this study were also surveyed in a study that took place in 2012. Some of these sites therefore had existing benchmarks that were utilized in order to link current data to the previously recorded profiles. These data was very useful as it allowed us to identify changes that took place over the nine-year period. Chokwe on the Limpopo River, Mozambique is an example of this ([Figure 5.2](#)). One such benchmark was recorded with current data, the benchmark in the form of a corner wall ([Figure 5.3](#)). With the use of previously recorded GPS coordinates, photographs and descriptions, we were able to identify the exact locations of the start and end of the previously recorded transect as seen in [Figure 5.2](#) below.

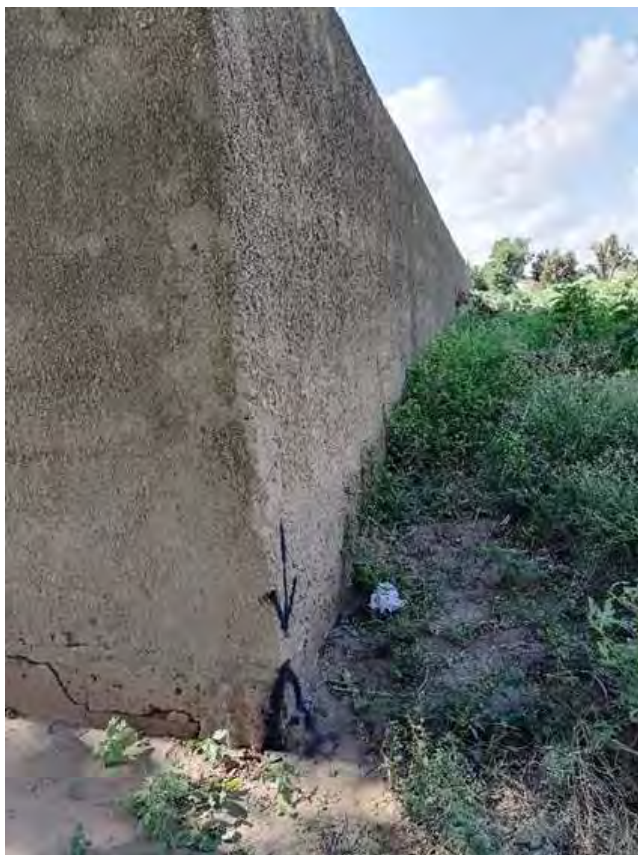
**FIGURE 5.3. PREVIOUS BENCHMARK SURVEYED INTO CROSS-SECTION TRANSECT IN ORDER TO LINK 2012 DATA TO DATA COLLECTED DURING THIS SURVEY.**

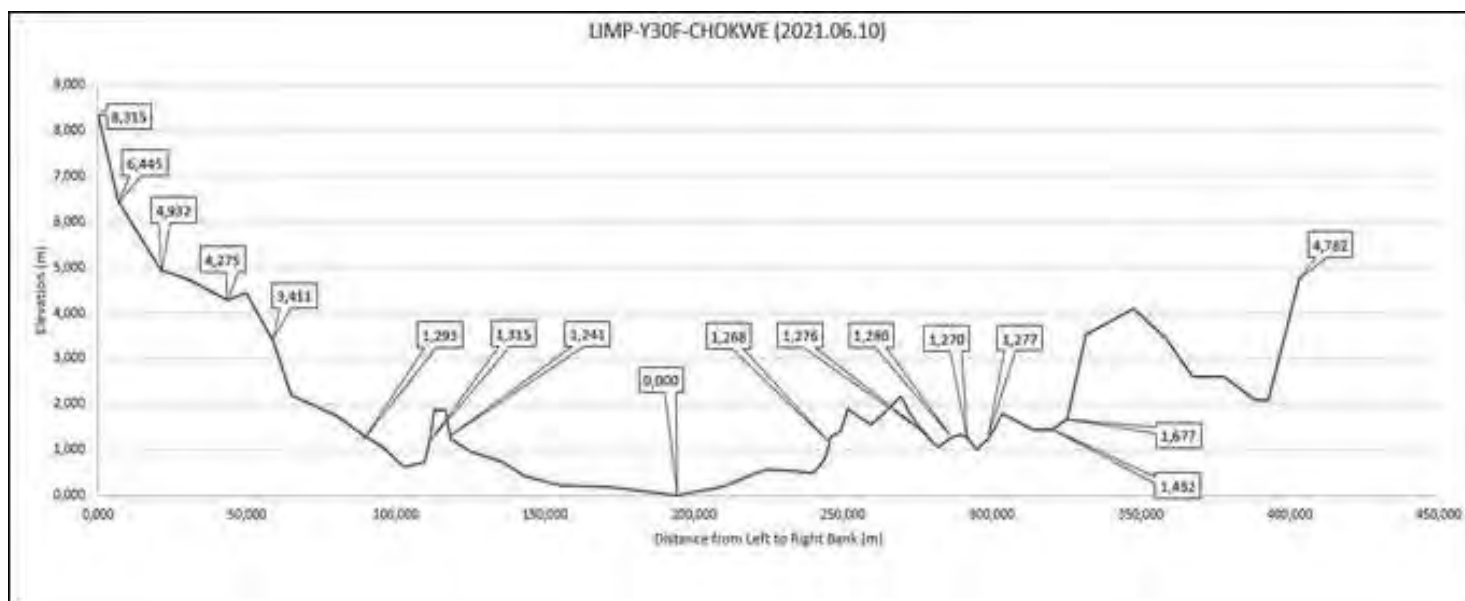
**FIGURE 5.4. CROSS-SECTION PROFILE RECORDED ON 10 JULY 2021 AT CHOKWE ON THE LIMPOPO RIVER IN MOZAMBIQUE.**

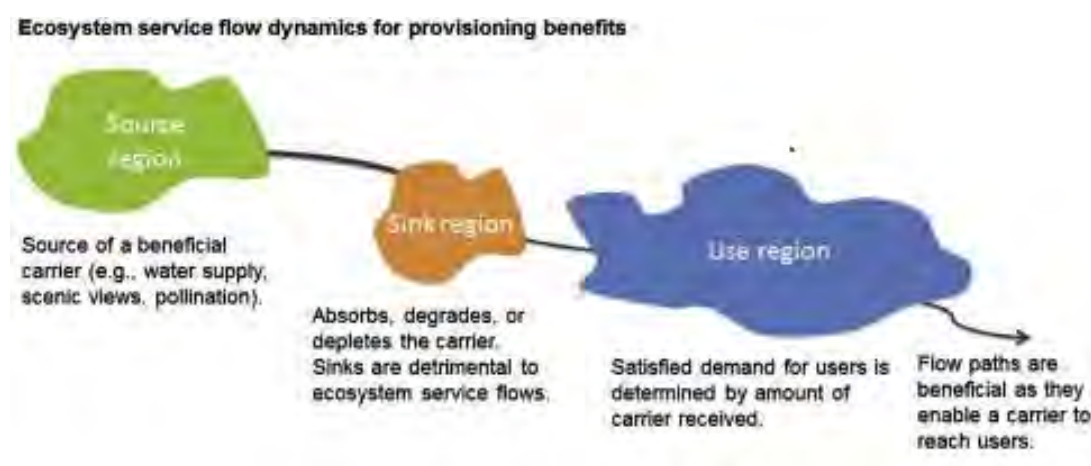
**FIGURE 6.1 SIMPLE ILLUSTRATION OF HOW PROVISIONING SERVICE FLOWS IN THE BASIN CATCHMENT (BAGSTAD ET AL., 2013)**

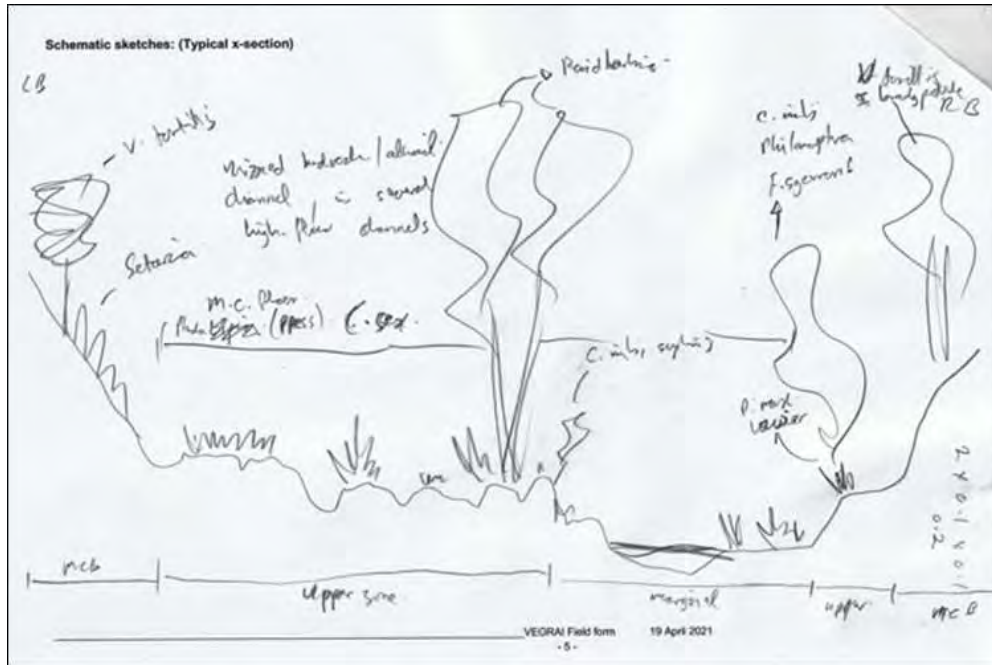
Schematic profile drawn in the field to show where vegetation components occur.

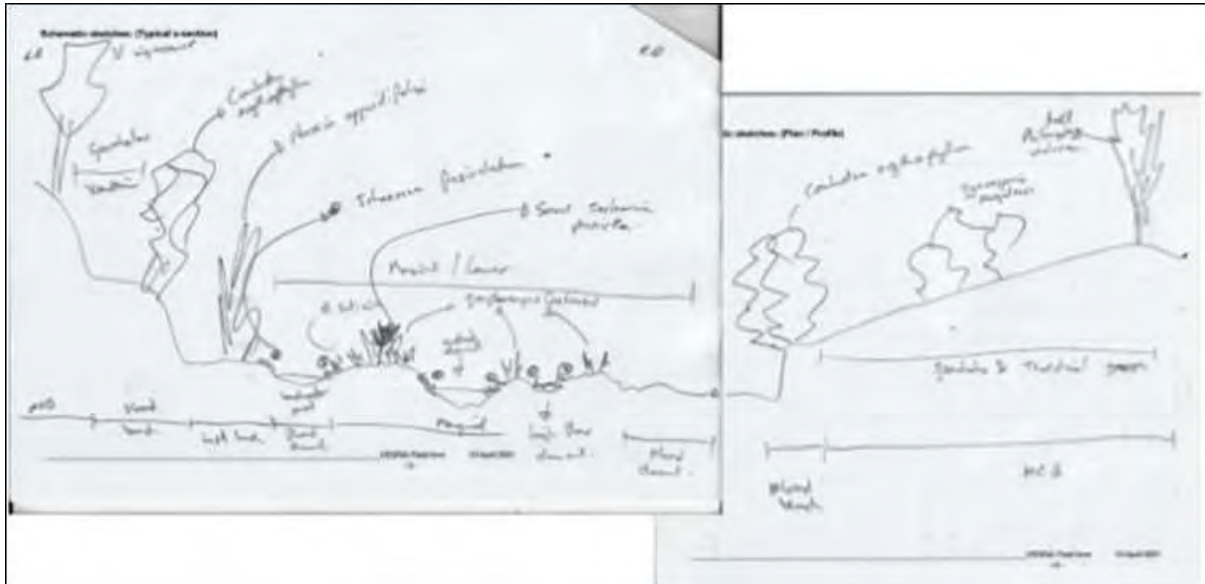
Schematic profile drawn in the field to show where vegetation components occur.
