VIRTUAL INSPECTION BASED ON 3D SURVEY SUPPORTING RISKS DETACHMENT ANALYSIS IN PIETRAFORTE STONE BUILT HERITAGE

KEY WORDS: Photogrammetry, GIS, Planned conservation, Built Heritage Management, Stone deterioration

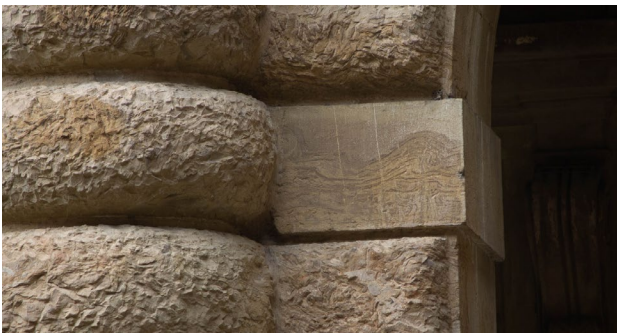
Figure 1. Detail of the convoluted lamination on the impost ashlar of the Doric order arch (August 2020).

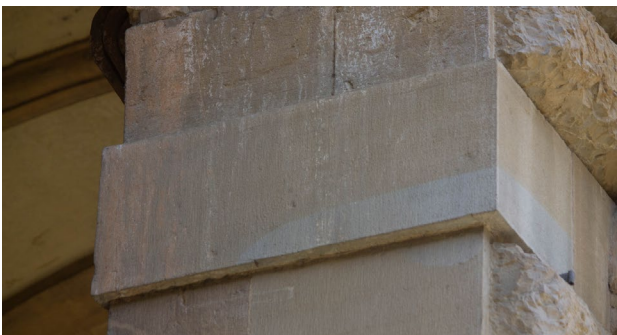
Figure 2. Detail of the impost ashlar of the Doric order arch showing the original colouring (May 2021).

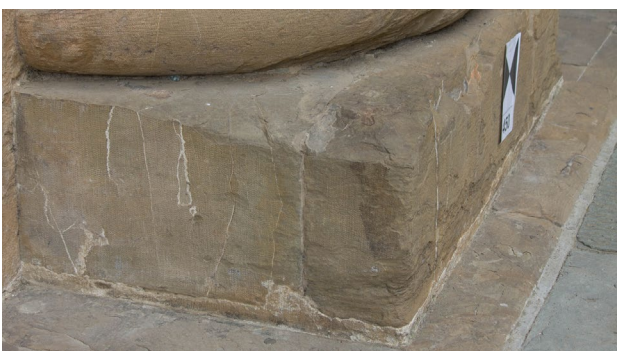
Figure 3. Detail of the calcite veins on the base of the Doric Order half column (May 2021).

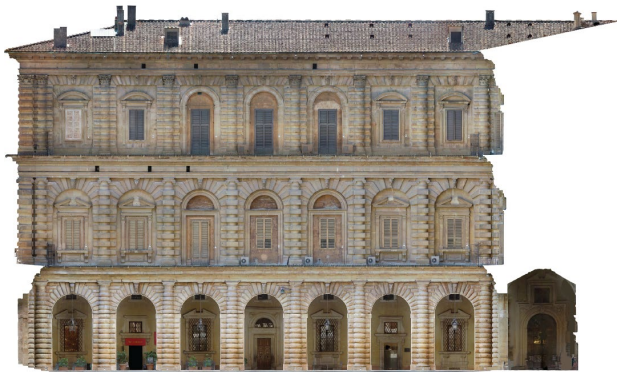
Figure 5. Ortho-mosaic.

High-resolution ortho-mosaic: It allows an overall view of the façade and easy zooming in on the area of interest, with the obvious limitation of viewing it in an orthogonal view, that sometimes compromises the interpretation of undercuts (Figure 5). On the ortho-mosaic it is, in fact, relatively easy to identify ashlar, while it is more complex to delineate stone blocks: often, an architectural element does not consist of a single block, or in turn, a block may encompass more than one architectural element. Moreover, the ashlar drafted-margin tapes are thin and sometimes in different positions (some on the upper part of the ashlar, others on the lower).

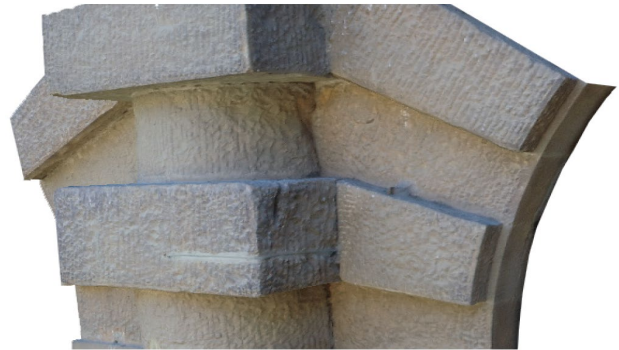
Figure 7. High-resolution textured 3D model of a detail: in addition to the stonework traces, connections between blocks, cracks, and metal elements are also visible.

Given the extent of the façade, however, using one texture at the highest resolution for the entire model is not sustainable: textures may be loaded progressively, but dynamically loading and transferring this large amount of data into GPU memory results in loading delays and poor performance. So far, multi-LOD management systems (Lefebvre et al. 2004), now widely used in real-time engines (Akenine-Moller et al. 2019), still need to be addressed. Currently, models of small portions, textured with millimetre resolution, have been developed in addition to the model of the entire façade (Figure 7).

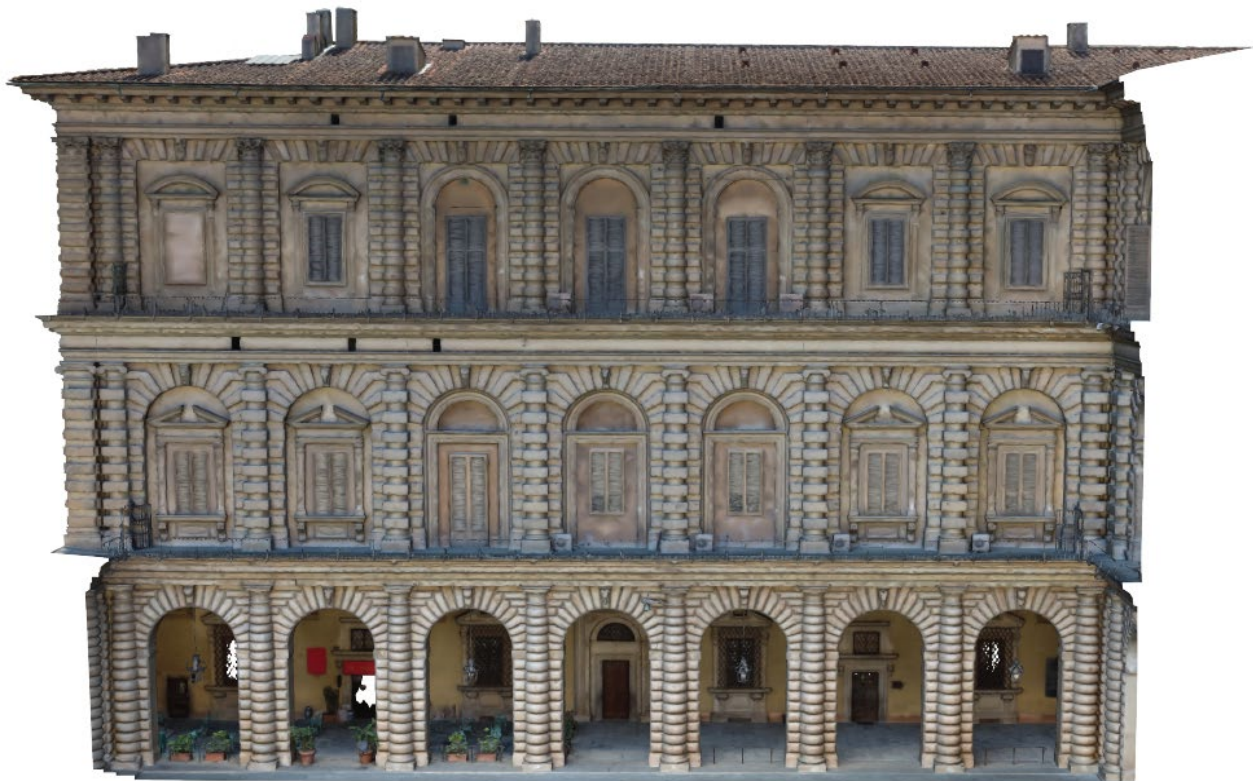
Figure 6. 3D model of the pilot facade.

Textured 3D model: The level of detail of a 3D model depends on two complementary aspects: the geometry (polygons count) and the texture resolution. Regarding the first aspect, the model resulting from the digitization of the façade makes it possible to accurately size the ashlars and assess their overhangs and the lack of any portions. Adding a high-resolution texture makes it possible to observe stone features that are significant for this project but not documented by the mesh, such as calcite veins or laminations (Figure 6).

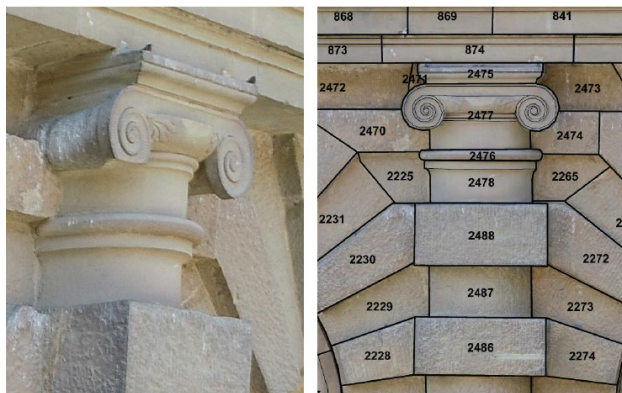
Figure 9. The capital consists of three different blocks (detail of the ortho-mosaic with identification of the blocks 2475, 2476, 2477).

In fact, there is not always correspondence between the architectural decoration, arranged in three superimposed orders characterized by ashlar of different shapes and surface finishing, and the structure of the façade. In many cases, a single architectural element is made of different stone ashlar; in others, the same block is carved to represent different architectural elements (Figure 9). The individual ashlar were then manually drawn by polygons thanks to a careful observation of both orthophotos and raw photos - particularly the converging ones helped identify less apparent discontinuities.

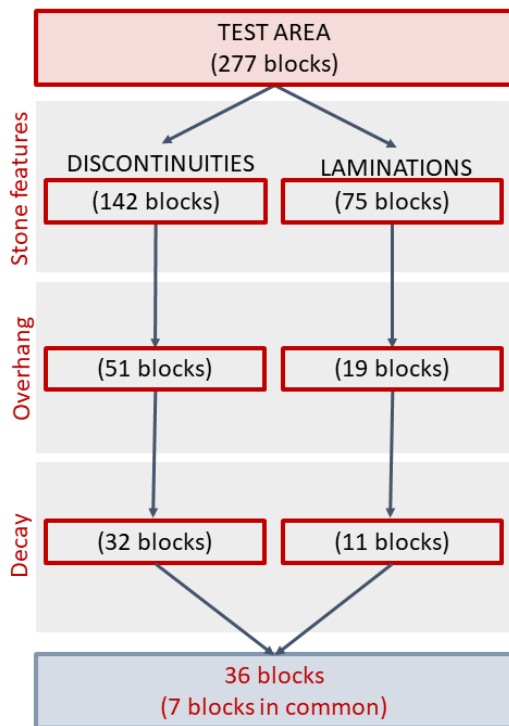
Figure 10. Virtual inspection workflow.

The virtual inspection was conducted considering the orthophoto, the 3D model, and the oriented images. In this case, a non-specialized operator did the inspection after brief training, which allowed her to recognize and map the presence of discontinuities and laminations; the overhang of ashlars and the co-presence of degradation forms were then assessed (Figure 10).
