Damage to a monumental organ due to wood deformation caused by church heating

H.L. Schellen, A.W.M. van Schijndel, D. Neilen, M.A.P. van Aarle

ABSTRACT: In a PhD study on the heating of monumental churches one of the problems, which was encountered, was the damage to wooden interior parts due to the changing of the indoor climate. Particularly warm air heating frequently leads to sudden changes in relative humidity, which turned out to be dramatically hard for monumental organs during wintertime.

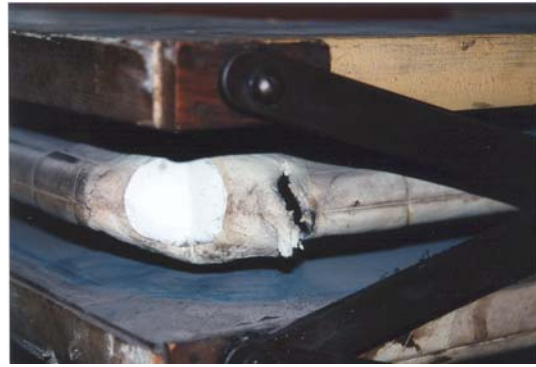
The bellows were severely damaged; severe cracks occurring within the wooden parts of the bellows; their sheepskin parts were torn.

Figure 2. Damage to bellows

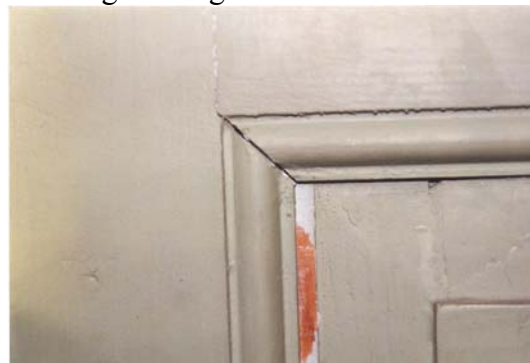
At the wooden cabinet of the organ in the church the following damage has been observed. The joints of the wooden panels in the wooden frames showed shrinkage damage.

Figure 4. One of the panels hanging loose in the frame

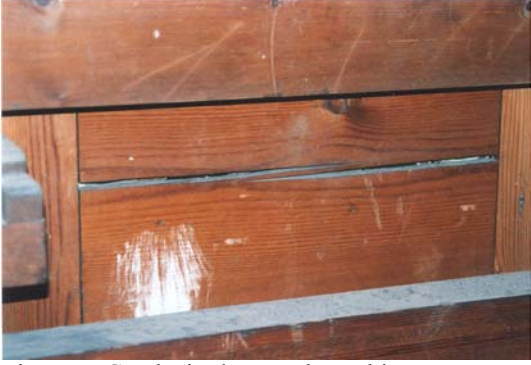
Within the wooden cabinet large cracks occurred and the door of the cabinet was stuck due to warping.

Figure 5. Cracks in the wooden cabinet

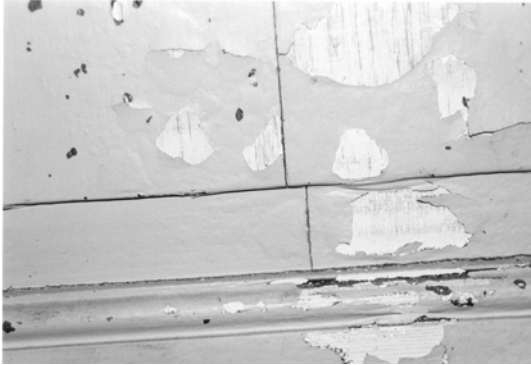
The lacquer of the wooden cabinet flaked off (in different parts).

Figure 6. Flaking off lacquer

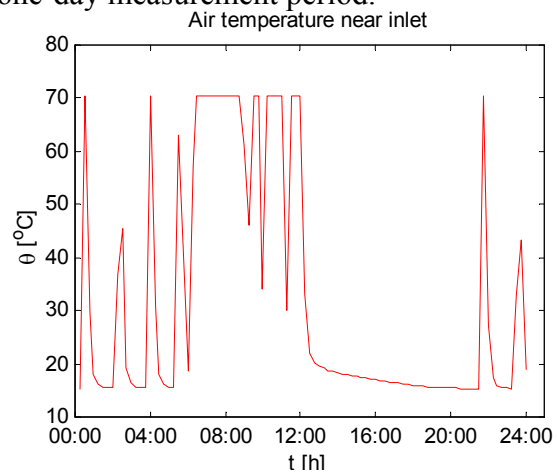
The inlet air conditions were measured at the inlet grille. Inlet air temperature was measured continuously during the long-term measurement period and inlet air velocity measurements took place during the one-day measurement period.

Figure 8. Air temperature at the inlet grille

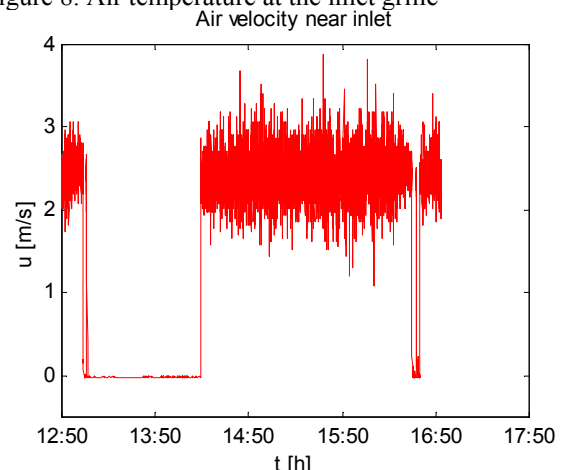
Figure 9. Air velocity at the inlet grille

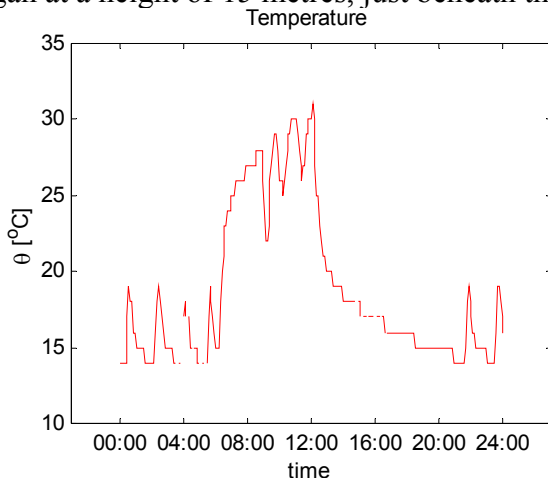
To determine the temperature stratification, the air temperatures and relative humidities were measured at four different height levels in front of the organ. From the data measured a typical period was extracted. Figures 12 and 13 indicate air temperatures and relative humidities measured at four different heights, 15 m being the total height of the church. From the indoor air conditions measured during a year a typical Sunday service (January 17th 2000) was extracted. Figures 10 and 11 indicate air temperatures and relative humidities in front of the organ at a height of 15 metres, just beneath the vault.

Figure 10. Air temperature in front of the organ

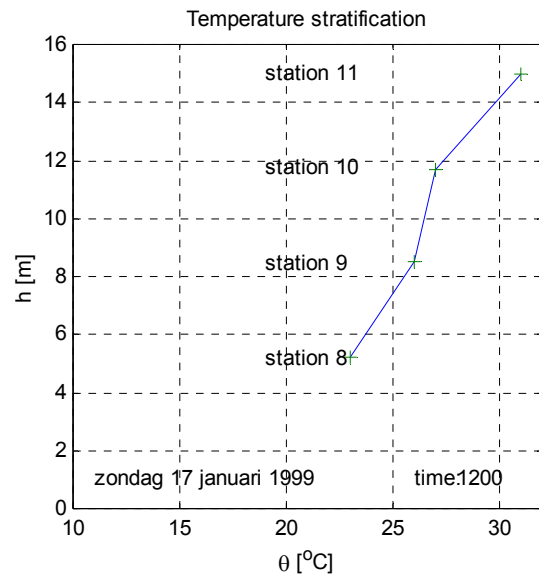
From the data of the temperatures at different heights the temperature stratification can be extracted. Figures 12 and 13 give a typical representation of the temperature and relative humidity stratification.

Figure 12. Typical temperature stratification during a service

The air heating with high air inlet temperatures led to high temperature stratification and thus to very low relative humidity in the upper part of the church. Ventilator devices, hanging at the ceiling of the church and mixing the air below the propellor blade, could not prevent the warm air to stick to the ceiling and move above the propellor blades to the organ.

The actual indoor climate conditions at the monumental organ were compared with recommendations from literature to protect it from deterioration. It was clear that the relative humidity dropped to very threatening low levels of 20 to 25 % RH. This must have had a great impact on the wooden parts and cabinet.

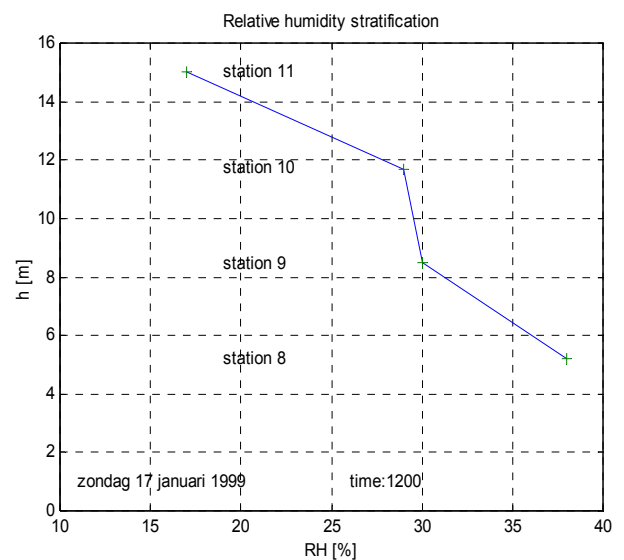
Figure 13. Typical relative humidity stratification during a service

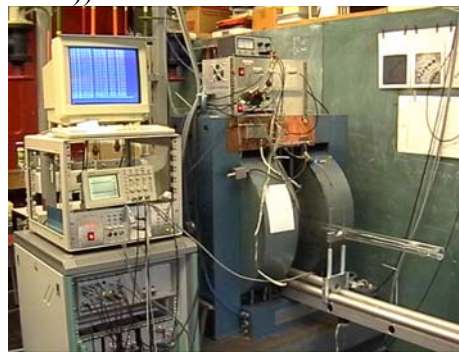
The NMR measurement set-up consists of a cylindrical coil inserted between two magnets. The cylindrical samples can be inserted in the cylindrical coil. In this scanner it is possible to measure quantitatively the moisture profiles with a spatial resolution of 0.5 mm in two dimensions. To enable the exposure of the sample to temperature and humidity conditioned air, one cylindrical wooden sample with a diameter of 25 mm and a length of 200 mm is placed in a cylindrical tube with an inner diameter of 50 mm and a length of 1500 mm. Conditioned air is prepared by mixing dry and moist air. It is brought into the tube at a temperature of 23 °C and is blown along the cylindrical surface of the wooden sample. To smooth the airflow along the cylinder a cylindrical synthetic sample with a pointed front is placed in front of the cylindrical wooden sample. Temperature and relative humidity of the air are measured at the in- and outlet of the perspex tube. The radial and tangential deformation of the wooden beech sample is measured by resistance strain gages, which are connected to clips over the diameter of the cylinder. The typical accuracy of this measurement is in the order of 1 µm. Figure 14 shows the NMR-setup and figure 15 shows the prepared beech wooden sample.

Figure 14. NMR set-up

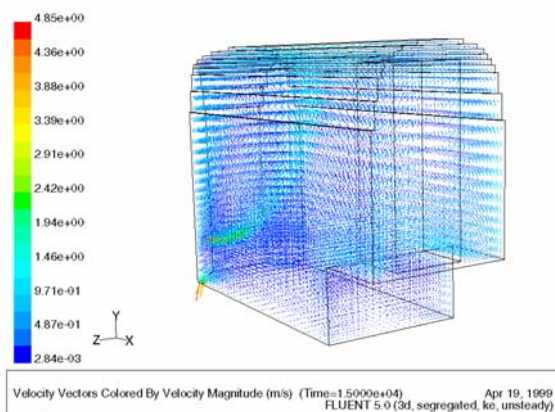
A CFD airflow study using Fluent was carried out to predict the effects of inlet air conditions on the stratification in the church (Loomans 1998). First airflow simulation results were compared with measurements in the actual situation, in order to estimate the accuracy of the CFD simulations. The boundary conditions for the simulation study were extracted from the measured inlet air conditions (inlet air temperatures and velocities as a function of time and turbulence intensity) and wall, floor and ceiling surface temperatures as a function of time. The geometry of the church was simplified to a global 3D model of it. Figure 17 indicates the flow pattern during the heating of the church.

Figure 17. CFD computed velocity vectors

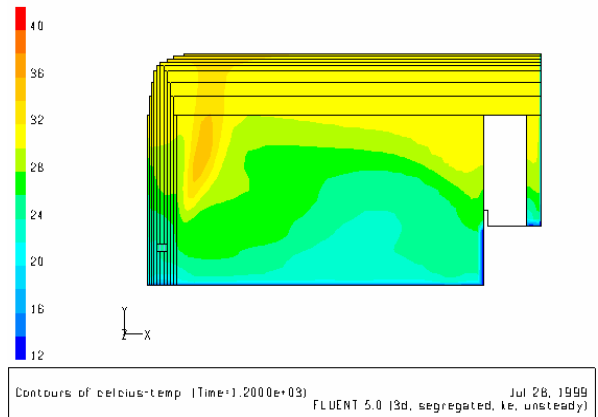
Figure 18. Heating up the church; interval 5', $\theta_{in}=70 \text{ }^\circ\text{C}$, $\theta_i=20 \text{ }^\circ\text{C}$, $u_{in}=2.4 \text{ m/s}$, $Ar=0.29$, $Re=2.4 \cdot 10^5$

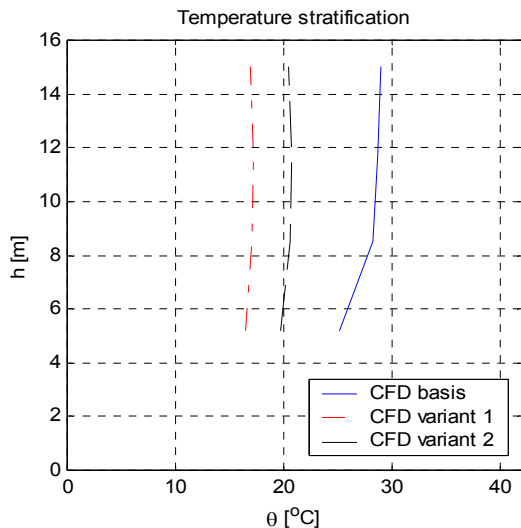
The inlet air conditions have been derived from literature recommendations (Schellen 1998/2): the inlet air temperature was reduced from 70 °C to 40 °C. Two variants have been studied: an air velocity of 2.4 m/s and an according airflow of 4200 m³/s (Ar=0.17) and an air velocity of 4.1 m/s and an according airflow of 6700 m³/s (Ar=0.05). The primary (initial) air temperature was 8 °C.

Figure 21. The expected temperature stratification for the CFD variants: Ar=0.29 (basis 1), Ar=0.17 (variant 1) and Ar=0.05 (variant 2)

Reducing the Archimedes number can reduce the temperature stratification. This can be accomplished by reducing the temperature difference between inlet air and indoor air to e.g. 25 K and to increase the inlet air velocity. The latter is needed to keep up the heating capacity.

A new air heating system was proposed. The new inlet conditions were based on a combination of low inlet air temperatures (up to 40 °C) and high air velocities (up to 4 m/s), leading to an Archimedes number less than 0.05. Afterwards the air stratification proved to be less than 2 K over the total height of the church.

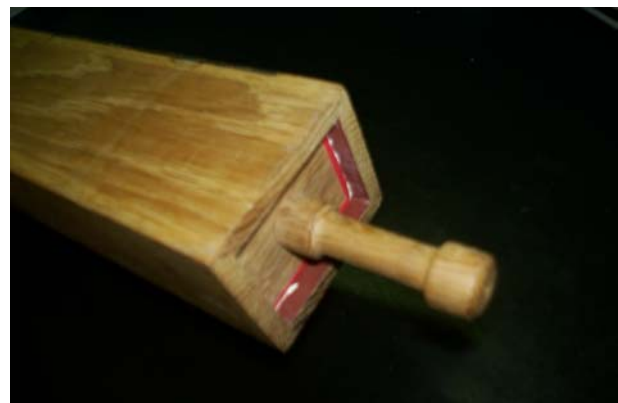
The results of the NMR measurements were used to predict the moisture content in a wooden element. From the results of the strain gauge measurement the free deformation of wood as a function of the measured moisture content was assumed to vary linearly with moisture content (Camuffo, 1998). A linear elastic 2D strain and stresses model was used to reproduce the strains and stresses in a wooden organ pipe and a wooden wind drawer (Lekhnitskii, 1963). A block shape change of a sudden drop in relative humidity was simulated. The drop in RH was simulated from 85 to 25 % RH. The first simulations took place with a wooden organ pipe with cross square dimensions of 100 mm * 100 mm * 5 mm. The cross section was taken at the place of the tuning cap. The wood direction of the tuning cap was assumed to be perpendicular to the wood direction of the pipe. Due to the drop of humidity at the outline of the pipe, the wooden pipe will shrink, which is limited by the tuning cap. Stresses will be the result.

Figure 23. Wooden organ pipe with tuning cap

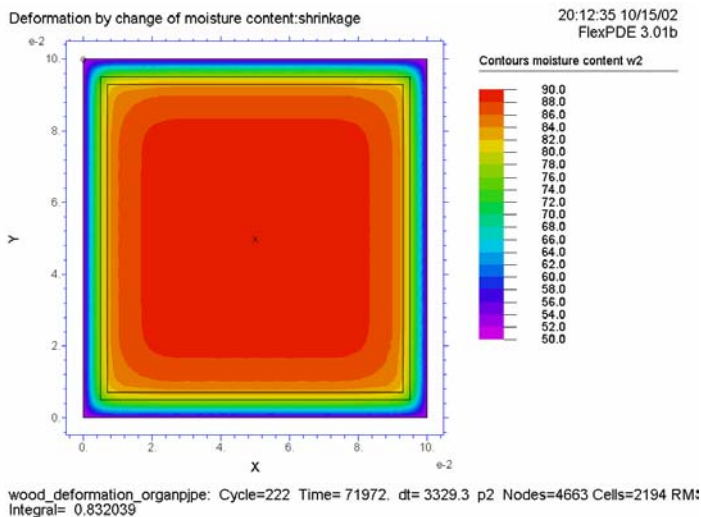
Figure 24 shows the moisture content of the square section, one hour after the drop in RH.

Figure 24. Moisture content in a wooden organ pipe at the cross section of a tuning cap

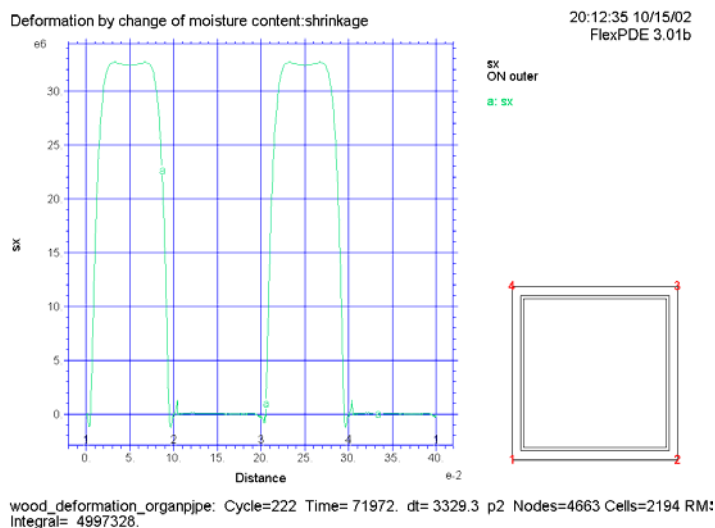
Figure 25 shows the calculated stress σ_x along the outer perimeter of the square section. The order of magnitude is 10^7 N/mm².

Figure 25. Stresses σ_x along the outer perimeter of the square section

When we look at the order of magnitude of the stresses in both simulation studies, $\sigma \approx 10^7$ N/m² (10 N/mm²), and compare these results with the maximum allowed stresses of hard wood parallel to the fibers (ft;0;rep=14 N/mm²), and in the direction perpendicular to the fibers (ft;90;rep = 0.4 N/mm²) cracks will probably occur parallel to the fibers. Therefore cracks in the wooden organ pipes could be explained by changes in relative humidity. In the model, however, no relaxation was involved. In practice the situation might be less critical.
