Assessment matrix for timber structures : basis for standardized building checks

Abels, M. (2011). *Assessment matrix for timber structures : basis for standardized building checks*. [Phd Thesis 2 (Research NOT TU/e / Graduation TU/e), Built Environment]. Technische Universiteit Eindhoven. <https://doi.org/10.6100/IR712624>

Beurteilungsmatrix für Holzkonstruktionen
Grundlage eines standardisierten Gebäudechecks

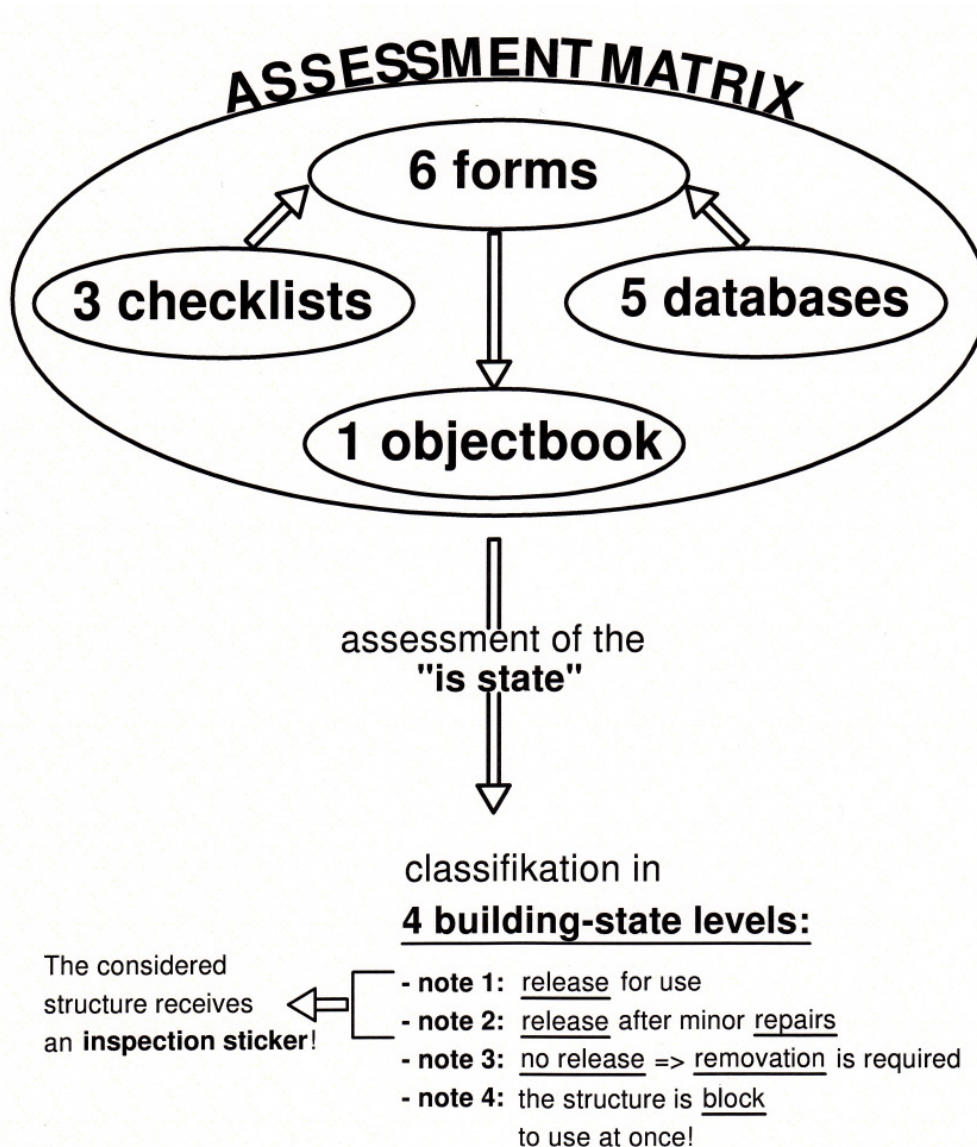
Figure 0.1: Structure of the Assessment Matrix

The described course of procedure is based on the assessment matrix, which will be developed in the 2nd chapter and applied in the 3rd chapter of this work. Among others, the current status of all common construction types, common inspection methods, handling of possible damage and material characteristics knowledge was incorporated into this assessment matrix.

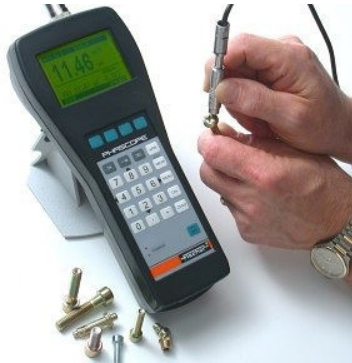
Figure 1.13: Zinc layer thickness using a leptoskop measuring device (=thick layer scale)

Depending on the usage class of the analyzed building, Euro Code 5 defines minimum requirements for the corrosion protection of metal components and connections, which are mostly used in the discussed engineered wood constructions. Using an investigation device (see fig.: 1.13) the coating layer thickness can be checked.

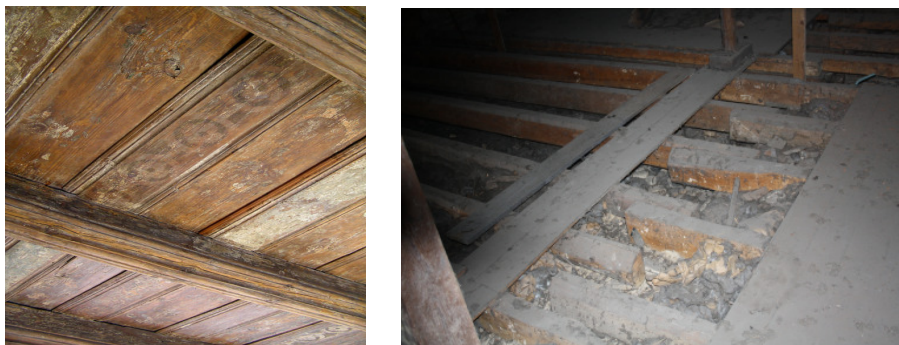
Figure 1.32: Bottom view of a wooden ceiling (left); Beam joint to an inner wall after removal of the top formwork (right)

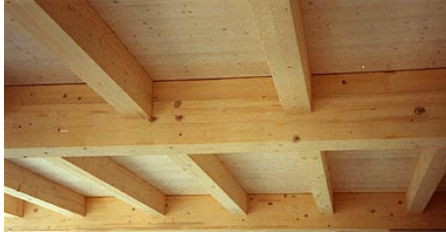
Figure 1.33: Wooden-beam ceiling in visible implementation

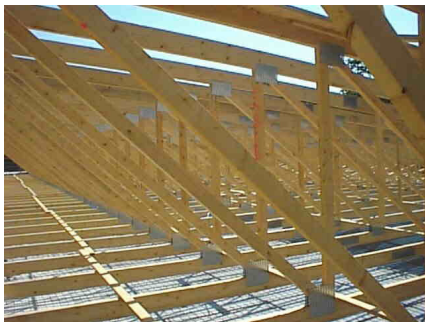
Figure 1.51 Lattice girder as nail plate construction in installed condition

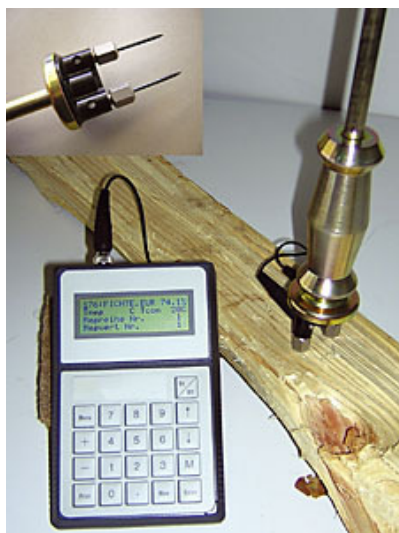
Figure 2.8: Wood moisture meter with electrodes

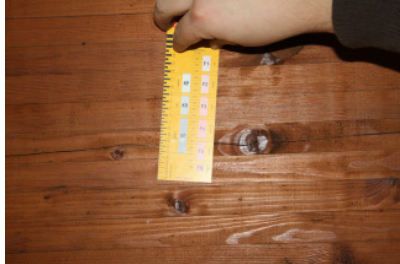
Figure 2.9: *Crack gauge*

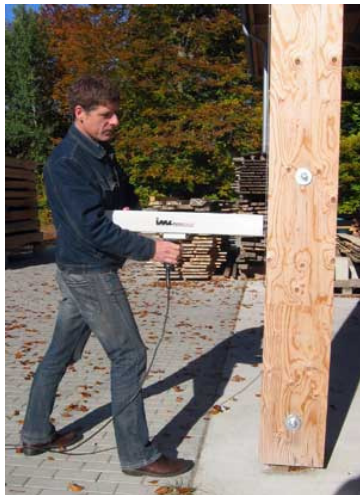
Figure 2.11: Drilling resistance measurement on a damaged supporting structure

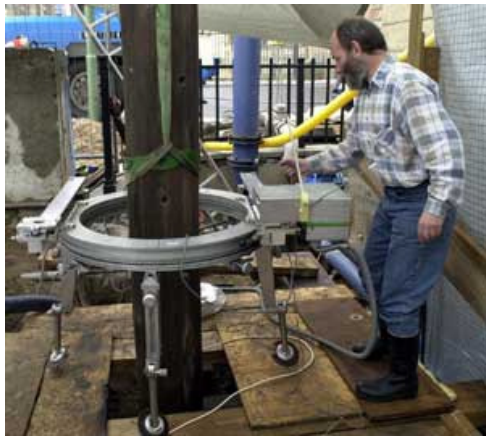
Figure 2.13: Mobile computer tomography on wooden foundation piles

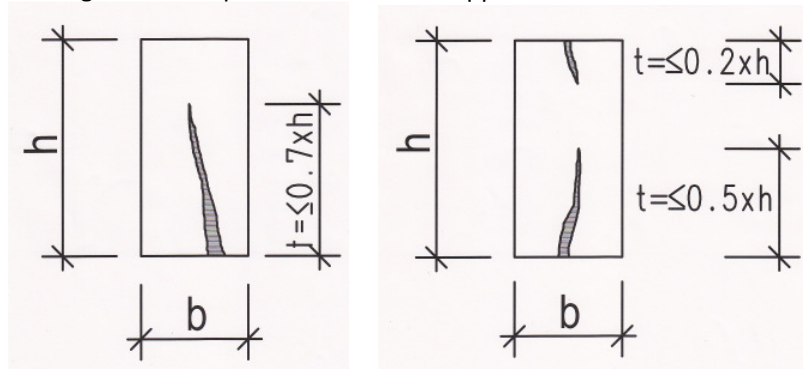
t = single crack depth and the sum of opposite individual cracks

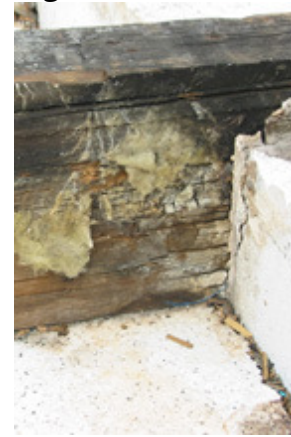
Figure 4:

Answer: The damage described is caused by **brown rot fungus**. Brown rot fungi occur mainly in buildings. They destroy the wood and result in the loss of strength.

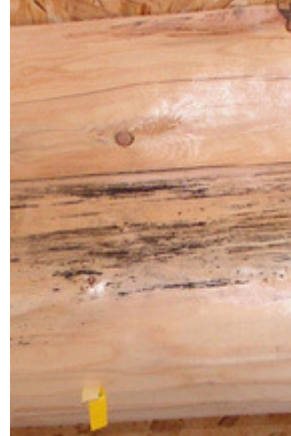
Figure 23:

Answer: The damages described are caused mainly by **blue stain fungi**. Blue stain fungi populate damp timber. They penetrate the top timber layer and cause dark discoloring. Despite these appearances, however, these fungi bring about no significant reduction in stability. Thus the blue stain fungi play only a secondary roll for timber usage in the building industry. The fungi mainly destroy coatings on timber (e.g. windows, facades). In the long-term, therefore, moisture can penetrate the cracks that have formed in the covering, which leads to damage (decay).

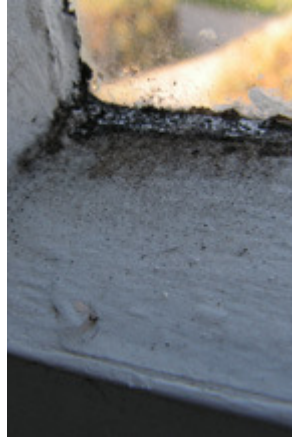
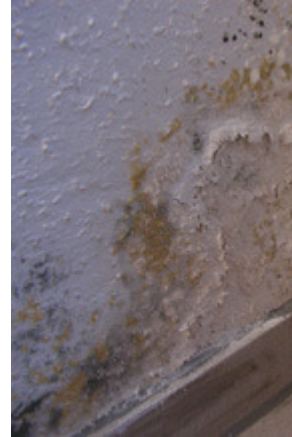
Answer: The damages described are caused mainly by **mold**.

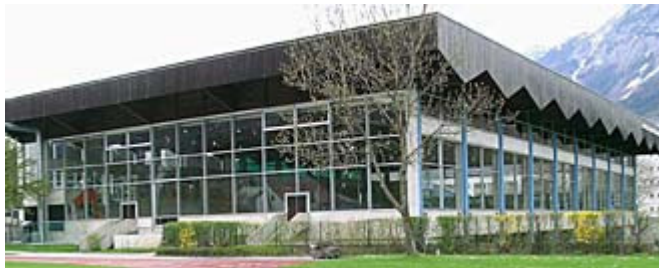
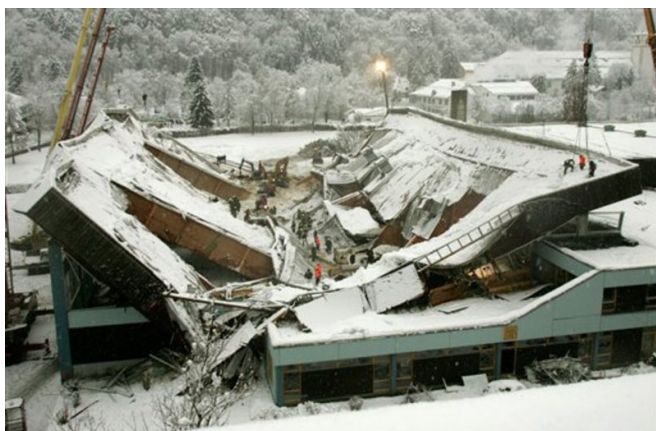
Figure 2.52: Ice pavilion in Bad-Reichenhall, Germany, before and after the structural collapse on 01.03.2006

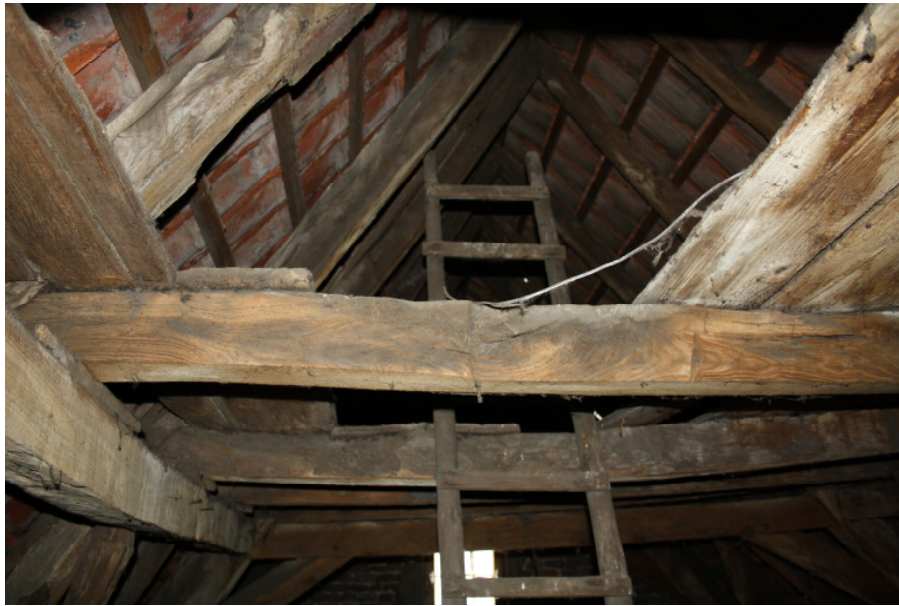
Figure 3.16: Photo – Transfer from level 2 onto level 3

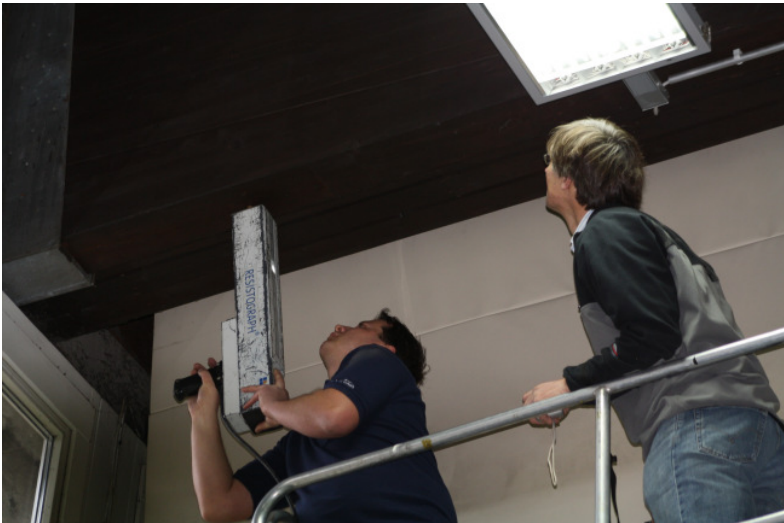
Figure 3.28: Inspection of the binder support points using the resistograph

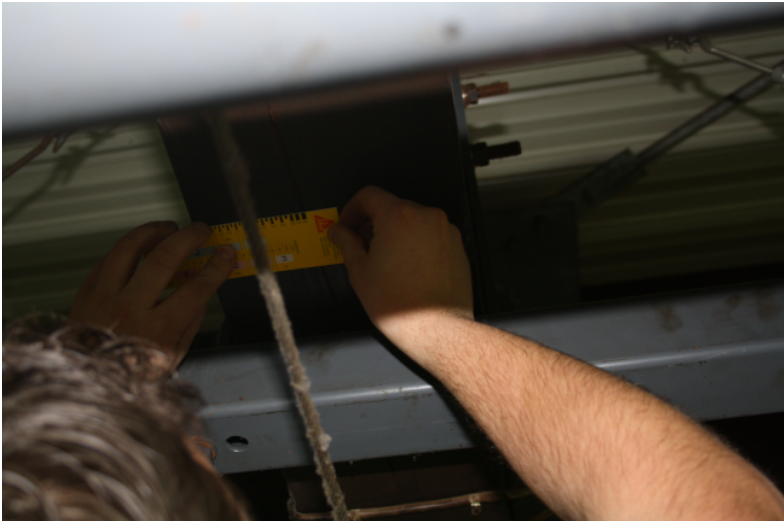
Figure 3.29: Inspection of a crack using a crack gauge

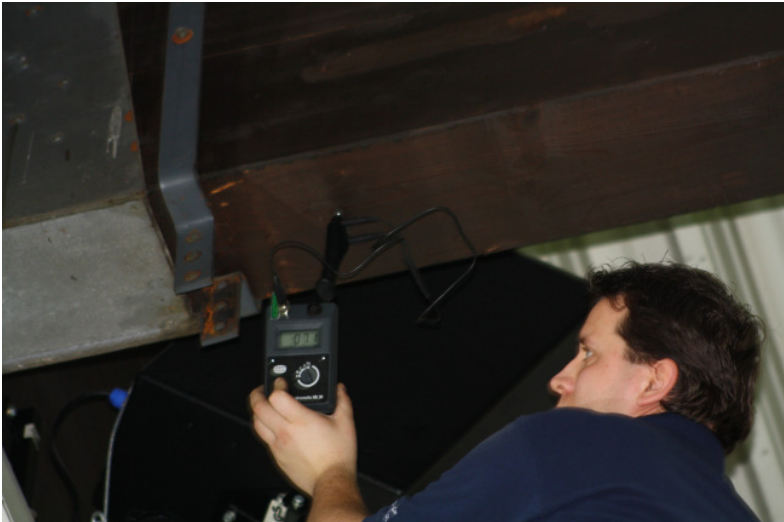
Figure 3.30: Electrical wood moisture test
