Indoor climate assessment and improved HVAC control for energy savings in museums a case study for the Amsterdam Museum

Indoor climate assessment and improved HVAC control for energy savings in museums

A case study for the Amsterdam Museum

Document type Master of Science Thesis
Project title Indoor climate assessment and improved HVAC control for energy savings in museums:
A case study for the Amsterdam Museum
Date June 29, 2016

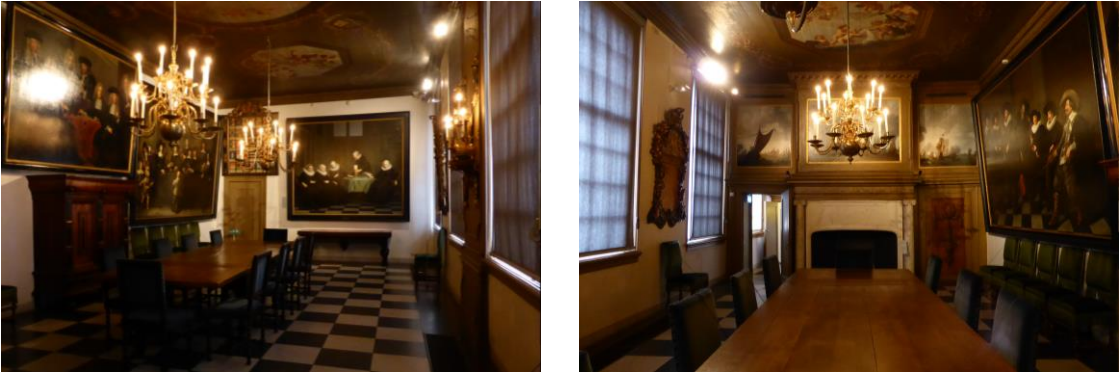
Figure 2.2 The Regentenkamer with highly valued objects; east direction (left), west direction (right)

This chapter explains the building structure, exhibitions and objects, internal heat and moisture gains, and the HVAC system of the Amsterdam Museum. For this case study, the *Regentenkamer* in particular has been explored in more depth, because it exhibits highly valued objects, see Figure 2.2. In addition, this room is ideal for modeling because only one room is connected to one AHU.

Figure 2.2 and Figure 2.4 show that the *Regentenkamer* exhibits a lot of highly valued objects of the orphanage. After renovating the Regentenkamer in 1634-1635, decorative painting on the orphanage were created on the ceiling of the room in 1656. In addition, the wall was covered with 18th century paintings of sea views. The room also displays four regent paintings in oil on canvas dated from the 17th and 18th century. Finally, the room exhibits an 18th century coat of arms, a nameplate of the orphanage's board (dated 1861) and a cabinet of oak wood. For a detailed description of objects, see Meischke (1975).

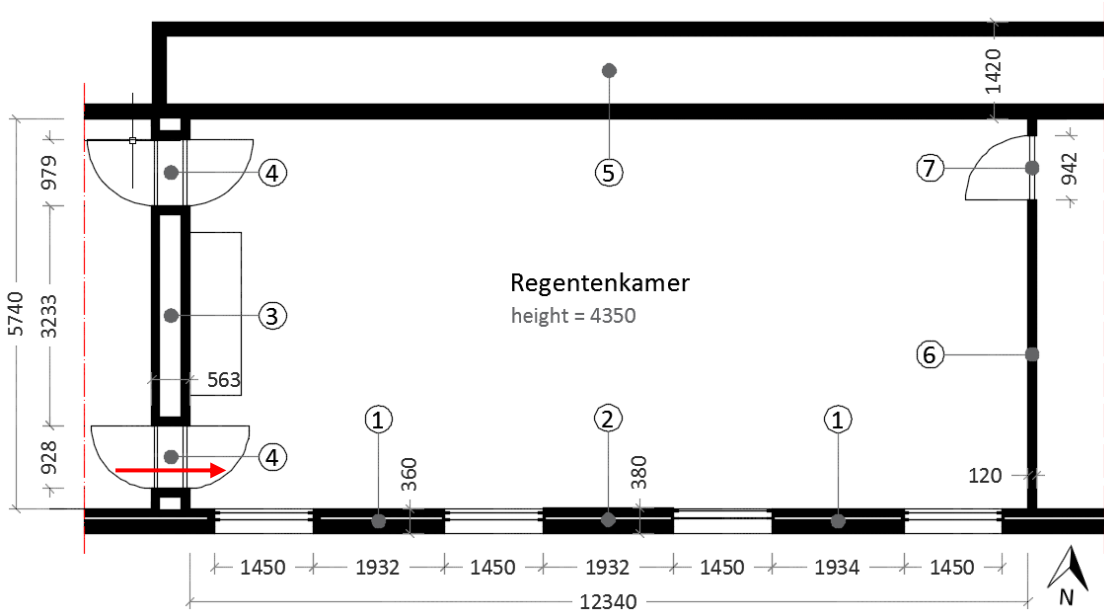
Figure 3.2 Floor plan of the Regentenkamer including structure types. Structure layers from inside to outside: 1: plaster-brick-cavity-brick, 2: wood-brick-cavity-brick, 3: wood-brick-air-brick-plaster, 4: solid wood-air-solid wood, 5: plaster-brick-cavity-brick, 6: plaster-brick-plaster, 7: solid wood, 8 (floor): tiles-concrete, 9 (ceiling): wood-plenum-wood-timber flooring.

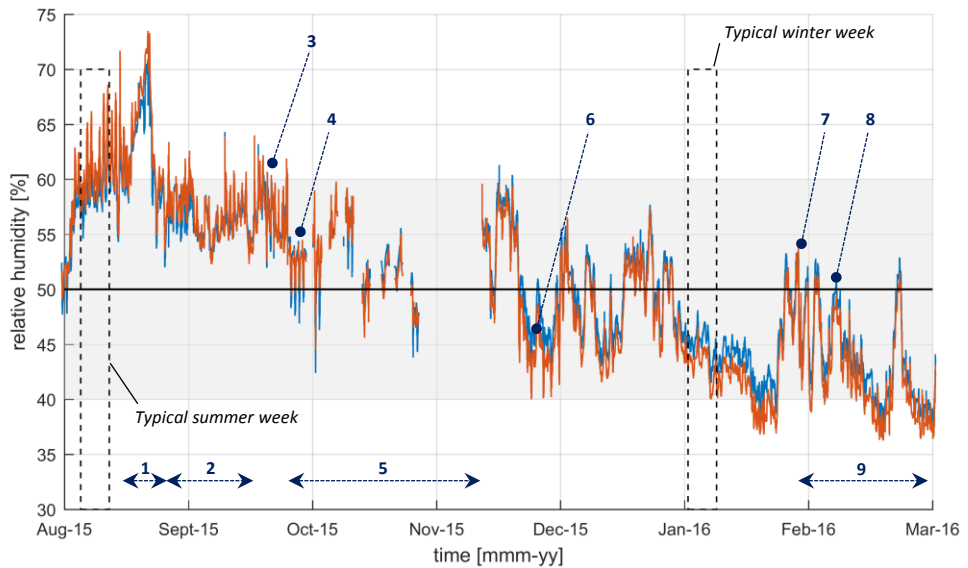
Figure 4.4 Measured temperature and relative humidity for the measurement positions Exhaust 1 and Cabinet of the Regentenkamer. Events during the measurement period: 1: replacing distributors, 2: connecting water pipes, 3: regulation? 4: heating/cooling in operation, 5: data loss, 6: sensors AHU calibrated, 7: farewell director, 8: power failure and 9: Regentenkamer closed

Figure 4.4 displays the measurement data for the *Regentenkamer* for temperature and relative humidity. Results are shown for the measurement position *Exhaust 1* and *Cabinet*, which show more fluctuating and more constant temperatures respectively. The numbers in the figure denote the remarks from the logbook, according to Appendix A. The grey line shows the museum setpoints of 20°C and 50% RH and the grey area shows the museum bandwidths of 18.5-21.5°C and 40-60% RH.

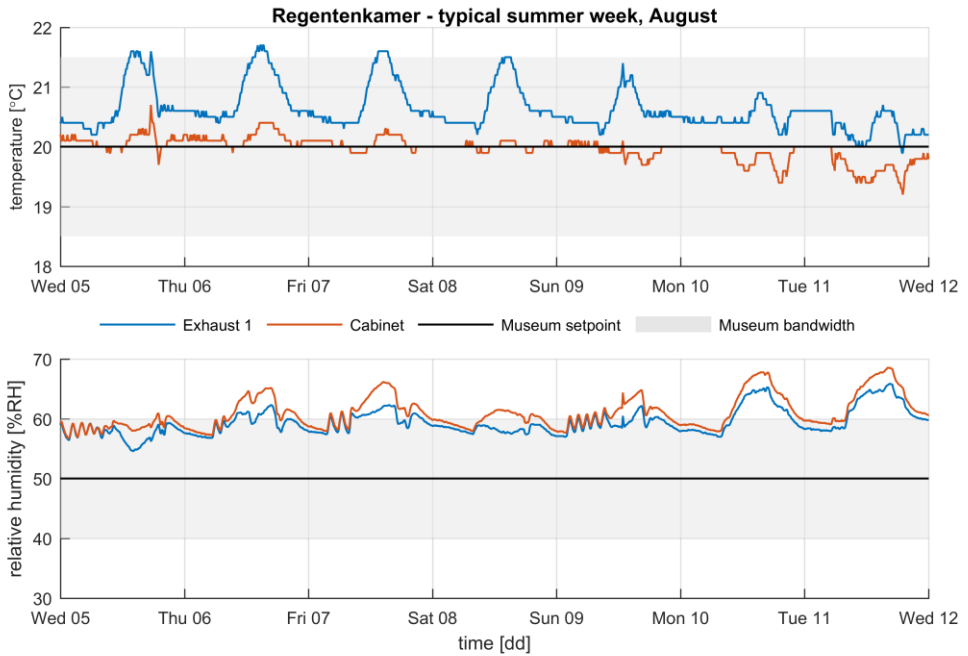
Figure 4.5 Measured temperature and relative humidity for a typical summer week in August for the measurement positions Exhaust 1 and Cabinet of the Regentenkamer

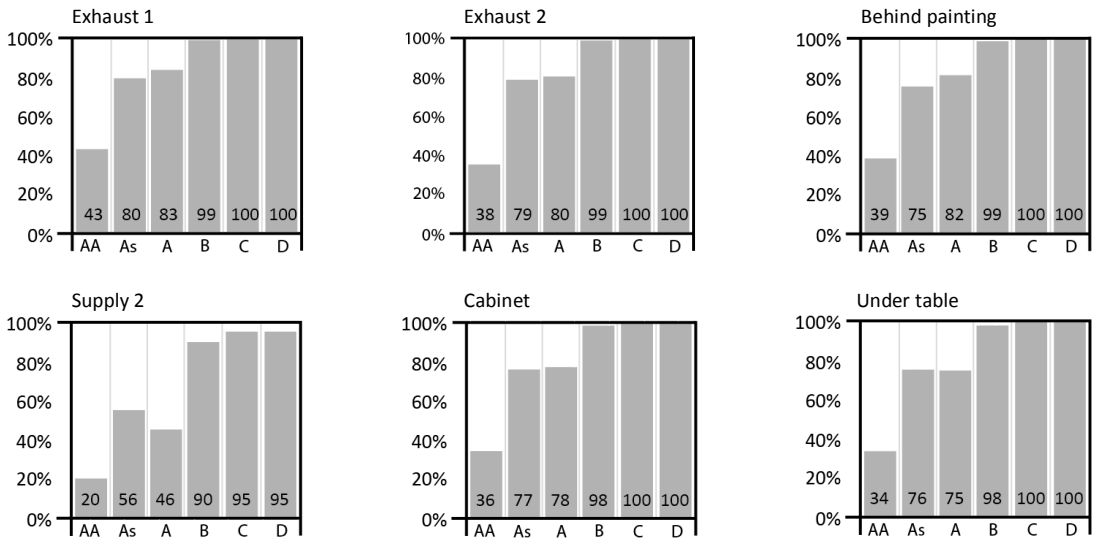
Figure 4.10 General risk assessment for the measurement positions of the Regentenkamer: Exhaust 1, Exhaust 2, Behind painting, Supply 2, Cabinet and Under table

Figure 4.10 displays the general climate risk assessment for the measurement positions of the *Regentenkamer*. For the measurement positions *Behind painting*, *Cabinet*, *Under table*, *Exhaust 1* and *Exhaust 2*, the indoor climate is within class C. Climate class B is met 98% or 99% of the time. Replacing and presetting central distributors of the HVAC system is the main cause of the outliers in climate class B. Because objects are positioned above the supply air grille, results are also shown for measurement position *Supply 2*. For this position, no climate class is met 100% of time due to high RH.

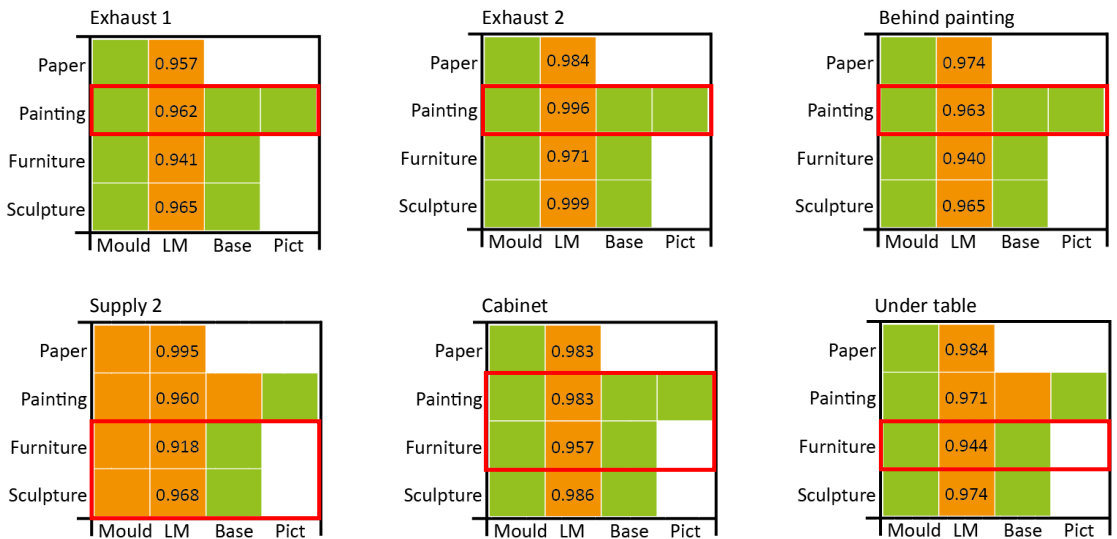
Figure 4.11 Specific risk assessment for the measurement positions of the Regentenkamer: Exhaust 1, Exhaust 2, Behind painting, Supply 2, Cabinet and Under table. The red box denotes the object type which is positioned near the measurement position.

Figure 4.11 displays the specific climate risk assessment for the measurement positions of the Regentenkamer. The red box in the figures depicts the type of objects which are located near the measurement position. All positions show a LM < 1 for all types of objects, which denotes an increased risk on chemical degradation. However, risks are limited because the high relative humidity levels during the replacement of distributors are compensated by lower relative humidity levels in winter.

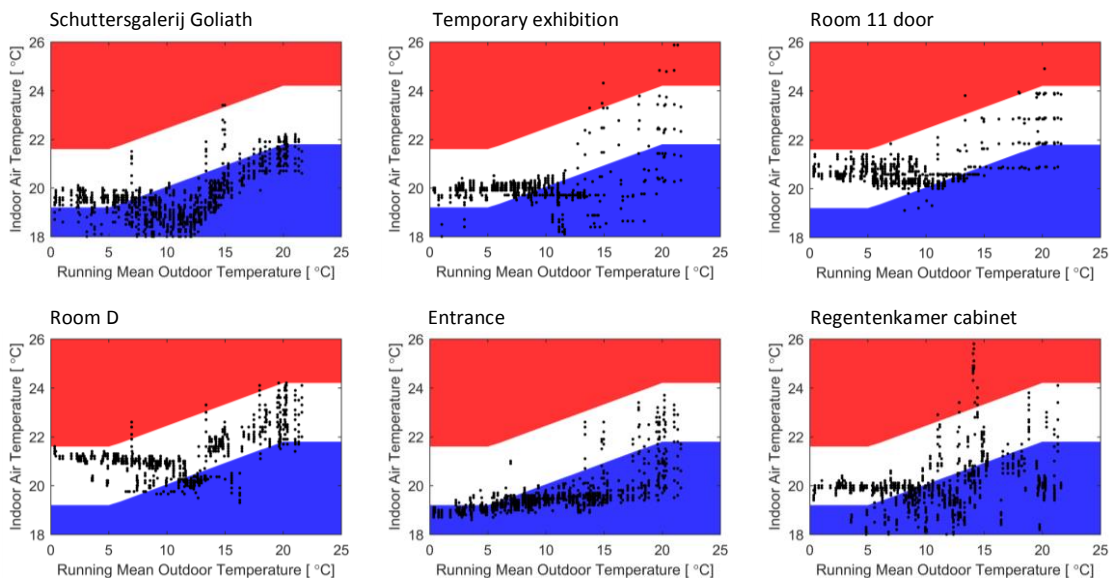
Figure 4.12 Thermal comfort assessment using the Adaptive Temperature Guideline for museums for the measurement positions Schuttersgalerij Goliath (top left), Temporary exhibition (top middle), Room 11 door (top right), Room D (bottom left), Entrance (bottom middle) and Regentenkamer cabinet (bottom right).

Figure 4.12 and Table 4.4 show that overheating hours in the rooms are limited to 2.3%. Overheating is mostly caused by replacing the distributor of the AHU. However, underheating shows many exceeding hours in a range of 20.8% and 88.3%. Thermal comfort is the best in *Room 11* and the worst in the *Entrance*. The *Regentenkamer* is somewhere in between. In general, the indoor climate in museum rooms and in the *Entrance* are too cold regarding thermal comfort.

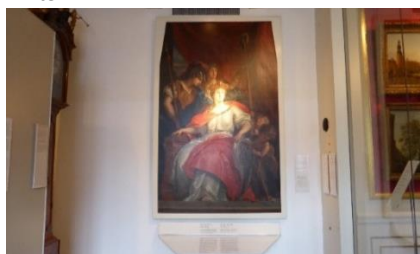
Figure 4.14. Room D (2nd floor), position 1; visual image (top), infrared thermal image - winter (center) and calculated infrared hygric image - winter (bottom). January 13th, 2016, 2:44pm

Figure 4.14 depicts the images of a painting lighted by a warm spot in *room D* at the 2nd floor. The painting shows a surface temperature of 21.0°C and relative humidity of 46.5%. However, the light spot causes unevenly distributed surface temperatures and relative humidity over the painting with a local surface temperature of 25.7°C and relative humidity of 35%. As a result, cracks due to mechanical degradation may occur. Besides, the high surface temperature increases risks on chemical and biological degradation. It has to be noticed that the varnish on the painting reflects the heat of the light spot. Therefore, too high surface temperatures and too low relative humidity are displayed. Risks may be lower than expected. Actual temperatures could be measured by installing a surface temperature sensor on the painting.

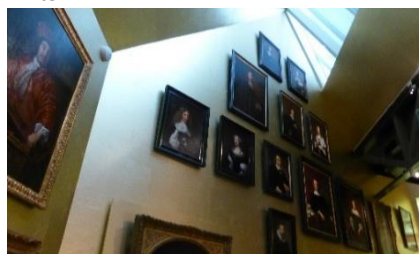
Figure 4.15. Room 11 (2nd floor), position 2; visual image (top), infrared thermal image - winter (center) and calculated infrared hygric image - winter (bottom). January 13th, 2016, 2:50pm

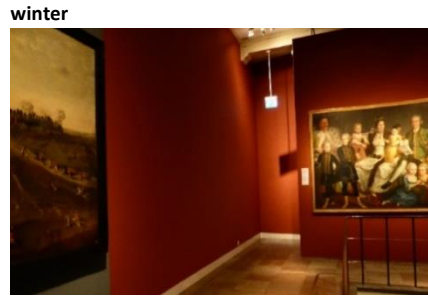
Figure 4.17. Room D (1st floor), position 4; visual image (top), infrared thermal image - winter (center) and calculated infrared hygric image - winter (bottom). January 13th, 2016, 3:10pm

Figure 4.17 depicts a building corner of the same room. Near the edges, cold areas with a high relative humidity are displayed. The corner has a minimum temperature of 14.0°C and a maximum relative humidity of 70.9%. There is an increased risk on mould growth near the corner due to the high relative humidity. Different causes are: 1) in corners, the air velocity is lower and the surface coefficient of the convective heat transfer is smaller than elsewhere; 2) the radiant exchange between the surface close to the corner and these surfaces exchange less heat with the room (de Wit, 2009).

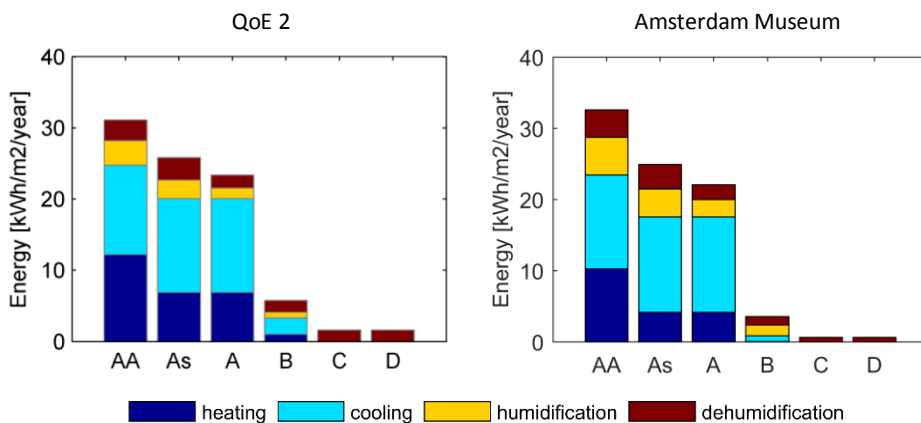
Figure 5.1 Comparison of the energy use for QoE 2 (Kramer, Schellen et al., 2015) and the Amsterdam Museum, when simulating according to ASHRAE climate classes

A study to the energy impact of ASHRAE’s museum climate classes for different qualities of envelope was performed by Kramer, Schellen et al. (2015). The simulation results on ASHRAE climate classes for the Amsterdam Museum (strategy 8-13 in this thesis) were compared to the simulation results for QoE 2, see Figure 5.1. The figure shows that the energy use for both simulations are within the same range. The spread of temperature and relative humidity are also comparable. The energy needed for humidification and dehumidification is a bit higher compared to QoE 2. The cooling energy is a bit lower. The same conclusions of Kramer’s research can therefore be drawn for this research: class B saves a lot of energy compared to class A. However, it has to be noted that energy savings were not related to thermal comfort requirements, despite thermal comfort requirements are more strict than the temperature setpoints according to ASHRAE climate classes.

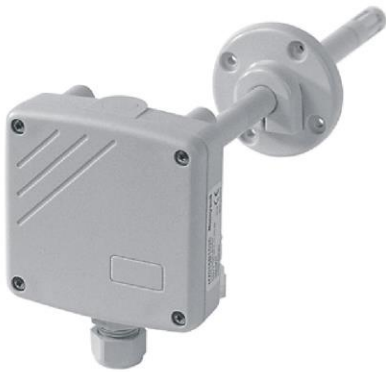
DUCT HUMIDITY SENSOR/ COMBINED HUMIDITY/TEMPERATURE SENSOR

The H7015A Duct Humidity Sensor is a capacitance-type relative humidity sensor for duct mounting.
