Indoor climate assessment of monumental and modern museum buildings a case study for the Van Abbemuseum

Paulussen, E.M.N.L.

Award date:
2017

'This thesis is presented for the degree of Master of Science
of the Eindhoven University of Technology'

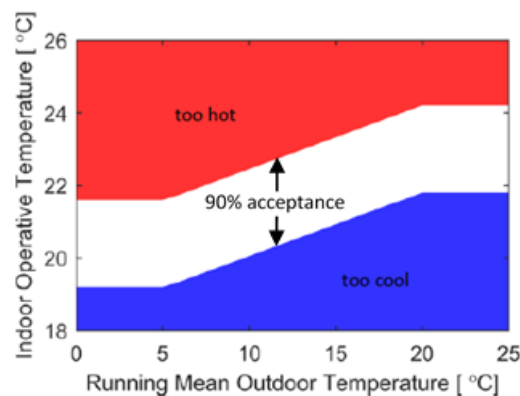
Figure 1.1: Adaptive Temperature Guideline for museums, according to the 90% acceptance class (Kramer et al., 2016).

Due to the lack of thermal comfort guidelines specific for museums, Kramer et al. (2016) developed the Adaptive Thermal Guideline (ATG) for museums in which thermal comfort limits for air-conditioned museums in temperate climate regions can be assessed. The developed guidelines are based on a 1200+ survey study, measurements and an intervention study in a strictly conditioned renovated museum with insulated walls in the Netherlands. The guideline takes the adaptive behavior of humans into account and is based on the Running Mean Outdoor Temperature (RMOT) of the current day and on the preceding three days. The comfort acceptance limits according to the 90% acceptance class (excellent) are shown in Figure 1.1. Although the analysis method can only be used to determine the 90% acceptance class, the 80% class would also be good because of a higher energy saving potential and thermal comfort is not the main priority in museums. A drawback of the current ATG for museums guideline is the lack of data when T_e is below 0°C (Kramer et al., 2016).

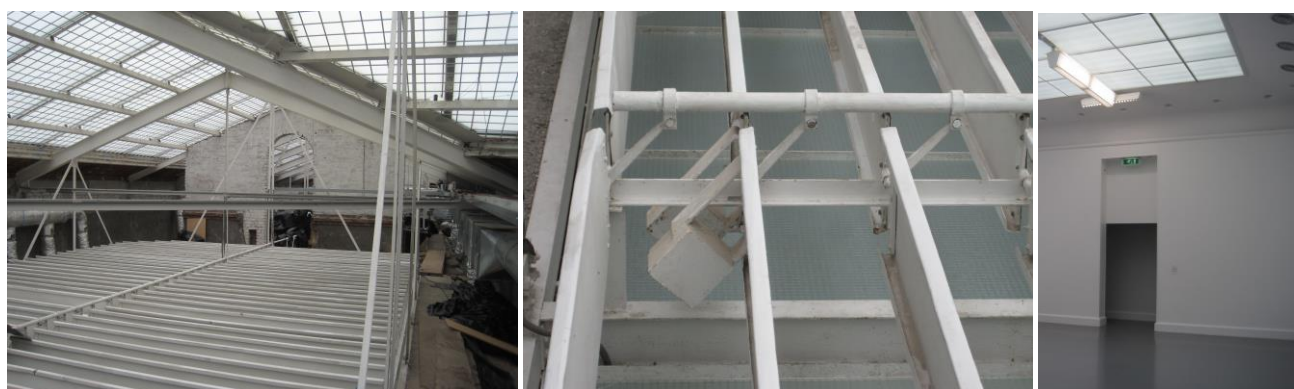
Figure 1.3: Plenum, lamellae detail which can regulate the light transmission into the exhibition rooms, and exhibition room.

risks to museum objects. The museum board assumes that the increased T_i and RH_i are caused by the plenums (space between the upper roof and lower separation ceiling of the exhibition room), see Figure 1.3. The plenums have a low thermal resistance, are not conditioned (Engelen, 2006), and no thermal resistant layer is added. Currently, it is impossible to open the outer structure of the plenums (roof surface) to cool or ventilate the plenums.

During July 3rd, 2015, a surface temperature (T_s) of 41°C is measured with an infrared (IR) camera at the bottom surface of the plenum separation structure (Kompatscher, 2015). During this measurement moment, T_e was about 30.4°C (KNMI, 2017). Another study by Engelen (2006) showed that temperatures above 55°C were measured in the summer of 2006 in the plenum. Engelen (2006) concluded that the HVAC system in the monumental building part is unable to cool the exhibition rooms enough to reach the preferred indoor climate (T and RH). In addition, Engelen (2006) states that changing the current HVAC installations for larger installations with more power is impossible since they do not fit in the current installation spaces. Since the museum assumes that the increased T_i and RH_i are the effects of the heated up plenums in the summer, the most manageable option would be to mechanically cool down the plenums. Engelen (2006) recommends to integrate mechanical ventilation of the plenums into the current HVAC system, based on the measured T_i and T_e . The T in the plenum should be close to T_e . Another recommendation by Engelen (2006) is to insulate the return ventilation pipes to minimize the effect of the plenum on the mixed air. This should have a positive effect in both summer and winter periods. However, using mechanical ventilation comes with high investment and maintenance bills. Instead of mechanical ventilation, it is also possible to make use of natural ventilation for the plenums by opening skylights in the roof. This will not cost extra electric energy, but the air flow is hard to control (Engelen, 2006). The museum does not want to place ventilators due to the large amount of noise. Engelen (2006) has also concluded that the plenum can function as a heating buffer when T in the plenum is below 26°C. When T is higher than 26°C, the plenum has a negative effect on the T_i and so on the RH_i in the exhibition room.

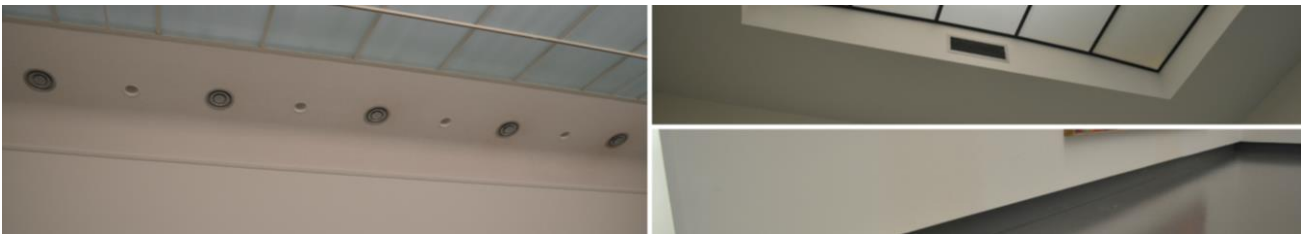
Figure 2.2: Inlets and outlets. Left: monumental building part A, right: modern building part B.

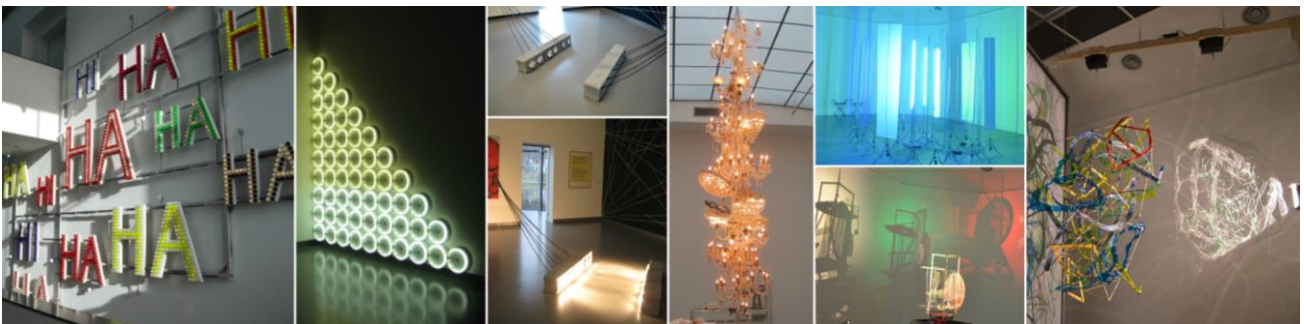
Figure 2.3: Museum objects consisting luminaires: LED lamps, tubular fluorescent lamps, halogen lamps, incandescent lamps, and several art objects consisting lamps during ‘Glow Eindhoven 2016’.

During the measurement period, a few works of art consisting of luminaires have been present in the exhibition rooms of the VAM, see Figure 2.3 for an impression. These works of art emit heat, and as a result the T_i and RH_i of the surrounding air are fluctuating a lot when the luminaires are turned on/off. Figure 9.87 and Figure 9.88 show the impact of the luminaires on the indoor climate during opening hours. As can be seen, the daily fluctuations are much smaller on Mondays, when the museum is closed for visitors. The works of art near Eltek sensor 7A (halogen lamps, emitted approximately 1250W of heat) and Eltek sensor 20 (tubular fluorescent lamps, emitted approximately 650W of heat) have been present during the whole measurement period, the work of art near Eltek sensor 13 (extreme amount of incandescent lamps) has been present from September 2016 to February 2017. The tubular fluorescent lamps near Eltek sensor 20 have the highest impact on the indoor climate: when the luminaires are turned on, the T_i increases with 1.5°C and the RH_i decreases by 8%.

Figure 9.67 shows the data measured by BMS sensor 5 placed in the modern building part on the 1st floor and the data measured by Eltek sensors 7A and 20. These sensors are located near works of art consisting luminaires, see also the tubular fluorescent and halogen lamps in Figure 2.3. The luminaires are turned on during the opening hours of the museum, so not on Mondays. The luminaires emit much heat, approximately 650W at the tubular fluorescent lamps and 1250W for the halogen lamps, resulting in extreme daily fluctuations of T and RH. Although the constantly higher T and lower RH measured by the BMS sensor compared to the data measured by Eltek sensor 7A, the results are very similar. BMS sensor 5 is placed at eye height right under Eltek sensor 7A, which is placed under the ceiling. The data measured by Eltek sensor 20, more closely located near the tubular fluorescent lamps, shows extremer daily fluctuations. The seasonal fluctuations are similar for all the locations.

Figure 9.69 shows the data measured by BMS sensor 2 placed in the modern building part on the 2nd floor and the data measured by Eltek sensors 9 and 13. Although there is a lot of data loss for the Eltek sensor 9, the available data still gives a good impression of the current indoor climate. The T and RH measured by the BMS sensor are very similar to the data measured by Eltek sensor 9. The data measured by Eltek sensor 13 shows a little lower T and little higher RH than the data measured at the other locations. The increased daily fluctuations from September 2016 to February 2017 measured by Eltek sensor 13, and to a smaller extent measured by BMS sensor 2, are a result of the work of art consisting an extreme amount of incandescent lamps, see Figure 2.3 for an impression. All locations show the same seasonal fluctuations of T and RH.

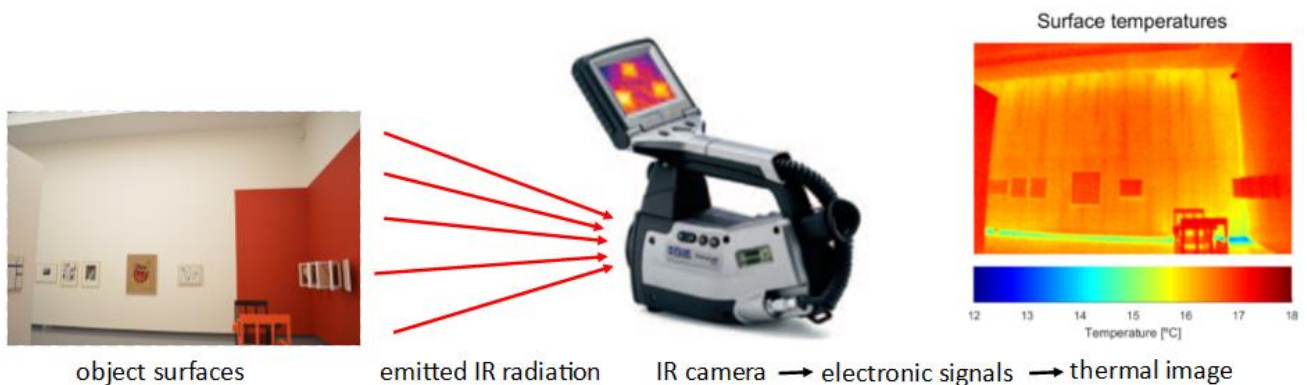
Figure 3.1: Principle of IR thermography. IR camera (Flir systems, 2004) detects the IR energy (heat) that a surface emits (the higher T , the higher the emitted IR radiation) and transforms it into electronic signals. These signals are converted to a thermal image (Flir, 2016)

To indicate the microclimates in the VAM, infrared (IR) thermographs have been conducted with an IR camera of the structures of the museum. Microclimates are local deviations in which T_i and RH_i significantly differ from the average indoor climate. The principle of IR thermography is shown in Figure 3.1. To get accurate and reliable thermograms, large differences between T_i and T_e are required. Therefore, IR thermograms have been conducted during the winter ($T_e < 5\text{ }^\circ\text{C}$) on February 17th 2016 and in the summer ($T_e > 30\text{ }^\circ\text{C}$) on July 20th 2016. Before measuring, a measurement plan has been designed. The IR thermograms have been mostly taken at the same locations, for the comparison between the seasonal climate situations. In addition, on July 20th 2016 IR thermograms have been made of the bottom surface of every internal plenum structure, see Figure 3.2, to compare the T_s of the different plenum separation structures. For every IR thermogram, the T and RH at that location have been noted, including the time and the location of the picture, and an extra visual picture was made. The IR results were of great importance for determining the locations of the T_s sensors, see Paragraph 3.1.2 for more information. Appendix G provides more information about the IR measurements, including the used devices, difficulties, outdoor climate conditions, and measurement locations.

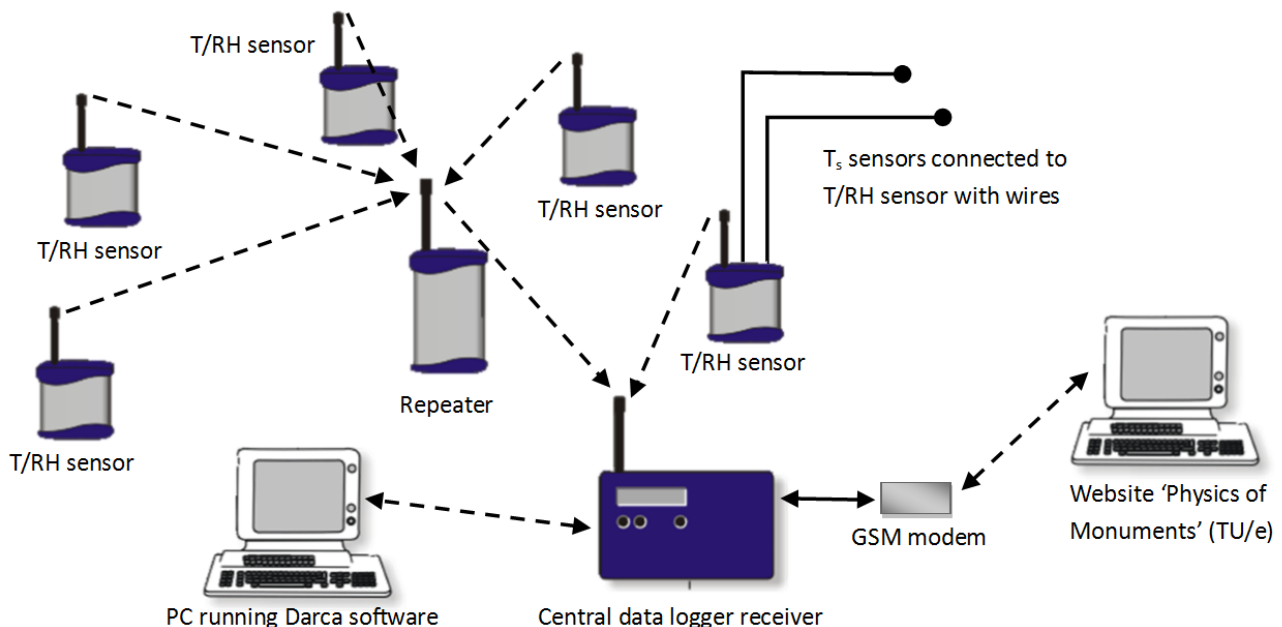
Figure 3.3: Principle of measurement setup continuous measurements Eltek sensors.

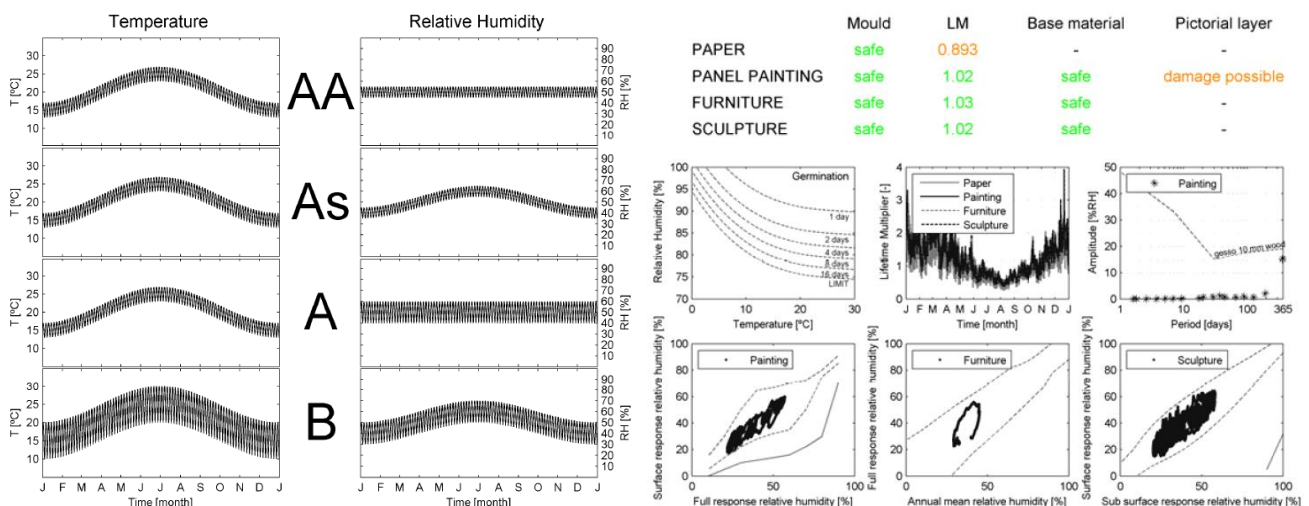
Figure 3.9: Left: tolerated short-fluctuations of temperature and relative humidity over a year according to the ASHRAE climate classes (Martens, 2012), right: example result risk overview specific risk assessment method (Martens, 2012).

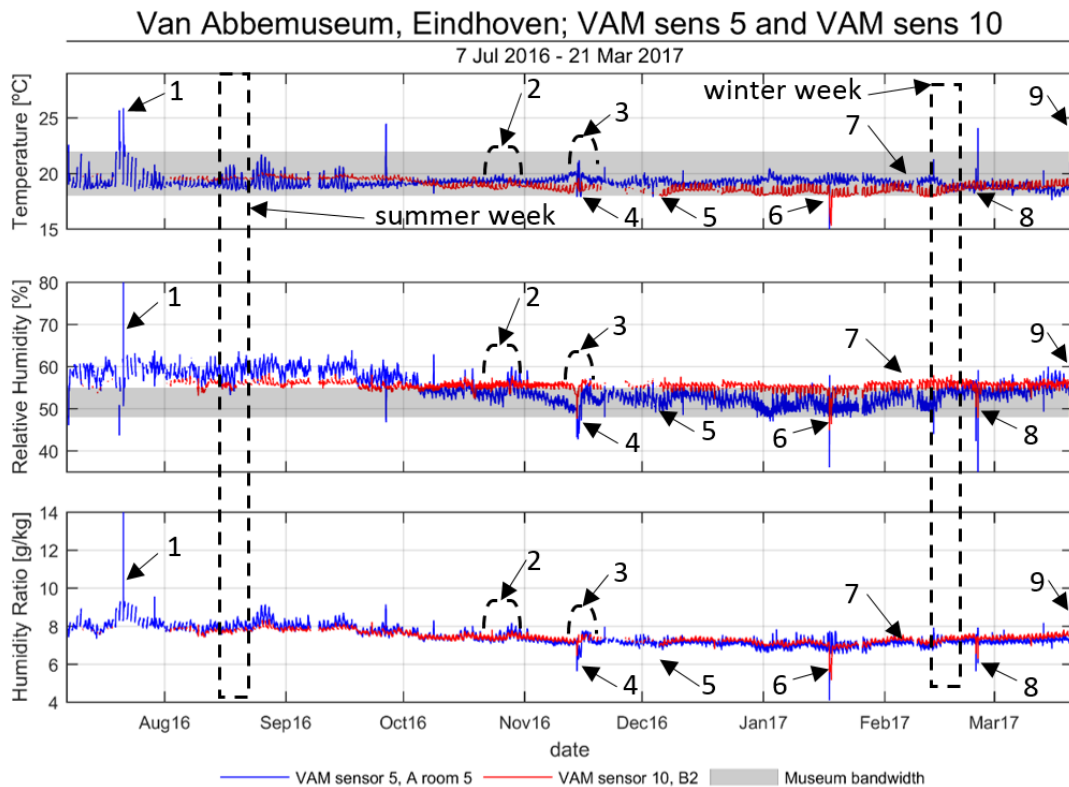
Figure 4.1: Measured T_i and RH_i for the measurement positions Eltek sensor 5 (monumental building part room 5) and Eltek sensor 10 (modern building part B2). Events during the measurement period: 1: open valves, 2: Dutch Design Week, 3: GLOW, 4: power failure, 5: placement 1st repeater, 6: fire alarm, 7: placement 2nd repeater, 8: fire alarm, 9: AHU test.

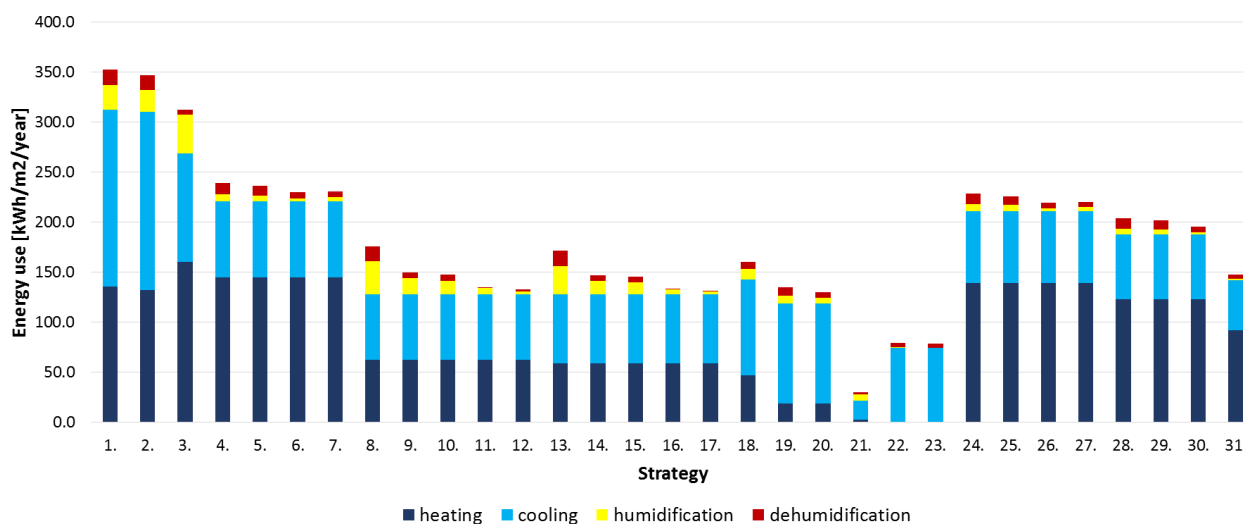
Figure 4.10: Simulated energy demand per setpoint strategy, divided in heating, cooling, and (de)humidification. The setpoints per strategy can be found in Table 4.11.

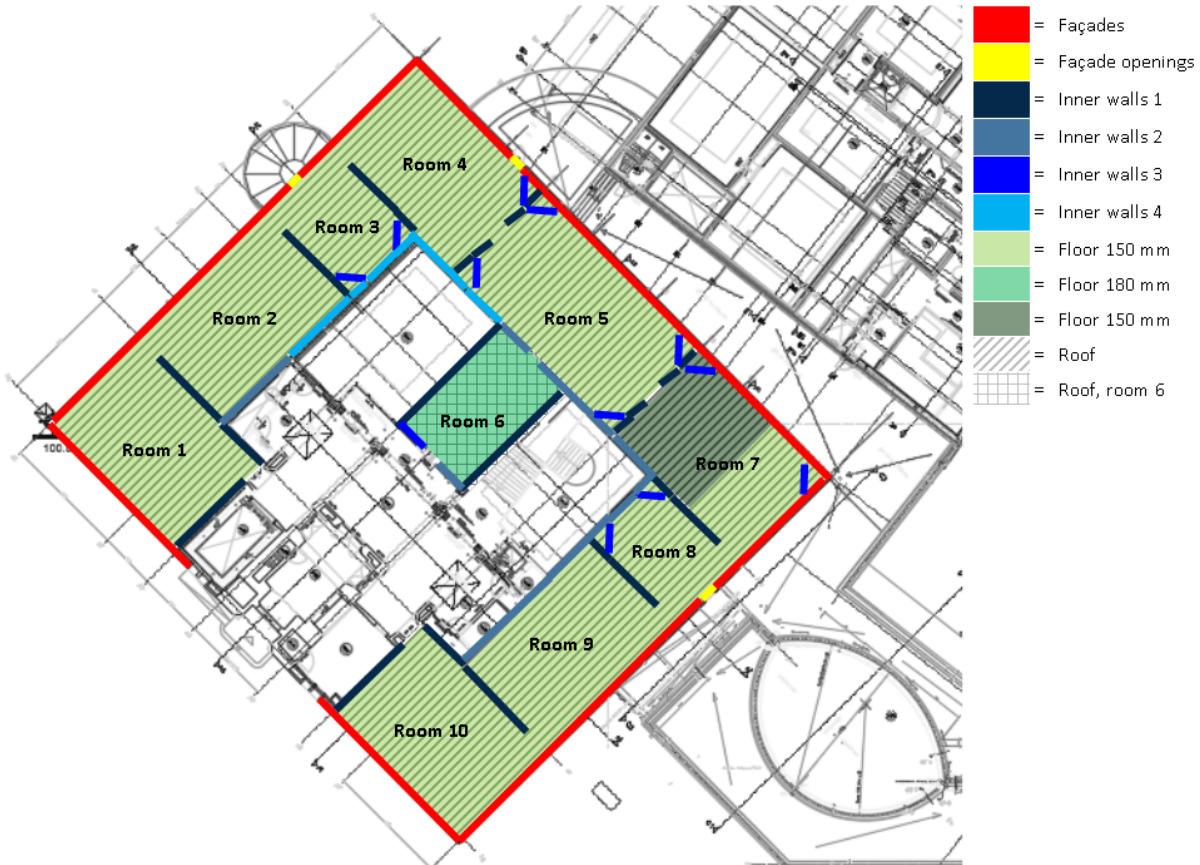
Figure 9.9: Structure types monumental building part A, floor plan under layer by Cahen (2003). All the walls of exhibition rooms have an extra double wall with a layer of multiplex and plasterboard.

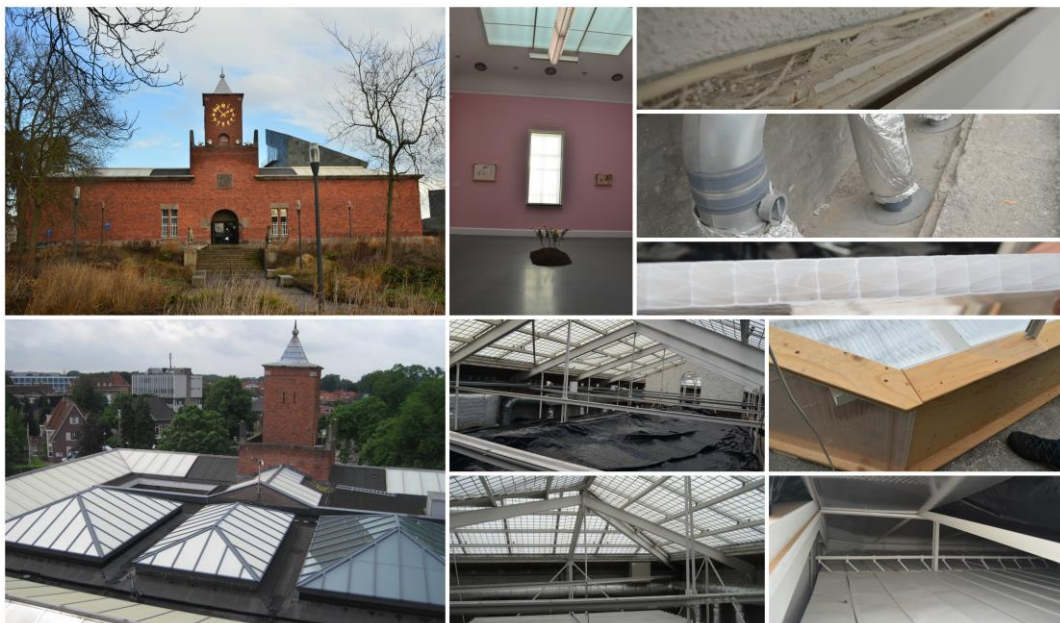
Figure 9.11: Structure types monumental building part A. South façade, interior exhibition room, double wall, plenum concrete, polycarbonate channel plate, roof view, plenums, polycarbonate channel plate structure covered with non-translucent plastic sheets above room 5.

During the summer of 2016, both room 4 and 5 in the monumental building part had an internal plenum structure covered by non-translucent plastic sheets. Both rooms have the same orientations. However, room 5 has an extra structure of polycarbonate channel plates build on the internal plenum structure. See Figure 9.11 in Appendix D for impressions of the polycarbonate channel plates placed on the plenum structure. Figure

An overview of the materials per structure type are shown below. All the walls of the exhibition rooms have an extra double wall (meranti multiplex 18mm + plasterboard 12mm, see Figure 9.11). Walls with a fire protection door (room 1, 6 and 10) have an extra double wall: structure of wood.

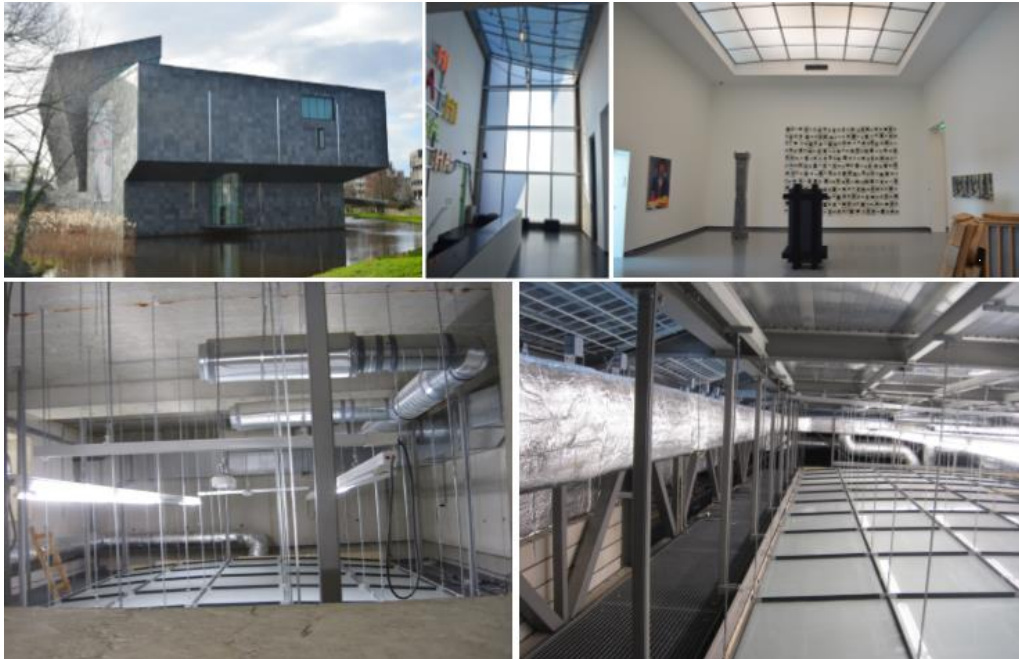
Figure 9.12: Structure types modern building part B. North and east façade, glass surfaces, interior exhibition room, plenum between floors, plenum below upper roof.

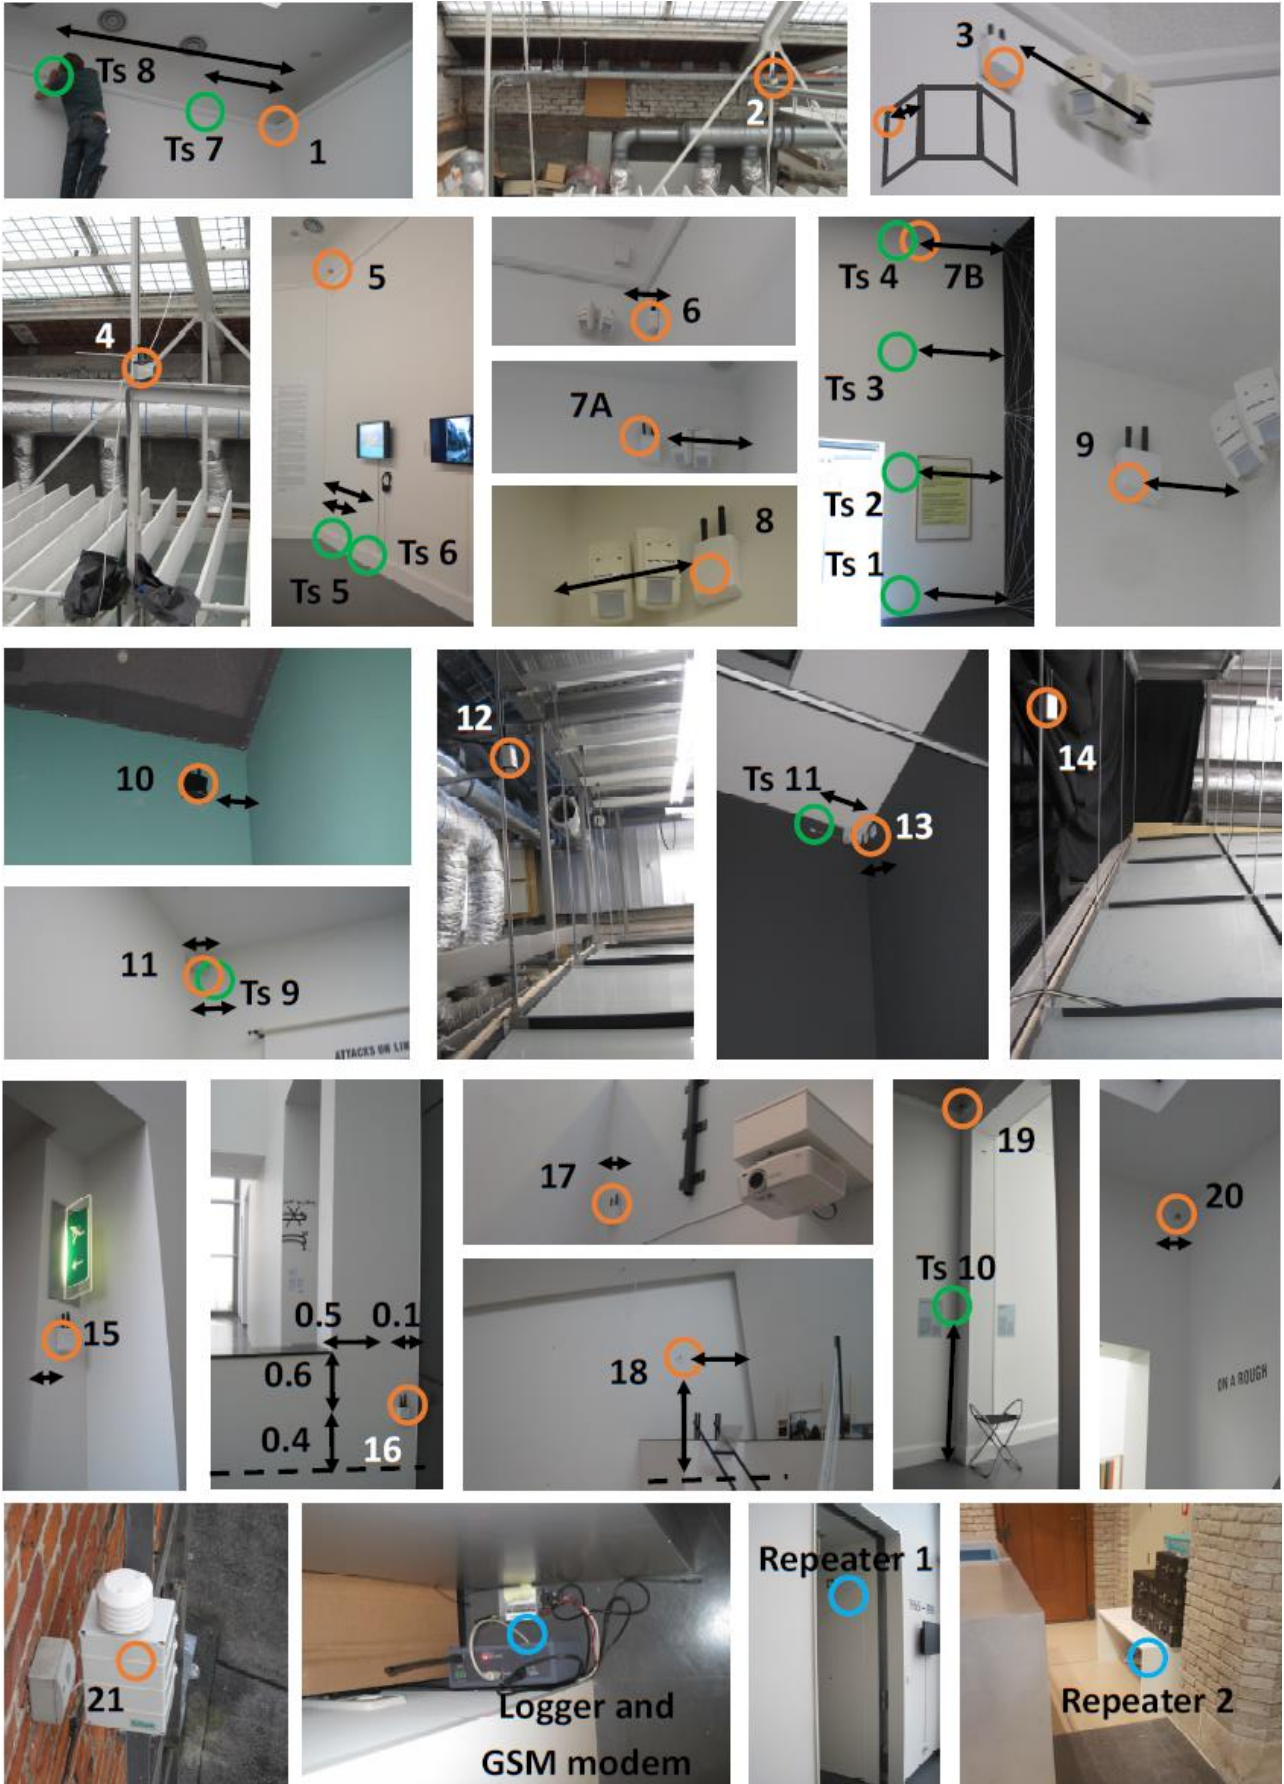
Figure 9.31: Exact locations of the logger, repeaters and sensors. Orange circles represent T/RH sensors, green circles represent T_s sensors.

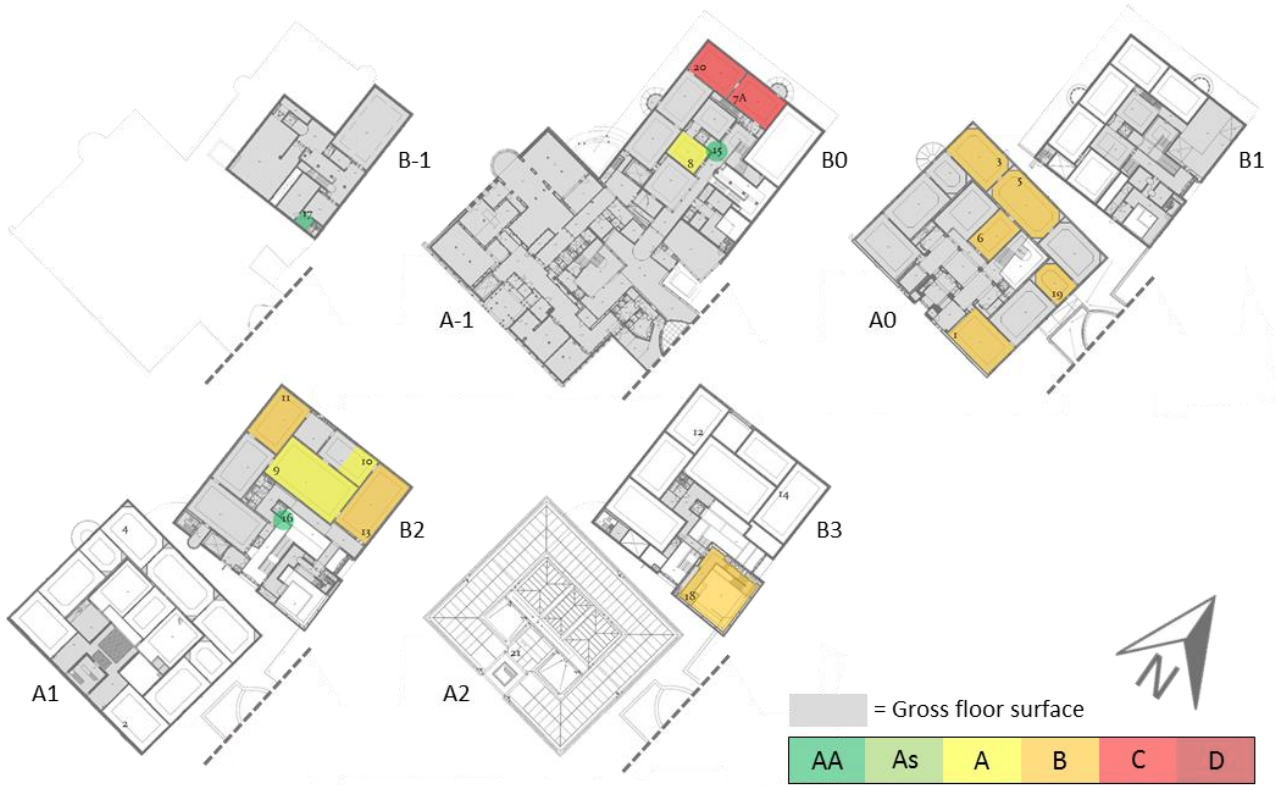
Figure 9.100: Best ASHRAE classes met 100% of the time, based on general climate risk assessment, during the total measurement period, floor plan under layer by Cahen (2003).

The results of the general climate risk assessment have shown that no higher class than ASHRAE class B is met 100% of the time in the monumental building part, due to the high thermal radiation from the plenums and malfunctioning of the HVAC systems (causing outliers in the T_i and RH_i). ASHRAE class B is granted for historic buildings and since the most vulnerable objects of the VAM are not placed in the monumental building part, there is no reason for concern regarding the risks to objects displayed in this building part. The malfunctioning of the HVAC systems also caused lower ASHRAE classes met 100% of the time in the modern building part of the VAM. If no malfunctioning of the HVAC systems occurred, ASHRAE class AA would be met 100% of the time in almost every room of the modern building part. Class AA is the highest ASHRAE class and expected for modern museum buildings, and comes with very low risks for the museum objects.
