Explosion free in fire self-venting (TPRD-less) composite tanks: Performance during fire intervention

V. Molkov, S. Kashkarov*, D. Makarov

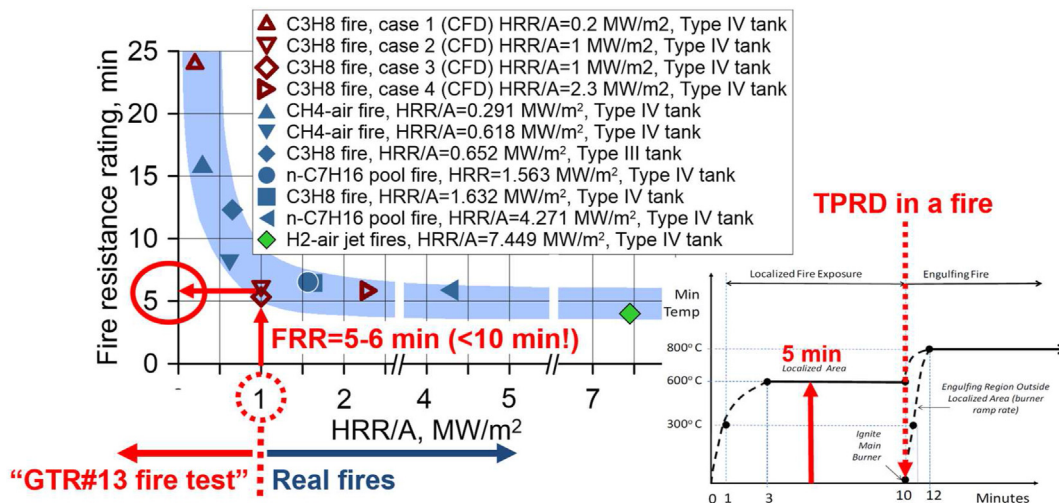
Fig. 2 – Dependence of FRR on HRR/A demonstrating that in a fire of typical for gasoline spill fire intensity of $HRR/A = 1 \text{ MW/m}^2$ the FRR = 5–6 min, i.e., shorter than the localised fire stage duration (see the insert at the right bottom corner) [20,21,30,31,32–37].

Figs. 1 and 2 show the results of experimental and numerical studies on the dependence of FRR as a function of HRR/A (blue strip). The FRR decreases with HRR/A. It does not practically change for $HRR/A \geq 1-2 \text{ MW/m}^2$ characteristic for gasoline/diesel spill fires. Hydrogen regulations and standards, e.g., GTR#13 [31], require fire testing of CHSS following the protocol. The prescribed currently by the regulation values of HRR/A are below those for typical real fires such as gasoline/diesel spill fires. The reason is explained below. However, the authors believe that hydrogen storage tanks should be able to withstand any fire without rupture, not only fires of lower intensities. This has become possible by virtue of the μ LNB safety technology.

The situation changes drastically if the same tank is in a fire of a higher intensity, e.g., gasoline/diesel spill fire of $HRR/A = 1\text{--}2 \text{ MW/m}^2$ after a traffic incident. Fig. 2 shows that in such a fire intensity the tank could rupture in 5–6 min, i.e., before the TPRD is affected by the engulfing fire (see the insert at the bottom right corner of Fig. 2). This can create unacceptable hazards and associated risks for life and property in fires of higher intensity. It is thus understandable, that the fire test protocol suggested in GTR#13 could have serious life safety implications in real life, especially for the first responders, and must be amended to include fires of higher intensity.

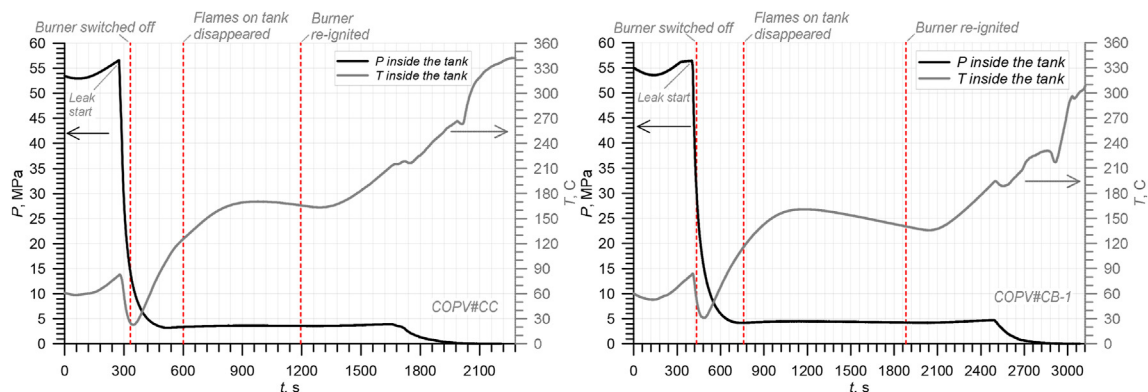
Fig. 4 – Pressure and temperature transients in μ LNB tanks with liner of grade L1 during the fire test. Left: carbon-carbon double-composite wall tank COPV#CC. Right: carbon-basalt double-composite wall tank COPV#CB-1.

Fig. 4 (left) shows the pressure and temperature dynamics in the μ LNB tank made of carbon-carbon double-composite wall (COPV#CC) during the fire test. Fig. 4 (right) presents the pressure and temperature transients for carbon-basalt double-composite wall tank (COPV#CB-1) during the fire test of the same intensity of realistic fire of $HRR/A = 1 \text{ MW/m}^2$. Both tanks undergone the same testing procedure. Pressure and temperature transients inside the tanks demonstrated similar

tendencies with few differences. The initial pressure in both tests of CEA in real tunnel was 54–55 MPa, i.e., below the NWP = 70 MPa. In the fire, pressure and temperature inside the tank grow due to heat transfer through the wall from the external fire. In the case of carbon-carbon (COPV#CC) μ LNB tank, hydrogen release through the microchannels of the composite wall started at about 4 min 40 s, and for the carbon-basalt (COPV#CB) tank later at 6 min 40 s. The microleaks are manifested by a sharp pressure drop from 56 to 57 MPa to about 15 MPa in just a minute. During this short time of pressure drop, the hydrogen temperature inside the tank decreased from about 80 °C to 24 °C for the COPV#CC tank and to 29 °C for the COPV#CB tank due to gas expansion. To imitate the removal of vehicle located over a spill fire, the burner was switched off (left vertical dashed line on the graphs) when the hydrogen release started (following the melting of liner in the μ LNB tank).

Because combustion of the resin of the composite continues after the burner was switched off, hydrogen temperature in tanks was growing further. Hydrogen temperature continued to grow even after the visible flames disappeared on the tank surface (middle vertical dashed line) at 10 min for the COPV#CC prototype and 12 min 40 s for the COPV#CB-1 tank (invisible microflames could still be present [43]). Because of heat accumulated in the wall and its higher temperature, hydrogen temperature continued to raise for about 6 more minutes for both tanks. Only then hydrogen temperature began to decrease. The pressure decrease stopped at about 8 min for the COPV#CC tank and 12 min for the COPV#CB-1 tank when the pressure in both tanks stabilised at 3.5–4.3 MPa pressure plateau. Such residual pressure of 4.3 MPa would require more than 33 times (NWP = 70 MPa multiplied by safety factor 2.25 and divided by 4.3 MPa) thinner wall compared to the initial wall thickness to bear the load. This could be equivalent of one composite ply, if tanks original wall thickness would be 33 mm. The decreased pressure inside the tank seems was not able to initiate microleaks in the absence of external fire even if the temperature of hydrogen measured by the thermocouple reached 160–170 °C, i.e., above the liner melting temperature. This can be explained by the extreme contraction of the composite due to the abrupt pressure drop and therefore, tightening the microchannels and terminating the leak. Due to the follow-on heat transfer from the re-initiated fire, the resin of the remained load-bearing virgin composite continued to decompose and hence, to form more micro-channels. This resulted in a later secondary leak and drop of inner pressure to atmospheric.

To complicate the intervention scenario, it was assumed that the fire re-ignites. To imitate this, the burner was re-ignited in the experiment (right vertical dashed line on the graphs of Fig. 4). The COPV#CC tank started to leak again after 7 min 30 s from re-ignition, and the microleaks in the COPV#CB-1 tank began with 10 min 30 s delay after re-ignition. Hydrogen temperature reached at the time of the second leak about 210 °C in the COPV#CC tank and about 195 °C in the COPV#CB-1 tank. Only at this comparatively elevated temperature of hydrogen, which is above the melting temperature of liner, in the combination with reduced significantly below NWP pressure, can re-start microleaks. The second initiation

of microleaks is manifested by a slight temperature drop due to gas expansion. Finally, the pressure drops to atmospheric in 5 min after the re-start of the microleaks for both tanks. Yet, the hydrogen temperature continues to grow due to heat from the fire even there is no overpressure in the tank. Thermocouple readings reach about 340 °C for the COPV#CC tank and 310 °C for the COPV#CB-1 tank at the end of the measurements. This is close to epoxy resin decomposition temperature of about 280–375 °C in the composite, e.g. Ref. [11], but significantly below the decomposition temperature of carbon fibres of about 700–750 °C for carbon fibres [44]. The increase of temperature after the pressure in the tank dropped to atmospheric could be explained, e.g., by the contact of thermocouple with melted liner or resin, or by penetration of hot combustion products inside the tank.

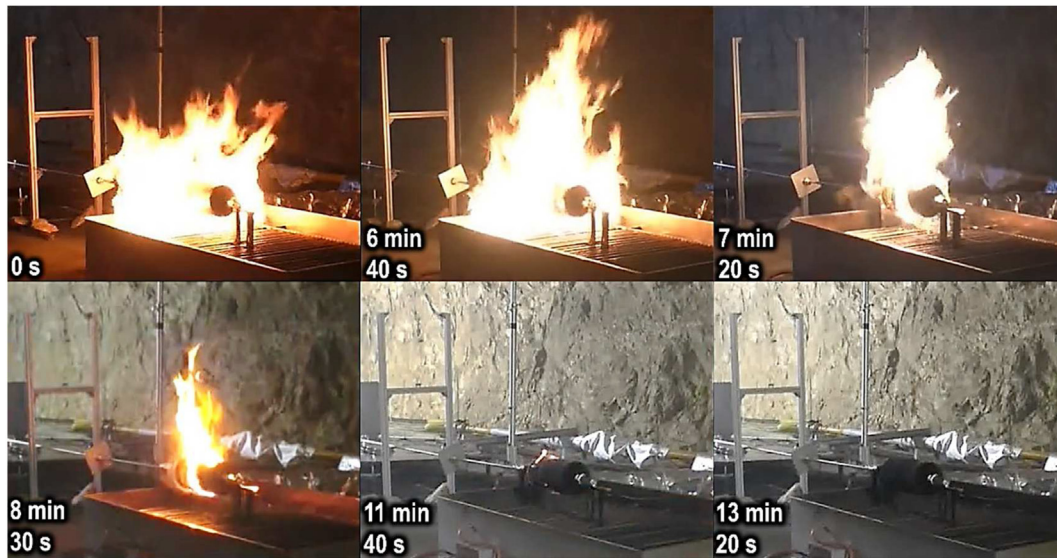
Fig. 5 – Snapshots of the μ LNB tank fire test with COPV#CB-1.

Fig. 5 shows a series of snapshots of fire test with COPV#CB-1 prototype. The test starts when the burner is ignited (snapshot “0 s”). Microleaks are started after the liner melting at 6 min 40 s (snapshot “6 min 40 s”). The flame size around the tank is the same with insignificant increase at the moment of leak start. Snapshot “7 min 20 s” shows combustion of resin of the tank when the burner is switched off. What is seen in this snapshot is the combustion of composite resin assisted by hydrogen released through the microchannels in the wall. This hydrogen-assisted resin combustion is seen almost a minute after, in snapshot “8 min 30 s”, where the flames got smaller. Few residual flames only are seen in snapshot “11 min 40 s” that corresponds to the time when pressure drop stops due to the contraction of the composite wall at significantly decreased pressure and formation of the pressure plateau at level of 4.3 MPa, as well as freezing of melted before liner. No flame observed at snapshot “13 min 20 s”.

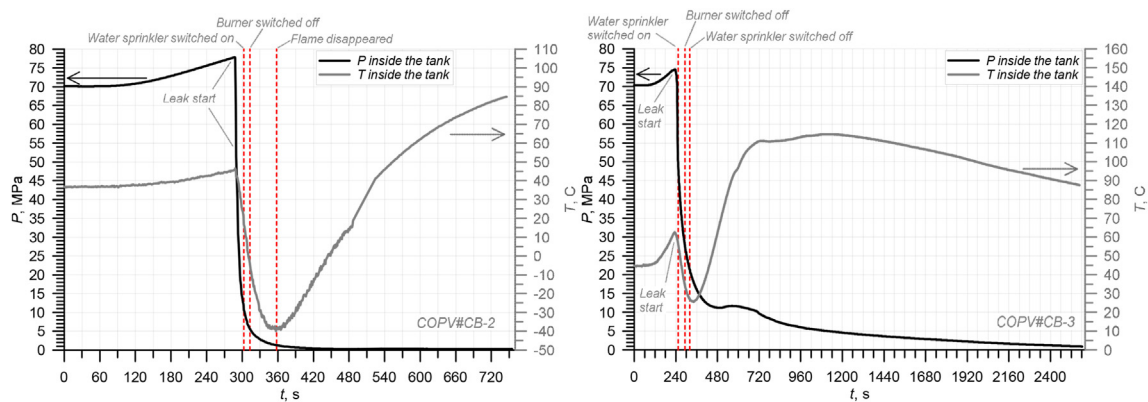
Fig. 6 – Pressure and temperature transients measured inside μ LNB tank prototypes during the fire tests: COPV#CB-2 with liner L2 (left), COPV#CB-3 with liner L1 (right).

Fig. 6 shows comparison of pressure and temperature dynamics for tank COPV#CB-2 (left) and tank COPV#CB-3 (right) for scenario with water jets supply to the tank from the above. The only difference in tanks' design is the grade of liner. The order of actions in the tests was as follows. The burner was ignited when pressure in tanks was equal to NWP = 70 MPa. Tank COPV#CB-2 started to leak after melting of liner L2 after 4 min 45 s when pressure inside the tank increased to 78 MPa, while liner L1 in COPV#CB-3 melted faster at 3 min 50 s when pressure raised to only 74.5 MPa. The rate of pressure growth was the same in both tanks but in test COPV#CB-3 liner L1 melted earlier. The drop of pressure in the test with tank COPV#CB-2 is responsible for the decrease of hydrogen temperature from 45 °C down to –38 °C (decrease by 83°), while the smaller rate of pressure decrease in tank COPV#CB-3 resulted in temperature decrease from 62 °C to minimum of 26 °C (decrease by 36° only).

In about 10 s after the start of microleaks the sprinkler was switched on and water sprays were applied to the top to the burning tank surface. Then in 10–20 s the burner was switched off. Then the two tests proceeded differently. While in the test with tank COPV#CB-2 the water supply continued to the test end, in the test with tank COPV#CB-3 the water supply

was switched off in 20 s after the burner was switched off. This is thought to be a reason of larger temperature drop in test with COPV#CB-2. The visible flames on the tank surface disappeared in both of these tests.

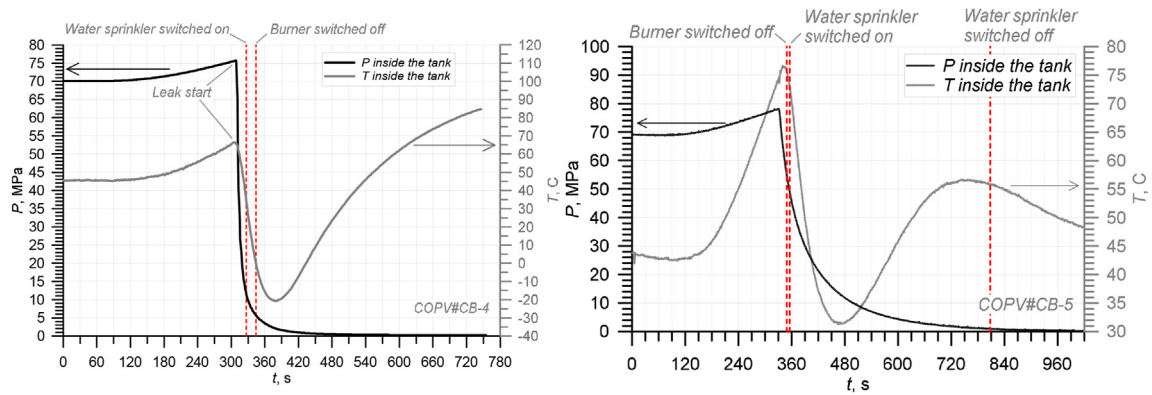
Fig. 7 – Pressure and temperature transients inside μ LNB tank prototypes during the fire tests: COPV#CB-4 (left) and COPV#CB-5 (right) both with liner L2.

Fig. 7 shows the pressure and temperature dynamics inside μ LNB tank prototypes COPV#CB-4 (left) and COPV#CB-5 (right) during the fire tests performed in different laboratories. Both tanks had liner L2 and the external diameter of tank COPV#CB-4 was slightly (2%) larger than in the original standard tank and other prototypes.

The analysis of temperature transient in Fig. 7 (right) shows that the initial hydrogen temperature in the tank was 43°C (probably above the ambient due to insufficient time for colling after filling the tank by hydrogen), and then went up to 76°C before the microleaks started, then dropped to the minimum of 32°C (by 44°) due to the gas expansion during pressure relief through microleaks. Then temperature started to grow again even in the presence of water supply on the tank top. However, the residual combustion at the bottom of the tank visible in the video seems was sufficient to provide temperature increase from 32°C up to the maximum of about 57°C at time 12 min 30 s. The combustion at the tank bottom could be hydrogen assisted resin combustion that

ceases when the pressure at the tank tends to atmospheric. This explains temperature decrease after 12 min 30 s of the test.

Hydrogen temperature in the test with tank COPV#CB-4 (Fig. 7, left) grows after the pressure in the tank drops to atmospheric. Like for tests with COPV#CC and COPV#CB-1, it could be explained by the contact of the thermocouple in the tank with melted and deformed liner or resin, or penetration of hot fire products through the matrix of fibres with degraded resin.
