Using Fine-Grained Sediment and Wave Attenuation as a New Measure for Evaluating the Efficacy of Offshore Breakwaters in Stabilizing an Eroded Muddy Coast: Insights from Ca Mau, the Mekong Delta of Vietnam

Citation: Luom, T.T.; Phong, N.T.; Anh, N.T.; Tung, N.T.; Tu, L.X.; Duong, T.A. Using Fine-Grained Sediment and Wave Attenuation as a New Measure for Evaluating the Efficacy of Offshore Breakwaters in Stabilizing an Eroded Muddy Coast: Insights from Ca Mau, the Mekong Delta of Vietnam. *Sustainability* **2021**, *13*, 4798. <https://doi.org/10.3390/su13094798>

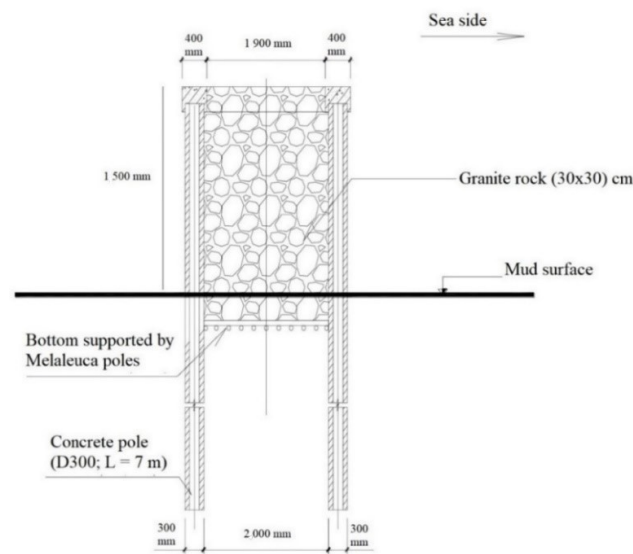
Construction of the HMS commenced in late 2010, and was completed in 2013. With a total length of approximately 6318 m, it cost approximately USD 1400 per meter. The HMS rises +1.5 m above the mud surface, and is composed of two lines of concrete piles with 2.6 m spacing. Melaleuca poles were used as base support that prevents granite rock from sinking in the mud. Granite rocks were used for filling the gaps between the concrete piles [11]. The technical design and elements are provided in Figure 2.

Figure 2. The HMS's structural design (adapted from [11]).

A remaining issue involves the compaction of liquid mud in the remaining gap of Section D and the deep areas surrounding the channel openings of the HMS. *Avicennia* species as pioneers assist in trapping and compacting sediment within muddy environments [35,43]. However, the transplantation of this species in the sections did not resolve this issue because the current topographical conditions were unsuitable for the growth of this species or other species (see Figures 11D and 12). Therefore, further measures will need to be taken. One measure involves the complete elevation of the gaps to provide suitable mangrove substrates [36–38]. A second measure involves the construction of supplementary structures inside the gaps to compartmentalize the gaps. The compartmentalization would provide additional wave dissipation, thus further aid siltation. Supplementary structures could include melaleuca fences of the Vam Ray model [34,35]. A further measure involves a redesign of the HMS, with the aim of accumulating additional sediment transported onshore by incident waves, particularly at high tides that would help to build up these areas. This measure would use the sediment accumulated in front of the HMS. The crest of the HMS could be lowered, the width narrowed, and gaps adequately explained, or more opening areas created to connect the sedimentation process between the sections and the sea. The lowering would allow waves to overtop the structure, thus allowing fine-grained sediment to accumulate within the restoration sections. The narrowing should be ideally undertaken by reducing gaps between the two rows of concrete piles and using

less granite rock. The increase in porosity would allow sediment to be transported through the HMS. The construction of additional structures and the redesign of existing structures, while incurring additional costs, are likely to be more cost-effective than the elevation of all the gaps behind the HMS.

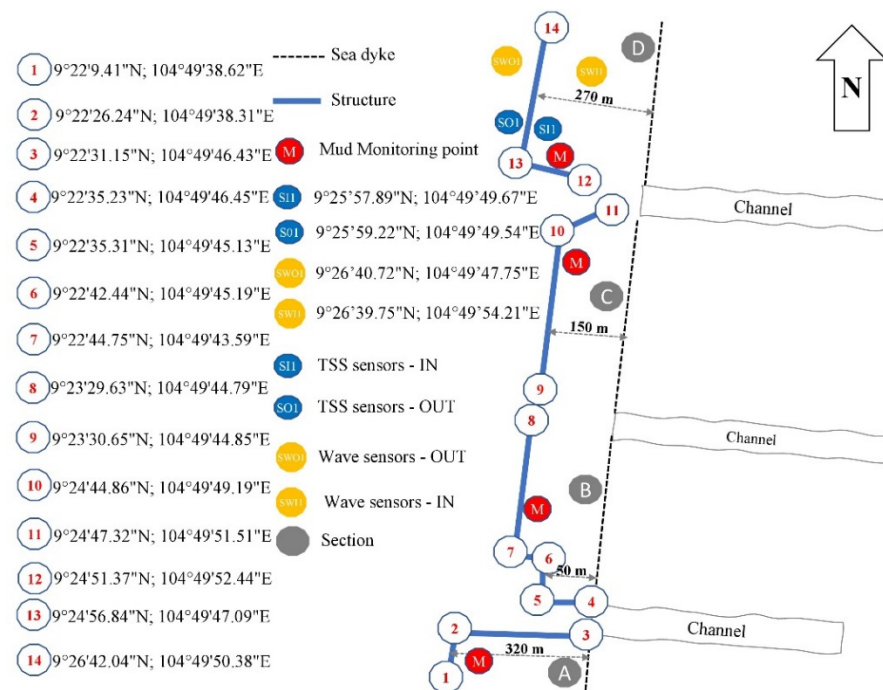
The HMS is in four sections, with three openings, created for local boating purposes. Gaps between the structure and the shoreline vary from section to section. Of the four sections, three (Sections A, B and C) incorporated landfill in order to elevate the soil surface, where seedlings were transplanted. Six-month-old seedlings of *Avicennia marina* were transplanted in straight lines at a density of 10,000 seedlings/ha in the gaps (Figures 3 and 4 and Table 1).

Figure 3. The HMS layout.

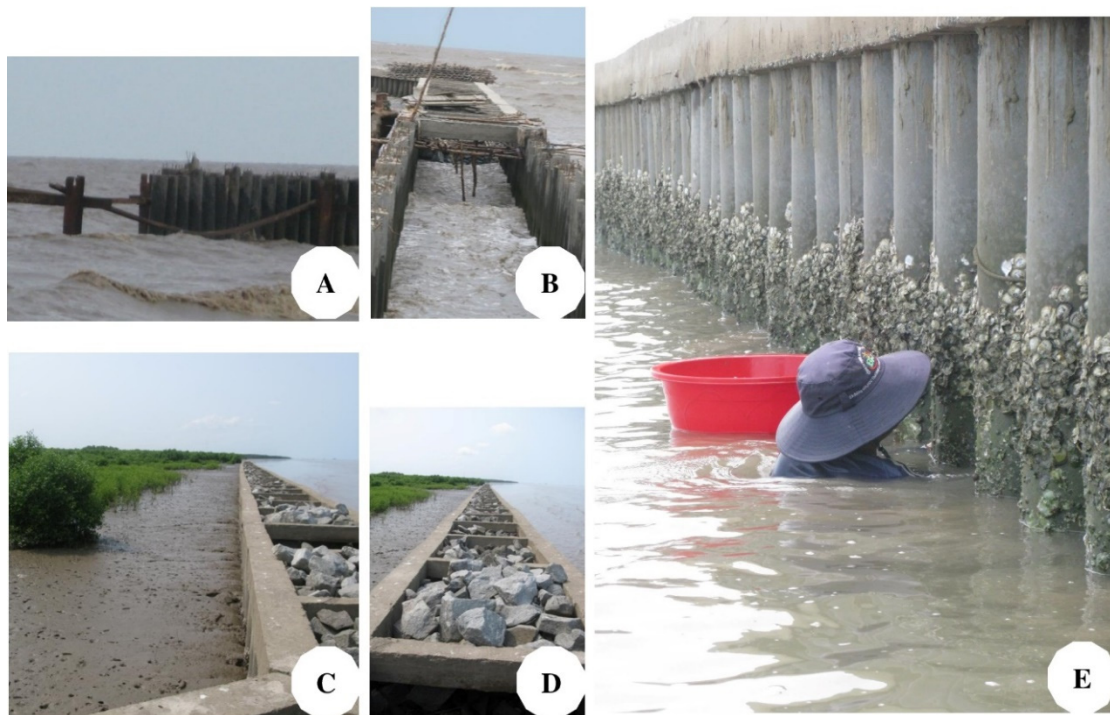
Figure 4. The HMS construction. (A,B) Two lines of concrete piles were first constructed. (C,D) Granite rocks filled the gaps between the two lines with 6-month-old seedlings of *Avicennia marina* transplanted in the gaps between the pile lines and the sea dyke. (E) Low tides against the height of the structure.

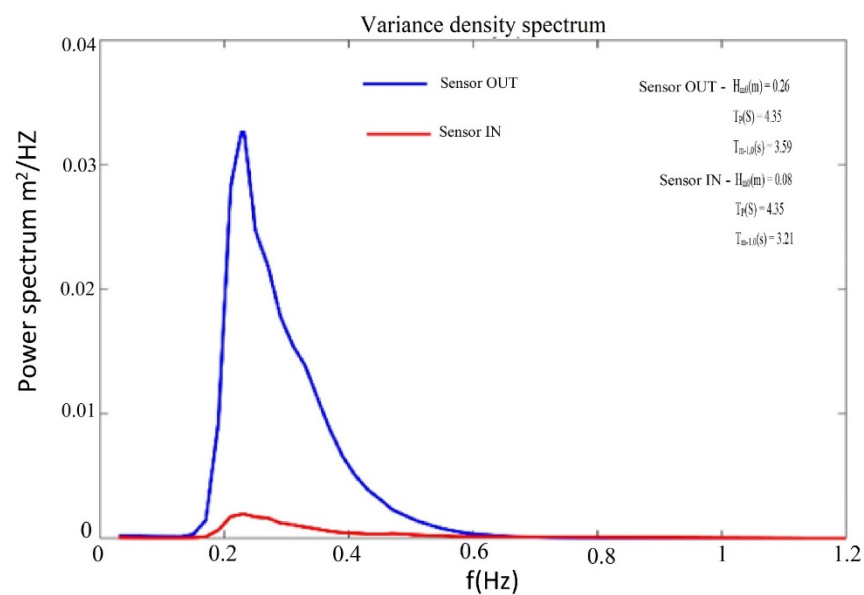
Figure 5. Wave spectrum with the blue line representing the power spectrum outside the HMS, and the red line indicating the power spectrum inside the sections.

The HMS was effective in dissipating the energy of incident waves, even at high tides. The wave spectrum outside the HMS had a highly peaked wave power spectrum with a high energy distribution of more than 0.03 Hz, while the spectrum inside the sections became flattened due to the energy attenuation provided by the HMS (Figure 5).

T (wave period) = 4.35 s (retrieved from Figure 5) of the results.

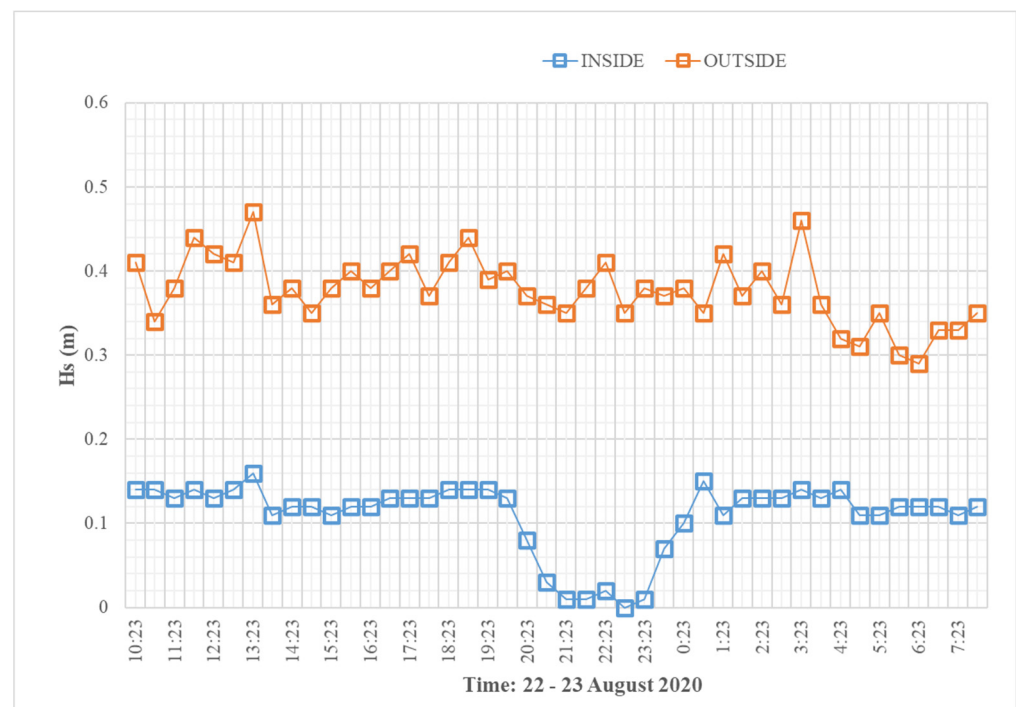
Figure 6. Wave height measurement.

The wave height outside the HMS ranged between 0.29 and 0.47m, and between 0.01 and 0.16 m inside the HMS (Figure 6).

H (wave height) = 0.12 m (retrieved from Figure 6 of the results)

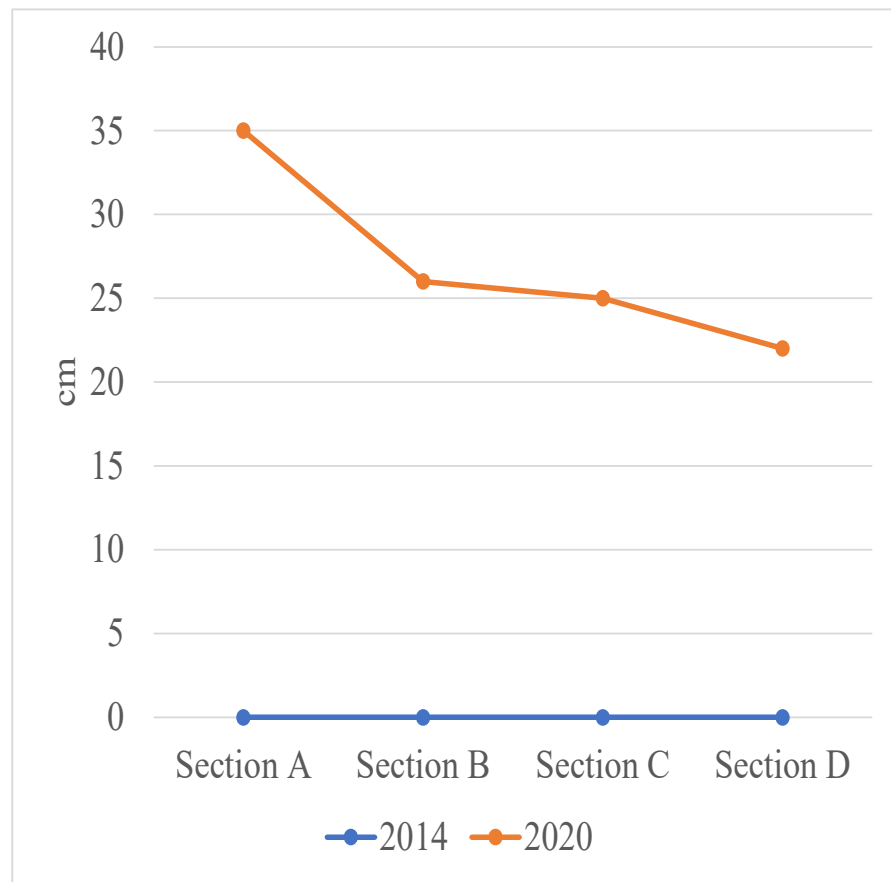
The recording showed that there was a low level of sediment accumulation across the sections (Figure 7).

Figure 7. Accumulation of fine-grained sediment inside the sections between February 2014 and November 2020.

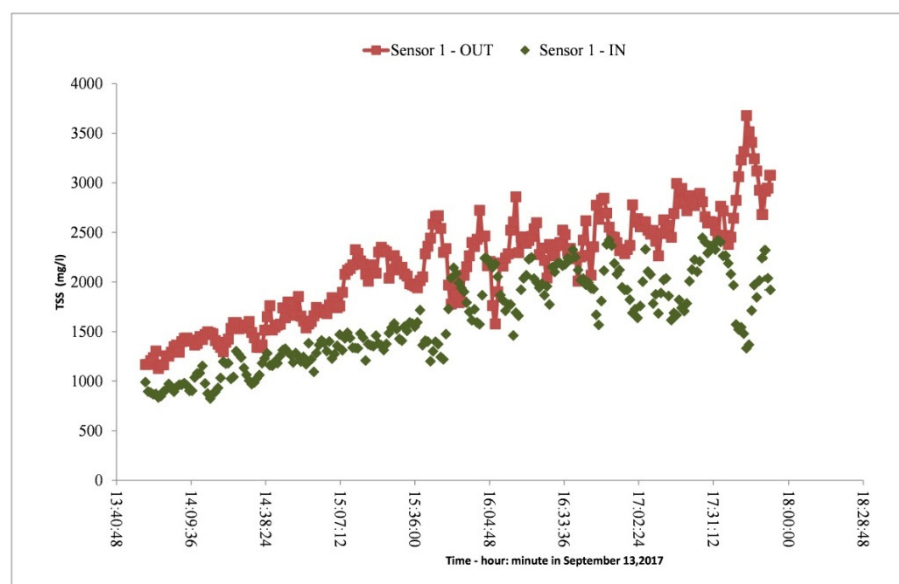
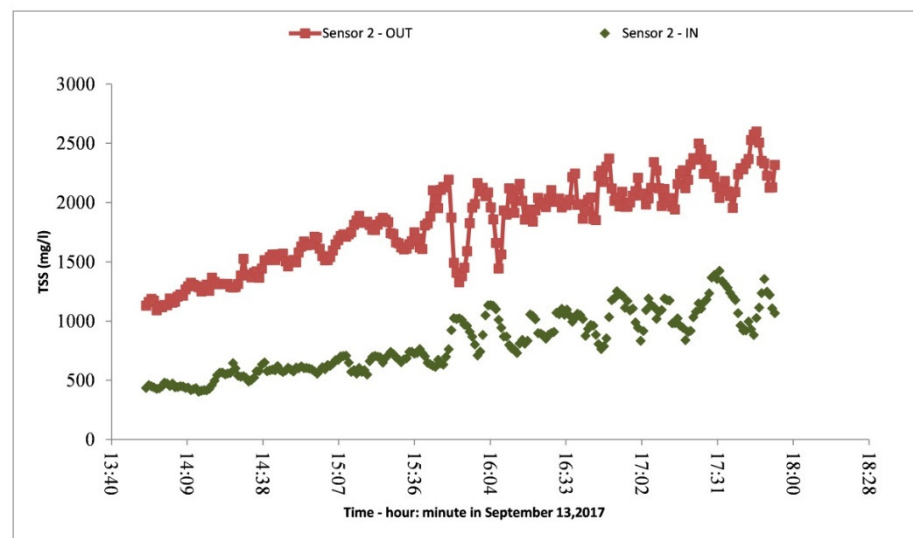
The field-based measurements indicated that the sections experienced a high level of TSS, possibly a few thousand mg/L on either side of the HMS in July 2017. This occurred when the southwest monsoon dominated. However, the sections gained a lower level of TSS than the foreshore of the HMS (Figure 8).

Figure 8. TSS recorded in the middle of the southwest monsoon on both sides of the HMS.

The HMS was effective in reducing up to around 70% of incident wave energy (Figures 8 and 9). Thus, transplanted seedlings were well-protected in the sections, as shown in Figures 10 and 11. In addition to the protection from the HMS, transplanted seedlings' survival was aided by the use of landfill to elevate soil, thus providing a more favorable growing condition. This may explain why Sections A, B and C experienced

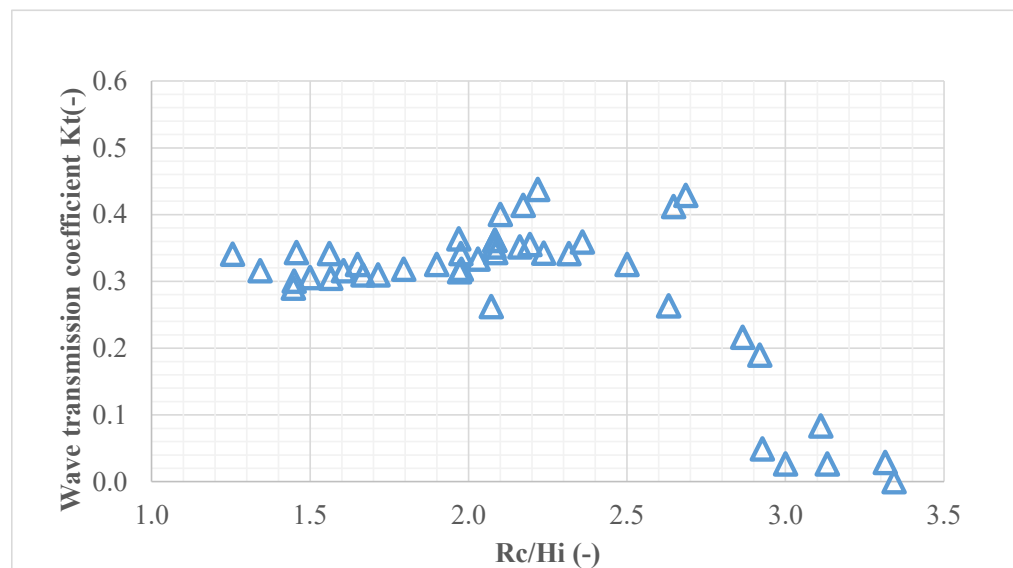
The transmission coefficient K_t through the HMS ranged between 0.29 and 0.44 with respect to the R_c/H_i value of more than 1.0 (Figure 9).

Figure 9. Wave transmission coefficients through the HMS.

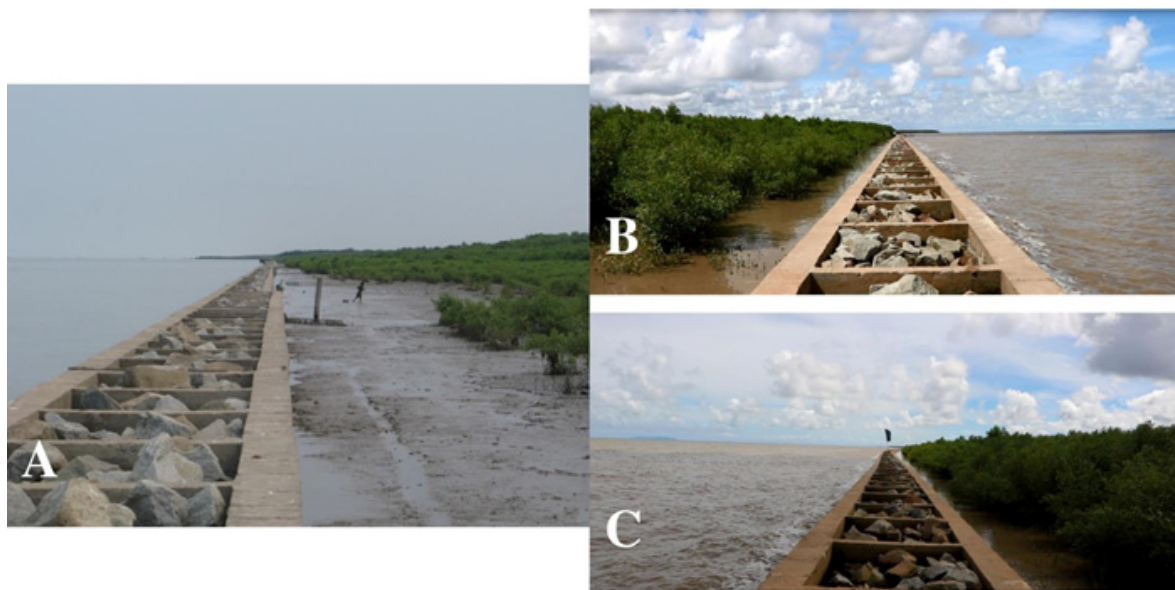
From the field visits, it was apparent that the HMS was higher than incident wave crests, even at high tides, therefore preventing the waves from overtopping the structure. The HMS is structurally strong, with the maximum width of 2.6 m effectively attenuating the energy of incident waves, even at high tides. Fine-grained sediment accumulated in the foreshore of the structure, while liquid mud was observed around the openings along the HMS (Figure 10 and Table 2).

Figure 10. Incident waves at high tides did not overtop the HMS in November 2020, which was the period of highest tides in the area. (A) Low tide, and (B,C) high tides with strong incident waves.

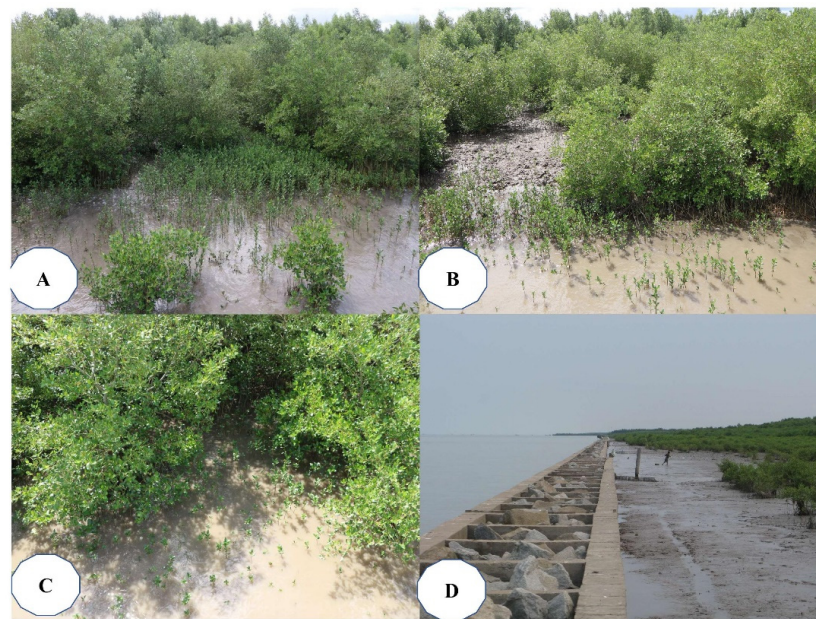
The sections were still in liquid mud condition, with limited regeneration of mangrove trees in gaps among mother mangrove trees in Sections A, B and C and elevated soil surfaces (Figure 11 and Table 2).

Figure 11. Natural regeneration among transplanted mangrove trees across the sections. (A) Section A; (B) section B; (C) section C; (D) section D.

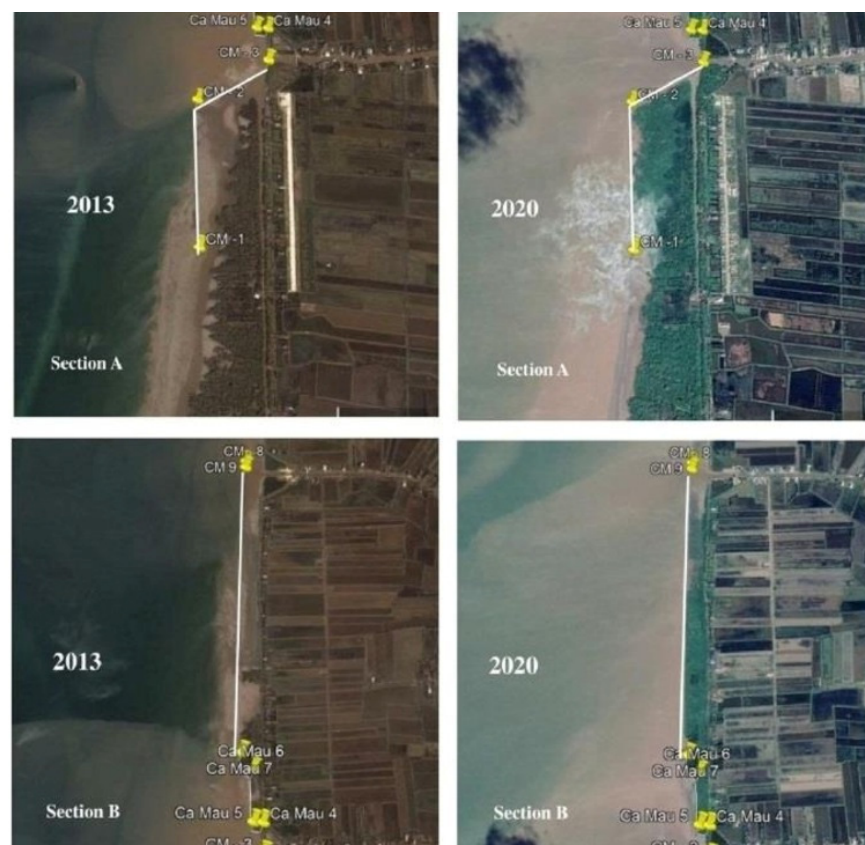
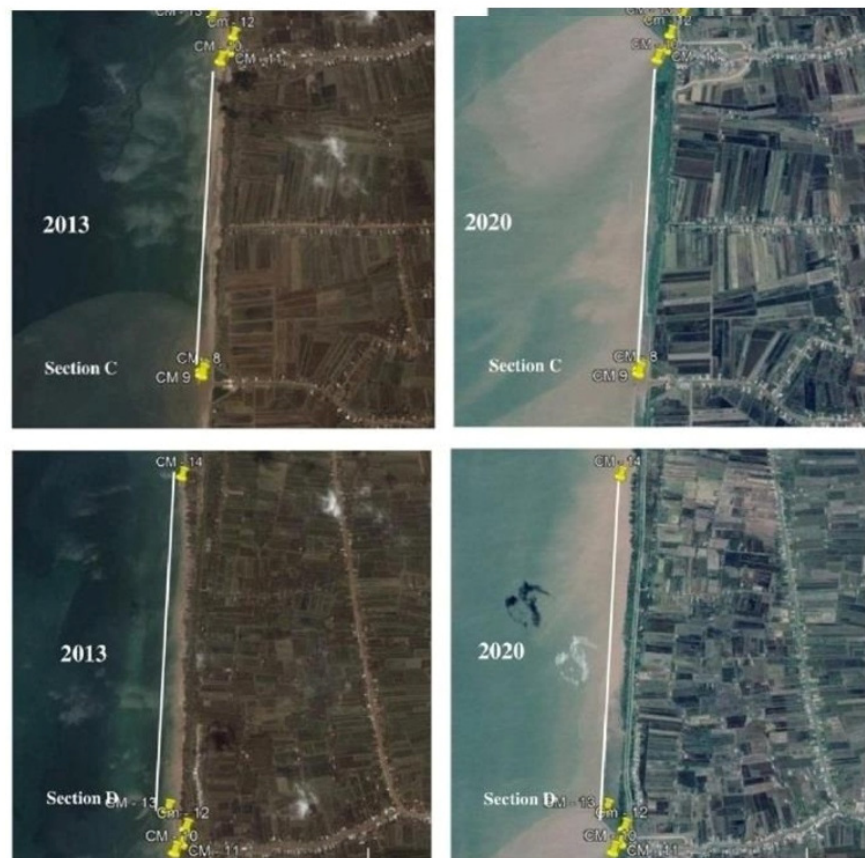
The image analysis revealed that the sections experienced variable levels of stabilization between 2013 and 2020. Of the four sections, Section A was entirely stabilized with the largest coverage of mangrove species, with Section D the least stabilized and with lowest mangrove coverage (Figure 12).

Figure 12. Changes across the sections between 2013 and 2020. The white line represents the HMS.
