DRAWINGS FOR THE REUSE OF NINETEENTH CENTURY GREENHOUSES IN THE GARDEN OF VILLA CICOGNA MOZZONI

D. Jovanović^{1*}, D. Oreni¹

¹ Dept. of Architecture, Built Environment and Construction Engineering, Politecnico di Milano, Milan, Italy
(dina.jovanovic, daniela.oreni)@polimi.it

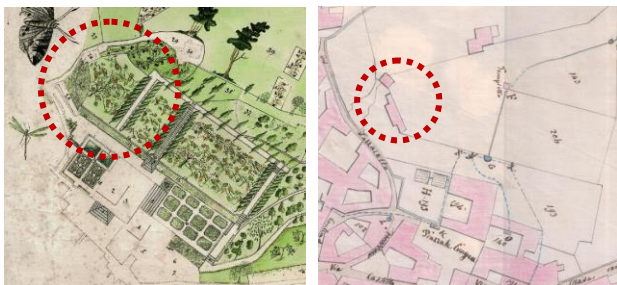
Figure 2. Left: *Tipo dimostrante il Celebre Giardino* from 1813 (Source: A.C.M.). Right: Detail of the Census Map of Bisuschio from 1898 (1:2000), with the indication of *Acquedotto Cicogna* (Source: Archivio di Stato di Varese). The space of the greenhouses is marked.

The first detailed drawing of the garden of Villa Cicogna dates back to 1813, the year in which the plan called *Tipo dimostrante il Celebre Giardino e Palazzo dell'Ill.mo Sign.r Conte Franco Leopoldo Cicogna Mozzoni* was surveyed and depicted by Della Besta Giacinto being *Agrimensore e Geometra*. The land that is now occupied by the greenhouses, known also as 'the hill', was covered with meadows, vines, and fruit trees (on the map, No.33 this reads *prato vitato con frutti*), at the base of which was a 'lemon house' (No. 24) for 'citrus fruits and flowers' and a 'small garden dug into the massif for flowers' (No. 25). Toward the north, on the boundary of the property, connected to the gardener's house (No. 30), there was a 'little house for sheltering flowers' (No. 26) which is the Villa's first greenhouse that no longer exists today (Figure 2). In historical documents from the Historical Archive Cicogna Mozzoni of Bisuschio (A. C. M.) are mentioned some minor maintenance works done on the *Limoniera* in 1853 and 1854.

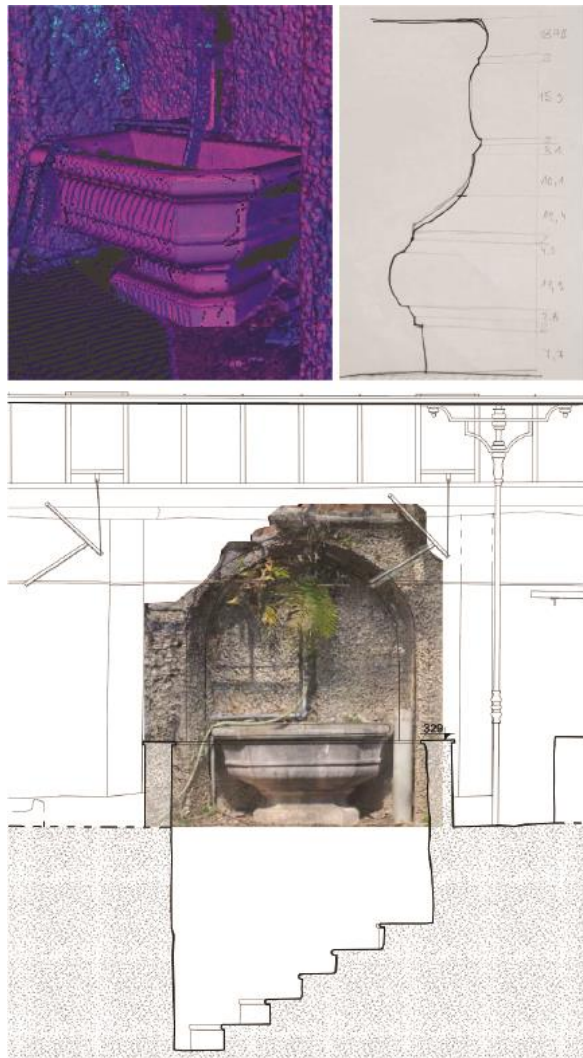
Figure 8. Orthophoto created in Agisoft Metashape was integrated into a technical drawing to show different materials. Sketches and photographs are helping in the creation of better drawings (Source: Authors).

Photographic material has been divided into two parts. The first regards documentation of details, surroundings, and used equipment and the second part that concerns photo acquiring for the application of photogrammetry techniques. The software Agisoft Metashape Pro was used to texturize mesh models and build dense point clouds to finally obtain orthophotos. The environment (i.e., very bright interior, reflecting and transparent surfaces, overgrown vegetation) and typology of these buildings presented a constraint in creating complete orthophotos. For the glass surfaces and iron elements, direct measures were taken and photographs are acquired, while the orthophotos were reserved for other features made from non-transparent materials, such as iron or stone, with a distinguished geometry (Historic England, 2011). The orthophotos were produced for some of the particular decorative and furnishing elements, mechanical systems for opening the windows, and cast-iron staircase railings columns. The brick masonry wall inside greenhouse B is covered with spongy tuff stones with playful black stone lines imitating the vines. The pavement is decorated in white and black pebbles, imitating the vine with leaves, going around in an elongated oval shape on the whole plan. Photo acquisition, direct measuring and hand sketching were done *in situ*. This approach is following the guidelines for surveying greenhouses

and their decorative finishing features, by mapping materials, colours, and damages (Figure 8).

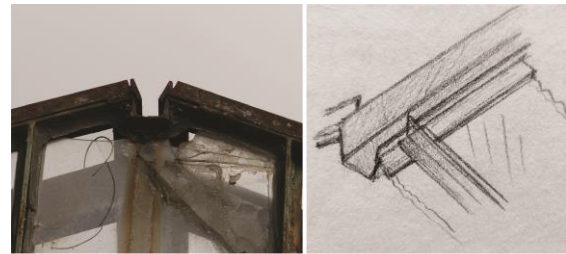
Figure 12. Roof ridge of greenhouse B. Detail of the fixture and iron glass frame (Source: Authors).

Iron fixtures and structural systems are complex to understand and document. Often because of their characteristics, they are only partially surveyed with the laser scanner. Here the crucial importance has photographic documentation, direct measuring, and sketching. To be able to understand iron intersections, which are now oxidised and covered with various types of decay, an in-depth study is necessary (Figure 12). Along the structure of the investigated greenhouses, not all the elements are the same and they should be treated separately.
