Nondestructive Evaluation of Structural Defects in Concrete Slabs

NONDESTRUCTIVE EVALUATION OF STRUCTURAL DEFECTS IN CONCRETE SLABS

ABSTRACT

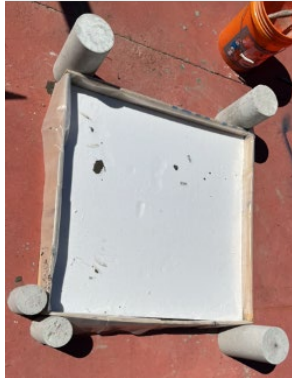
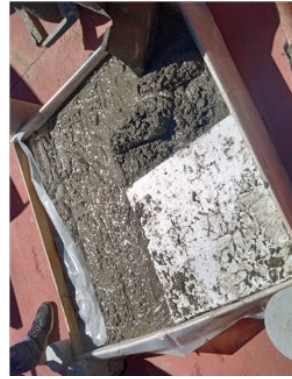
Figure 2: Specimen S2 embedded with polystyrene sheets to simulate delamination

Specimen ID	Simulated Defect(s) ^c	Additional Description
S1 ^a	–	Control (or witness) slab shown in figure 1.
S2 ^b	DL	Polystyrene sheets of 3/8 in. (0.95 cm) thick were placed in two layers to simulate DL. The first sheet (3 ft. × 3 ft.) was placed at a depth of 3.5 in. beneath the top face of the panel (Figs. 2a & 2c). The second sheet (1.5 ft. × 1.5 ft.) was placed 2.5 in. below the top on side “A” (Figs. 2b & 2d). After the formwork

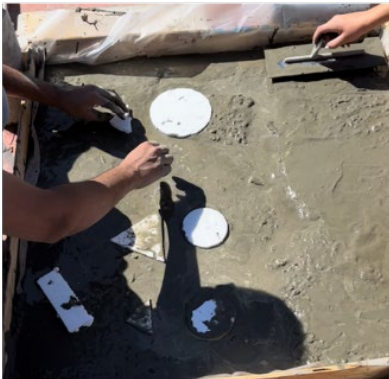
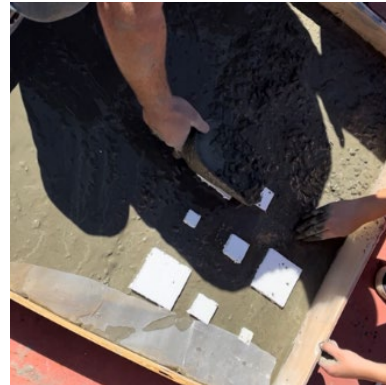
Figure 3: Specimen S3 implanted with small delamination targets (polystyrene blocks)

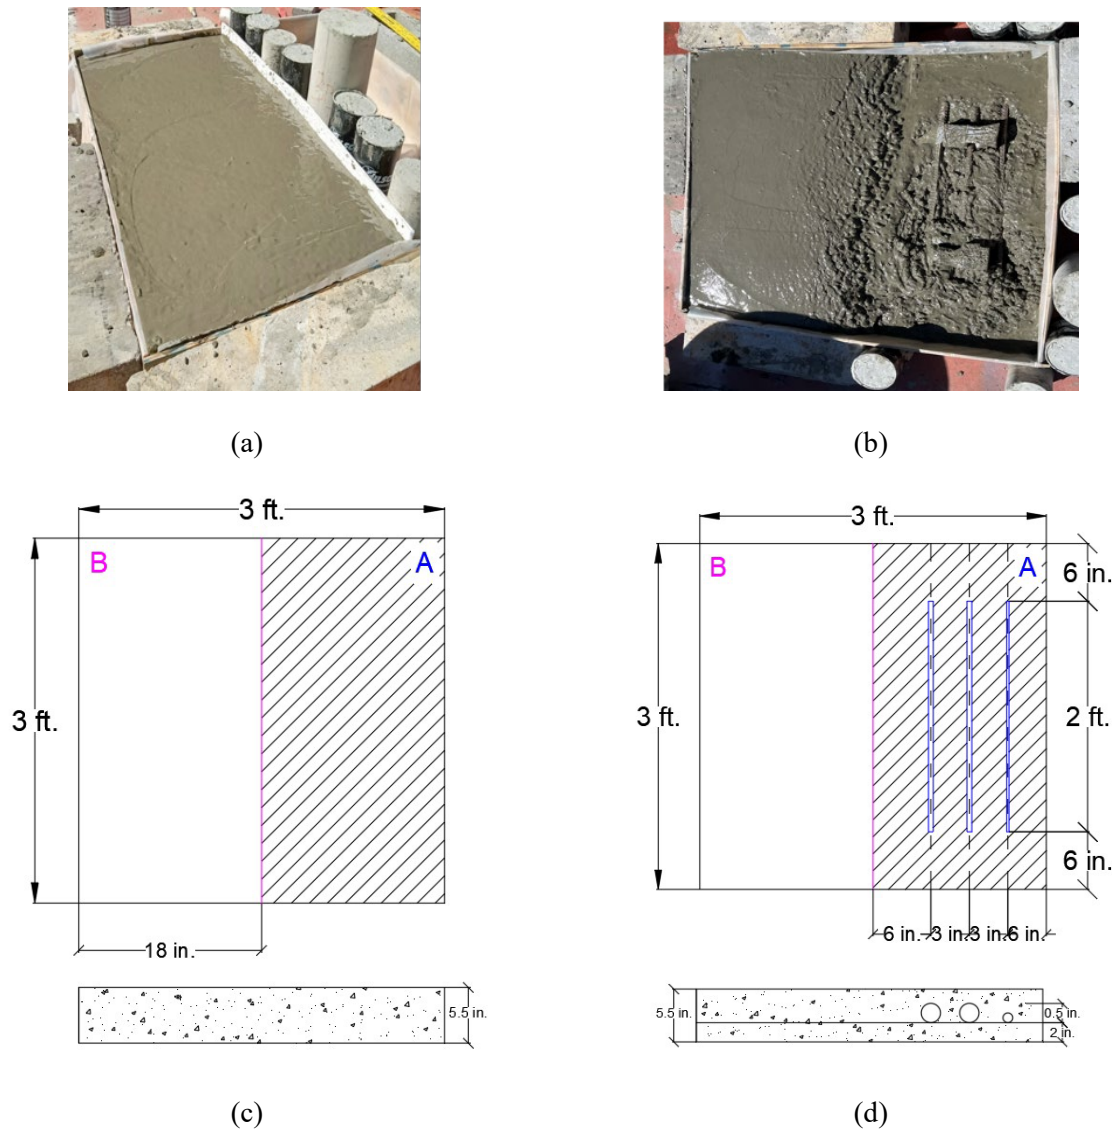
Figure 5: Specimen S5 embedded with corroded rebars

S5 ^b	C	In this case, side B was employed as control (or witness) slab since it has no defects.

<p>On the opposite side A, two No. 4 (diameter = 12 mm or 0.50 in.) and one No. 3 (diameter = 10 mm or 0.375 in.) bars were placed. ASTM standard rebars were used. The No. 3 bar on the slab was in the corner. To maintain uniform spacing between the rebars and clear cover from the bottom of the slab, concrete blocks of 3×3 inches (for spacing) and 2×2 inches (for cover) were used respectively. The blocks were placed and secured with rebars from the bottom. To simulate corrosion, corroded rebars were used.</p>
<p>^a slab thickness of 5 inches</p> <p>^b slab thickness of 5.5 inches</p> <p>^c Corrosion (C), delamination (DL), honeycomb (H), voids (V)</p>

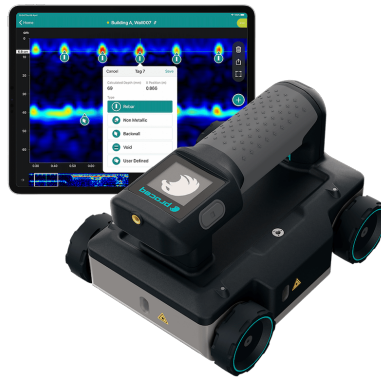
Figure 6: Proceq GP8000 GPR unit

from Screening Eagle Technologies (USA), for example, employs a monostatic (or transceiver) ground-coupled antenna system for transmitting and receiving EM waves (Fig. 6). It uses the stepped-frequency continuous-wave (SFCW) radar technology to generate modulated frequencies ranging from 200 – 4000 MHz with a penetration depth of 31.5 inches (80 cm). The waveform of SFCW radar is generated by transmitting a series of single-frequency waves separated by ΔF hertz. The amplitude and phase of the received data are sampled and recorded at each frequency. The data is then transformed into the spatial domain using the Inverse Discrete Fourier Transform (IDFT) in most implementations which produces a synthesized pulse (0-20 ns) (Langman and Inggs, 2001).

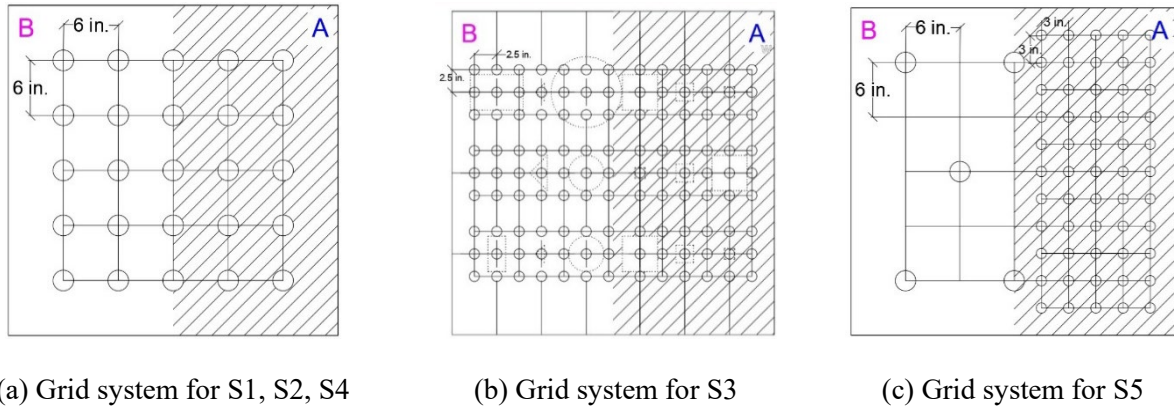
Figure 13. IE data acquisition process

When collecting IE data for this study, the ASTM C1383 – 15 guidelines were followed (ASTM, 2022). The data acquisition process used a grid system of transverse and lateral gridlines that were marked on the top surface of the concrete slabs as shown in figure 13. For this study, three grid systems were selected for the concrete slabs, covering the entire defect or defect areas, and excluding the boundary edges. The side ‘B’ of the tested specimen is shown by a hatched section. Before beginning data recording, the data acquisition parameters were manually adjusted in the NDE-360 system to meet the measurement requirements (Figure 14).

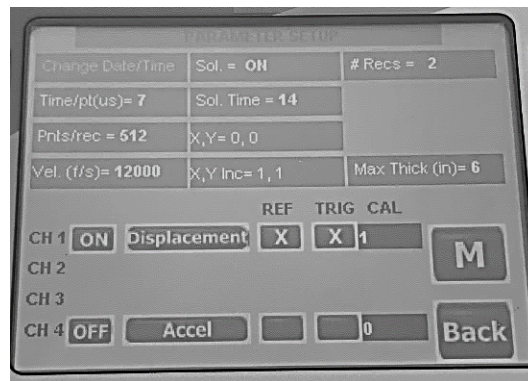
Figure 14. IE data acquisition parameters

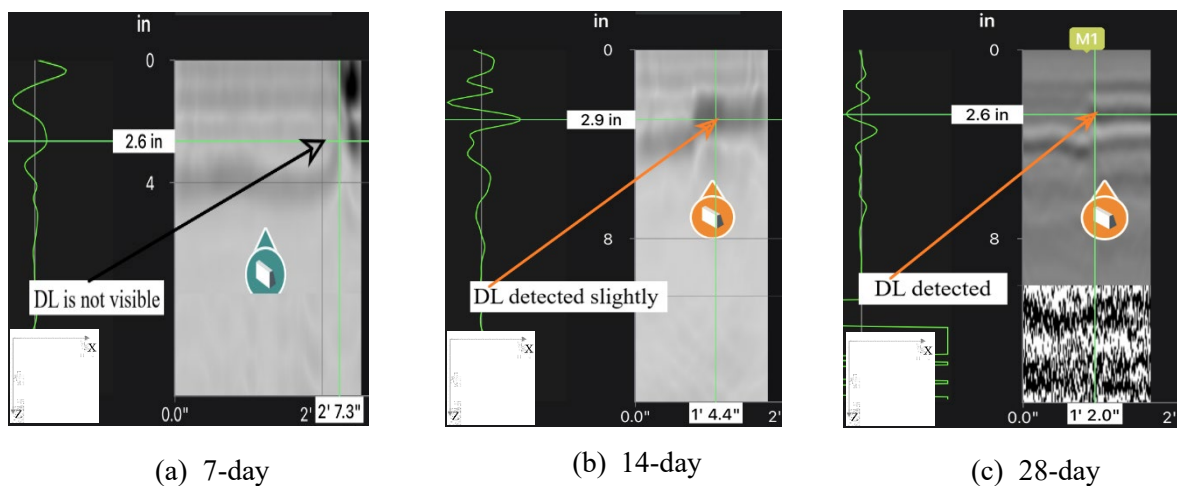
Figure 15: A-scan and B-scan data S2 (side A)

Table 5 summarizes the GPR results for defect visibility and detection based on the three types of scans. For specimen S2, the 14-day scan results showed evidence of delamination from the two different types of Polystyrene sheets, as illustrated in figures 15 (b) and 16 (b). After the concrete had cured for 28-days, the shapes were clearly distinguishable as can be seen in figures 15(c) and 16(c). The same behavior was observed in specimen S5, where corroded rebars were employed to detect corrosion (figure 17). One possible explanation for this phenomenon is that the moisture content of concrete varies with age (Hedjazi and Kabir, 2022), which will be discussed in greater detail in section 5. Furthermore, GPR C-scan data confirmed the definitive shapes of three corroded rebars in specimen S5 as shown in figure 18(c). The C-scan data of S2 also produced credible shapes for the two Polystyrene sheets simulating delamination. However, GPR results for specimen S3 were ambiguous to picture any delamination targets embedded at
