A Study of the Effect of Machine Parameters on Defects Produced in EOS Additive Manufacturing Builds

A Dissertation Presented for the
Doctor of Philosophy
Degree
The University of Tennessee, Knoxville

Tina White Malone
May 2023

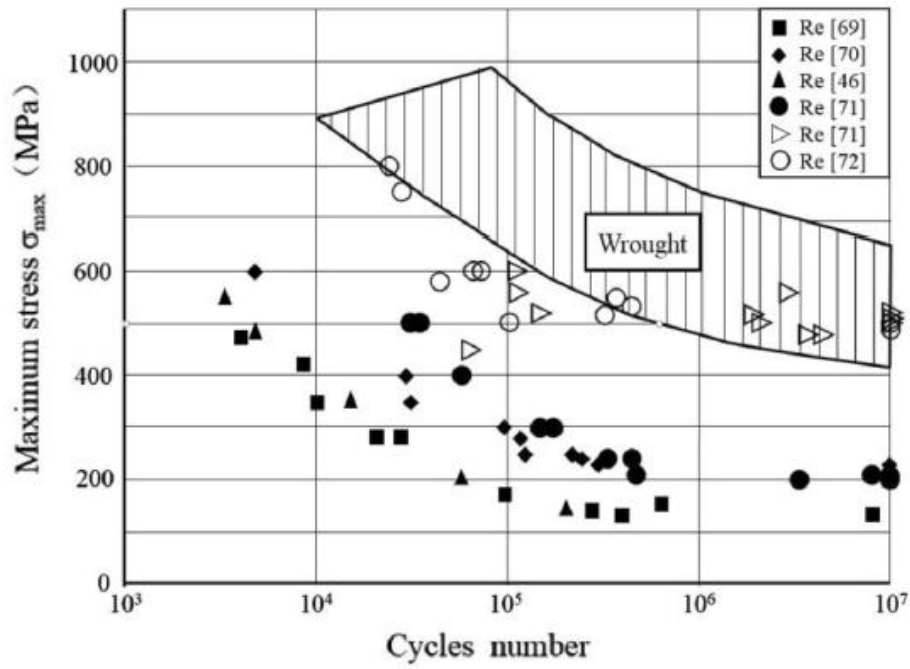
Figure 2.9 Summary of Fatigue Data for Ti6Al4V SLM Parts Containing Defects [1]

¹Defects are detrimental to the fatigue life of any part and impacts SLM parts as well. Defects serve as crack initiation sites and points of stress concentration that will ultimately reduce the fatigue life of a part. References 40, 41, 42, 43, 44, and 45 all present data for Ti6Al4V that demonstrates this phenomenon as it relates to SLM produced materials and represents the summary of the data that Zhang used to develop Figure 2.9.

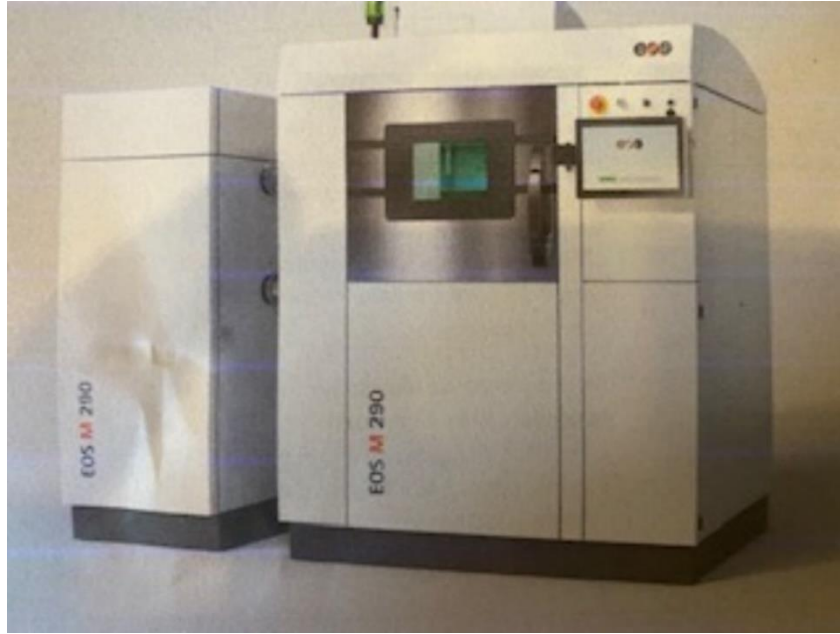
Figure 3.1 EOS M290 DMLS Printer

⁵⁴An EOS M 290 located at Marshall Space Flight Center was used to build the test panels. The EOS M 290 is an industrial 3D printer. Figure 3.1 shows a picture of the EOS M 290. The M 290 is a DMLS printer which uses a 400W Yb fiber laser scanning up to 7.0 m/s with a focusing diameter of 0.004 in. The high beam quality of the laser spot is regarded as exceptional producing detail resolution ideal for manufacturing highly complex DMLS components that are expected to ensure homogeneous part properties from part to part, job to job, and machine to machine. It uses a 32A/400V power supply and consumes up to a maximum of 8.5 kW with an average consumption of 2.4 kW. The system software includes a CAM tool, EOSPRINT, for developing and managing each job, a module for inputting desired parameters called EOS Parameter

Editor, for application specific optimization of parameters and a comprehensive monitoring suite called EOSTATE which includes five different monitoring systems. These monitoring systems include system, laser, powder-bed, melt-pool, and exposure (optical tomography).

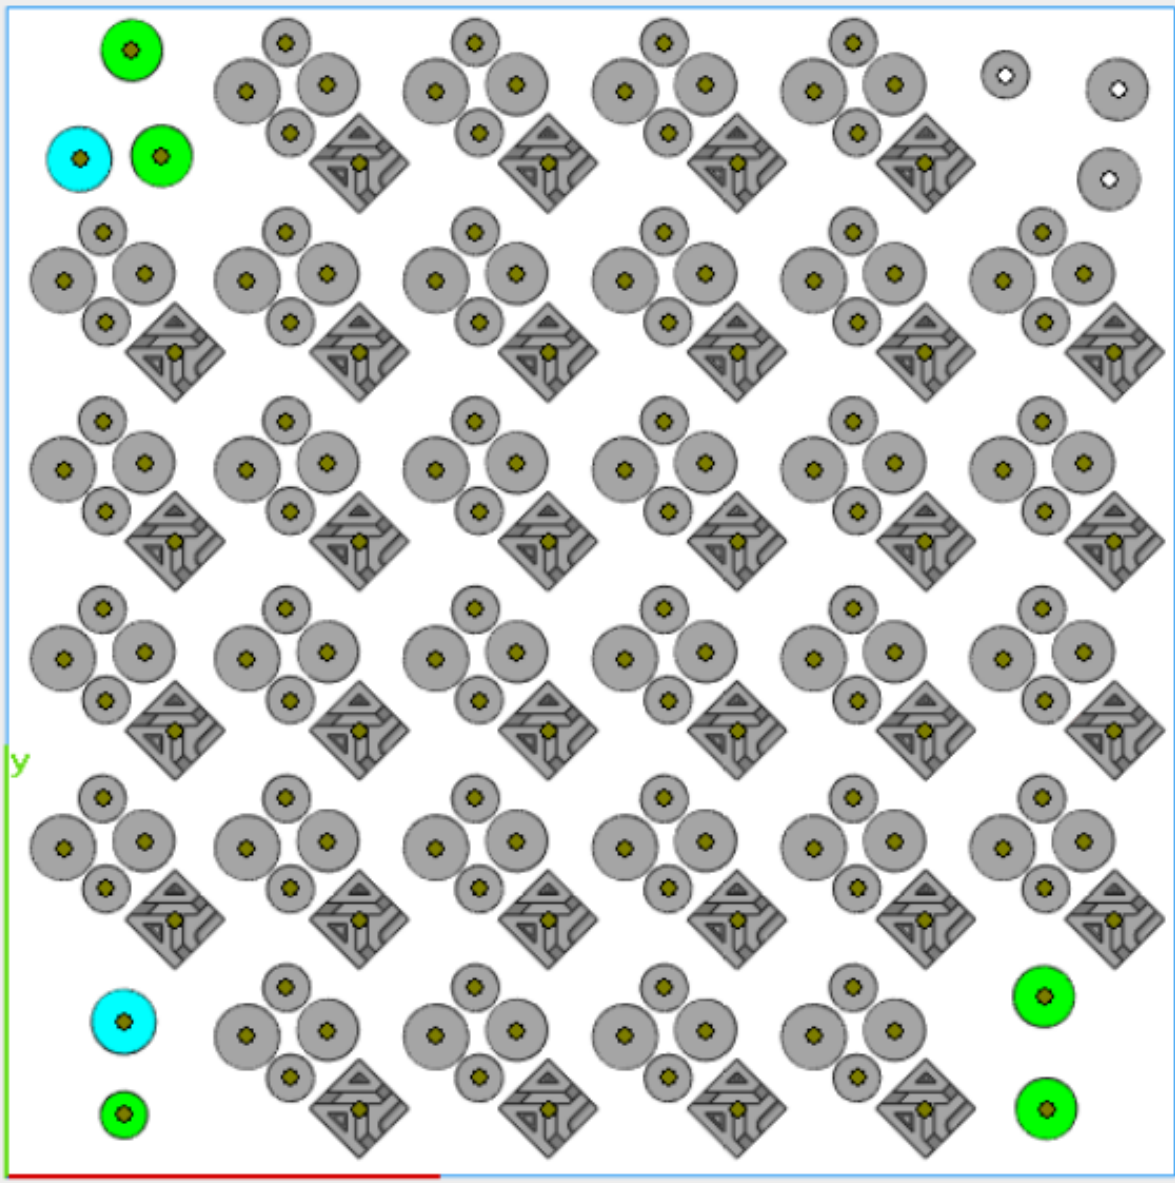
Figure 4.2 Specimen Build Plate Layout (build plate is 250 mm x 250 mm).

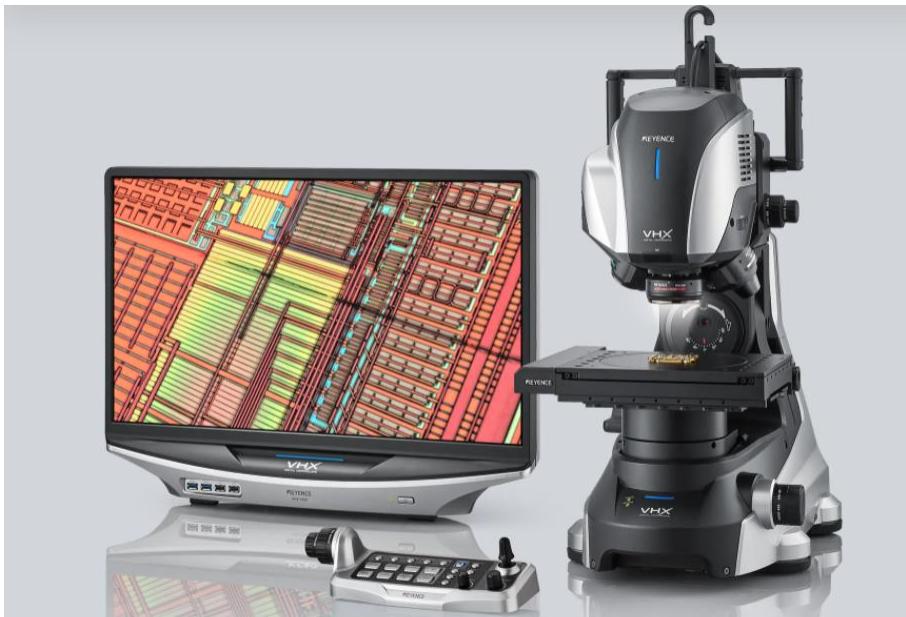
Figure 4.9 Keyence 3D Microscope System

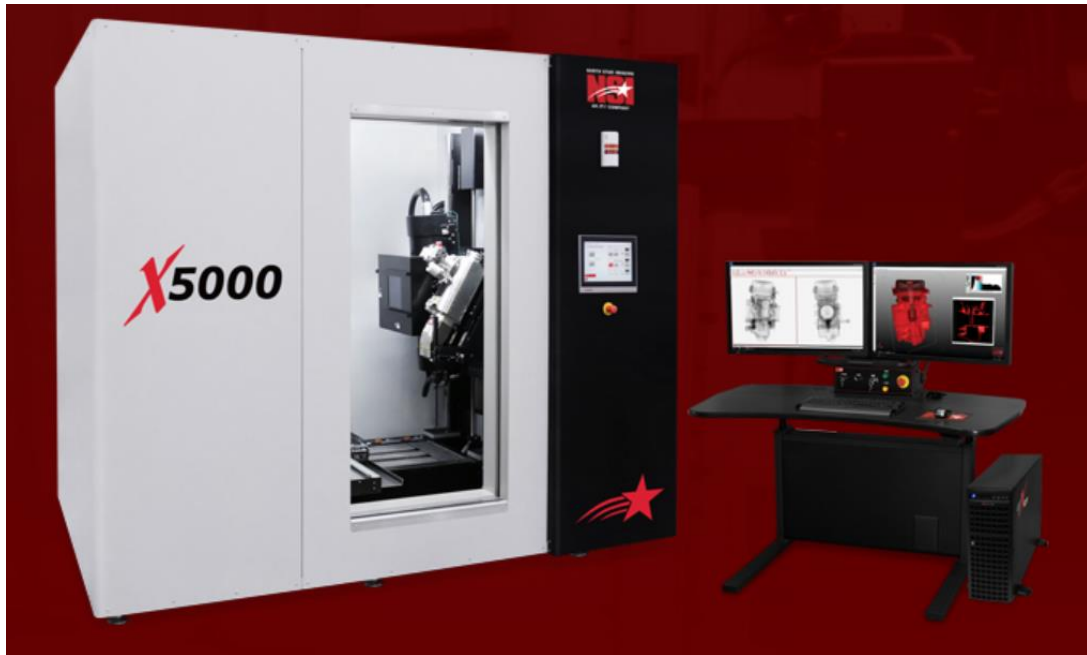
4.10 North Star X5000 CT System

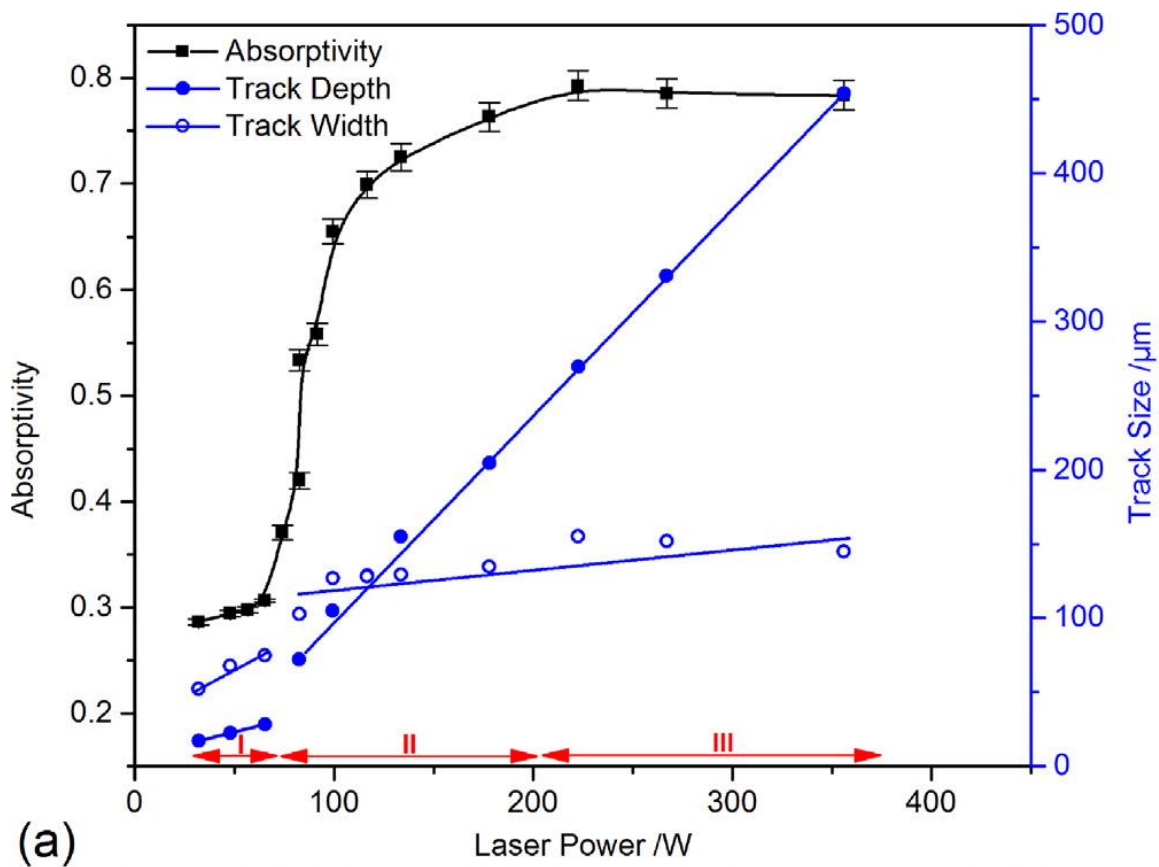
Figure 5.2 Absorptivity versus Laser Power for 316L Stainless Steel (71)

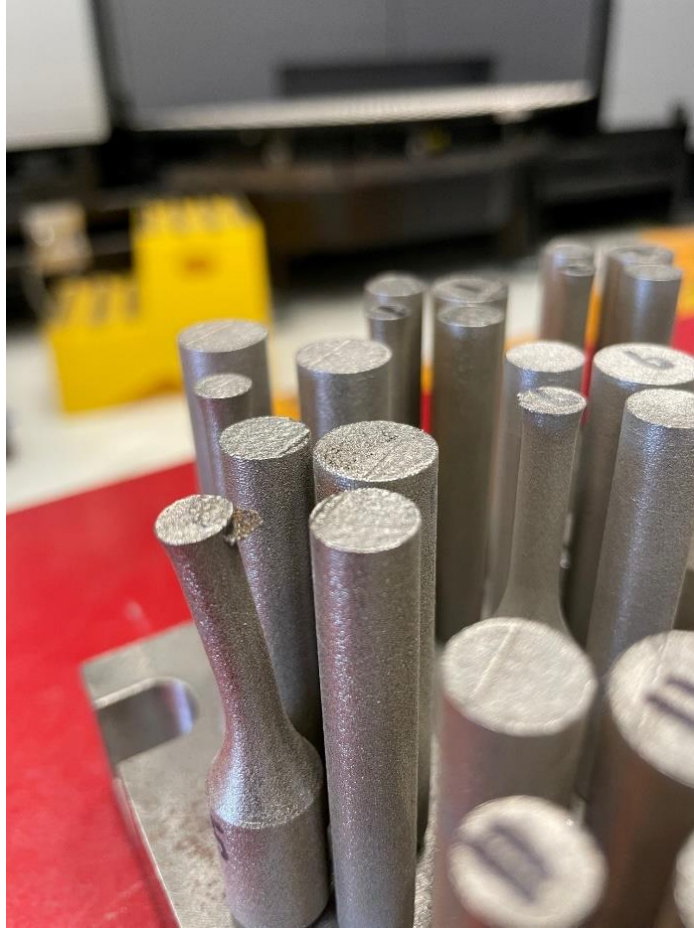
Figure 6.5 Photograph of Tensile Embedded with Shrapnel from Overheating.

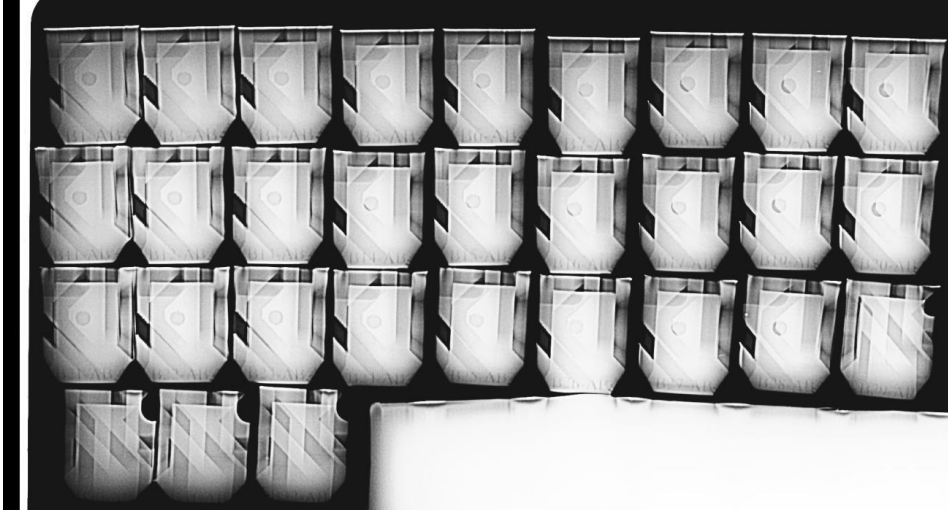
Figure 6.6 X-ray of Build #3 Measurement Samples

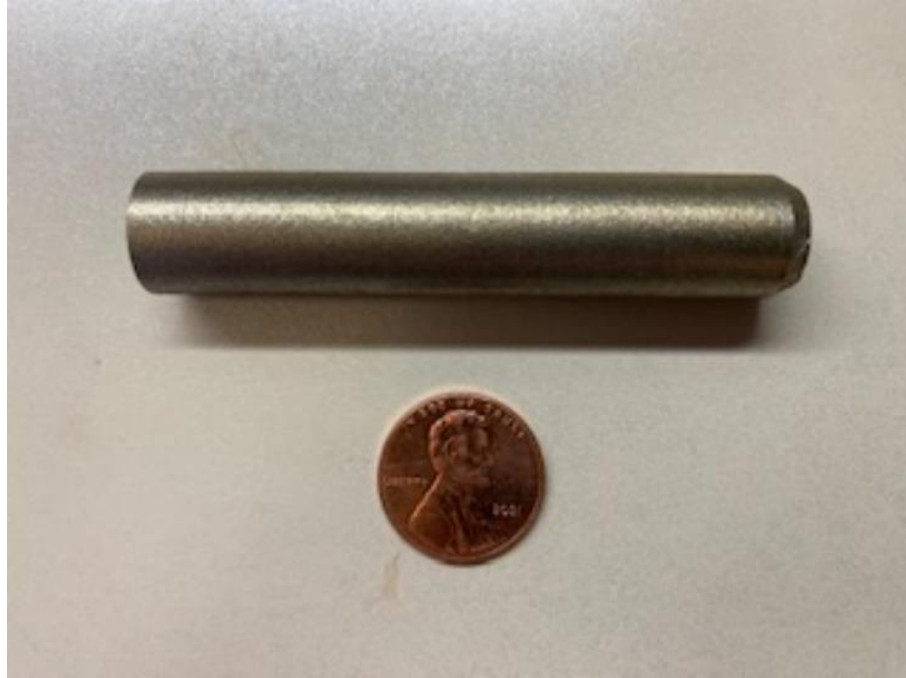
Figure 6.16 Configuration used for density measurements

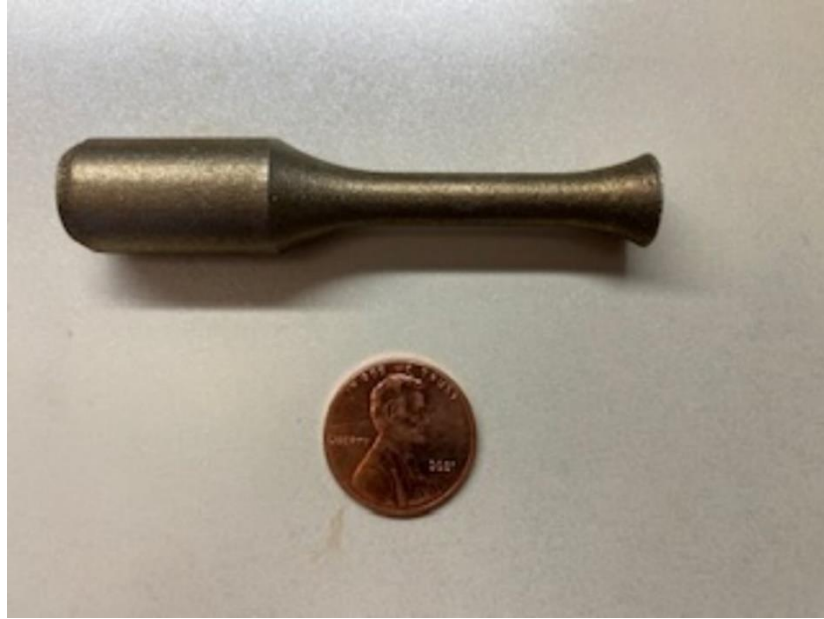
Figure 6.20 Sample configuration used for Metallographic sectioning

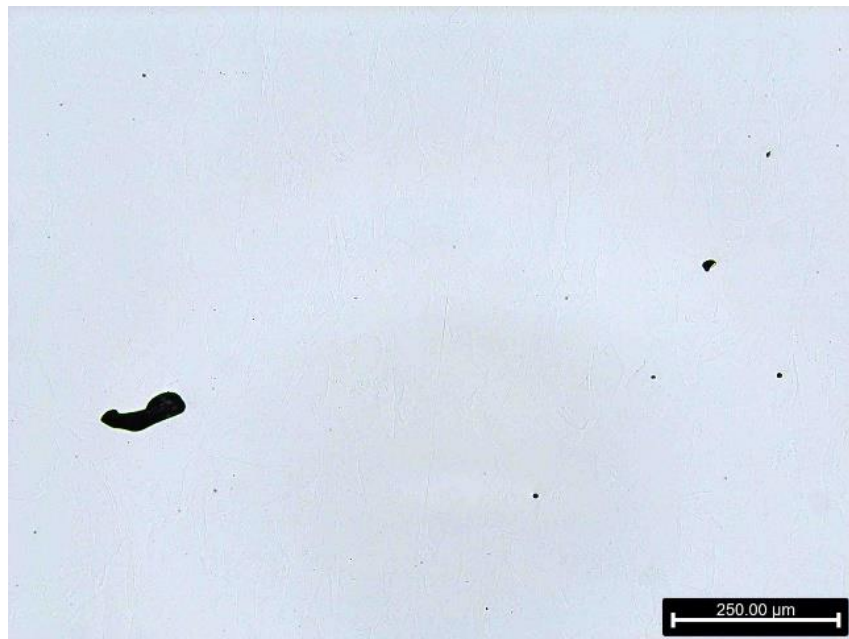
Figure 6.23 Defects from the Run #5 from Core1 XZ direction, 100x

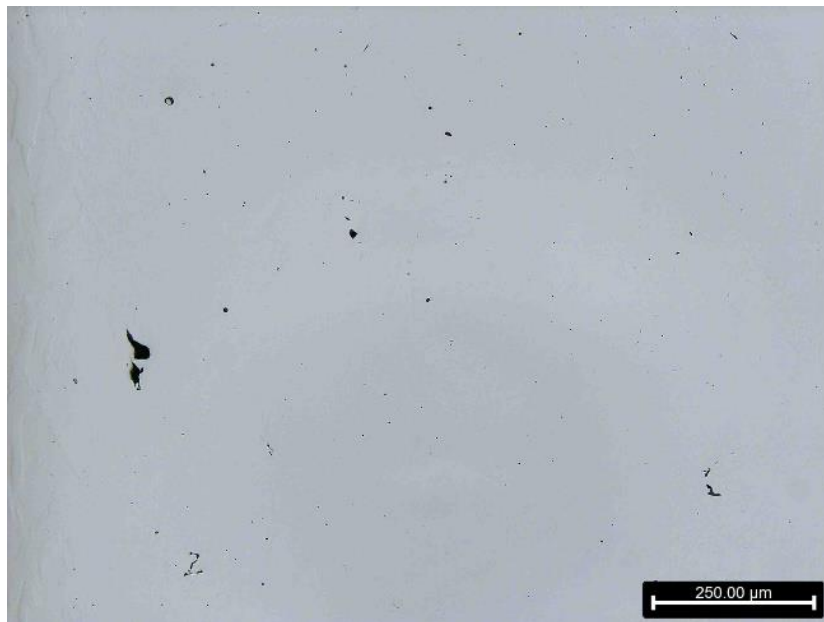
Figure 6.25 Defects From the Run #14 Core1 From XZ Direction, 100x

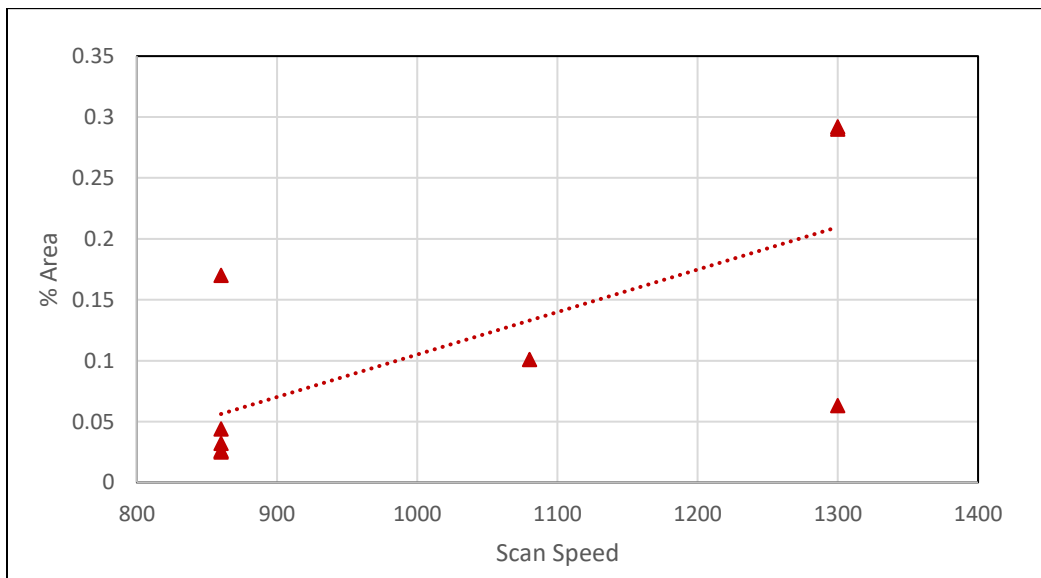
Figure 6.35 Percentage Area of Porosity versus Scan Speed
