## Residual Strength and Fatigue Characterization of SCS-6/Ti-6-4

THESIS

Sang-Myung Lee  
Major, ROKA  
AFIT/GAE/ENY/96D-7

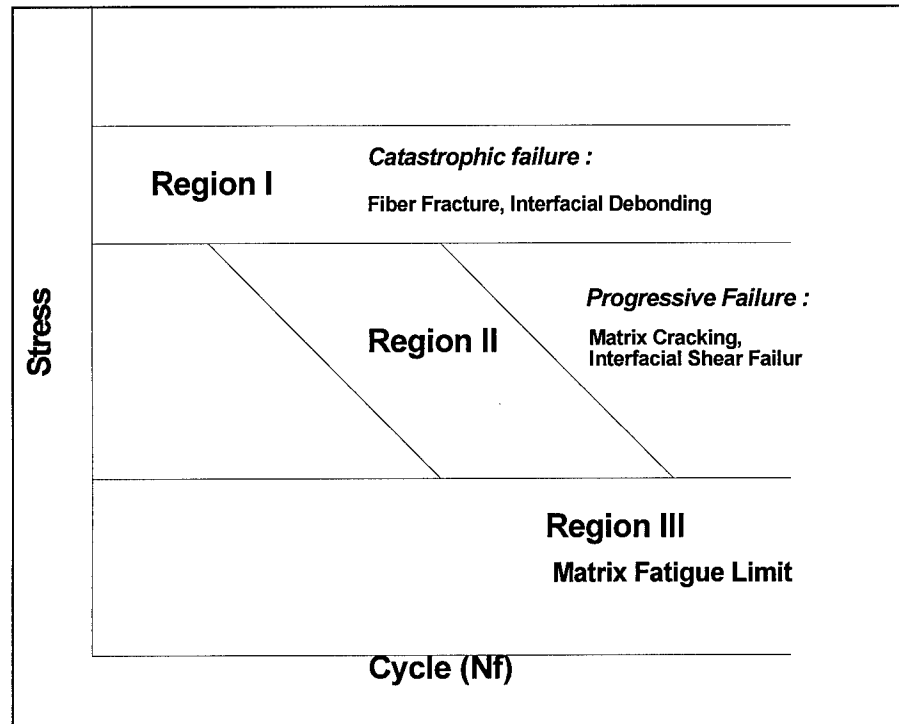
Figure 2.3 Typical S-N diagram

Following Talreja's approach [38] for unidirectional polymeric composites, fatigue life diagrams are often broken into three distinct regimes ( Regime I, II and III). Region I corresponds to fiber breakage and the resulting fiber-matrix interfacial debonding. The scatter band in this region accounts for variations in fiber strength and matrix ductility. Damage in Region I is characterized as non-progressive. Region II corresponds to progressive fatigue damage. Damage mechanisms in Region II include matrix cracking and fiber-matrix interface failure. Region III corresponds to the matrix fatigue limit. In this region, matrix cracking, if it does occur, is non-propagating. Thus, the three region fatigue curve provides a useful tool for depicting a relationship between the damage mechanisms, the fatigue life, and the applied load or strain. Majumdar and

Lerch [20] also showed that the S-N curve in regime I is dominated by fiber failure, while in Regime II it is dominated by matrix failure. Regime III represents the fatigue limit of the material. These regimes are shown in figure 2.3.

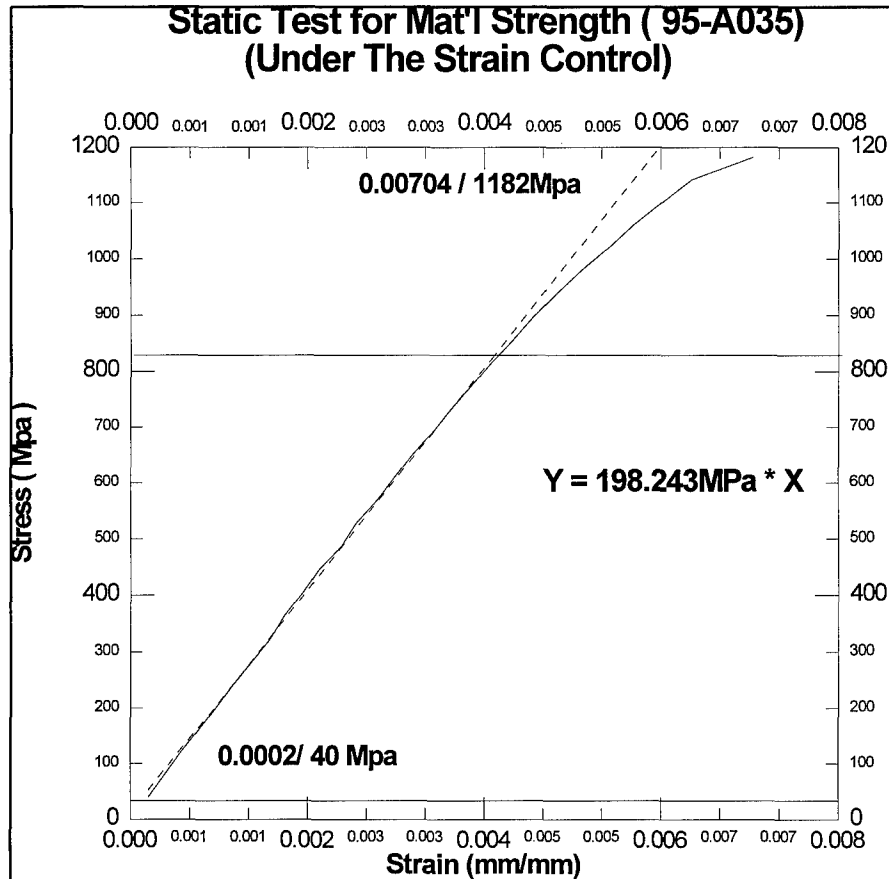
Figure 3.5 Tensile Response of the Composite at 427°C

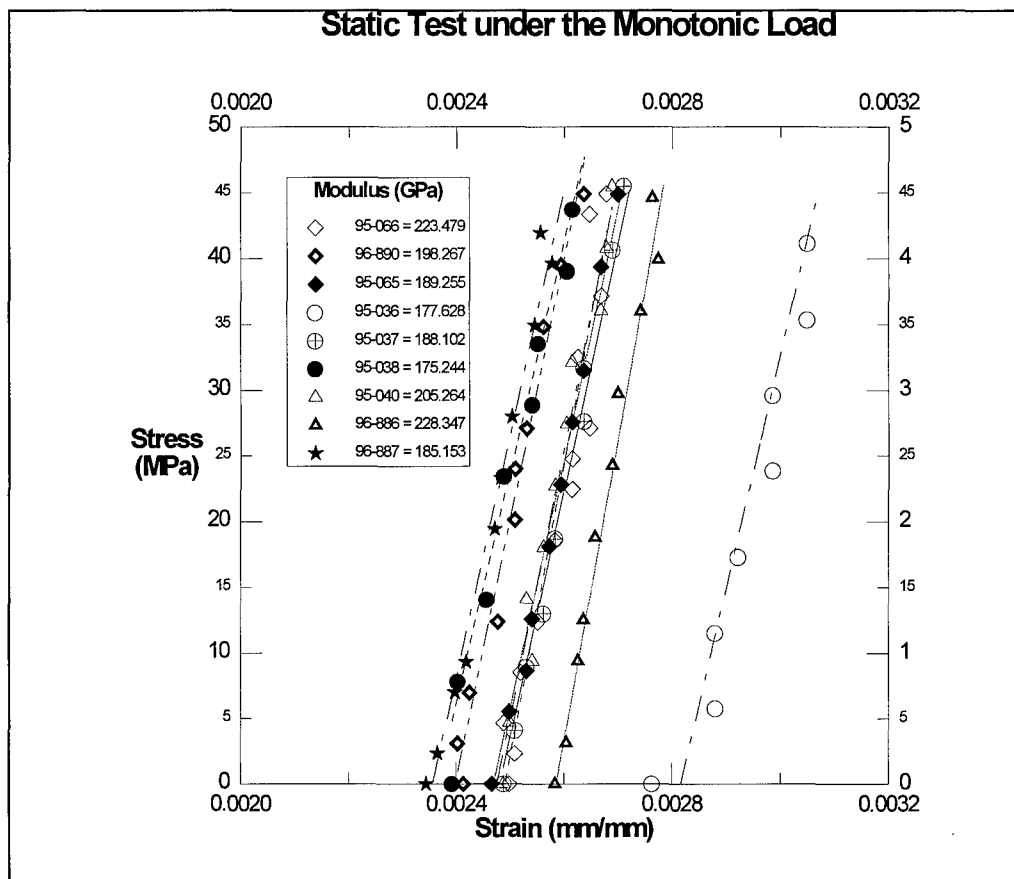
Figure 3.6 Modulus Tests For Three different parent plates

Parent Plate	5-2L ~ 5-7L	7-2L ~ 7-7L	10-1L ~ 10-7L	Total
Specimens	035 ~ 040	061 ~ 066	884 ~ 891	20
Average (E)	187 GPa	214 GPa	199 GPa	200 GPa

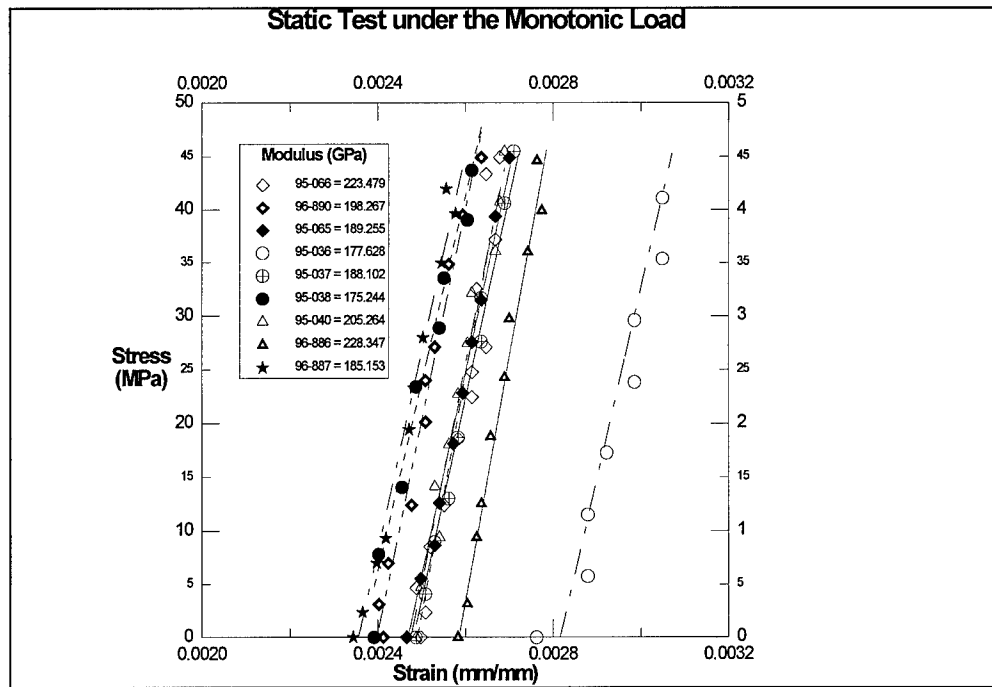
Figure 4.1 Modulus measured by monotonic test within 45MPa

consistent from specimen to specimen. Also, the moduli found from the 1Hz tests (192.2 GPa) and the moduli of the 0.01 Hz tests (196.8 GPa) is well within plate to plate and specimen to specimen variation. Deviation from linear-elastic behavior was found to occur between 820 ~ 870 MPa.

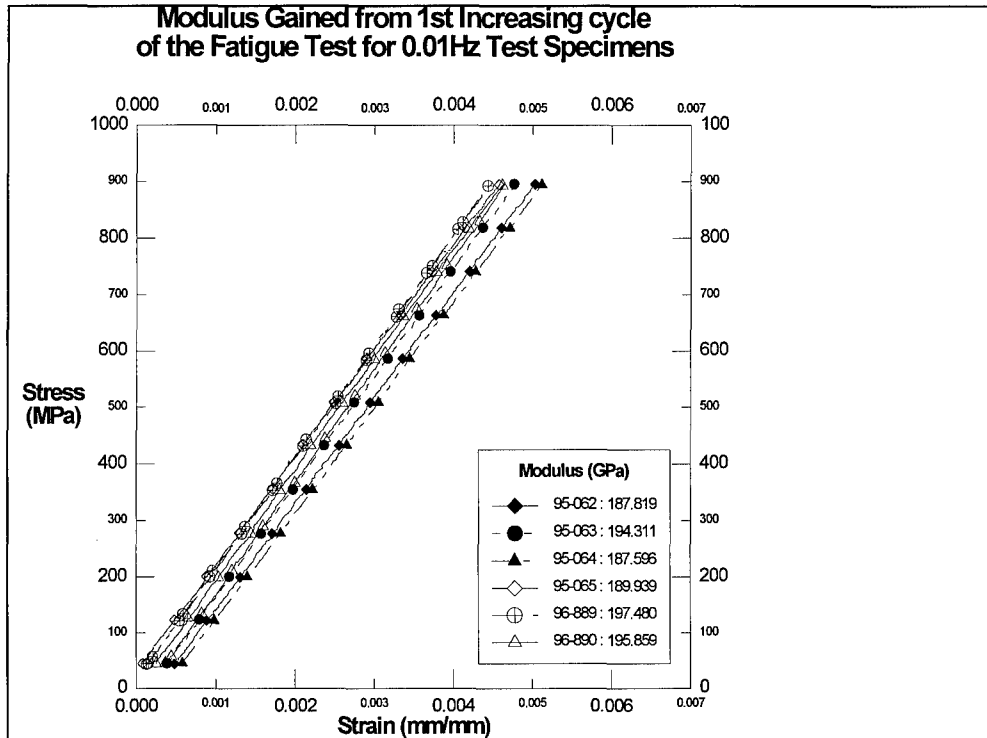
Figure 4.2 Modulus measured at the first fatigue cycle under 0.01Hz.

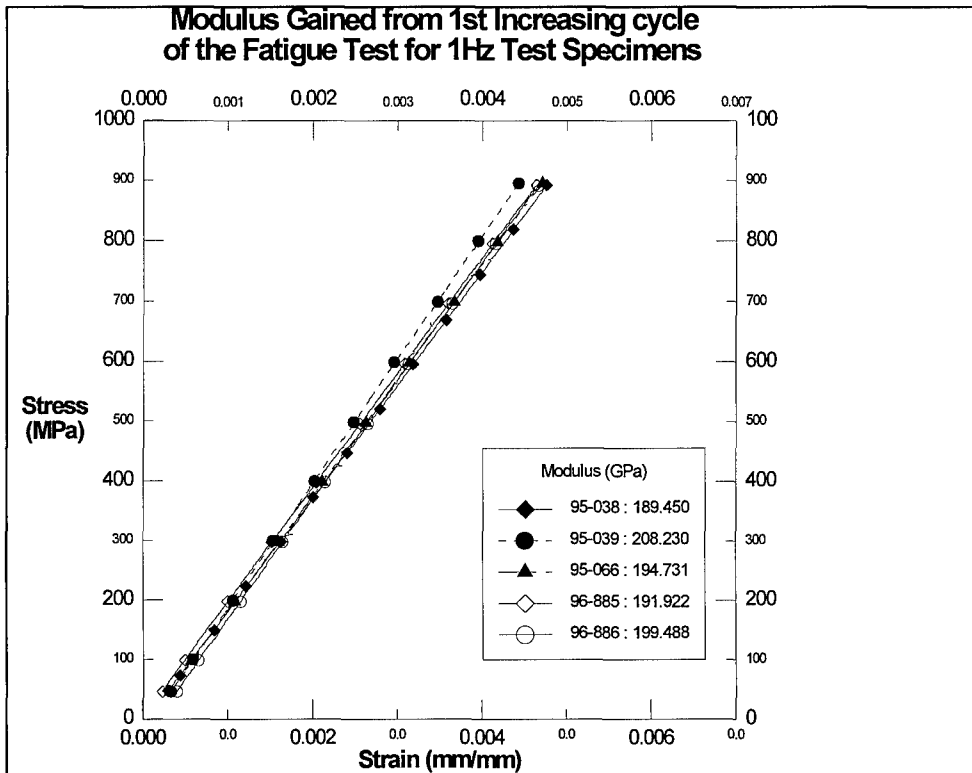
Figure 4.3 Modulus measured at the first fatigue cycle under 1Hz.

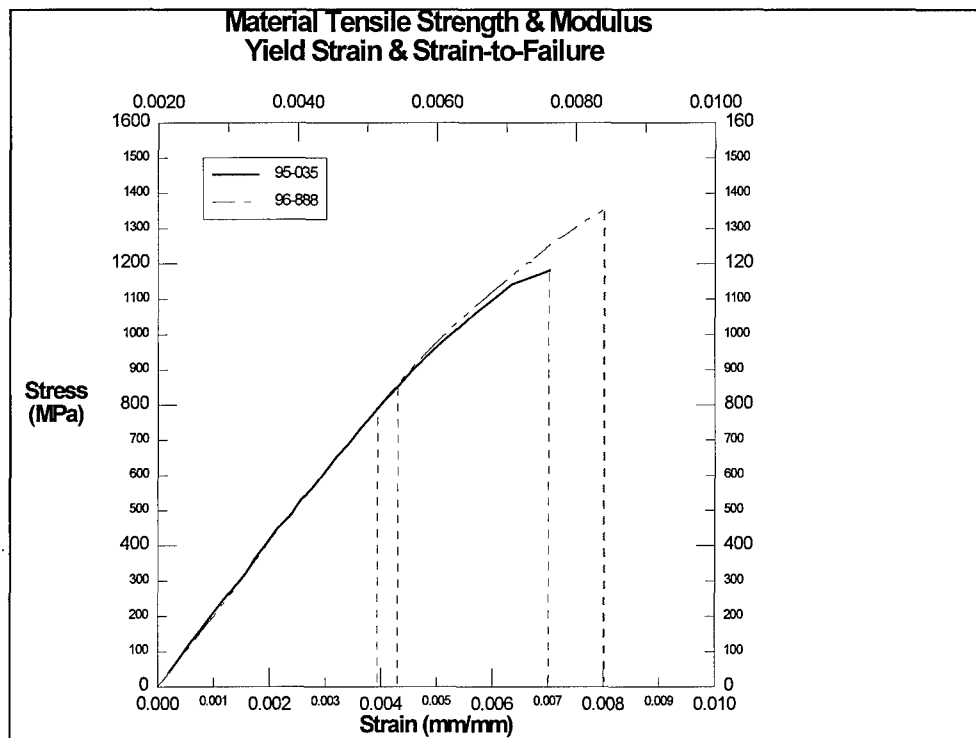
Figure 4.4 Strength, Yield point and Strains , T=427°C

Table 4.2 and Figure 4.4 show the elastic moduli, ultimate tensile strength and strain-to-failure of the composite. The composite exhibited an initial linear elastic region followed by a non-linear stress-strain behavior. The transition from linear to non-linear occurred between a strain level 54 ~ 55% of strain-to-failure. This is most likely due to yielding of the matrix and the possible formation of microcracks in the interfacial reaction zone.

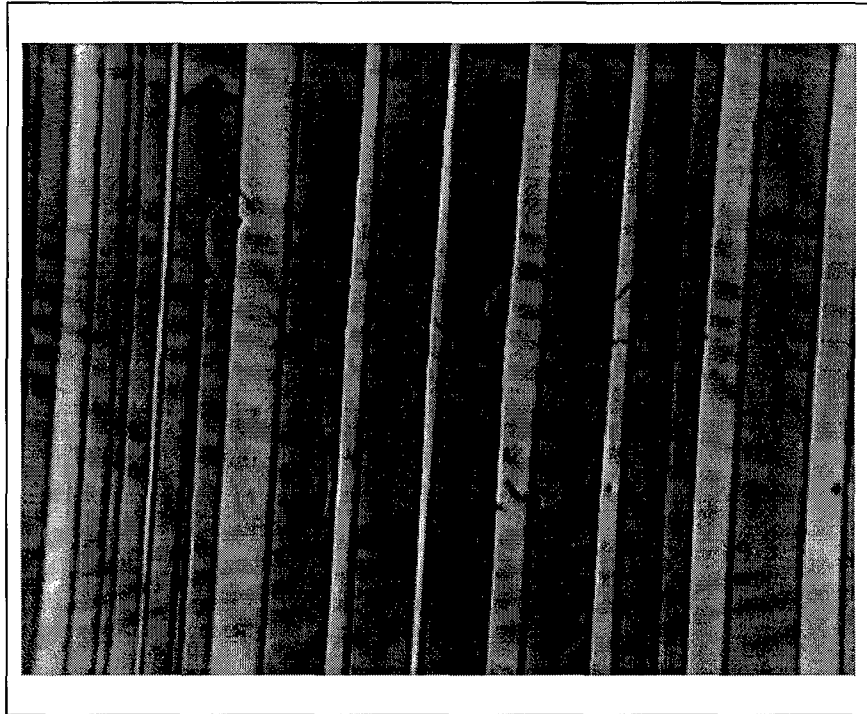
Figure 4.14 Interior Matrix Crack

Figure 4.14 shows the microscopy, which revealed the condition of the fibers and matrix directly behind the fracture surface. The specimen was sectioned so that the face could be ground and polished down or etched to the first layer of fibers. There were several surface cracks on both sides of the specimens that originated at damage sites on the edge or surface of the specimen. Figure 4.15 and 4.16 clearly show the crack

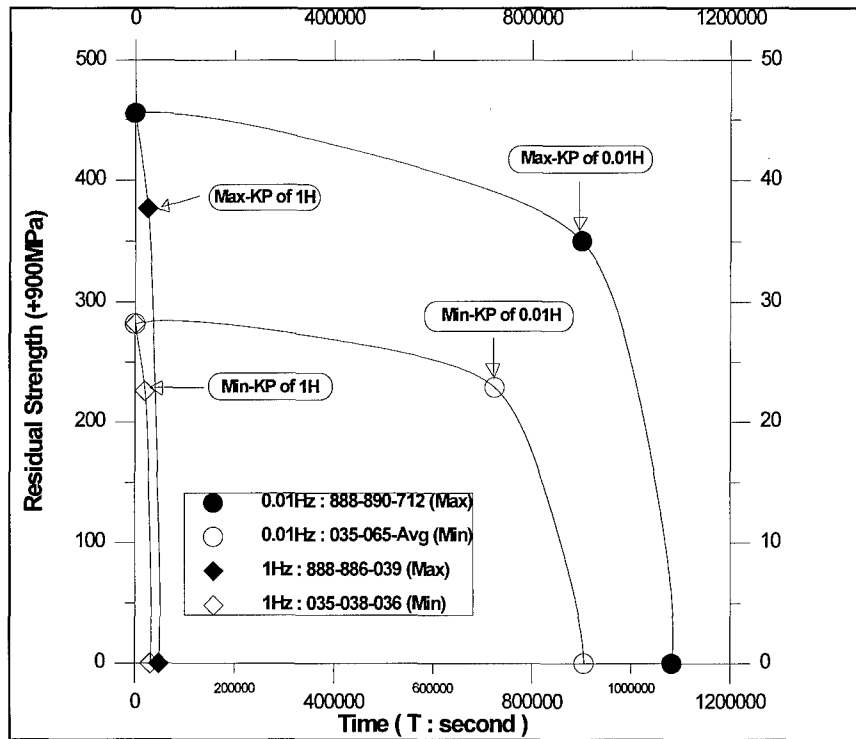
Figure 4.58 The residual strength bands ( $\sigma_{Max}-\sigma_{Res}$ ) vs. Cycle.
