Upgrading of Fire Resistance to Architectural Heritage Escape Route Timber Doors

Anne-Marit Haukø^a, Barbro Wedvik^b, and Mikael Bergius^c

^aDepartment of Architecture, Materials and Structures, SINTEF Community, Trondheim, Norway; ^bConservation department, NIKU, Oslo, Norway; ^cRISE Fire Research, Trondheim, Norway

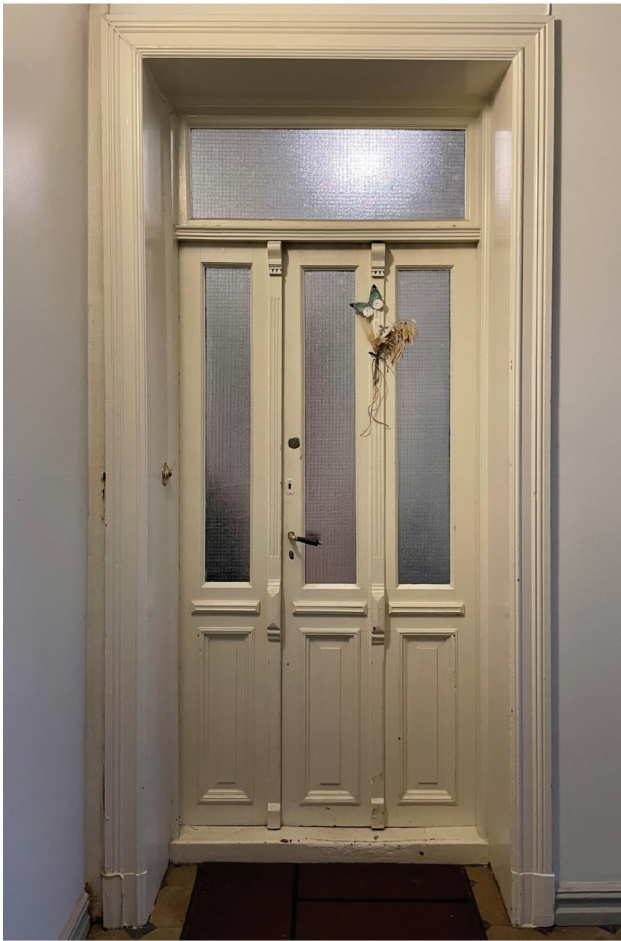
Figure 1. Typical stairwell door from a historic masonry residential building in Oslo, view from the stairwell side. In this example, the original glass panels have been replaced earlier with wired fire-resistant glass. Photo: Caroline Lundegaard Hannisdal, Murbyen, 2022.

upper part of the door leaf is often fitted with glass panels. Many doors also have side panels and top panel with glass. See [Figure 1](#). The glass panels were originally made of cylinder glass, often with “acid-etched” decorative patterns ([Wedvik 2018](#)). Such glass had very poor fire resistance ([Stenstad 1983](#)). The traditional filling doors were often made of a solid pine wood frame holding an upper glass panel and a lower thinner wood panel. The frame parts were usually joined together with plugs or wedges. These types of doors normally have a thickness of 40–50 mm on the frame part and about 10 mm in the thinnest parts of the wood panel.

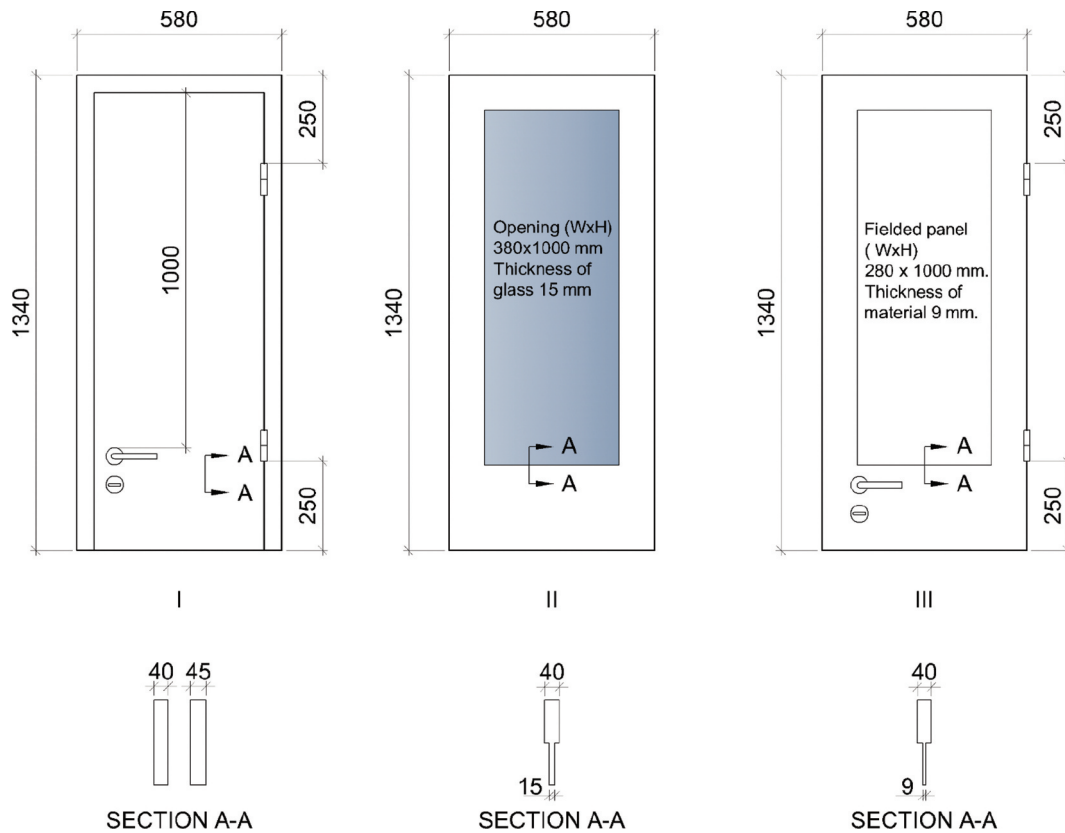
Figure 2. Dimensions of door configurations in mm. Door I was used in test 01A, 01B and 02B. Door II was used in test 03A, 03B, 04A and 04B. Door III was used in test 02A.

A total of eight different door configurations were tested, and each test included two configurations. The testing was performed as a non-standard intermediate-scale fire resistance test using an indicative fire resistance test furnace, as described in section 2.2. The door leaf with nominal dimension (width × height) 580 × 1340 mm consisted of cross-laminated pine with a thickness of 40 or 45 mm and was equipped with two hinges and a lock case. The door frame consisted of cross-laminated pine with nominal dimension (thickness × width) 114 × 45 mm and was fastened with two steel screws on each vertical side. The frame was equipped with a strike plate, and the gap between the frame and the wall was filled with stone wool. The glass had nominal dimensions of (thickness × width × height) 15 × 370 × 980 mm, a nominal weight of 12.6 kg and was fire-resistant for 30 minutes (integrity and insulation). The fielded panel had nominal dimensions of (width × height) 380 × 1000 mm and was milled out from both sides, leaving 9 mm of wood thickness in the centre. The fielded panel was filled with stone wool and covered with a robust gypsum board type R with nominal dimension (thickness × width × height) 12.5 × 470 × 1075 mm on the fire exposed side. The gypsum board was secured with steel screws spaced 100–120 mm measured from centre to centre. There was a groove milled into the door leaf to support the smoke seals; a (width × thickness) 15 × 1 mm intumescent strip and a cold smoke seal in silicone. Dimensions of the door configurations are given in Figure 2.

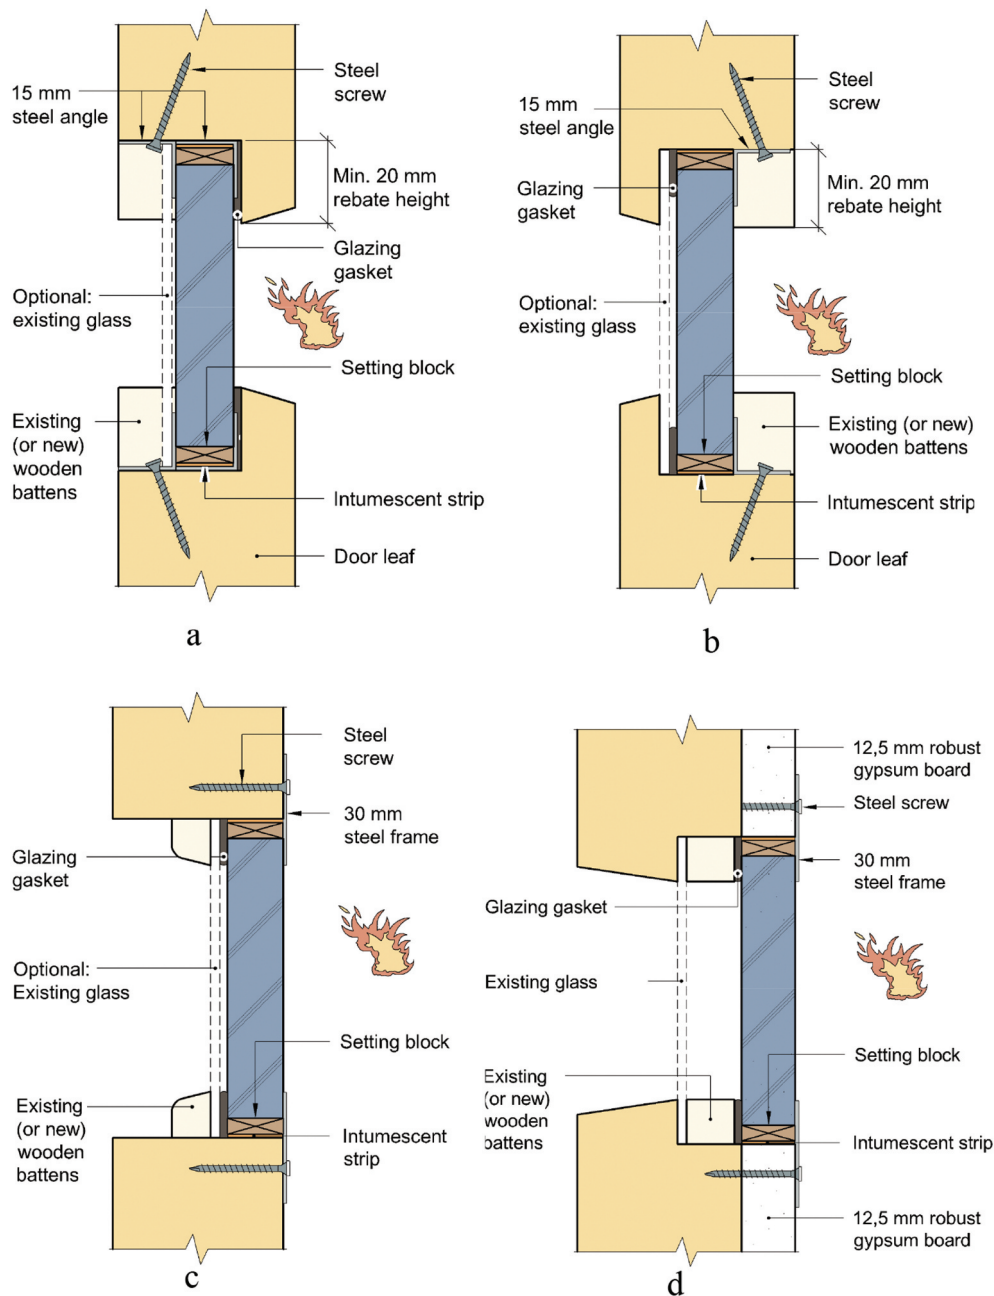
Figure 3. Mounting of fire-resistant glass inside the rebate on the stairwell side (a) of the door or (b) on the apartment side of the door, using steel angles (test 03A and 04A). (c) shows mounting of fire-resistant glass inside the rebate with steel frame on the apartment side of the door (test 03B). (d) shows mounting of fire-resistant glass outside the rebate with steel frame (test 04B).

Four different methods for fastening of fire-resistant glass were tested, as shown in Figure 3. The methods were chosen to cover differences in the available space in the rebate and whether the original glass was mounted on the stairwell side or on the apartment side of the door. A 15 mm intumescent

lasted for 33 minutes, and this indicates that it might be the most robust fastening method of fire-resistant glass of the four methods described in Figure 3. Tests 01A/01B and 02A/02B lasted for nearly 40 minutes or more. This indicates that 40 mm of laminated wood and the upgrading of thin timber panels using stone wool and robust gypsum boards type R are robust solutions with good safety margins.

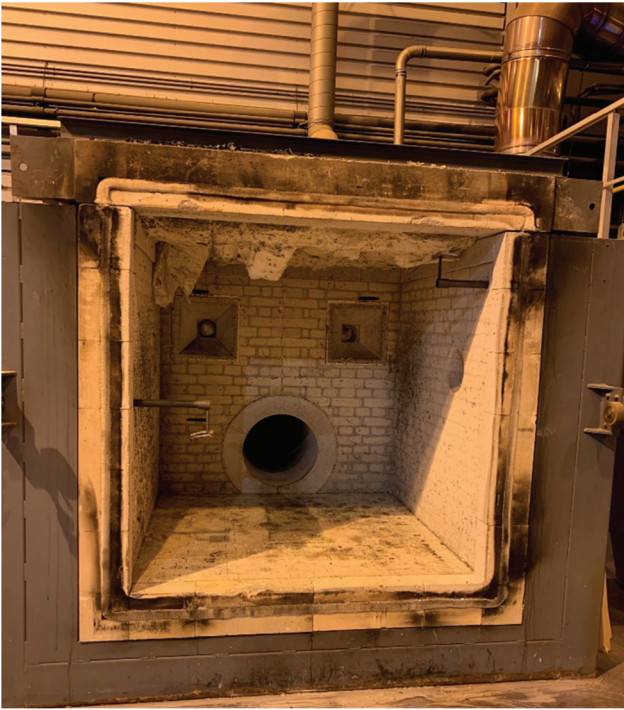
Figure 5. The fire resistance test furnace used for the tests.

The four fire tests were performed in a fire resistance furnace with internal chamber dimensions of $1550 \times 1550 \times 1550$ mm, see Figure 5. The furnace was fuelled with a premixture of propane gas and air, with three gas burners embedded in the sides of the chamber. The fire exposure followed the standard time temperature curve described in EN 1363-1 (Standard Norge 2020). This curve represents a model of a fully developed fire in

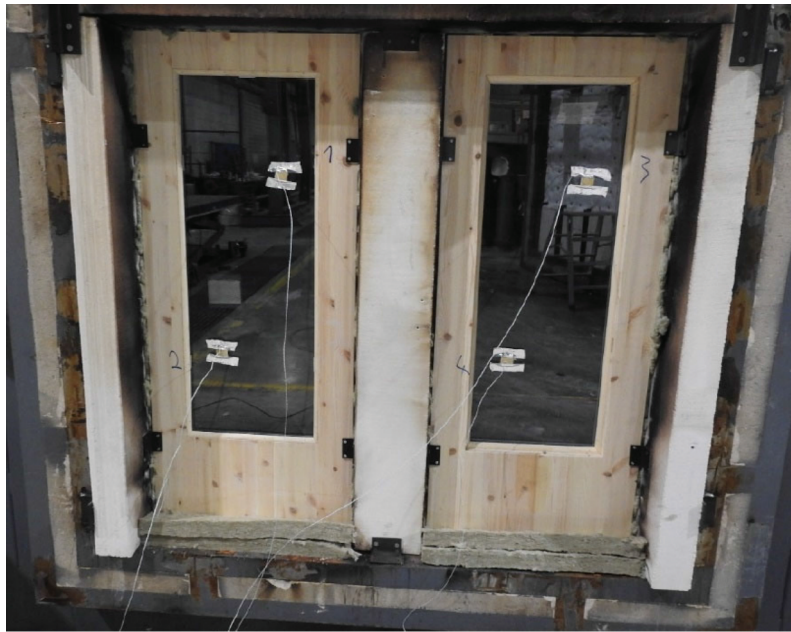
Figure 6. Photo showing positioning of thermocouples on the unexposed side of test specimens 04A and 04B.

the unexposed side for the recording of temperature. Table 2 and Figure 6 shows the location of the thermocouples.

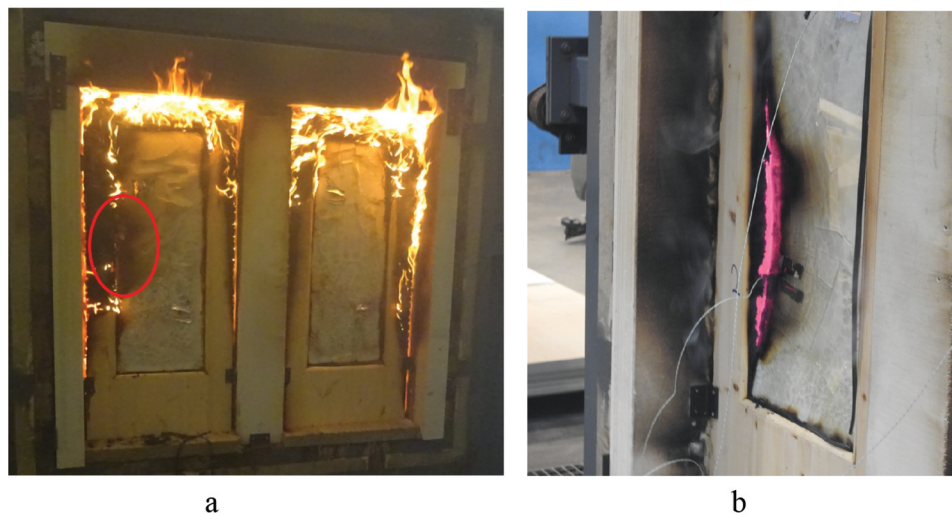
Figure 8. Close ups from the tests (a): 03A/03B after test termination. Cotton wool ignited in the marked area after 29.5 minutes, (b): 04A after 29 minutes, with sustained flaming and failure in temperature criteria.

Table 3 shows that all configurations except 03A and 04A passed the integrity acceptance criteria for at least 30 minutes. Configuration 03A failed the integrity criteria because the cotton wool pad ignited after 29.5 minutes at the connection between the glass and door leaf at mid-height, see Figure 8a. Configuration 04A failed the integrity criteria due to a sustained flame after 29 minutes at the connection between the glass and door leaf at mid-height, see Figure 8b. Table 3 and Figure 7 show that all configurations except 04A passed the insulation acceptance criteria

The reasons for not passing the acceptance criteria for the cotton wool test (29 minutes in test 03A) and sustained flaming and insulation (29 minutes in test 04A) are unknown. Fire testing is not an exact science, and small deviations in the materials (like knot holes in the wood) or in the mounting of for instance steel angles or intumescent strips around the fire-resistant glass can lead to different outcomes in the same test. Test 04B
