## Railcar Wheel Impact Detection Utilizing Vibration-Based Wireless Onboard Condition Monitoring Modules

RAILCAR WHEEL IMPACT DETECTION UTILIZING VIBRATION-BASED WIRELESS  
ONBOARD CONDITION MONITORING MODULES

Submitted in Partial Fulfillment of the  
Requirements for the Degree of  
MASTER OF SCIENCE IN ENGINEERING

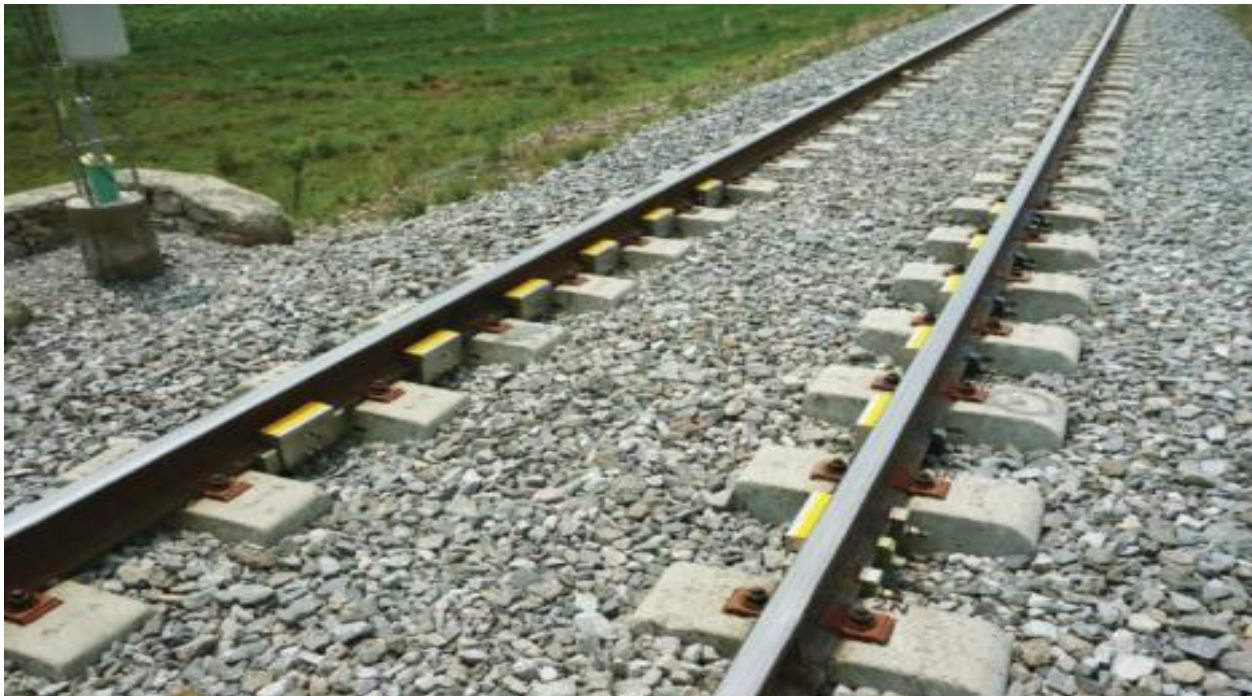
Figure 4. Wheel impact load detector (WILD) [22]

the Federal Railroad Administration (FRA) to detect defective wheels in the Northeast Corridor (NEC) of the U.S. rail system for the prevention of potential rail system and railcar suspension damage [22]. Using strategically track-mounted strain gauge sensors, WILDs monitor and detect the dynamic load behavior of passing railcar wheels by measuring the wheel to rail contact force. Wheels exceeding the predefined high impact load thresholds seen in are flagged for corrective/preventive maintenance.

This wheel monitoring method, however, is limited by the strategic placement of these sensors along the track. Progression of a pre-existing defect or the propagation of a new anomaly within the wheel profile will not be monitored nor detected until the next WILD location. Unfortunately, because continuous monitoring of the wheels is unachievable, a wheel can unexpectedly fail between WILD sites without warning. According to an implementation guide for wayside monitoring systems issued by the FRA in 2019, only about 185 WILD systems were operational nationwide as of 2017 [22].

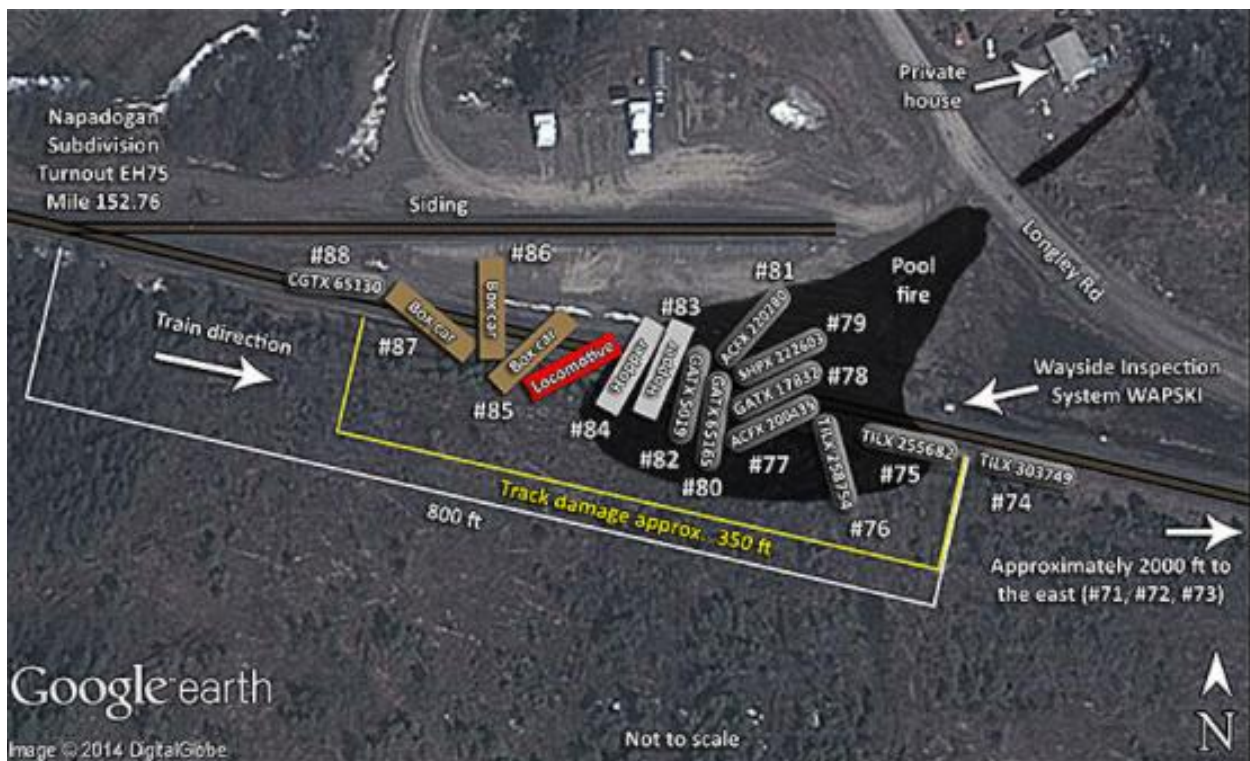
Figure 6. Diagram of freight train M30831-06 derailment [27]

near Plaster Rock, New Brunswick. The derailed cars were transporting about 230,000 L of hydrocarbons including butane and crude oil. Ethanol and acid residue were also being transported. The accident caused the tanks to spill their cargo which triggered a fire that led to the evacuation of 150 residents within a 1.6 km radius of the area -- no injuries were reported. A diagram of the accident is shown in Figure 6. The investigation delineated that the primordial cause of the incident was a shattered rim (SR) from wheel L3 of railcar CRDX 15109. The fracture had originated from a fatigue crack triggered by subsurface porosity in the wheel tread. As seen in Figure 7, the crack propagated until reaching the wheel hub. After the crack caused part of the wheel tread to fall, wheel L3 then shifted from its axle seat inboard towards its mate (R3). In the process, derailment of CRDX 15109 inflicted repeated wheel impacts on the track causing the rail infrastructure to fail as well. About 350 feet of track were destroyed, creating a gap in the rail system which derailed the other 18 railcars.

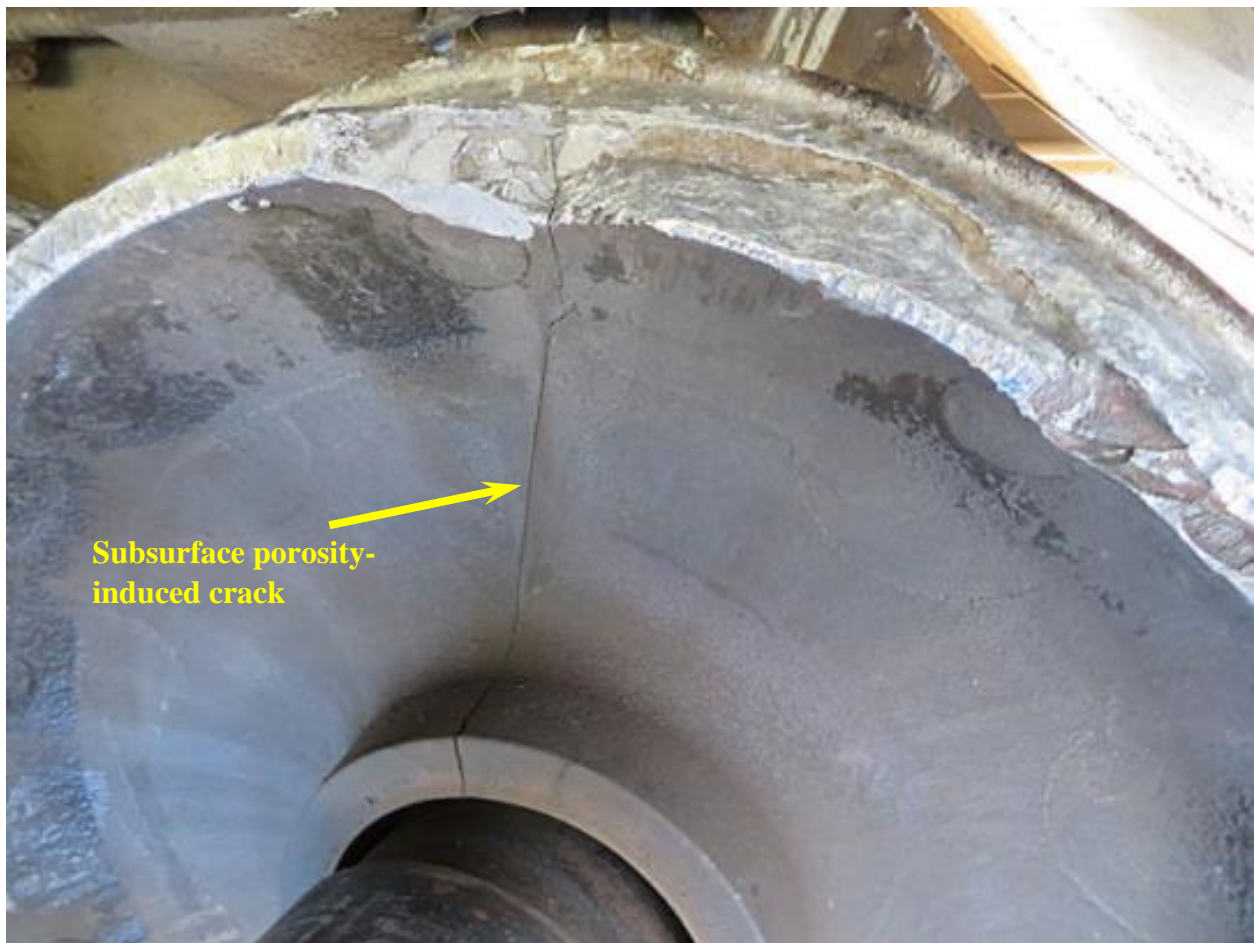
Figure 7. Cracked wheel L3 of railcar CRDX 15109 [27]

According to the investigators, CRDX 15109 had passed a WILD on January 6, 2014 (i.e., the day before the accident) under fully loaded conditions and no abnormality was reported. Previous inspections of the wheel profile had also been compliant with Class C AAR wheel standards. As the root cause of the SR was due to subsurface porosity, the report stated that ultrasonic testing (UT) had been performed when the wheel was manufactured in 1991, but the defective zone had gone undetected. In 2006, the wheel was removed from service for reprofiling, and another UT was conducted. The post-derailment metallurgical analysis of the component denoted that the porous region was about 3.2 mm (1/8 in) long and should have technically been detected. However, at the time, data logging of UT results was not a requirement.

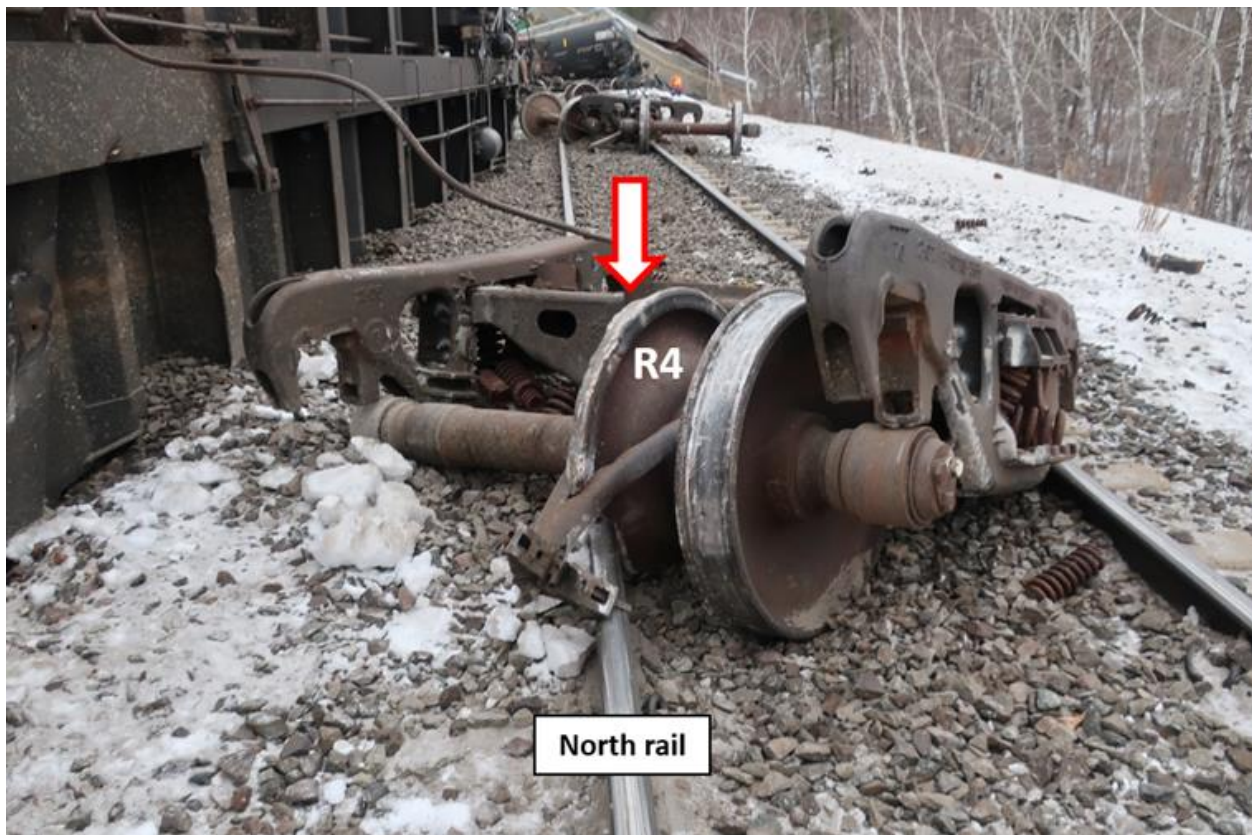
Figure 8. Derailed railcar ATW400515 [15]

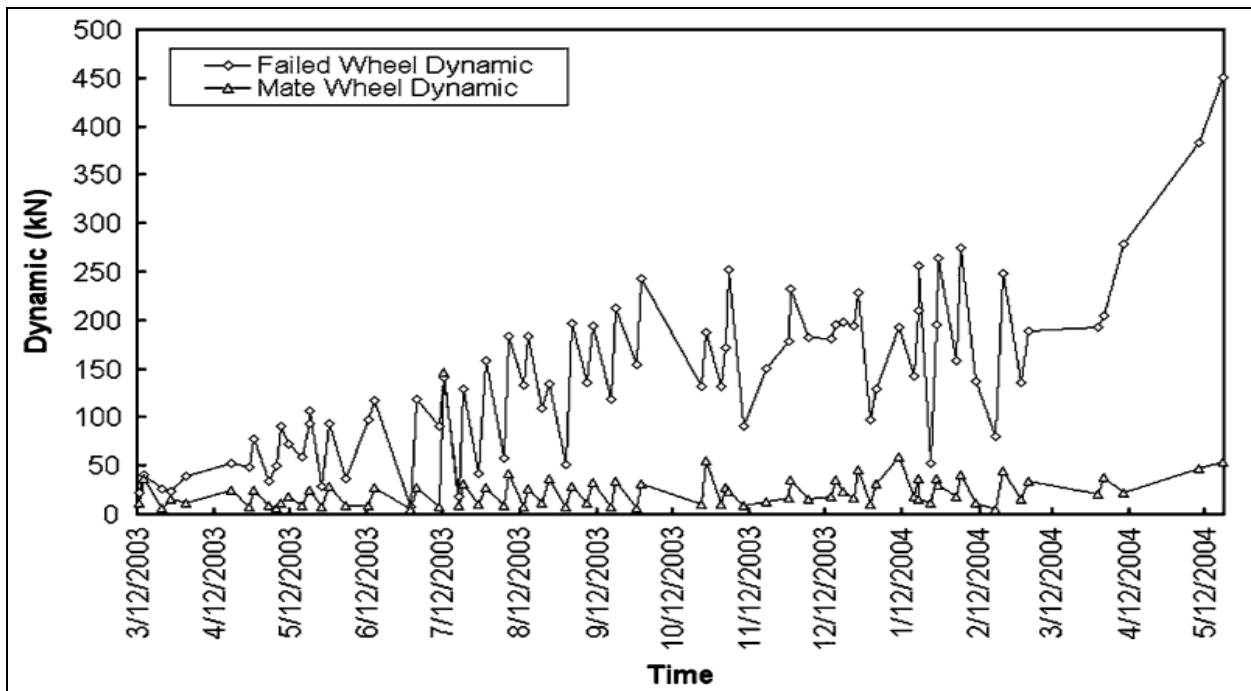
Figure 10. First criterion example (rapid increase in impact readings) [31]

reading needed to occur within a 50-day lapse or less with a peak dynamic impact of at least 311 kN (70 kip). By referencing a wheel failure database from a major North American railroad, they determined that at least 10.53% of the failing modes had this successive impact reading increase. This meant that if C1 were to be implemented along the time frame these failures occurred, then 10.53% of those failures could have been prevented. Furthermore, the data also revealed that approximately 200 wheels operated under this criterion per year in North America. A deeper analysis of this data for previous years revealed that the criterion could have detected 78.2% of affected wheels before traditional methods. This meant 156 damaged wheels were left in service causing additional rail infrastructure damage. Moreover, the wheelsets would have been removed, on average, 31.7 days prior to the day of failure. Thus, 31.7 days of additional rail unit and line potential damage could have been prevented. Figure 10 displays a wheel operating under this criterion.

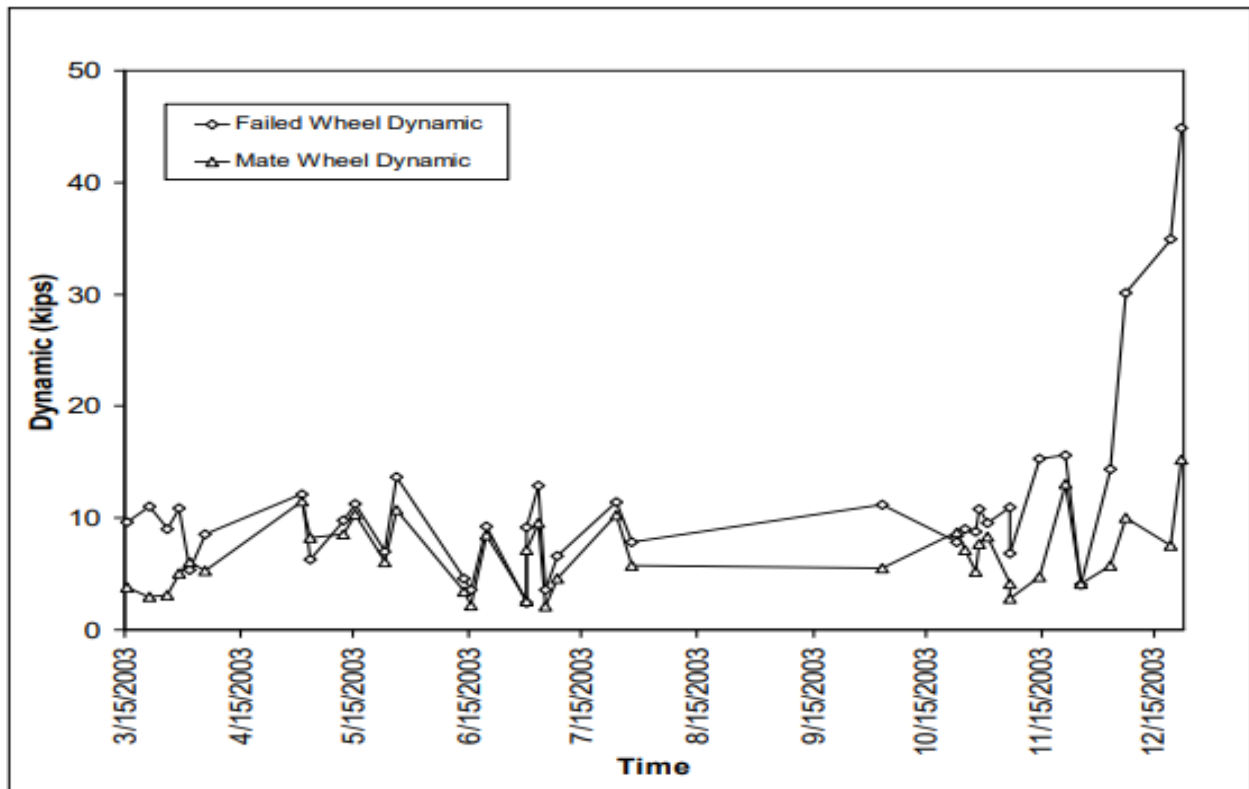
Figure 11. Second criterion example (sudden increase in impact reading) [31]

The second criterion (C2) was developed with respect to normal impact reading wheels with a sudden increase in impact over a short period of time. Under this wheel removal strategy, the wheel needed to have a dynamic impact of at least 177.9 kN (40 kip) with three consecutive and incrementing impact readings of 8.9 kN (2 kip) or more between readings with an average increase of at least 44.5 kN (10 kip) between the three readings. This behavior needed to occur within a 20-day time frame. Furthermore, no impact reading 30 days prior to the initial impact deviation reading could be greater than 22.2 kN (5 kip) or less than 67 kN (15 kip) of the initial impact deviation value. Like the wheel failure database analysis of the first criterion, about 5.26% of the failures followed this trend. This indicated that implementation of this wheel removal methodology could have been prevented 5.26% of the failures. The data also illustrated that annually about 1400 wheels in North America follow this criterion. Based on previous year data, 47.5% of those wheels could have been detected early. Thus, 665 damaged wheels were left in service risking property and safety. Further analysis of the data in this database demonstrated that the wheels could have been removed about 66.6 days earlier, preventing unnecessary detriment along that time frame. Figure 11 demonstrates an example of a wheel displaying this behavior.

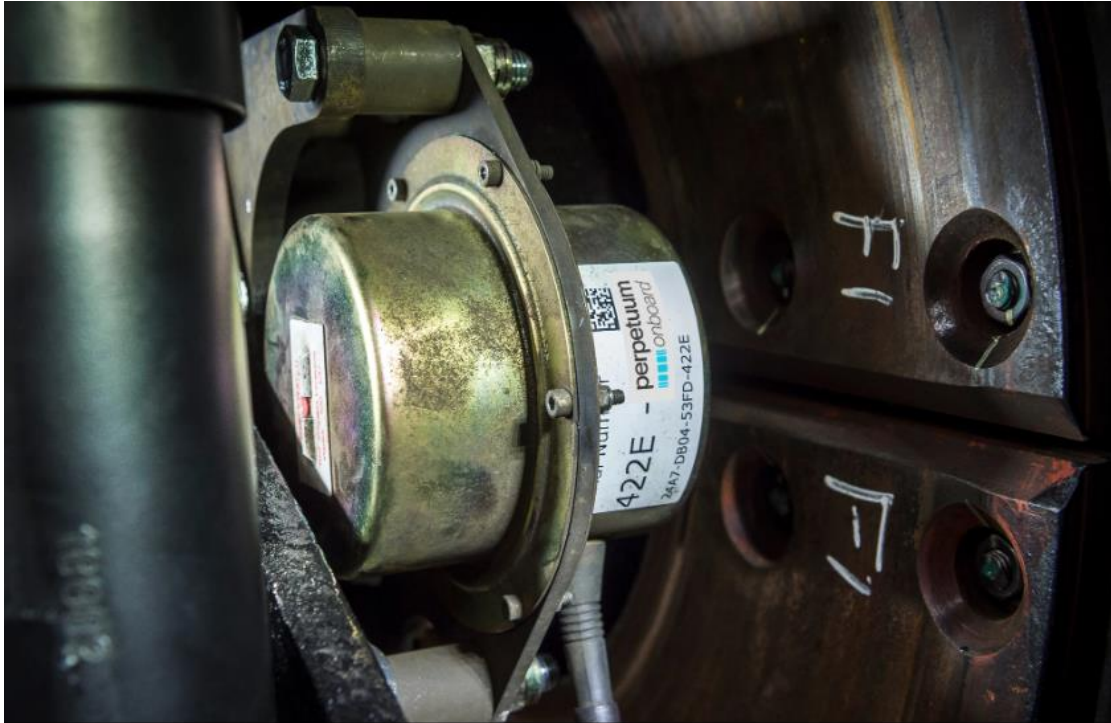
Figure 15. Perpetuum system mounted on railcar wheel hub [46]

Perpetuum is another wireless technology capable of rolling stock wheelset monitoring. Both wheels and bearings health metrics are diagnosed by a three-axis accelerometer and a temperature sensor. The device is mounted onboard rail units and powered through a “battery-less” system that uses an electromagnetic energy harvester with a claimed life expectancy of up to 100 years. The functionality of the device has been proven with over one billion miles of study, and as of December 2016, about 7000 units have been installed in over five countries. Yet, despite the solid track record, there is uncertainty regarding the installation compatibility of the system. That is, the device, as seen in Figure 15, is designed to fit specific railcar wheel hubs. Based on the information given in the company website, it is unknown whether these sensors are capable of being mounted onto other railcar wheel configurations [46], [47], [48].

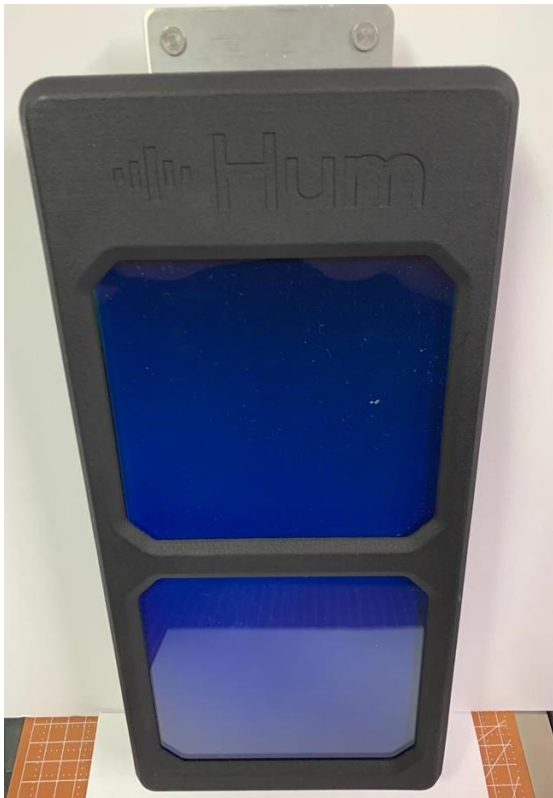
Figure 18. HUM central communication unit (i.e., Gateway)

generating automated notifications for the end user when a bearing health index surpasses established thresholds. The Gateway is necessary for flashing the Boomerang with the latest software updates. Sampling time interval modifications, Boomerang-Gateway linking, and other programming procedures are also enabled by the Gateway.

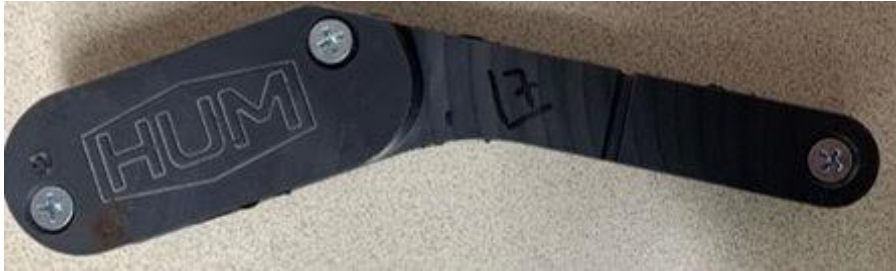
Figure 19. HUM Boomerang prototype

Additionally, A2 has an integrated attribute that enables the maximum operating range to be adjusted to either 100 or 200 g's based on modifications to the main code that can be pushed to the Boomerang by flashing its main circuit board. Note that, once a measured value exceeds these disclosed ranges, the sensor will "saturate", and the exact g-reading will be undefined. If this occurs, the data will simply demonstrate values at the maximum limit of the sensor.

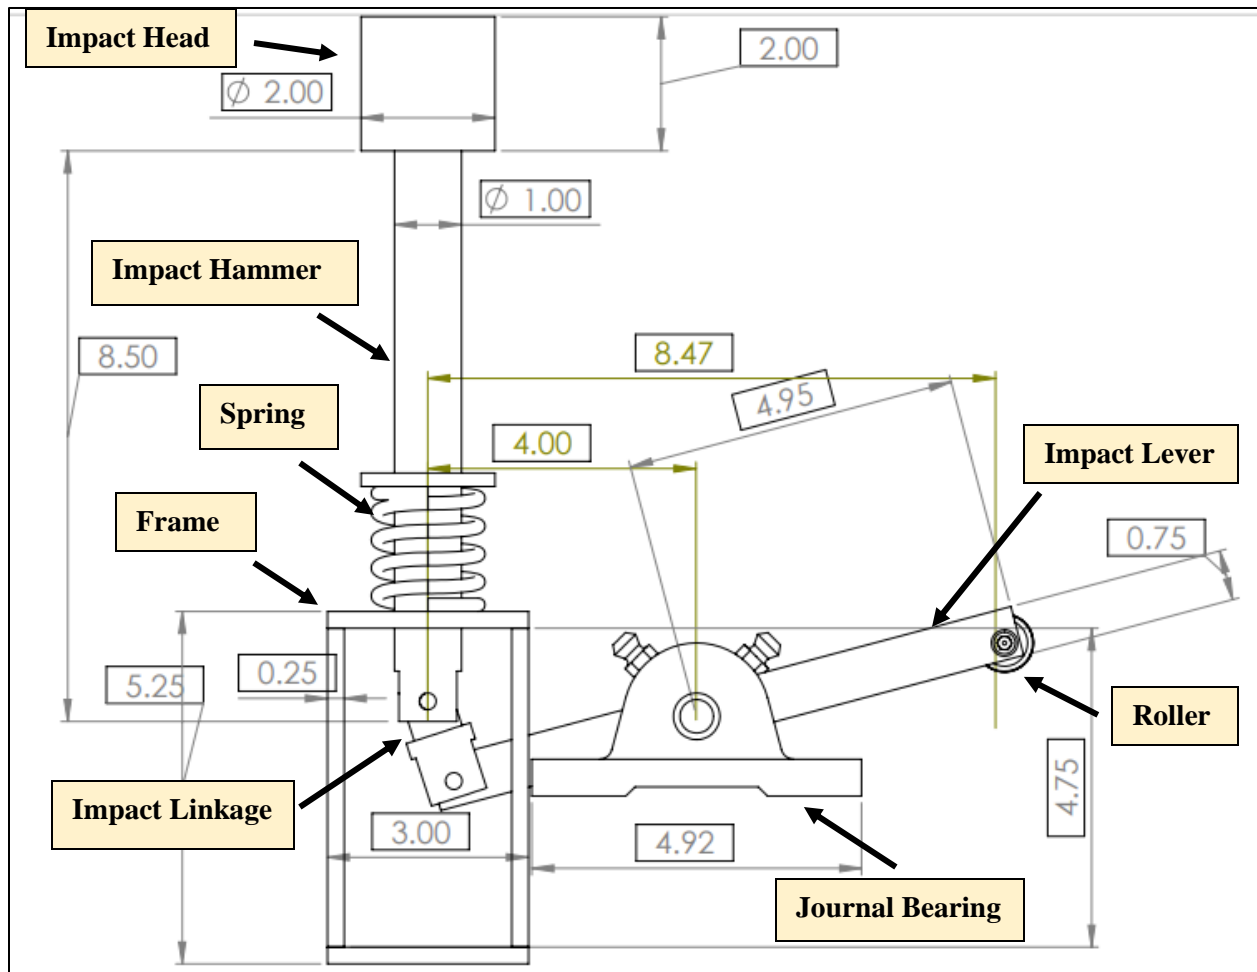
Figure 21. Impact mechanism CAD drawing (dimensions in inches)

input frequency or voltage on the VFD, the speed of the motor can be adjusted, allowing for different impact frequencies to be tested. Connected to the motor is a solid steel shaft retrofitted with a custom-made cam that sits between two journal bearings. The cam creates a rotational to translational energy conversion in the system as it is connected to a lever that sits on a small shaft between two smaller-size journal bearings. This lever, which is 21.51 cm (8.47 in) in length, has a Delrin homopolymer roller at the cam-lever interacting end to reduce friction and wear between the components. It connects to the impact hammer via a linkage housed within the impact mechanism frame securing the impact hammer and lever together using two clevis pins locked with cotter clips. Because the lever is connected to the impact hammer, the energy transfer between the cam and lever gets transferred to the impact hammer as well. This energy transfer, however, is limited to the rotation of the cam. Thus, to maximize the energy output of the impact hammer, a spring with a specified constant is fitted on top of the impact mechanism frame. The spring is secured into position under a square plate that is part of the impact hammer's structure.

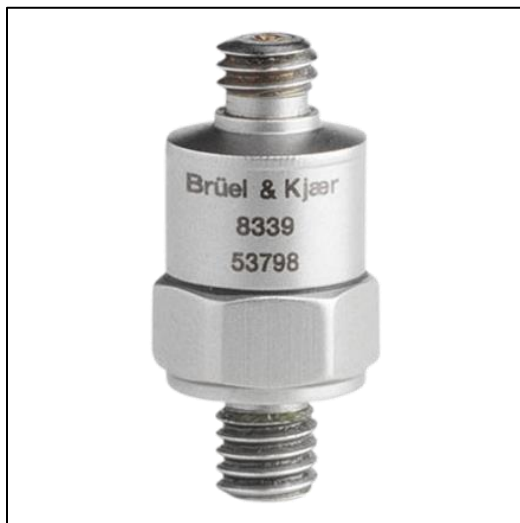
Figure 24. Brüel & Kjær shock accelerometer (20,000g measuring range)

true. In other words, a VFD input of 10 Hz will not equal a 10 Hz impact frequency output. To this end, an experiment was constructed using the SBT and impact system to determine the precise input to output frequency yield. The test involved 60 seconds of continuous impacts with a 67 N/mm (384 lb/in) spring for each VFD input frequency (i.e., 1-60 Hz). The reciprocal of the time between successive impacts for each input would then be used to calculate the actual output frequency. To acquire those impacts, a shock accelerometer with a 20,000g measuring range and a 0.2681 mV/g sensitivity (factory calibrated) was affixed to the L-shaped bracket of the impact head.

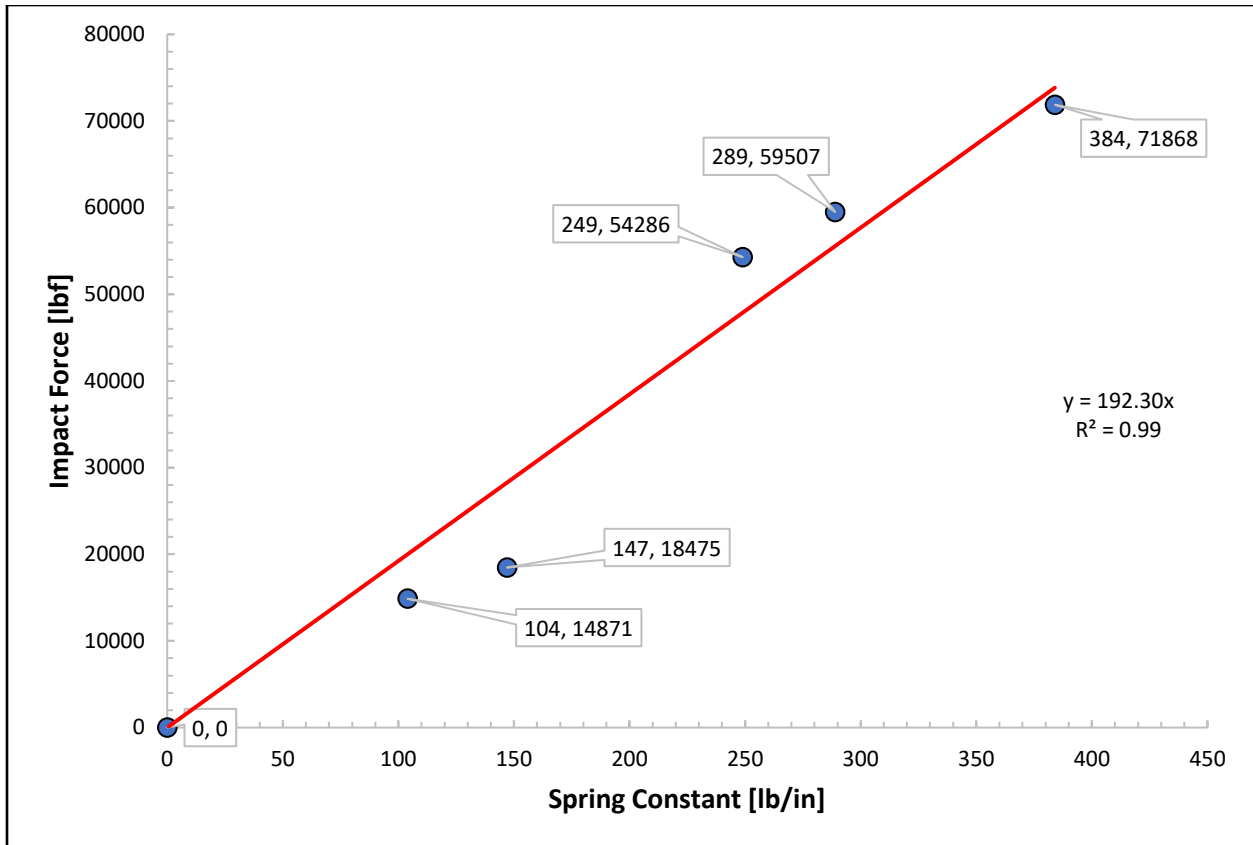
Figure 27. Linear regression fit correlating the spring constant [lb/in] to the impact force [lbf]

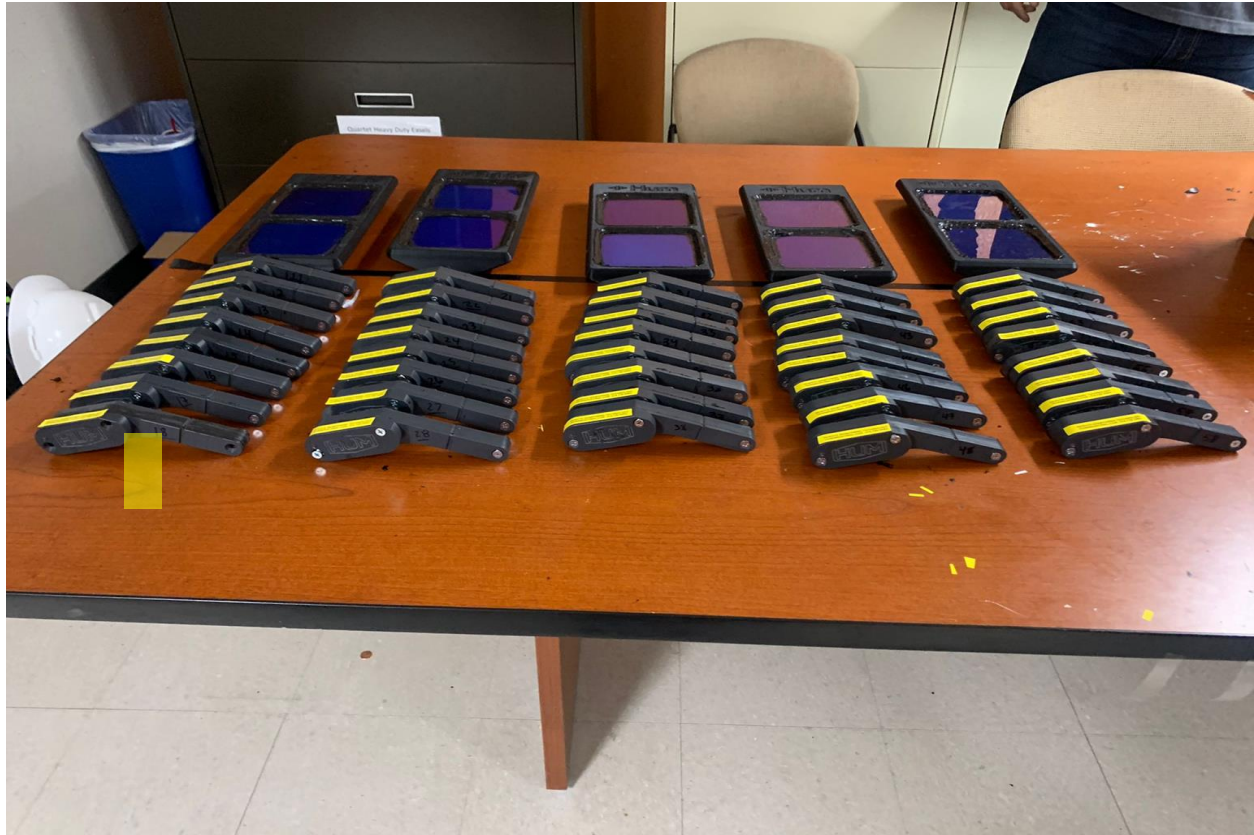
Figure 28. Assembled Gateway and Boomerang units at UTCRS

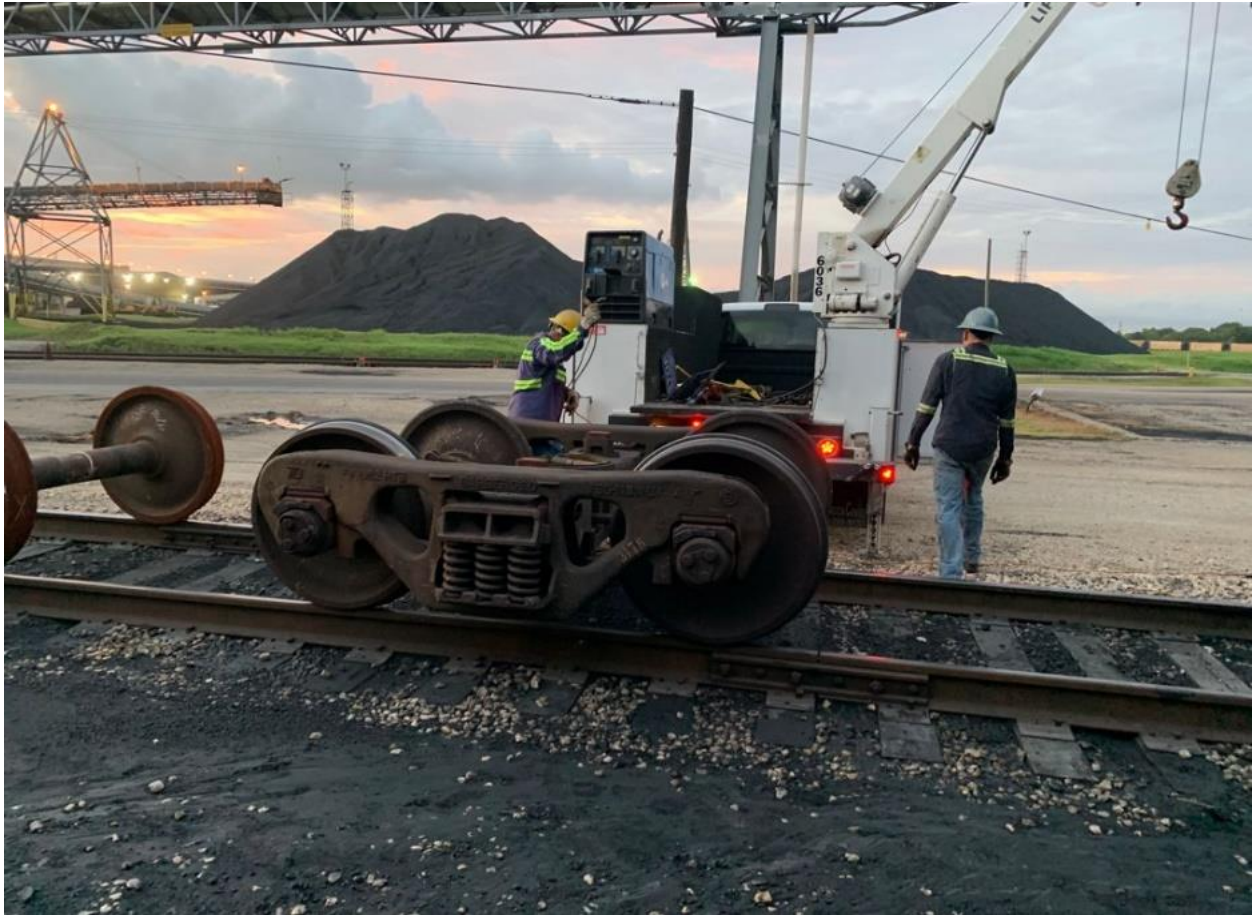
Figure 31. Wheelset removal process

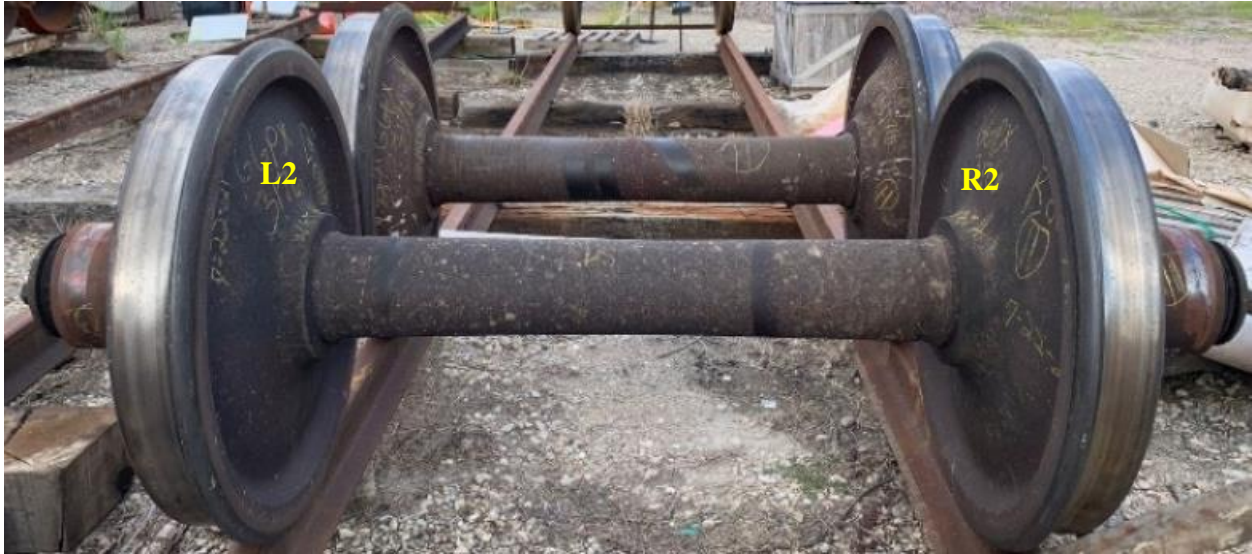
Figure 32. Axle 2 low-concern wheelset (healthy)

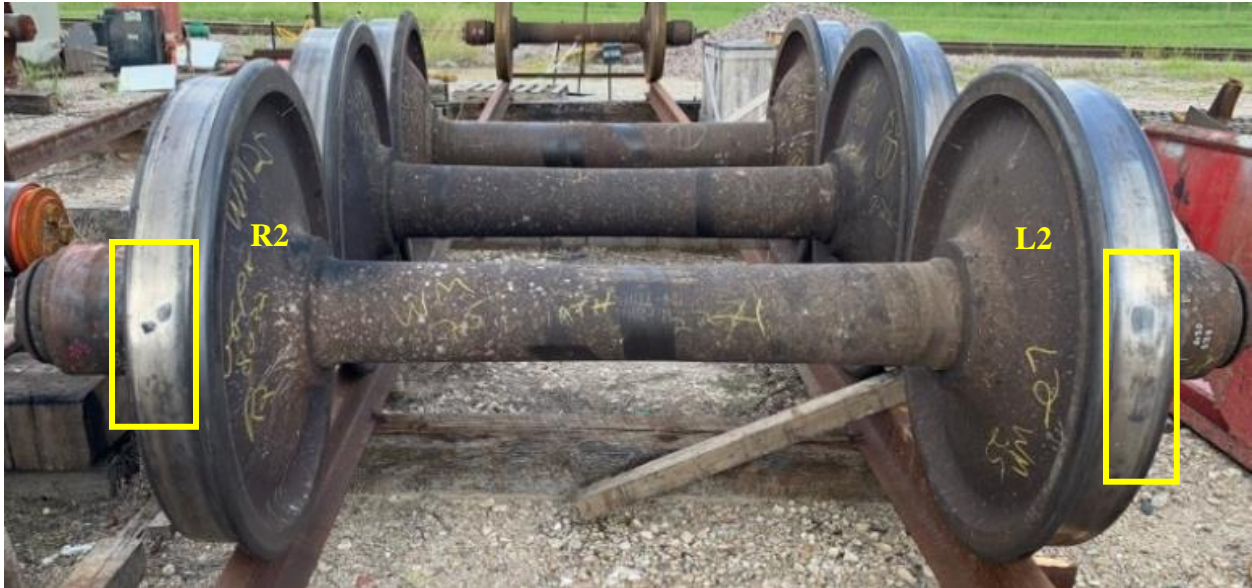
Figure 33. Axle 2 high-concern wheelset (defective)

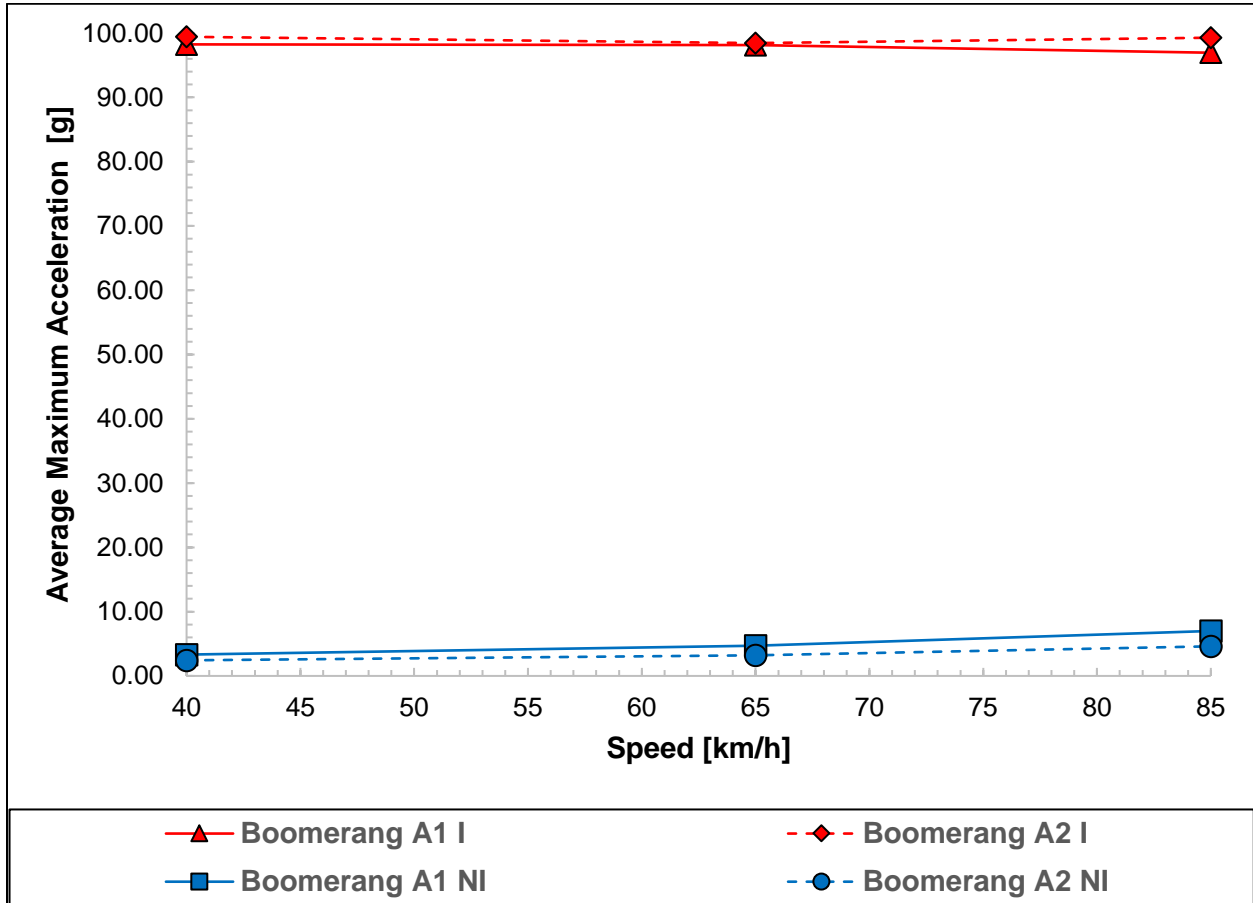
Figure 34. Experiment 244 unloaded control bearing impact (I) and no-impact (NI) Boomerang Accelerometer 1 (A1) and Accelerometer 2 (A2) average maximum [g] results

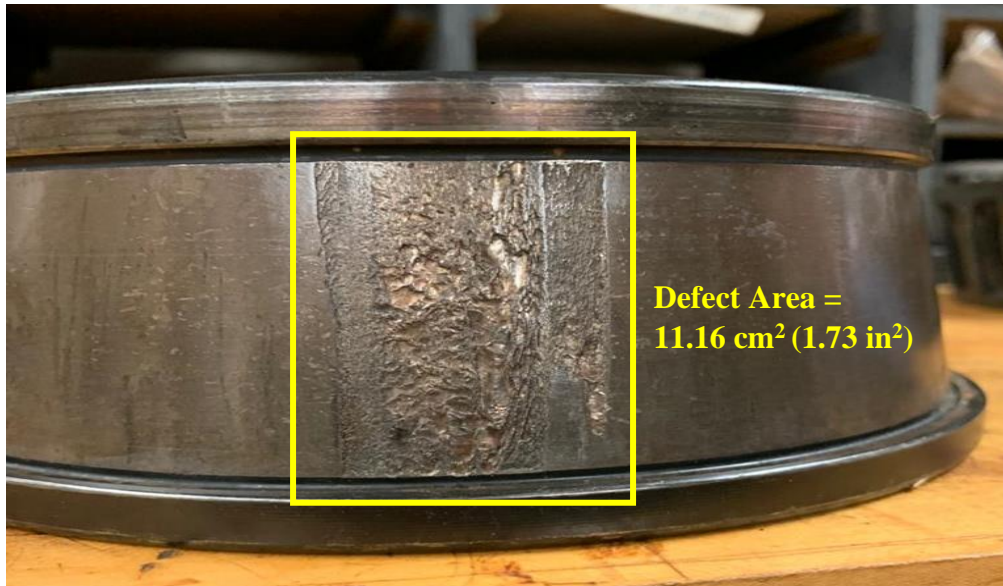
Figure 36. Experiment 245 cone containing a raceway spall of 11.16 cm<sup>2</sup> (1.73 in<sup>2</sup>)

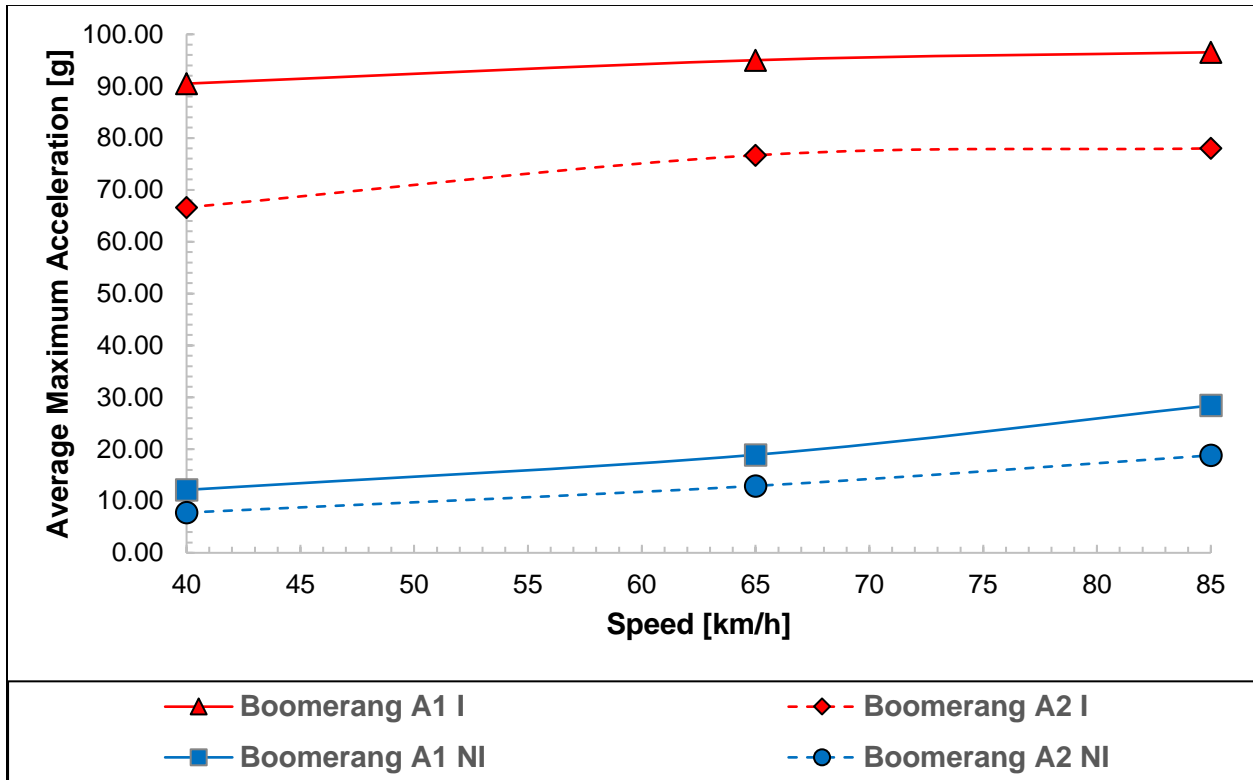
Figure 37. Experiment 245 unloaded bearing with cone spall impact (I) and no-impact (NI) Boomerang Accelerometer 1 (A1) and Accelerometer 2 (A2) average maximum[g] results

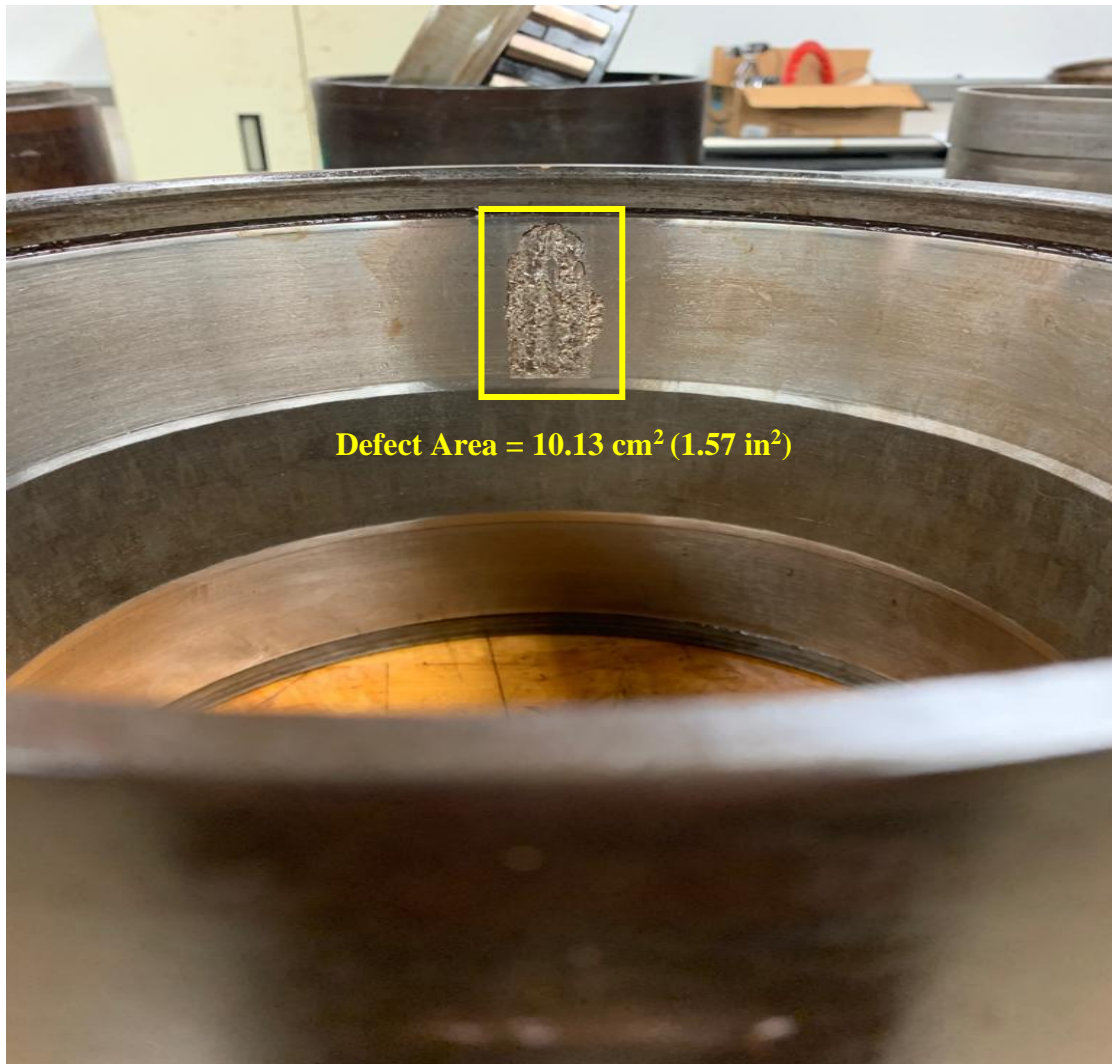
Figure 39. Experiment 246 cup containing a raceway spall of 10.13 cm<sup>2</sup> (1.57 in<sup>2</sup>)

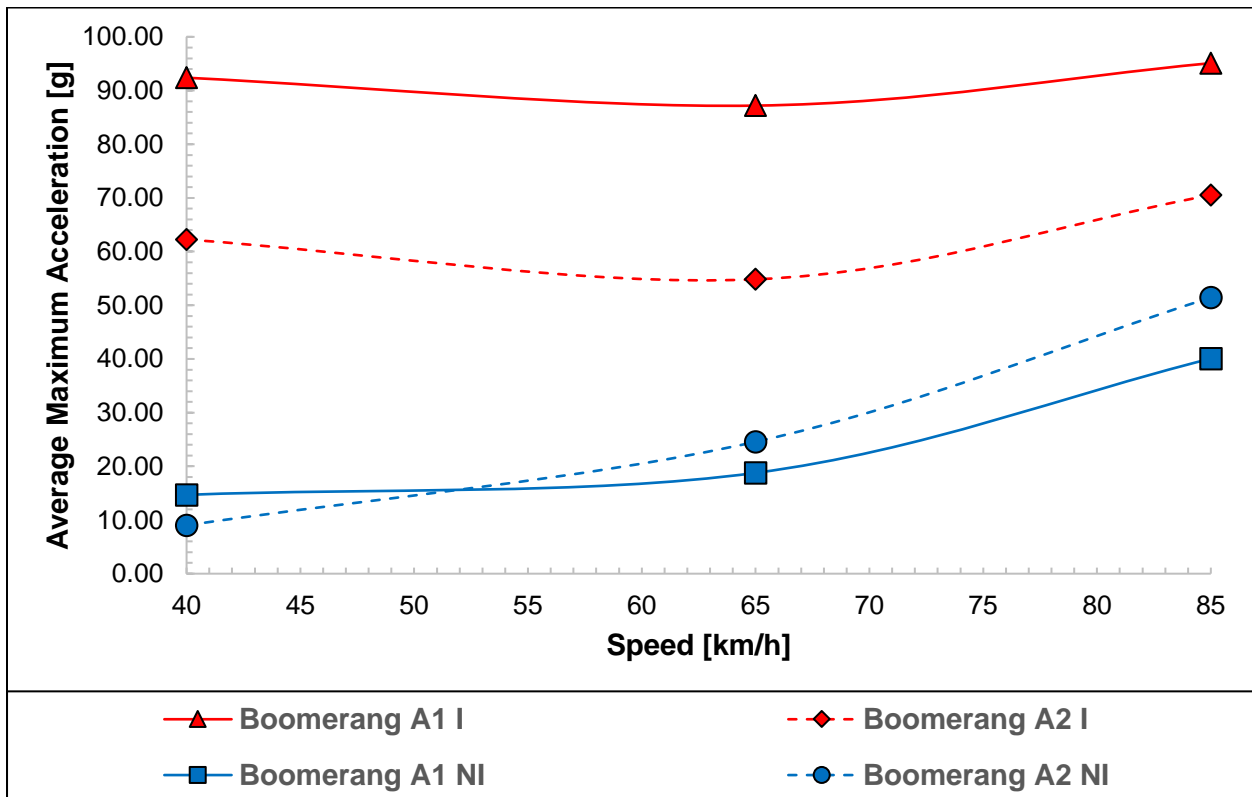
Figure 40. Experiment 246 unloaded bearing with cup spall impact (I) and no-impact (NI) Boomerang Accelerometer 1 (A1) and Accelerometer 2 (A2) average maximum [g] results

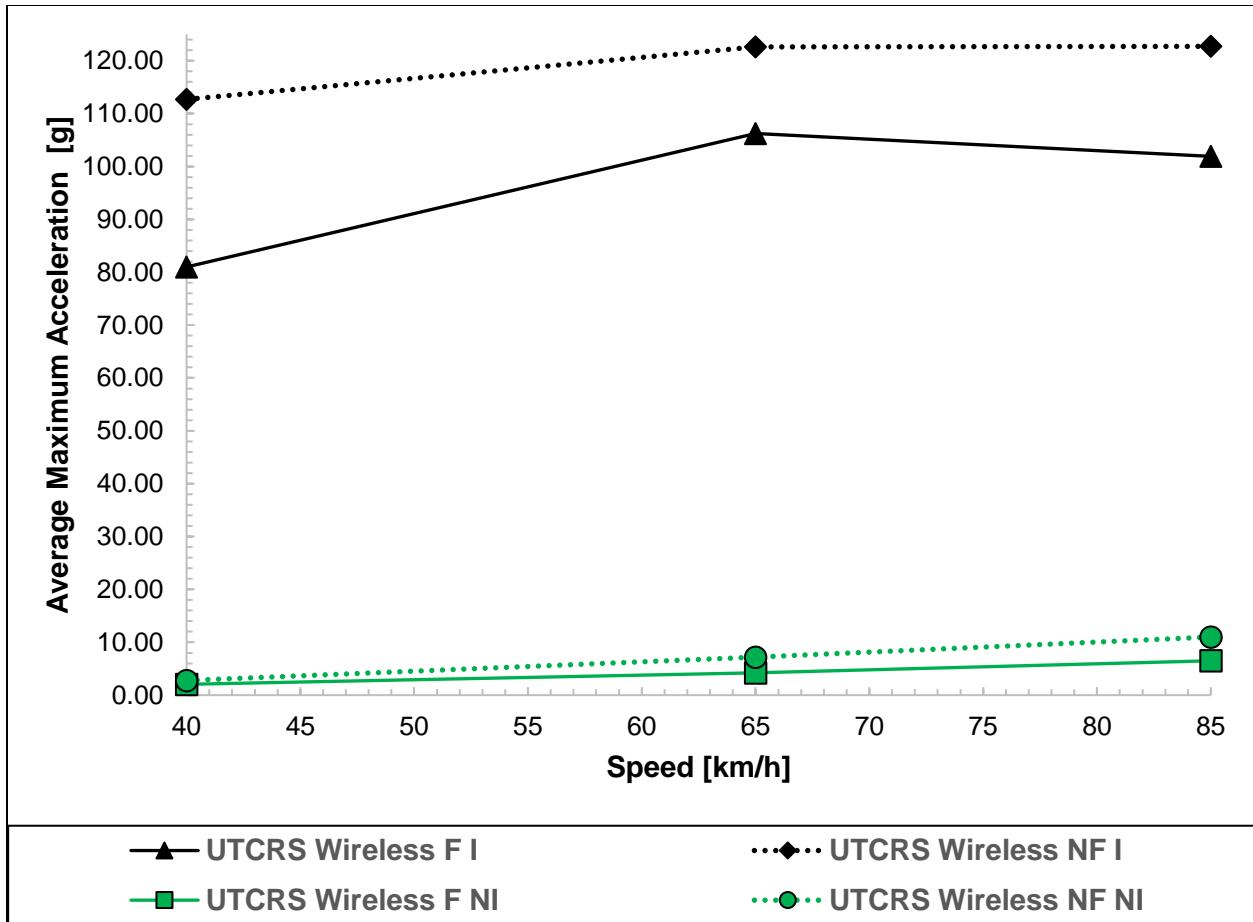
Figure 42. Experiment 244 unloaded control bearing impact (I) and no-impact (NI) UTCRS wireless module filter (F) and no filter (NF) average maximum [g] results
