## Railcar Wheel Impact Detection Utilizing Vibration-Based Wireless Onboard Condition Monitoring Modules

RAILCAR WHEEL IMPACT DETECTION UTILIZING VIBRATION-BASED WIRELESS  
ONBOARD CONDITION MONITORING MODULES

Submitted in Partial Fulfillment of the  
Requirements for the Degree of  
MASTER OF SCIENCE IN ENGINEERING

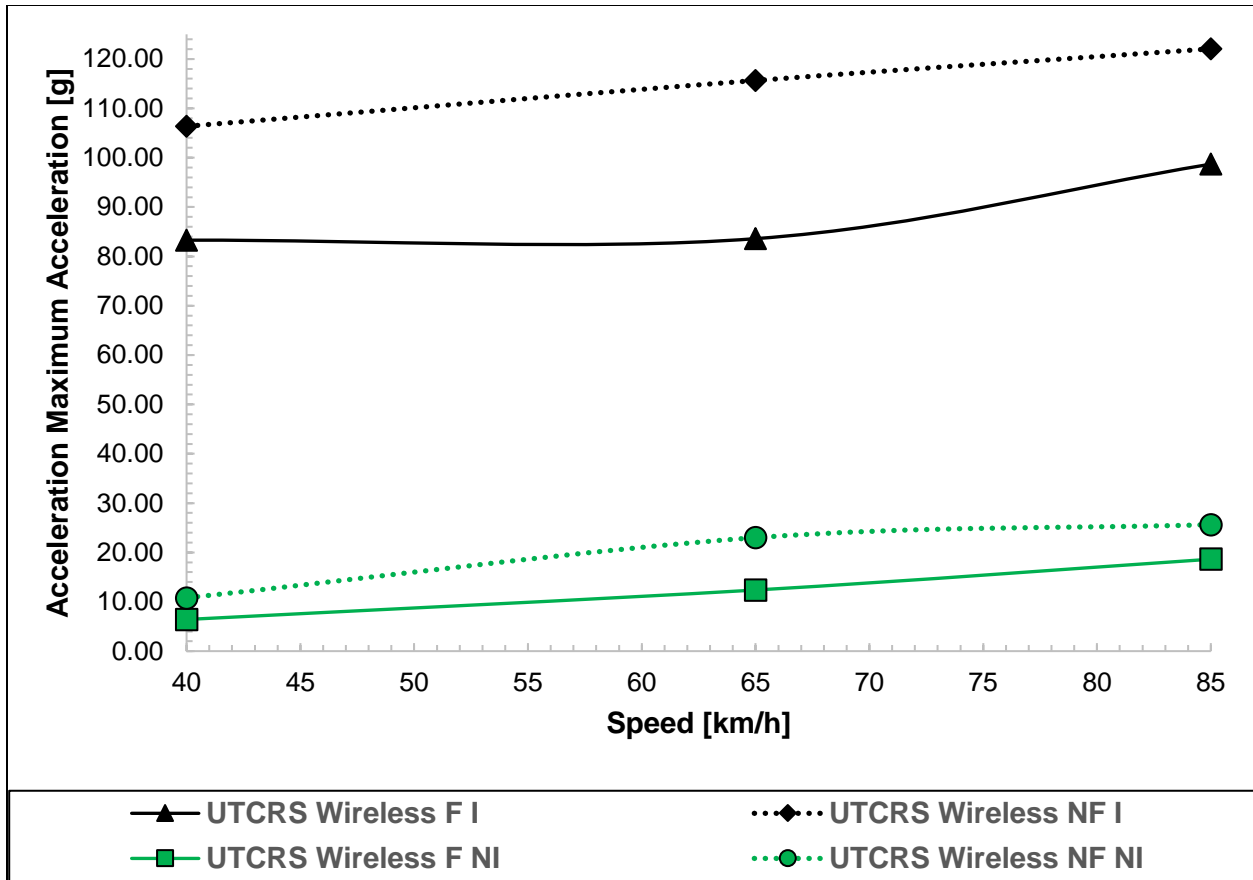
Figure 44. Experiment 245 unloaded bearing with cone spall impact (I) and no-impact (NI) UTCRS wireless module filter (F) and no filter (NF) average maximum [g] results

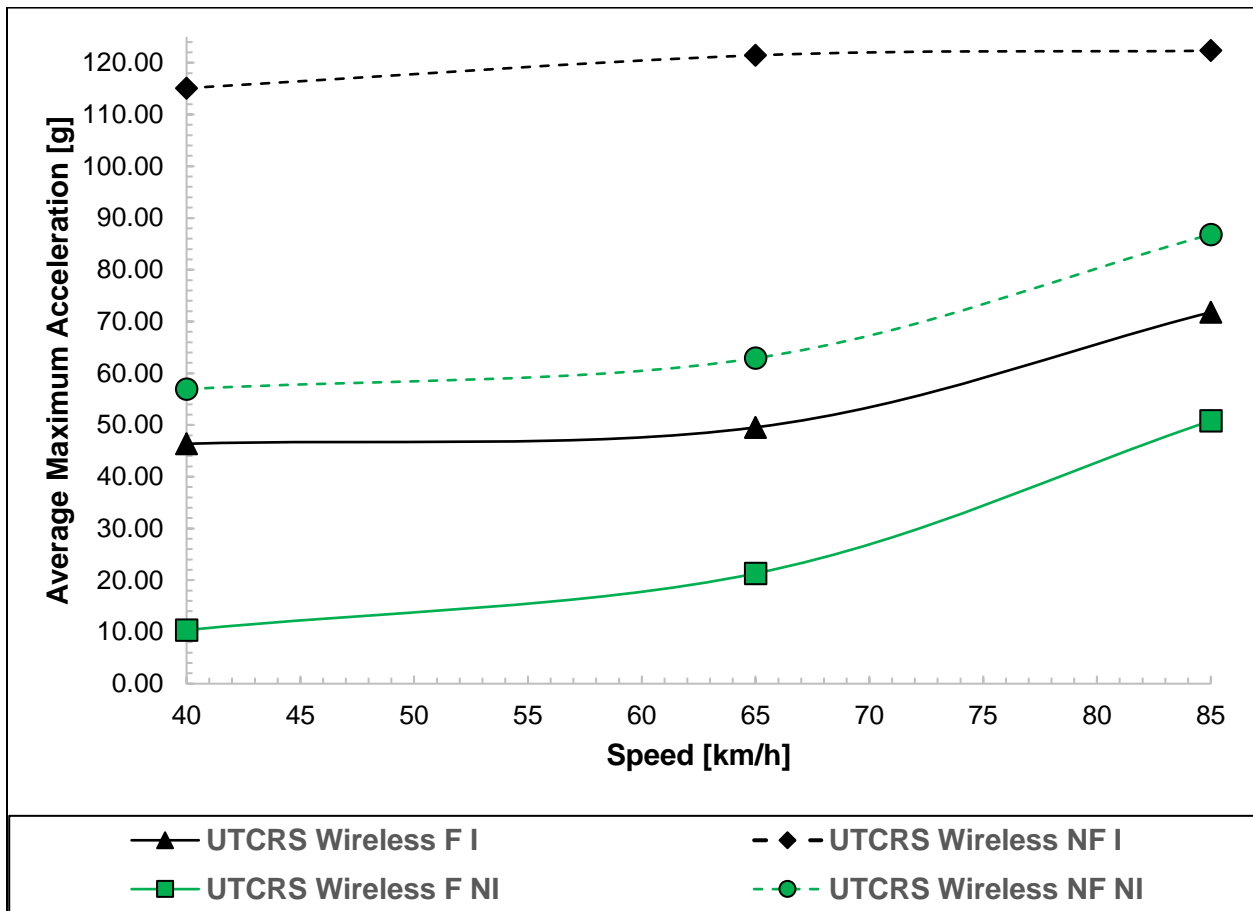
Figure 45. Experiment 245 loaded bearing with cone spall impact (I) and no-impact (NI) UTCRS wireless module filter (F) and no filter (NF) average maximum [g] results

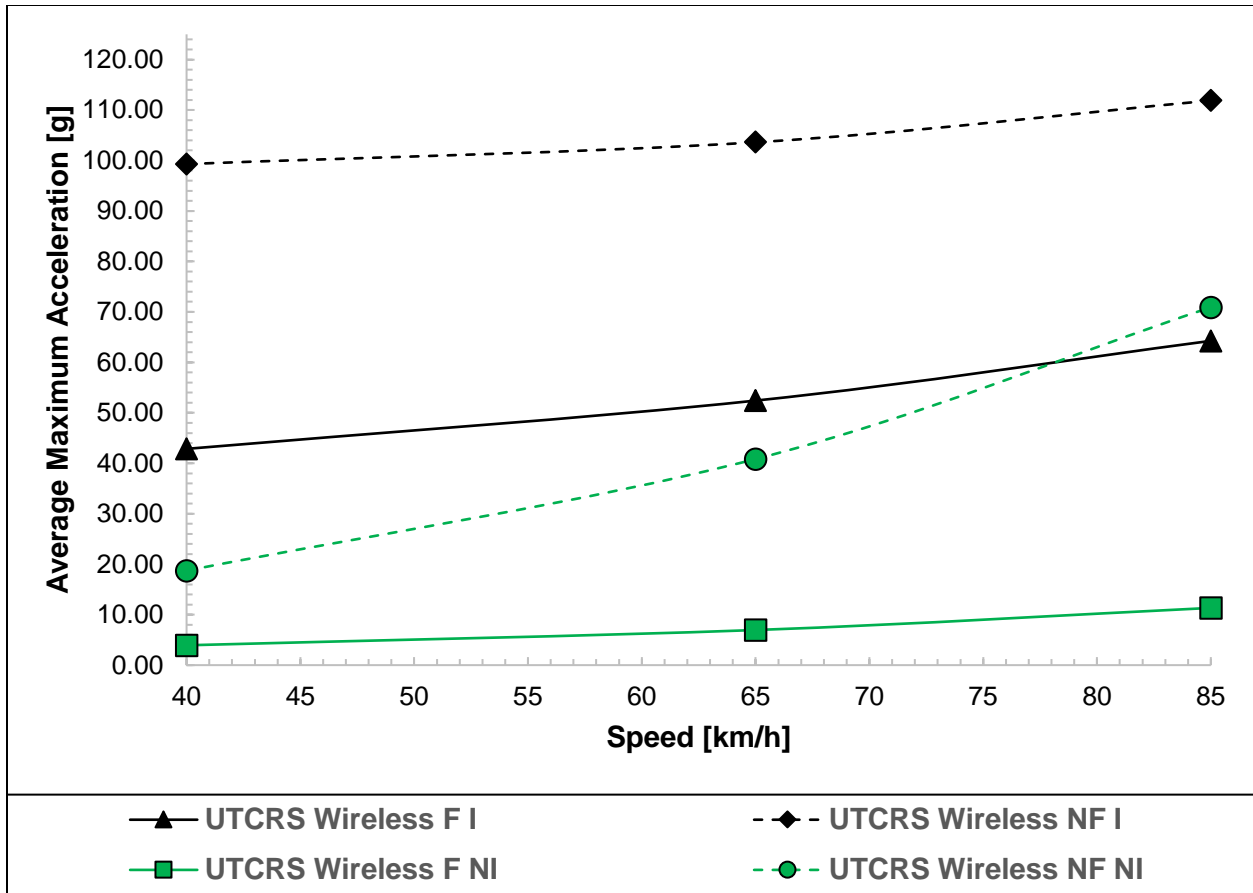
Figure 46. Experiment 245 unloaded bearing with cup spall impact (I) and no-impact (NI) UTCRS wireless module filter (F) and no filter (NF) average maximum [g] results

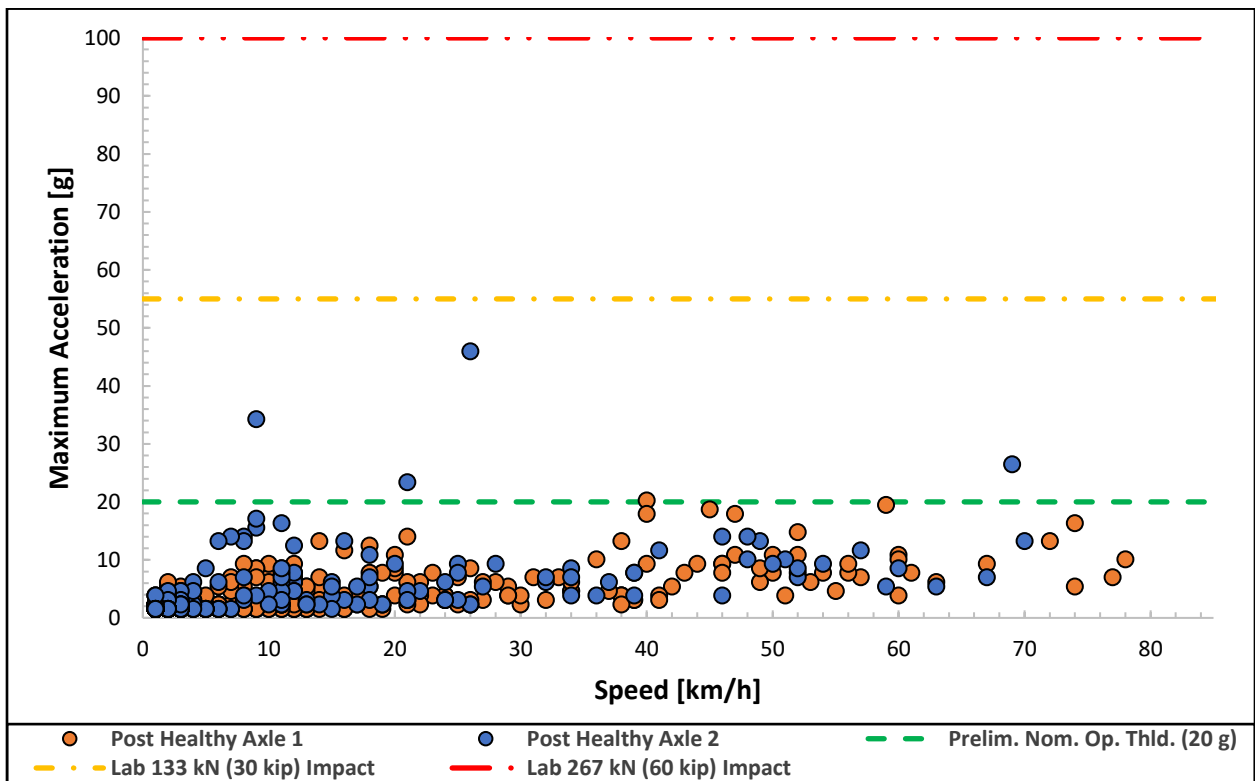
Figure 49. Healthy Axle 1 and 2 maximum acceleration [g] values post-changeout

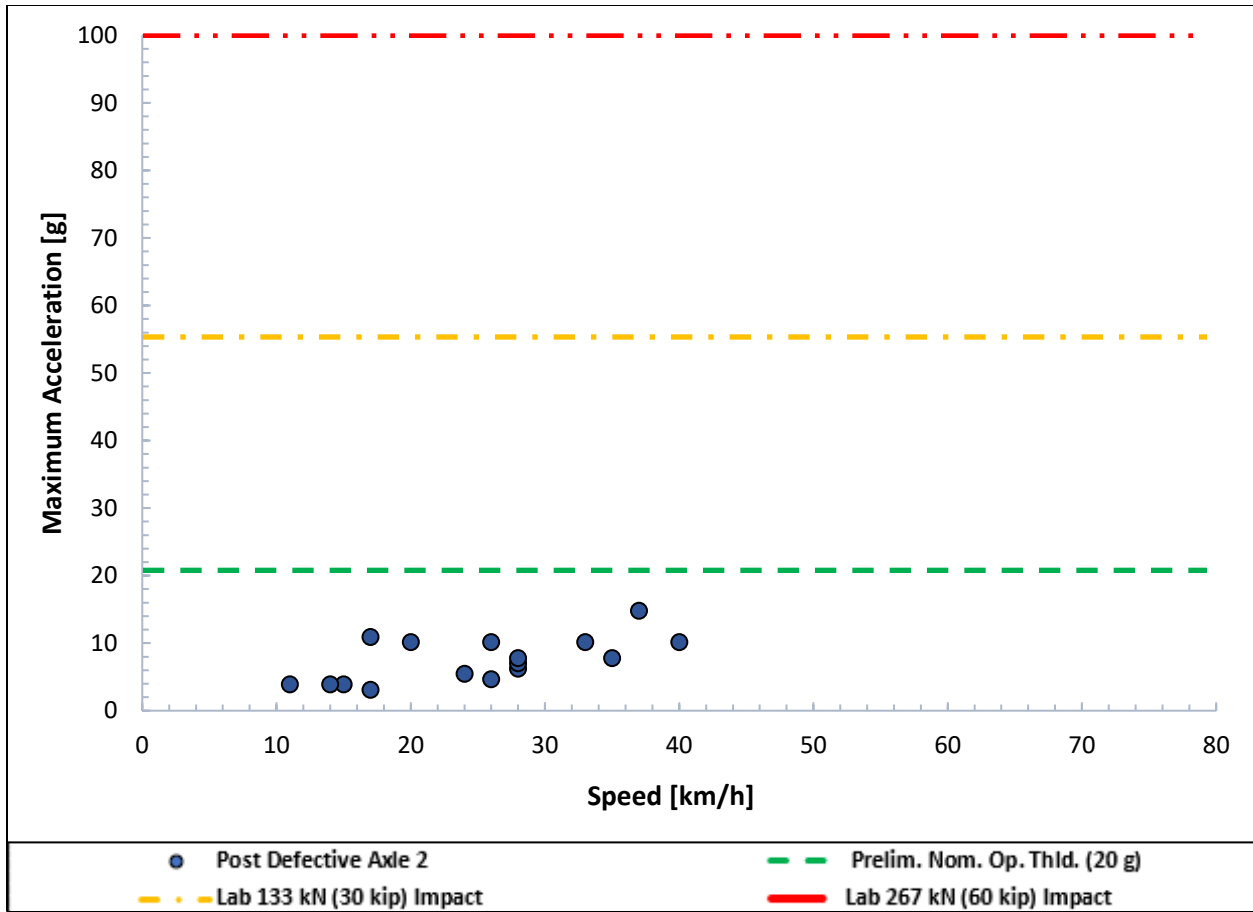
Figure 51. Defective Axle 2 maximum acceleration [g] values post-changeout

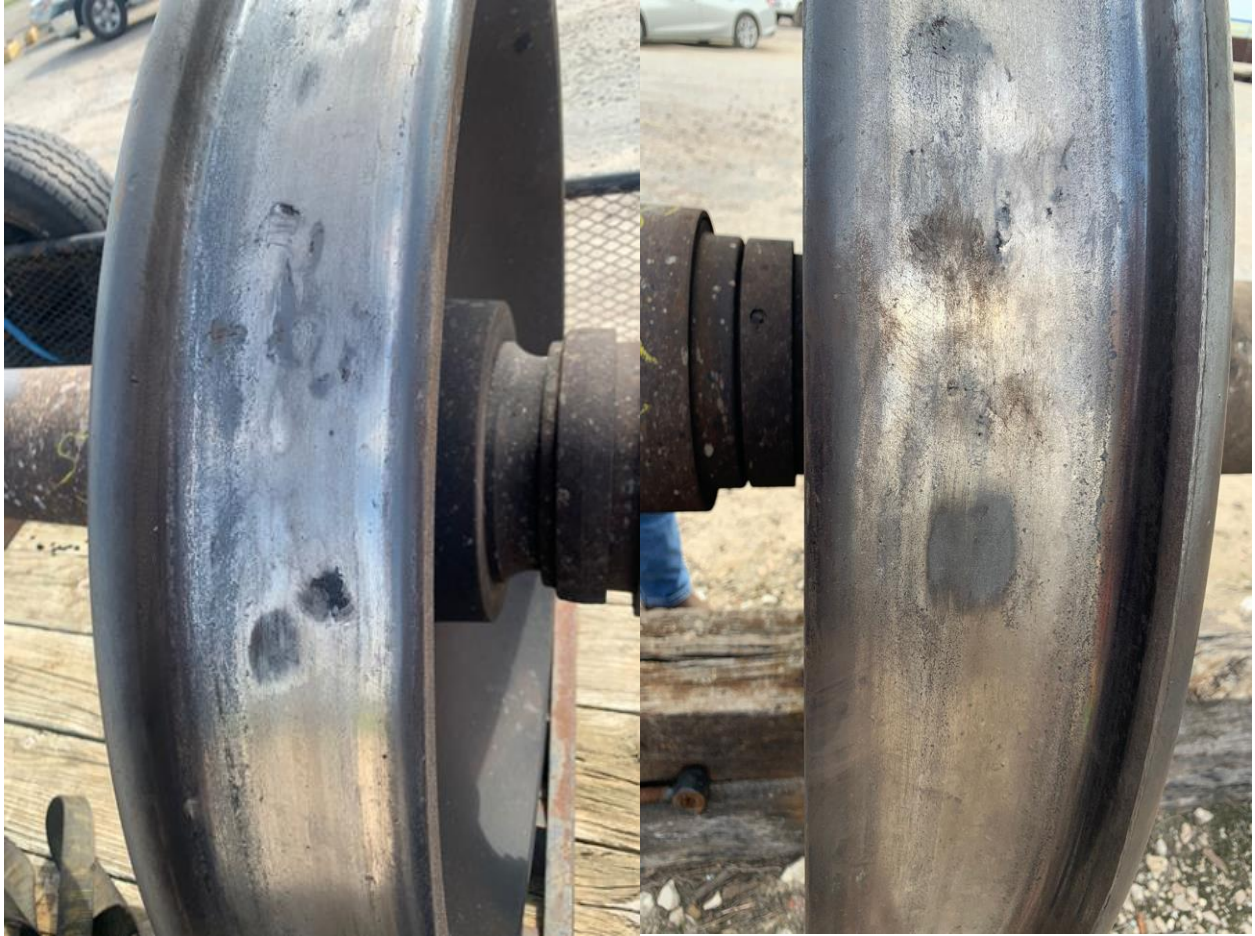
Figure 52. Defective Axle 2: wheel R2 defects (left) and wheel L2 defects (right)
