Rockfalls change the runout and frequency of debris flows at Punta Nera (Eastern Italian Alps).

Alessandro Simoni^{1*}, Matteo Barbini², Leonardo Battistel¹, Martino Bernard², Matteo Berti¹, Osvaldo Cargnel³, Pier Paolo Ciuffi¹, and Carlo Gregoretti²

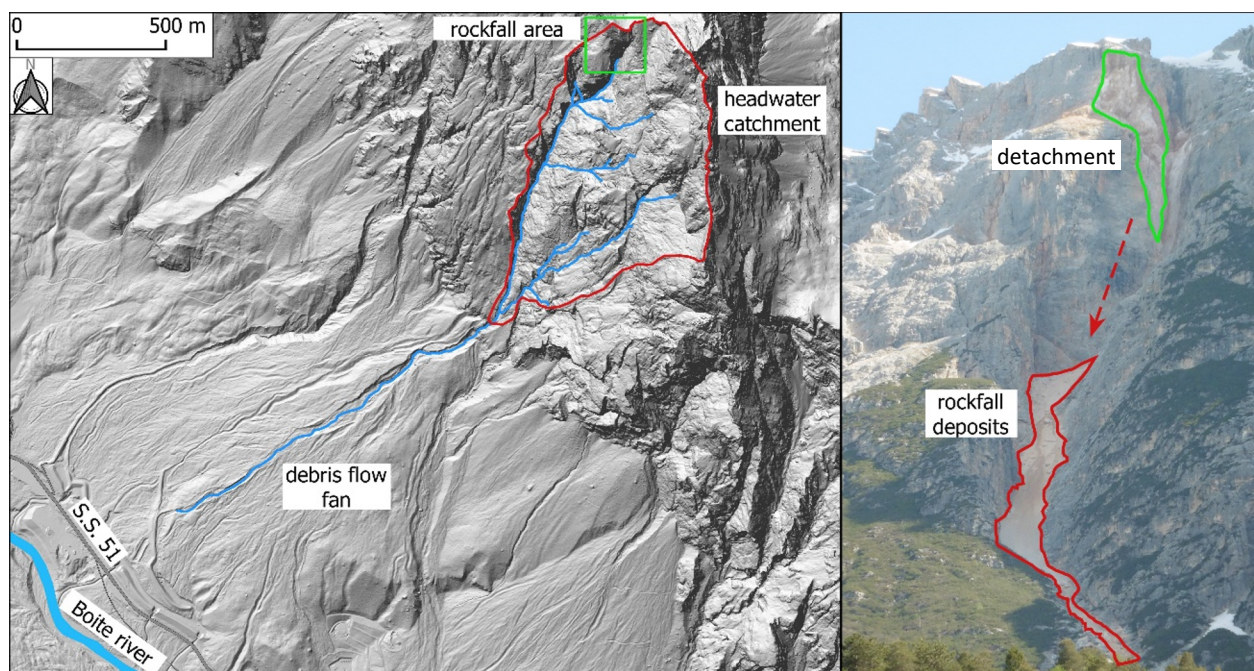
Fig. 1. Hillshade of the Punta Nera debris flow basin (left) derived from a 2015 lidar-derived DEM (1 m) and photograph (right) taken shortly after the occurrence of the main rockfall event on May 20th, 2016.

The first evidence of rockfall occurring in the Punta Nera basin dates back to October 2013. Similar events occurred between October and November of the following year. All rockfalls involved the dolomite walls in the upper western part of the headwater (Figure 1). Based on terrestrial photographs and direct observations, we estimate volumes in the order of a few tens of thousands of m³, although even the mapping in the 2015 aerial photographs is problematic due to extreme steepness (>60°) causing shadowing.

All of the 2013 and 2014 events are likely precursors of the main rockfall occurred on May 20th, 2016 in the same area. In this case, aerial photographs and videos taken from the helicopter on the following day, allowed precise mapping of the area (4,000 m² approx.) of the

detachment (Figure 1). The deposits spread along the main chute cutting through the headwater, covering an area of about 14,000 m². In this case, pre- and post-event photographic documents indicate the detachment of a thick pinnacle of dolomite. Assuming an average thickness of 30 m, we obtained a total volume exceeding 100,000 m³, which is likely an underestimate.

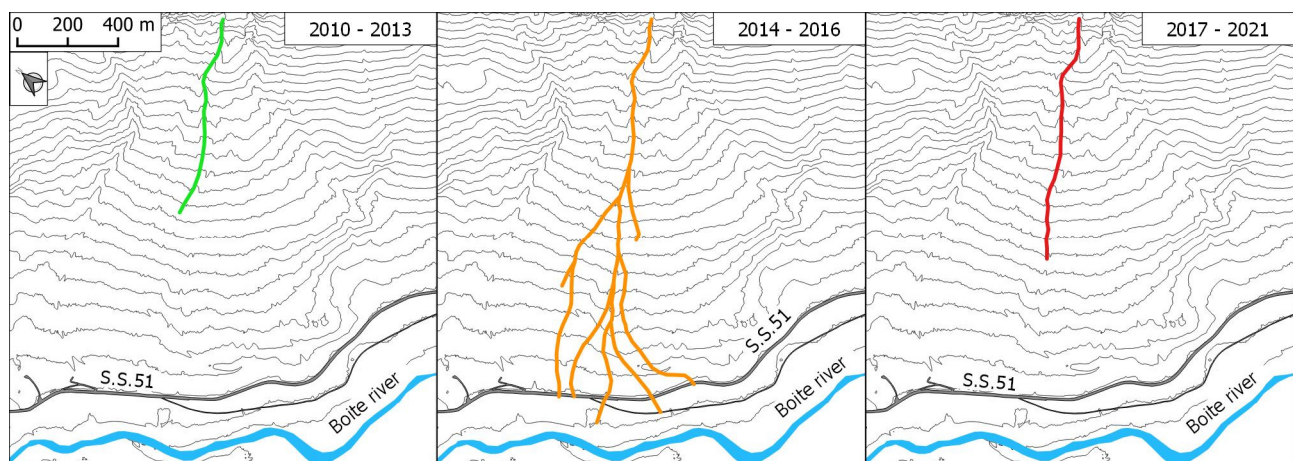
Fig. 2. Active debris flow channels on the Punta Nera fan during the summer seasons preceding the rockfalls (left), following the rockfalls (centre) and following the evacuation of the rockfall deposits from the headwater (right). Channel mapping derives from aerial photographs and lidar surveys.

below. The analysis of aerial photographs demonstrate that the active channel was confined to the upper middle part of the fan (Figure 2) while a dense coniferous forest covered the lower fan.

By comparing aerial photographs (2012, 2015, 2017, 2018, 2020) and lidar surveys (2010, 2011, 2015, 2020) we identified how the runout of debris flow events increased abruptly during the years 2015 and 2016. The path of the debris flow channel remained relatively unchanged in the upper part of the fan while multiple avulsions occurred further downstream with creation of new channels reaching the national road and several lobes of debris deposited in the lower fan (Figure 2).

During recent years (2017-21), the debris flow activity at Punta Nera gradually returned to earlier levels (i.e., no active channel in the lower part of the fan). No traffic disruptions were recorded thanks to the retention basin but also because debris flow activity retreated in the middle part of the fan (Figure 2). No subsequent flow showed the mobility, nor the magnitude, of the large events that occurred during 2015 and 2016.

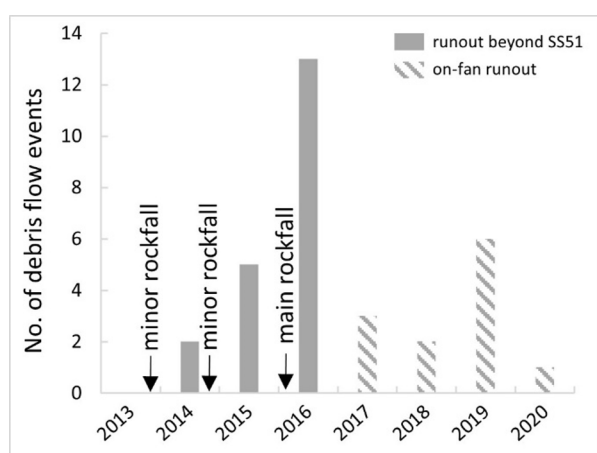
Fig. 3. Number of recorded debris flow events per year and rockfall episodes.

In addition to an increase of magnitude, the years 2015 and 2016 saw a notable increase in debris flow frequency, because of the rockfalls. This indicates a change in the critical conditions required for debris flow initiation. Although anomalies in rainstorm frequency may also have played a role, we believe that debris availability was the primary factor responsible for the increase in frequency and volume of events observed during the two-year period. Ongoing rainfall data analysis is expected to reveal a temporary rainfall intensity/duration ID threshold modification. Results of previous research [14] support the use of rainfall ID thresholds across a range of decreasing sediment supply conditions. In other cases [12] rainfall thresholds showed substantial changes following a dramatic increase of sediment availability across the landscape.
