MORPHODYNAMICS OF THE TELUK NIPAH SHORELINES

W.Y. Foo¹, H.M. Teh^{2,3} and A.L. B. Balogun²

²Department of Civil and Environmental Engineering, Universiti Teknologi PETRONAS, Malaysia

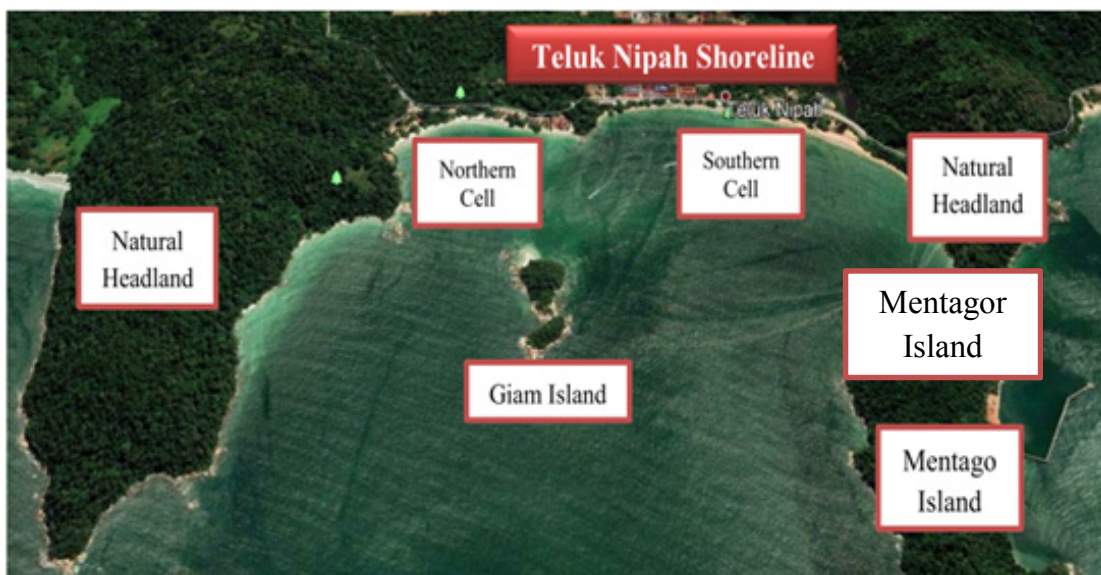
Figure 1 Teluk Nipah shoreline

Teluk Nipah, as shown in Figure 1, is a 1500 m long sandy beach and is recognized as the most visited recreational beach on the island. The extent of Teluk Nipah is relatively obvious with the existence of a pair of natural headlands sheltering the beach on both ends. Giam Island and Mentagor Island partially shelter this mild-sloping beach with clear water and fine white sand. The commercial development alongshore of Teluk Nipah is considerably dense due to the overwhelmed anthropogenic activities and littoralization effects. Restaurants, homestay, resort, hawker stalls and commercial shop units built along the coastal road and some of them are relatively close to the shoreline.

The stretch of Teluk Nipah shoreline can be divided into two coastal sub-cells, namely the northern cell and the southern cell, as illustrated in Figure 1. Figure 2 shows the coastal developments along the shoreline at the northern and southern cells. In the northern cell (Figure 2a), the beach width, i.e. the distance from the shoreline to the coastal road, varies from 35 to 70 m. Most of the development is located at the south of the northern shoreline. For the southern coastal cell (Figure 2b), the beach at the north is considerably narrow, whereas that at the south is relatively broad. The northern beach is currently under enormous pressure due to rapid development and other anthropogenic activities.

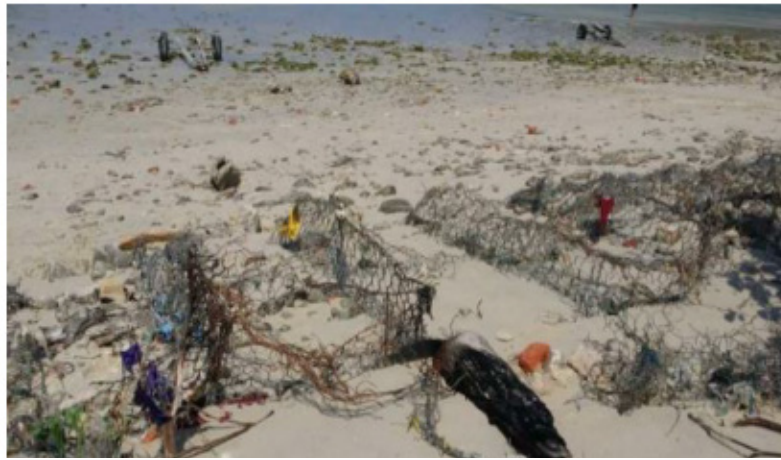
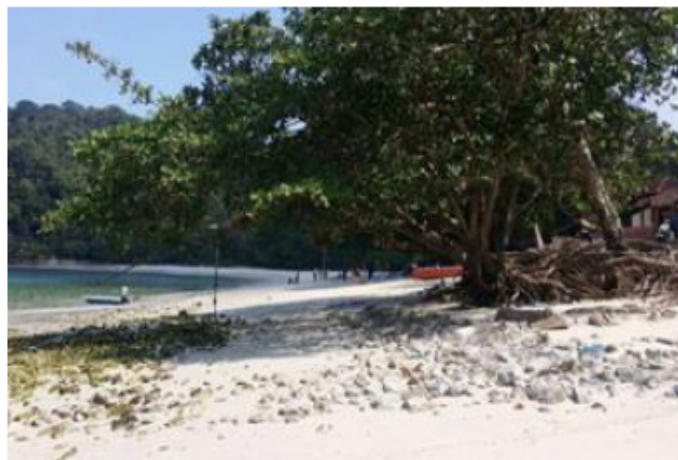
Figure 3 Traces of coastal erosion at the beach of Teluk Nipah
(a) Damaged gabion blocks (b) Scattering of gabion rocks

In the northern cell of Teluk Nipah, the coastal erosion invaded the steady-state of the coast when the gabion block in providing shelter to the chalets was disintegrated (Figure 3). Consequently, it led to the scattering of the rocks, which are contained initially within the steel cages of gabion blocks, all over the beach area. Thus, the serenity of the beach had turned into an atrocious and unsafe place to walk. Aside from the damaged protection structure, the aggressive wave actions also crumbled the temporary shelters, and the intrusion of seawater undermined the footings of the public shelters. The aftermath of erosion is evident at the northern cell as the tree roots exposed to the atmosphere due to the beach lowering effect, though the reinforced concrete slab of the coastal food court was severely degraded.

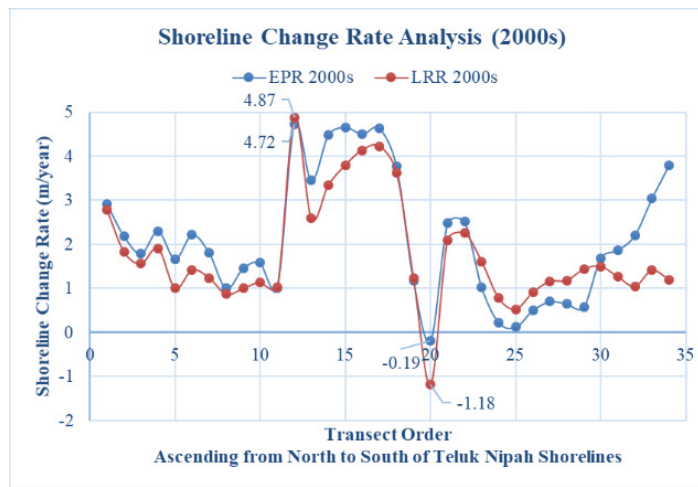
Figure 6 Shoreline change rate analysis (a) 1990s (b) 2000s (c) 2010s

Figure 6 depicts the graphical analysis of the decadal shoreline change rates of Teluk Nipah in the 1990s, 2000s and 2010s using EPR and LRR approaches. Based on the overall trendlines of the decadal EPR and LRR change rates in the 1990s (Figure 6a), even though the shorelines of Teluk Nipah are dynamic; they are relatively stable as the occurrence of erosion and accretion are quite consistent over a series of the transects. In other words, the shoreline is claimed to be in an equilibrium state. The maximum erosion rate goes up to -1.64 m/year whilst the maximum accretion rate reaches 2.95 m/year. During the 2000s (Figure 6b), it is evident that the Teluk Nipah shorelines experienced a major increase in the beach width. The maximum accretion rate and the maximum erosion rate are approximate $+4$ m/year and -1.18 m/year, respectively. In the 2010s, it is evident that from Figure 6c that Teluk Nipah has experienced severe shoreline retreat, particularly at the southern cell starting from Transect 12 to Transect 33. At Transect 23 (the centre of the commercial hub at Teluk Nipah), the annual erosion rate reaches as high as 5 m. The erosion is considered critical at this point. To further evaluate the morphodynamics of the coastal zone at Teluk Nipah, critical profile analysis has been undertaken. The results are presented in the following section.

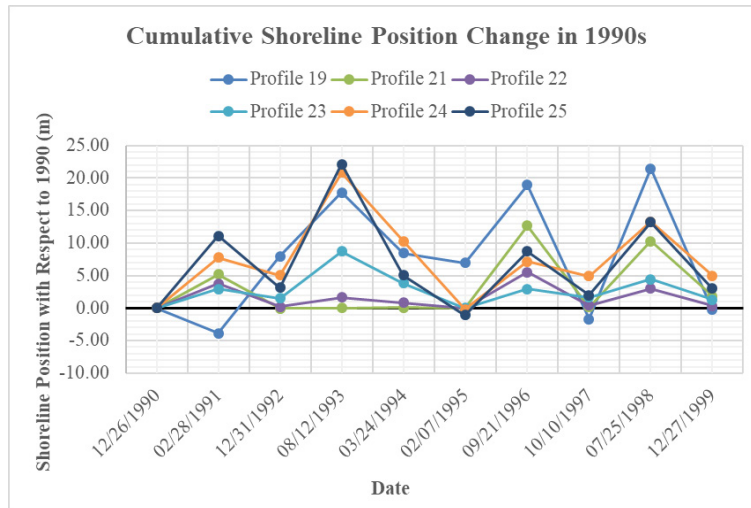
Figure 8 Cumulative shorelines position changes (a) 1990s (b) 2000s (c) 2010s

Figure 8a shows the cumulative shoreline position change of the 1990s shorelines in relative to the earliest shoreline in the decade, which is 1990, at Transect 19 to Transect 25. Based on the graph, it can be interpreted that the 1990s shorelines confined between Transect 19 and Transect 25 experienced accretion of different extents. The same observations are found for the 2000s shoreline, except for a period of 2002 and 2003 in which the stipulated area was subjected to erosion. Overall, the shorelines confined between Transect 19 and Transect 25 are of good states during the 1990s to 2000s. Nevertheless, the good state of the shore deteriorates significantly in the 2010s (Figure 8c). It is evident that the shoreline profiles of the critical zones have moved landwards starting from 2013, and the downward trends of the beach profiles continue in the subsequent years

the shoreline of Teluk Nipah experiences a significant retreat, as shown in Figure 8c. Hence, it is suggested that the anthropogenic activities have also contributed to alterations on the coastal morphology at Teluk Nipah. All in all, the plausible sources of erosion at Teluk Nipah are identified as the extreme storm events, the commercial development plans and the longshore sediment transport processes.

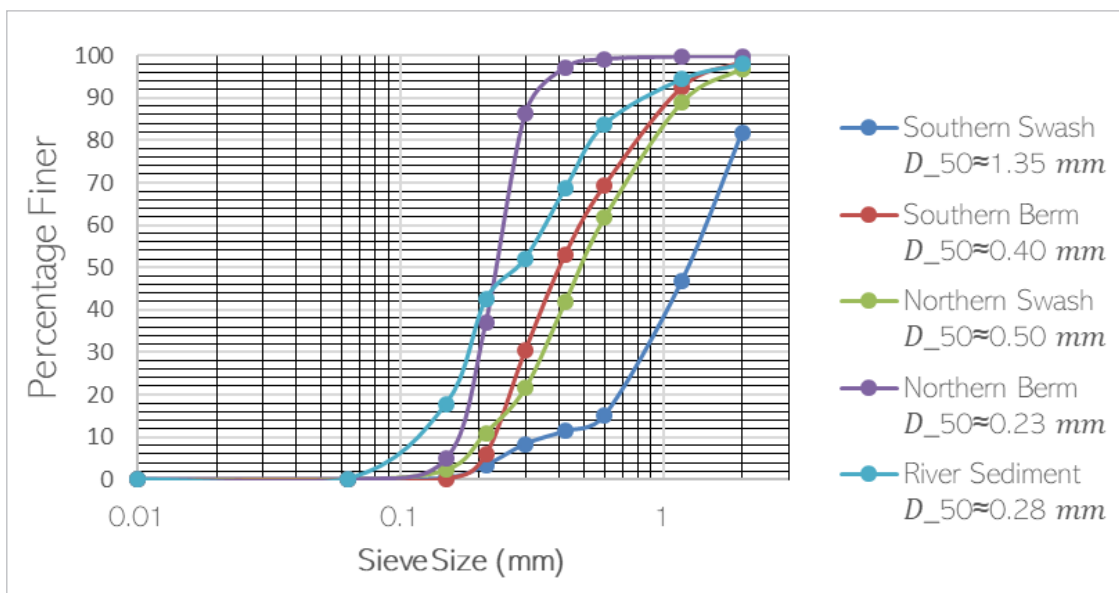
Figure 9 Sediment grain size distribution curves for the beach of Teluk Nipah

Soil samplings were performed at the berms and swash zone of both cells, as well as the river at the southern cell. The grain size distribution of the soil samples was assessed using sieve analysis. Figure 9 presents the grain size distribution curves of the five soil samples taken at various locations along Teluk Nipah. The sediment grain size of the beach of Teluk Nipah ranges from 0.23 to 1.35 mm. The grain size is uniform and well-distributed. It is learnt that the sediment of the northern cell is finer than that of the southern cell, and the sediment at the swash zone is courser than that at the berms. During site investigations, it was found that the top sand of the southern beach is covered by a thin layer of fine sand of brighter colour. It is believed that the fine sand was carried from the beach at the northern cell via alongshore sediment transport.
