## Cliff Vulnerability Assessment on Rocky Coasts in southern Portugal

### ABSTRACT

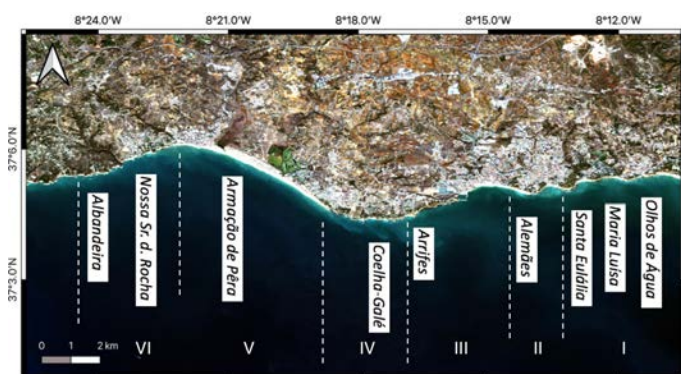
Figure 1: Study area in the southern Algarve, Portugal, identifying six sectors (STOCK 2020, ESA 2019).

The area under study is defined by the about 40 km long coastal stretch between Olhos de Água and Albandeira in the southern Algarve, Portugal and was divided into six sectors according to respective lithological characteristics (Figure 1). To investigate possible associations between certain parameters and cliff vulnerability to erosion and to obtain the necessary data, a multi-tool approach was implemented. This included fieldwork to explore lateral facies variation and geomorphological features, laboratory analysis of rock samples (CaCO<sub>3</sub> content), coupled with UAV (unmanned aerial vehicles) image analysis, and photogrammetry.

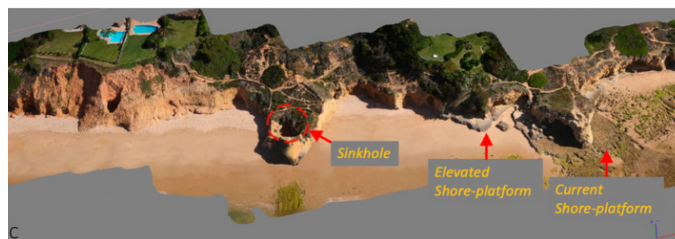
Figure 4. 3D model of the cliffs near Maria Luísa displaying sinkholes and shore platforms (STOCK 2019).

The outputs from AgiSoft Metashape established the possibility to observe cliff features from different and usually inaccessible angles. The created 3D model (Figure 4) helped to identify the overall morphology as well as minor scale features such as evidence of rock fall events, sinkholes and sediment fans, as well as to measure cliff heights.

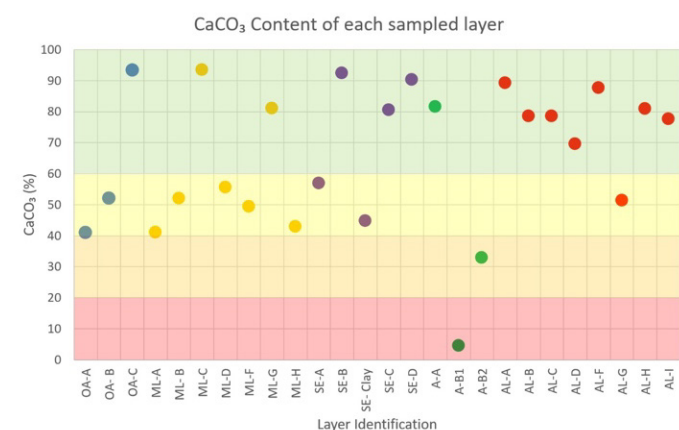
Figure 3. CaCO<sub>3</sub> content of each sampled lithofacies organized from east to west with distinctly coloured dots according to the locations.

The highest average CaCO<sub>3</sub> content values were detected at Albandeira (77,9%), followed by Santa Eulália (73%), Olhos de Água (59,7%) and Maria Luísa (56,6%), while the lowest average CaCO<sub>3</sub> content could be found in the cliffs of Alemães (39,68%) (Figure 3). The CaCO<sub>3</sub> content analysis provided valuable information as it is directly linked to rock strength and hence, resistance to erosion.
