Engineering Senior Design Reports

Autonomous Planetary Rover Final Project Report

Final Project Report

Autonomous Planetary Rover

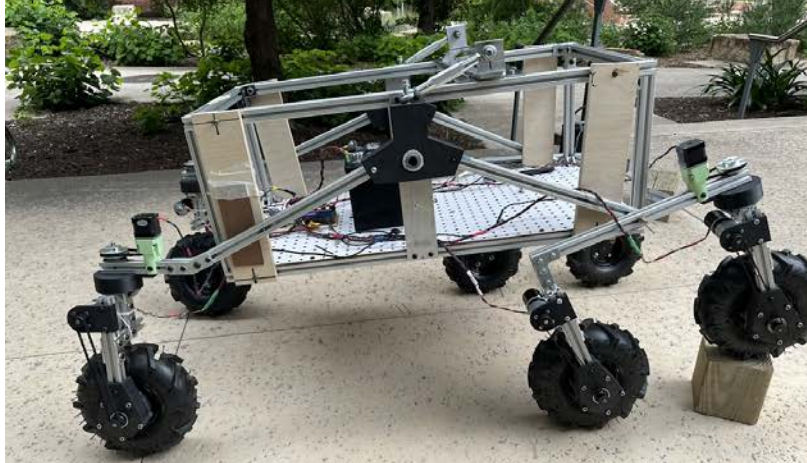
Figure 1: Fully Constructed Rover

Our design work this year was primarily focused on mechanical aspects of the rover that needed improvement. We broke down our design into one minor and three major subsystems: body, suspension, steering, and electronics. The main design components that were kept from the previous team were the frame, the gearboxes, and the overall materials choice of 80/20. Our primary focuses were the suspension and steering systems, as finalizing them will set the next teams up for success. To have a final prototype capable of fulfilling our design requirements, we took inspiration from previous design teams on this project as well as planetary rovers launched by NASA. Previous design team prototypes also included a rocker-bogie suspension system seen in our final design, which was improved upon to better incorporate the steering system. The steering system we decided to implement is an active steering system, with four steering motors and six driving motors. The six drive motors are brushless DC motors which have built-in speed controllers and operate at 12V. The four independent stepper motors also operate at 12V, and are controlled using external bipolar stepper control boards. These boards and the internal speed controllers of the BLDC motors are controlled by an ESP32 microcontroller development board. In terms of resources, the team was able to take full advantage of the Makerspace and Electronic shop available to us at Trinity. Every subsystem includes pieces that were custom designed and fabricated by the team on site, such as milling, CNC, or 3D printing. A total fusion mockup of our final design can be seen in Fig. E1, and an image of the completed rover can be seen in Fig. 1.

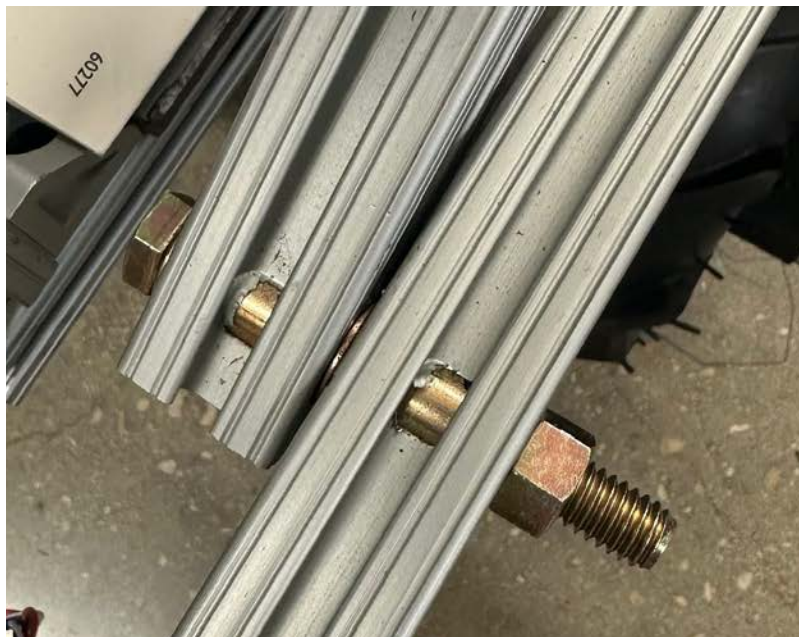
Figure 3: Bogie Joint Setup

To best determine the relationship between the lengths of each of the leg members and the angles at which the members must meet to create a rocker-bogie suspension, we created a mathematical model (Fig. C1 and Fig. C2 in Appendix C) of the expected forces presented in our Preliminary Design Report. Using a force analysis, as well as trigonometry, we predicted the expected lengths, angles, and applied forces on each of the members (see Appendix C). Our design consisted of straight vertical columns to allow for the implementation of independent steering that introduced six total members to the suspension system instead of the typical four seen on the Mars rovers. The overall design of the suspension members and connections did not change from these predictions and calculations, but once we began implementation and construction of the rover we discovered that the overall height of the rover calculated in our model was too tall. While we maintained the main 127 degree joint connection (Fig. E3) for the rocker, and the overall dimensions of the bogie, we shortened all six legs to lower the rover's center of mass. Each member of the suspension was a length of 80/20 extrusion. The main joint used to connect the members of the rocker system was fabricated using the MarkForged 3D printer and was printed in composite nylon, seen in Fig. 2. The bogie joint consists of two oil-embedded sleeve bearings housed in each 80/20 member, connected using a $\frac{3}{8}$ "x3" partially threaded screw and nut to hold the joint together while allowing for a smooth rotation, seen in Fig. 3. The remaining joints connecting the leg members are aluminum cut using the HAAS Mini mill and designs from Fusion 360.

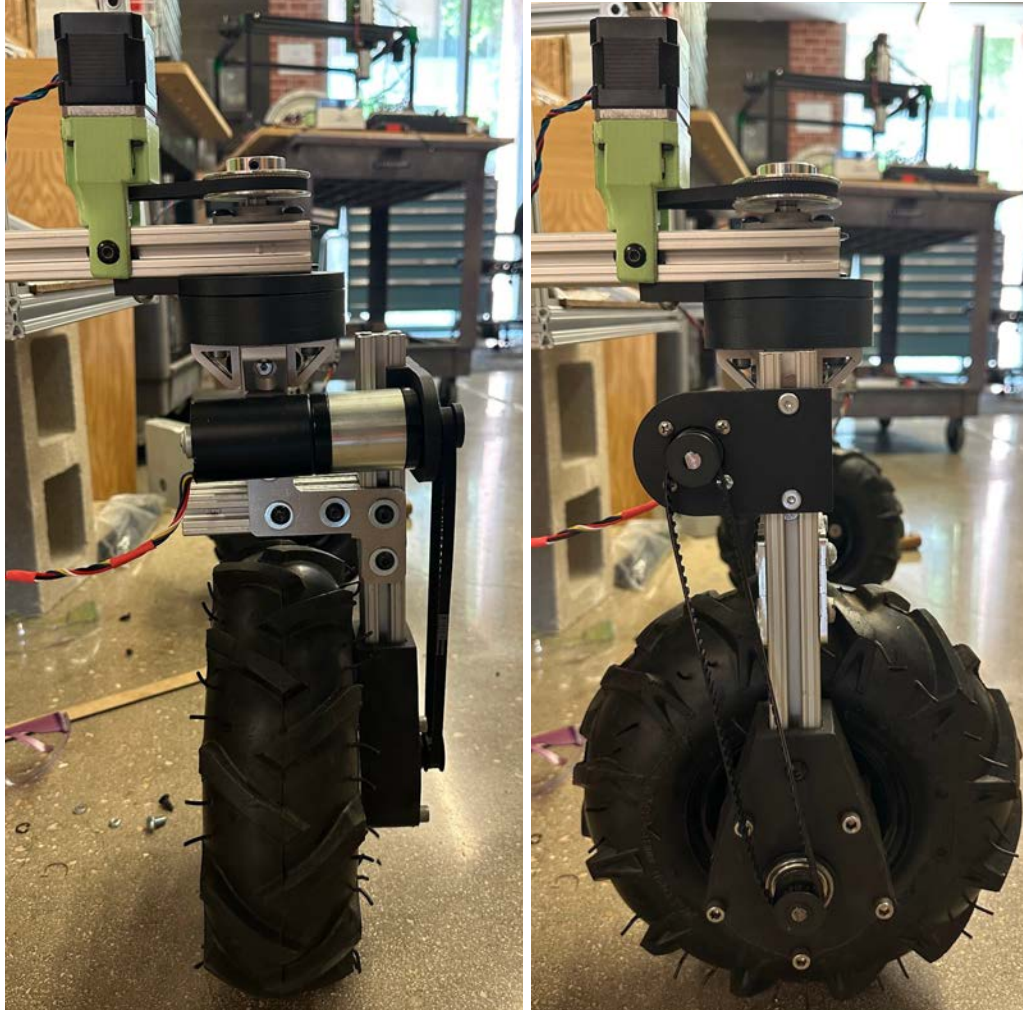
Figure 5: Fully Constructed Steering Column

Construction of the steering system began by cutting the various lengths of 80/20 used in the steering column. After cutting all pieces to length, the custom steering column plates pictured in Fig. E5 were made on the HAAS mini mill in the Makerspace. These plates were used in conjunction with 80/20 T-nuts and screws to construct the frame of the steering column. Next an 8mm hole was drilled through the horizontal 80/20 member that the steering column shaft will be housed in. After this, the custom steering column base pictured in Fig. E5 was connected to the vertical steering column member using 80/20 mounting brackets and screws. After this step, an 8 mm shaft flange was attached to the steering column base using screws, and then the 8mm shaft was placed in the flange using its included set screws. Next, the custom 3D printed steering supports were press-fitted onto the steering column using a mallet. With the steering column assembly completed, two 8mm flange bearings were then attached to the horizontal 80/20 member on either side of the pre-drilled 8mm hole using 80/20 T-nuts and screws. The steering column assembly's 8mm shaft was then fed through the bearings, and the 8mm ID gear was then attached to the top of the 8mm shaft using its included set screws. Lastly, our custom 3D printed stepper motor mounts (Fig. E4) were then attached to the horizontal 80/20 member using 80/20 mounting hardware, and its belt was placed around the 8mm ID pulley and the stepper motor's pulley. These steps were then repeated to construct all four steering columns. To connect the steering columns to the main legs of the rover, the custom cut aluminum brackets seen in Fig. E8 were made using the HAAS mini mill and mounted using 80/20 t-slots and associated screws, as can be seen in Fig. 1. The final steering column design with the pulley and motor mount can be seen in Fig. E9. Lastly, the two middle wheels which did not have steering implemented were mounted to the bogie 80/20 member using the custom made 90-degree aluminum joint seen in Fig. E10.

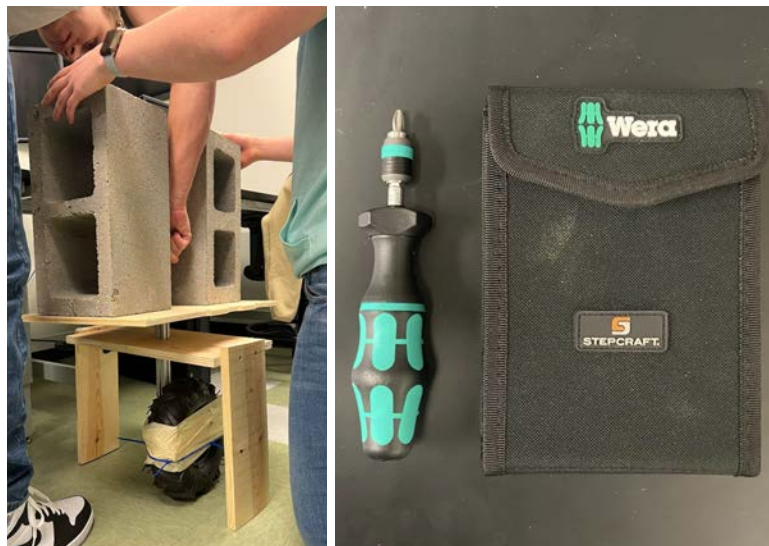
Figure 11: Steering Torque Test Setup

Procedure: A screw was inserted into the center of the wooden sheet, and the Wera torque screwdriver was used with the screw to turn the steering column assembly. The torque screwdriver is designed to be set at certain torque values such that when that value is reached, the screwdriver fails. With this setup and the reading from the torque screwdriver, we were able to develop an idea of how much torque is required

With the lowest torque setting being 1.2 Nm on the Wera screwdriver, 1.2 Nm was the team's reference value. The wheel and steering assembly could be turned at the 1.2 Nm setting without the screwdriver failing while carrying loads that varied from ~28 lbs to ~59 lbs and only required 1.7 Nm for the load of ~79 lbs.

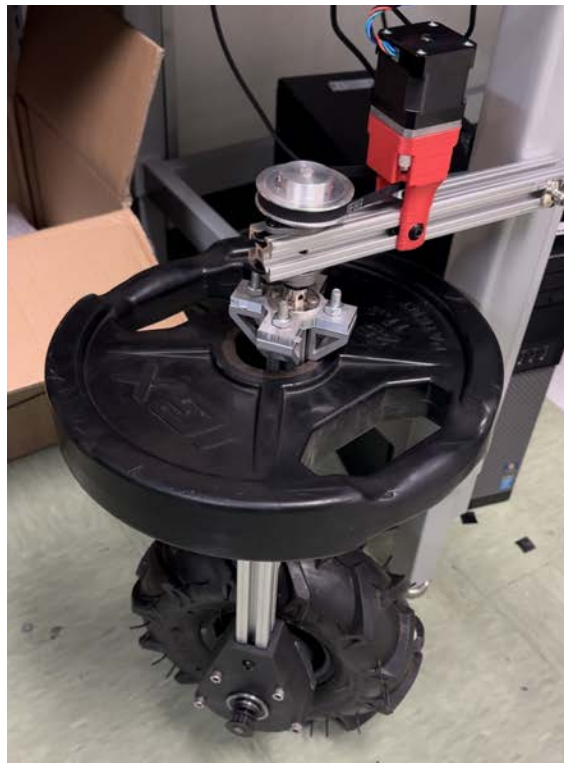
Figure 12: Final steering motor assembly test setup

After conducting the preliminary steering subsystem test we found that the selected steering motor was unable to produce an adequate amount of torque to rotate a steering column loaded with 25lbs. The stepper motor functioned correctly while the steering motor was unloaded, with the steering column spinning in a full 360 degree turn, but once load was added, no turning motion could be achieved. A second iteration of the test was conducted after making improvements to the system, which included

installing a larger pulley with 80 teeth instead of 60 teeth and changing some of the wiring in the motor circuit. During this test, the same stepper motor was able to turn a steering column loaded with 25lbs 90°. The turn itself was very slow, but the movement of the wheel was consistent and the motor did not fail or catch.

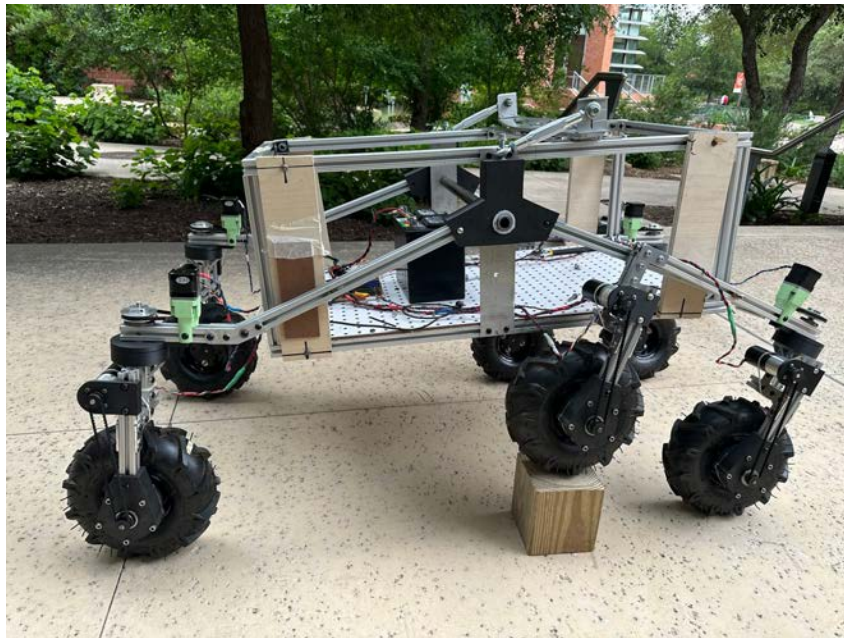
Figure 14: Differential Bar and Tipping Test Setup

With all measurements below our set limits, we were able to demonstrate that the rocker bogie was functioning properly and was keeping the chassis stable while the obstacle was under each of the six wheels, mimicking several different obstacle configurations. Visually, the team did observe bending in the bogie joints, specifically with the right side bogie bending outward and the left side bogie bending inward. While we still deem this test a success because no fracturing occurred in the beams, it did pinpoint key areas of weakness that the team must address moving forward. It was due to this bending that the team did not feel confident the rover could support a full 100-lb load yet, and thus the test was performed with no load. Nonetheless, it was successful in demonstrating that our differential bar was functioning properly.

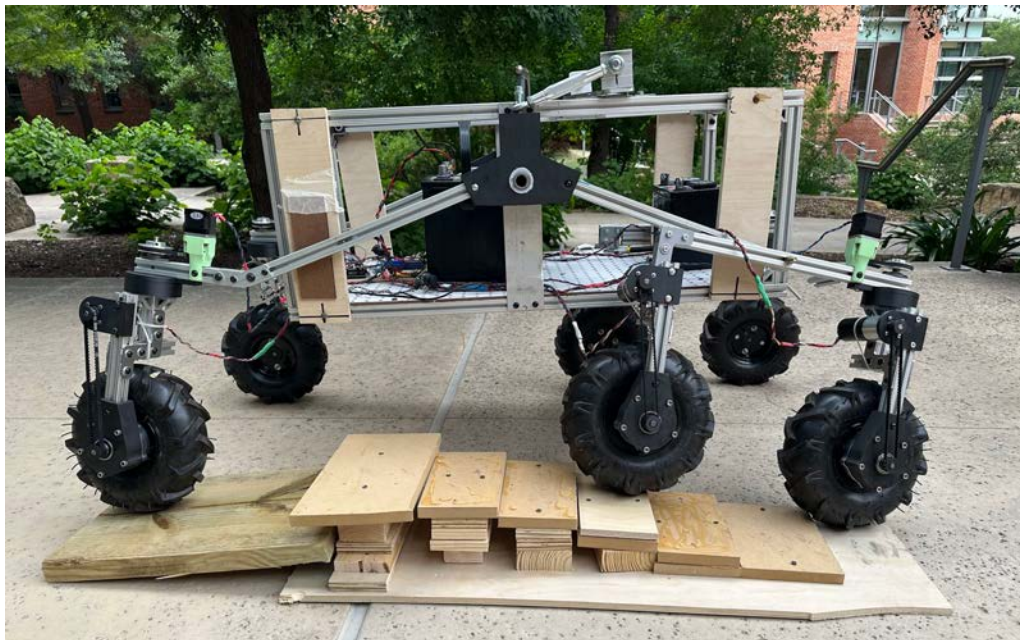
Figure 16: Rover placed on the “uneven terrain” obstacle in the obstacle course

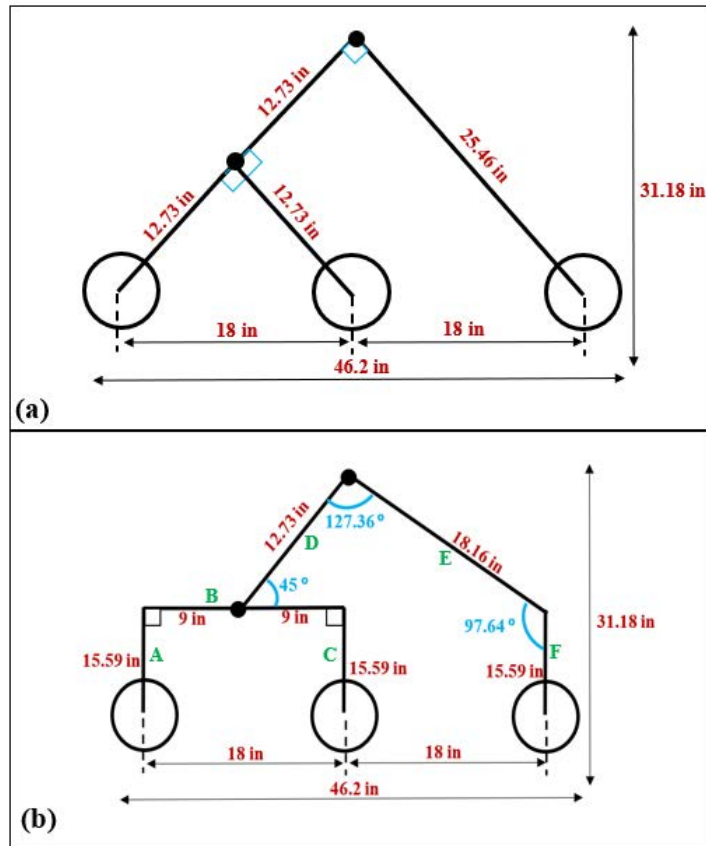
Figure C1: Calculated angles and lengths for two different styles of rocker-bogie suspensions using the known total length of the rover. **(Left)** Typical angled rocker-bogie with 90-degree angles and only four linkages. **(Right)** The team's design for a rocker bogie with vertical steering columns, and the resulting necessary lengths and angles.

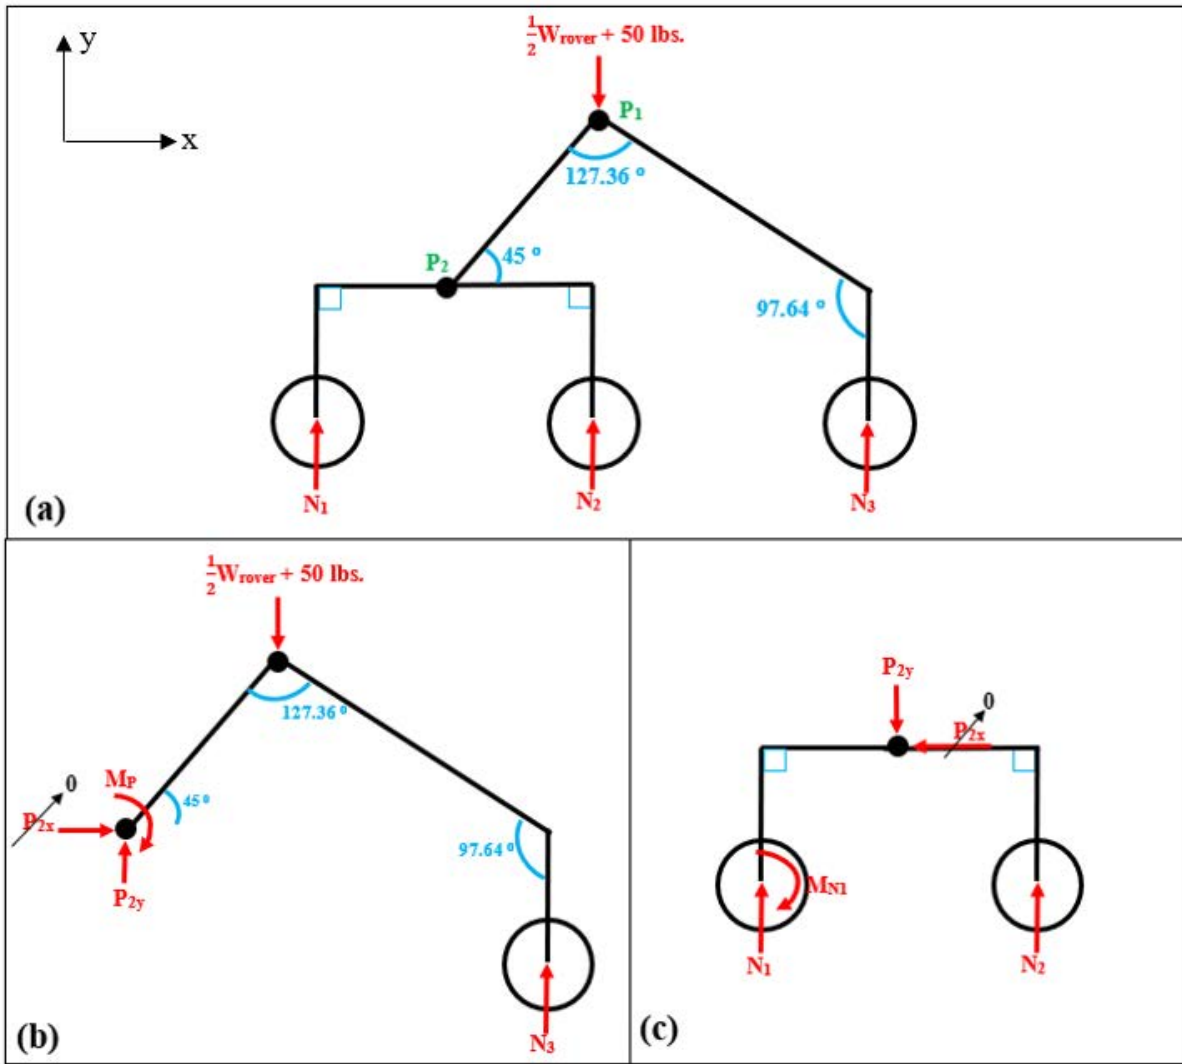
Figure C2: (a) Force diagram for the whole suspension system with half the total weight of the rover and the additional 100-lbs and the three normal forces. (b) Individual rocker body with the pin force at P2. (c) Individual bogie body with the same pin force at P2

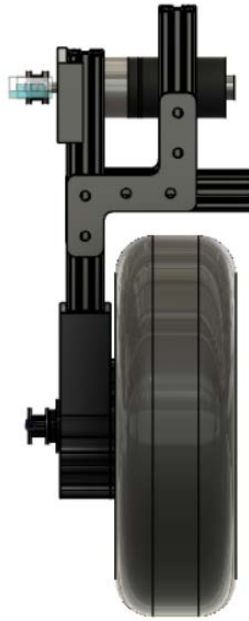
Figure E7: Mounted Steering Column Faceplate

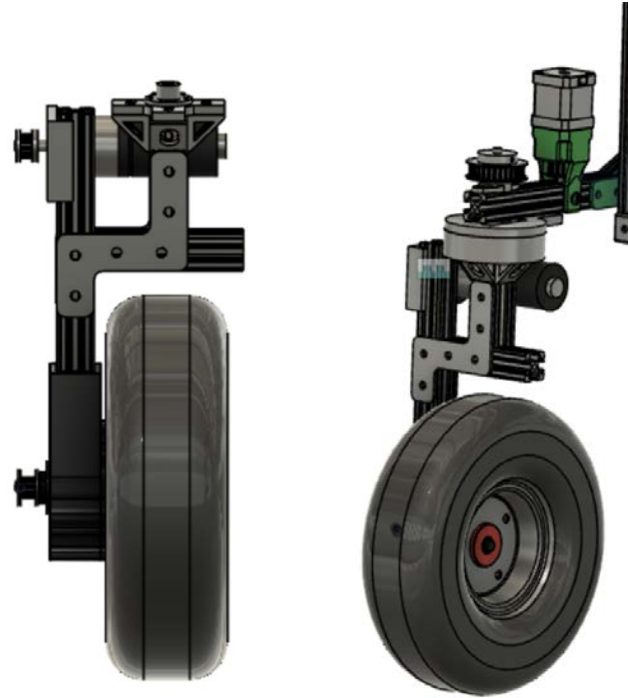
Figure E9: Steering column assembly before (left) and after (right) mounting to the main rover body with the 3D printed supports
