GLOBAL JOURNAL OF HUMAN-SOCIAL SCIENCE: B
GEOGRAPHY, GEO-SCIENCES, ENVIRONMENTAL SCIENCE & DISASTER
MANAGEMENT

The Devastating Effect of Gully Erosion Menace on Urban Infrastructures in Calabar Metropolis, Nigeria

By Dr. Eni, D. Imoke & Miss. Udoh, U. Isidore

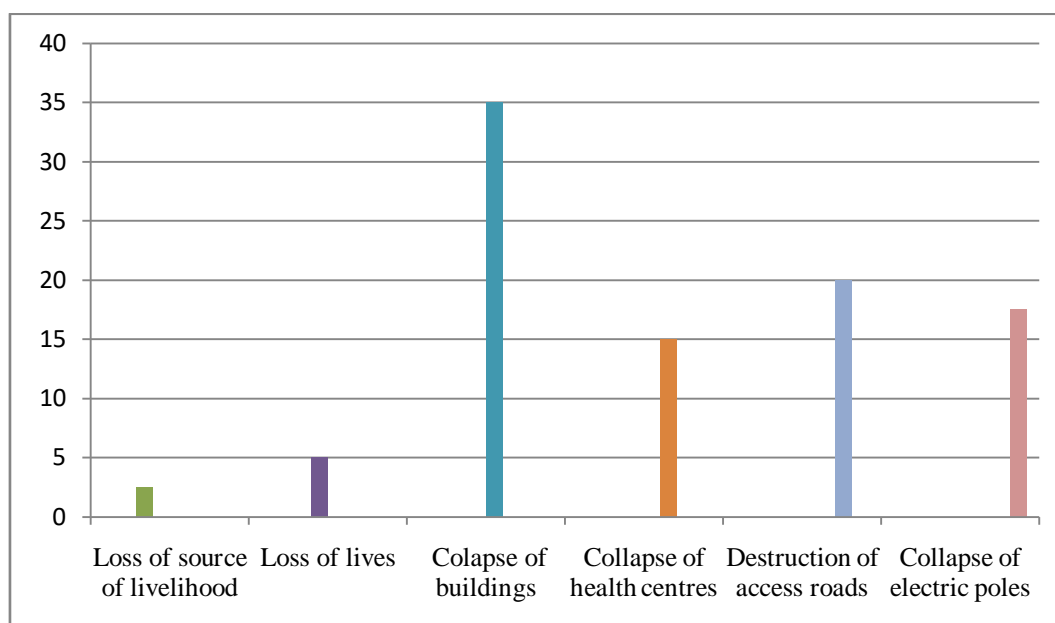
Fig. 1: Effects of gully on urban infrastructures

The table and figure revealed that 70 respondents agreed that the collapse of buildings was the major problem associated with gully erosion menace with 35 percent. But loss of livelihood, destruction of farmlands and collapse of communication installation were least affected with 2.5 percent.
