GLOBAL JOURNAL OF HUMAN-SOCIAL SCIENCE: B
GEOGRAPHY, GEO-SCIENCES, ENVIRONMENTAL SCIENCE & DISASTER
MANAGEMENT

Morphometric and Morphological Analysis of Gullies in Lafia Lga, Nasarawa State, Nigeria

By Alkali Mohammed, A.T Ogah & I. M Anzku

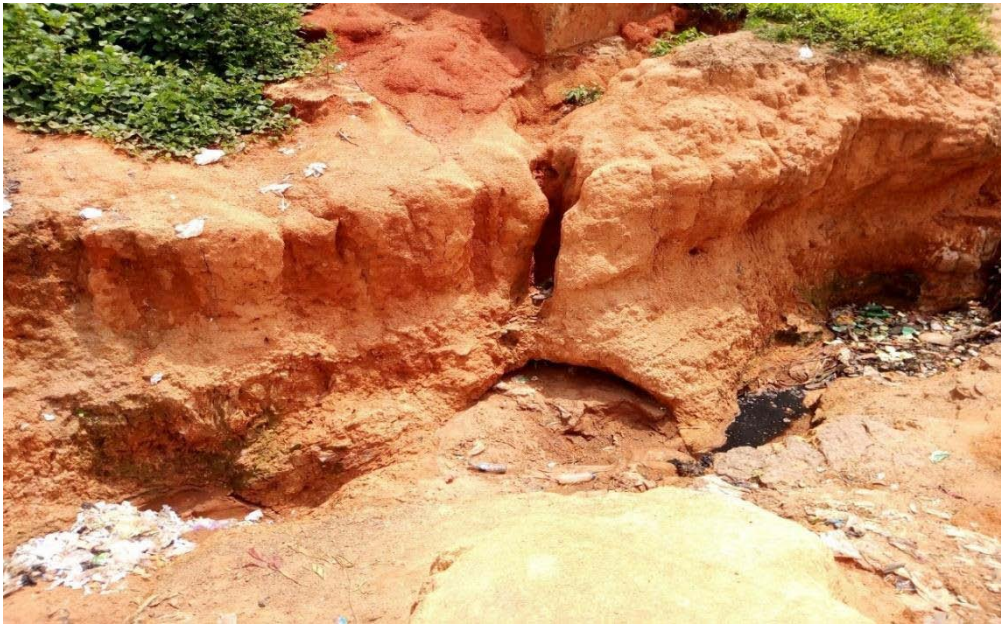
Plate 1: A typical gully site in Adogi, Lafia LGA

Gully found in Adogi recorded in a gully length of 256m, with a gully width of 6m, gully depth of 5.3m, and covering an area of 1536m². In terms of particle sizes recorded at Adogi site, sand had 90.2%, silt 3.4% and clay 6.4%. In Kilema, the gully found recorded a length of 315m, width of 21.2m, and depth of 8.2m. In the same vein, this gully covered an area of 6678m², with particle sizes of; sand 91.2%, silt 3.4 and clay 5.4%. It is important to point out here that Kilema had the largest gully recorded in Lafia Local Government Area, during the course of this study.

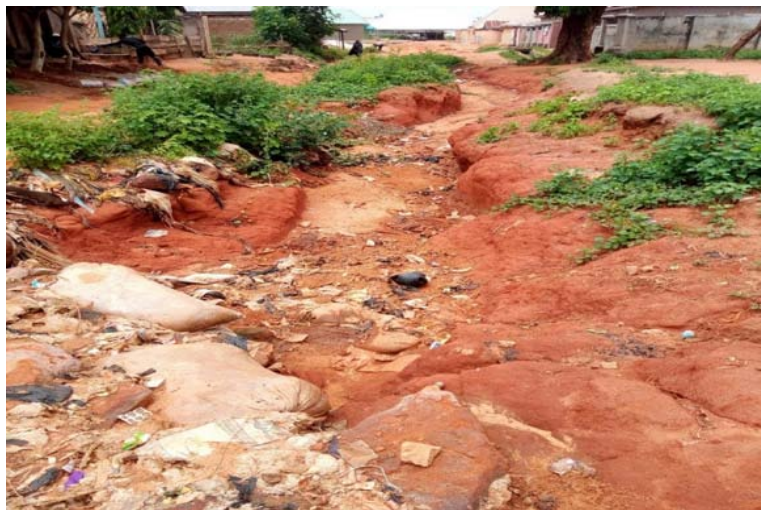
Plate 5: A typical gully site in Danka, Lafia LGA

The small size gully recorded in Danka site had a particle size distribution of; sand 92.2%, silt 2.4% and clay 5.4%. This gully covered an area of 390m², and recorded a gully length of 78m, gully width of 5m, and a gully depth of 5.7m. Similarly, Akunza site has a particle size distribution of sand 84.2%, silt 5.4% and clay 10.4%. In the same vein, the geometric characteristic, Akunza site recorded a depth of 6m, width of 5m, covering an area of 440m² with a length of 88m.
