Conservation and Restoration of the House of Butehamon 21st Dynasty 1054 BC - The Medinet Habu Temple Precinct

By Lotfi Khaled Hassan

Chicago University

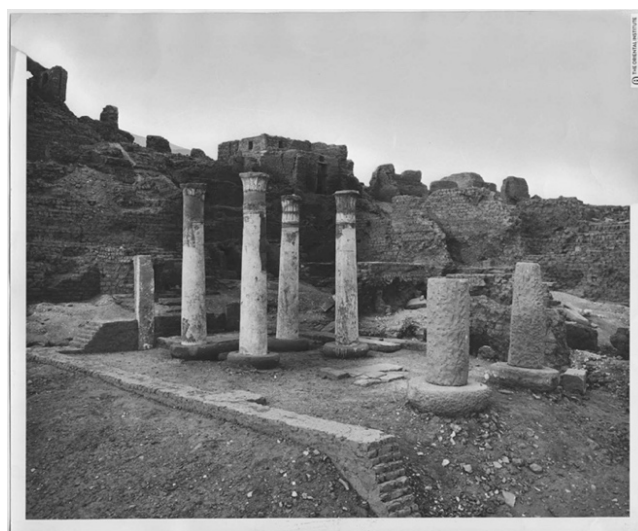
Figure 1: Butehamon house, the state of conservation in 1930 (photo by Hölscher).

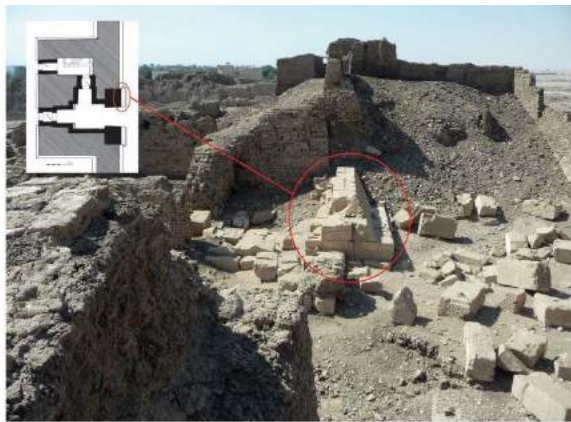
The Western High Gate

The base of the gate's southern tower (circled above in the photo and reconstructed plan) represents some of the few stones belonging to that edifice that are still in their original positions. The remainder - excepting those that have been quarried for reuse in other buildings - lie scattered about the immediate area of the gate, as can be seen above.

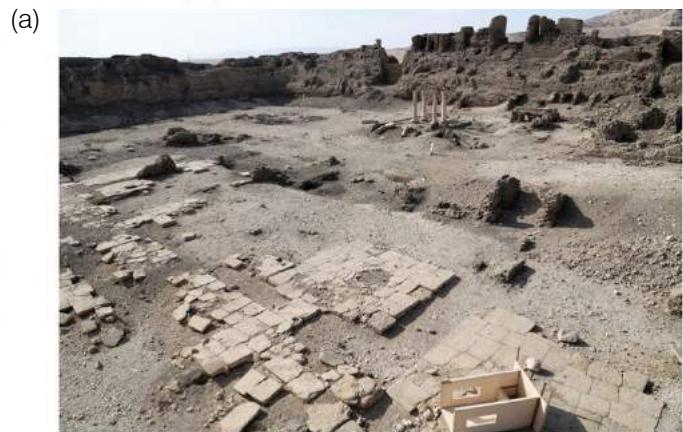
View of the South-West Corner of the Medinet Habu Temple Precinct

Here one can see an area of ancient pavement that is still in position - in the background is the Butehamun House. In the foreground is an abandoned, overturned sun shelter that used to be employed by security personnel; this area of the precinct is no longer guarded.

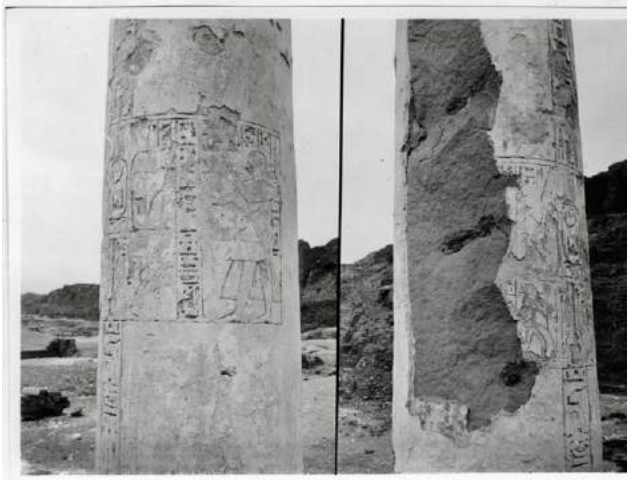
Figure 3: The reliefs of the column n.60 1930, (photo by University of Chicago).

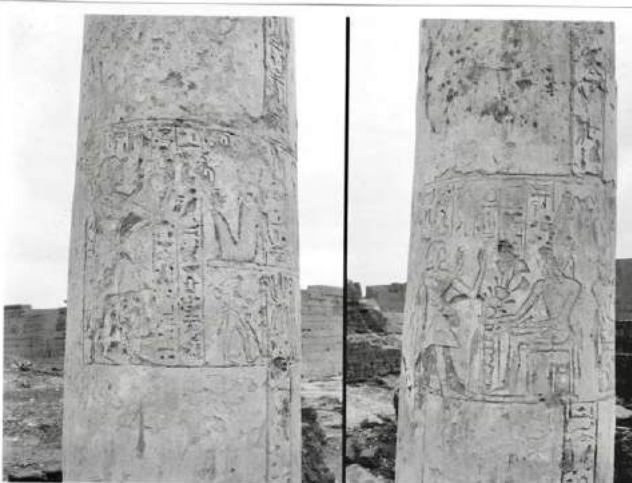
Figure 4: The reliefs of the column n.61 in 1930, (photo by University of Chicago).

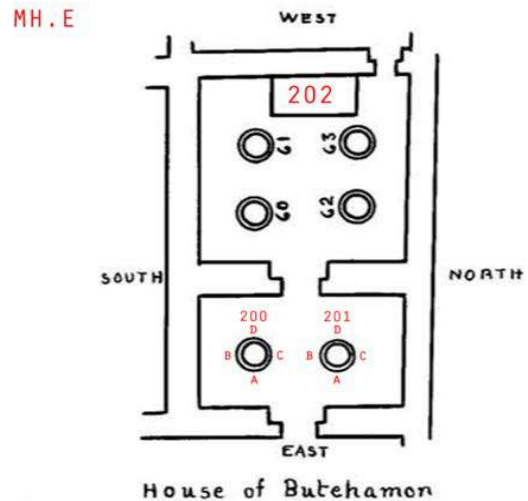
Figure 5: Butehamon house Plan, (Hölscher 1930) [1].

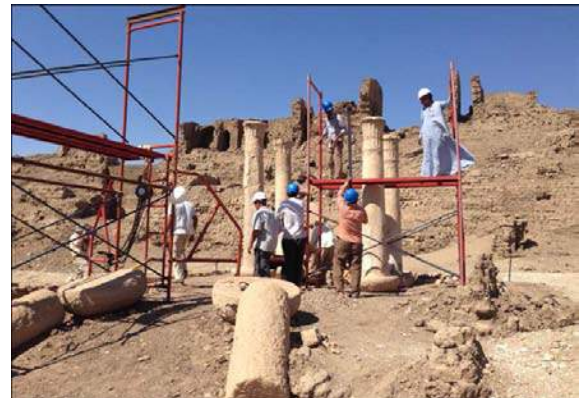
Figure 6: Site under preparation phase, scaffolding installed, 2016.

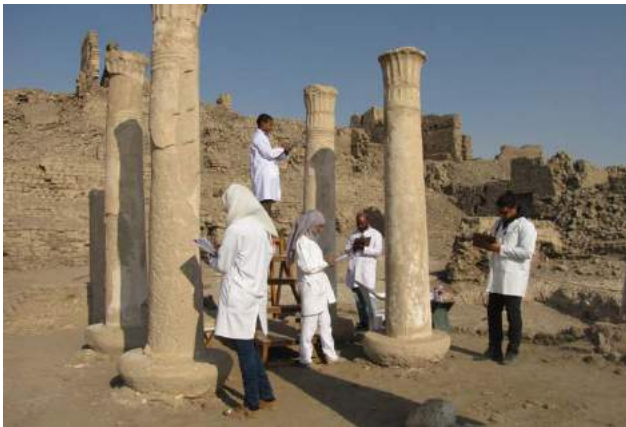
Figure 7: Site before restoration, studying the state of conservation of the columns.

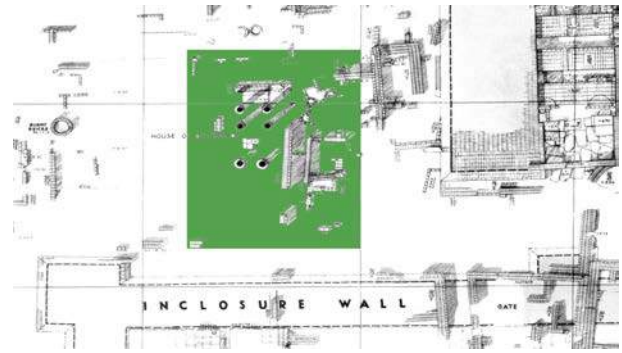
Figure 8: The excavation map for the archaeological remains of the House of Butehamon Done in 1930 by Hölscher.

- The entrances and exits of Butehamon documented on Hölscher's excavation map are one direction, it means that the doors can open to inside direction, but we have found the cross stone of the door in opposite direction comparing with other two, it means that the west door open inside, so it's an entrance from outside to the western section. Unfortunately, it became evident that the mud brick walls were in a much better condition in the time of Hölscher. The mud brick walls of the main entrance of the house of Butehamon in east side are completely missed and documented in Holscher's map excavation [1][5].

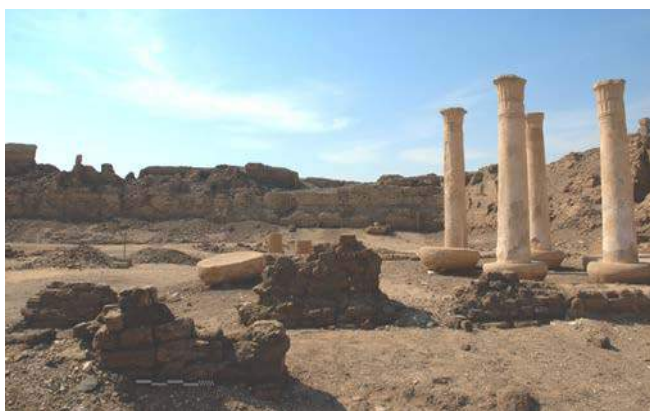
Figure 11: The conditions of the old mud brick and stone columns walls before restoration.

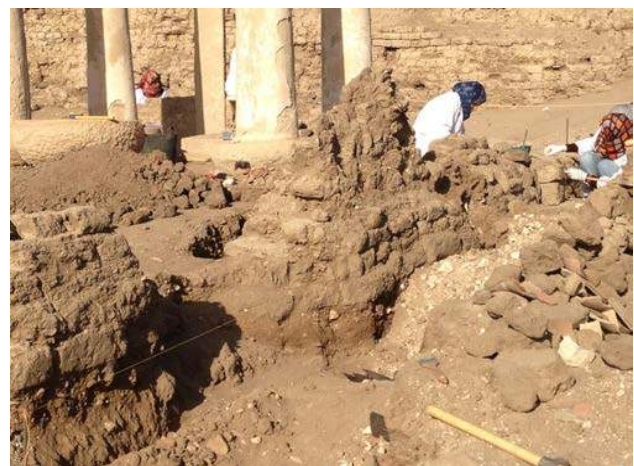
Figure 12: The site, during the clearing of the north side section of the original 21st dynasty adobe wall.

It was investigated by cleaning the foundation and we found traces of old mud bricks which it defined the wall angel from the north side. Cleaning of the area around the mud brick walls to investigate the shape and the condition of the foundation of the mud bricks.

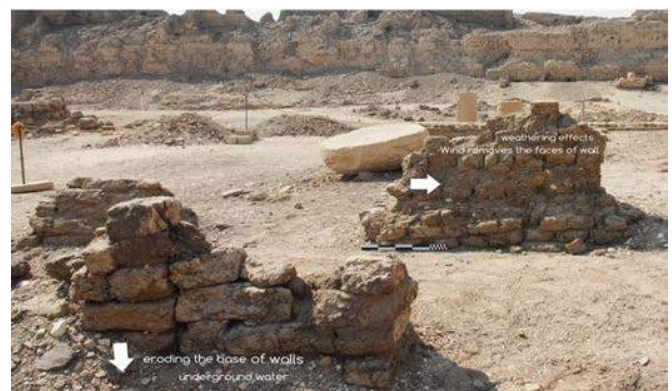
Figure 13: The state of conservation of the old mud brick walls before the restoration works.

The most of original mud brick walls are in poor condition because of weathering; falling water in the form of rain and make the surface much more fragile, and rising groundwater seeps into the bottom of the walls, and as this dries the salts in the water crystalline on the wall surface, eroding the base of wall. It's so windy for many months in Luxor winter.

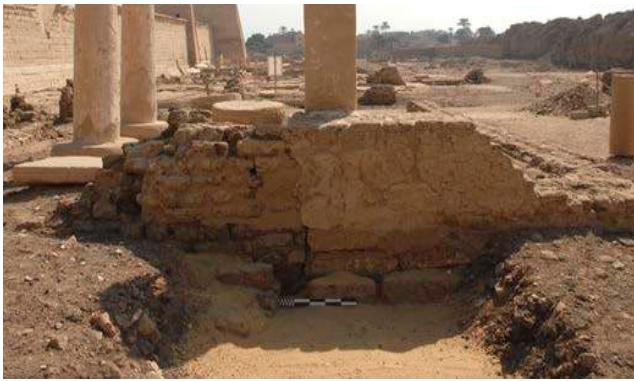
Figure 14: The state of conservation of the old mud brick foundation before the restoration works.

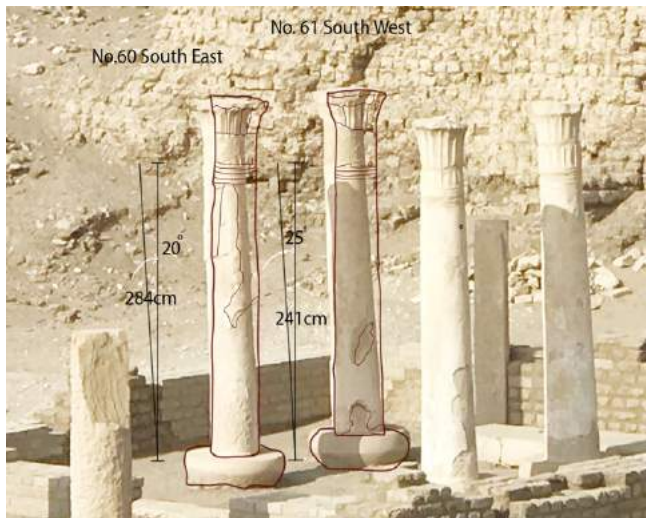
The four columns that appear to have been moved during the excavations of 1930, there are evidence of adding recently lime mortar between the column and its base and they have been restored using cement mortar and lime mortar. There is a tendency in columns. The bases of the columns built on a foundation of mud bricks. Four columns in the western section are plastered and two columns (with large parts missing) that were down to earth, no plastered in eastern section. the plaster was in bad condition and were missed in many areas. The plasters are in bad condition, a lot of lost because of weathering and the technique used where they had Applied a very thick layer of plaster to be good for carving.

Figure 15: The inclination of the column of South East n.60 of 20° and the column of South West n.61 of 25°, looking from North side.

- (2) Dismantling the inclined columns by removing the capital, the shaft and the base.
- (3) Excavate and stabilization of the foundation of the columns by replacing the decayed mud bricks with new bricks.
- (4) Reassembly of the columns in right position using lime mortar.
 - Scaffolding was set up surrounding the columns to allow for work and movement during straightening.
 - The cement mortar between the capital and the shaft was removed carefully with a chisel and

- Removing the cement joined the shaft of the columns with stone base, which was covered used with a layer of lime mortar.
- Lifting the column from the base after packing it carefully.
- Moving the column base to detect the foundation and rebuild it.
- Replace the parts of the column in right position.

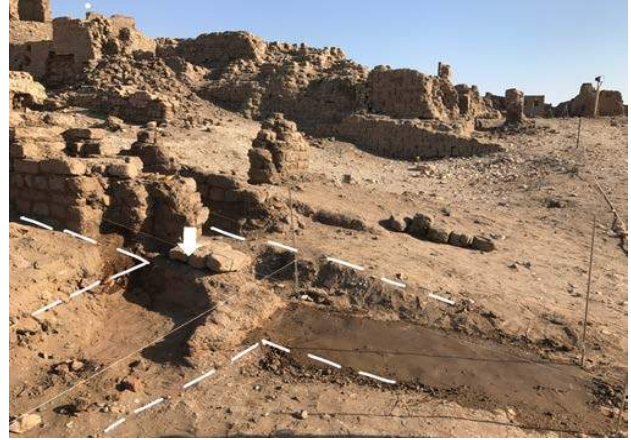
Figure 16: The foundation of the east entrance wall.

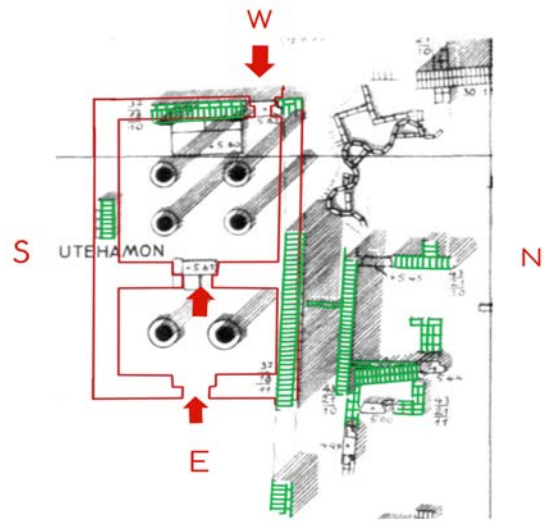
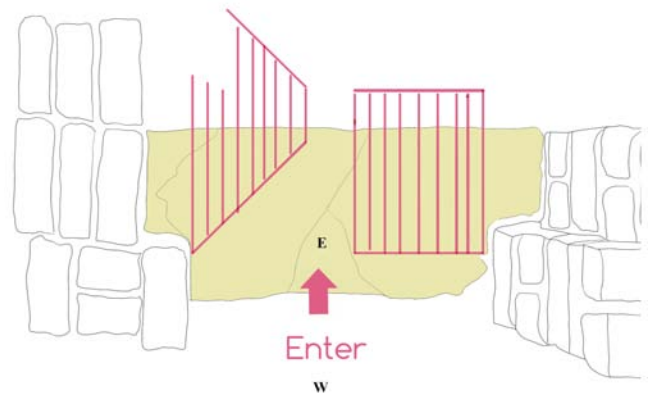
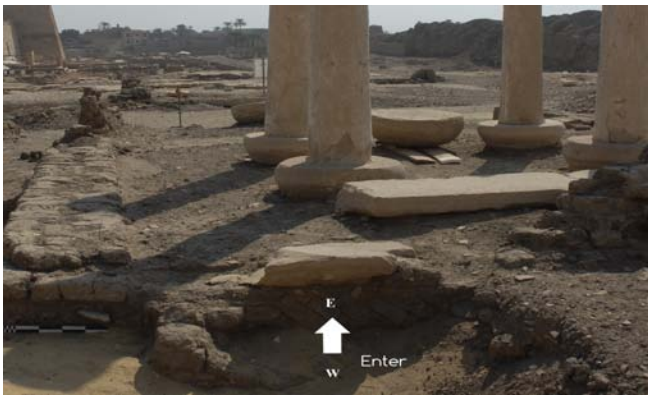
Figure 17: The plan of 1930, in green color the rests of old wall parts (a), illustrative drawing of the entrances direction (b), pic shows the entrance in site.

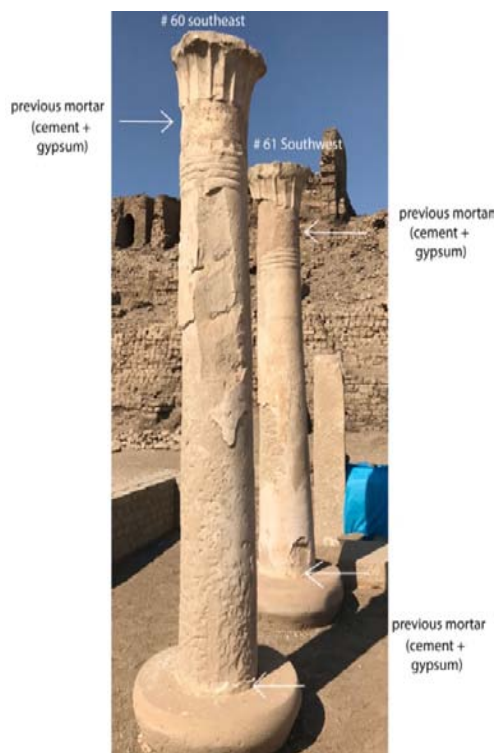
Figure 18: Shows the parts of the previous mortar used to reassemble the column of South East # 60 and the column of Southwest # 61 in 1930.

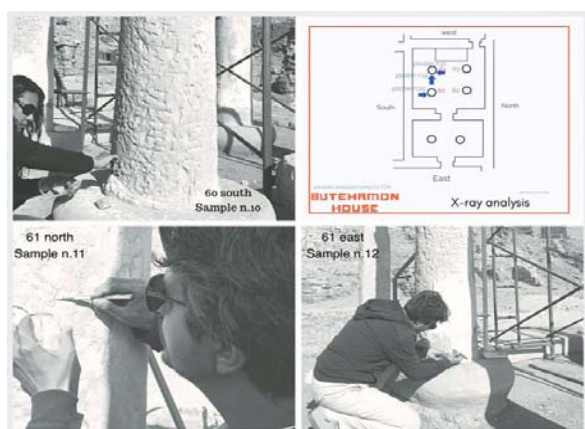
Figure 19: Shows the places of plaster samples were taken.

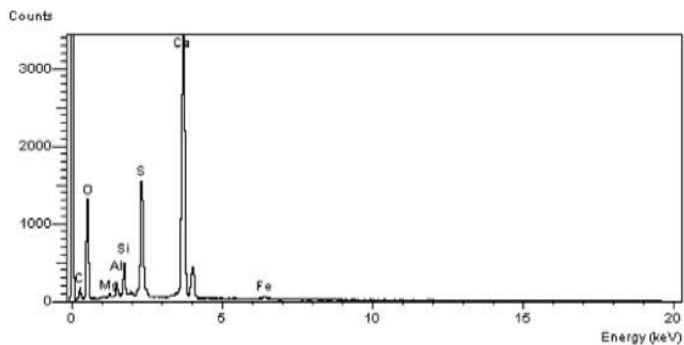
The analysis also revealed a high concentration of Sulphate S (8.10%) and calcium Ca (28.03%) ions which may be attributed to the crystallization of gypsum and anhydrite salts on the plaster. In addition, the moderate amount of Aluminum Al (0.73%) and potassium (K) (0.20%) attributed to feldspars and phyllosilicates group. EDXS analysis indicated small quantities of Magnesium (0.27%). The presence of relatively high amounts of iron (0.89%) and also due to atmospheric pollution. They play an important role in deterioration.

Figure 21: The chart of elements in sample n. 10.

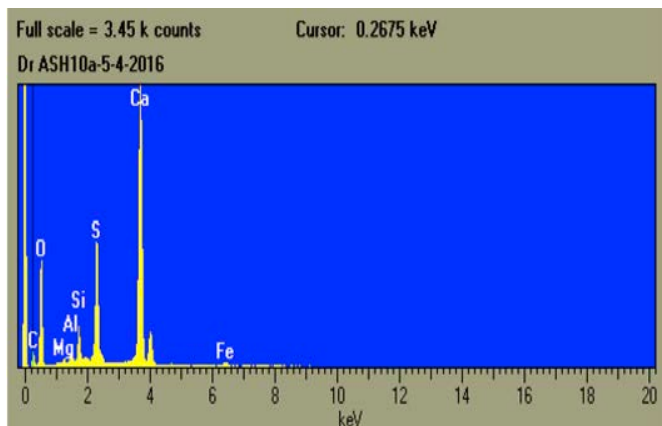
Figure 22: The diagram of elements detectors, in sample n.10.

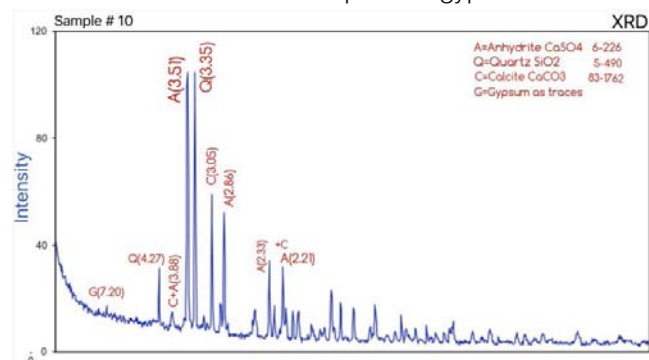
X-ray diffraction pattern of the powder samples have proved that anhydrite, quartz and calcite are the principal minerals in sample of plaster taken from Butehamon are found in sample with gypsum as traces.

Figure 23: The diagram of compounds in sample n. 10 and its charts.

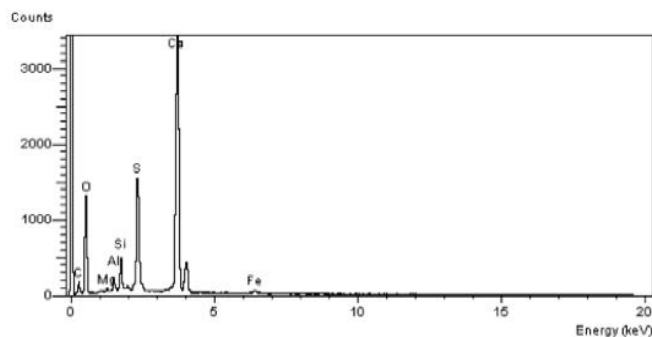
Figure 24: The chart of elements detectors, sample n. 11 which is close to sample n.10

The obtained results help understanding the weathering mechanisms affecting the object. The sample contained C refer to an organic material founded, Ca and S and C as the major elements. The analysis also revealed a high concentration of Sulphate S (12.27%) and calcium Ca (22.06%) ions which may be attributed to the crystallization of gypsum and anhydrite salts on the plaster.

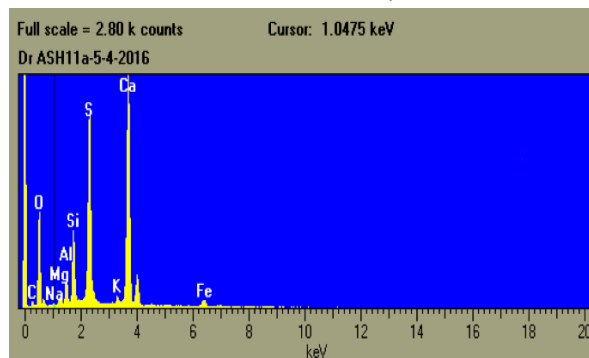
Figure 26: The diagram of elements detectors, in sample n.11.

In addition, the moderate amount of Aluminum Al (1.55%) and potassium (K) (0.68%) attributed to feldspars and phyllosilicates group. EDXS analysis indicated small quantities of Magnesium (0.43%). The presence of relatively high amounts of iron (1.62%) and also due to atmospheric pollution. They play an important role in deterioration.

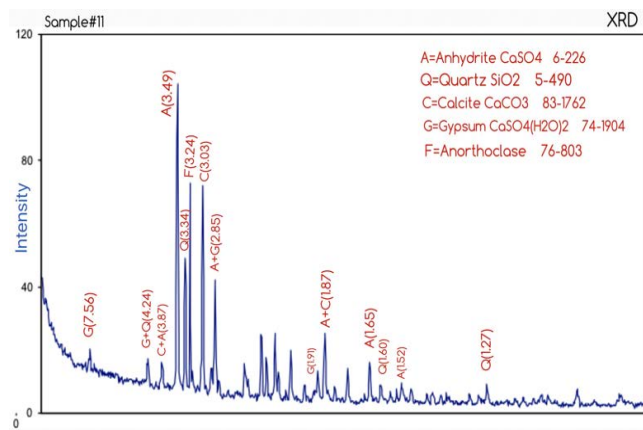
X-ray diffraction pattern of the powder samples have proved that anhydrite, quartz and calcite are the principal minerals in sample of plaster taken from Butehamon are found in sample with gypsum as traces [12].

Figure 27: The diagram of compounds in sample n. 11 and its charts.

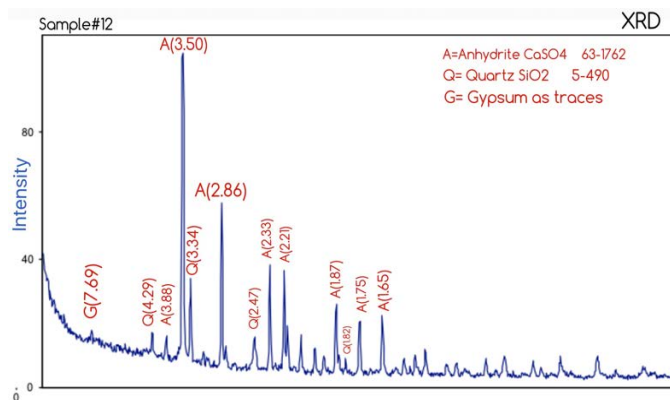
The powder samples are examined by using JEOL X-ray diffractometer model JSX-60 PA of the Central Laboratory, El Minya University. The analysis was run with Cu K radiation, Ni filtered (=1.54184 Å) at 35 Kev and 15 mA, under a normal scanning speed of 2 /1mint, within the range of 2 θ = 4-100. X-ray diffraction pattern of the powder samples have proved that gypsum, quartz and Anhydrite are found in sample# 12. Anhydrite and quartz are the principal minerals in the samples12. Gypsum {CaSO₄(H₂O)₂} is characterized by its strongest d-lines at (d=4.28 Å; 7.59 Å & 3.06 Å; PDF n.74-1904). Quartz (SiO₂) is characterized by its strongest d-lines at (d=3.34 Å, 4026 Å & 1.82Å; PDF n. 5-490).Anhydrite (CaSO₄) is characterized by its strongest d-lines at (d=3.50 Å, 2.85 Å & 2.33Å; PDF n.6-226).

Figure 29: The diagram of compounds in sample n. 12 and its charts.

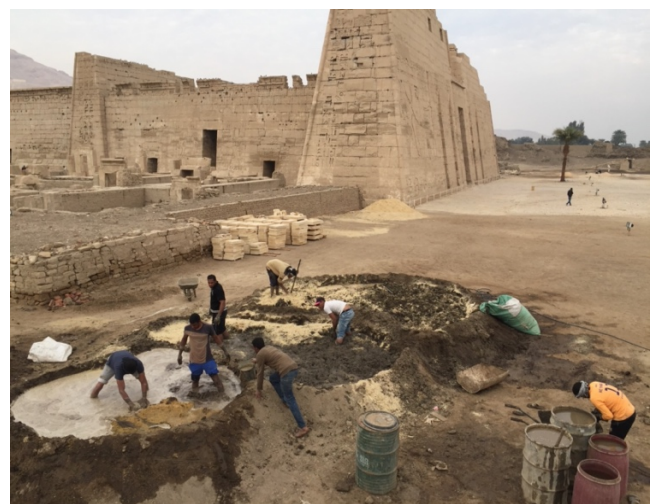
Figure 30: The big pit, large hole filled with water.

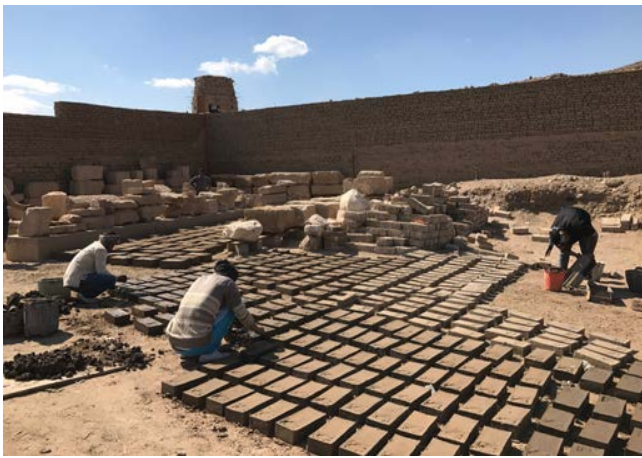
Figure 31: Workers add the mixture (clay & straw) to the mold for making adobe bricks.

Before we begin, make sure to clear out a dry area for making bricks. They could take several weeks to dry and need to be protected from rain.

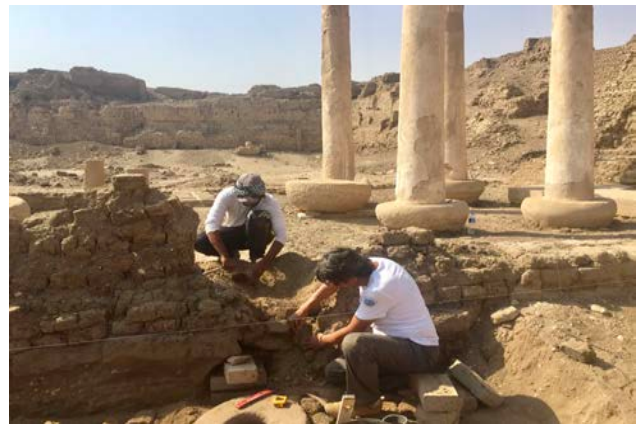
Figure 32: The senior conservator, Lotfi Hassan, the Author disassembles the inclined sections to clean, strength and rebuild them in the right position.

Restoration & stabilization the old mud brick walls; support, consolidation and filling of gaps

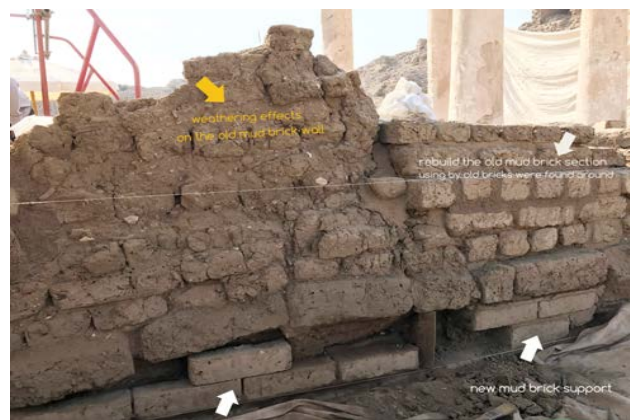
Figure 33: Shows the condition of the inclined wall in action to be restored & supported.

In many cases, we used both solutions using a porous plastic grid material and using natural materials covering the old mud bricks with a thick layer of clay plaster visible before using the new mud bricks. It used in settling old mud brick level with a layer of clay after covered it with fiber grid material.

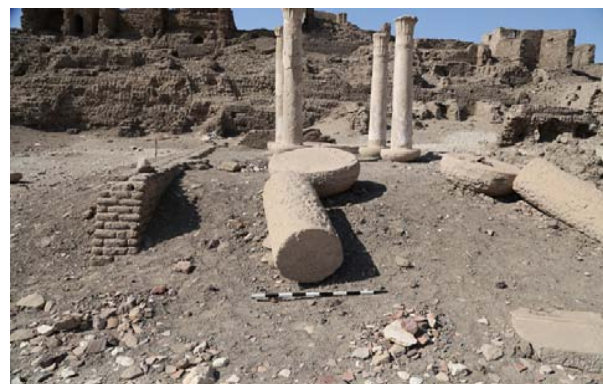
Figure 38: The Butehamon House before interventions; showing the state of conservation, 2016.

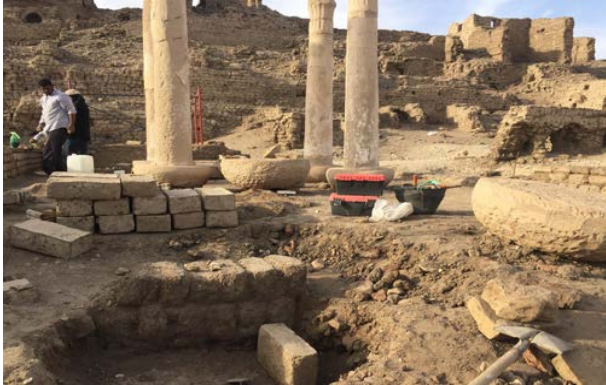
Figure 39: The original place of the southern column base.

To reset columns in their original place must be detected and investigated the right position of the bases of the two columns. The bases of the two columns were settled on Ramses III mud bricks (big size) in vertical position. From the original locations of the bases, we understand that the northern column is not aligned with the columns of the northwestern section, but the southern column is nearly aligned with the columns of the north in the western section [11].

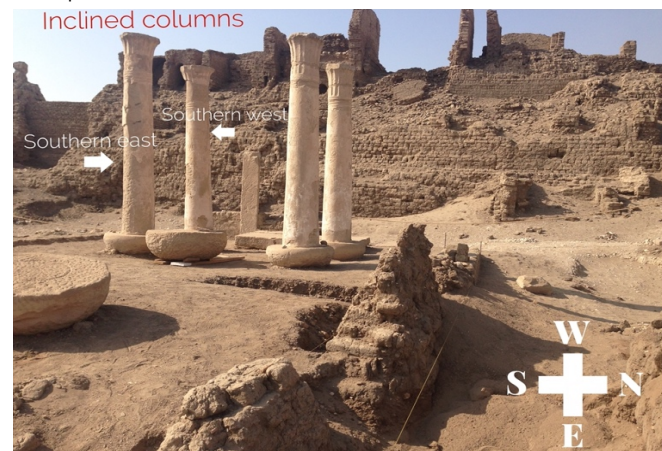
Figure 42: Illustrative photo of the two inclined columns, n.60-n.61.

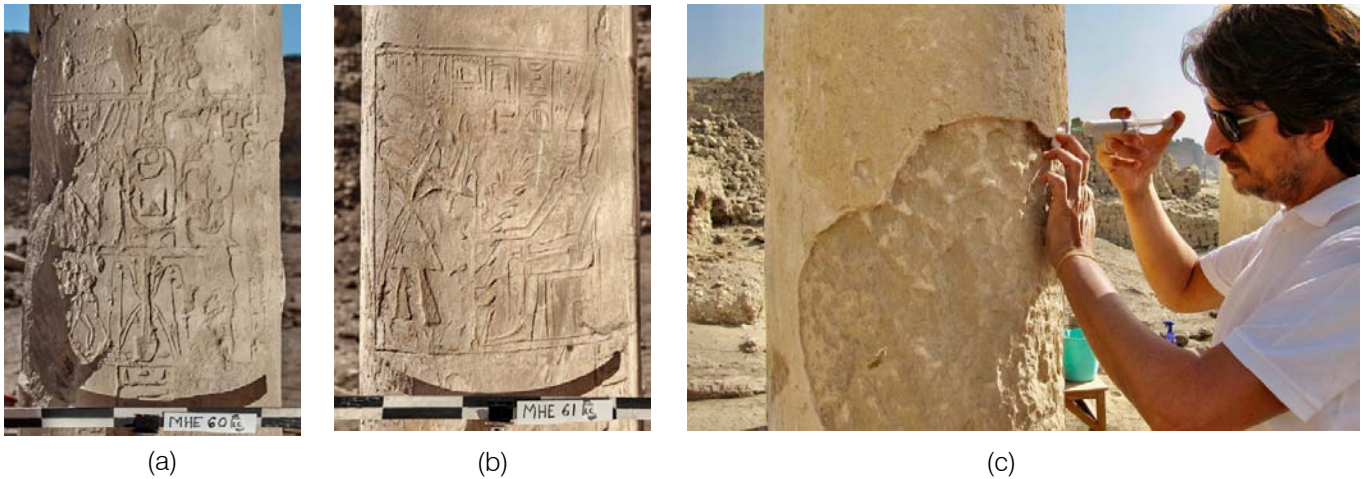
Figure 43: Detail of carved plaster of column n.60 (a), detail of carved plaster of column n.61 (b), The conservator Lotfi Hassan, the Author during the pre-consolidation of the plaster before dismantling and moving the column (c).

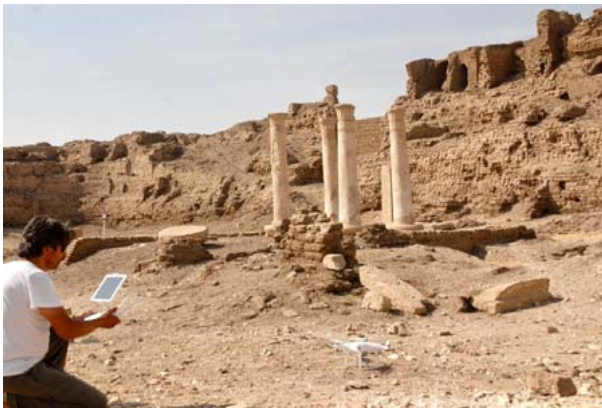
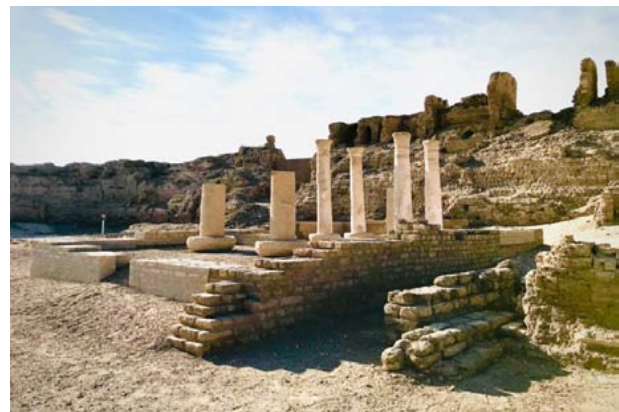
Figure 45: The Butehamon House from north side, surveying using by drone before restoration (a), the House from north side after restoration of mud brick walls and stone columns (b).

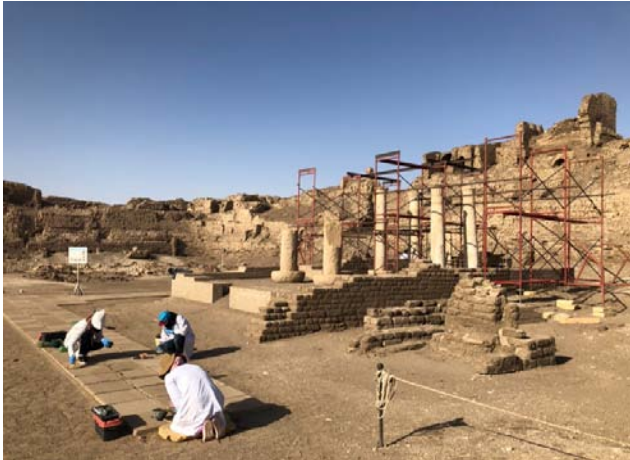
Figure 47: The conservators during the final restoration works of clay tiles of walkway.

It has been planned to create a walkway of clay tiles around the house which will enable visitors to see the house and columns without entering, the work plan focused too on its site management plan and the site's coordination. And it has been built a wooden bridge to protect and cover an archaeological feature and to linked to restoration project of the Ramses III enclosure

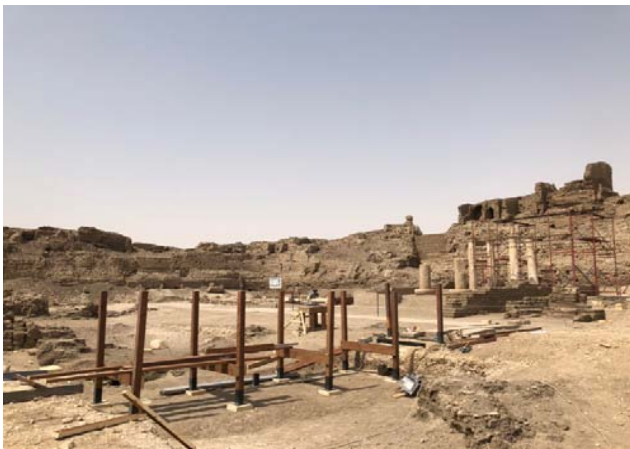
Figure 48: The construction of wooden bridge on archaeological features to protect it and to do way to reach the walkway to visit the butehamon house.

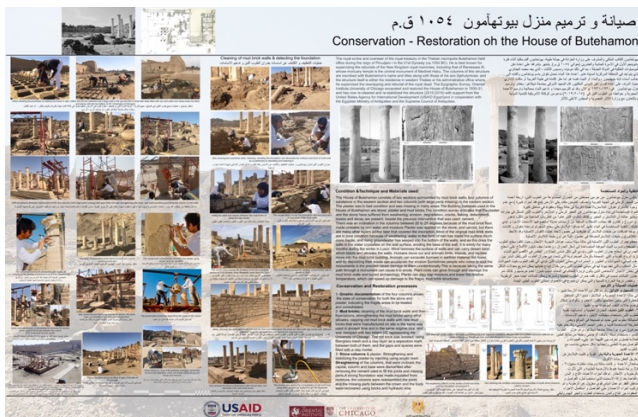
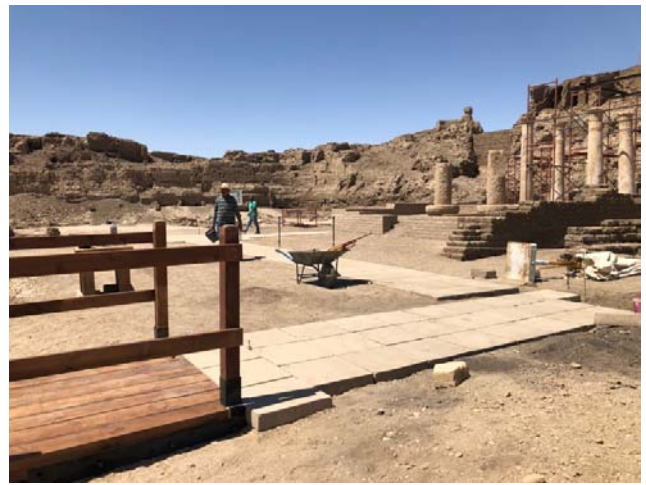
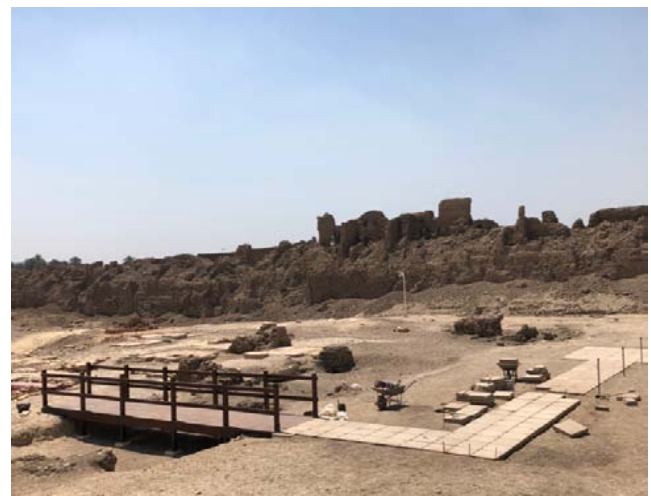
Figure 49: Illustrative panel, history and conservation works done (a), Views of walkway & the wooden bridge (b, c).

wall and its stone pavement. It has been added illustrative panels to explain the historical value of the monuments and its restoration. then the site was managed after the restoration and to protect the archaeological work and features on site, from two elements; the walkway as a guide and illustrative panel to help visitors understand the value of the archaeological site.
