Historically Accurate Reconstruction of the Materials and Conservation Technologies Used on the Facades of the Artistic Buildings in Lecce (Apulia, Italy)

Citation: Fico, D.; Rizzo, D.; Casciaro, R.; Esposito Corcione, C. Historically Accurate Reconstruction of the Materials and Conservation Technologies Used on the Facades of the Artistic Buildings in Lecce (Apulia, Italy). *Materials* **2022**, *15*, 3658. <https://doi.org/10.3390/ma15103658>

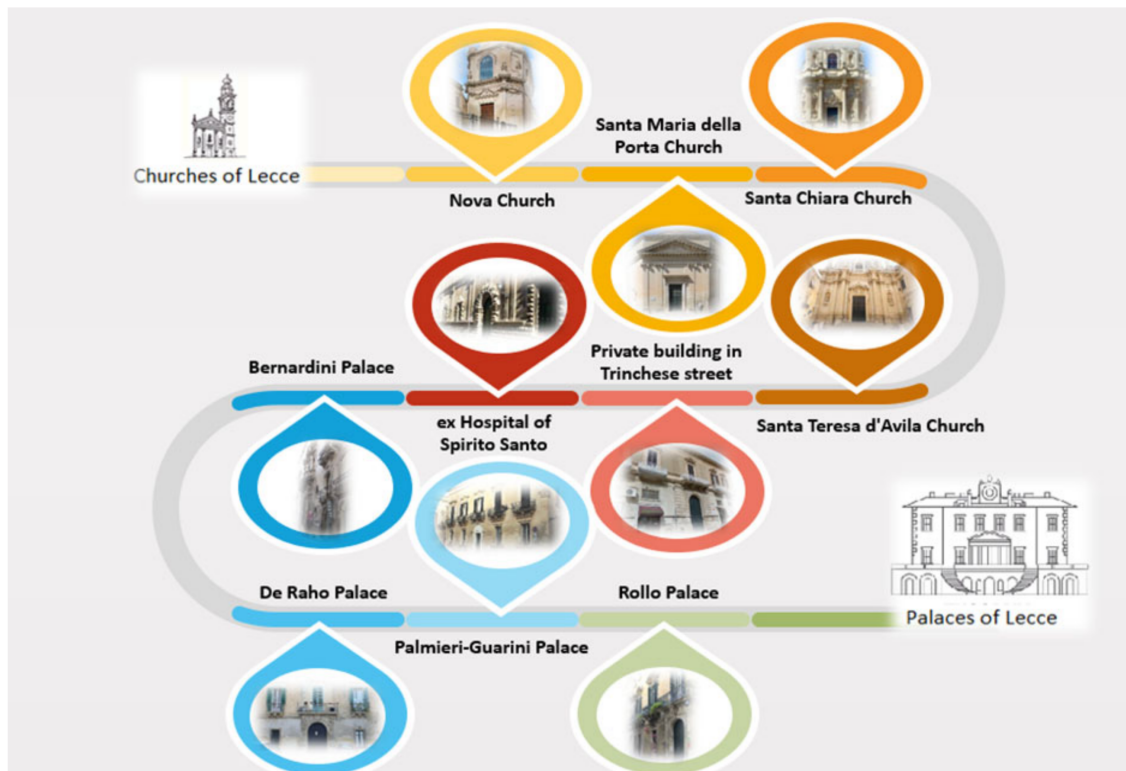
Figure 2. Synthetic representation of the investigated religious and civil buildings and main facades.

Ten buildings of historical-artistic value located in the city of Lecce (Apulia, Italy) were studied (Figures 1, 2, S1 and S2), and more than 50 samples were collected from their facades (the most significant are shown in Tables 1 and 2 and Figure S3). The identification of the samples was carried out taking into account the two main objectives of the work, namely the characterization of finishing techniques used in the past on stone facades and the study of degradation processes. Both civil and religious buildings of notable artistic value were selected in order to highlight possible differences in the methodologies of conservation of stone surfaces and investigate the surfaces not subjected to certified and published restoration interventions at the time of the research. The choice of the buildings to be investigated and of the sampling points was preceded by a first phase of knowledge of the artistic and historical context of the city of Lecce, carried out not only through archival and bibliographic research but also through visual analysis of the patina and coloring covering the facades of some buildings. From the visual analysis, the presence of “scialbature”, plastering and paintings is evident. In most cases, on the buildings of the historic center of Lecce, the presence of patinas of similar colors has emerged: the surfaces appear covered with beige, yellowish, orange, brown and especially pink patinas. Evidence of deterioration and alteration is also present on the stone surfaces, such as black crusts, saline efflorescence or subflorescence, alveolization, exfoliation, capillary rise of water and sulfation [19]. Overall, all the monuments investigated were built in “pietra leccese”, while some have a basement in “carparo”.

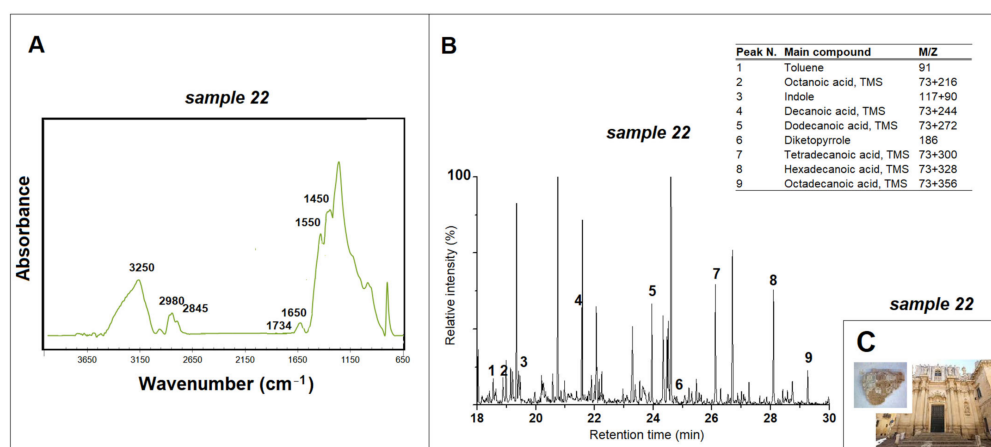
Figure 3. (A) ATR-FTIR spectrum for sample 22 taken from the *Santa Teresa D'Avila Church* (Lecce) and peaks related to the protein material; (B) pyrogram of sample 22 obtained by silylation (HMDS) and table with the main compounds identified; (C) images of *Santa Teresa D'Avila Church* and of sample 22.

Most of the samples taken from the facades of religious buildings located in the city of Lecce did not show the presence of ancient conservation treatments. The results depend mainly on the restoration operations probably carried out in some places on the surfaces of the churches, in addition to the natural process of degradation of the materials. The most significant data have emerged for the *Santa Teresa D'Avila Church*. Specifically, samples 22 and 23 taken on either side of the church portal prior to restoration operations in 2004 showed evidence of protein material (Figure 3). The ATR-FTIR spectra of these samples showed the presence of the specific absorption bands located at about 3400 cm^{-1} , related to the stretching of the N-H bond, and around 1650 cm^{-1} and 1550 cm^{-1} , attributed to the presence of amide I and amide II, as well as the peak located at 1450 cm^{-1} related to amide III, only in sample 22 [10,22,23]. There are also characteristic bands of methyl groups at approximately 2950 cm^{-1} and 2850 cm^{-1} and carbonyl groups at 1734 cm^{-1} attributable to the presence of lipid material [10,22]. Characteristic markers of milk appear in the respective pyrograms, such as toluene and indols (derived from tryptophan), pyrrole and derivatives (derived from hydroxyproline and proline, in quantities less than 50%) and compounds derived from the fragmentation of polysaccharides and fatty acids (FAs) [24–26]. Among these, some short- and medium-chain fatty acids are present in the pyrograms of the samples, such as C8:0, C10:0, C12:0 and C14:0, in addition to palmitic (C16:0) and stearic acids (C18:0). Their presence, the low percentage of dicarboxylic acids ($\Sigma D\%$, only traces), the very low ratio of palmitic and stearic acids C16:0/C18:0 (equal to 3.32 and 2.83 in the samples 22 and 23, respectively), and the ratio between lauric and capric acids C12:0/C10:0 equal to 0.55 in sample 22 and to 0.35 in sample 23 confirm that milk was applied on the facade of the church [10,25–27].

The Py-GC/MS data, while confirming the presence of milk, previously suggested by ATR-FTIR analysis, do not, however, allow for the identification of the type. Historical sources report, for example, the use of milk diluted with water or mixed with talc [3,10]. In other cases, the use of goat, sheep or cow's milk is specified [2,3]. The scientific literature generically shows in some cases the use of protein materials as binders in protective and aesthetic treatments on the surface of the stone [10,15,18,28]. In more specific cases, the use of sheep or cow's milk has been better hypothesized; the origin of milk can sometimes be identified by the content of short- and medium-chain fatty acids and the ratio of lauric acid

to capric acid (C12:0/C10:0) [29,30]. The value of the C12:0/C10:0 ratio of 0.35 measured in sample 22 [26,27] and the presence in the infrared spectrum of the peak still identifiable at 1734 cm^{-1} [10] could be associated with the use of sheep's milk. However, the data are not conclusive, due to the presence of other pyrolyzed materials that may alter the value of the determined ratio.

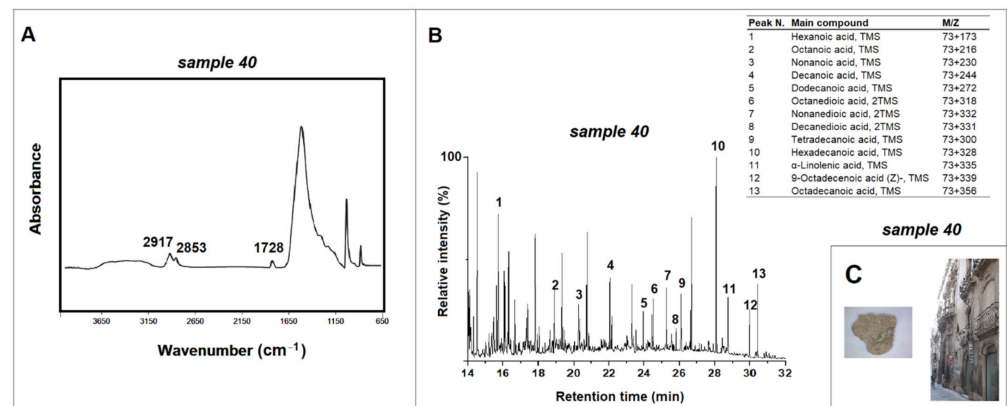
Figure 4. (A) ATR-FTIR spectrum for sample 40 taken from the *Bernardini Palace* (Lecce) and peaks related to the lipidic material; (B) pyrogram of sample 40 obtained by silylation (HMDS) and table with the main compounds identified; (C) images of *Bernardini Palace* and of sample 40.

In sample 40, the ATR-FTIR analysis showed the presence of absorption bands of infrared radiation typical of fatty acids, such as characteristic peaks at 2917 cm^{-1} and 2853 cm^{-1} related to the C-H stretching and at 1728 cm^{-1} related to the C=O stretching (Figure 4) [10,22]. The presence of lipidic material has been confirmed by Py-GC/MS analysis, which showed significant amounts of dicarboxylic acids (DCAs), such as azelaic (C9) and suberic (C8) acids, the main stable products found in aged pictorial films of the autoxidative processes involving the unsaturated acyl chains of siccative oils, during drying and aging [25,26]. In addition, significant amounts of saturated and unsaturated fatty acids are present in the pyrograms of sample 40. The presence of all these markers, 65.38% monocarboxylic acids, 21.49% dicarboxylic acids, the azelaic and palmitic acids ratio of 0.05, and the oleic and stearic acids ratio of 0.51 confirm the use of a siccative oil in the original finishing layer of sample 40 [10,25,26]. In fact, the drying oils are mixtures of triglycerides of saturated and unsaturated fatty acids, and this drying oil in particular would be walnut oil, as can be deduced from the measurement of the ratio of palmitic and stearic acids equal to 2.09 [3,10,27].

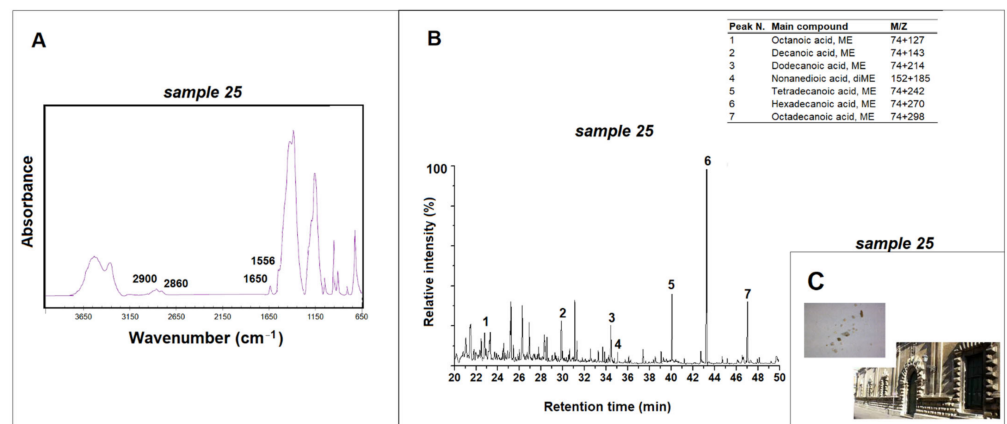
Figure 5. (A) ATR-FTIR spectrum for sample 25 taken from the *Ex-Hospital of Spirito Santo* (Lecce) and peaks related to the proteic material; (B) pyrogram of sample 25 obtained by methylation (TMAH) and table with the main compounds identified; (C) images of *Ex-Hospital of Spirito Santo* and of sample 25.

The ATR-FTIR spectra of samples 25, 27 and 28 taken from the *Ex-Hospital of Spirito Santo* showed the presence of absorption peaks related to methyl groups and located at about 2900 cm^{-1} and 2860 cm^{-1} (Figure 5). The infrared spectrum of sample 25 also shows amide bands at 1650 cm^{-1} and 1556 cm^{-1} , indicating the presence of proteinaceous material (Figure 5) [26,37]. The results of Py-GC/MS analysis indicate the presence of saturated and unsaturated fatty acids in these samples. Azelaic acid (C9) is also present in low concentrations in samples 25 and 27. From the percentages of monocarboxylic acids (between 30 and 40%) and dicarboxylic acids (less than 10%) and the ratio of azelaic and palmitic acids (less than 0.1%), the presence of proteinaceous material in the samples analyzed can be deduced [26]. However, the absence of toluene, indole, pyrrole and pyrrole

derivatives leads to the exclusion of the use of milk or animal glues as waterproofing agents, while the absence of cholesterol and hexadecanonitrile excludes the use of egg yolk [25,26]. An egg-white-based finishing treatment was therefore used, although its use on large surfaces seems to have been obsolete in the past according to literary sources and limited moreover to the gluing with sugar addition of stone parts, rather than to the realization of finishes for conservation purposes [3].

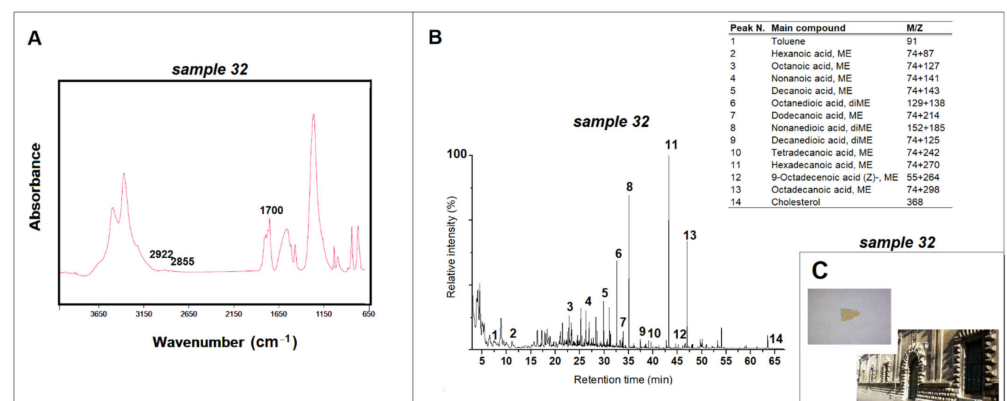
Figure 6. (A) ATR-FTIR spectrum for sample 32 taken from the *Ex-Hospital of Spirito Santo* (Lecce) and peaks related to the lipidic material; (B) pyrogram of sample 32 obtained by methylation (TMAH) and table with the main compounds identified; (C) images of *Ex-Hospital of Spirito Santo* and of sample 32.

Sample 32 taken from the same building deserves separate consideration (Figure 6). The ATR-FTIR spectrum shows the peaks associated with the presence of lipidic material, located at 2922 cm^{-1} and 2855 cm^{-1} , related to the C-H methyl groups, and a peak at 1700 cm^{-1} , characteristic of the C = O carboxylic functional group [10,22,26]. Further information comes from the qualitative and semiquantitative analysis carried out using Py-GC/MS that shows the probable use of a mixed technique. In this case, the use of an emulsion of egg and siccativ oil is indicated by the presence of cholesterol (and its degradation products), traces of toluene and monocarboxylic (39.52%) and dicarboxylic (equal to 25.04% and therefore higher than 10%, as reported in the literature) acids in the pyrogram, as well as by the azelaic and palmitic acids ratio of 0.34 [24,26].

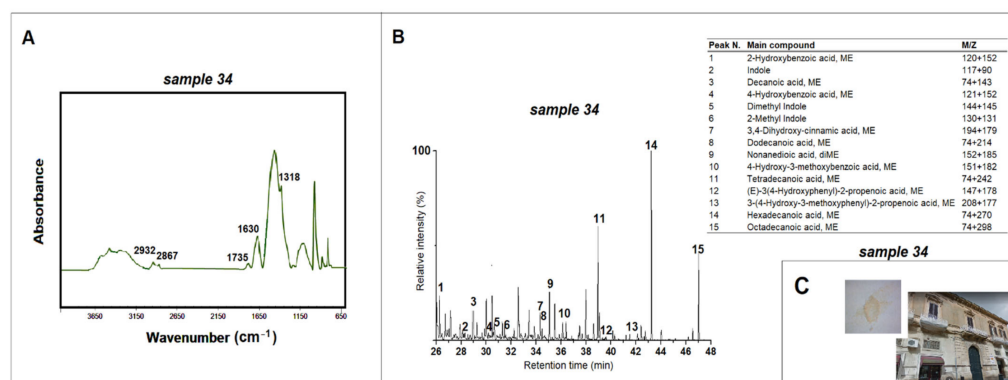
Figure 7. (A) ATR-FTIR spectrum for sample 34 taken from the *private building on Trinchese street n.18* (Lecce) and peaks related to the lipidic material and calcium oxalate; (B) pyrogram of sample 34 obtained by methylation (TMAH) and table with the main compounds identified; (C) images of the *private building on Trinchese street n.18* and of sample 34.

Sample 34, taken from a *private building on Trinchese street n.18* (Lecce), is of particular interest compared to the other samples analyzed. The ATR-FTIR spectrum (Figure 7) shows absorption bands of infrared radiation at 2932 cm^{-1} and 2867 cm^{-1} related to C-H bond stretching. Moreover, absorption bands at 1630 cm^{-1} and 1318 cm^{-1} related to calcium oxalates are present [10]; calcium oxalates are usually found on surfaces affected by artificial finishes [15], and such absorption peaks remain together with methyl groups specifically after the aging of surface treatments based on some plant species, according to a previous experimental study [10]. Py-GC/MS analyses show predominantly the presence of indoles, lignin degradation compounds, polysaccharides and fatty acids [24]. The presence of methyl groups and significant amounts of disaccharides and the absence of toluene and pyrroles (characteristic markers of milk together with indoles and thermal degradation products of polysaccharides) confirm the use of a surface finishing technique based on polysaccharide material, already suggested by FTIR analysis [18]. The pyrogram of sample 34 (Figure 7) also shows the presence of some phenolic acids and flavonoids, characteristic markers of *Opuntia Ficus-Indica* leaf, confirming the use of this species for stone surface protection [18,38,39]. *Opuntia Ficus-Indica* is a plant belonging to the Cactaceae family and is very widespread in Apulia. Its leaves are rich in water, carbohydrates, waxes, phenolic compounds, minerals, oxalates and fatty acids. These substances have now led to its widespread use in various application fields due to its antimicrobial, adhesive and water-repellent properties. Even if the leaf of *Opuntia Ficus-Indica* is an unusual material, its use for the conservation of surfaces is not surprising today, since it has already emerged in a previous study on the facade of the *Church of San Giorgio* (Melpignano, Lecce) [18].
