РАСЧЕТ И ПРОЕКТИРОВАНИЕ СТРОИТЕЛЬНЫХ КОНСТРУКЦИЙ ANALYSIS AND DESIGN OF BUILDING STRUCTURES

RESEARCH ARTICLE / НАУЧНАЯ СТАТЬЯ

Strengthening of reinforced concrete structures by composite materials taking into consideration the carbonization of concrete

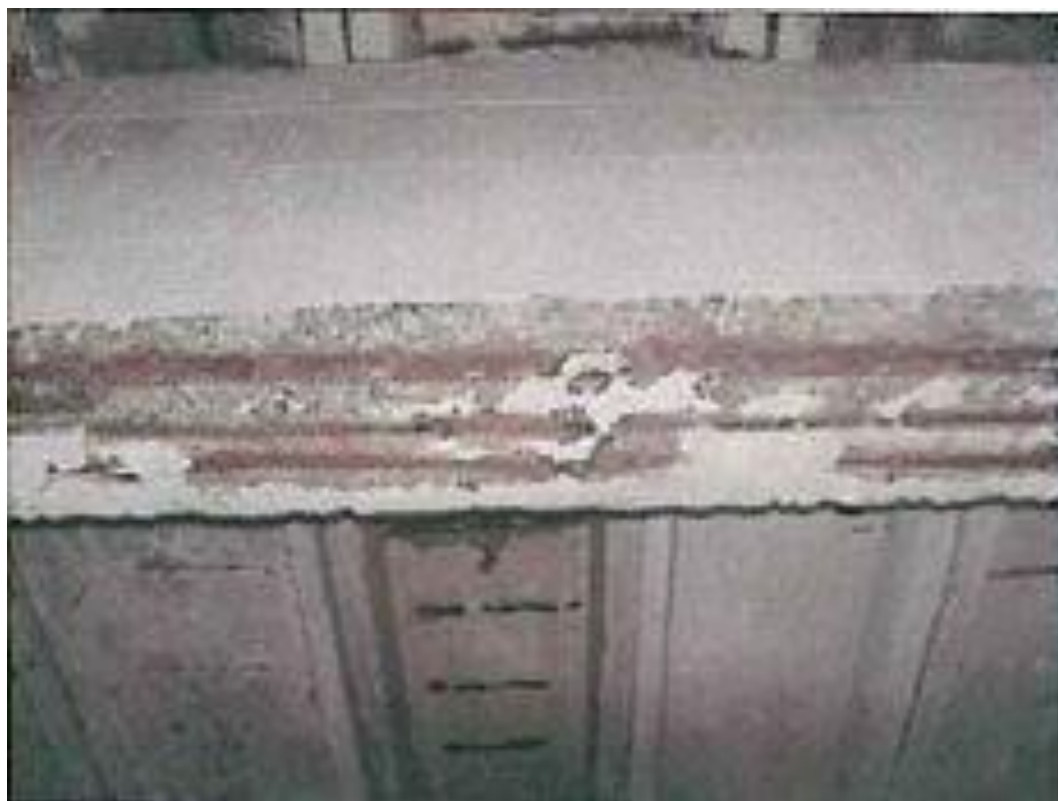
To conduct the research, we studied silt reservoir structures, which were exposed to carbon dioxide CO_2 , resulting in the formation of calcite CaCO_3 in the body of the structure. This indicates the occurrence of the reaction of carbonization in the body of the reinforced concrete structure (Figure 1) [10–12]:

- destruction of the protective layer of concrete beams with bare and corrosive damage to the power reinforcement in the lower zone and support units;
- failure of the adhesion of the working reinforcement to the concrete due to corrosion of the reinforcement and destruction of the concrete;
- longitudinal cracks in the concrete formed because of reinforcement's corrosion.

Figure 1. Corrosion of reinforcing bars in a beam

Thus, when the destruction of concrete protective layer and corrosion of reinforcement is detected, the most probable reason is carbonization of concrete with increased impact of CO₂ on the operated structure.

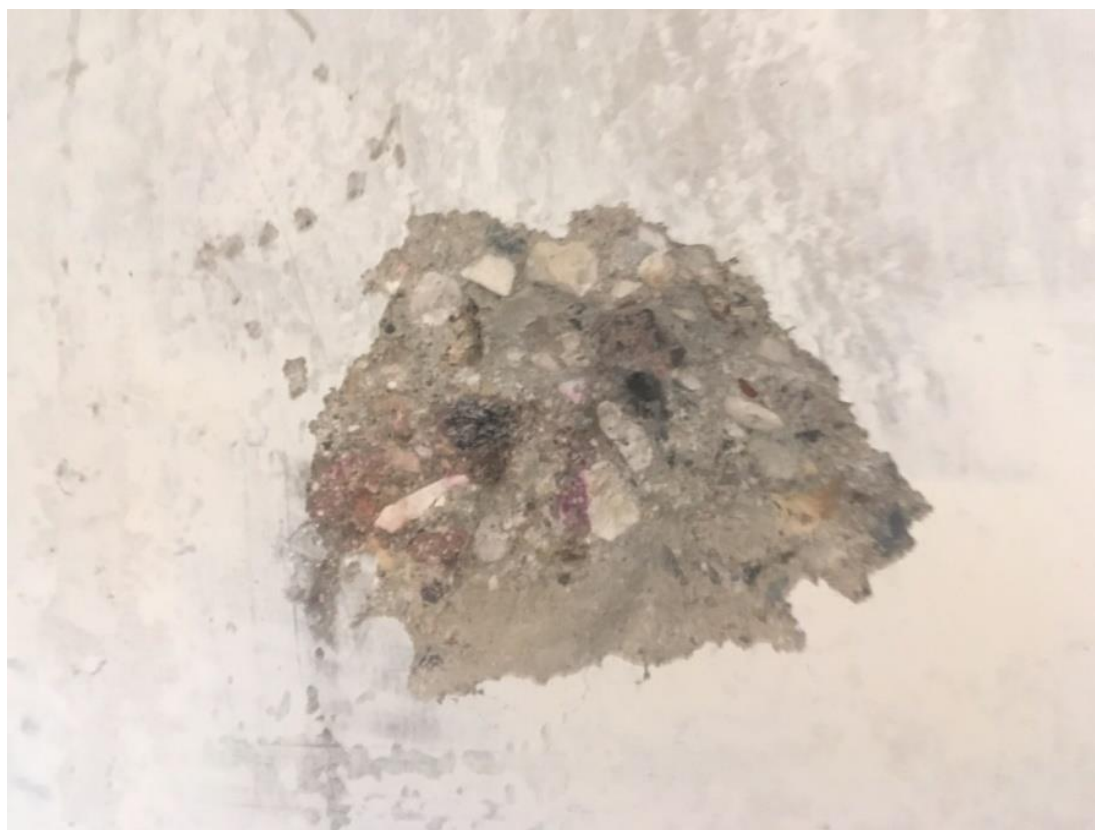
The phenolphthalein test revealed that the pH of the medium was less than 8, to a depth greater than the thickness of the protective layer of concrete (Figure 3). It was used 1% phenolphthalein solution in ethanol to conduct the phenolphthalein assay.

Figure 3. Absence of visible signs of concrete carbonization from the results of phenolphthalein test
