# Intraoperative periprosthetic humeral fracture during reverse shoulder arthroplasty: a sequelae of prior biceps tenodesis

**Level of evidence:** V.

**Keywords:** Shoulder; Tenodesis; Suture anchor; Humeral fracture; Arthroplasty

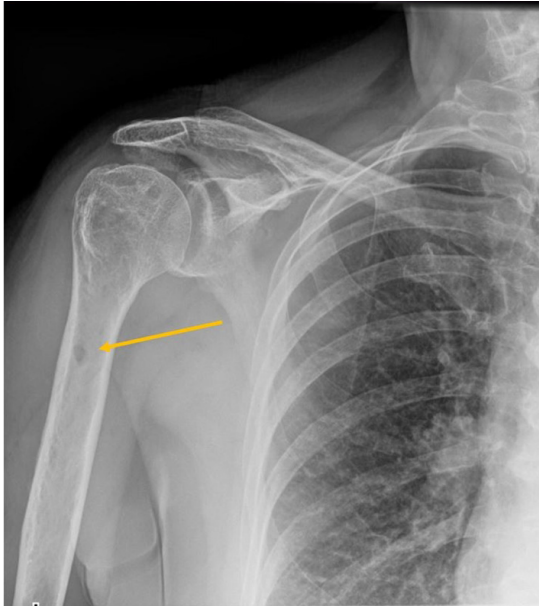
**Fig. 1.** X-ray showing the biceps tenodesis hole (arrow) prior to reverse shoulder arthroplasty in the patient.

arthroscopy and biceps tenodesis for a painful irreparable rotator cuff on January 29, 2019. The patient provided consent for her case to be reported in this study; as such all relevant data were deidentified, anonymized and included in this case presentation. Tenodesis was performed in a subpectoral position using an all-suture anchor with a 1.8-mm-pilot drill hole to minimize bone loss. The patient failed to improve significantly, and we proceeded with a reverse prosthesis on March 10, 2020. X-ray imaging performed prior to the reverse shoulder arthroplasty clearly revealed the tenodesis hole of the prior procedure (Fig. 1).

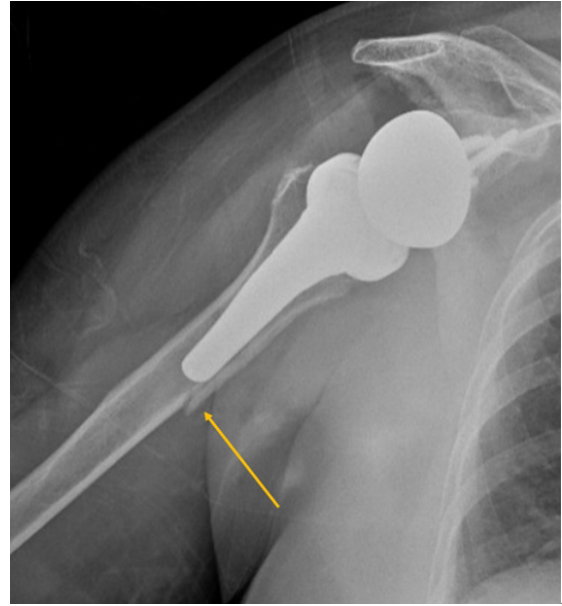
**Fig. 2.** Intraoperative X-ray showing an oblique fracture of the humerus (arrow) in the patient.

achieved, the humeral stem was unstable, and an oblique fracture line was identified involving the site of the osteotomy and exiting through the hole used for anchoring the biceps. An intraoperative X-ray of the shoulder is shown in Fig. 2. The stem was removed, and the fracture was fixed by cerclage using two non-absorbable sutures. The stem was inserted and found to be stable before and after reduction with a 6-mm liner. The procedure was uncomplicated, and the patient wore an arm sling for 2 weeks. Follow-up at 5 months from surgery revealed a stable implant with a good location and good bone healing (Fig. 3).

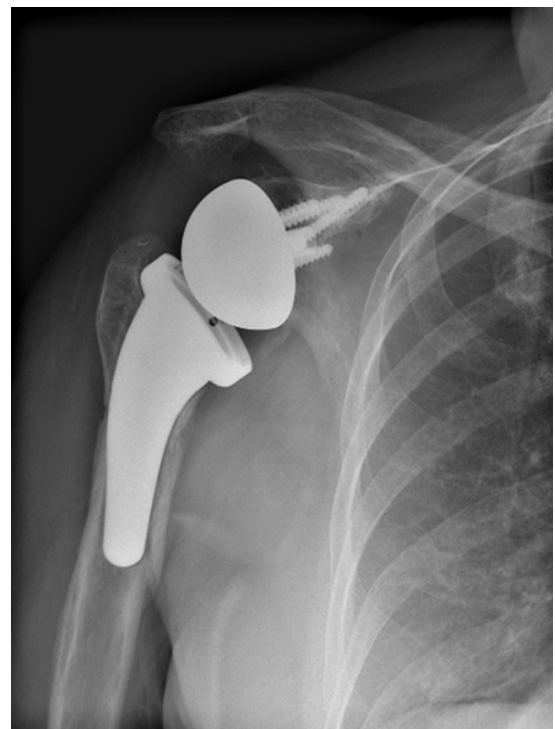
**Fig. 3.** X-ray of the shoulder at 5-month follow-up showing a stable implant in a good location with good bone healing.

The periprosthetic fracture was fixed intraoperatively in our patient using a suture cerclage. Several studies have asserted and emphasized the efficiency and safety of using a suture cerclage rather than a stainless steel wire or other methods of fixation [22-24]. This was supported further by the uneventful postoperative course of our patient, who exhibited good bone healing and stability on follow-up (Fig. 3).
