RIVER HABITAT AND MACROPHYTE SURVEYS IN POLAND

RESULTS FROM 2003 AND 2007

A report by Paul Raven¹, Nigel Holmes², Peter Scarlett³,
Krzysztof Szoszkiewicz⁴, Agnieszka Ławniczak⁴ and Hugh Dawson³

March 2008

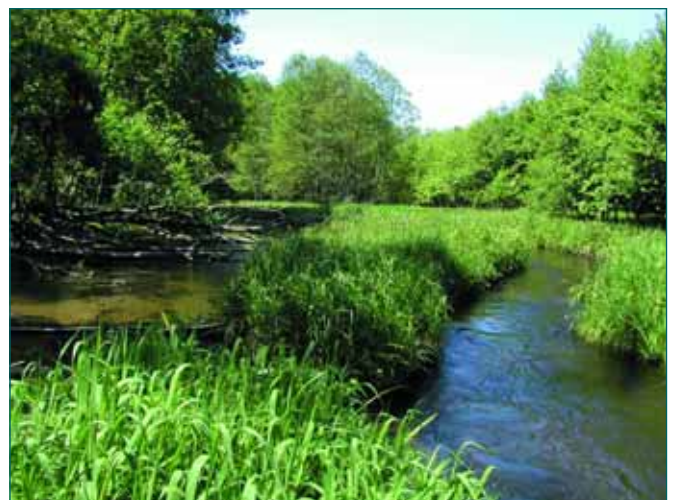
Diversity of natural in-channel, bank and riparian habitat produces a high HQA score.

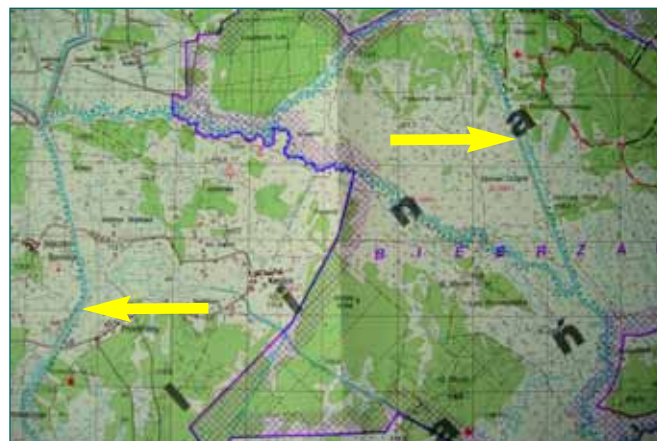
Major drainage channels disrupt the natural hydrology of many rivers such as the Elk.

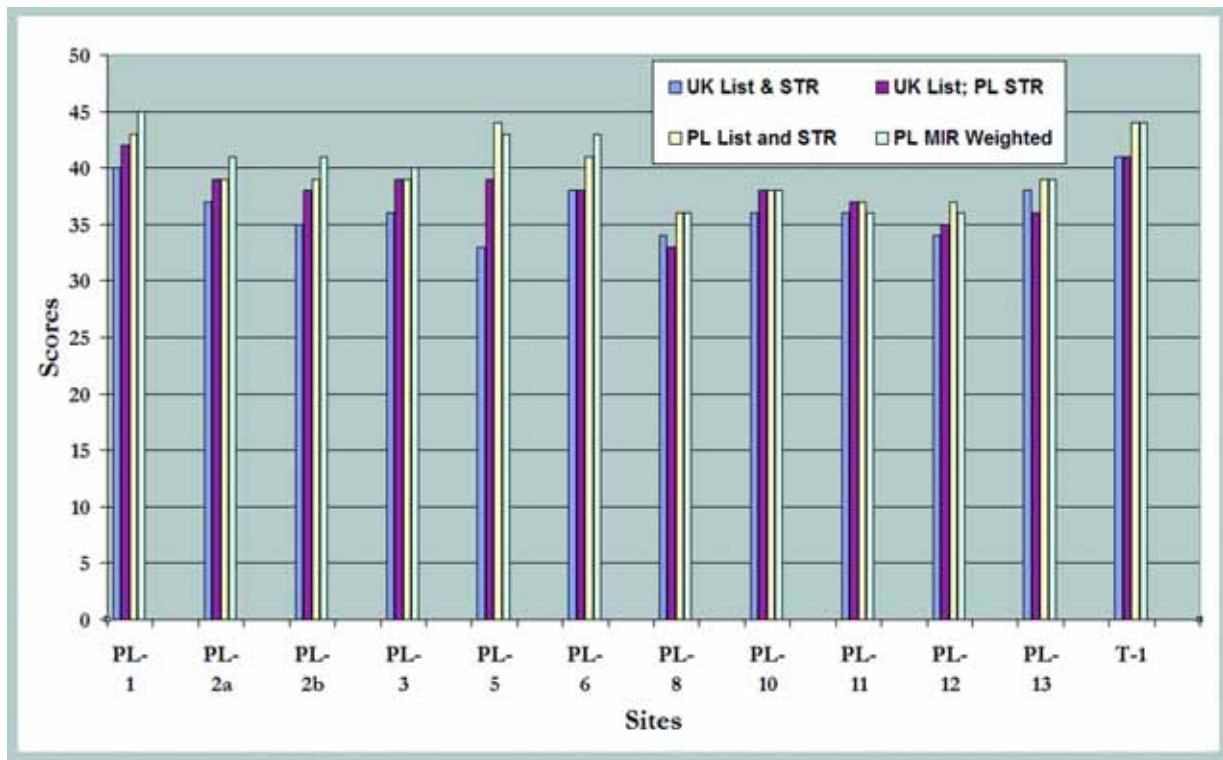
Figure 2. Comparison of MTR and MIR scores (see Appendices 9a-d for full details).

The MIR scores (i.e. including weighting, additional taxa and the MIR scoring system) are generally higher.

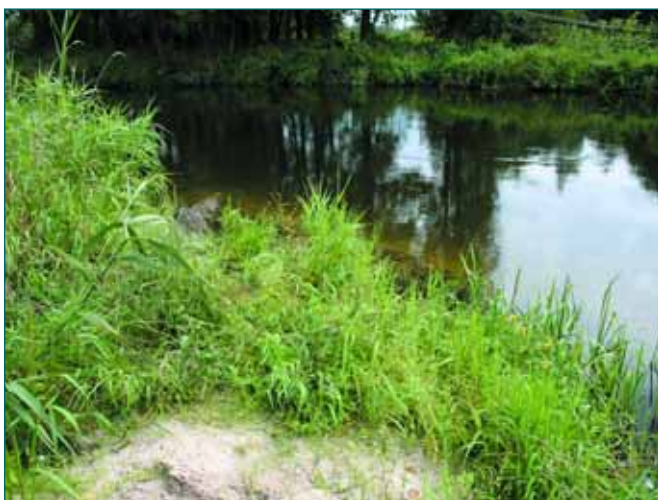
Sandy margins can become vegetated to form natural berms; PL-8.

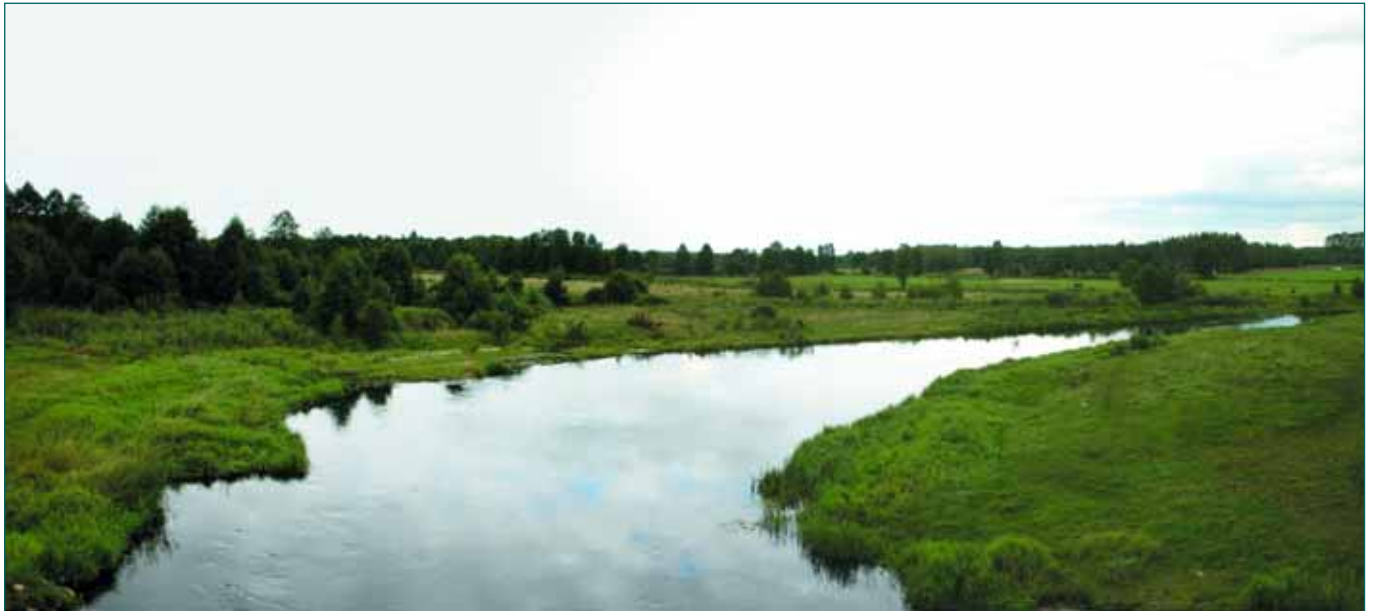
Natural berm/terrace features, plus a small wetland marking an old cut-off channel on the left; PL-10.

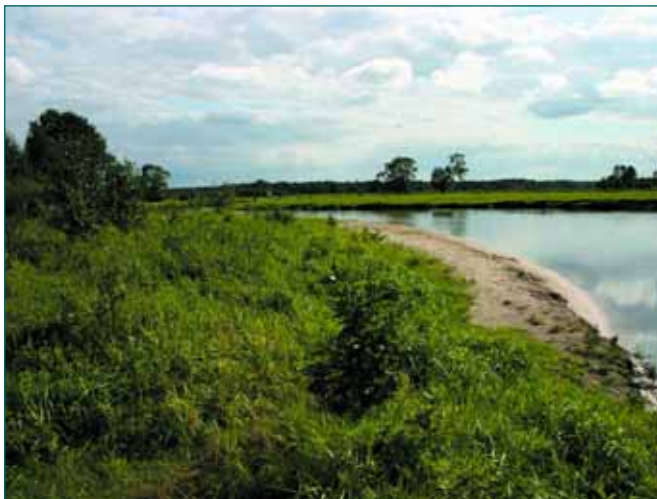
Actively meandering channels produce sandy point bars, with natural berms forming behind; PL-10.

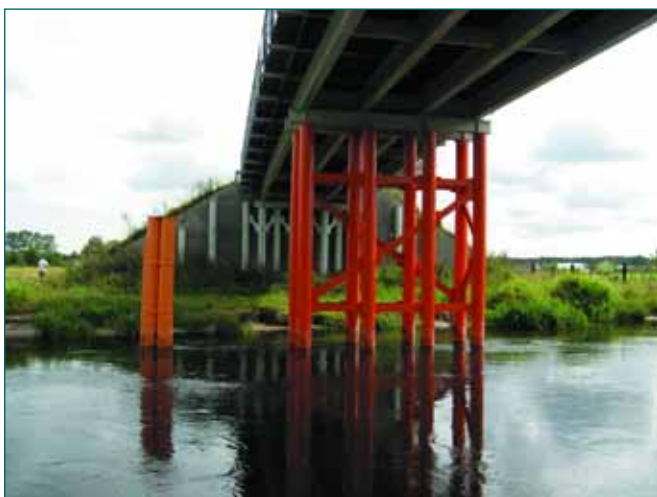
Major bridge structure on the Pisa River at PL-10.
