RIVER HABITAT SURVEY IN SOUTHERN BAVARIA AND THE TYROLIAN ALPS RESULTS FROM 2006

A report by Paul Raven¹, Nigel Holmes², Hugh Dawson³, Walter Binder⁴ and Helena Mühlmann⁵

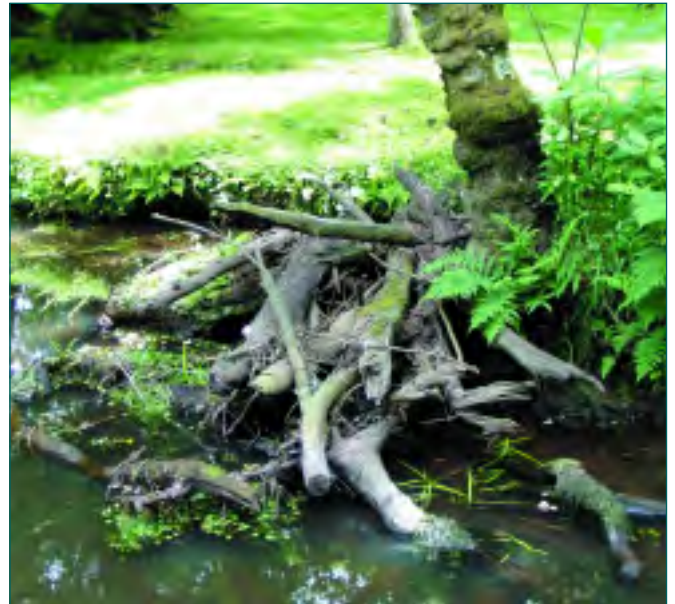
Bankside tree roots and woody debris contribute to HQA scores.

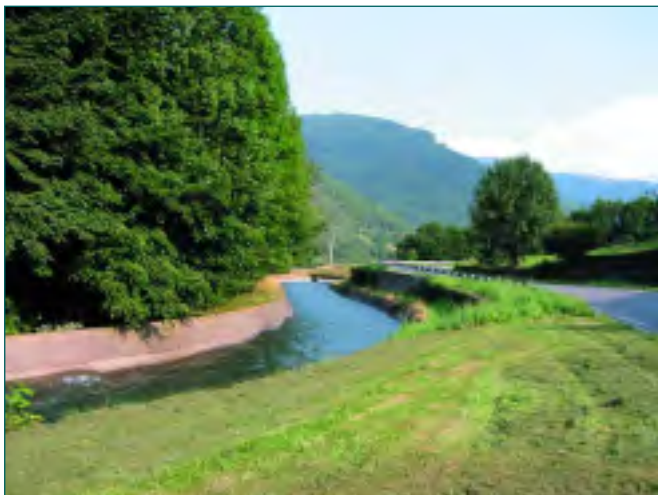
Heavily modified and artificial channels have high HMS scores.

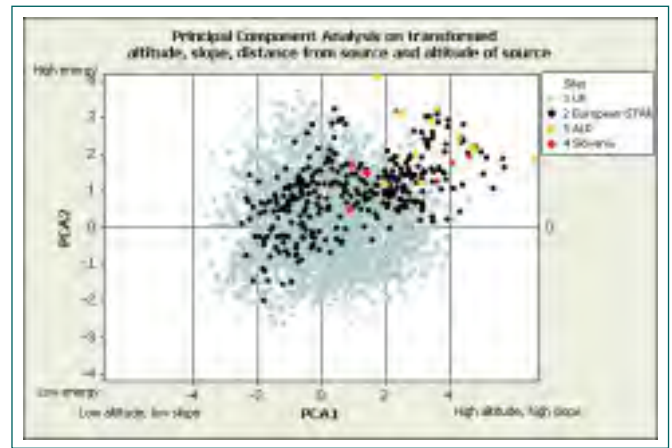
Figure 1: PCA plot showing UK, European STAR, Slovenian and ALP sites.

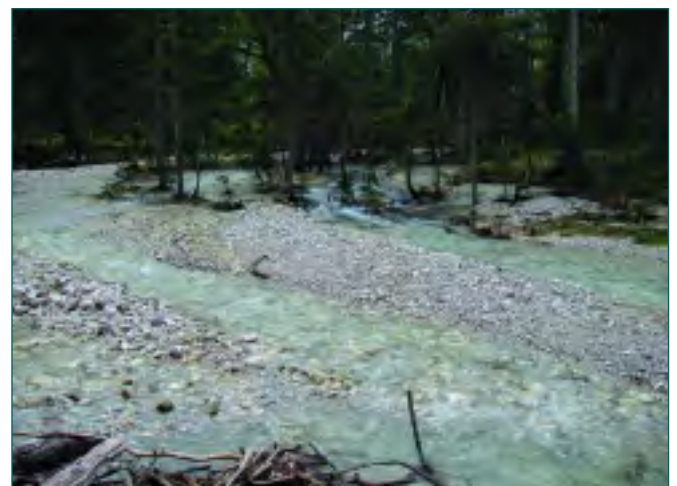
Braided channel and low terraces, ALP-12.

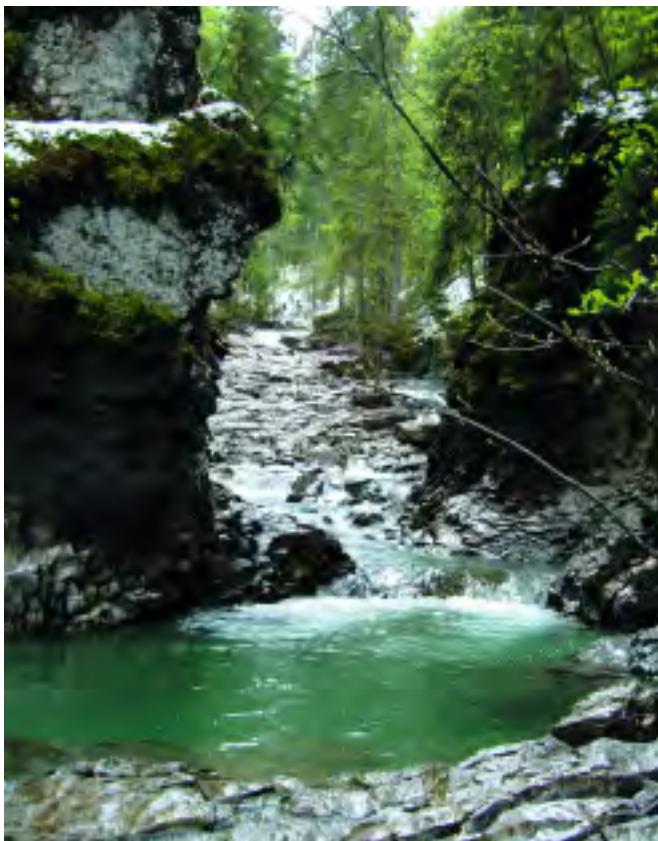
Bedrock and cascades on the Schwarzwasserbach, ALP-14.

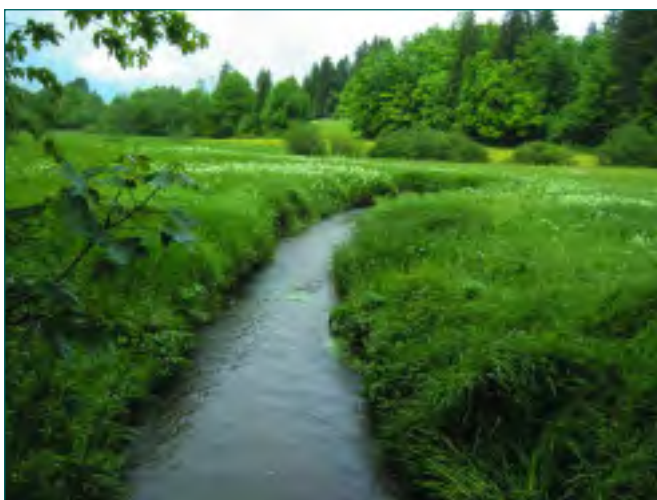
Recently straightened channel of the Rinnenb.

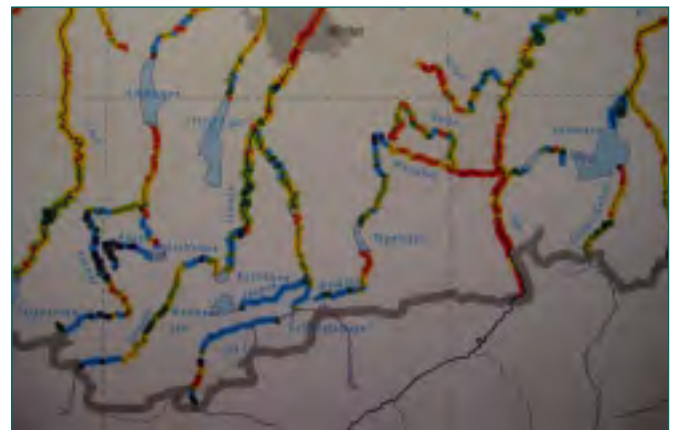
LAWA classification map of southern Bavaria.

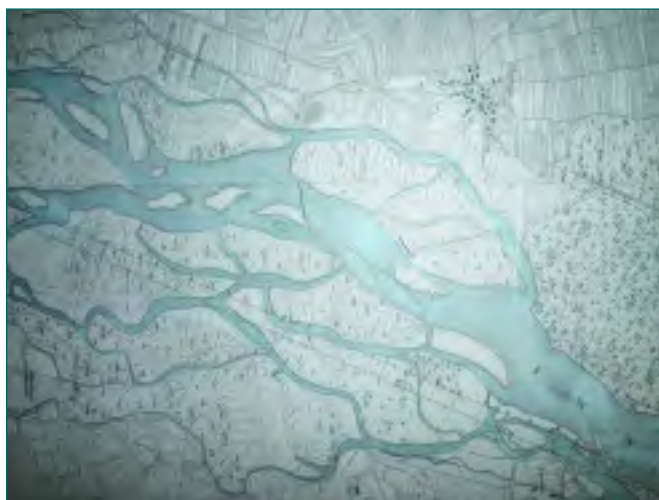
Historical map of the River Inn, showing braided channel before canalisation.

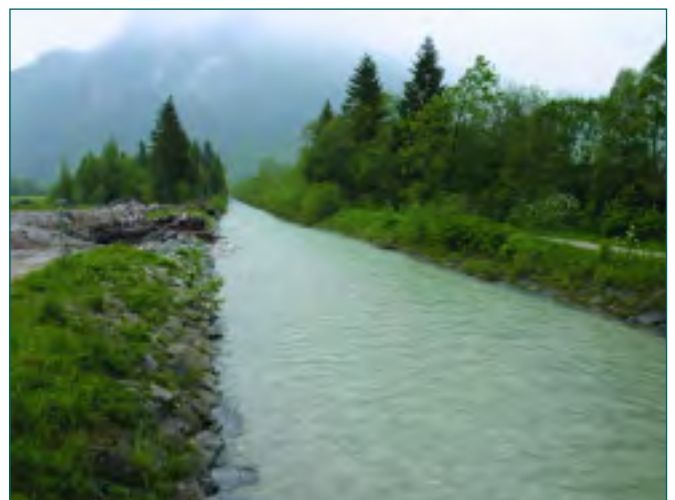
Straightened, armoured channel of a formerly braided river, near ALP-8.

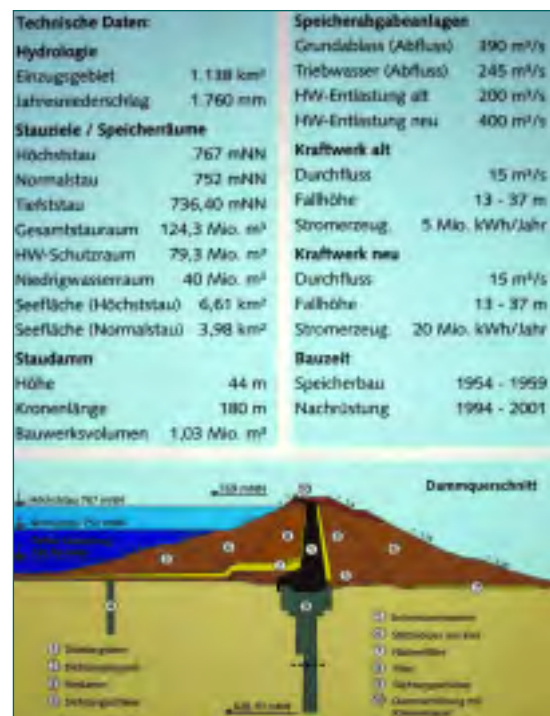
The dam across the Isar creating the Sylvensteinsee.

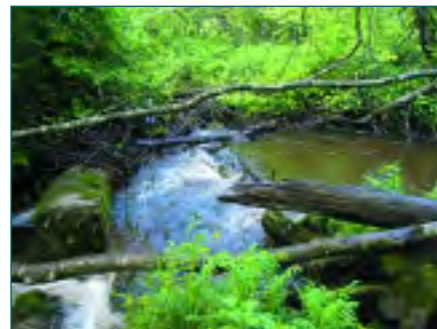
Dilapidated weir structure upstream from ALP-5.

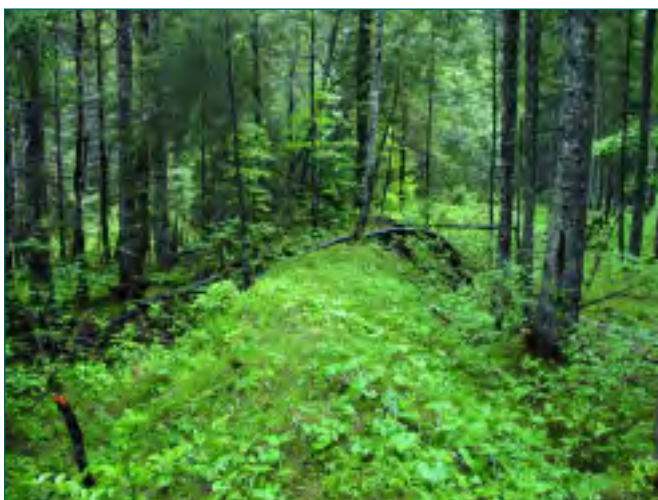
Set-back embankment, right bank, ALP-7.

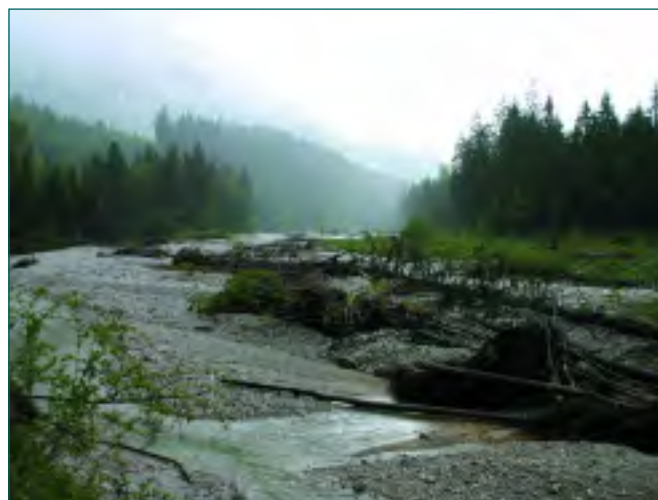
Classic braided channel features, ALP-7.

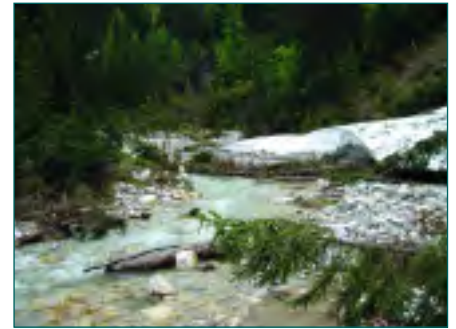
Snapped trees - evidence of avalanche damage, ALP-13.

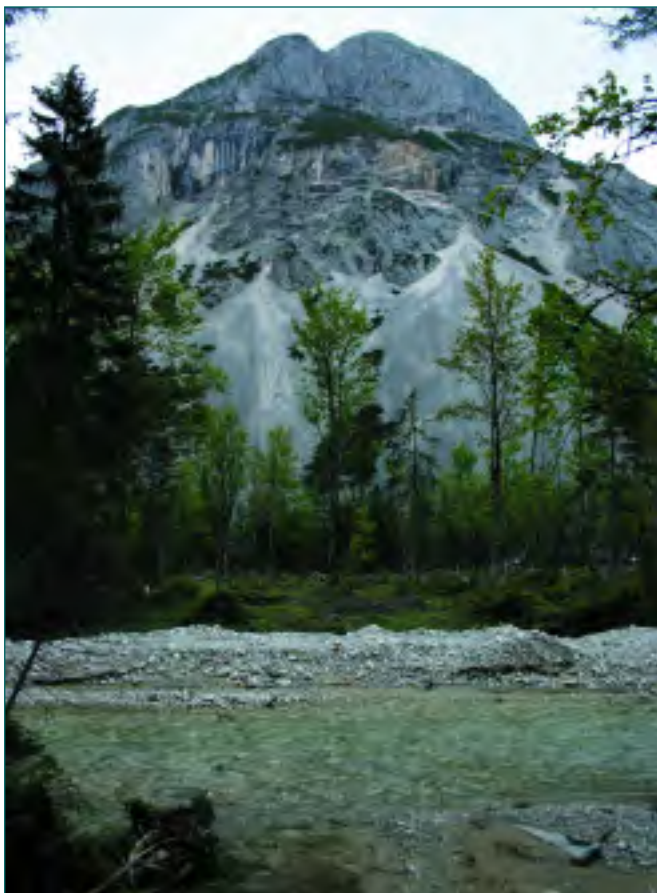
Scree - a source of gravel; plus evidence of gravel removal from the channel.

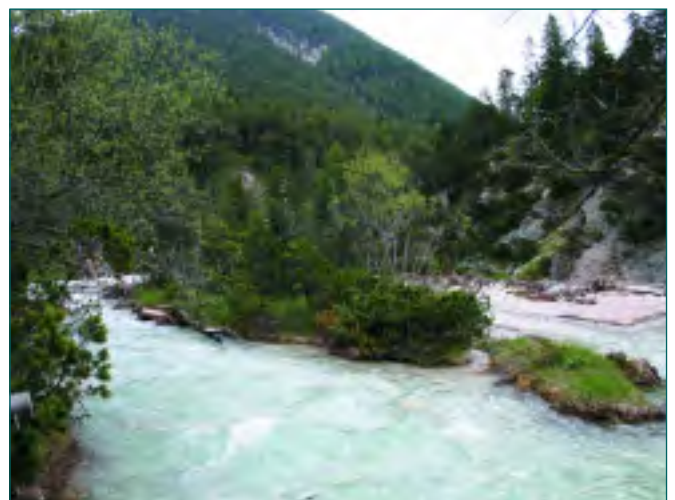
Clues other than strandlines are needed to determine the channel / bank boundary in deep vee valleys, ALP-11.

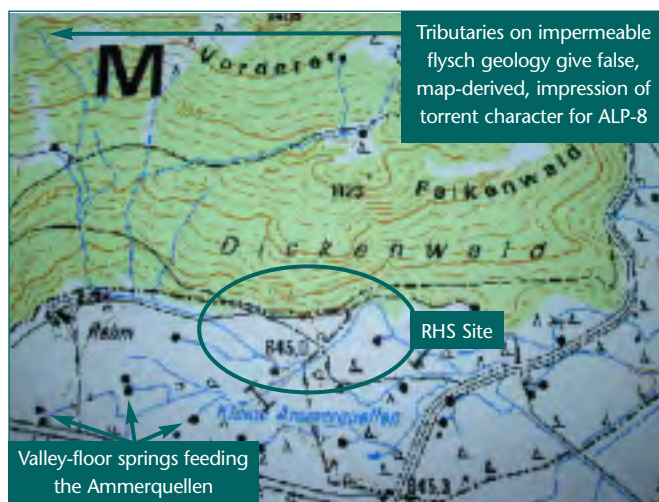
The Kleine Ammerquellen (ALP-8), clearly showing several spring sources (black dots) and mountainside tributaries of contrasting very steep gradient.

The PCA plot as currently derived depends on map-derived information, with height of source prominent as a determinand. For groundwater-fed streams and rivers this may produce misleading results. For instance, the Kleine
