WEATHERING OF MONUMENTAL ISLAMIC MARBLE IN EGYPT: A CONTRIBUTION TO HERITAGE STUDIES

Keywords: marble, deterioration, weathering, crystallization, moisture

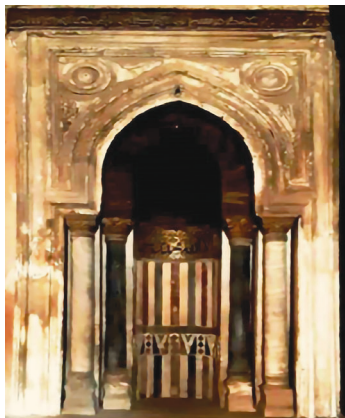
Figure 2A. Damaged marble of the archaeological Mihrab, Ahmed Ibn Tulun Mosque, in Cairo, Egypt.

Another phase of deterioration is the black discoloration (formed by a thin black layer) of the marbles slabs due to the salty surface deposits mixed with soot; the crystalline salts, mainly gypsum, cause several deterioration patterns in these slabs such as granular disintegration, blistering, scaling and delamination. Water and moisture are very severe deterioration dynamics, since destructive chemical responses in archaeological materials cannot occur without water, as the salts cannot easily dissolve and pass into holes or pores without water (Figures 2A and B).

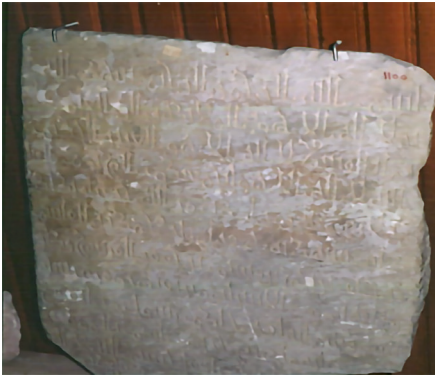
Figure 2B. A marble tombstone with kufic inscriptions engraved in 913 AD-1009 AD Egypt, in the Museum of the Faculty of Archeology, Cairo University. Despite its presence in the confined space, the accumulation of dust and dirt on the surface, which hides the writing, is evident.

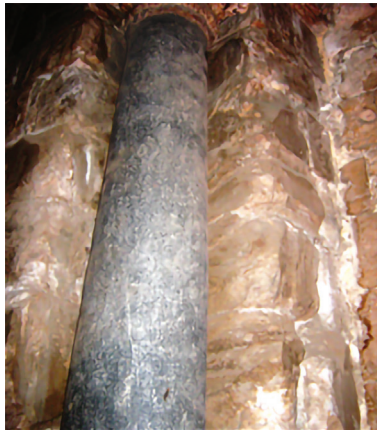
Figure 3A. A marble column with a Corinthian crown on the entrance door illustrates the Qalawun Group, Cairo, with obvious damage to the marble surface.

Sulphation of carbonate stones is a very common phenomenon in historical buildings in Cairo and Mecca, where the external surfaces of these stones have layers of black encrustation which are considered layers rich in crystalline salts, mainly calcium sulphate (gypsum). Due to this phenomenon marble surfaces become sugary because their mineral constituents have been separated and the physical structure has become very weak due to salt weathering (Figures 3A, B and C).

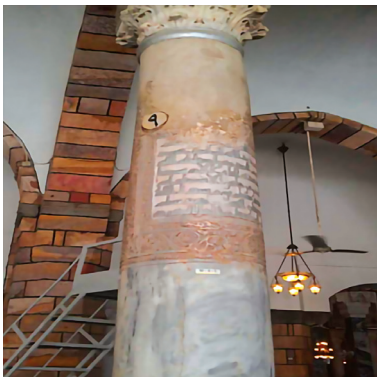
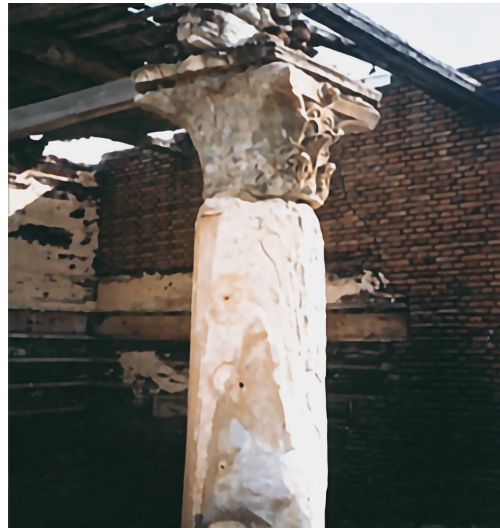
Figure 3B. Inside Omar Ibn Al-Aas Mosque, Damietta. Salt weathering of marble.

Figure 3C. Marble column with kufic inscriptions in the Grand Mosque in Mecca.

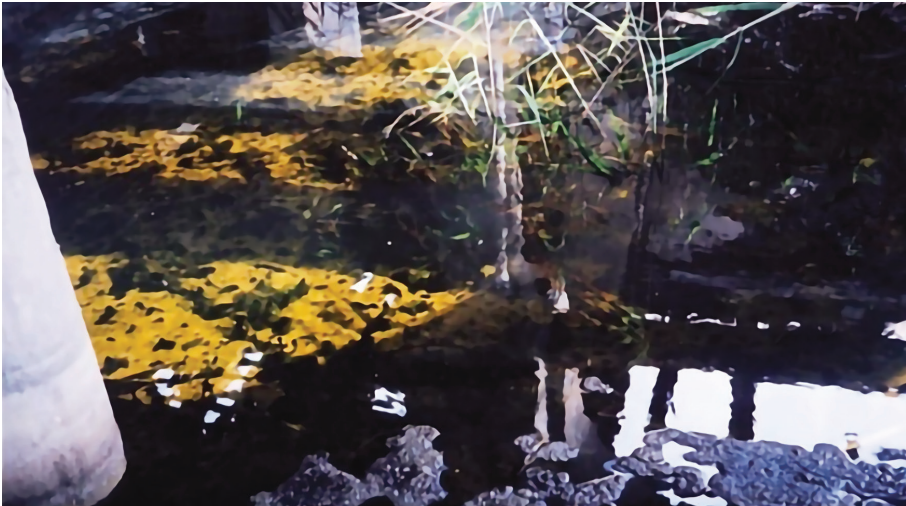
Figure 4. Bacterial colonies growing close to the marble columns of historical mosques; algae growth, and the spread of ground water inside the courtyard of Omar ibn Al-Aas Mosque, Damietta.

Cultural heritage monuments may be stained and degraded by the growth and activity of living organisms. As a result of the secretions of microorganisms, layers of biofilms form on stone surfaces, causing aesthetic and structural damage. Though the existence of biofilms on stone monuments exposed to outdoor environments is noticeable, thin films also occur on monuments under controllable indoor environmental conditions [72]. The organisms involved are bacteria, fungi, algae, and lichens [73]. Bio weathering of monumental stones is no less dangerous than other weathering factors where microorganisms, which are considered the most severe bio weathering factor, can cause serious damage to stone in all climates (Figure 4).
