Butte Priority Soils Operable Unit (BPSOU) Draft Final Insufficiently Reclaimed Sites – Field Sampling Plan (FSP) BRES No. 174 – Buffalo South and BRES No 174 – Buffalo Ditch

Re: Butte Priority Soils Operable Unit (BPSOU) Draft Final Insufficiently Reclaimed Sites – Field Sampling Plan (FSP) BRES No. 174 – Buffalo South and BRES No 174 – Buffalo Ditch.

This FSP describes field evaluation of the IR Site BRES No. 174 – Buffalo South and BRES No. 174 – Buffalo Ditch. The sampling boundary and proposed soil sampling stations and deficiencies identified during previous BRES evaluations are shown on Figure 1 and Figure 2.

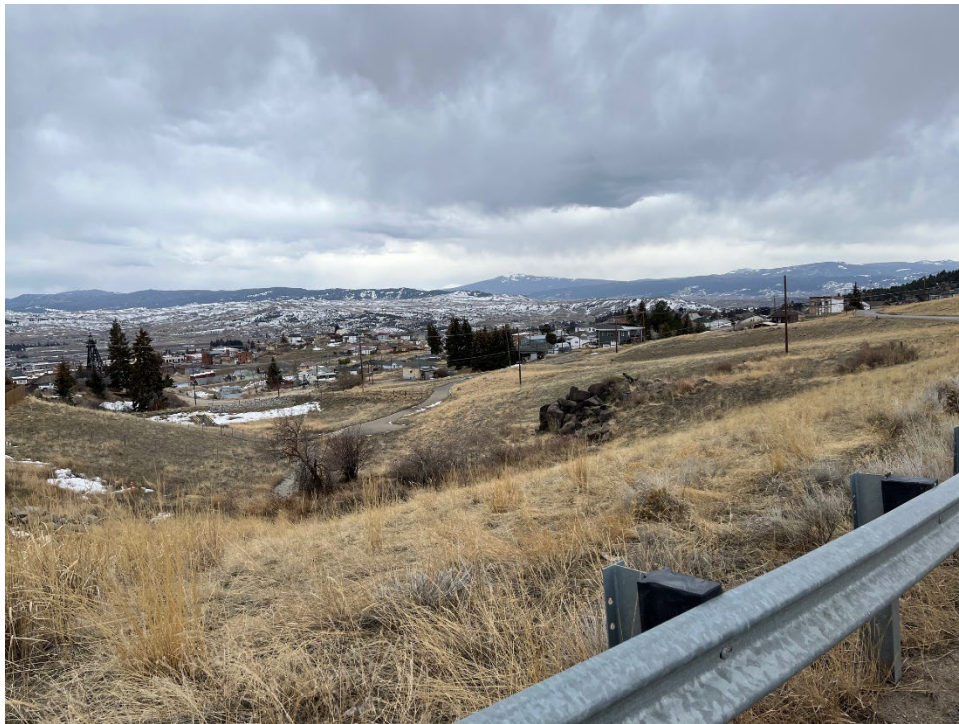
A preliminary site evaluation was conducted during development of this sampling plan to inspect current site conditions and identify focus areas for further investigation which included site photographs. Photograph 1 through Photograph 6 show current site conditions. The investigation found the site to have moderate vegetation establishment with a large area of low vegetation and barren areas. Undesirable vegetation and weeds are present throughout the whole site.

Photograph 1: Site overview facing southwest.

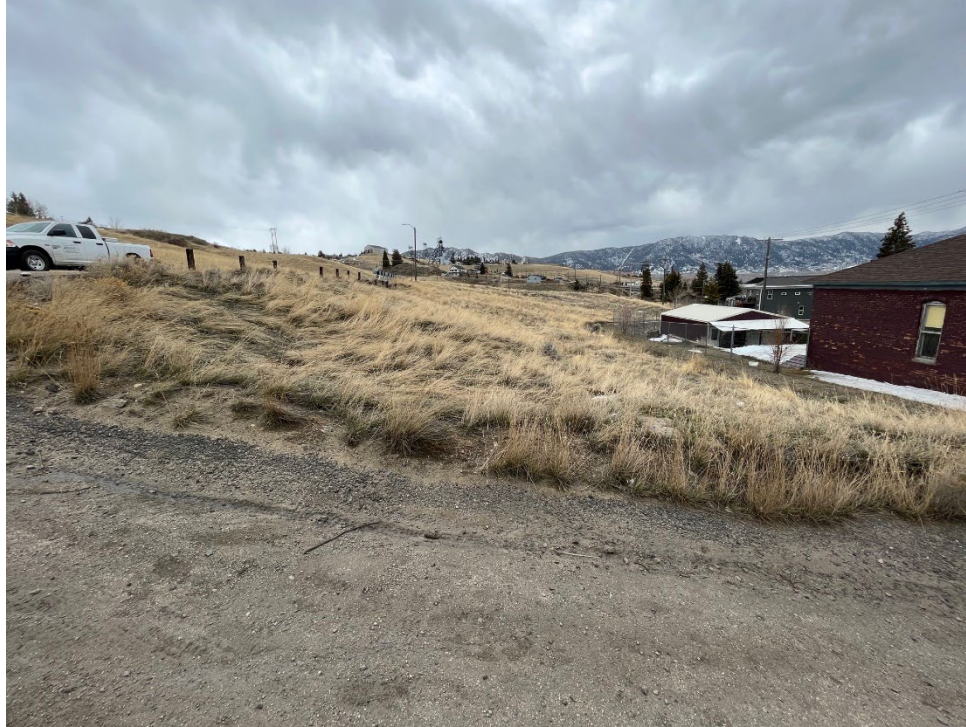
Photograph 2: Site overview facing east.

Sediment from Buffalo Street is migrating onto the site and is causing rills to form along the site edges. A few barren areas were also discovered. A culvert is located on the northeast portion of the site. This culvert diverts water from BRES No. 53 and 54, north of BRES No. 174, under Buffalo Street and onto BRES No. 174 Buffalo South site.

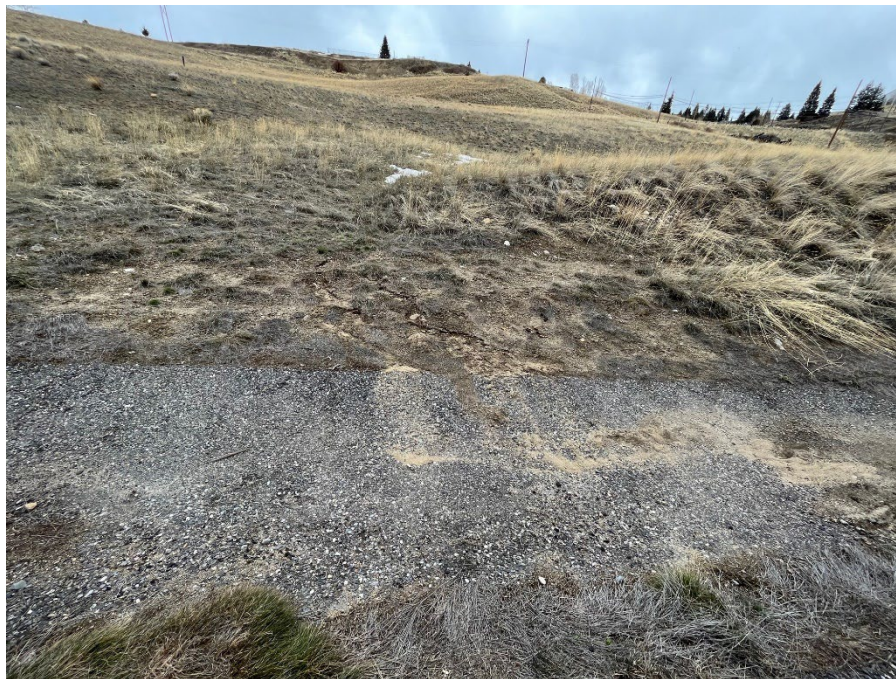
Photograph 3: Barren area on the south side of site.

Sediment from a barren area on the south portion of the site is depositing into the paved channel that runs along the south border of the site.

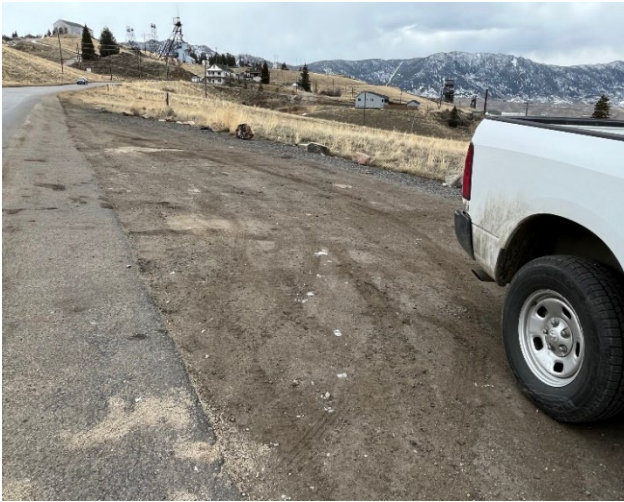
Photograph 4: East vehicle pullout area on Buffalo Street.

Two areas along Buffalo Street are used as vehicle pull outs. These two locations are not barren areas, but rather, an engineered cap with asphalt millings and appear to be in good condition. No samples will be collected here since it is capped and not included in the boundary.

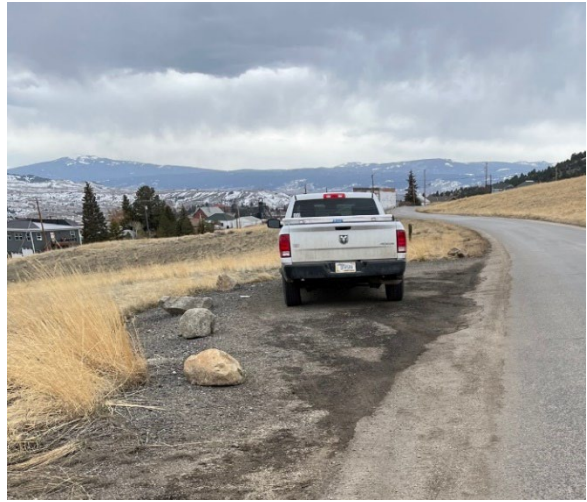
Photograph 5: West vehicle pullout area on Buffalo Street.

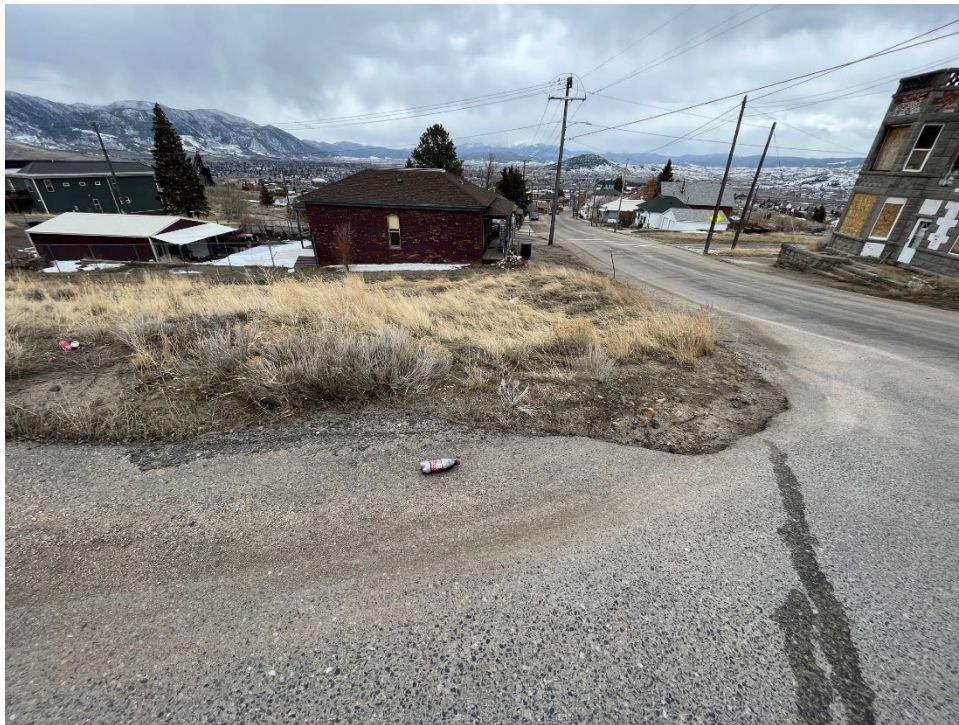
Photograph 6: East side of site along North Montana Street

The corner of Buffalo Street and North Montana Street shows heavy storm water and sediment collection and migration. Undercutting of this intersection was observed. Sediment and storm water run along the site, down North Montana Street, and into a storm water inlet north of the private property shown on Photograph 6.

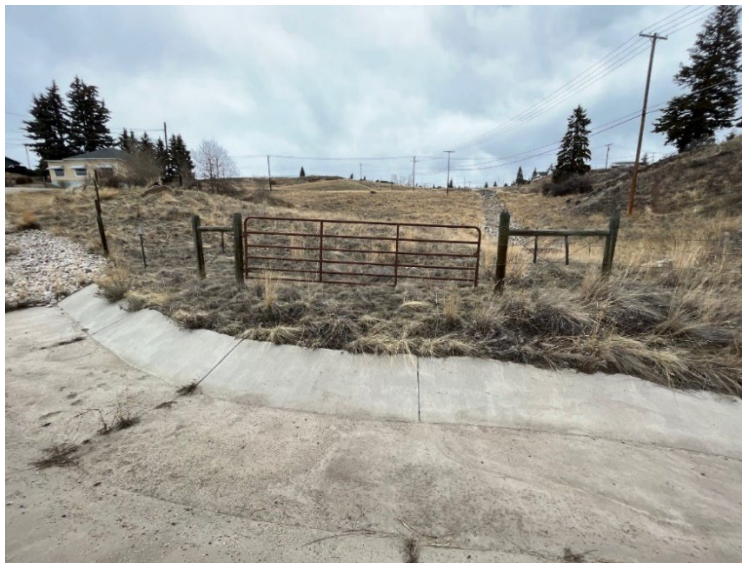
A preliminary site evaluation was conducted during development of this sampling plan to inspect current site conditions and identify focus areas for further investigation. Photograph 7 through Photograph 9 show current site conditions. The investigation found the site to have good vegetation establishment with undesirable vegetation and weeds throughout the whole site. Buffalo Gulch channel is located on the east side of the site. No samples will be collected from the channel.

Photograph 7: Overview of Buffalo Ditch looking north.

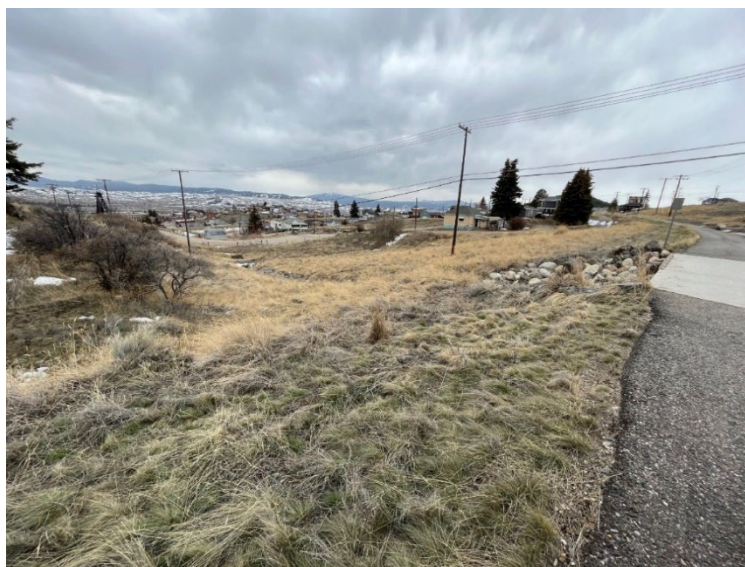
Photograph 8: Overview of Buffalo Ditch looking southwest.

A gravel and cement-lined channel (Buffalo Gulch channel) runs along the southwest and south borders of the site. A storm water inlet is located in the cemented line portion of the channel. BSB maintenance crews completed seeding along the north portion of the site, and vegetation is well established.

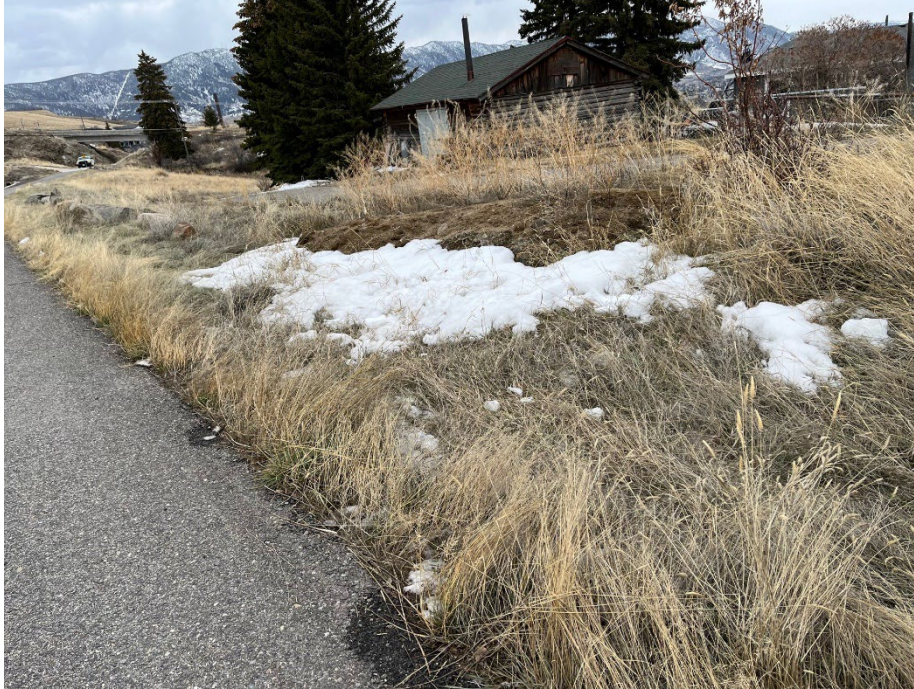
Photograph 9. Dirt pile on the northwest of site.

An unknown barren dirt pile was observed during the evaluation. A sample location has been proposed for this area.
