Corrosion Engineering Science and Technology

Insights into crystallographic and topographic characteristics of local corrosion attack on zinc

Xiangli Zhong, Philip J. Withers, Yi Guo, Xiaorong Zhou & Ivan S. Cole

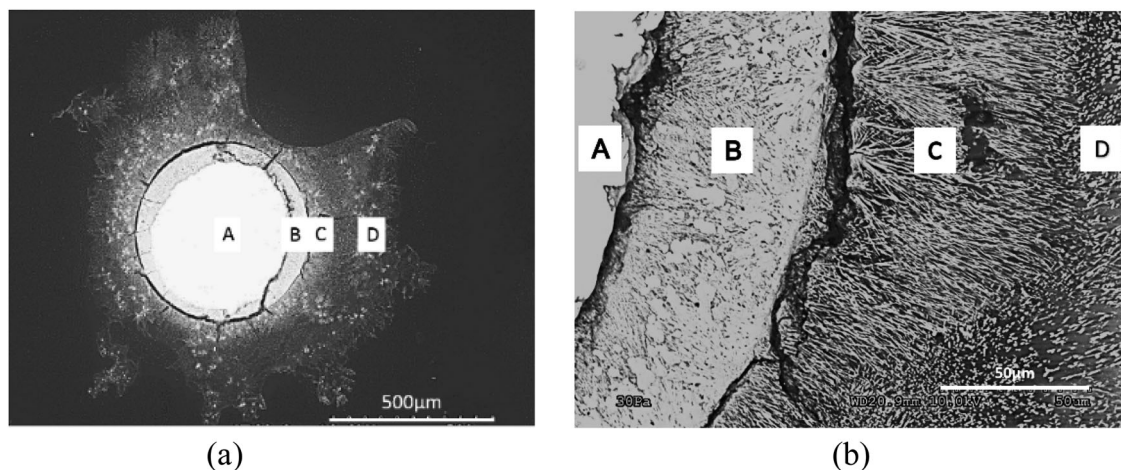
Figure 1. SEM image of the Zn wire after exposure in natural seawater under potentiostatic polarisation at 260 mV positive to the OCP (-1.26 V (SCE)) for 24 h. (a) the remaining uncorroded Zinc wire (A), the attacked layer (B), a dense layer (C) and a porous layer (D). (b) a higher magnification region of (a).

After exposure in natural seawater under potentiostatic polarisation at 260 mV positive to the OCP (-1.26 V (SCE)) for 24 h, it can be seen from the SEM image in Figure 1 that there has been very extensive corrosion of the 0.5mm diameter wire. The extent of corrosion varies greatly, extending to 1-2mm laterally over the cross-section with the corrosion product extending between 0.1 and 0.4 mm from the original wire diameter. In common with previous observations, the SEM imaging suggests that the oxide contains 3 distinct layers. An outer layer (D) of loose flaky and porous oxide, an intermediate layer of relatively dense oxide (C) and within the boundary of the original wire a layer of dense oxide containing significant voids (B). Throughout the paper we will refer to these from the outside in as: the porous layer, the dense layer, and the attacked layer. In Figure 1, the porous layer (D) is shadowy and variable in intensity, the dense oxide (C) is somewhat brighter and the attacked layer (B) brightest of all. This may reflect changes in density as discussed later. The extents and porosities as determined by analysis of SEM image (Figure 1) of the various layers are summarised in Table 1.

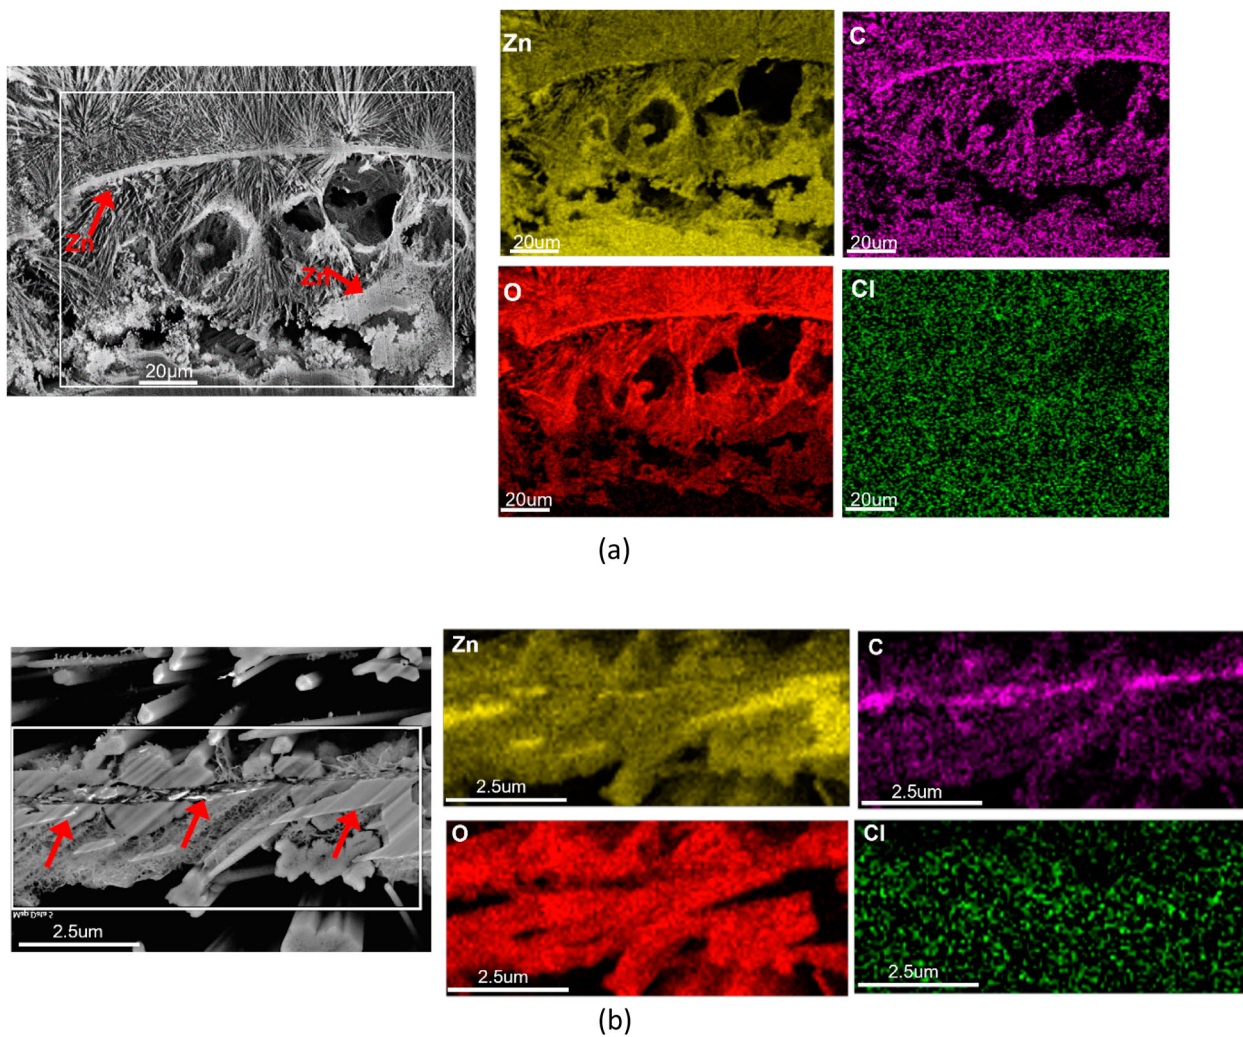
Figure 2. SEM and EDX of the two inner corrosion product layers: (a) the attacked layer contains large voids and has some remnant zinc (red arrows) embedded in the corrosion products; (b) higher magnification of the boundary between the dense and attacked layers showing crystalline oxide and remnant Zn (red arrows).

Closer analysis of the interfacial region between the porous and attacked layer is shown in Figure 2 and Figure 3. A thin layer rich in C and O is evident on the outer surface of the zinc wire (Figure 2). It is evident in Figure 3 that there are voids in the attacked layer and that it contains regions of zinc that are decohered from the wire. Oxides in both the attacked and dense layers are crystalline. Both oxide layers are rich in zinc, oxide, and carbon, but the attacked layer has a higher Zn content whereas the dense layer has higher C and O contents (Figure 3). A small amount of Cl was detected in both layers, but the attacked layer has the higher Cl concentration. From Figures 2 and Figure 3 it is evident that larger voids are present in the attacked layer compared to the dense layer. Further, Figure 2 shows remnant metallic Zn in the regions immediately beneath the perimeter of the original zinc wire (as indicated by the red arrows in Figure 2).

The remnant Zn embedded in the corrosion products in the region immediately beneath the initial zinc wire surface (Figure 2) probably arises due to the cumulative effect of the differential corrosion attack and corrosion product formation from the initial corrosion process onwards. The Zn surface may initially react with the environment to create zinc oxide, zinc hydroxide, simonkolleite or zinc hydroxy carbonate [2]:

The corrosion product Zn(OH)_2 , $\text{Zn}_5(\text{OH})_8\text{Cl}_2\cdot\text{H}_2\text{O}$, and $\text{Zn}_4\text{CO}_3(\text{OH})_6\cdot\text{H}_2\text{O}$ formed on the surface may be beneficial to the corrosion resistance of the zinc [29,30], as indicated in Figure 2. Higher O and C concentrations were detected at the outer most surface of the zinc wire (Figure 2a,b). This indicates a dense thin layer of oxide/hydroxide or carbonate formed at the surface during the initial corrosion process. The dense hydroxide/oxide and carbonate may protect the zinc so that it is not attacked as quickly as other areas where the dense layer has not formed or has been broken (Figure 2c). As the corrosion progress, the corrosive media

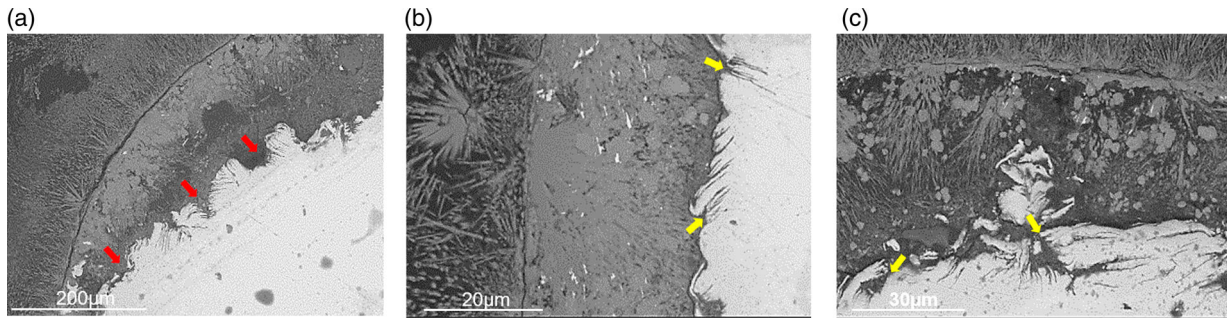
Figure 4. SEM micrographs of the metallic zinc-corrosion product interface: (a) relatively wide 'pits' or local areas of attack (red arrows), and (b)–(c) very narrow corrosion penetration extending 5–20 μm in depth (yellow arrows) represented by the striations in Figure 5.

The interface between the attacked layer and the corroding metal surface is shown in Figure 4 and is characterised by a number of features including:

- Large and relatively wide 'pits', ranging from 5 to $30\mu\text{m}$ with aspect ratios up to 1.
- Very narrow and deep 'pits' (which appear as striations in plane view, as shown later) from 5 to $20\mu\text{m}$ in-depth which are very close to each other. Further, these narrow 'pits' may occur at the bottom of the wide 'pits'.

The morphology of these narrow and deep corrosion features, i.e. narrow 'pits', observed in Figure 4 are more easily discerned from the surface of the zinc once cleaned of corrosion products as shown in Figure 5. The striated domains (magnified inset) exemplifies the crystallographic nature of corrosion attack that reflects the underlying grain structure.

Thus, the wide ‘pits’ (Figure 4) might be formed as the result of increased corrosion rate on non-basal planes for favourably oriented grains. This is clearly shown in Figure 7b where a wide pit is formed between grains 2 and 5 due to faster dissolution of grains 3 and 4.

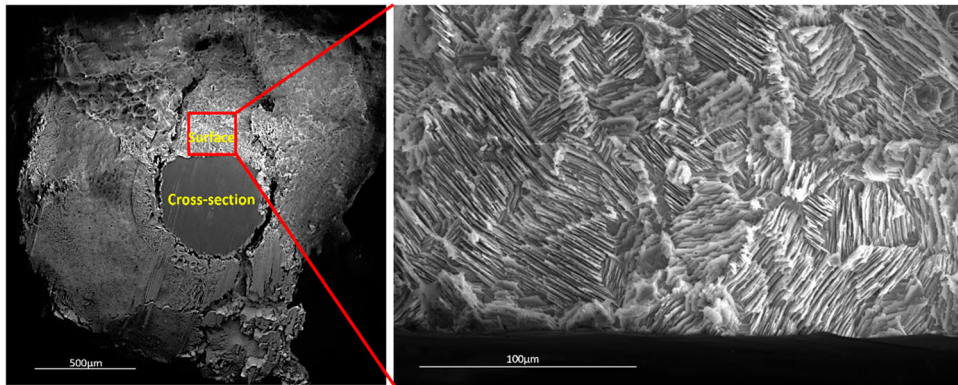
Figure 5. Topography of the attacked Zn wire surface after removal of corrosion products (surface is 38° to SEM electron column). The striated domain directions are determined by the orientation of the underlying grains.

As summarised in the Results section, in addition to the wide ‘pits’, very narrow and deep ‘pits’, i.e. striations, were observed on non-basal planes. The striations have formed as a result of preferential dissolution of non-basal planes. Figure 7c illustrates the corrosion developed on surfaces with basal and non-basal planes where striations are developed on non-basal planes whilst the basal plane is relatively flat. On non-basal planes, the lateral propagation of corrosion encounters more resistance for (0001). Consequently, the less attacked zinc volumes are left behind as plates and the more attacked volumes appear as grooves, resulting in striations on the corroding surface. As a result the surface striations lie on the trace of the (0001) with the surface. This observation agrees with Abayarathna et al. [5] who also found the corrosion attack is least on {0001}. As for a randomly textured crystalline aggregate the probability of basal planes facing the corrosion media is less than that of non-basal planes in HCP metals, most of the corroded surface of the Zn wire exhibit striations (Figure 5b). The striations reflect the underlying grain orientation.

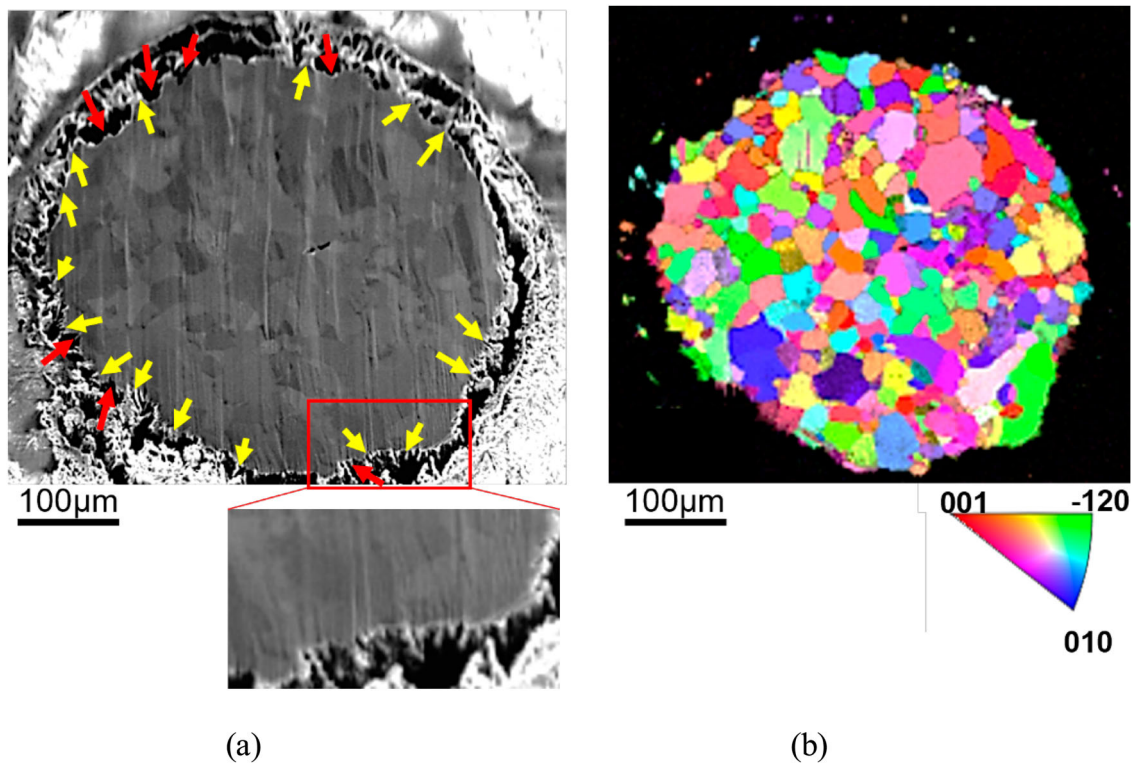
Figure 6. (a) SE image and (b) EBSD inverse pole figure map of a cross-section of the corroded wire showing how the striations relate to the underlying crystallographic orientations. Some grains show more pronounced striations (yellow arrows) compared to others; wide 'pits' are also evident (red arrows). The EBSD map also shows remnant Zn metal in the regions immediately beneath the original Zn wire surface.

sectioning with EBSD. Corrosion features on the basal plane $\{0001\}$ ($\text{hkl}\{001\}$), the prismatic plane I $\{10-10\}$ ($\text{hkl}\{100\}$), the prismatic plane II $\{11-20\}$ ($\text{hkl}\{110\}$), the pyramidal plane I $\{10-11\}$ ($\text{hkl}\{101\}$) and the pyramidal

plane II $\{11-22\}$ ($\text{hkl}\{112\}$) were characterised, as shown in Figure 6 and Figure 7.

From this work it can be observed that the striation-like corrosion features (yellow arrows in Figure 6) are more

pronounced for some grains than others. In fact some grains appear more resistant and others appear less resistant. Wide ‘pits’ (Red arrow in Figure 6) were also observed on some grains along the circumference of the wire corrosion front.

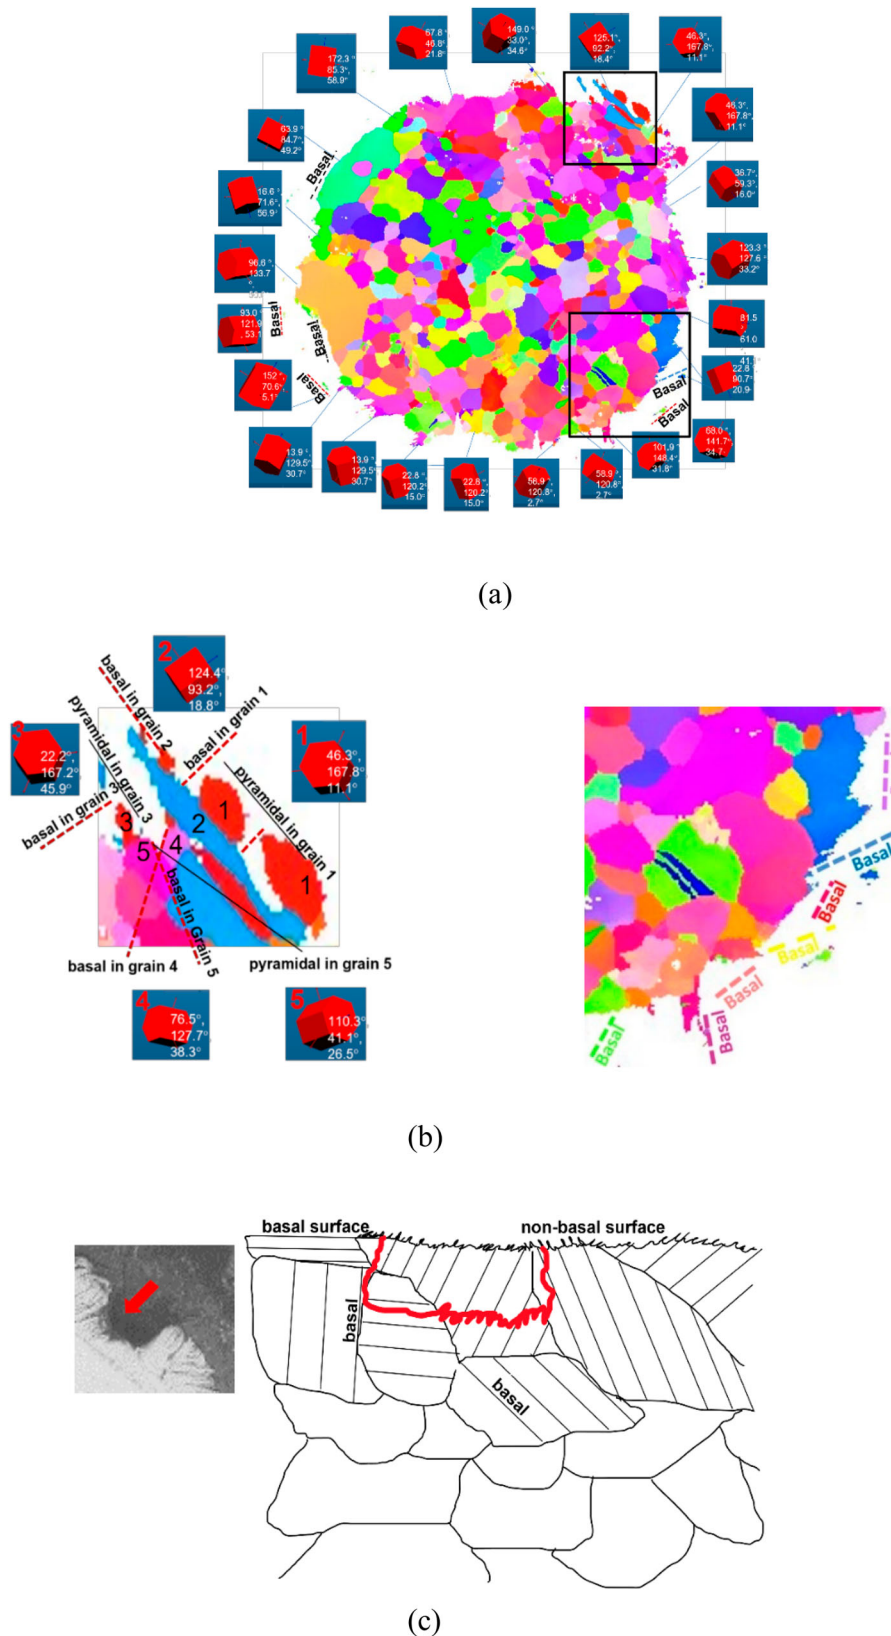
Figure 7. Analysis of crystallographic orientation of the corrosion attack where red dashed lines indicate the trace of basal planes and black lines the prismatic planes. (a) EBSD orientation analysis for all the exposed grains showing the relation between corrosion and orientation, (b) Trace analysis reveals that corrosion develops preferentially on non-basal planes leaving ‘edges/blades’ lying perpendicular to [0001], (c) schematic representation showing preferential surface attack, as well as the formation of deep pits (red lines) similar to that shown inset (region from Figure 4a).

Figure 7a shows a typical example of an EBSD map extracted from the serial cross-sectional EBSD analysis carried out for successive sections along the length of the wire. The corrosion features, namely the wide ‘pits’ and striations, were matched with specific planes, i.e. the basal planes, prismatic planes and pyramidal

planes where the red dashed lines show the orientation of the basal planes. Figure 7a shows that grain surfaces oriented with the basal planes facing the corrosion media tend to appear relatively flat compared to other grain orientations. Corrosion striations are most commonly observed on grains having a non-basal plane facing the corrosion media. Figure 7b shows a higher magnification trace analysis confirming that the basal planes are the least attacked and the striation-like topographical appearance is the result of preferential attack on higher index planes.

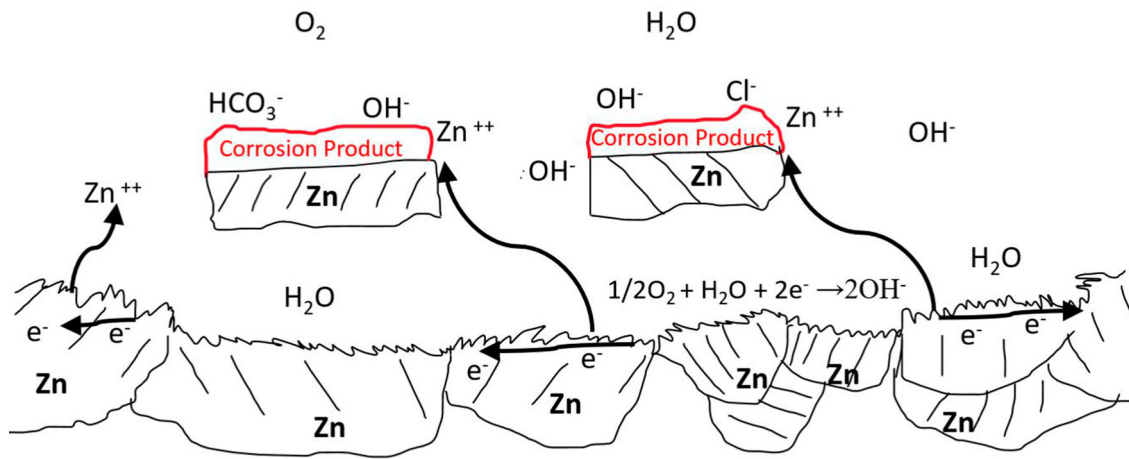
Figure 8. Schematic representation of the corrosion process resulting in remnant Zn.

can penetrate the protective corrosion product where its thickness is less or where it can penetrate through cracks in the initial protective dense thin layer, hence dissolving the zinc metal beneath the cracked thin protective layer. Figure 2a shows that the remnant Zn lying at the initial Zn wire surface typically has its basal plane facing the corrosive media. We anticipate it is the combined result of (1) the intact initial protection layer formed on the surface, (2) the difficulty of dissolution on the surface grains with basal planes facing outwards [7], and (3) micro-galvanic cells formed between the remanent grains and surrounding grains galvanically protecting the remnant grains [31]. As the corrosion propagates the surrounding grains are consumed but leaving the grains having basal planes facing the corrosion media (Figure 8). Nevertheless, the hypothesis of the micro-galvanic protection needs more in-depth investigation.
