**National Center for Transportation
Infrastructure Durability & Life-Extension**

Project ID: 2020-UCD-01

**Fiber Reinforced Polymer (FRP) Seismic Retrofit of Reinforced
Concrete Bridge Columns Vulnerable to Long-Duration Subduction
Zone Earthquakes**

May 2022

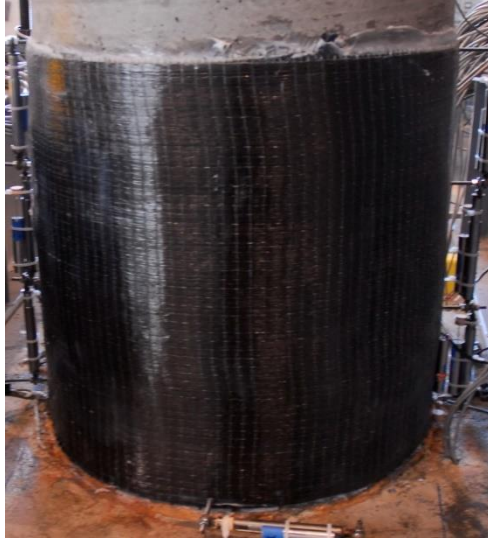
Figure 3.4: CFRP Jacket Before Testing for C(CFRP)-4.0-#7(1.3)-0.05

Several months after column construction, CFRP jackets were installed by a professional team. Installation began with roughening of the concrete surface, using a grinder, to facilitate bond of epoxy to concrete. Dust from roughening was removed from the column using acetone. The CFRP wrap was cut to lengths approximately equal to one circumference of the column plus 12-inches. The epoxy was mixed in batches due to a 1-hour pot life at 70°F (21°C). After the first epoxy batch was mixed, an epoxy primer was applied to the columns using a nap roller. CFRP sheets were hand saturated using plastic trowels. Care was taken to ensure full fiber saturation without saturation so excessive that the sheet would settle once on the column. After saturating the fibers, the sheets were wrapped around the column and the plastic hand trowels were used to remove any entrapped air and excess saturate. The sheet had a lap length of 12-inches, with the lap intended to provide adequate bond. The seams had additional epoxy applied per manufacturer specifications. After the first layer, additional layers were applied with the start of the new layer on the opposite side of the column as the end of the previous layer, such that all seams were offset. After all 5 layers were applied, an epoxy paste was applied as an outer coating, and the columns were given at least 72 hours to cure before testing of the first column. A finished jacket is shown in Figure 3.4. Lacking of bulging in the jacket suggests that epoxy was appropriately applied, with bonding between layers.

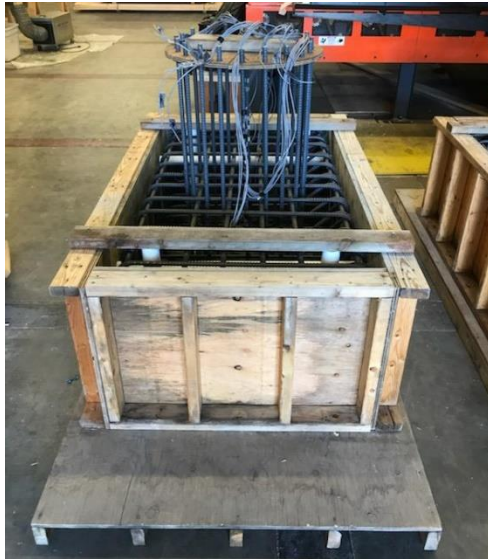
Figure 3.5: Footing Construction

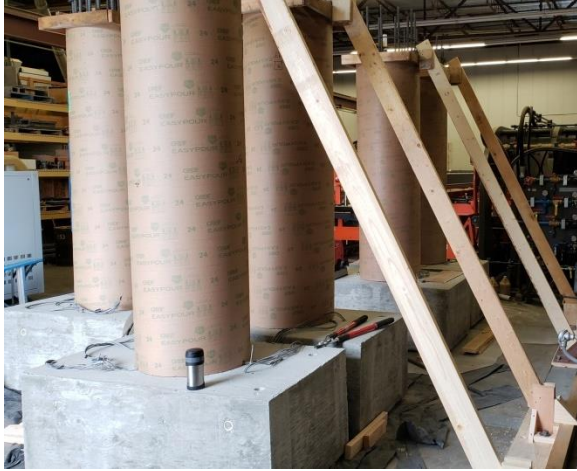
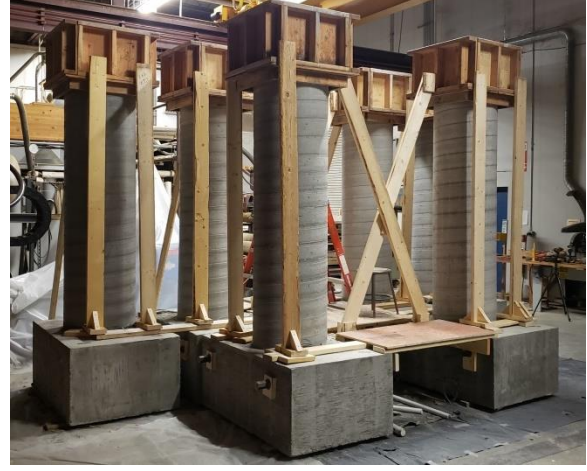
Figure 3.6: Construction: a) Bracing for Column Concrete Pour, and b) Bracing for Top Block Concrete Pour

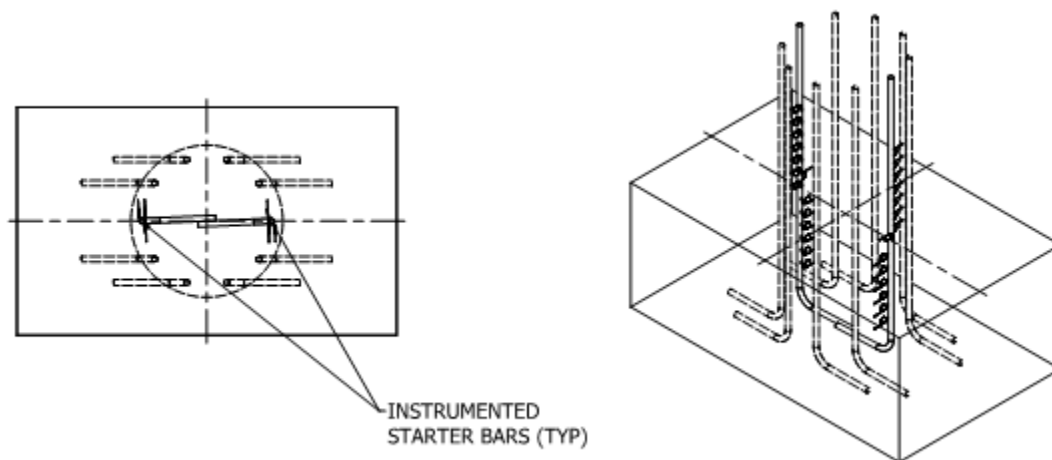
Figure 3.10: Instrumented Starter Bar Layout

penetration into the columns and footings. Installation of each strain gauge required removal of one bar deformation. Reinforcement bar deformation removal was limited to the surface area required to adhere a gauge to the bar, which was typically one-half of the circumferential deformation. The exception was full circumferential removal of the bar deformation at a location of ½-inch above the column-footing interface to facilitate the additional installation of a redundant gauge on the opposing side. Strain gauge wires were arranged to exit from the top of the footing.

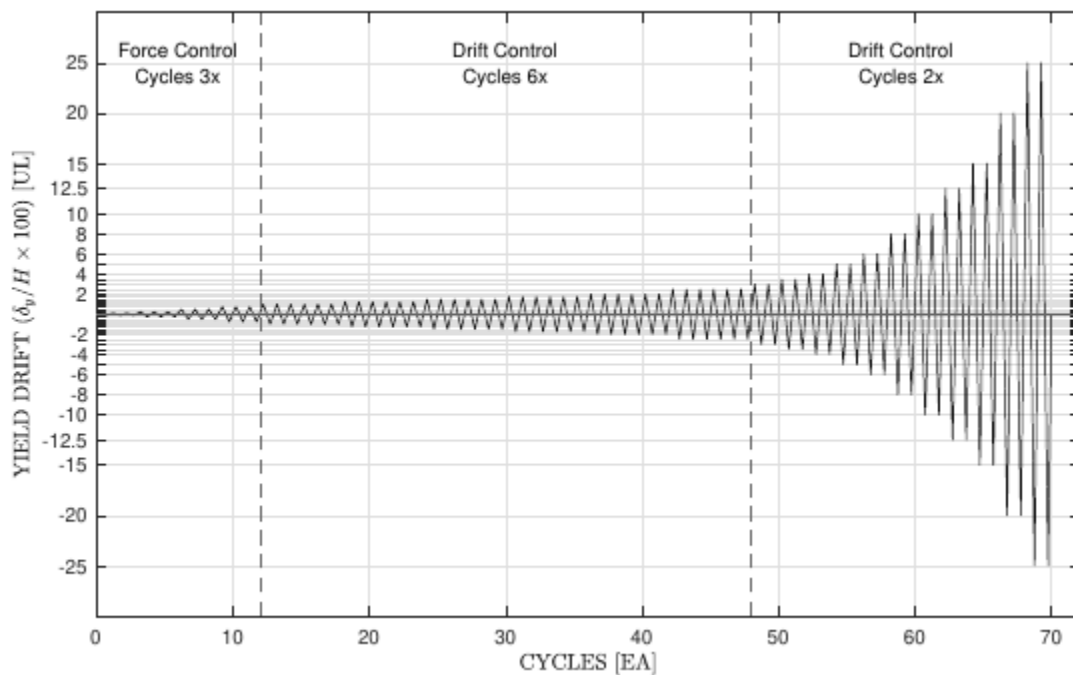
Figure 3.14: Standard Cyclic Loading Protocol

C(CFRP)-4.0-#7(1.3)-0.05 used a modification of the reversed cyclic protocol that had twice the number of cycles at each increment. Consistent with the steel jacketed columns tested by McGuinness (2021), the yield drift was taken as 0.4% for C(S)-4.0-#7(1.3)-0.05, C(S)-4.0-#5(1.4)-0.05, and C(S)-4.0-#7(1.3)-0.05-2X and 0.5% for C(S)-4.0-#7(2.7)-0.05 and C(S)-4.0-#7(1.3)-0.15. C(S)-4.0-#7(1.3)-0.05-EQ was tested using an earthquake response history protocol that consisted of a main-shock and aftershock, as shown in Figure 3.36 with values provided in Table 3.6 and 3.7, respectively. For displacement-controlled cycles, the drift used to control the test was corrected to account for footing sliding and rotation.

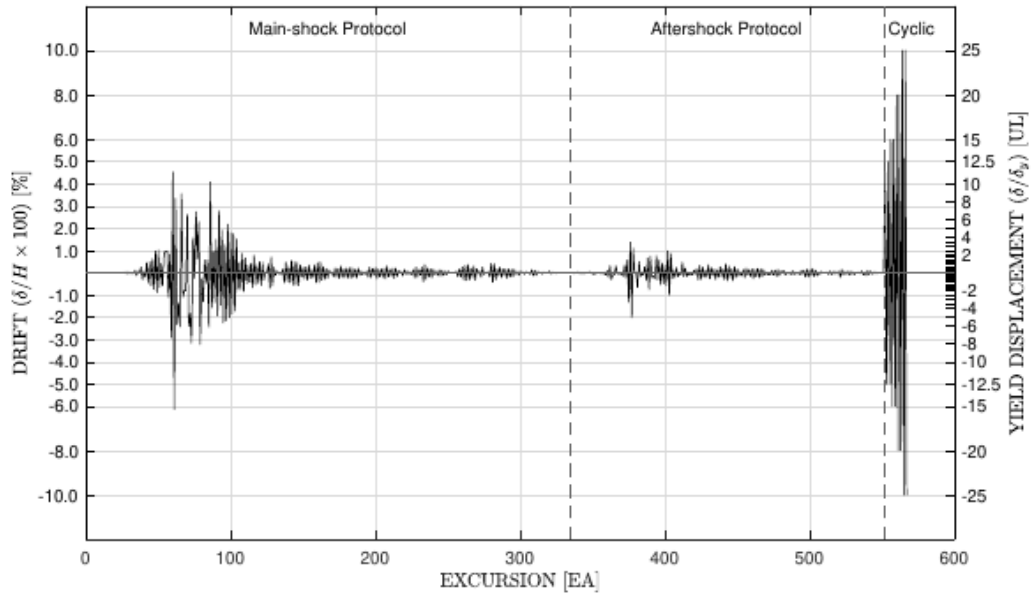
Figure 3.15: Earthquake Loading Protocol

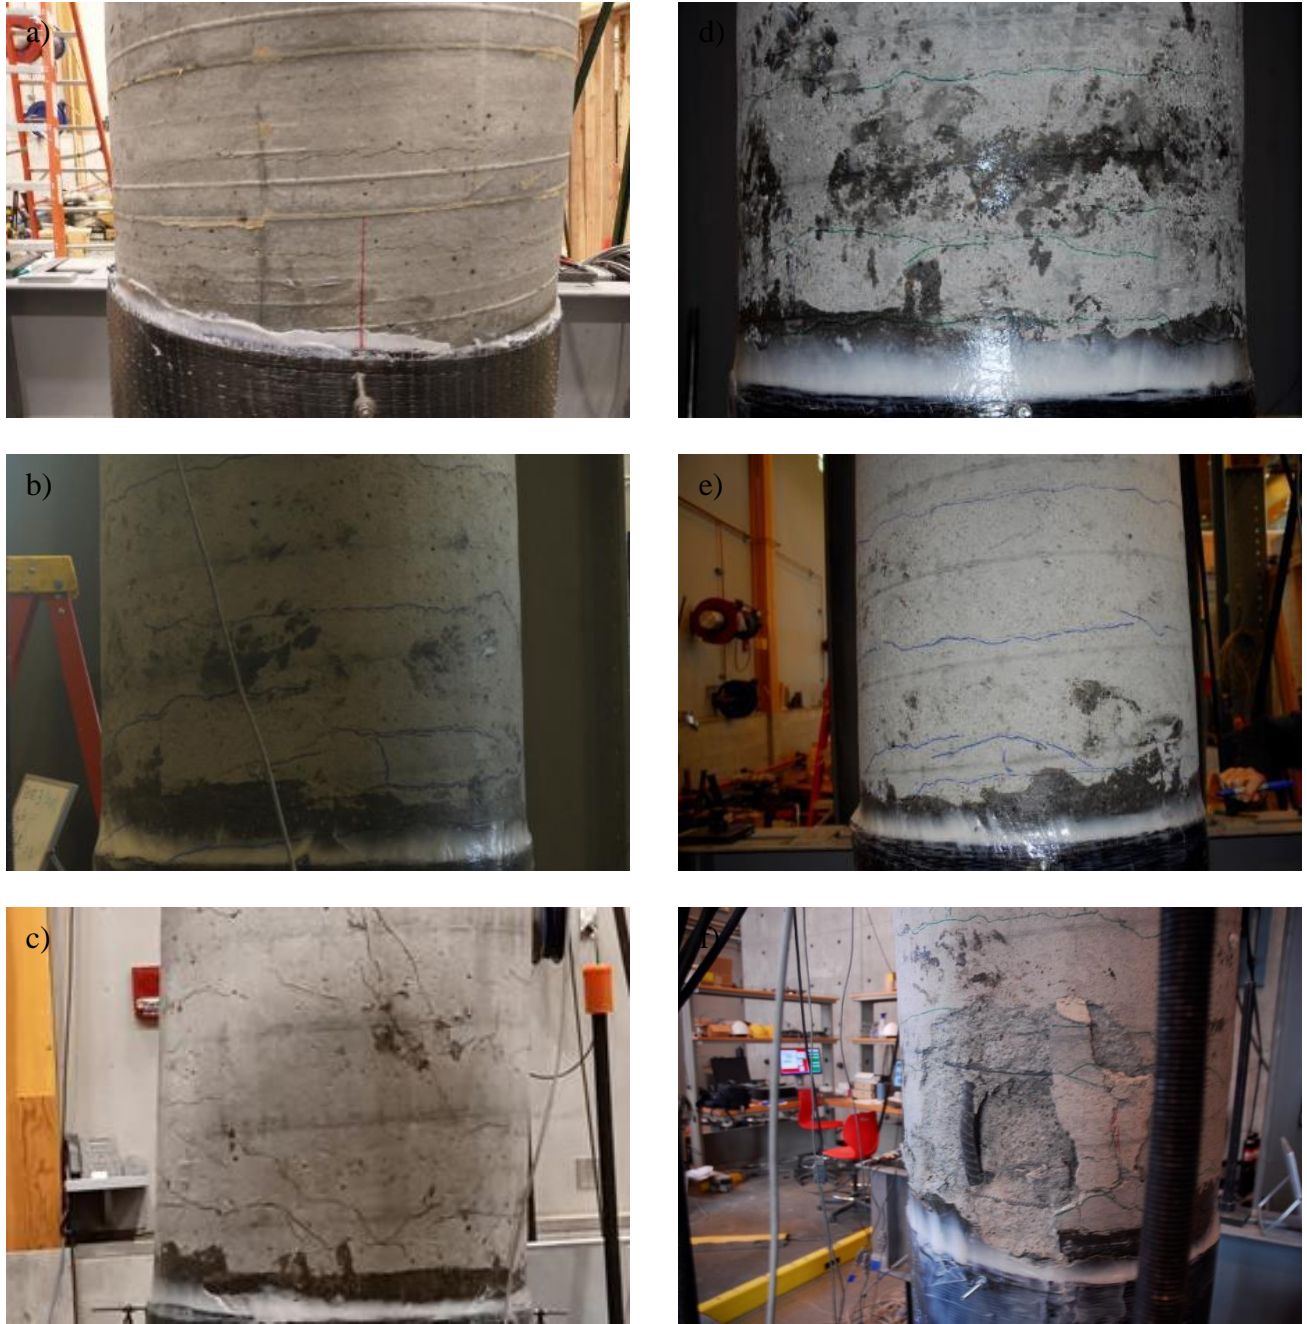
Figure 3.21. Concrete Damage Above Jacket at $15\delta/\delta_y$ for: a) C(CFRP)-4.0-#7(1.3)-0.05, b) C(CFRP)-4.0-#5(1.4)-0.05, c) C(CFRP)-4.0-#7(2.7)-0.05, d) C(CFRP)-4.0-#7(1.3)-0.05-EQ, e) C(CFRP)-4.0-#7(1.3)-0.05-2X, and f) C(CFRP)-4.0-#7(1.3)-0.15

Photos that show damage at $4 \delta/\delta_y$, $8 \delta/\delta_y$, $15 \delta/\delta_y$, $20 \delta/\delta_y$, and the completion of testing are provided in Figure 3.16 and Figure 3.17, Figure 3.18 and Figure 3.19, Figure 3.20 and Figure 3.21, Figure 3.22 and Figure 3.23, and Figure 3.24 and Figure 3.25, respectively. Concrete crushing was not observed within the jacketed region, indicating that the jackets adequately confined the concrete. Damage generally concentrated at the top of the footing in the vicinity of the column, with spalling observed in the footing. Cracking was observed above the jacket. Strength degradation was associated with fracture of longitudinal reinforcement, which is described in more detail in Section 3.2.1.2, as spalling of concrete and longitudinal

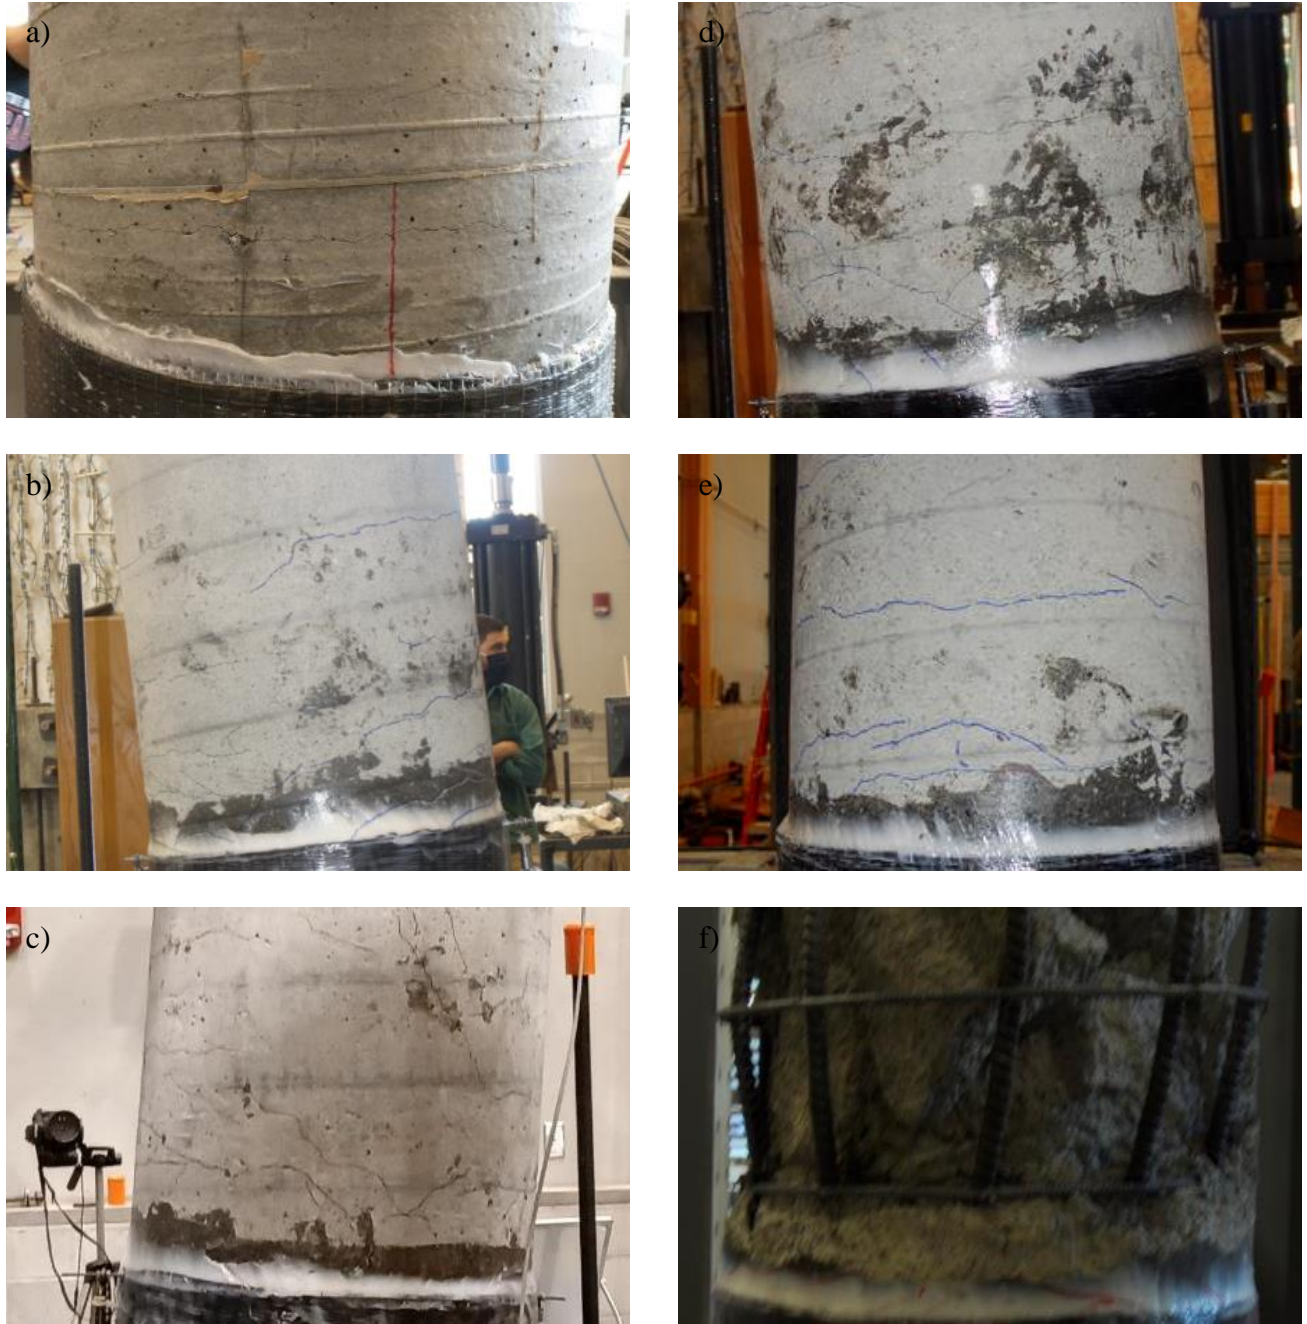
Figure 3.23. Concrete Damage Above Jacket at $20\delta/\delta_y$ (at $15\delta/\delta_y$ for C(CFRP)-4.0-#7(1.3)-0.15) for: a) C(CFRP)-4.0-#7(1.3)-0.05, b) C(CFRP)-4.0-#5(1.4)-0.05, c) C(CFRP)-4.0-#7(2.7)-0.05, d) C(CFRP)-4.0-#7(1.3)-0.05-EQ, e) C(CFRP)-4.0-#7(1.3)-0.05-2X, and f) C(CFRP)-4.0-#7(1.3)-0.15

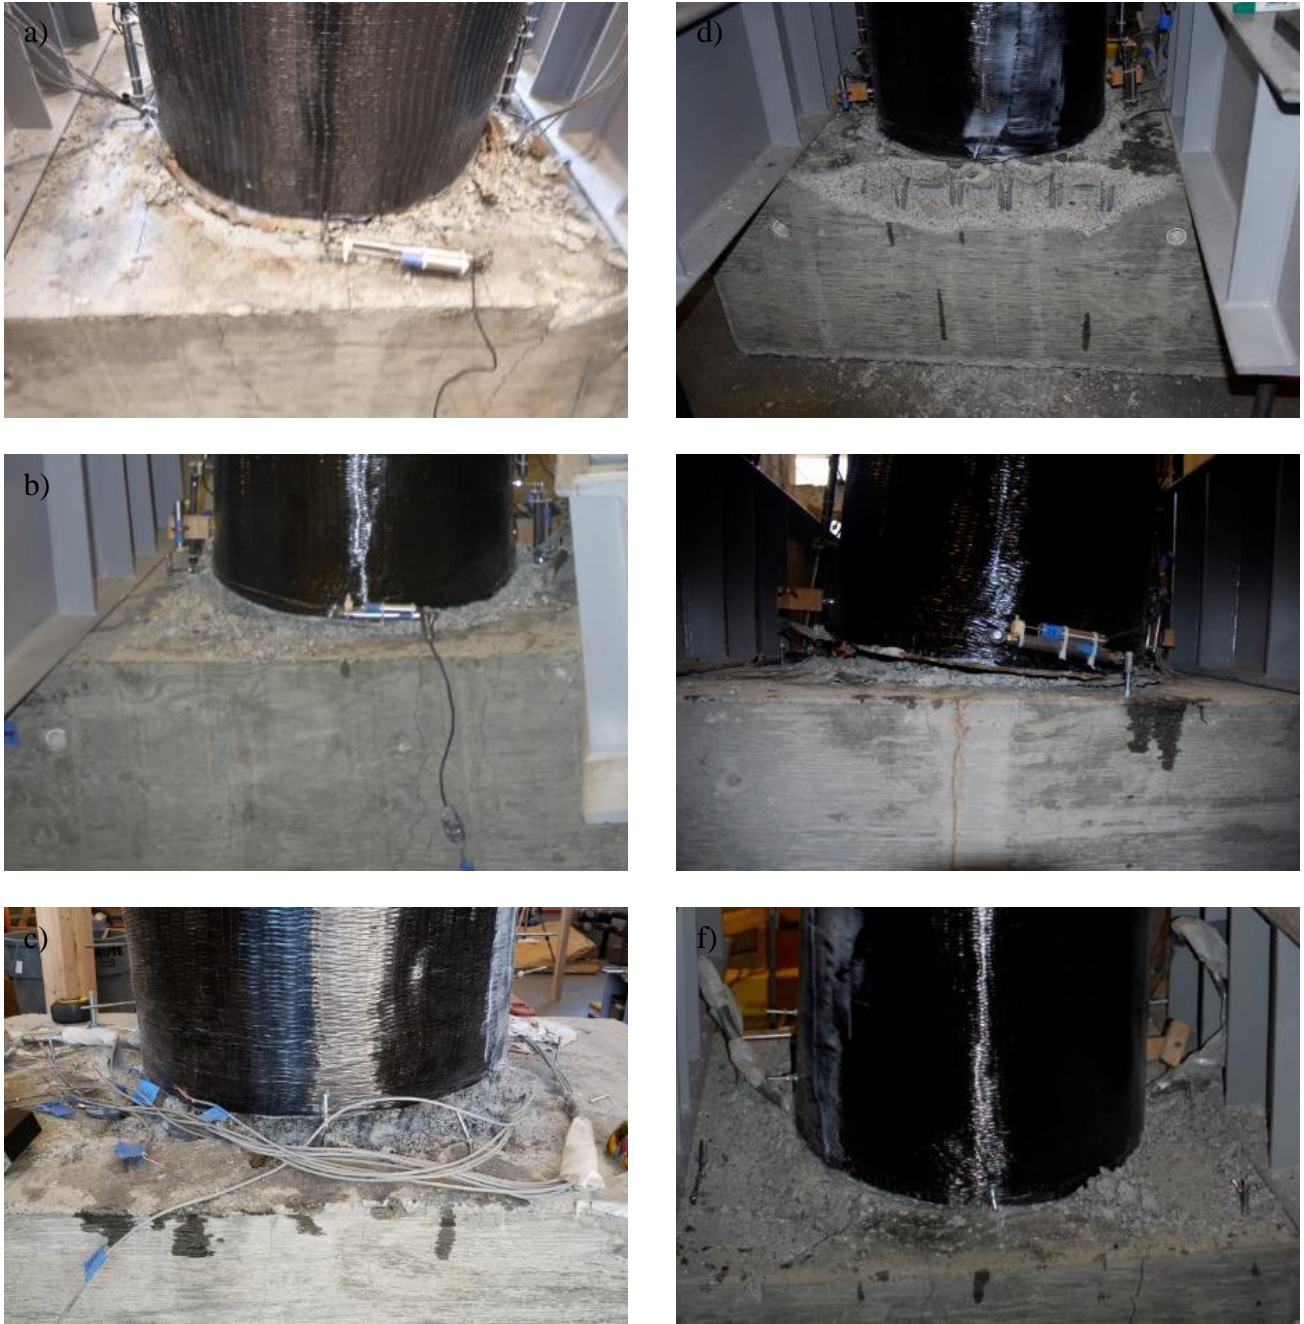
Figure 3.24. Concrete Damage at Base at Completion of Testing for: a) C(CFRP)-4.0-#7(1.3)-0.05, b) C(CFRP)-4.0-#5(1.4)-0.05, c) C(CFRP)-4.0-#7(2.7)-0.05, d) C(CFRP)-4.0-#7(1.3)-0.05-EQ, e) C(CFRP)-4.0-#7(1.3)-0.05-2X, and f) C(CFRP)-4.0-#7(1.3)-0.15

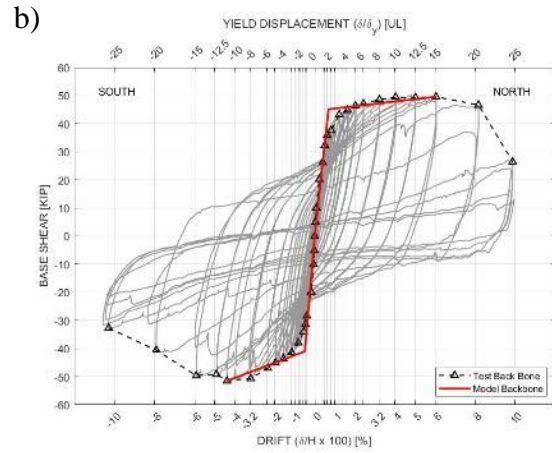
Figure 3.27. Backbone Model Fit for C(CFRP)-4.0-#7(1.3)-0.05: a) Base Shear, b) Effective Base Shear

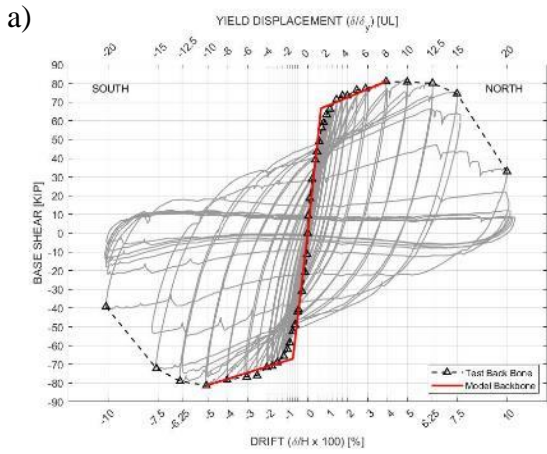
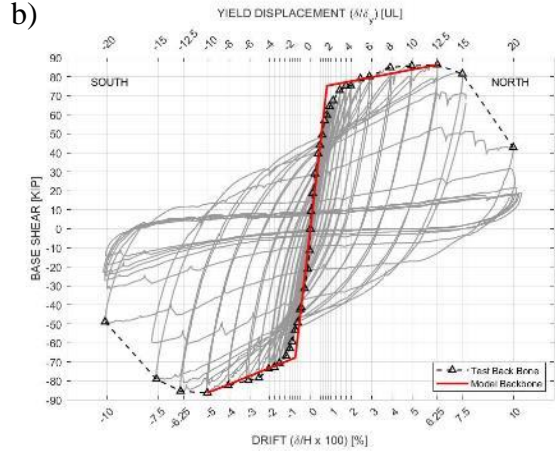
Figure 3.29. Backbone Model Fit for C(CFRP)-4.0-#7(2.7)-0.05: a) Base Shear, b) Effective Base Shear

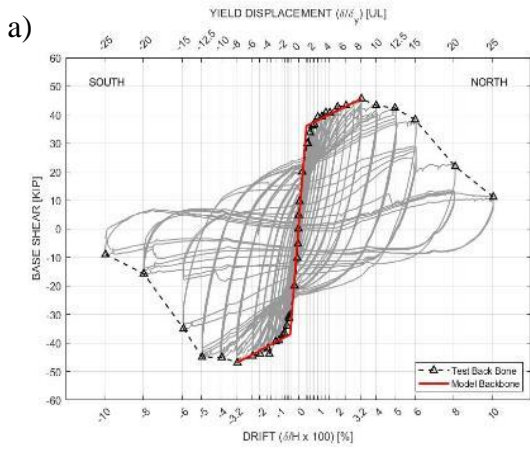
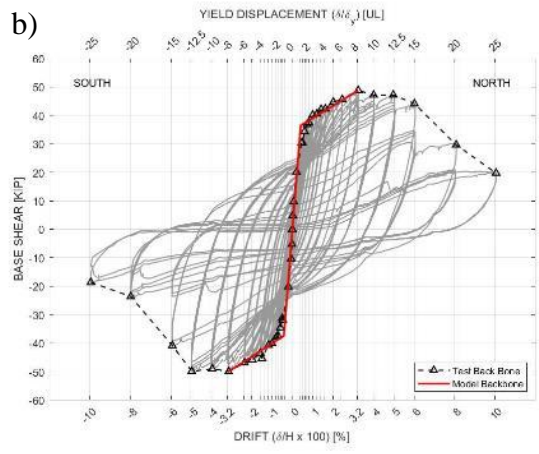
Figure 3.31. Backbone Model Fit for C(CFRP)-4.0-#7(1.3)-0.05-2X: a) Base Shear, b) Effective Base Shear

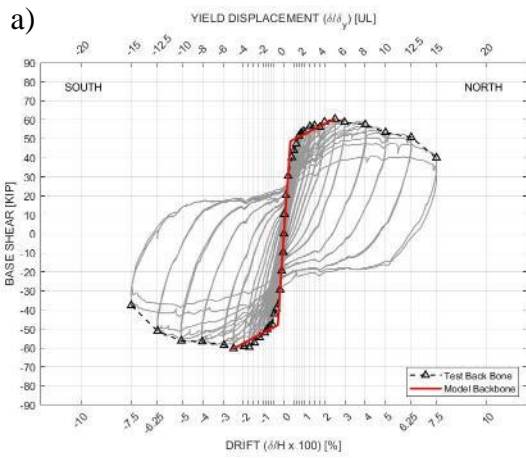
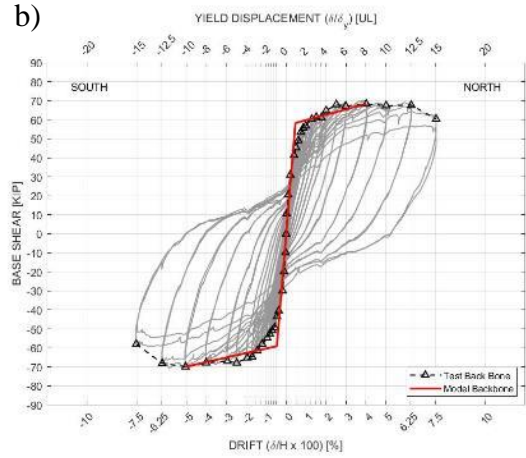
Figure 3.32. Backbone Model Fit for C(CFRP)-4.0-#7(1.3)-0.15: a) Base Shear, b) Effective Base Shear

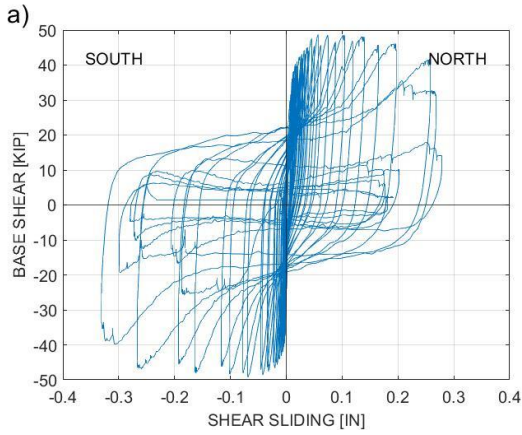
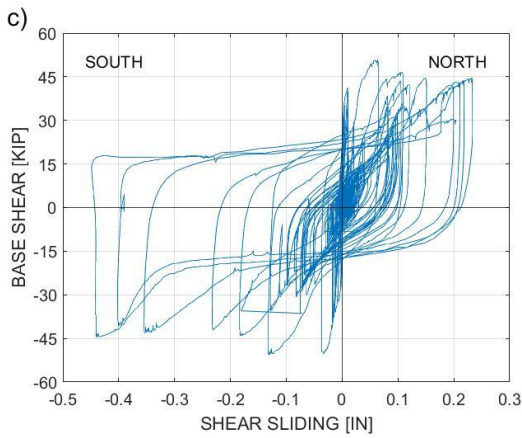
Figure 3.44. Shear Sliding: a) C(CFRP)-4.0-#5(1.4)-0.05, b) C(CFRP)-4.0-#7(2.7)-0.05, c) C(CFRP)-4.0-#7(1.3)-0.05-EQ, d) C(CFRP)-4.0-#7(1.3)-0.05-2X, e) C(CFRP)-4.0-#7(1.3)-0.15

Shear sliding and base twisting were determined using the horizontally oriented sensors spanning from the footing to the base of the column, with sensor locations shown in Figure 3.12. Plots of shear sliding and base twisting versus base shear are provided in Figure 3.43 and Figure 3.44, respectively, with clockwise and counter-clockwise indicating column twist direction relative to the footing. Data for C(CFRP)-4.0-#7(1.3)-0.05 were omitted due to sensor error. Included data for all columns were more limited at advanced deformation levels due to damage interfering with instrumentation. C(CFRP)-4.0-#7(2.7)-0.05 had the most shear sliding of any test, reaching almost 0.7-in of sliding in both directions. C(CFRP)-4.0-#7(1.3)-0.15 had the least shear sliding and base rotation, with less than 0.15-in of shear sliding in both directions and a maximum base twisting rotation of 0.0042 radians in the clockwise direction and 0.0000 radians in the counter clockwise direction. C(CFRP)-4.0-#5(1.4)-0.05, C(CFRP)-4.0-#7(2.7)-0.05, C(CFRP)-4.0-#7(1.3)-0.05-EQ, and C(CFRP)-4.0-#7(1.3)-0.05-2X had more shear sliding in the negative loading direction, while C(CFRP)-4.0-#7(1.3)-0.15 had more shear sliding in the positive loading direction. C(CFRP)-4.0-#7(1.3)-0.05-EQ had the most discrepancy in shear sliding in the positive and negative directions, with 1.92 times as much shear sliding in the negative direction than in the positive direction. This column had the most base rotation of any of the columns, with a maximum base twisting rotation of 0.094 radians in the clockwise direction and 0.033 radians in the counter clockwise direction. The twisting caused out-of-plane translation due to ratcheting, as described in Section 3.2.1.1.
