REVIEW / PRACA POGLĄDOWA

**PSEUDOTUMOR AS A COMPLICATION AFTER TOTAL
HIP REPLACEMENT**

Department of Traumatology and Orthopedics, Multidisciplinary Hospital in Inowrocław.
Acting head: Artur Szumlański, PhD

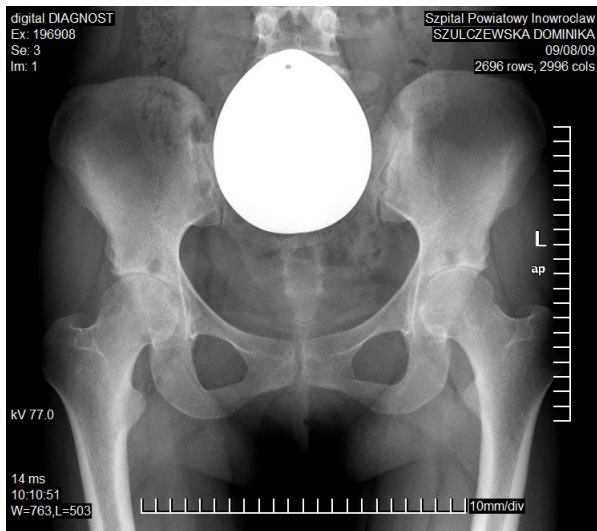
RTG

during childhood she was treated with glucocorticoids (was due to an illness of the respiratory system of an asthmatic). In the X-ray visible necrosis of the femoral head with joint space narrowing and a small collapse of the articular surface of the femoral head were observed.

Fig 1. Radiograph (date: 08.09.2009)

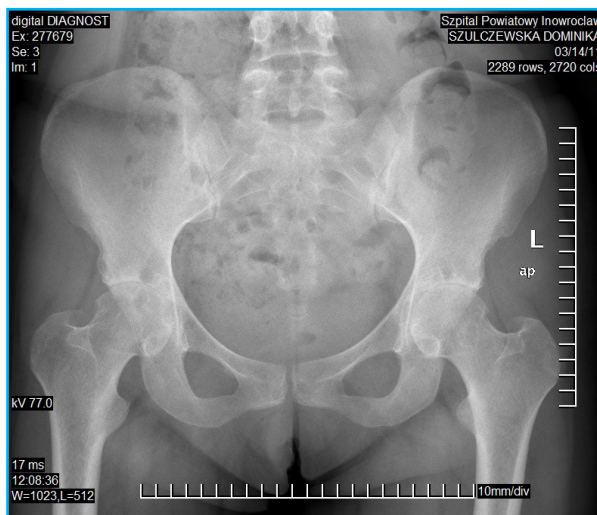
RTG

Fig 2. Radiograph (date: 14.03.2011)

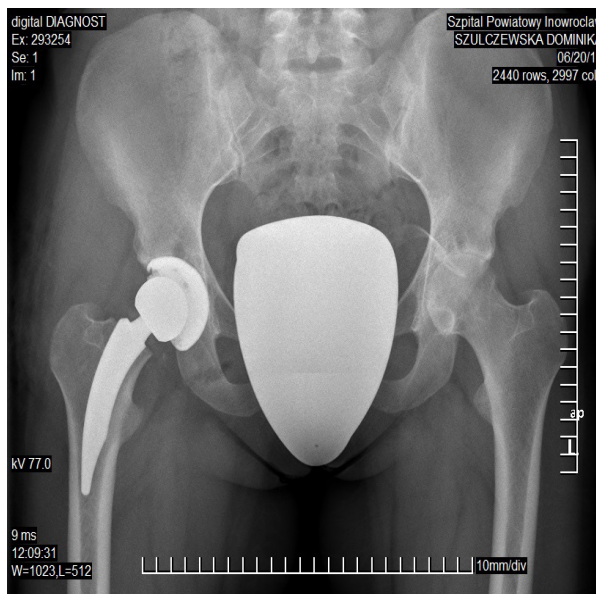
RTG

On 16.06.2011 operation of cementless total hip replacement was performed. Doctors came to cut bag hip arthritis and femoral hip. They implanted acetabular polyethylene and ink (press-fit 48mm). The procedure was performed with antibiotic prophylaxis and antithrombotic. The patient was discharged 8 days after surgery.

Fig 3. Radiograph (date: 20.06.2011)

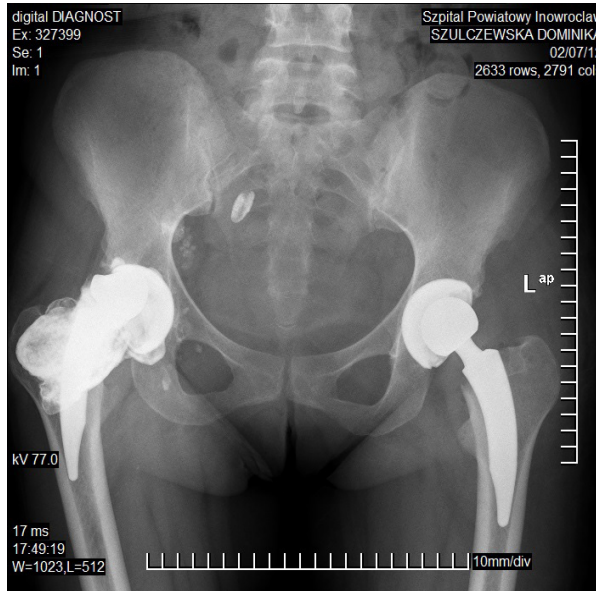
RTG

On 03.02.2012 the patient had metaphyseal hip arthroplasty with the use of Nano implants (left hip) performed.

Fig 4. Radiograph (date: 07.02.2012)

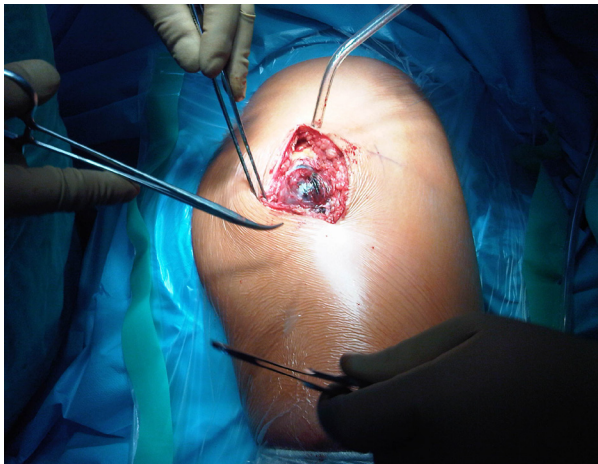
About 5 months after the surgery, the patient came to the clinic because of a palpable tumor on the posterior side of the right hip joint without pain. In the x-ray there are visible changes of a periprosthetic calcification. The right-hand side there is a destruction of the top edge of the acetabulum and the upper surface of the head. The patient was qualified for urgent surgery.

PHOTO
Fig 5. The course of the surgery to remove pseudotumor (1)
Tumor, of the size of the particles of fluid- filled black metal.

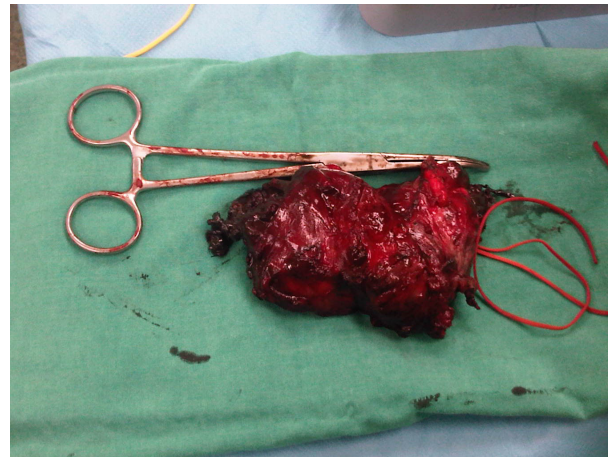
PHOTO
Fig 8. Tumor removed.
Soft tissue with features metallosis has been removed.

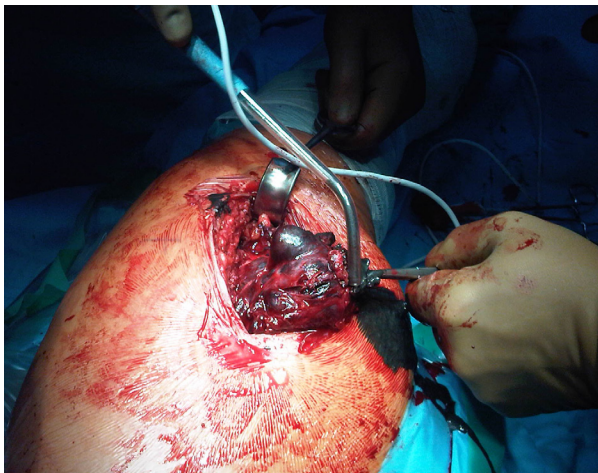
PHOTO
Fig 6. The course of the surgery to remove pseudotumor (2)

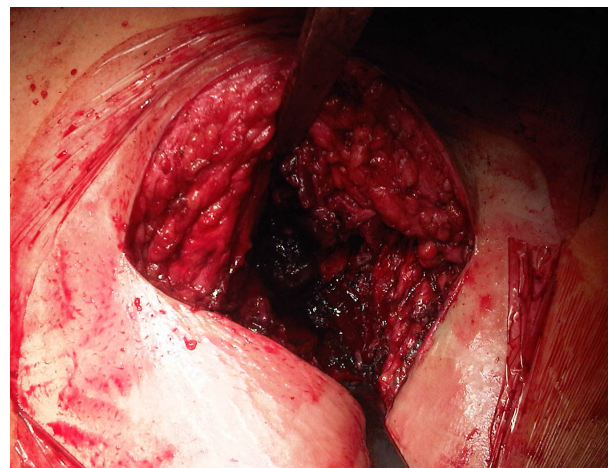
PHOTO
Fig 9. The course of the surgery to remove the pseudotumor (4). Then, the doctors came to implants and dentures were heads off to the equator along with part of the stem.

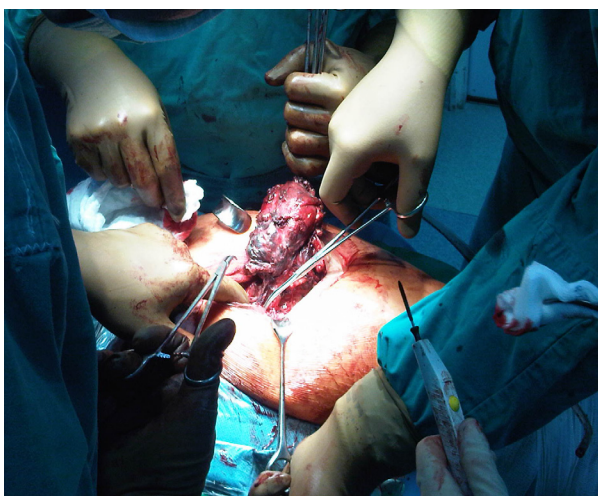
PHOTO
Fig 7. The course of the surgery to remove pseudotumor (3)
After isolation of the tumor and the tumor stalk ligation was completely removed.

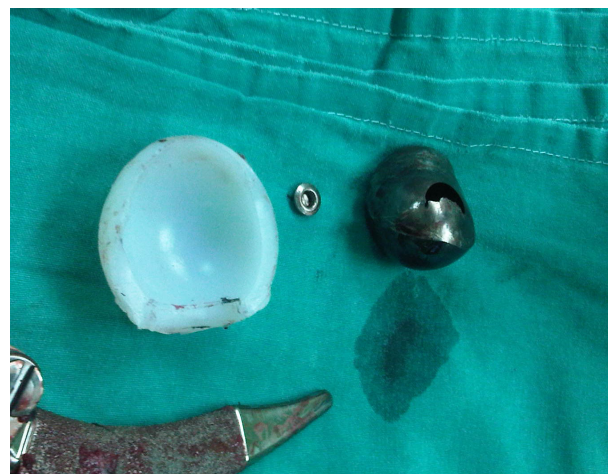
Pseudotumor trochanteric region after hip replacement is rarely described in the literature. The cause of the tumor is not clear. Metalosis that occurred in this case was established as a result of increased abrasion artificial elements on the border

PHOTO
Fig 10. Deleted item prosthesis (1)

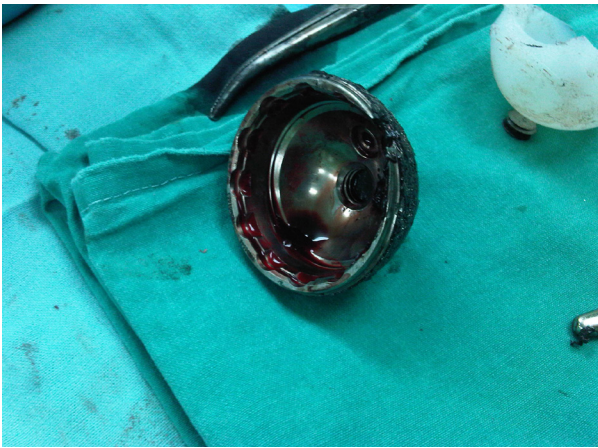
Fig 11. Deleted item prosthesis (2)

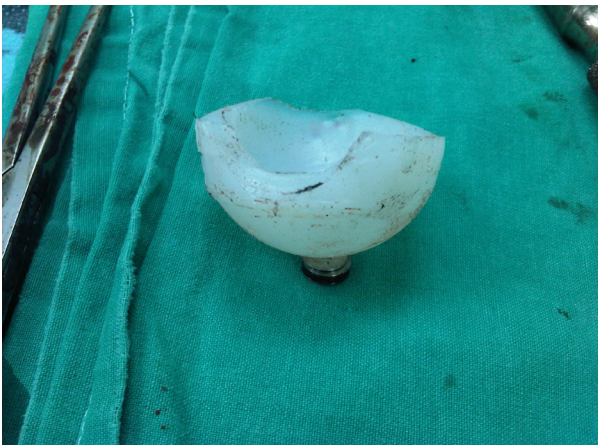
Fig 12. Deleted item prosthesis (3)

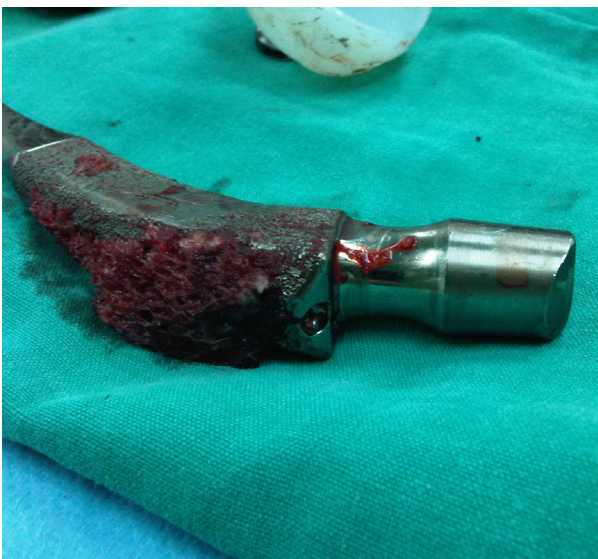
Fig 13. Deleted item prosthesis (4)

After removing the prosthesis implanted prosthesis metaphyseal Nanos for bigger size.

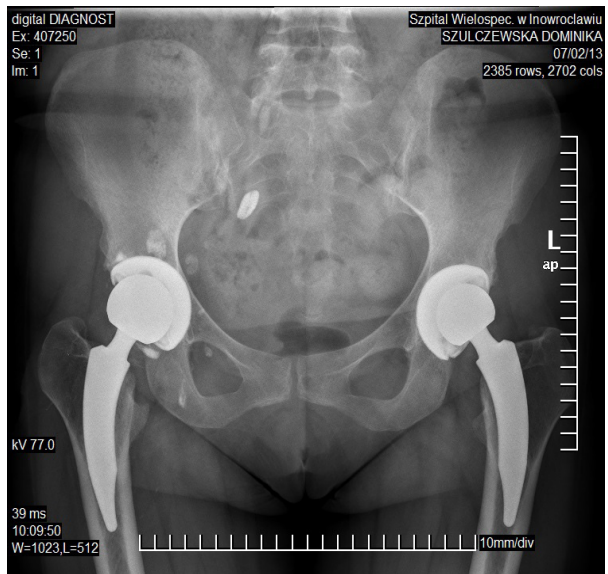
RTG

Fig 14. Radiograph (date: 02.07.2013)
