# Environmental problems of the Crimean coast territories

**Abstract.** The article describes the nature and degree of deformations of the coastal zone of the sea and coastal protection structures on the coast of the Kalamitsky Gulf of the Black Sea. In 2022, a team of authors made a visual survey of the coast on the territory of the Bakhchisarai district of the Republic of Crimea with a total length of 11.5 km. from the village of Beregovoe to the village of Uglovoye. As a result of the inspection, coast areas potentially dangerous for human health and life that are not suitable for normal use for recreational purposes were identified. Long-term field observations show that the creation of coastal protection in certain local areas, giving only a temporary positive effect for these areas, can have a very negative impact on neighboring and even remote areas; that is why the coastal protection issue should be solved at least on the scale of the coast of settlements, considering the conditions of a single system. When designing coastal protection measures, it is necessary to consider that separate protection of small areas of erodible coastal territories within a large area of the er

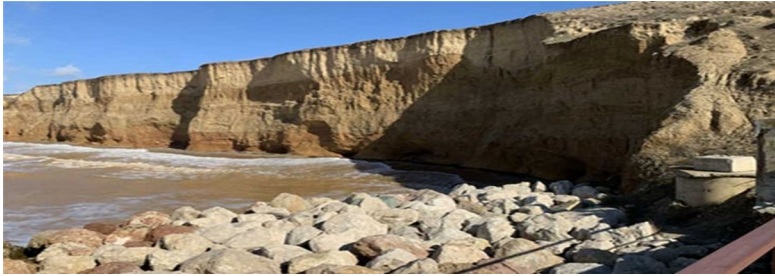
As a result of field observations in the northern part of the site (near the village of Beregovoe), potentially dangerous to human health and life areas of the coast were identified, where serious violations of the integrity of the slopes and the beach strip occurred, violating the environmentally safe conditions of their normal operation for recreational purposes.

**Fig. 1.** Abrasive-landslide bank to the north of the reconstruction site.

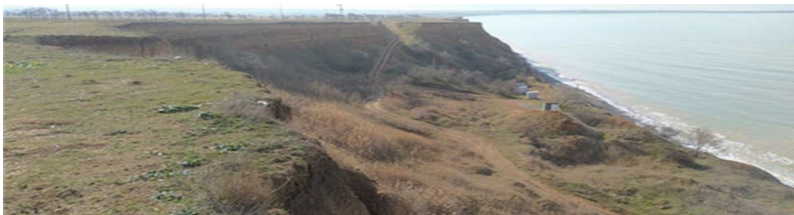
To the south, the coast is not fixed (Fig. 2) and has a pronounced abrasive character with landslides and landfalls. Actively retreating cliff up to 25 m high, composed of loam. There are traces of recent collapses, and there are also stabs and cracks in 1-3 m from the cliff edge. The few beams are filled with fine detritus material and form small beaches up to 9 m wide.

**Fig. 2** Abrasive-landslide bank to the south of the reconstruction site.

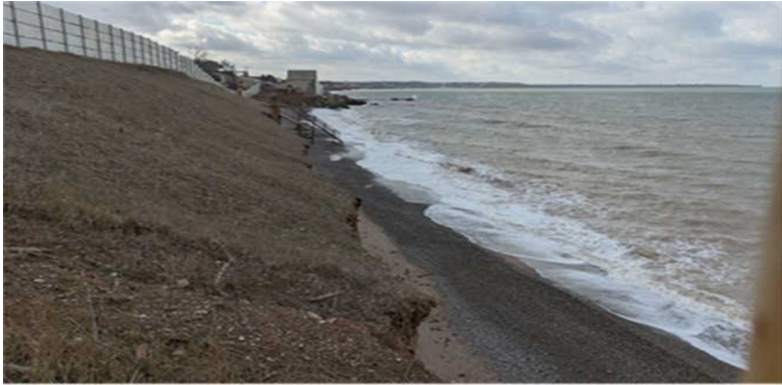
Within the boundaries of the village of Peschanoe, Bakhchisarai district, on the territory of the Rainbow boarding house, the width of the surface part of the beach is 12 m. The shore protection structures have been destroyed and dismantled; the natural retreating cliff on this site has a height of up to 6 m, and the edge of the cliff is very close to the boarding house fence, there is a threat of collapse of the soil masses (Fig. 3).

**Fig. 3.** Natural cliff on the site of destroyed shore protection structures in the area of the boarding house "Rainbow".

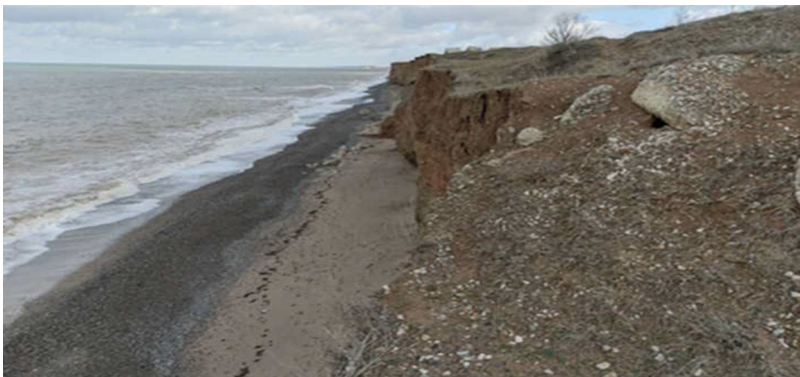
On the site of the recreation center "U Lukomorya" (Fig. 4), the beach is washed away, the beach material is completely washed away. The coastal fortifications were destroyed: to strengthen the shore, the marching slabs were stacked in the form of a breakwater wall; currently, the walls of the marching slabs and the embankment are destroyed, the building foundation is being eroded. The pier is destroyed. In the southern part of the site, the shore is being eroded, a section of the road is partially destroyed.

**Fig. 4.** A natural cliff on the site of destroyed shore protection structures in the area of the recreation center "U Lukomorya".

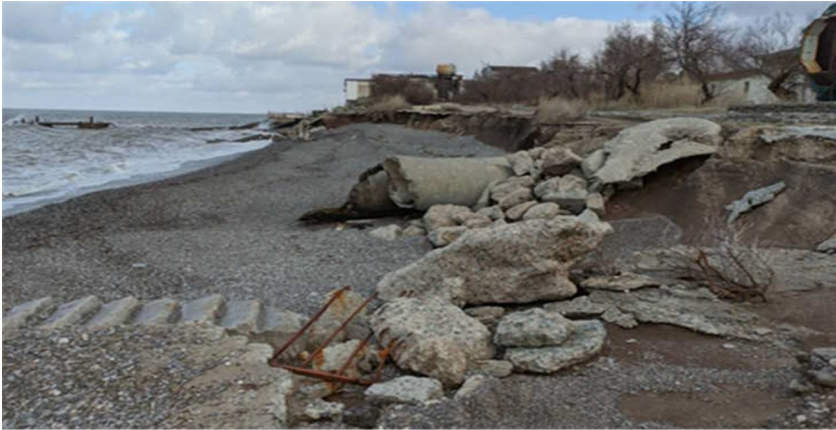
Further to the south of the studied section of the beach area in the area of the pioneer camp "Magarach", the coast is not protected. The coastal slope in the northern part of the site is subject to abrasion processes, there is a 2-2.5 m high cliff, as well as the access road destruction (Fig. 7). In the southern part of the site, the coastal slope is relatively smooth. The width of the beach in the surface part is 15 m.

**Fig. 7.** Active cliff in the area of the pioneer camp "Magarach".

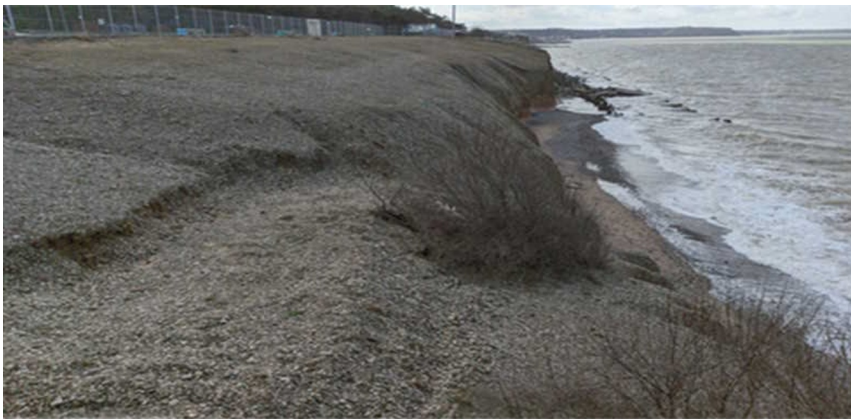
On the territory of public beaches, boarding house "Iskra", boarding house "Stroyindustria", boarding house "Minmontazhspetsstroy", boarding house "Volna" (Fig. 8) for 835 meters, the installations of shore protection structures were destroyed. The elements of the slope-stepped embankment collapsed into the sea (marching slabs, embankment covering blocks) and the retaining wall near the coastal slope formed a "talus" (5-7 m wide). Currently, the shore is not fixed in conditions of complete destruction of coastal protection; there are many abrasive niches at the base of the cliff, further destruction of the shore, landscaping elements, shedding and collapses of the soil. For recreational purposes, this section of the coast is not suitable, it is traumatic for people to stay on it.

**Fig. 8.** Destroyed coast protection in the area of the boarding houses "Iskra" of LLC "Ukrtelekom", the pioneer camp "Stroyindustria", shore protection structures of the public beach, boarding house "Minmontazhspetsstroy", boarding house "Volna".

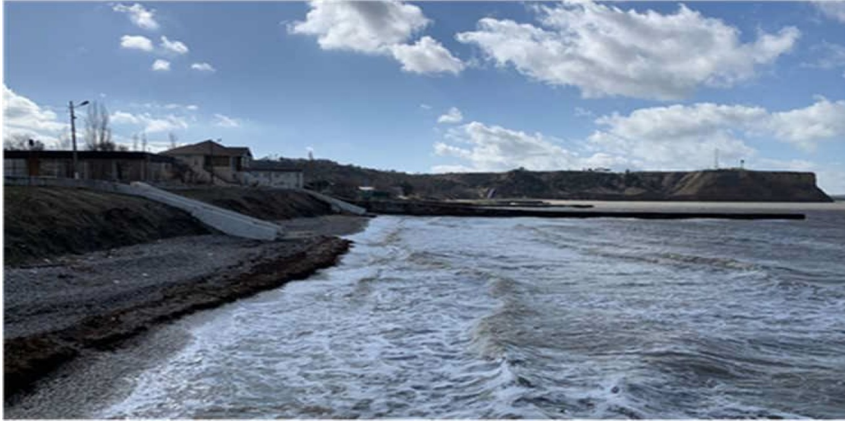
To the south, in the area of the boarding house "Peschanoye", the children's health camp "Yuzhny", the children's health camp "Peschanoye" (Fig.9), the beach is 6 to 16 meters wide in the surface part. The volume of the beach is insufficient to completely extinguish the wave effect. There are deep gullies in the root part of the groin No. 5, there is no filler in the chambers, corrosion of the groin metal structures occurs. No significant deformations were found in the shore protection structures, but there are surface defects. The base of the stairs to the beach is washed away, cracks are revealed on the side face.

**Fig. 9.** Coast protection of the boarding house "Peschanoe" and the children's health camp "Yuzhny".

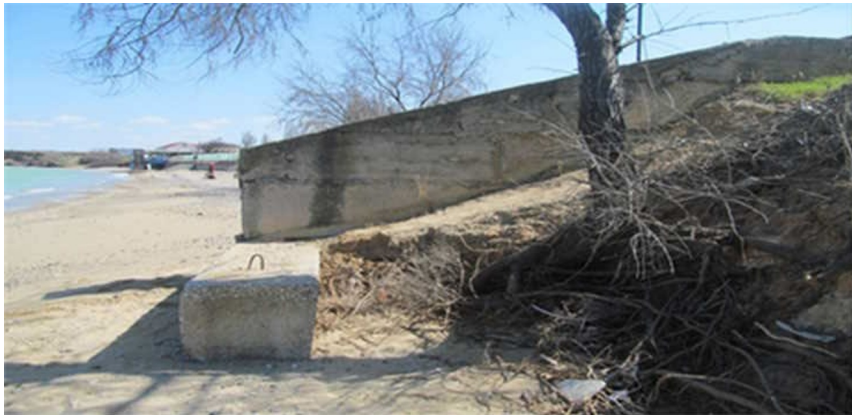
On the site of the recreational area of the village of Uglovoye coastal protection is a retaining wall with buttresses made of monolithic reinforced concrete (Fig. 10).

**Fig. 10.** Coast protection of the village of Uglovoye.

The width of the surface part of the beach in some areas reaches 20 meters. At the same time, the presence of calcareous monoliths in the underwater part of the sea near the village of Uglovoye was previously revealed. The formation of underwater elevations by 1-3 m leads to the transformation of the shore and waves – a change in their internal structure and external shape along the route [15] and according to the results of the survey of these sites it can be concluded that the identified process of formation of underwater elevations leads to the preservation of the beach width in this place.
